2/6/2019

TOWN OF LOS GATOS  
PLANNING DIVISION

Re: Arborist Addendum for Proposed Driveway at 16 Chestnut Ave. in Los Gatos

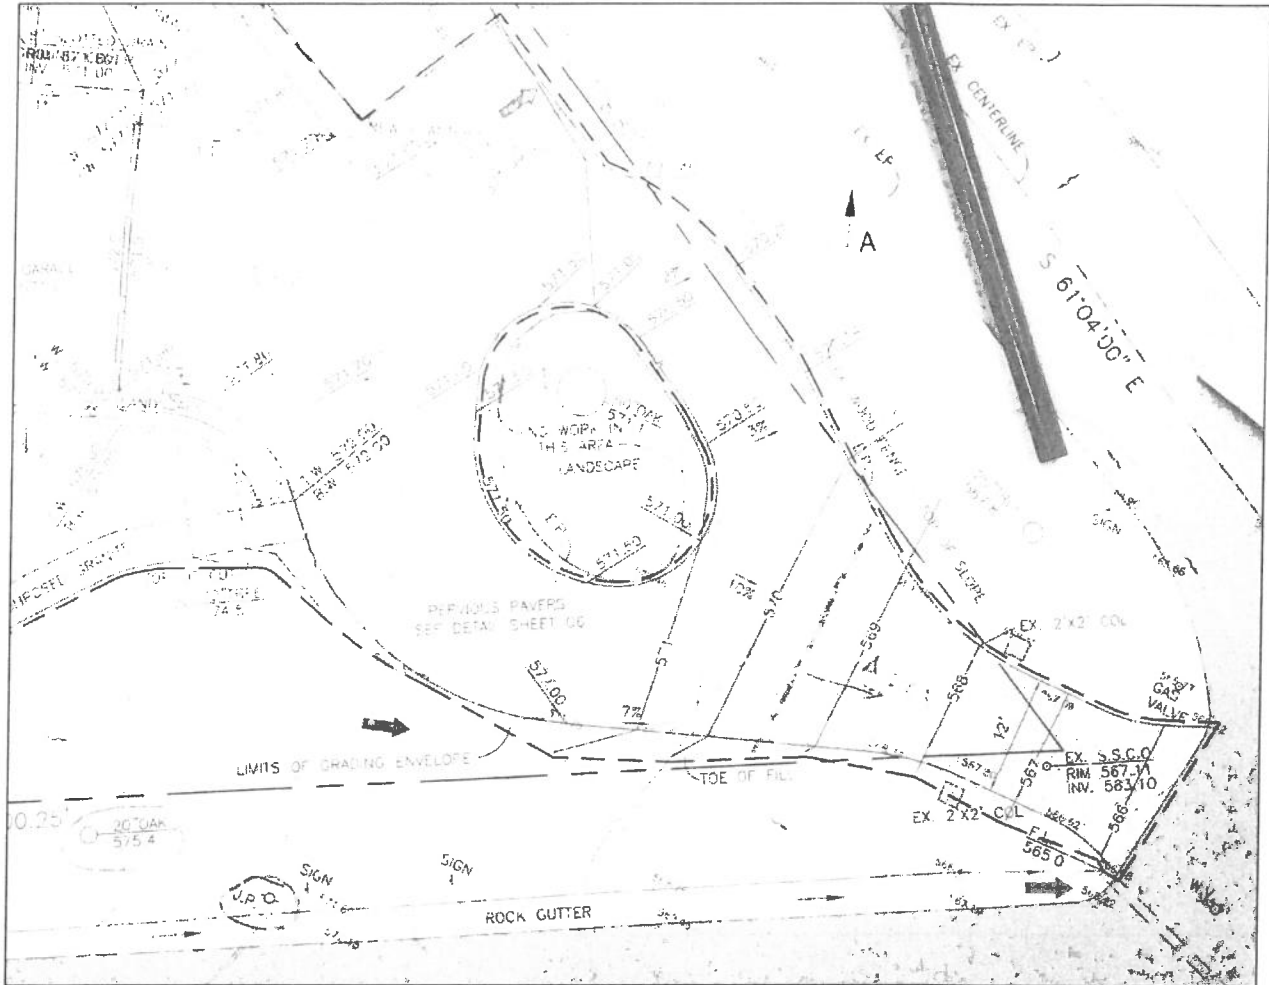
**Figure 1: driveway configuration option #1, retaining approximate original footprint**

#### ***Footprint option 1: similar to existing (Figure 1)***

The driveway footprint recommended by the construction team is largely the same as the existing footprint. The bare dirt area around the trunk would be expanded slightly. No grading would be needed immediately around the tree, and the existing sub base for the existing asphalt would remain in place, to be re-compacted and used for the new driveway material. A small amount of fill and additional sub base would be necessary in portions of the driveway between the tree and the street.

1. If feasible, implement option 1B for driveway installation: retain approximately the existing footprint, and use crushed rock for the new driving surface. Option 1A is also acceptable: retain approximately the existing footprint, and use pervious pavers for the new driving surface.

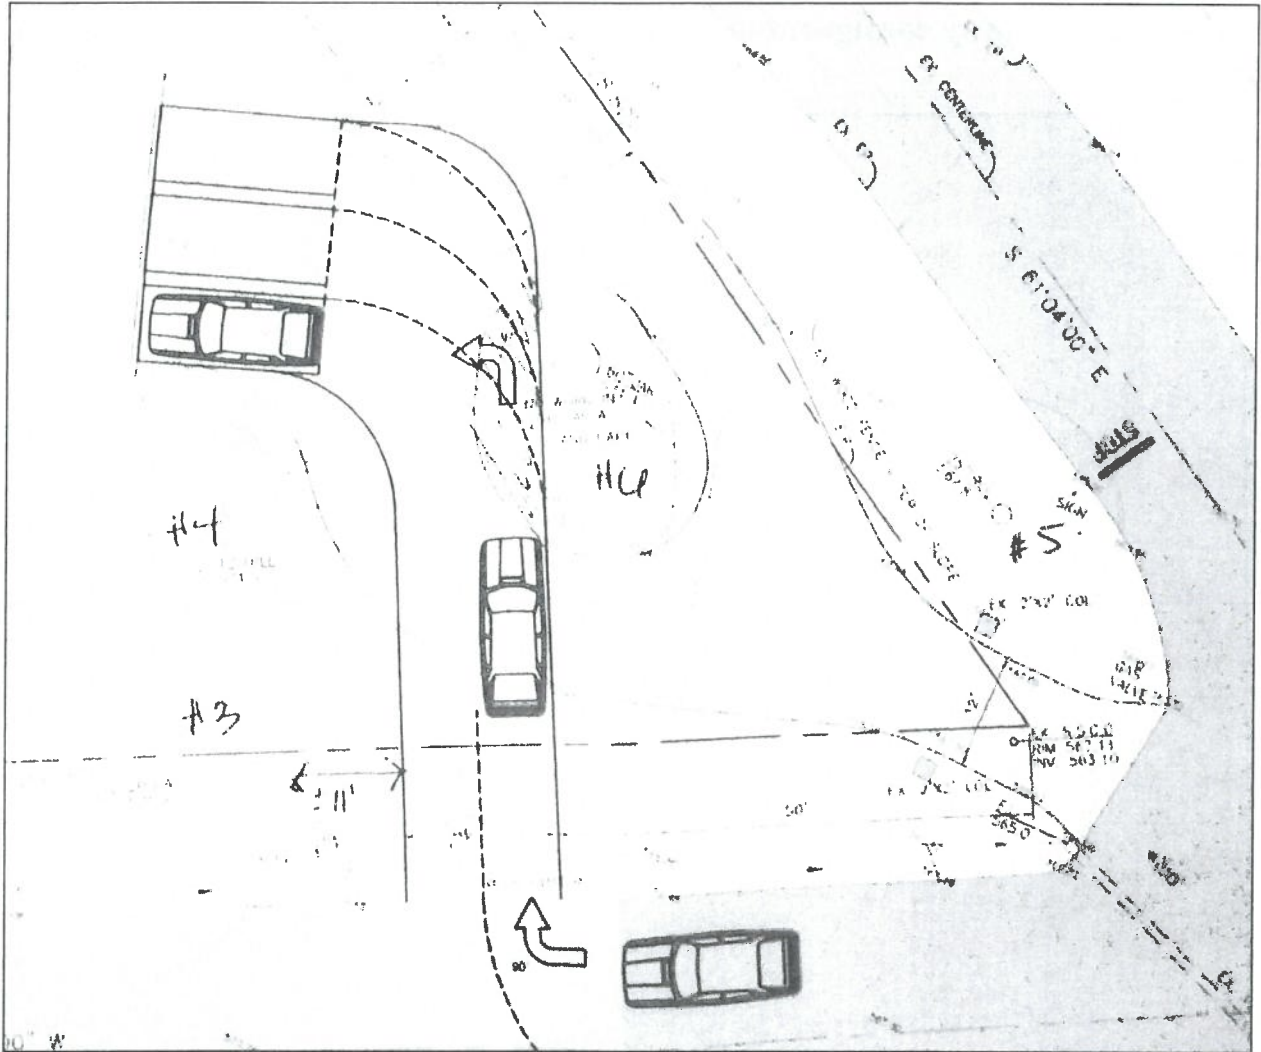
**Figure 2.1: driveway configuration option 2 (first version)**

#### ***Footprint option 2: entry from Chestnut Ave. (Figures 2.1 and 2.2)***

Reconfiguring the driveway to enter from Chestnut Avenue would require substantial grading in all areas. It would also require bringing the edge of pavement closer to tree #6, resulting in substantial root loss. Two versions of this option exist, both with the same issues.

The project engineer does not recommend this option, as it may create conflict between the driveway and underground utilities.

2. If driveway options 2 or 3 are used (entry from Chestnut Ave. or Hernandez Ave., respectively), remove tree #6 prior to making grading cuts.

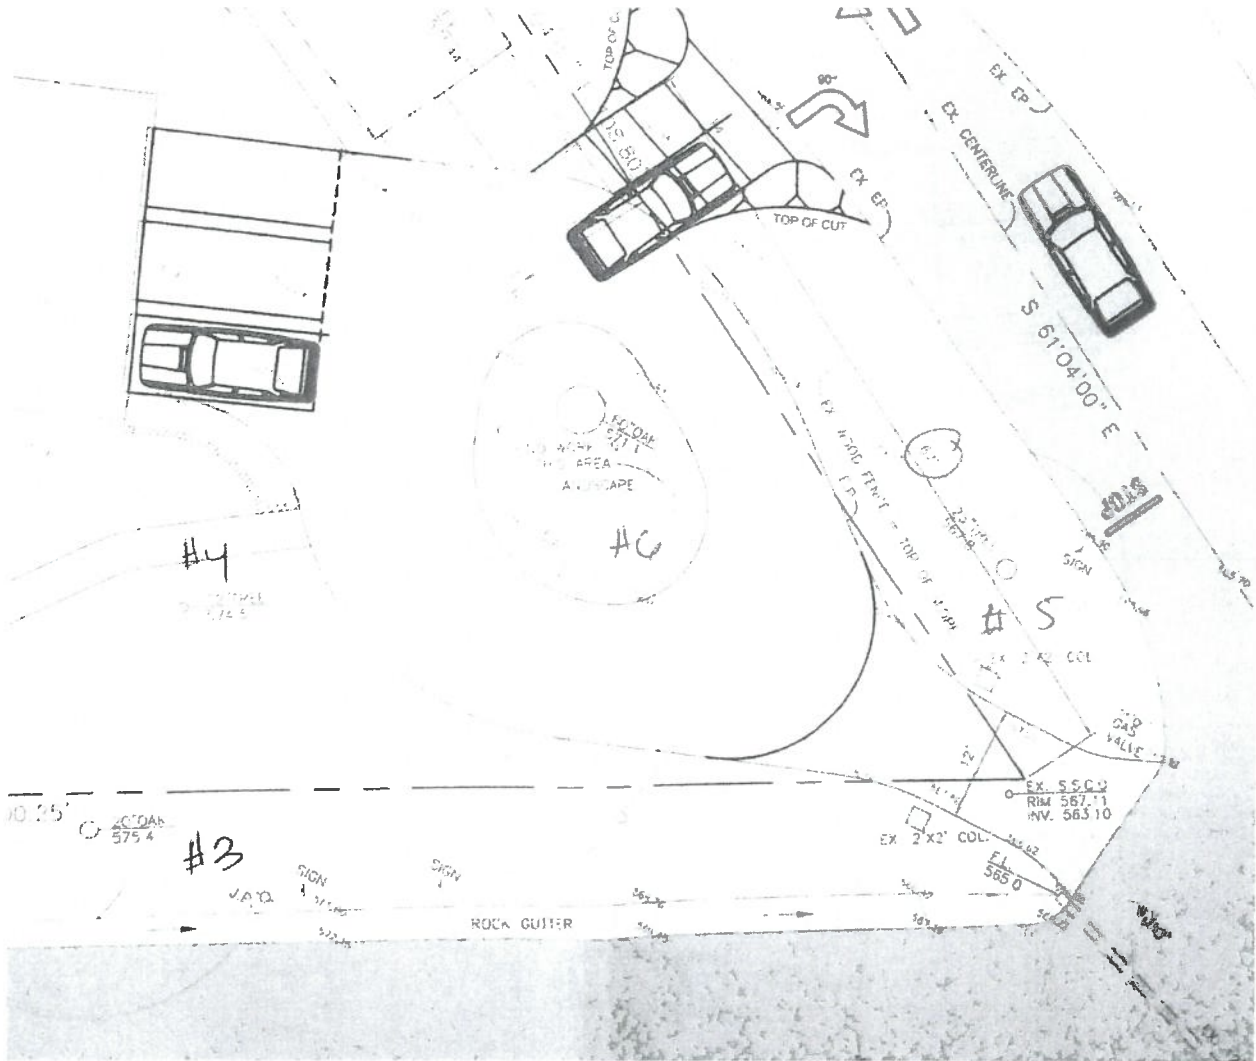
**Figure 3: driveway configuration option #3, with entry from Hernandez Avenue**

***Footprint option 3: entry from Hernandez Ave. (Figure 3)***

Reconfiguring the driveway to enter from Hernandez Avenue would require substantially more grading than entering from Chestnut Avenue. Because the existing grade change is so great, it is unclear whether it would even be possible to implement this footprint safely.

This driveway footprint would require bringing the edge of pavement closer to tree #6.

The project engineer does not recommend this option, as the existing grade change and poor visibility would make vehicle ingress and egress difficult and potentially dangerous.

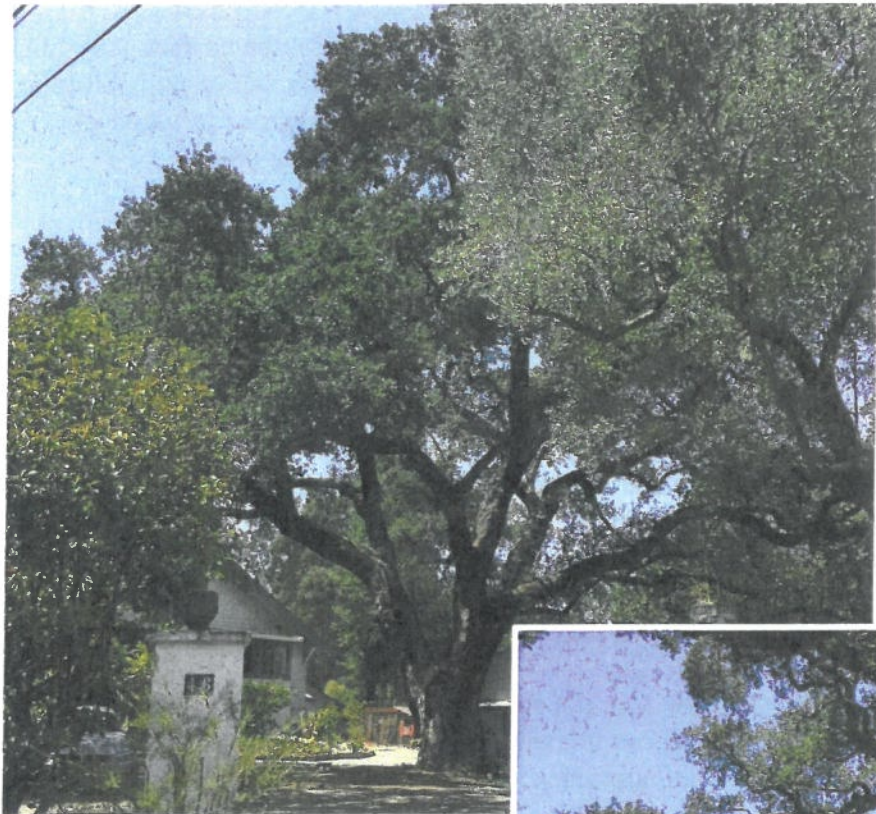
**Image 1: tree #6 (from my original arborist report)**

***Tree health and critical root zone (Image 1)***

Tree #6 is in poor condition. It appears over mature, with low vigor. Its critical root zone encompasses nearly the entire driveway area, and a substantial distance beyond. For a more detailed analysis of this tree's condition, please see the Tree Protection Report for this project.

Thin canopy  
for species

- a. Follow all care and protection measures recommended for tree #6 in the Tree Protection Report for this project.
  - b. After construction is complete, perform root zone remediation in all unpaved areas within the CRZ of tree #6, as recommended in the Tree Protection Report:

1. Decompact the soil with an air spade,
    2. Incorporate compost into the soil with the air spade, and
    3. Spread wood chips over the top of the decompacted soil to a depth of 3-6 inches.

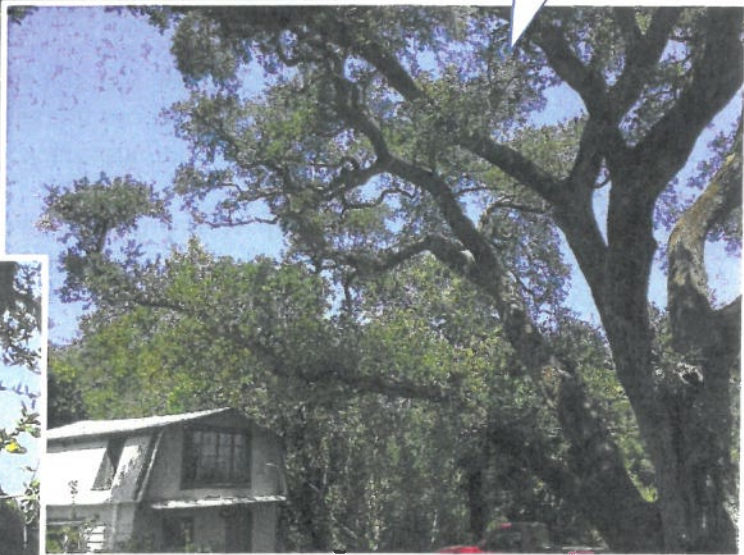
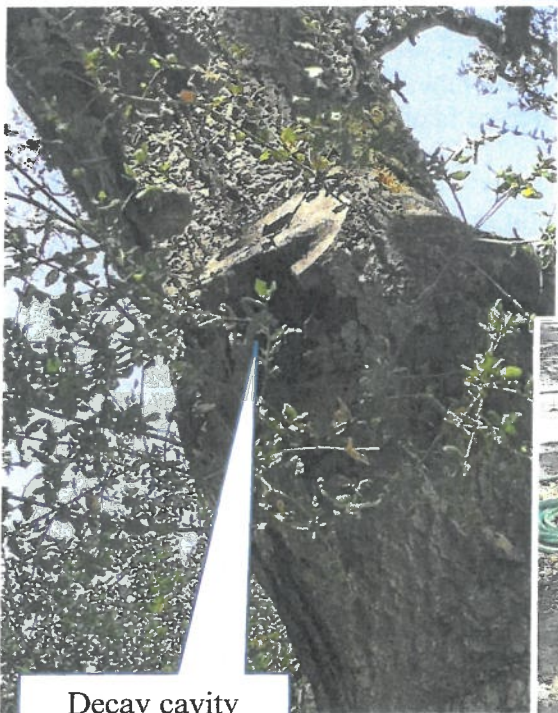
Decay cavity  
with little  
reaction growth

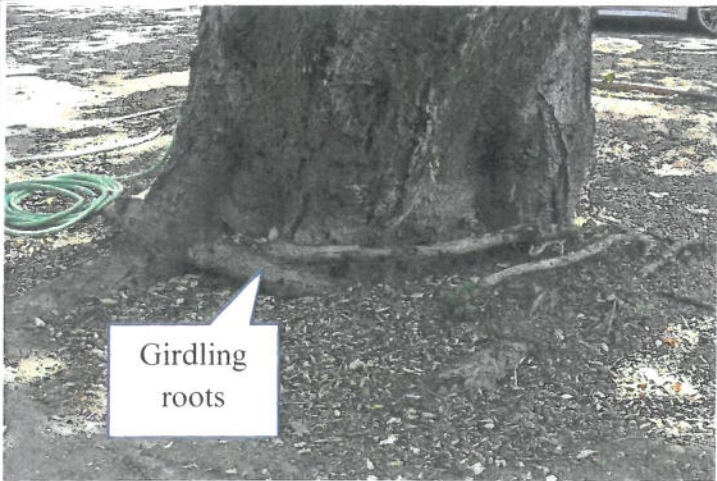
Girdling  
roots
