03/06/2024

Arborist Report

Client: Live Oak Associates - Attention: Katrina Krakow

Site: 50 Los Gatos-Saratoga Rd, Los Gatos CA

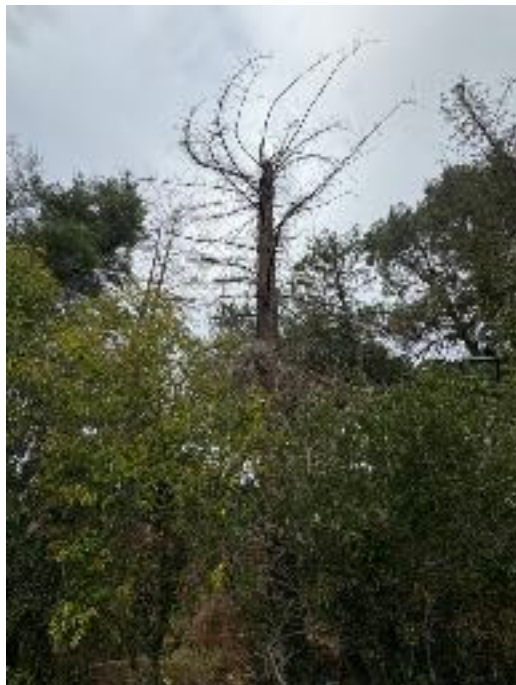
Tag 4836: Dead

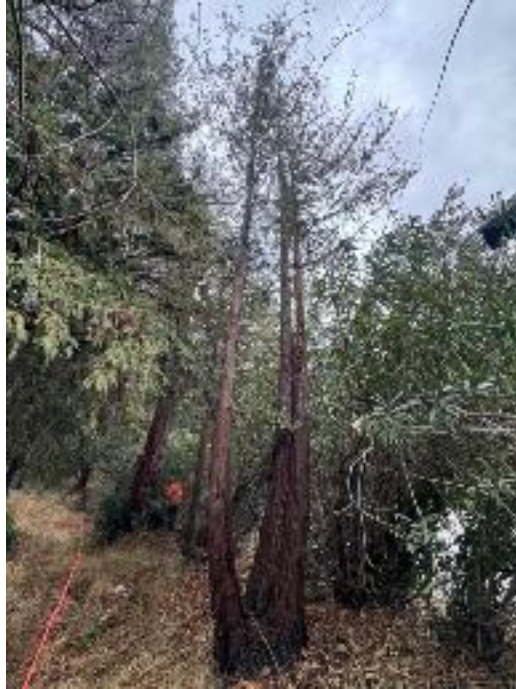
Tag 4837: Second upright growing out of trunk flare.
Included bark noted between uprights of main stem.

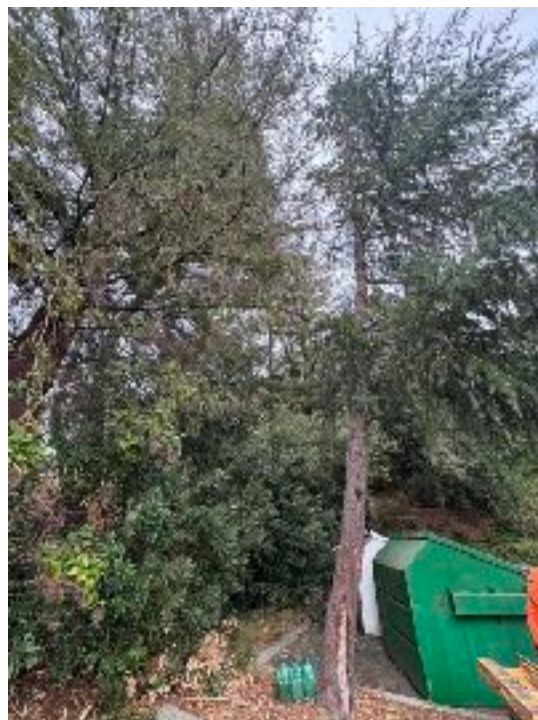
Tag 4840: Canopy is growing to the west due to competition with neighboring Redwood.

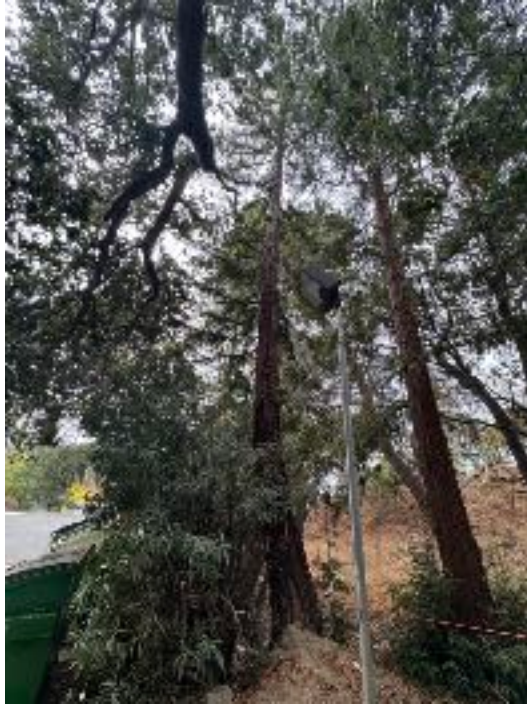
Tag 4841: Tree is in fair condition due to drought stress.
Construction materials - sand and sediment placed around base of the tree.

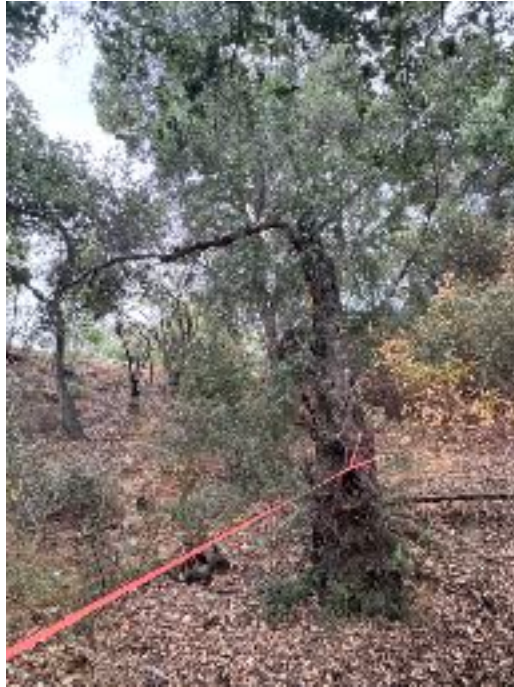
Tag 4843: Extensive decay in the main stem.
Loosing heartwood, inevitable death.

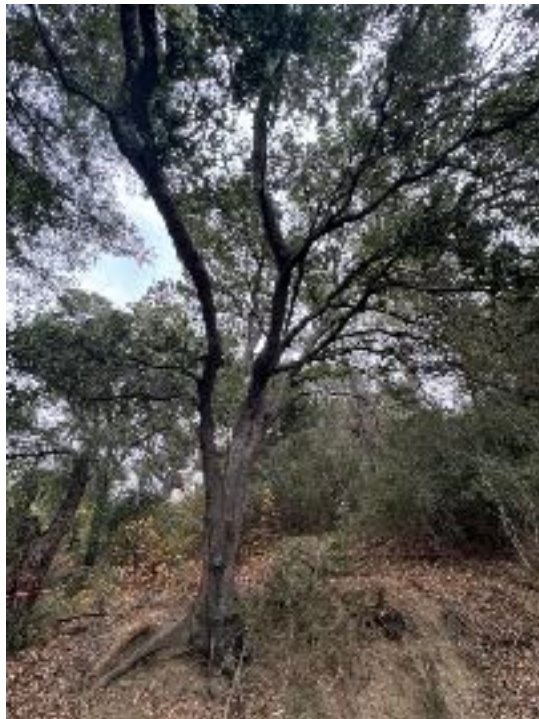
Tag 4844: Root ball is exposed on the northwest side of the tree.

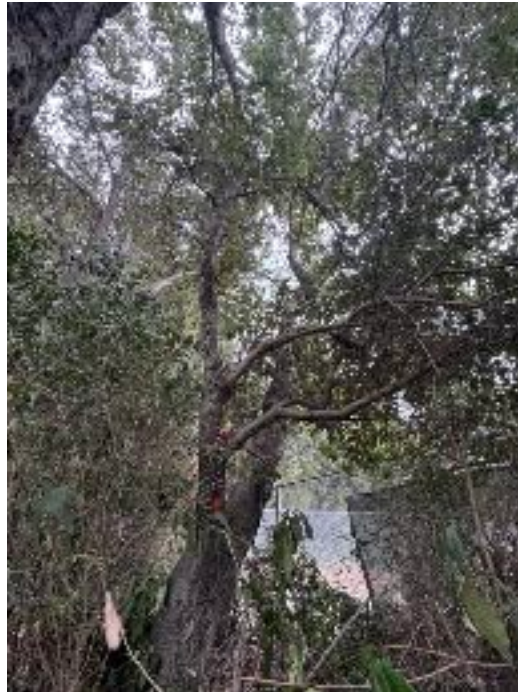
Tag 4845: Poor anchorage and connection at the base of the main stem which can lead to breakage and ultimately failure of the tree.

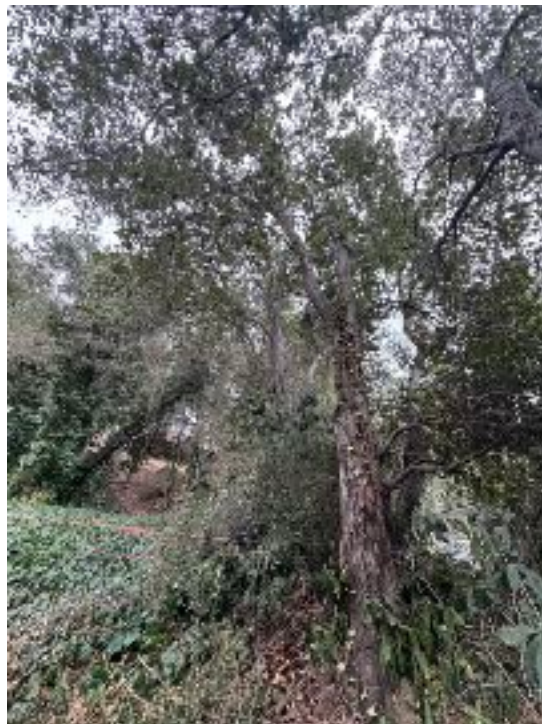
Tag 4846: Ivy growing up main stem.
Exposed root ball - poor anchorage.

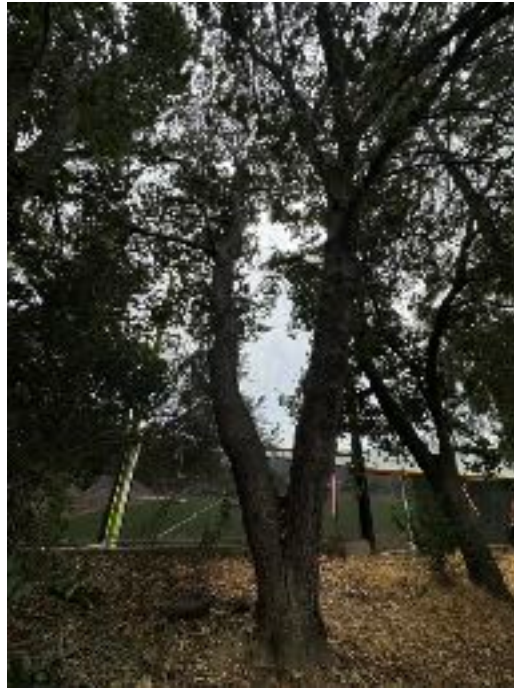
Tag 4847: Poor connection of uprights with included bark and evidence of decay on main uprights.

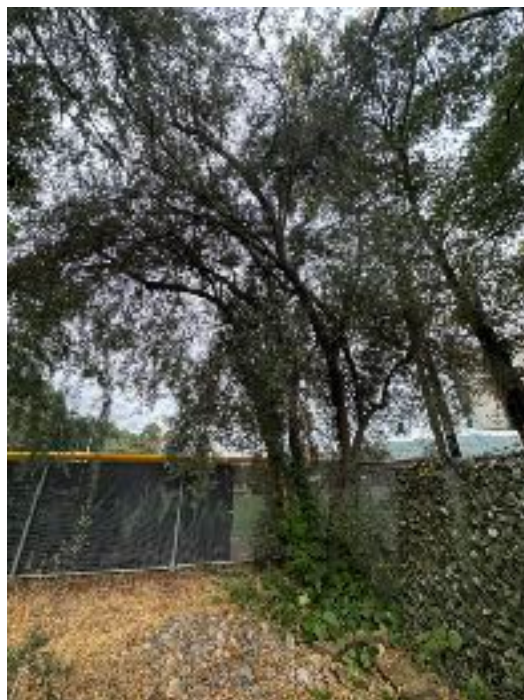
Tag 4850: Ivy growing on multiple uprights.
Decay pockets noted in multiple uprights.

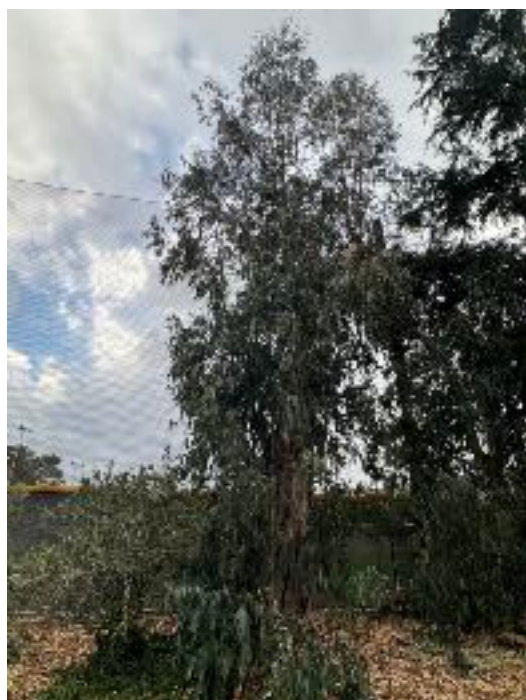
Tag 4856: Multiple epicormic shoots growing from root flare.
Tree has been pollarded.

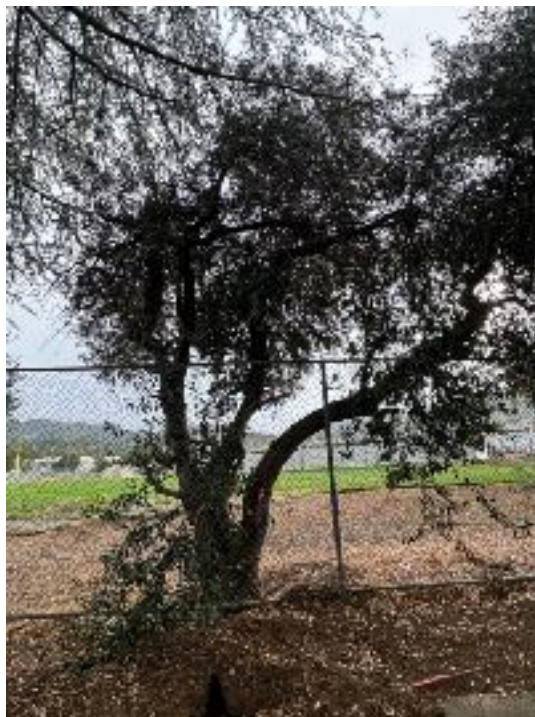
Tag 4872: Large dead vine still attached to main upright.
Located on adjacent lot, touching fence of property line.
Large holes noted around the root ball.

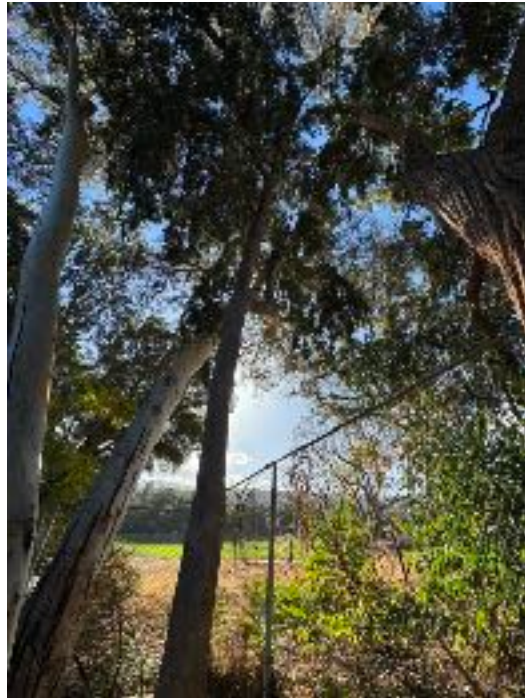
Tag 4881: Canopy is converging with neighboring trees.

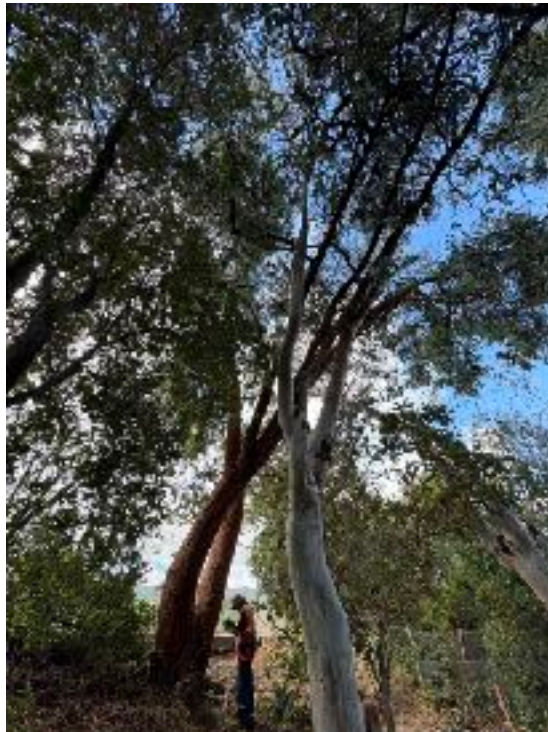
Tag 4892: Canopy branches are growing through and fusing to branches of canopies of two neighboring eucalyptus trees.

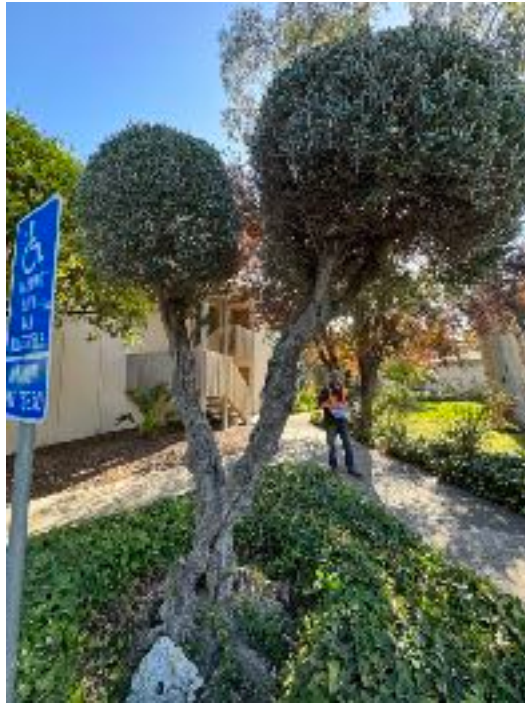
Tag 4906: Significant decay noted in the root flare and main stem.

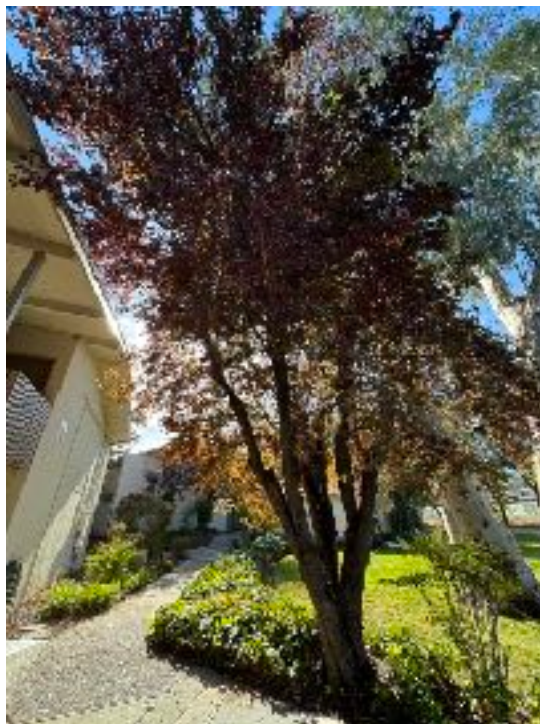
Tag 4907: Significant deadwood noted in canopy. Canopy branches are growing into roof.

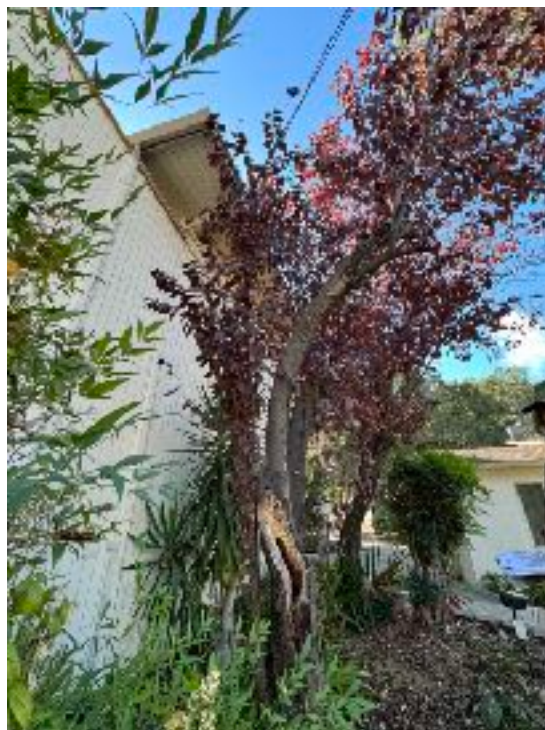
Tag 4909: Major decay in main stem and uprights have compromised structural integrity, death is inevitable.

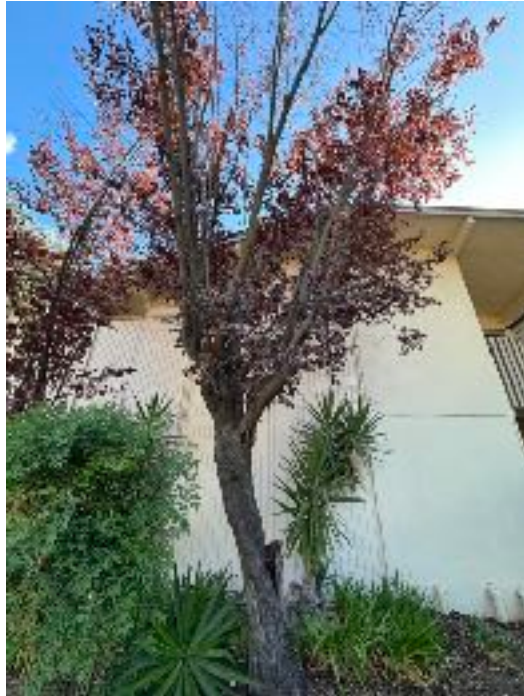
Tag 4910: Major decay in main stem has compromised structural integrity, death is inevitable.

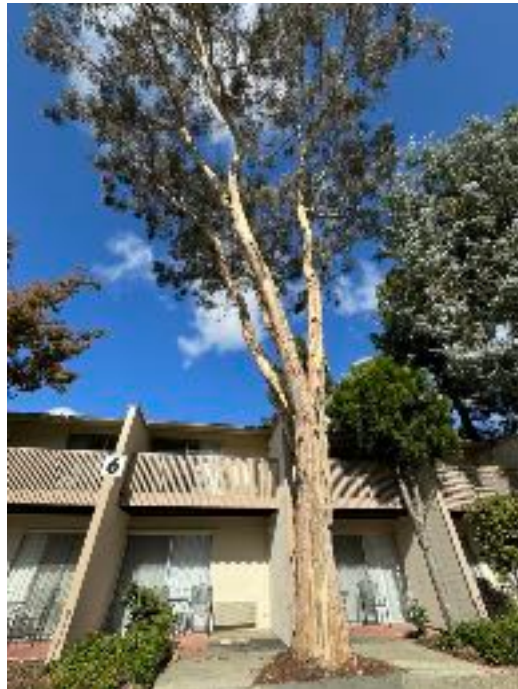
Tag 4912: Canopy of the tree is growing over property structure, large amounts of end weight in upright growing over property. If a failure was to occur, this tree could pose a threat to property or people.

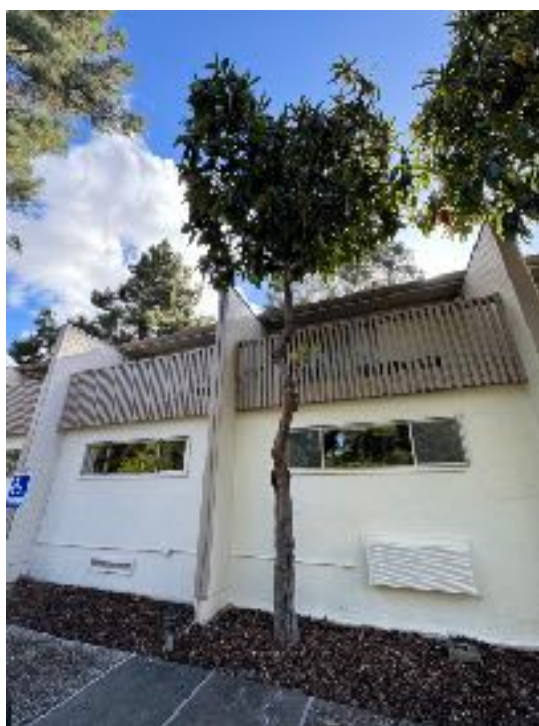
Tag 4917: Evidence of secondary upright recently split and broke off of the tree.

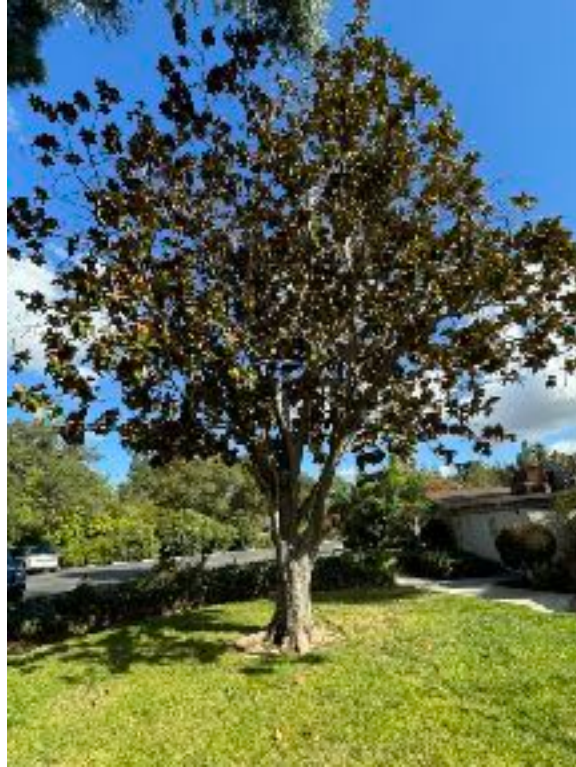
Tag 4922: Moderate die back noted in canopy.

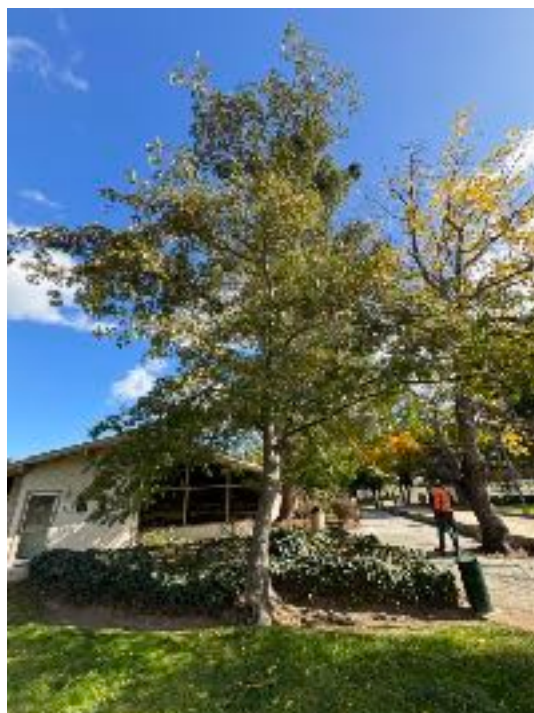
Tag 4923: Decay noted in the root flare and poor anchorage which could lead to failure.

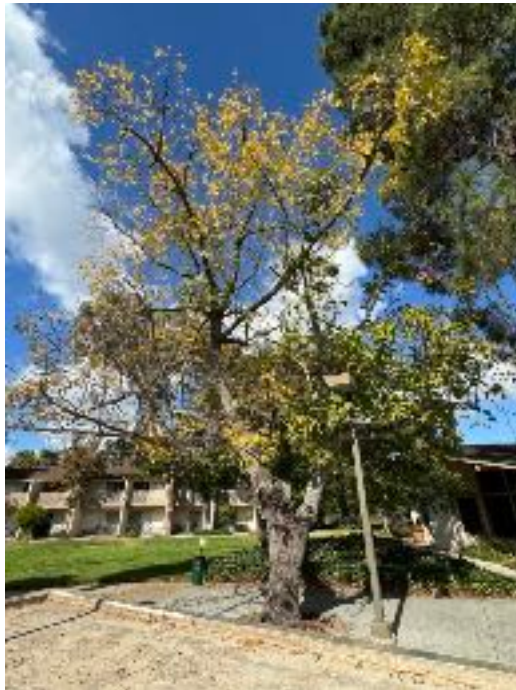
Tag 4924: Significant decay from old cut in main upright.

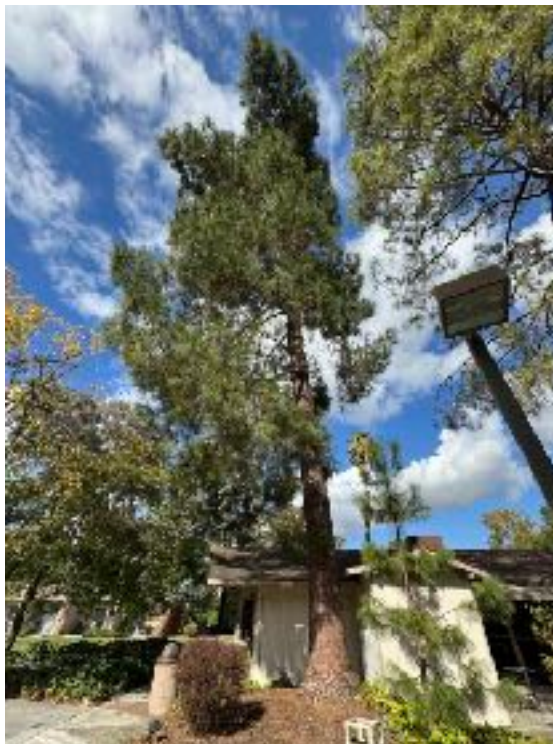
Tag 4925: Significant weight in branches of the upper canopy, and close proximity to property structure.

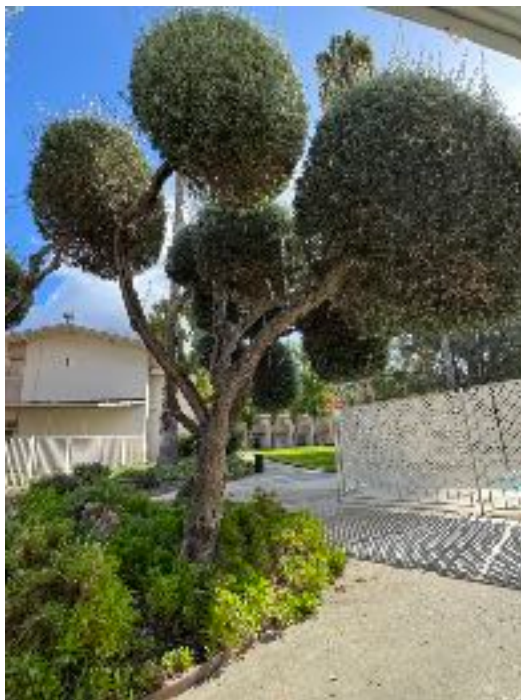
Tag 4937: Decay noted on main stem and main uprights.

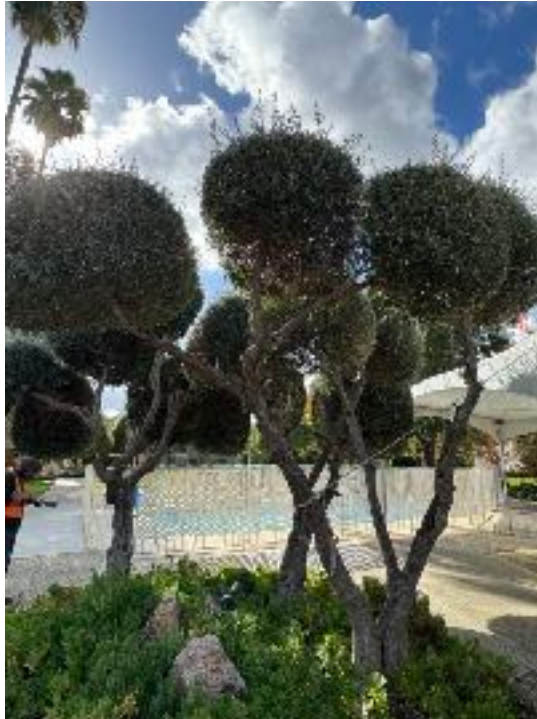
Tag 4938: Decay noted on main stem and main uprights.
Included bark between two main uprights.

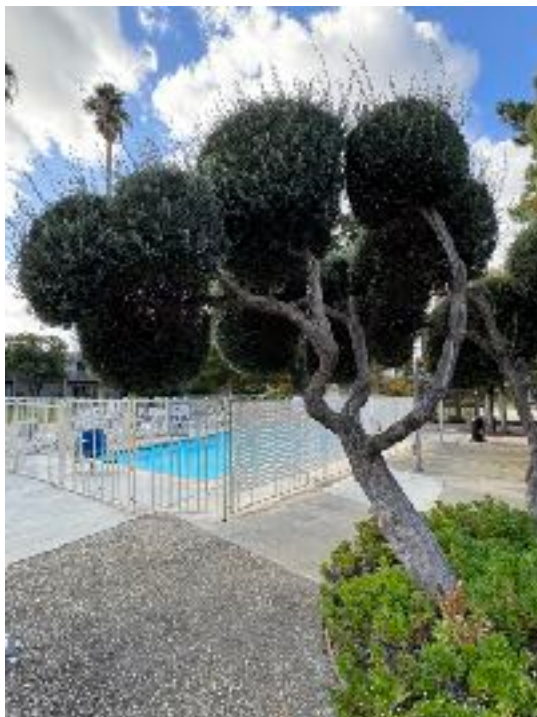
Tag 4939: Decay noted on main stem and main uprights.

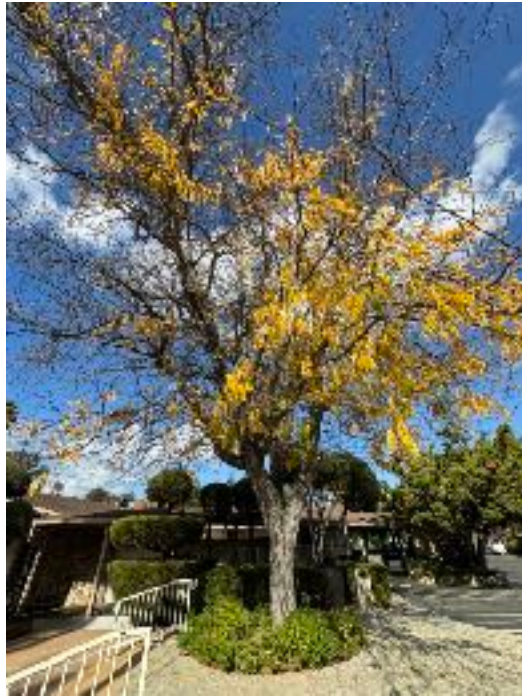
Tag 4942: Canopy is very dense, moderate deadwood noted in the canopy.

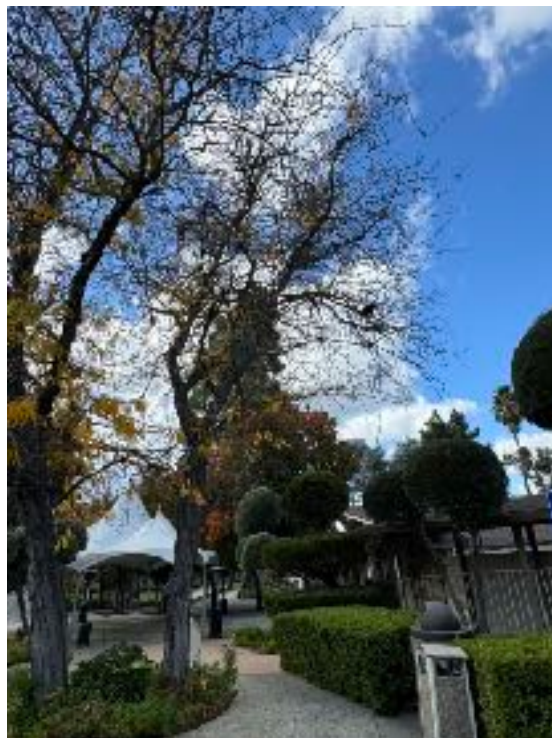
Tag 4943: Canopy is very dense, moderate deadwood noted in the canopy.

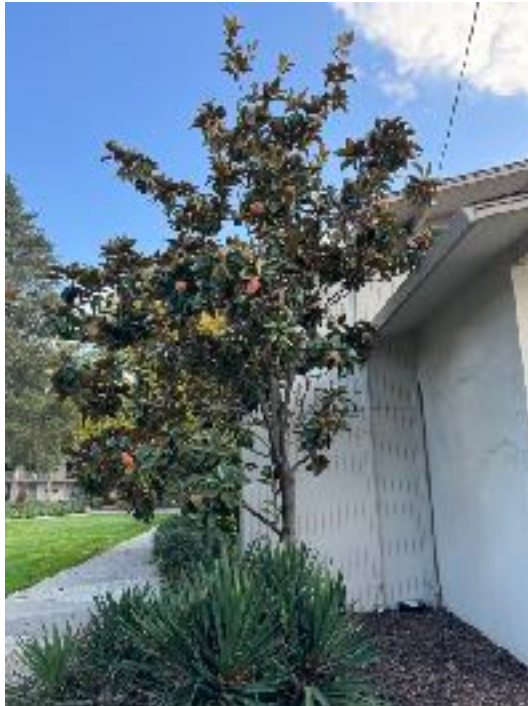
Tag 4956: Minor deadwood noted in canopy.
Branches in contact with roof.

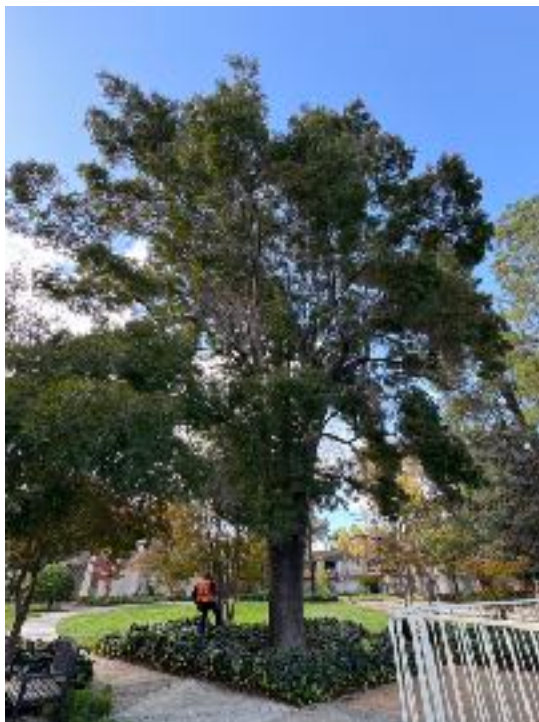
Tag 4957: Significant deadwood noted in canopy, overlapping branches of secondary growth.

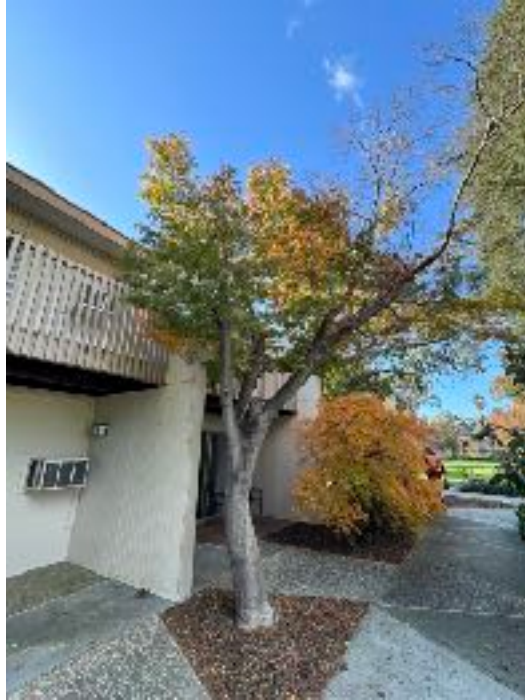
Tag 4980: Significant deadwood and decay noted in upper canopy limbs, as well as decay and fruiting bodies noted on main upright.

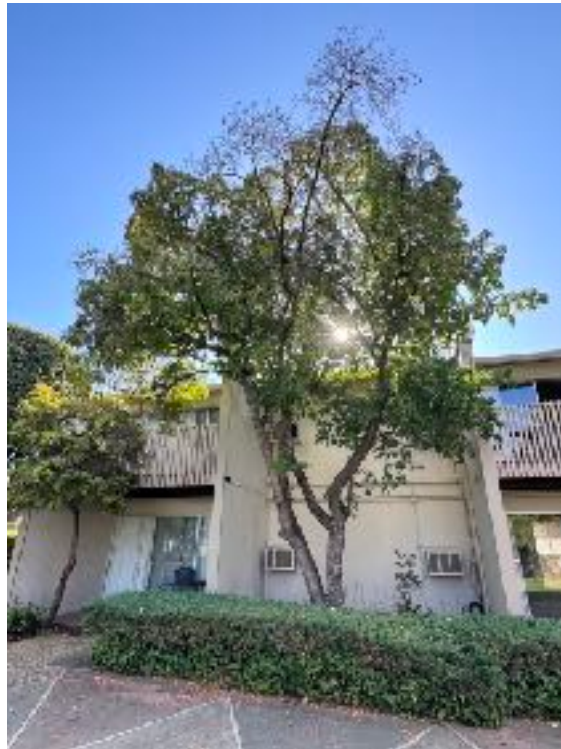
Tag 4986: Minor die back noted in canopy.

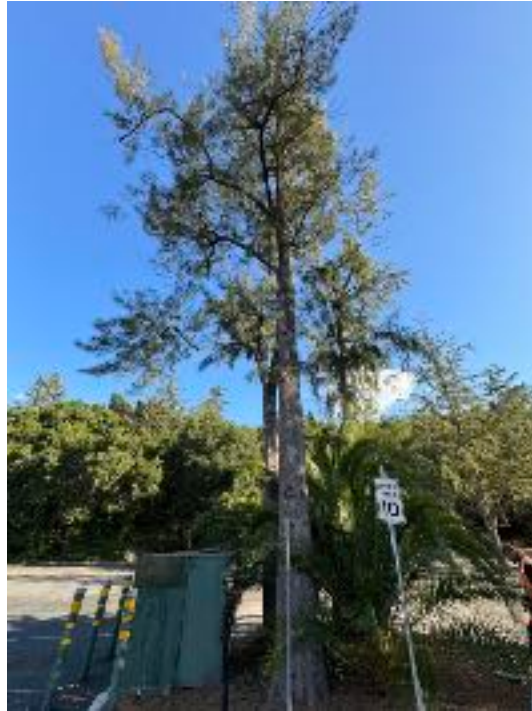
Tag 5002: Moderate die back noted throughout canopy from drought stress.

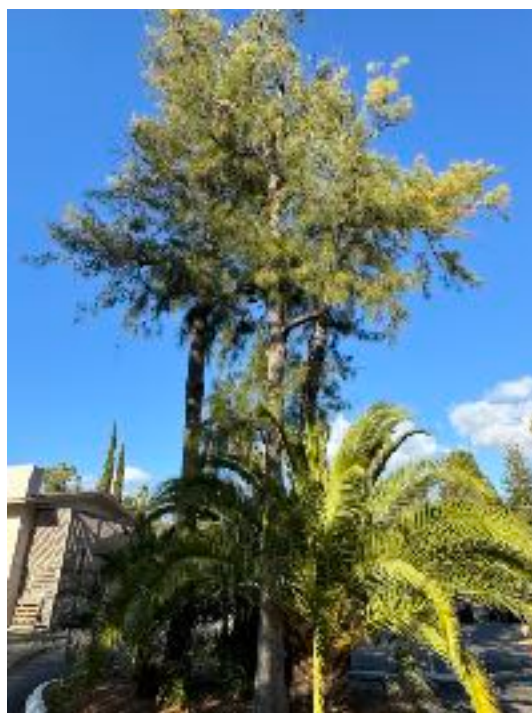
Tag 5003: Moderate die back noted throughout canopy from drought stress.

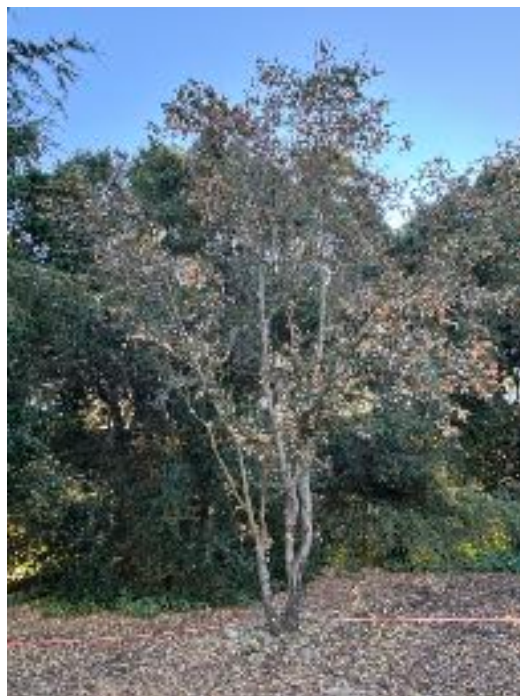
Tag 5007: Significant canopy dieback.

Fungal infection is causing the tree's decline.

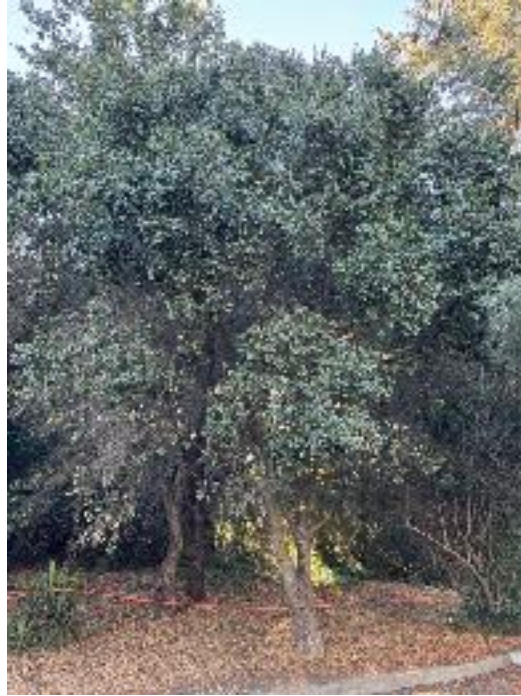
Tag 5008: Moderate deadwood noted in the canopy.
Slight mechanical damage on northwest side of the trunk.

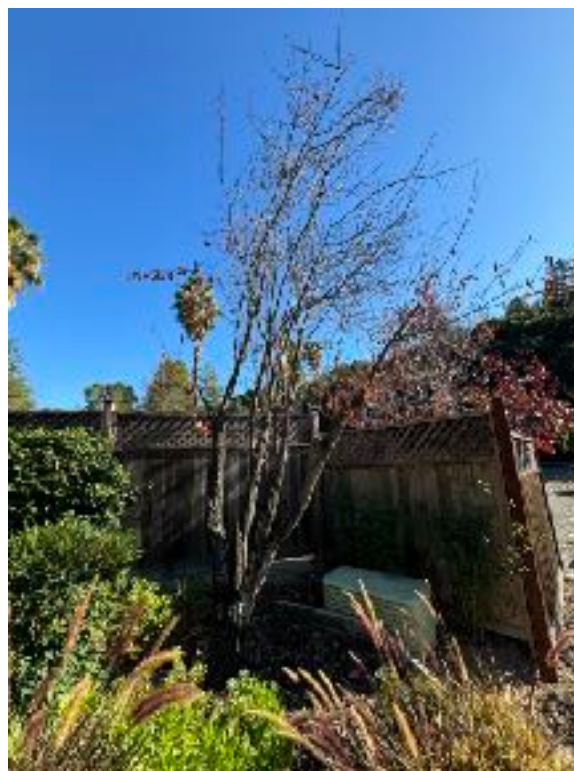
Tag 5027: Dead

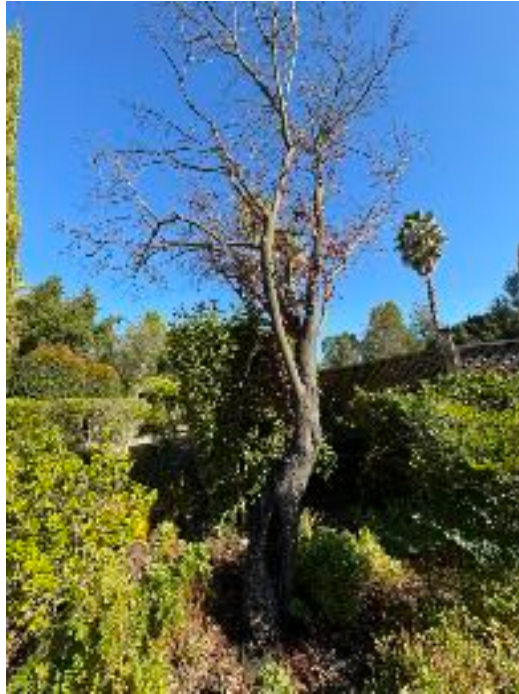
Tag 5028: Major decay on main-stem.
Death is imminent.

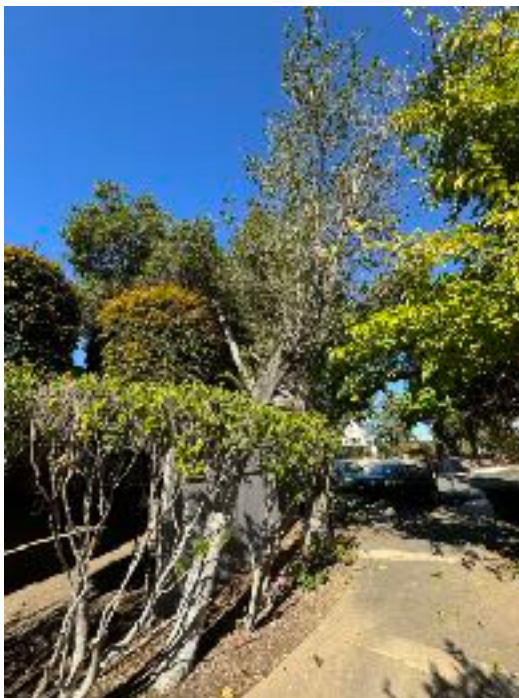
Tag 5029: Location is a poor for the health of the tree and surrounding trees.
Canopy is growing at a northward lean.

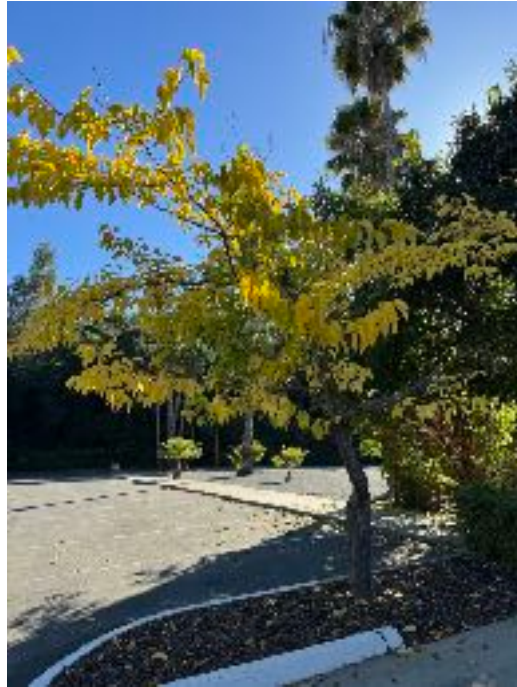
Tag 5032: Significant decay noted on trunk, larger co-dominant upright has been removed years ago and the wound is decaying.

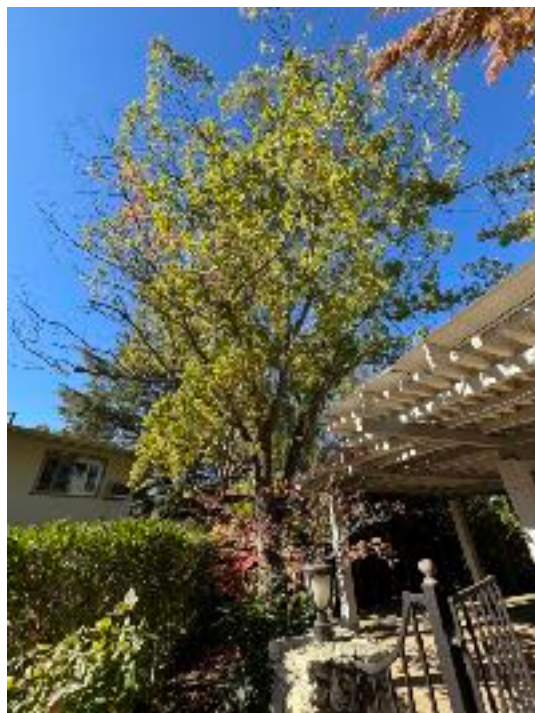
Tag 5040: Moderate die back noted in canopy.
Poor connection at first main crotch.
Canopy growing over roof of adjacent structure.

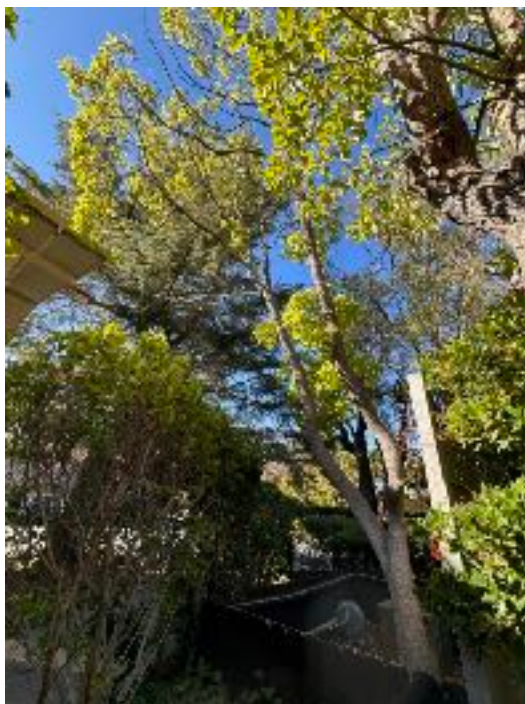
Tag 5042: Tree is approximately 4ft from property PG&E utility apparatus.
Canopy branches are close to roof of adjacent structure.

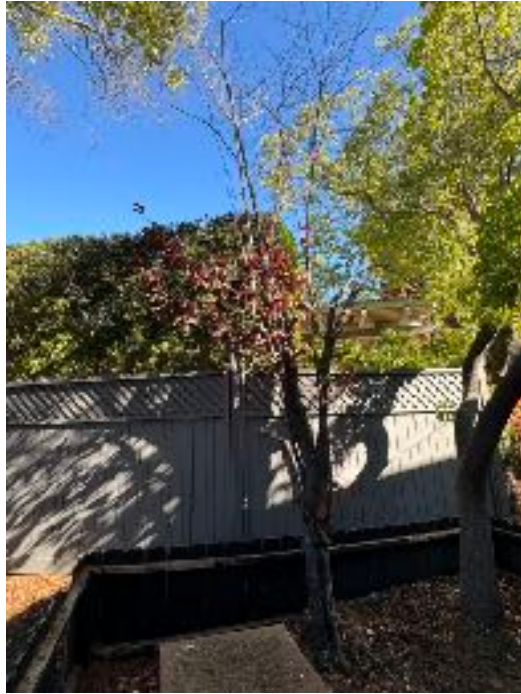
Tag 5043: Significant decay noted in main-stem of tree, death is imminent.

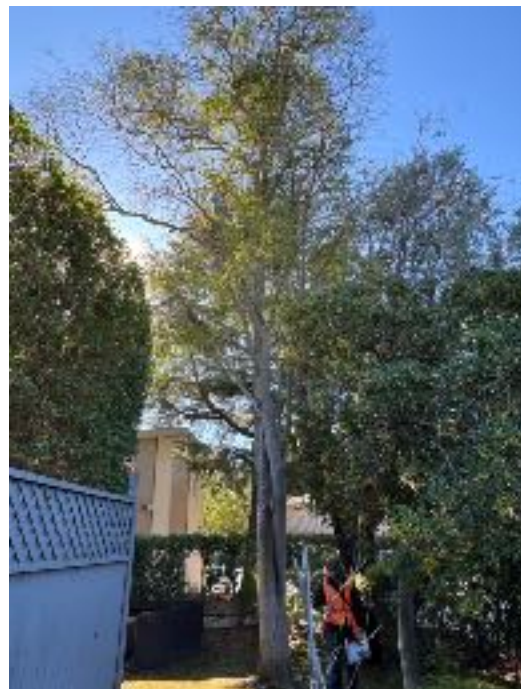
Tag 5044: Co-dominant uprights are fused together resulting in poor attachment.

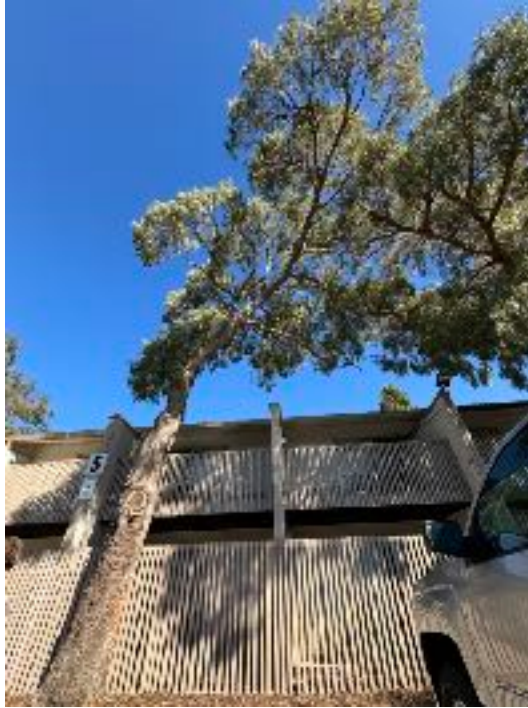
Tag 5049: Trunk is growing in contact with property patio fence, canopy limbs are extending over roof of adjacent structure.

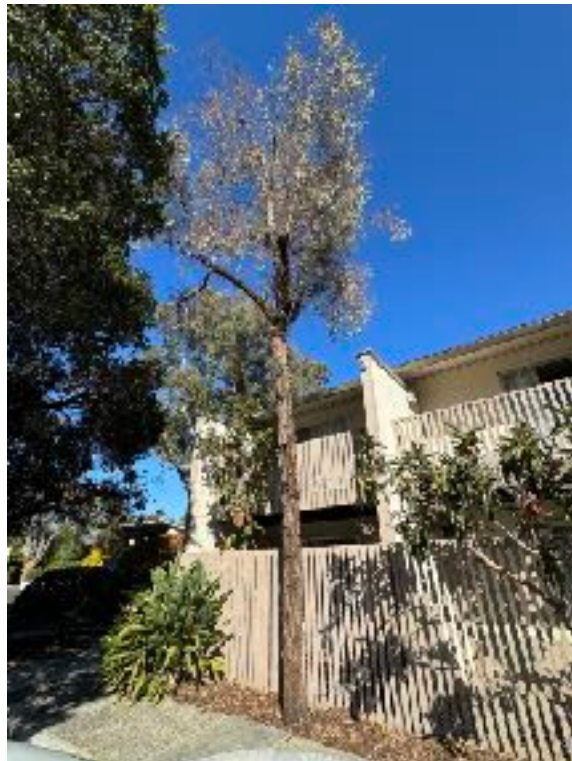
Tag 5050: Sparse foliage in canopy, minor die back noted.

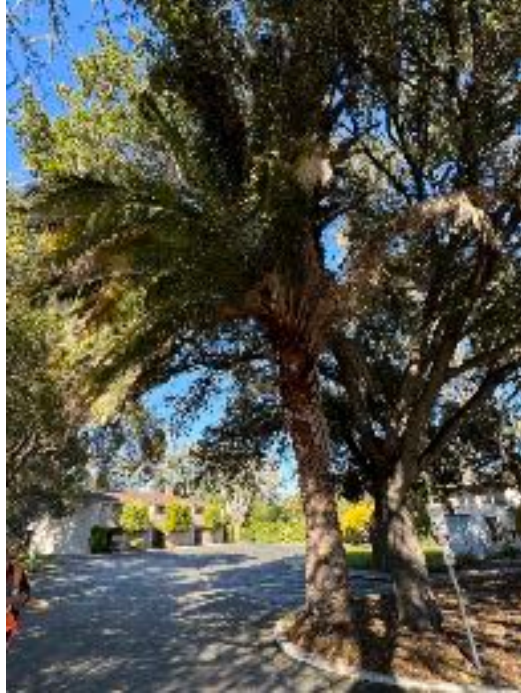
Tag 5053: Tree is being pushed over by neighboring oak tree.
Canopy is only growing on southwest side due to lack of sunlight.

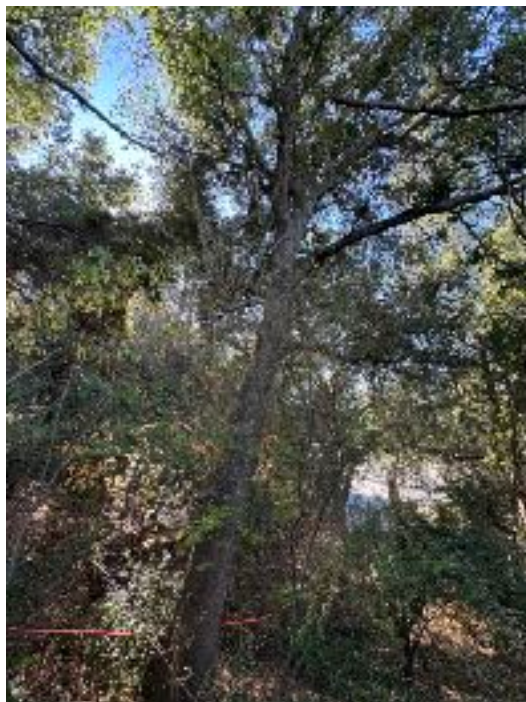
Tag 5054: Minor die back noted in upper canopy.

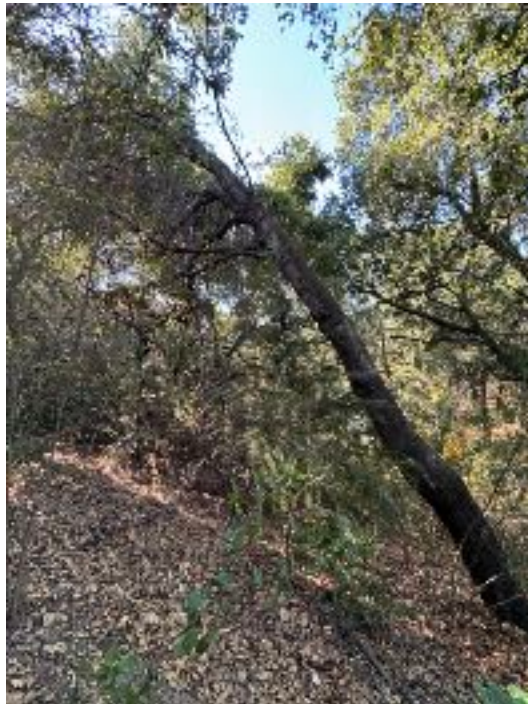
Tag 5055: Significant lean to the south, due to competition for light by neighboring oak trees.

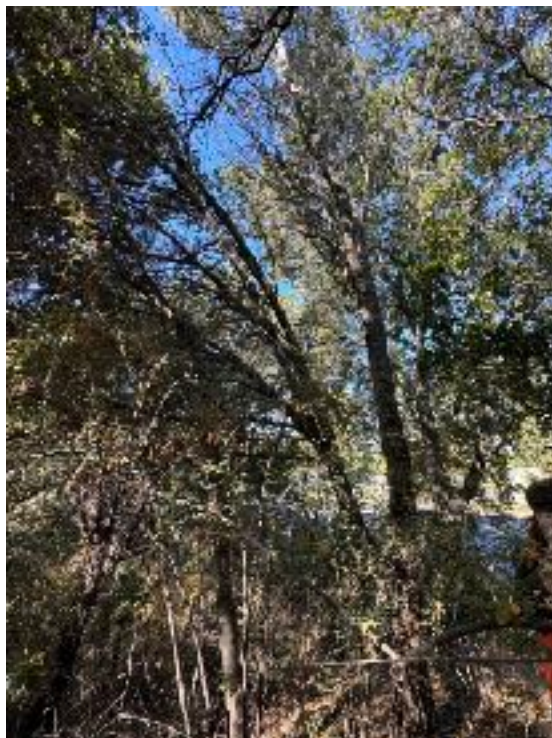
Tag 5058: Moderate deadwood in upper canopy. Dead limb noted in upper canopy.

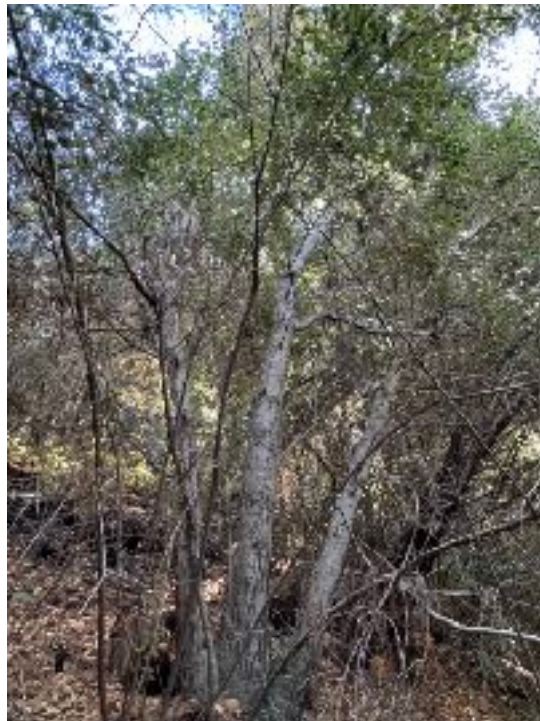
Tag 5071: Dead rounds of old palm near base.
Included bark between co-dominant uprights.

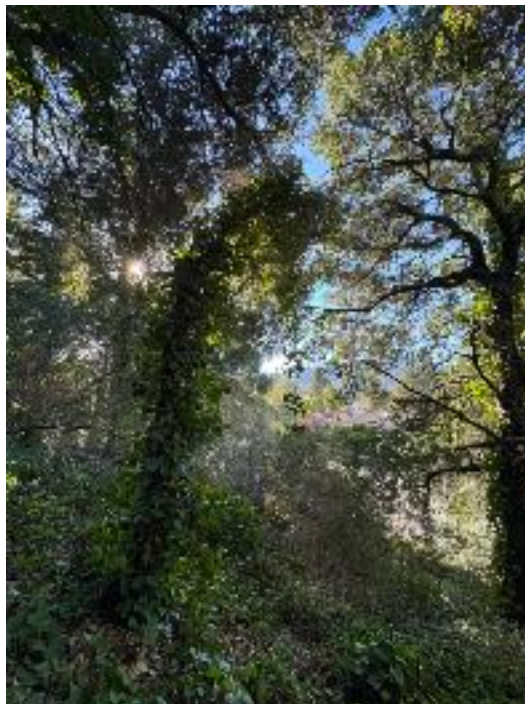
Tag 5078: Ivy growing up main stem up until upper canopy, tree has a significant lean to the west due to competition for light.

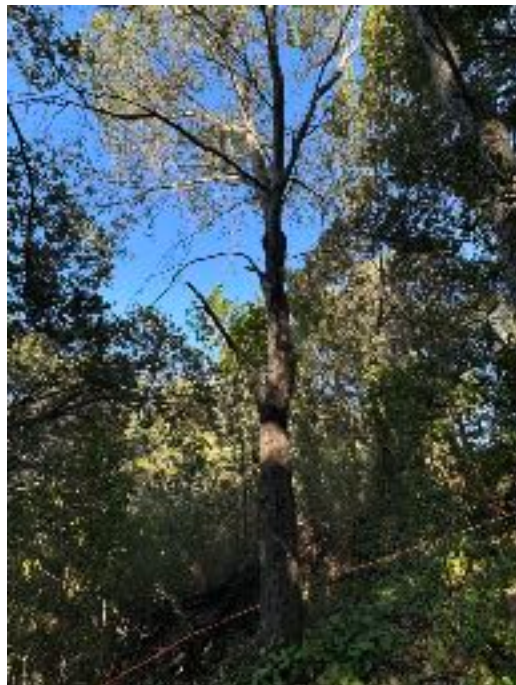
Tag 5090: Moderate deadwood throughout canopy.

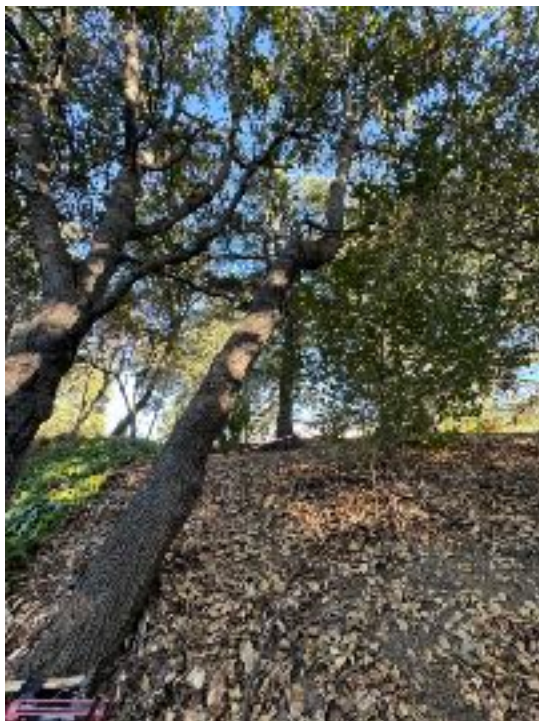
Tag 5092: Tree has a significant lean to the east due to competition light with neighboring oak trees.

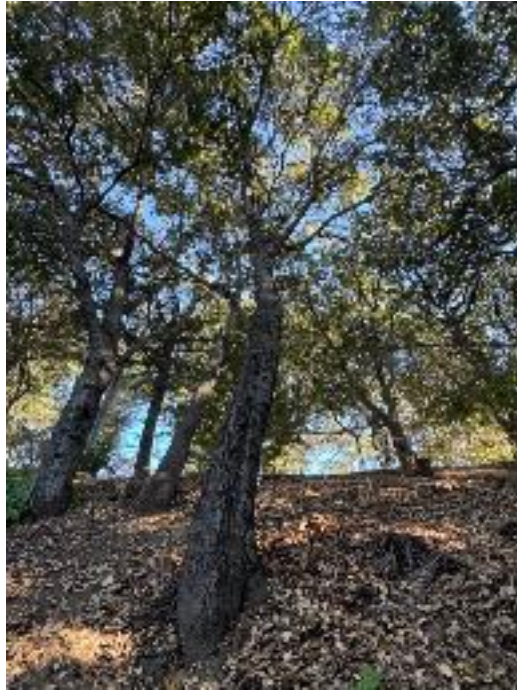
Tag 5093: Moderate deadwood noted throughout canopy.
Tree has a slight lean to the east.

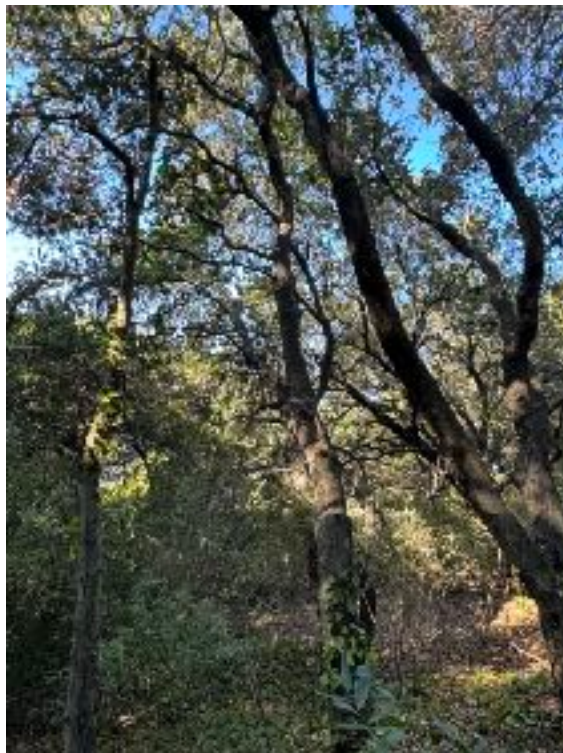
Tag 5094: Ivy growing on trunk.
Moderate deadwood noted throughout canopy.
