03/06/2024

Arborist Report

Client: Live Oak Associates - Attention: Katrina Krakow

Site: 50 Los Gatos-Saratoga Rd, Los Gatos CA

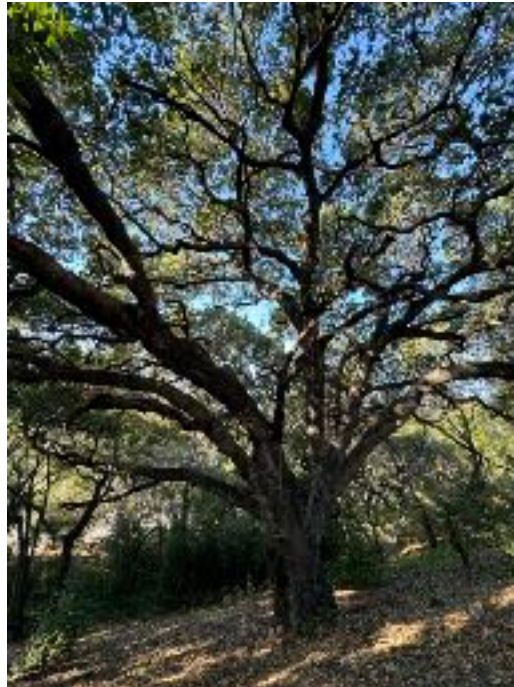
Tag 5095: Significant rot in the trunk, splitting crotch, cracking on the trunk.

Deadwood and decay throughout the entire tree.

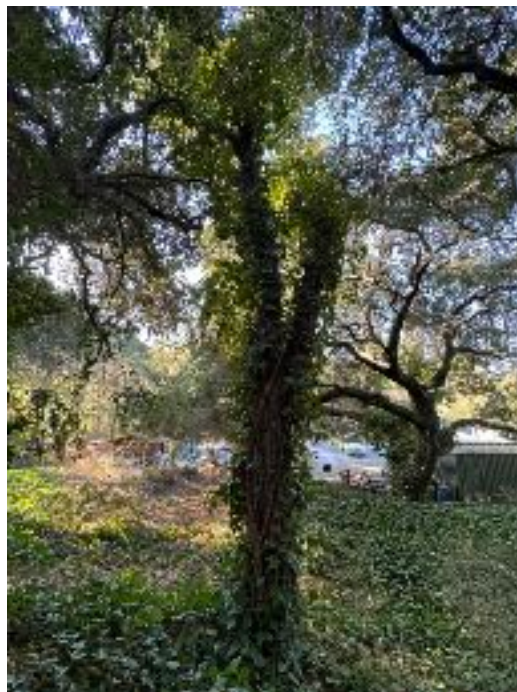
Tag 5108: Ivy is growing up trunk throughout branches and canopy.

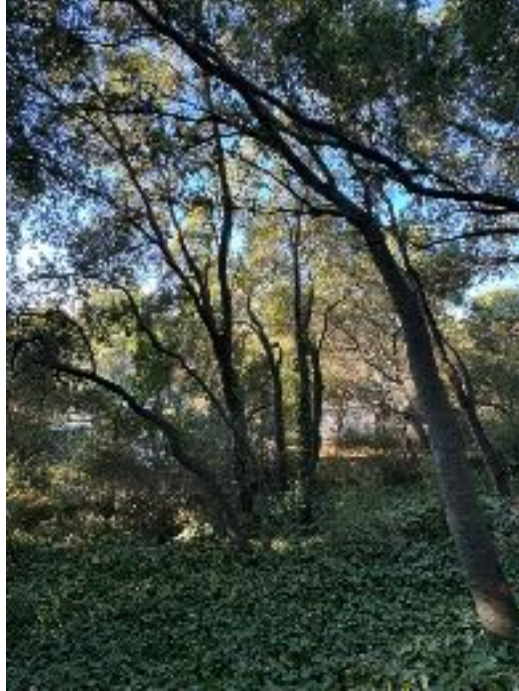
Tag 5117: Minor deadwood noted throughout canopy. Tree has a moderate Westward lean.

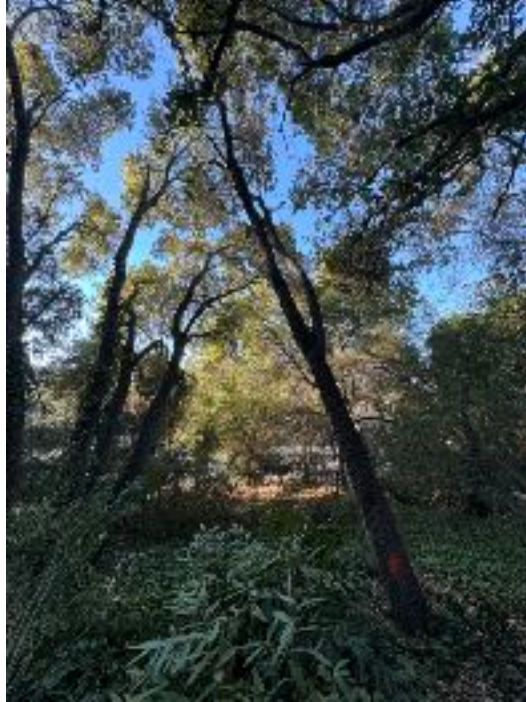
Tag 5119: Moderate deadwood, noted in the canopy.
Slight mechanical damage on trunk 4 ft above grade.

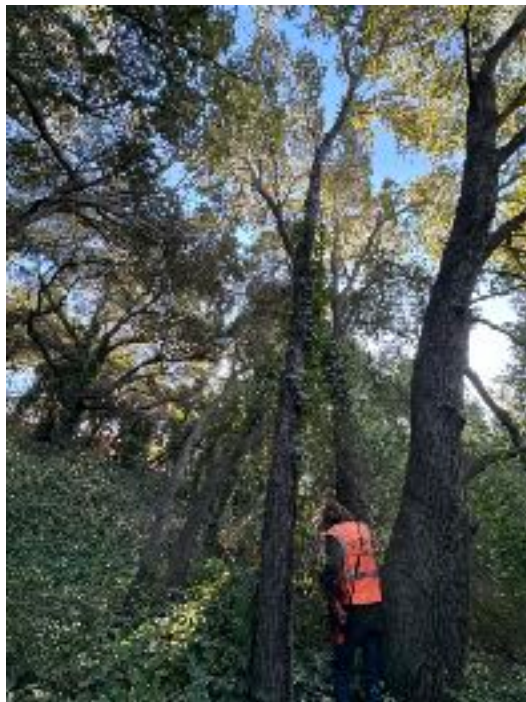
Tag 5120: Ivy growing up main stem.
Slight deadwood noted in canopy.

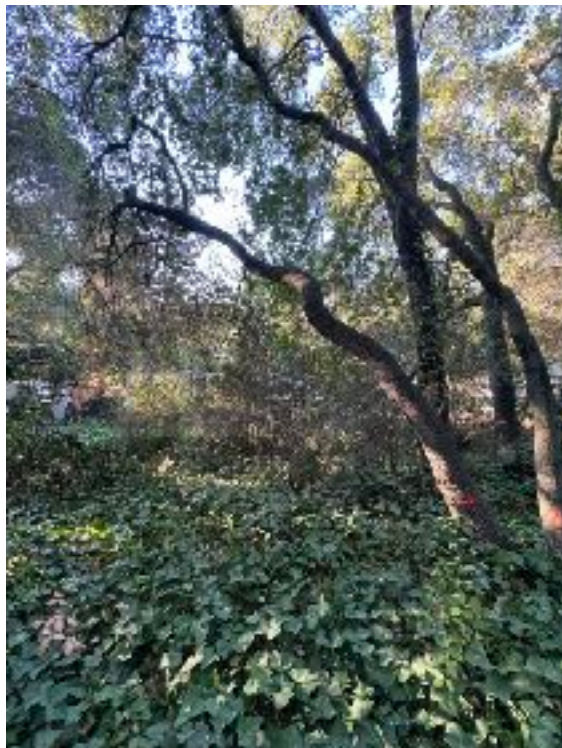
Tag 5124: Tree has a significant southwest lean.
