Tree Inventory, Assessment, and Protection Report

> 16511 Cypress Way Los Gatos, CA 95032

Town of Los Gatos

November 6, 2024

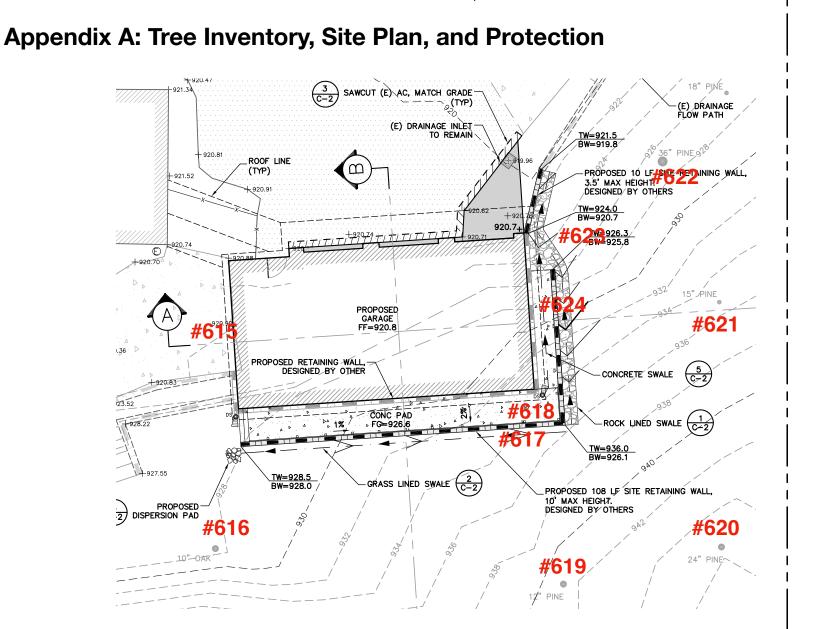
- 1. Provide a plan sheet or existing topographic survey that indicates the trees within the project area. None of the plan sheets show tree locations for #616, #617, #618, #623 or #624 which many are expected to be highly impacted (Appendix A).

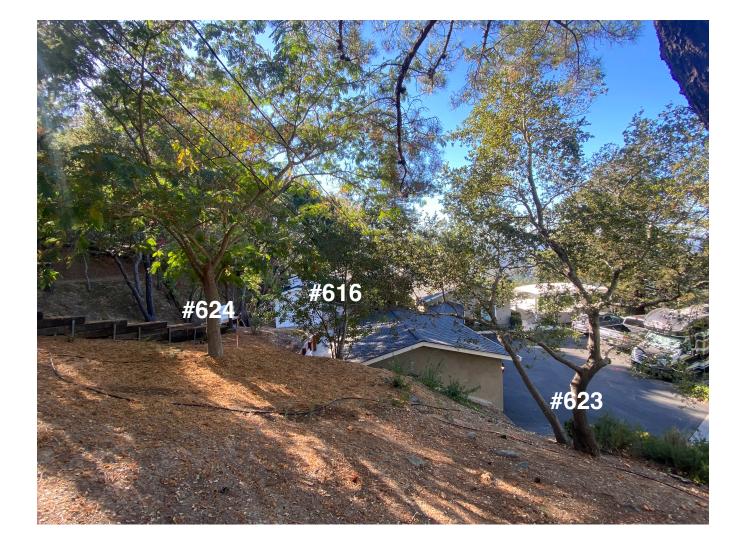
Appendix C: Photographs C1: Trees #616, #623 and #624

Four trees are expected to be highly impacted and removed which included holly #615, Chinese pistache #617, coast live oak #618, and silk tree #624 (Chart 3). One tree, coast live oak #623, could be moderately impacted and one of its codominant stems will need to be removed to provide clearance (and as a byproduct improve overall structure). The remaining five trees are not expected to be affected.

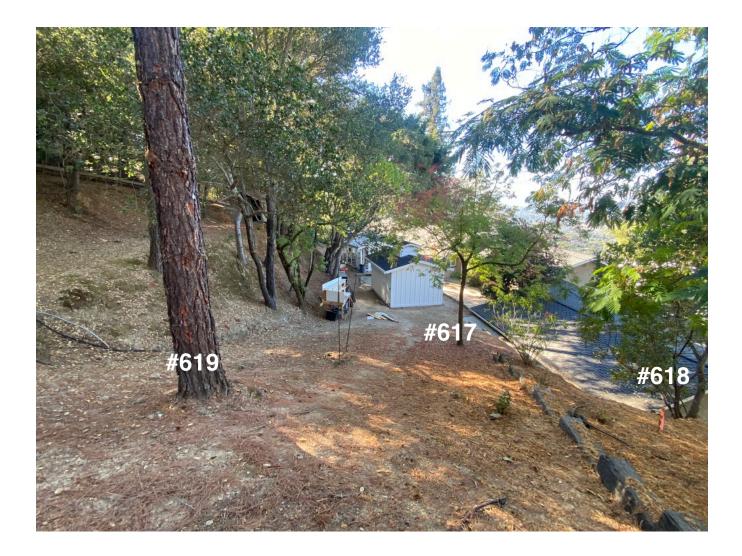
C2: Trees #617, #618, and #619

Seven trees are in good condition and the remaining three are in fair shape. One pine tree #619 has signs of red turpentine beetles (*Dendroctonus valens*) (Chart 2).
