STRUCTURAL CALCULATIONS

Forge Fitness

100 Drayton Avenue
 Lynden Wa 98264

Forge Fitness Roofing Moisture Content Testing

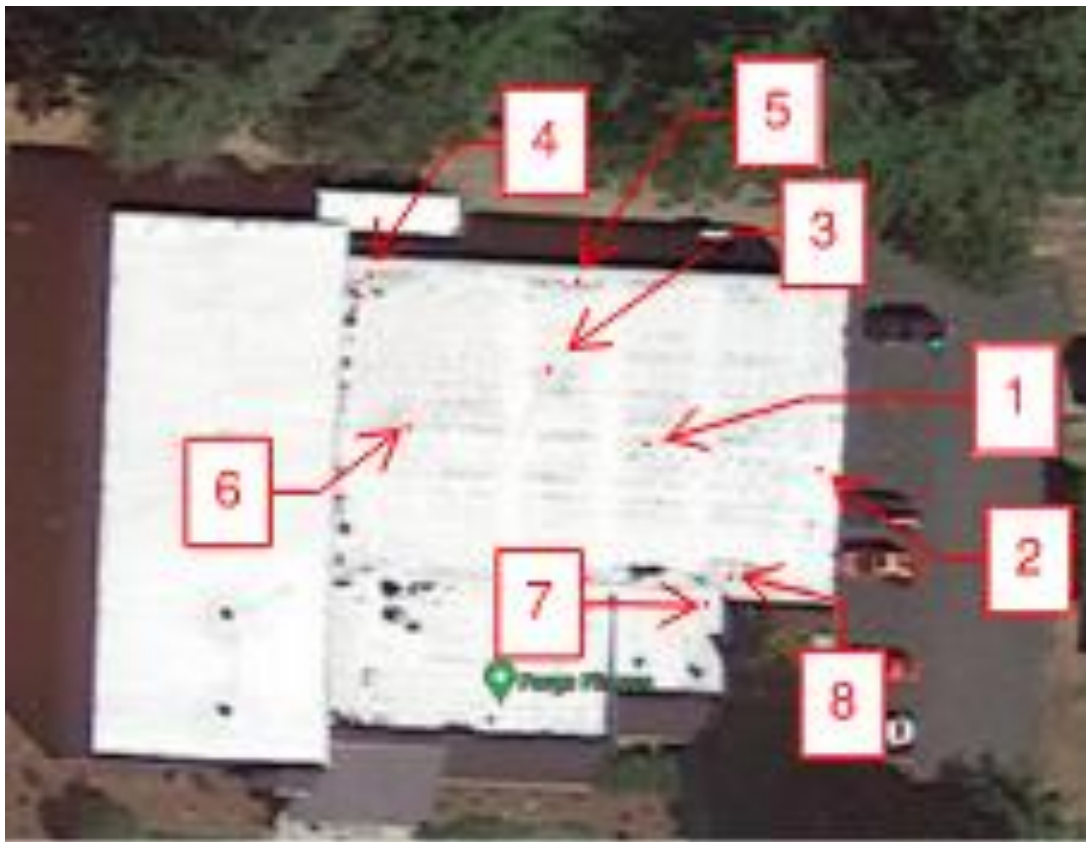
Figure 1: Location of the 8 samples removed from site.

Due to the history of multiple re-roofing operations, the assembly had varied layers which contributed to variances in recorded weight. Samples removed from the perimeter of the pool roof (2, 4, 5, and 8) had more saturation than samples removed from the center of the roof. Sample #7 was removed from the mechanical mezzanine roof that had a thinner assembly than the pool roof, thus had less mass.

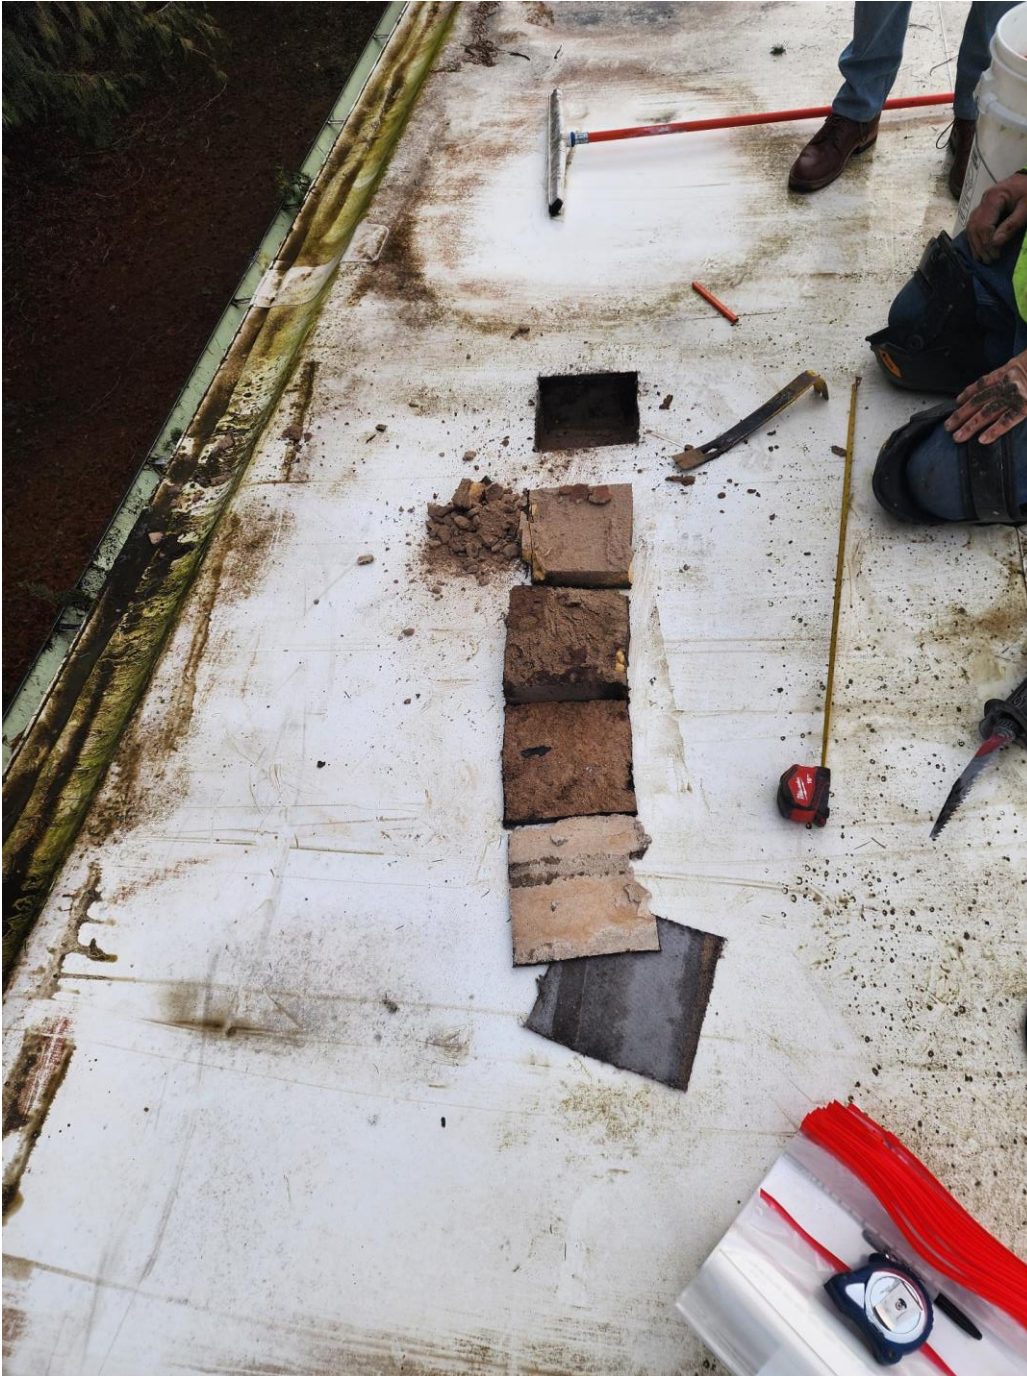
Figure 2: Removal of sample #4.

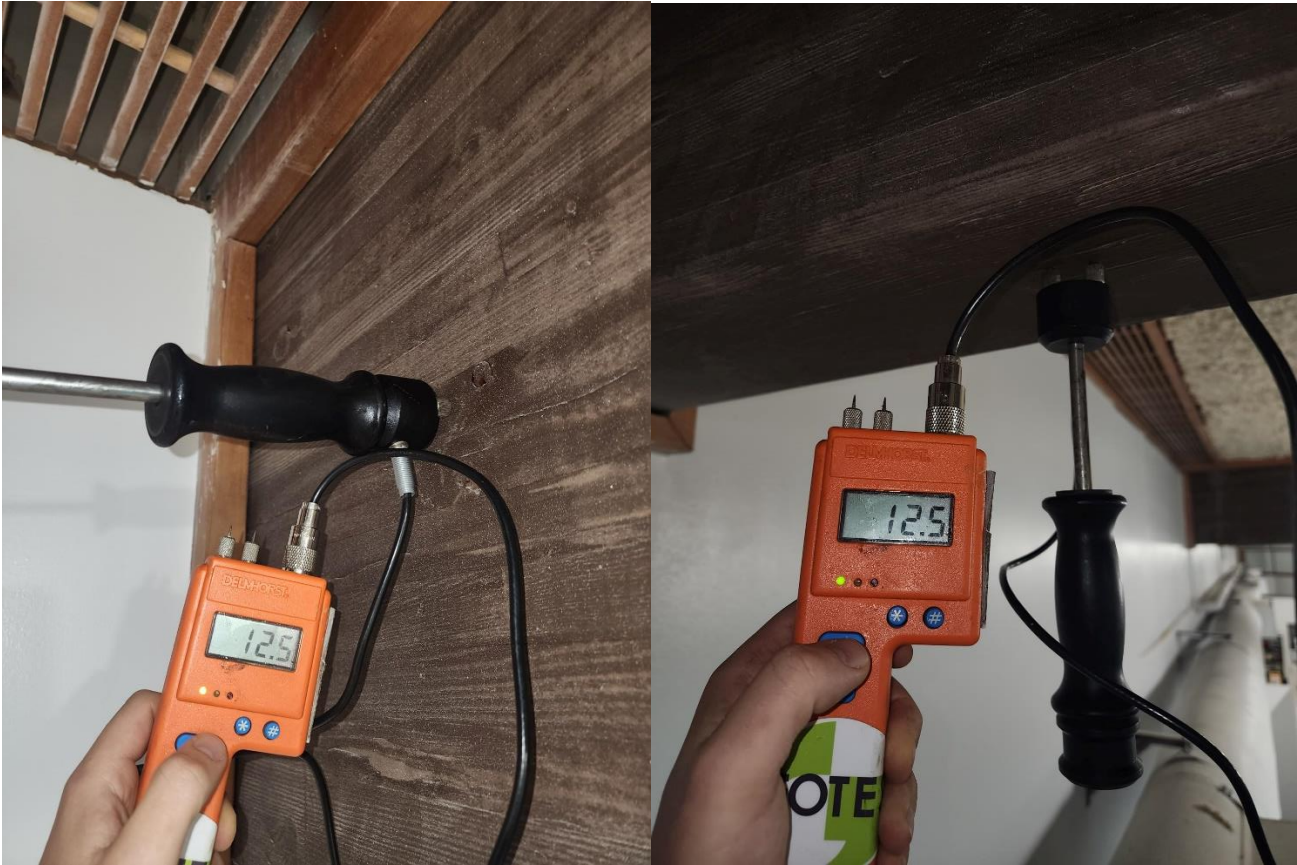
All 16 measurements were between 9% and 13.5%. Measurements were intentionally taken on what appeared to be a water stain from a previous roof leak, but moisture content was still within the 9% to 13.5% range. All locations were measured with ¼" pin depth and 2" pin depth. Pin depth did not increase or decrease the observed moisture content.

Figure 1: Beams were measured in two locations on the sides of the beams and two locations on the bottom of the beam.

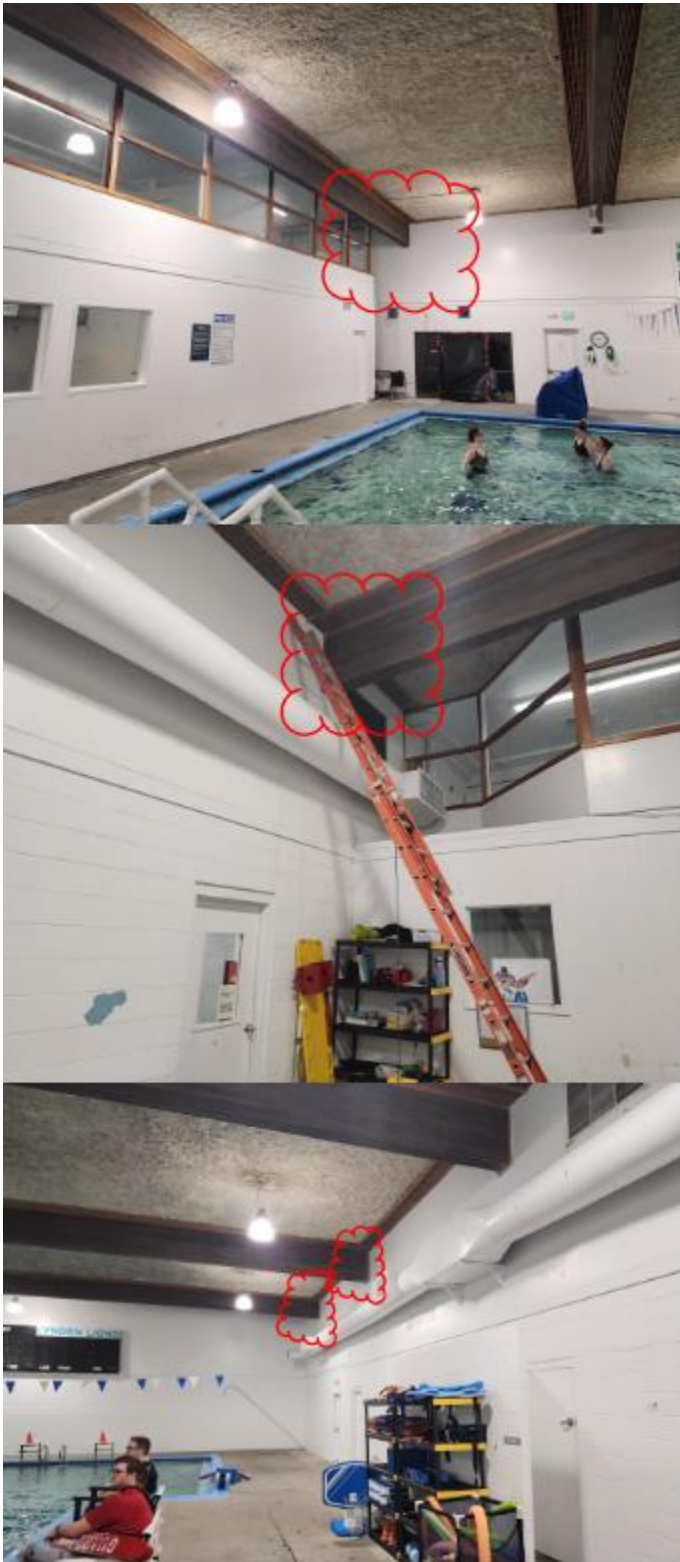
Figure 2: Location of moisture content testing on glulam beams.

Due to the pool below the mid span of the beams and ceiling fans along the north side of the pool the midpoint and north end of the beams were not measured. Given that all the beams are located within the same ambient environment and relatively small range of observed moisture content, the moisture content within the beams is likely consistent with a range from 9% to 13.5%.
