**MACKINAC ISLAND FERRY COMPANY  
MAIN DOCK EVALUATION**

**CITY OF MACKINAC ISLAND  
MACKINAC ISLAND, MICHIGAN**

**January 2024**

I hereby certify that the structural inspection, conditions study and feasibility report for the above referenced location were prepared by me or under my direct supervision and that I am a duly Licensed Professional Engineer under the laws of the State of Michigan.

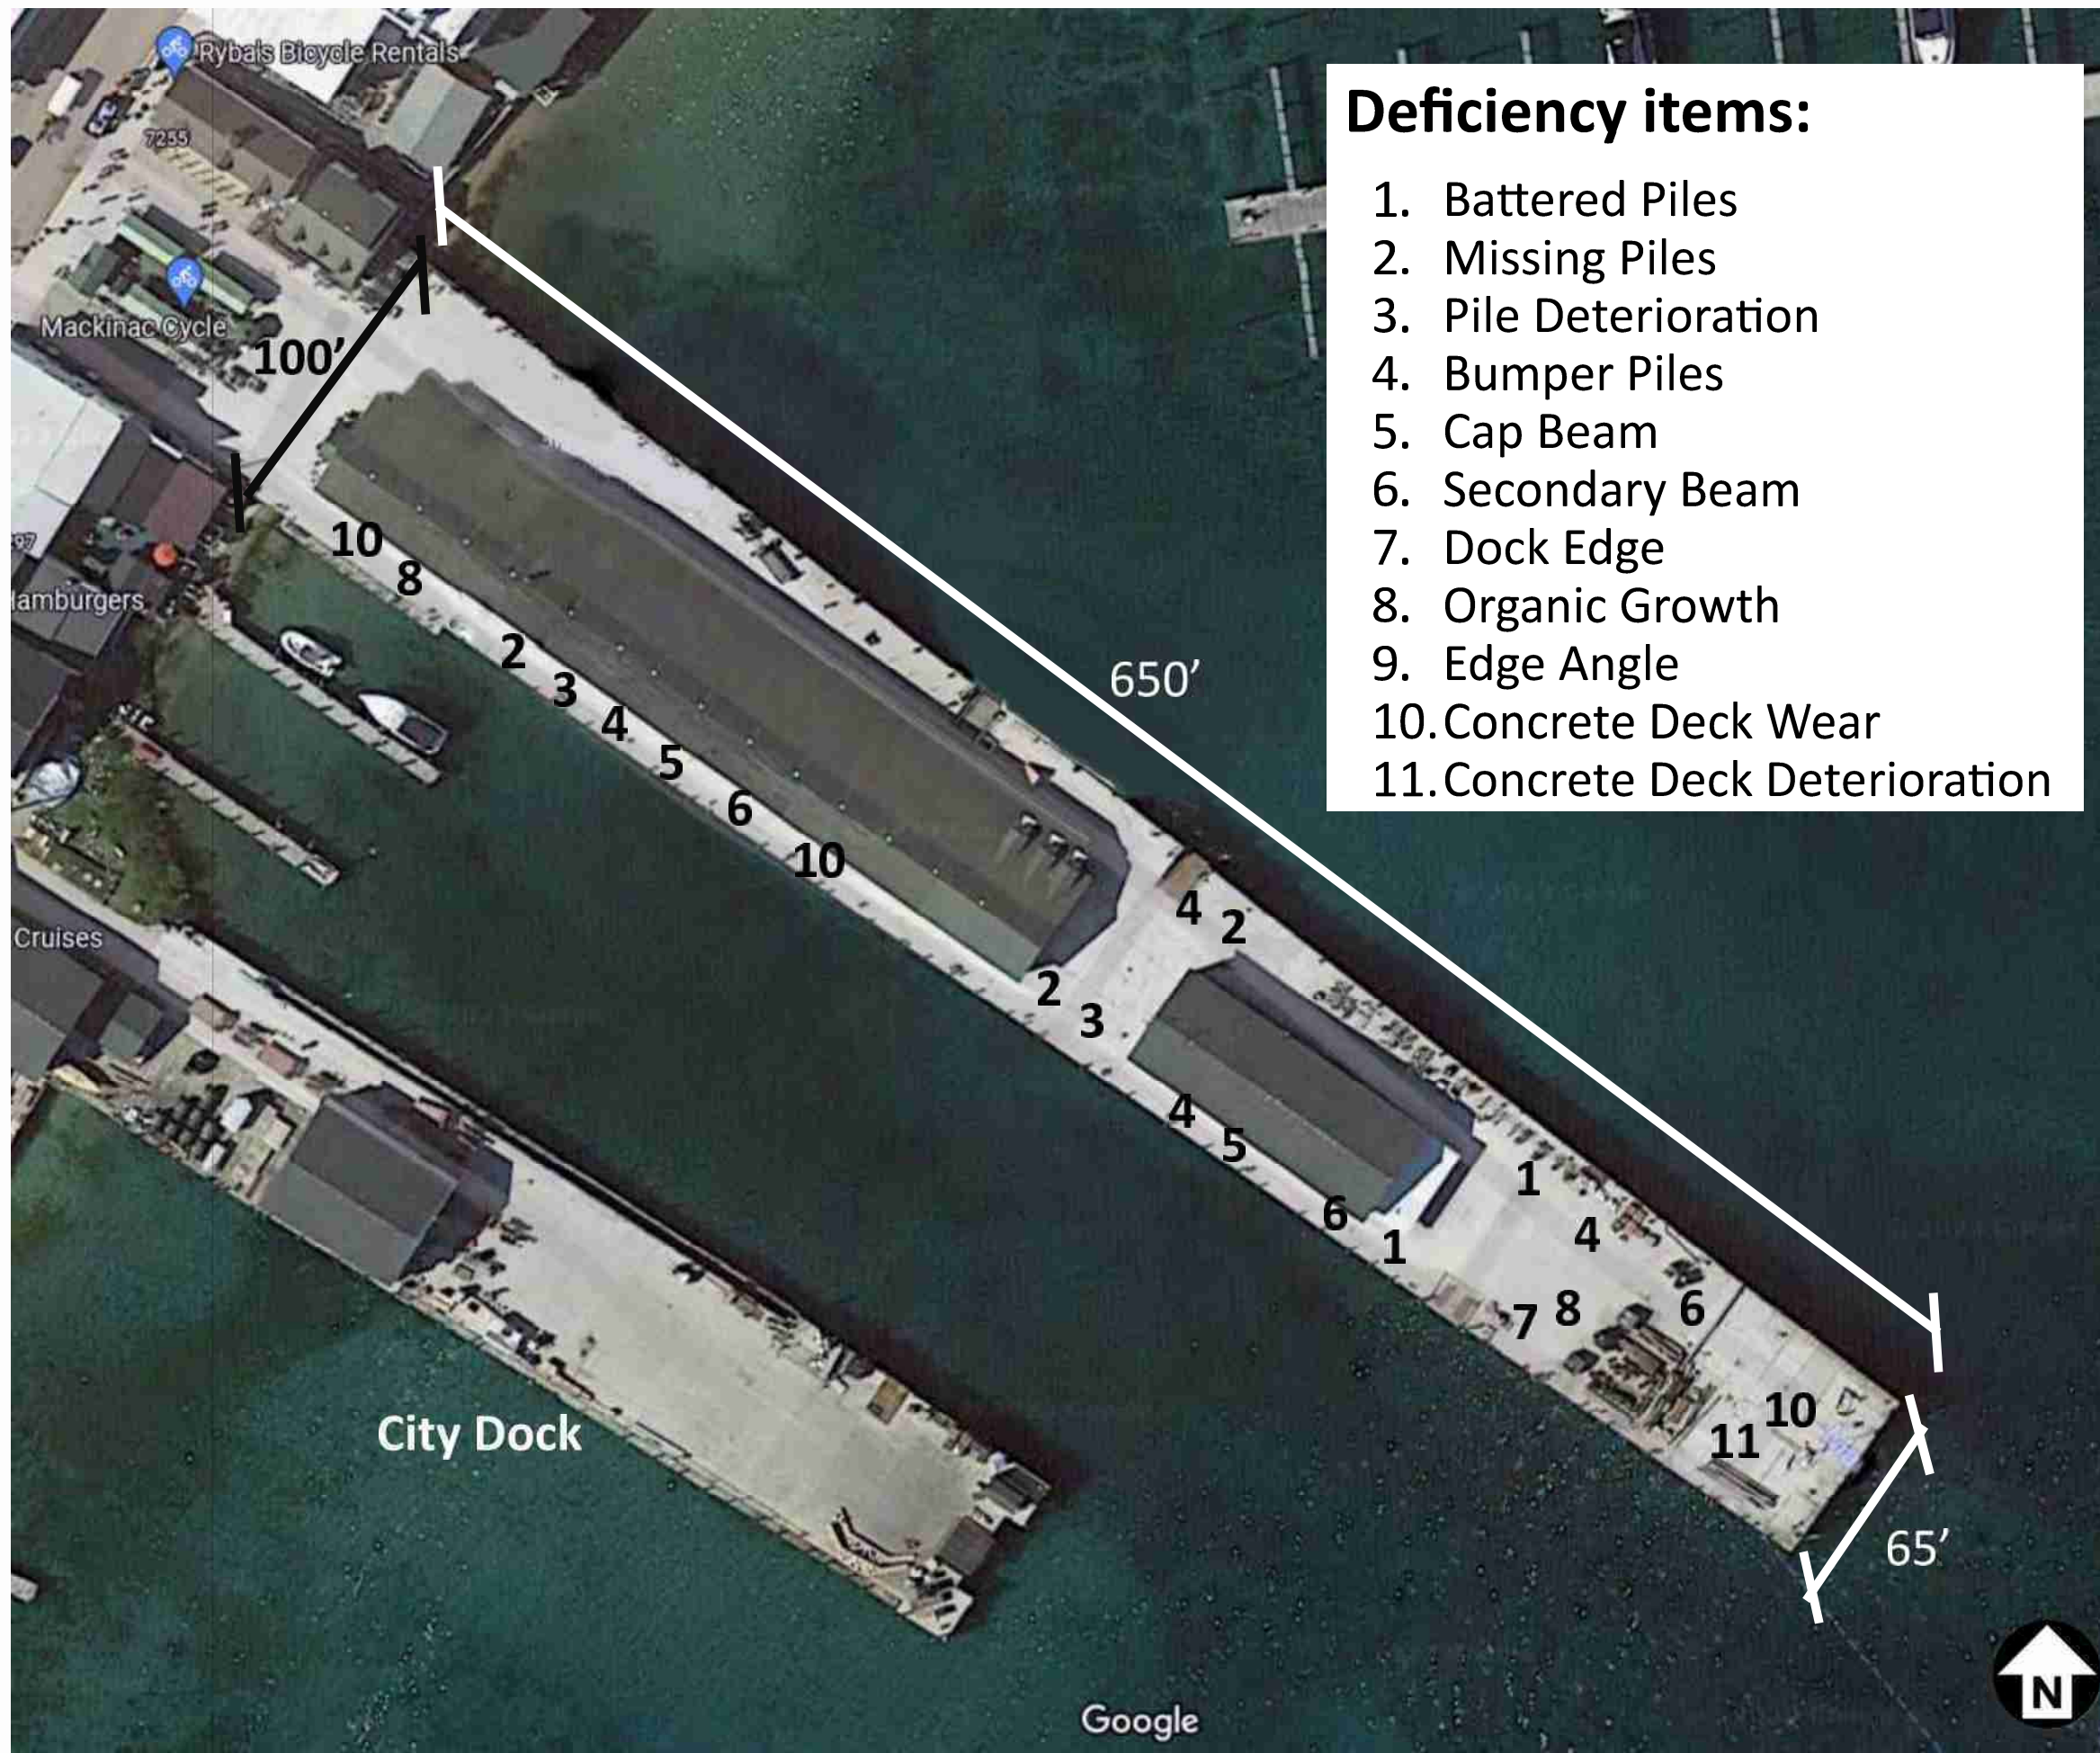
S002

- Deficiency items:**
1. Battered Piles
  2. Missing Piles
  3. Pile Deterioration
  4. Bumper Piles
  5. Cap Beam
  6. Secondary Beam
  7. Dock Edge
  8. Organic Growth
  9. Edge Angle
  10. Concrete Deck Wear
  11. Concrete Deck Deterioration

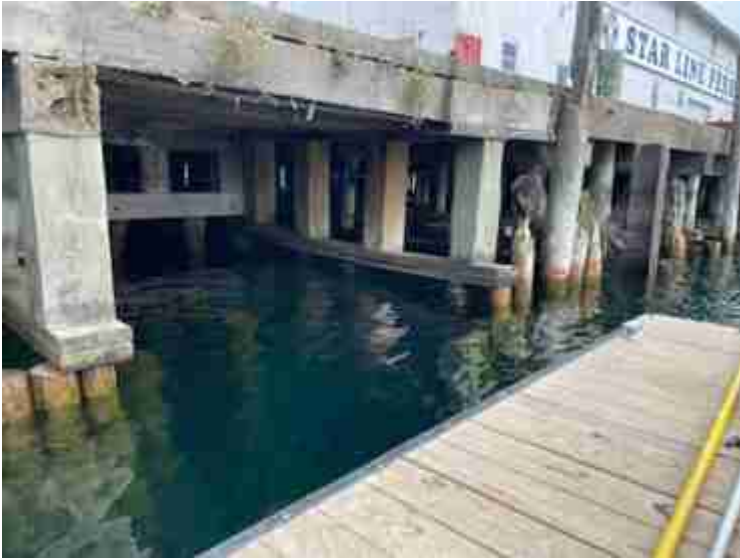
12) Dock (south)

Pile deterioration

3. **PILE deterioration:** Several piles are completely deteriorated. These piles should be removed down to the lake bottom and new piles installed as needed.

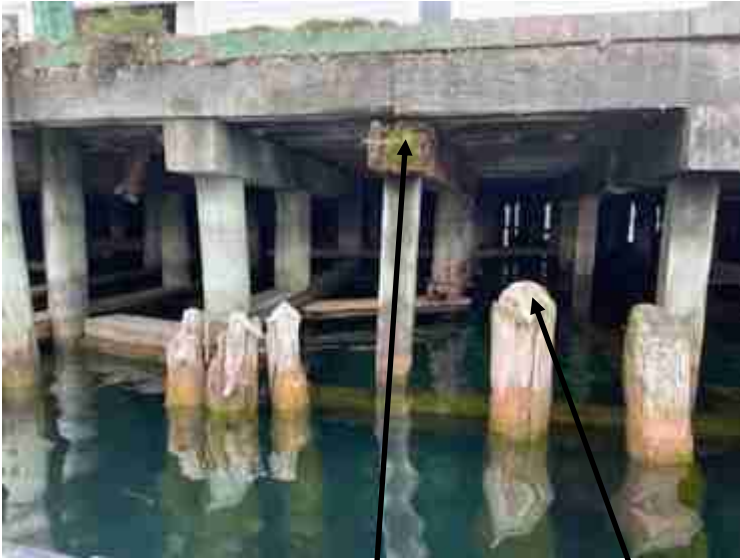
6) Dock (south)

Secondary edge beam deterioration

6. **Secondary edge beams:** Several edge beams have deteriorated. These beams should be removed and replaced with new edge beams.

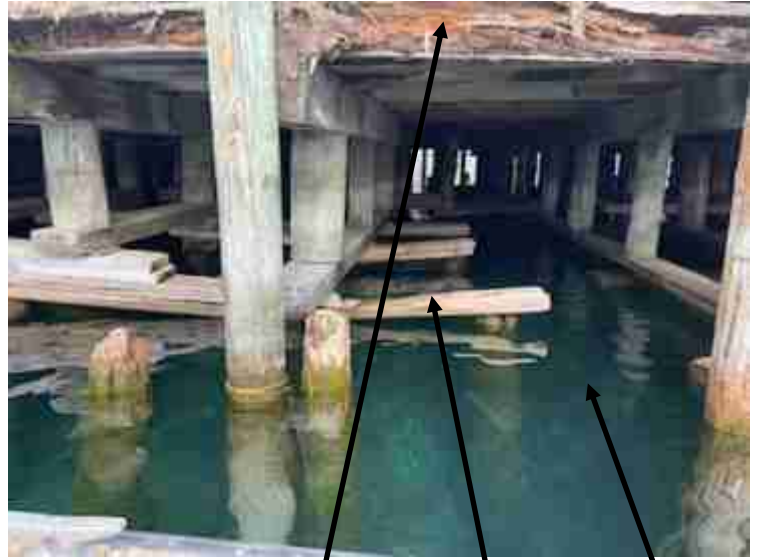
Dock (south)

Main girder deteriorated

Missing piles

4. **Damaged bumper piles:** Several bumper piles have been damaged. The top of these piles should be removed and replaced with new.
5. **Main girder or cap beam:** Several cap beams have deteriorated beyond repair. These beams should be removed and replaced with new cap beams.

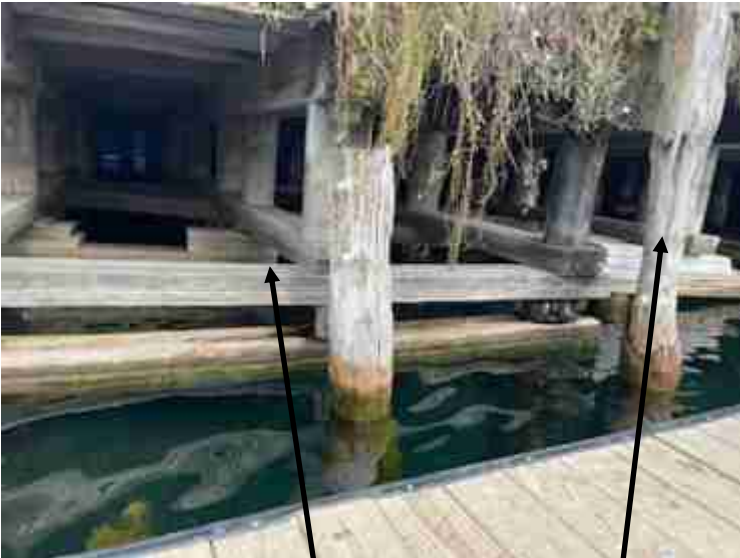
Dock (south)

Edge beam deterioration

Pile benching deformation

Missing Piles

2. **Missing piles:** there are several areas where piles are missing and extension benching has been installed. The benching in these areas should be removed and new piles driven along with new framing and decking.

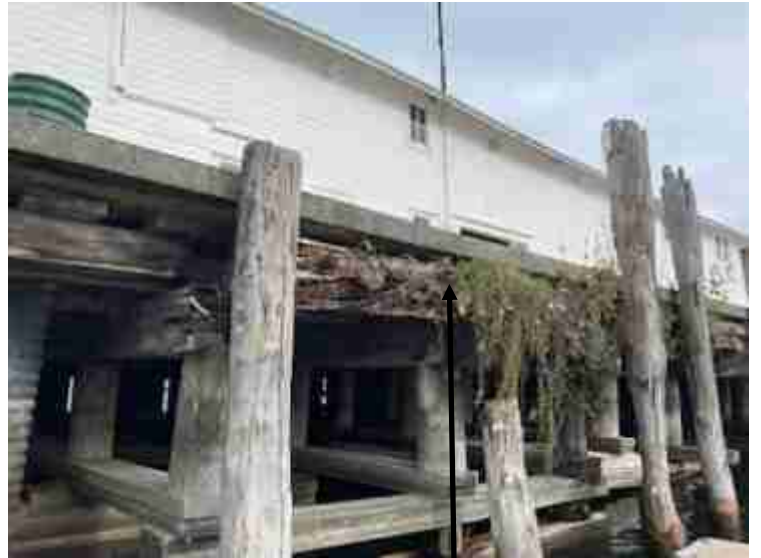
Dock (south)

Excessive benching

Pile deterioration

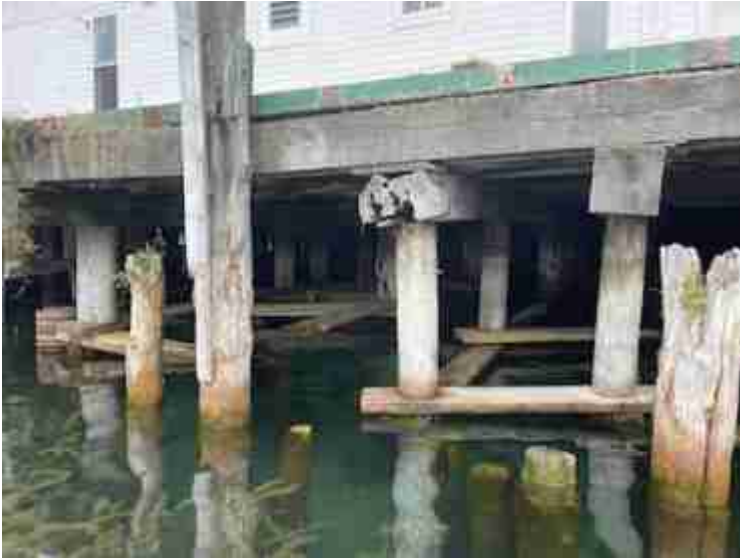
Dock (south)

Edge beam deterioration and organic growth

7. **Organic growth:** There are areas of organic growth from the existing timbers. The organic material should be removed and maintained so further growth is reduced or eliminated.
8. **Edge angle:** There are several areas where the edge angle on the deck is loose or is no longer in place. The edge angle should be replaced.
9. **Approximately a loss of 1 inch concrete deck:** The concrete surface along the south edge of the dock from the west to east end of the terminal building has over 20% of deck lose. It is anticipated that the loss will be over 50% by 2030. This concrete surface should be removed and replaced.
10. **Excessive deck deterioration:** There are areas of excessive cracking, spall and loose concrete deck. These areas should be removed and replaced.

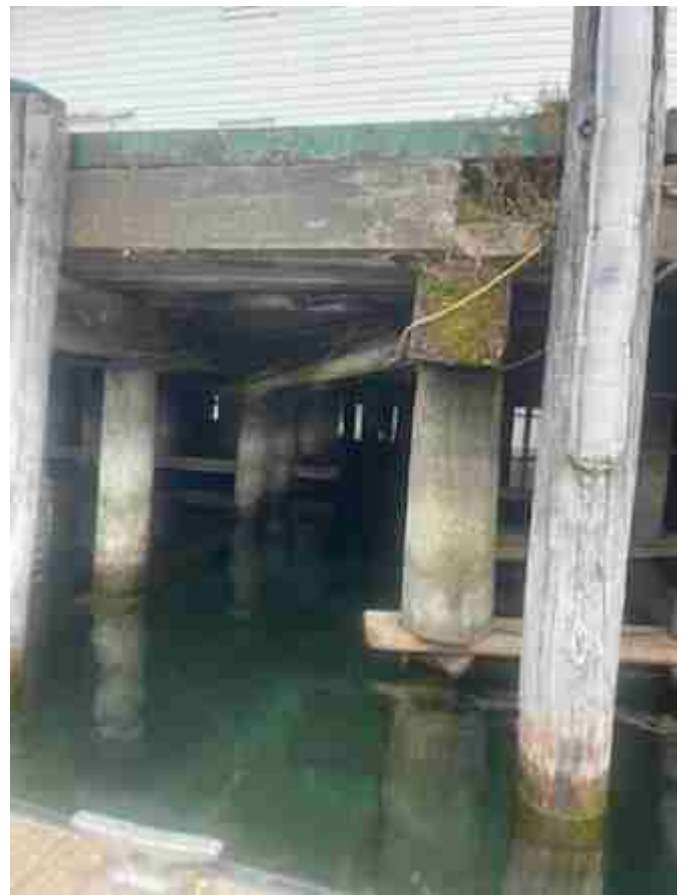
**25) Dock (south) (west end)**  
Main girder deterioration

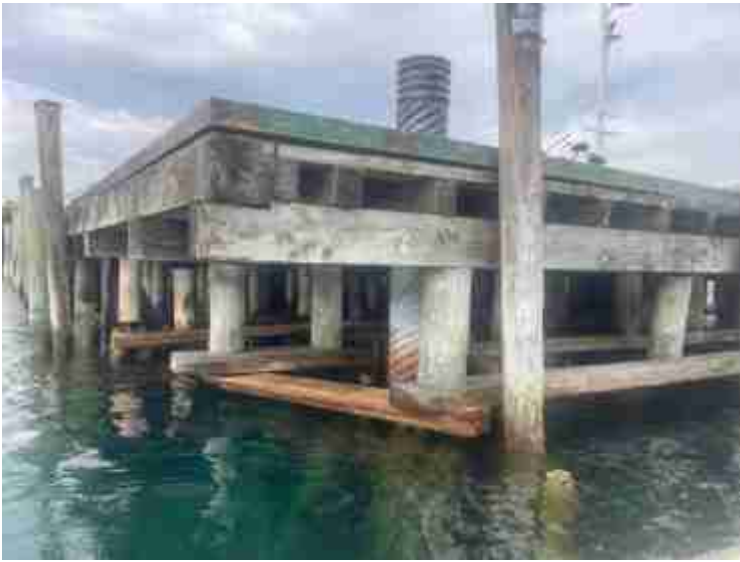
48)

Missing piles

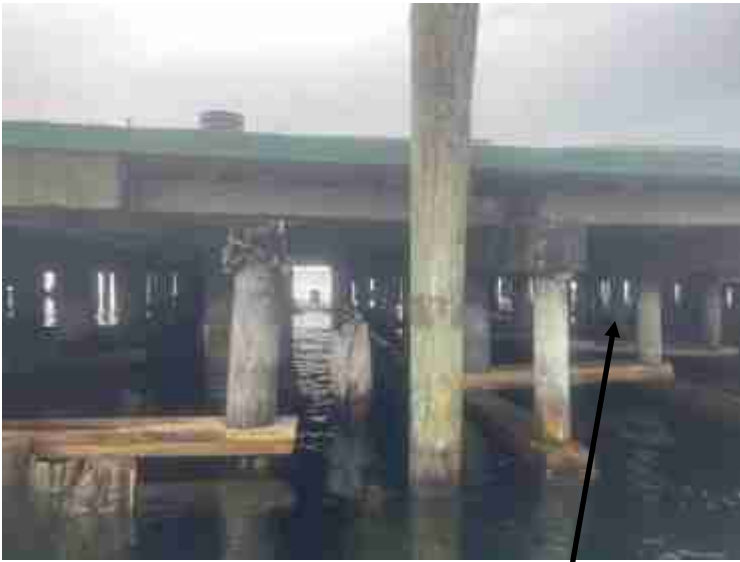
52) North dock east end

Pile missing

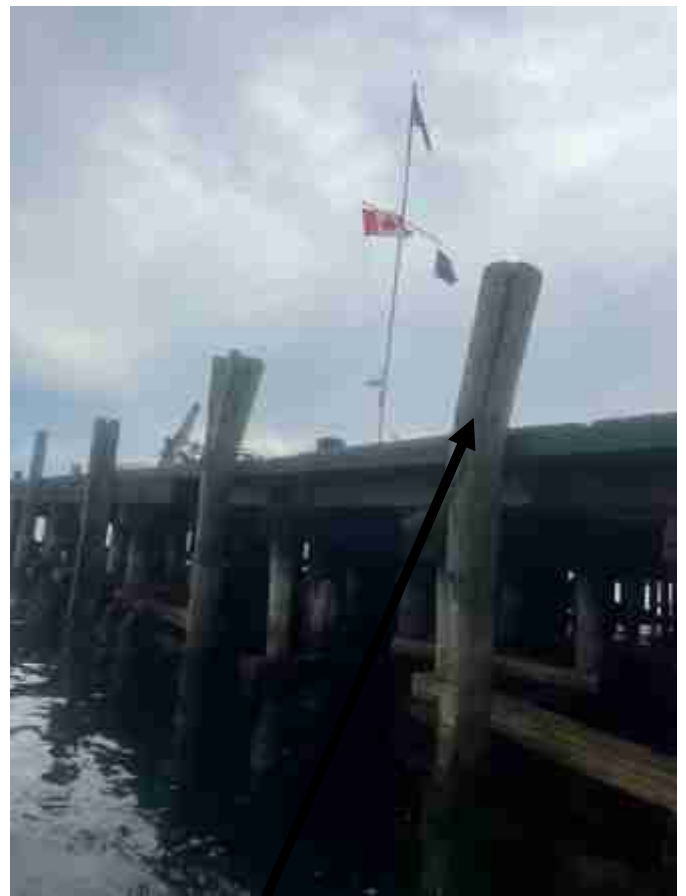
**53) North side east end**  
Excessive benching

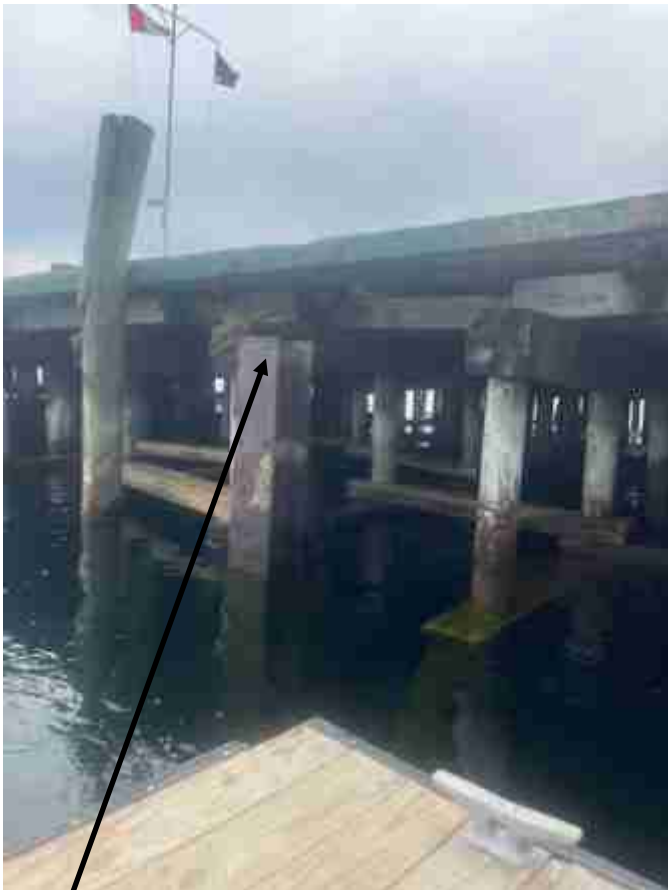
**54) North side east end**  
Bumper piles damaged

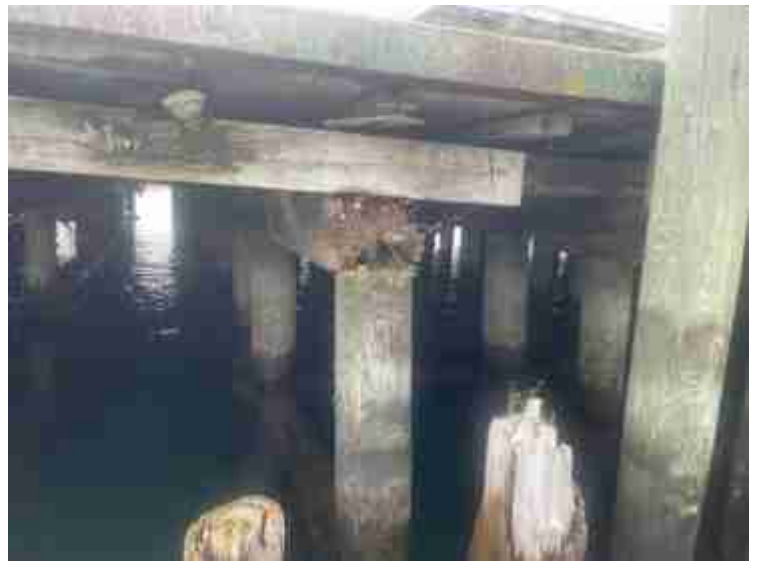
**59) Dock (north)**

Excessive piles missing

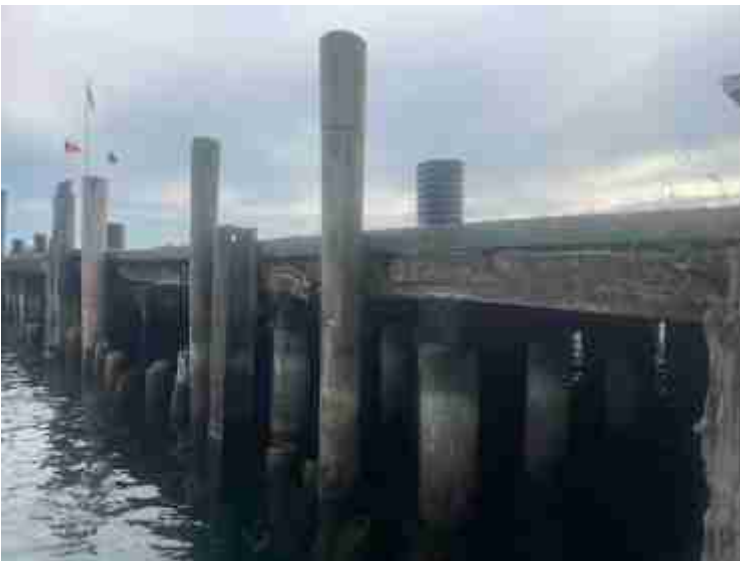
**62)** Dock (north)  
Deteriorated beam    Deteriorated piles

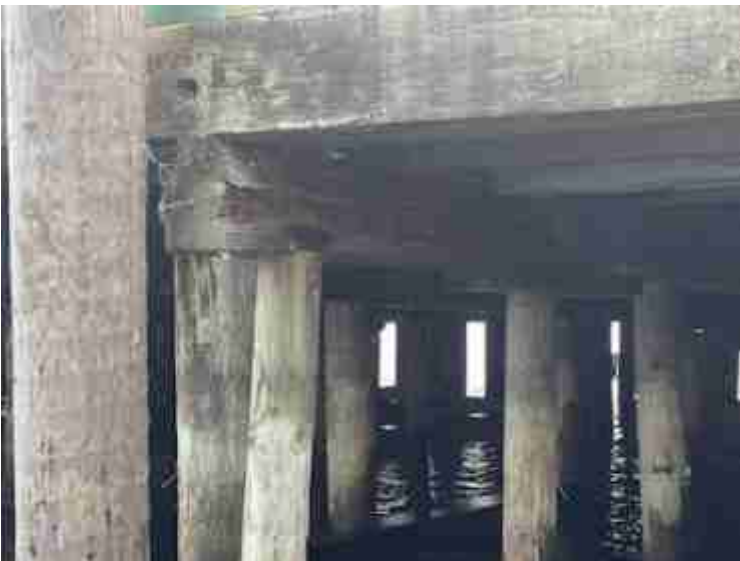
66) Dock (north)

Missing piles

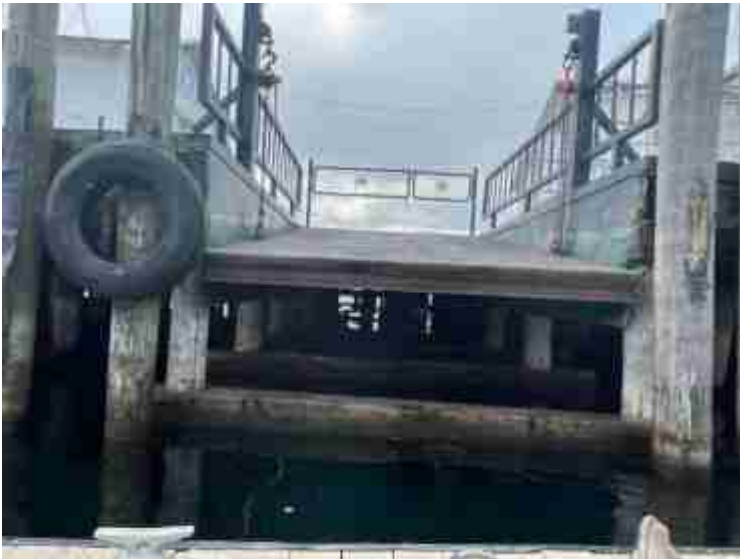
68) Dock (north)

Deteriorated beam

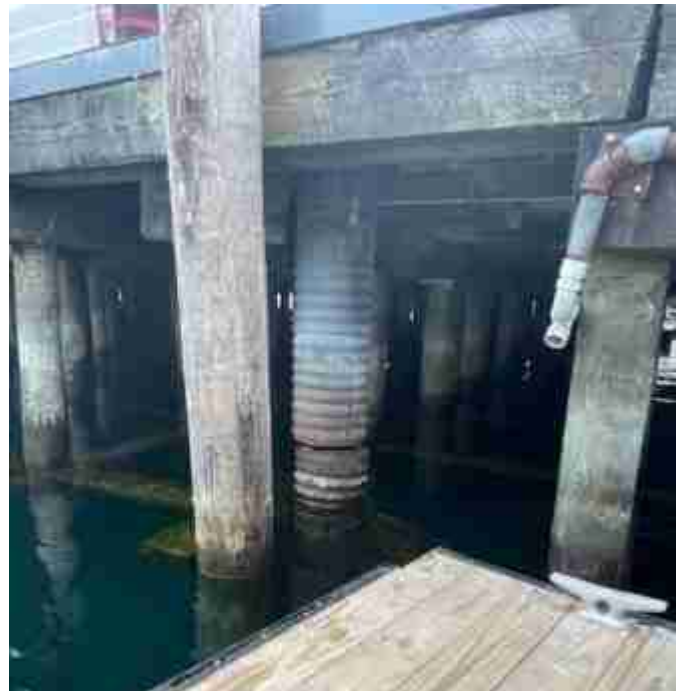
**79) Dock (north)**  
Deteriorated beam

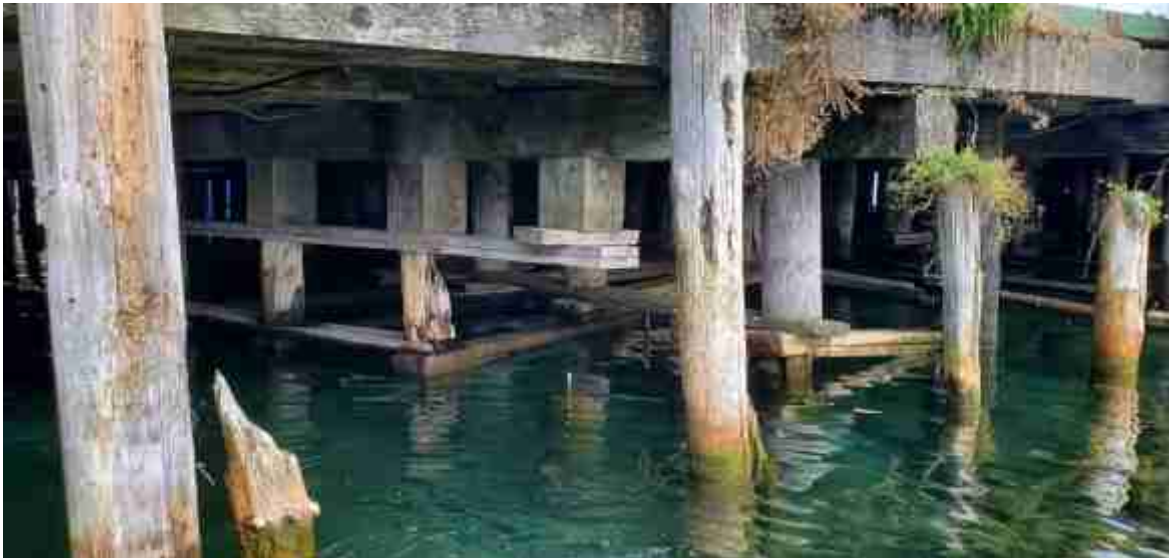
Excessive benching/missing or deteriorated piles

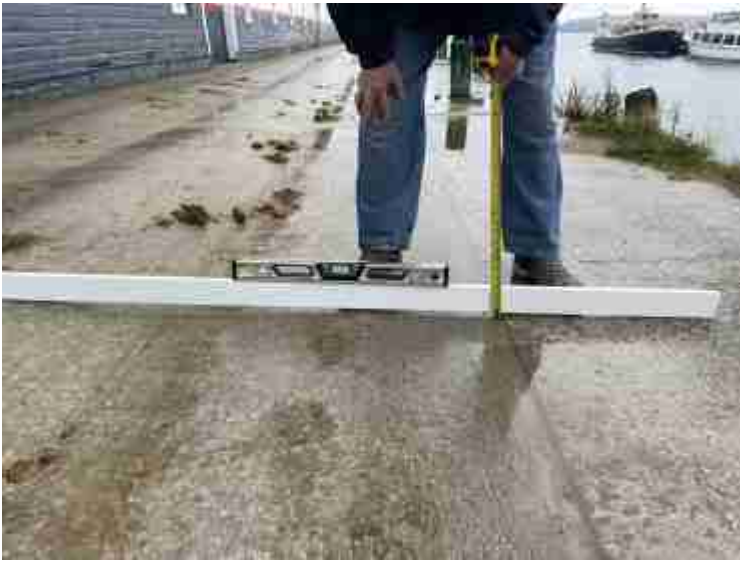
Excessive benching/missing or deteriorated piles

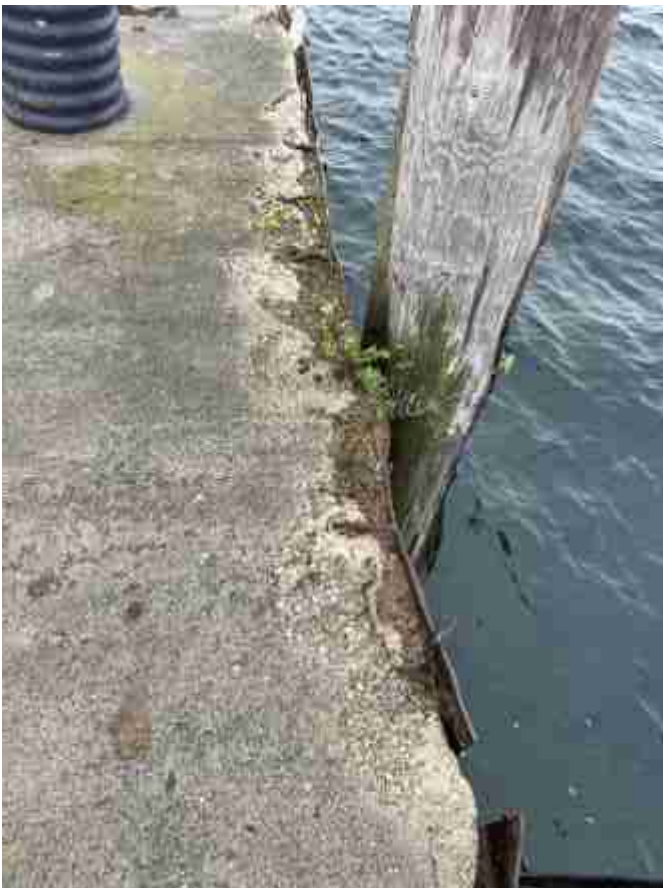
119) Deck angle

Damaged deck angle

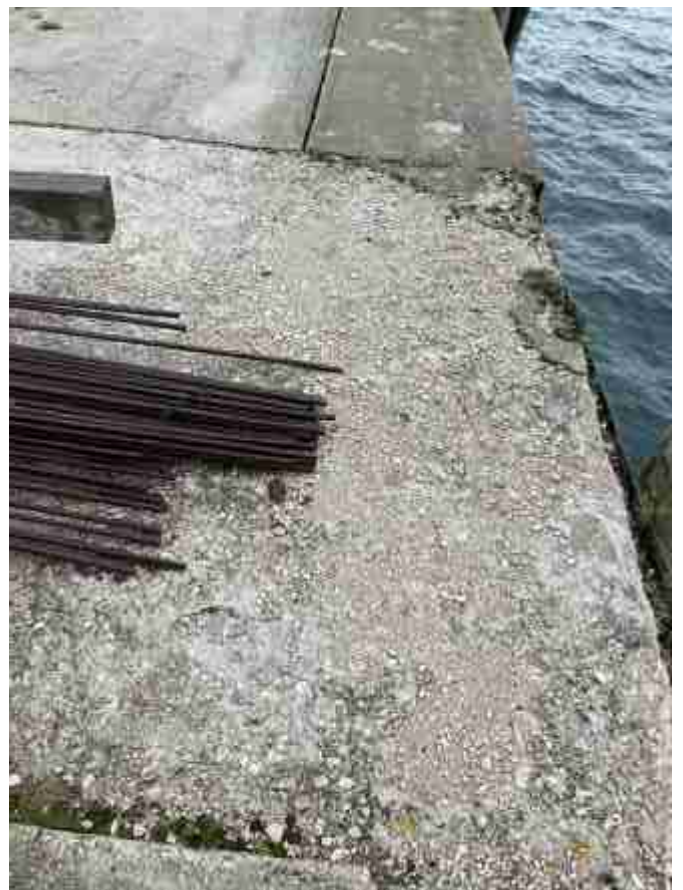
**124) Broken deck, angle separation**

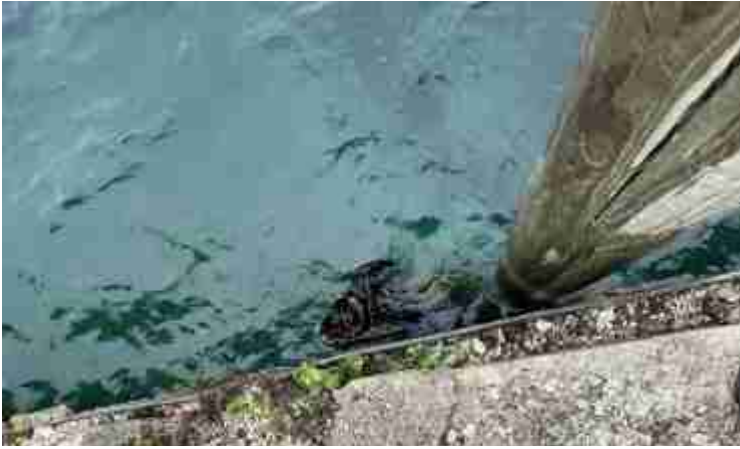
**125) Deteriorated deck**

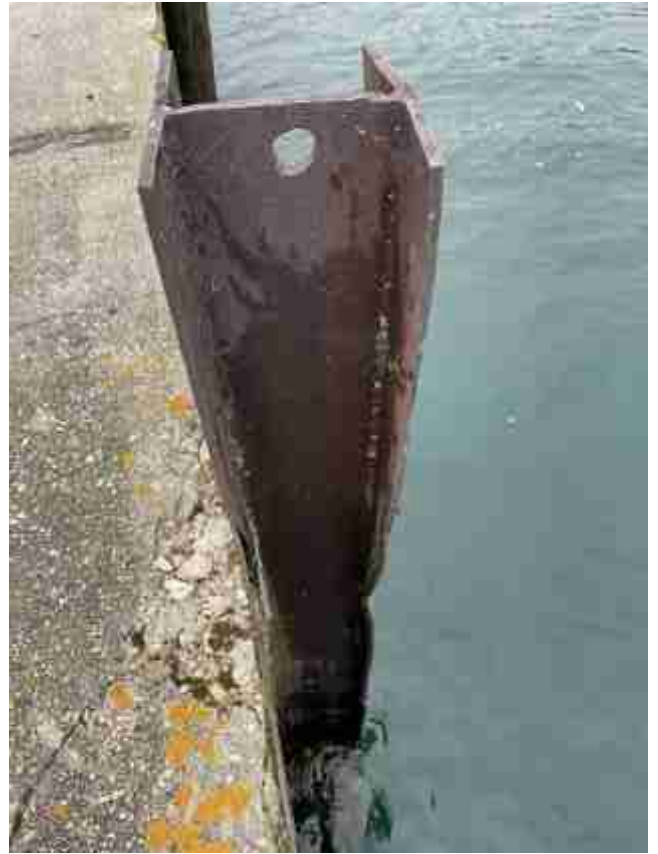
126) Deck deterioration

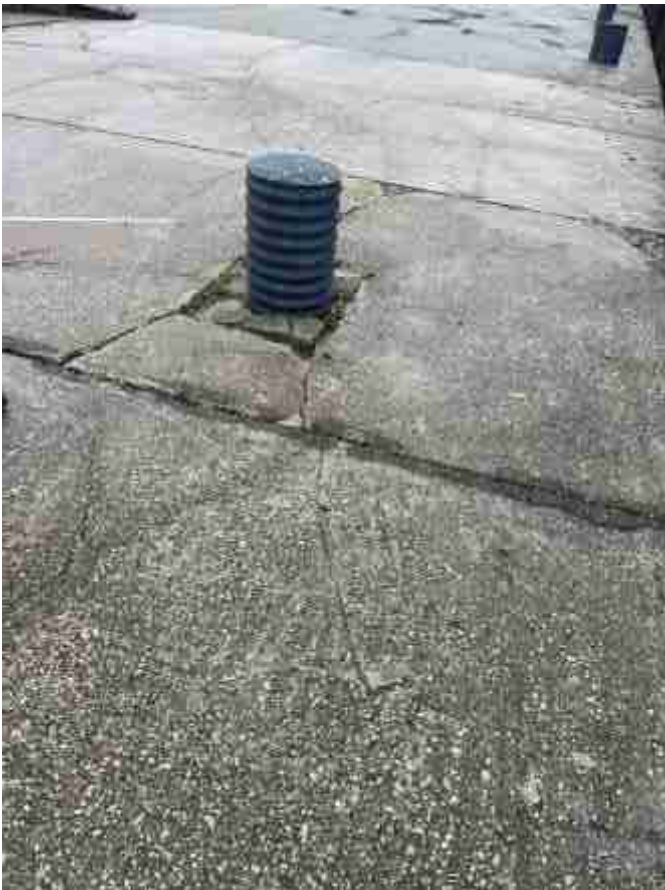
127) Deck deterioration

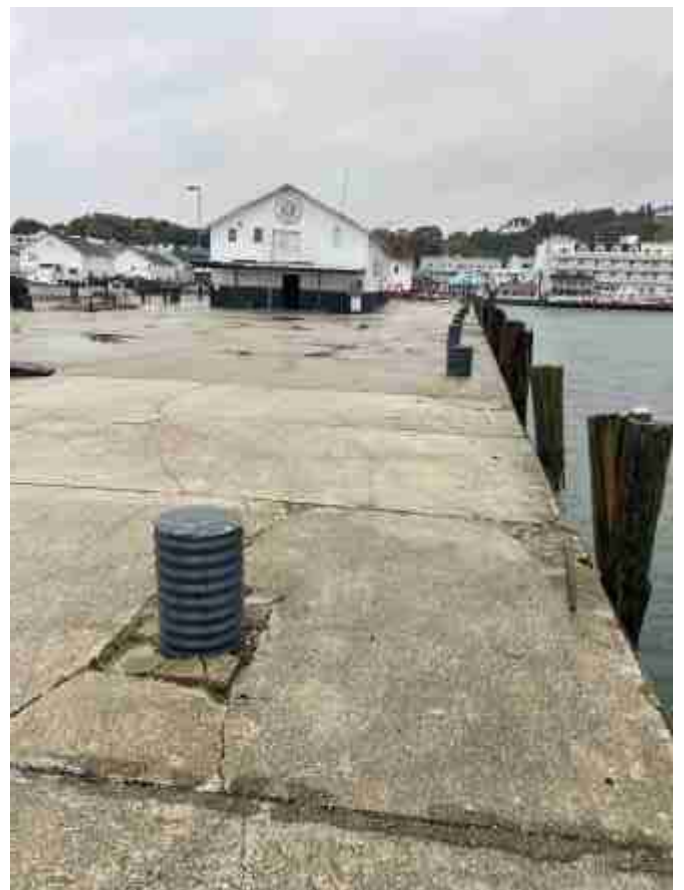
128) Bit/deck deterioration

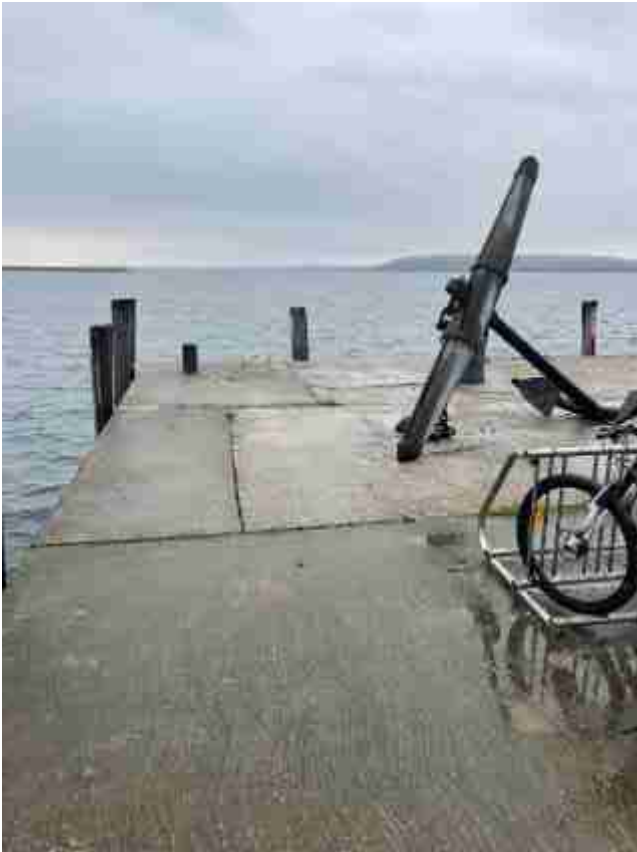
129) Bit/deck deterioration
