707 Ashmun Street Sault Ste. Marie, MI 49783

June 24, 2026

**RE: BUILDING FOUNDATION SYSTEM INSPECTION FOR UNIT 3 AT THE  
ARROWHEAD BUILDING ON MACKINAC ISLAND, MI**

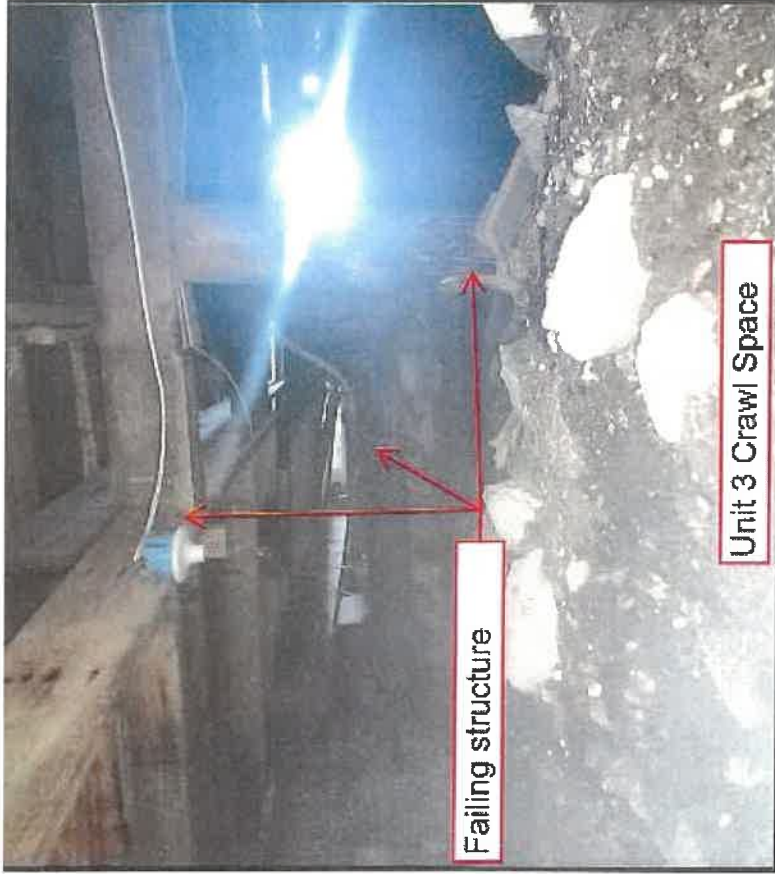
Unit 3 Crawl Space

3. The foundation system for the building consists different sized floor joists bearing on several different sized beams and columns. There are no concrete footings for the columns to bear on. There are also numerous broken beams and columns and portions of floor joists that do not bear on anything and are free floating.

1. The wood framed foundation system for the building is in irreparable condition and poses a significant risk of failure.

Failing structure

1. It is our opinion that the building and deck should be deconstructed and reconstructed with the proper construction methods and materials to meet all State and Local building codes (see the attached proposed conceptual plans for reconstruction).

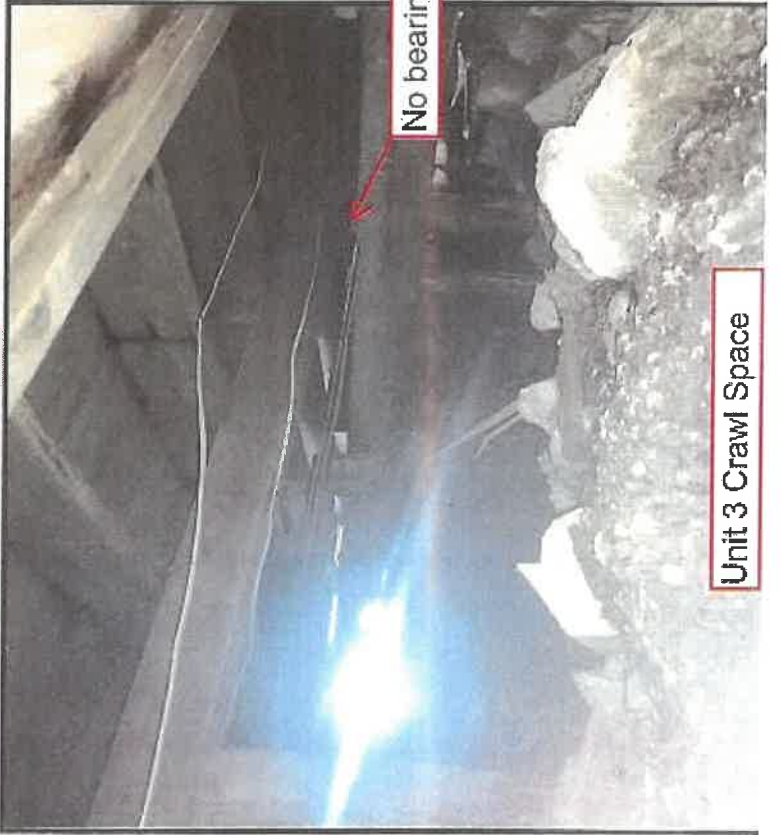
Unit 3 Crawl Space

No bearing

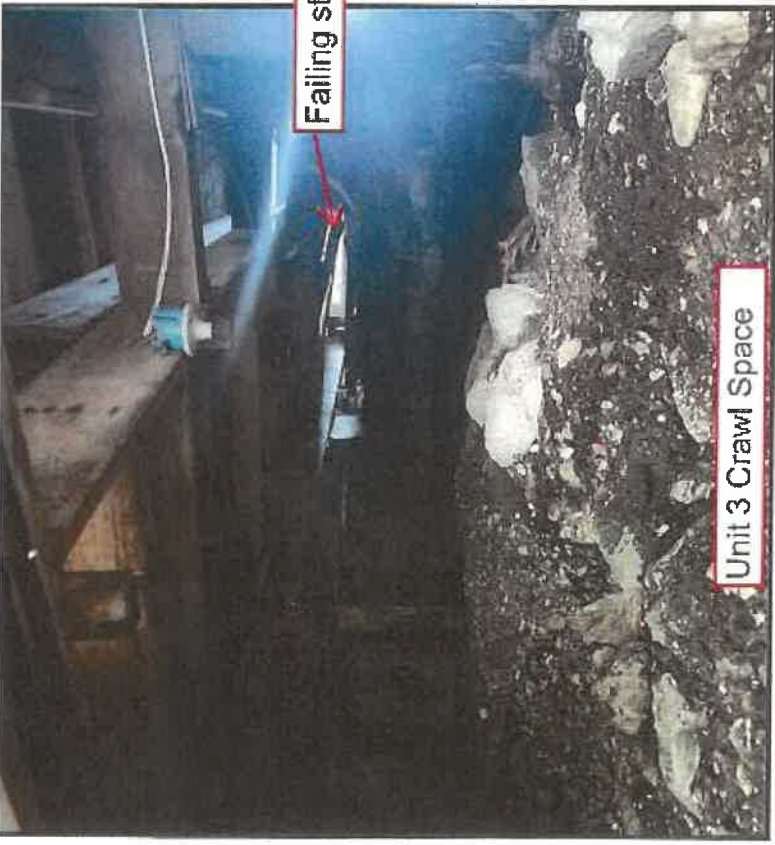
Unit 3 Crawl Space

Falling structure

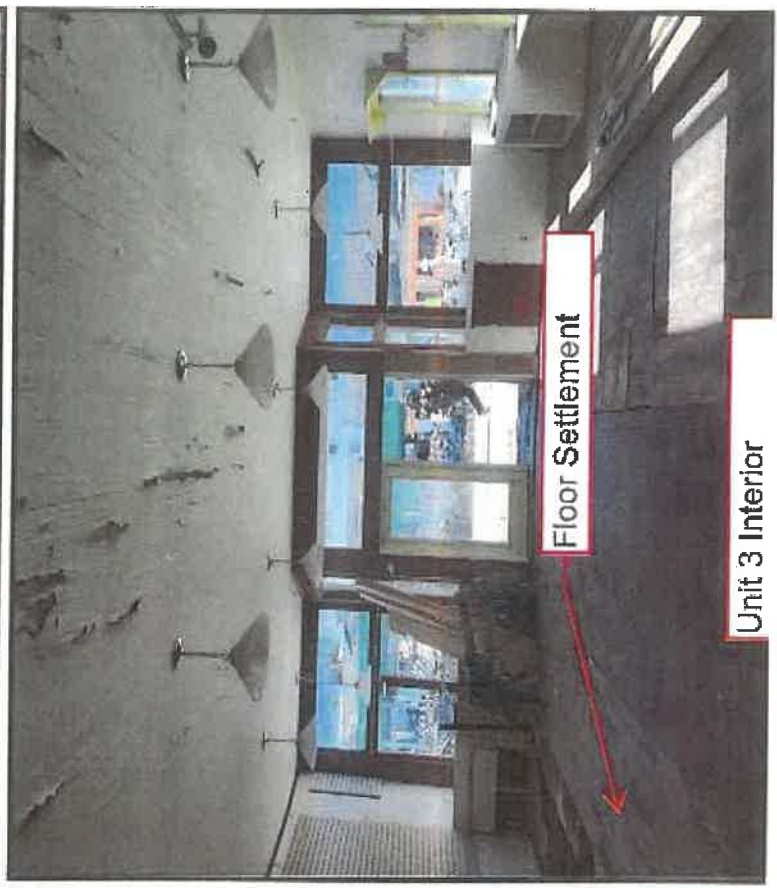
Unit 3 Interior

Floor Settlement

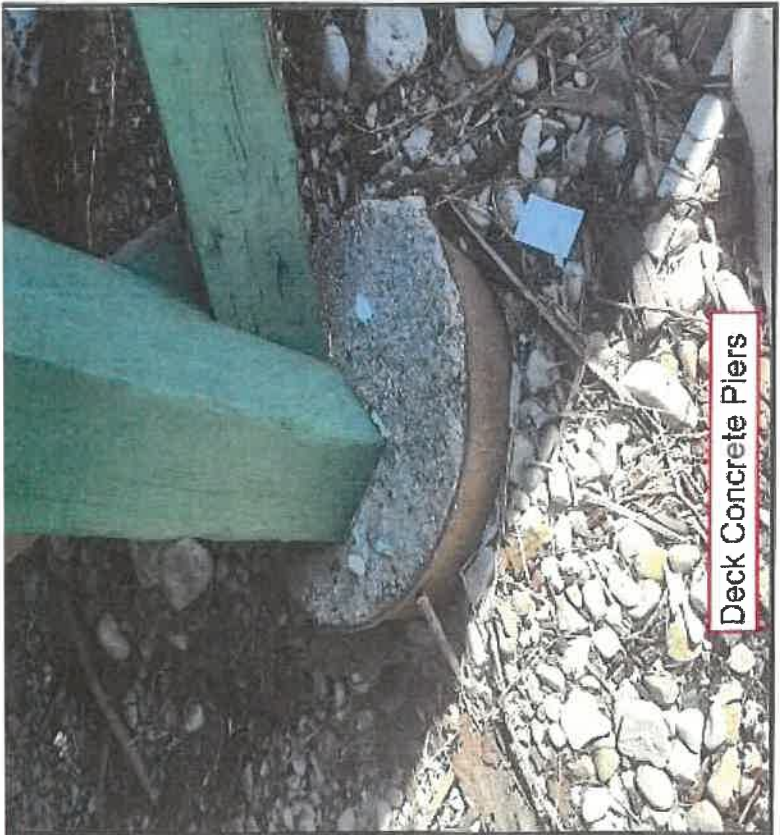
4. The foundation system for the deck consists of 2x10 joists at 18" on center bearing on double 2x10 beams. The beams are supported by 6x6 columns which bear on 18" diameter concrete piers of unknown depth. The deck foundation is tied into the building foundation at the south east side. The deck appears to be in fair condition.

Deck Concrete Piers
