Name: City of Madison Inspected by Calb Long Date 11-21-23
 Address 190 Graphics Dr Phone [H] _____ [W] _____
 City Madison State AL Zip 35758 Email _____ Cellular _____

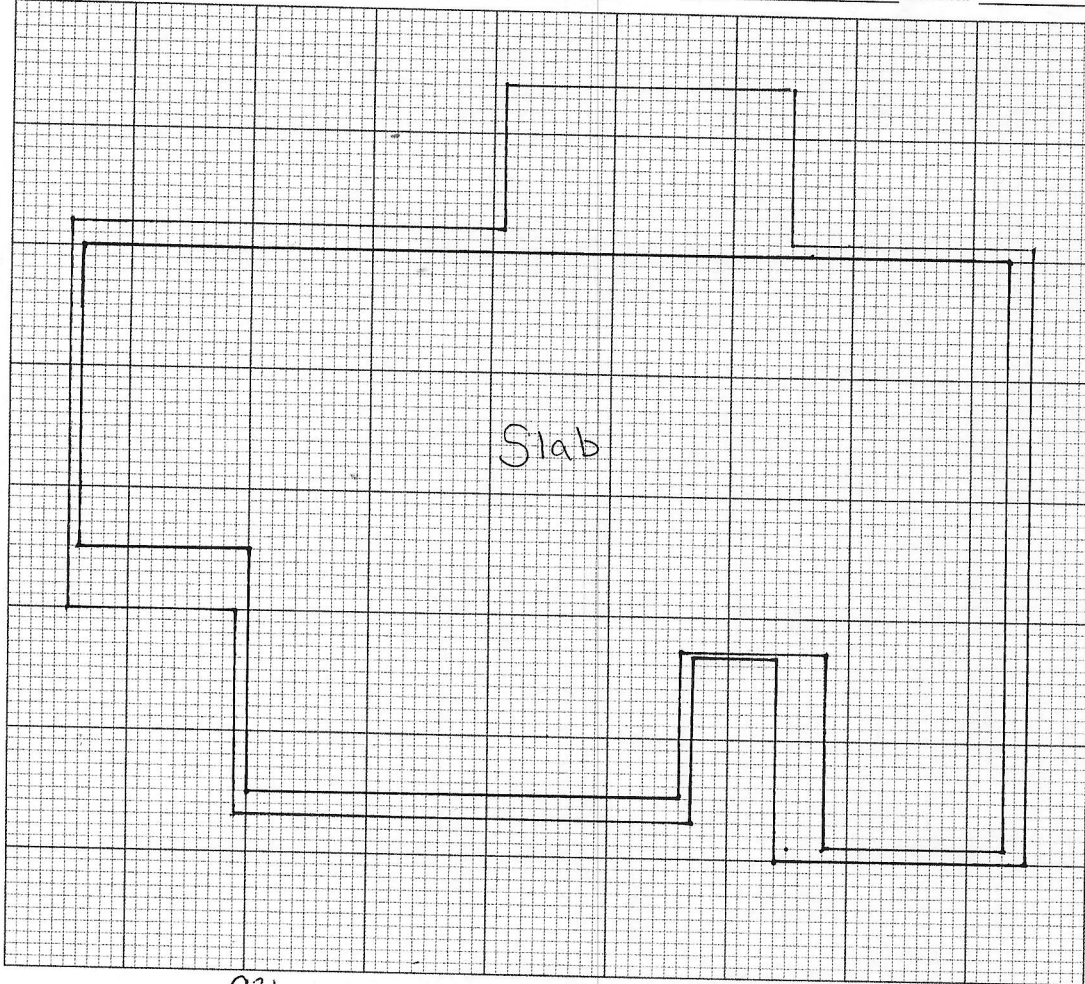
Structural Linear Feet 936 Sq. Ft. _____ Cu. Ft. _____ Scale: 1 Sq. = 3 Lin. Ft.
