FACILITY CONDITION REPORT: 40'X50' - POTABLE WATER TOWER

MANGUM, OK - COUNTY ROAD 1400 TOWER

AWWA D100 Potable Water Storage Tank (Location: North of Mangum, OK - East CR 1400)

12/14/2024 – Inspector: Alek Gray

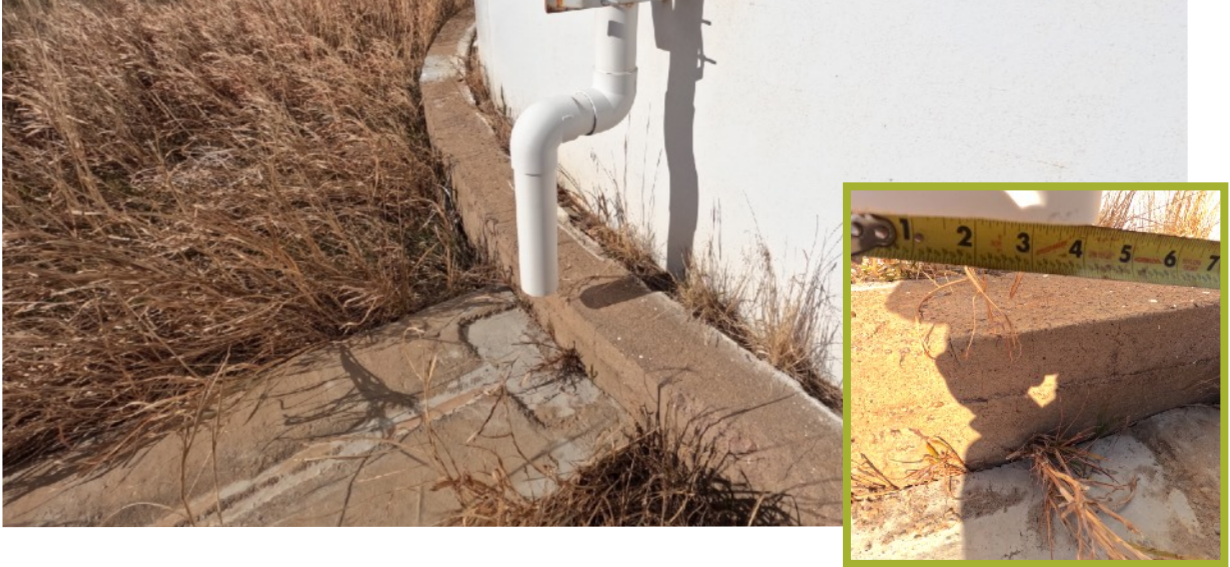
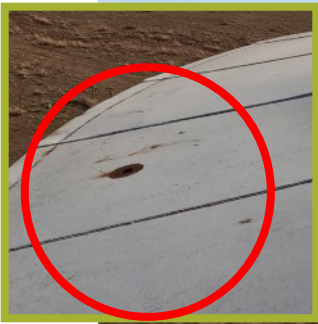
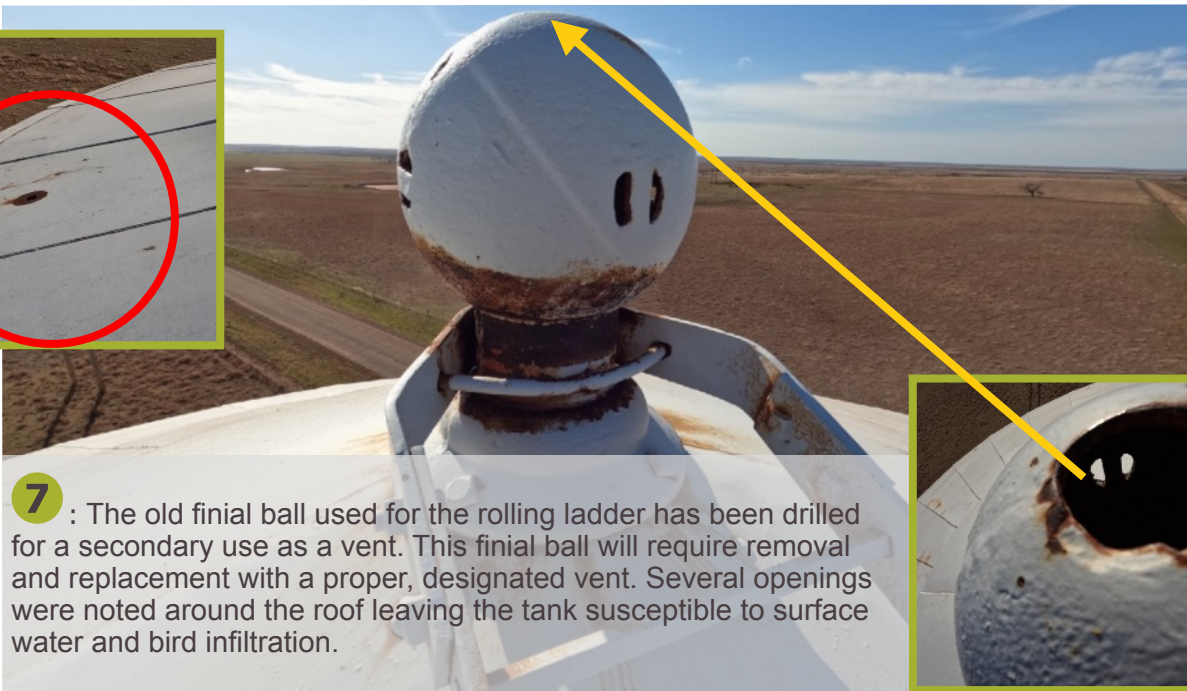
6 : The tower's overflow is unscreened and not equipped with a flap gate or any observable protection from insect infiltration.

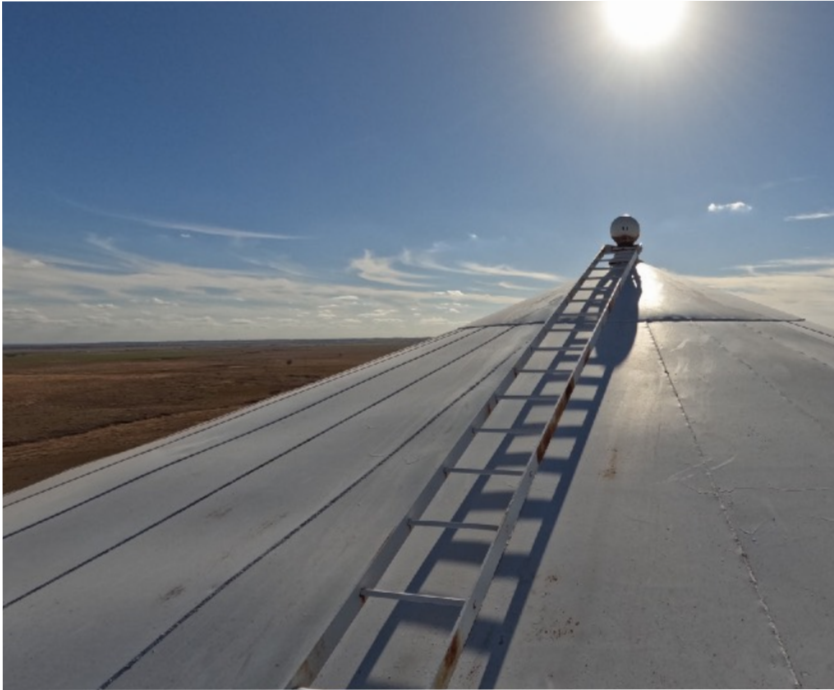
7 : The old finial ball used for the rolling ladder has been drilled for a secondary use as a vent. This finial ball will require removal and replacement with a proper, designated vent. Several openings were noted around the roof leaving the tank susceptible to surface water and bird infiltration.

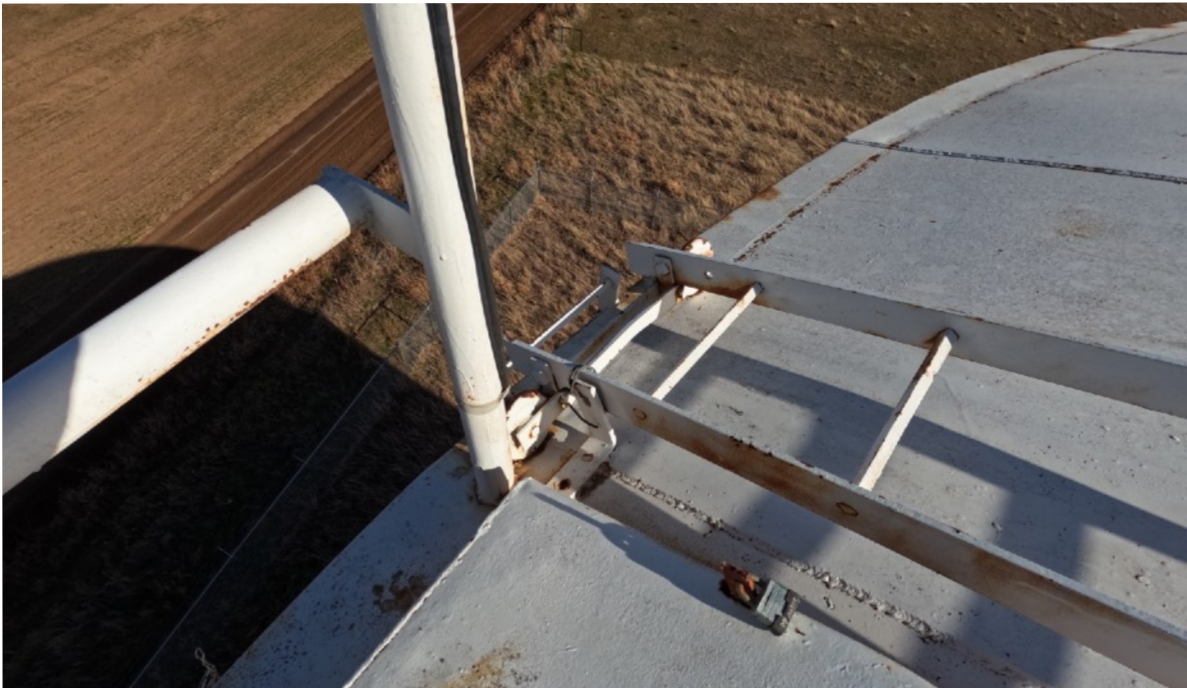
8 :The exterior, fixed ladders are not equipped with any fall protection devices as required by OSHA. The roof ladder is a rolling ladder, and will require being properly attached as rolling roof ladders are not allowed by OSHA.

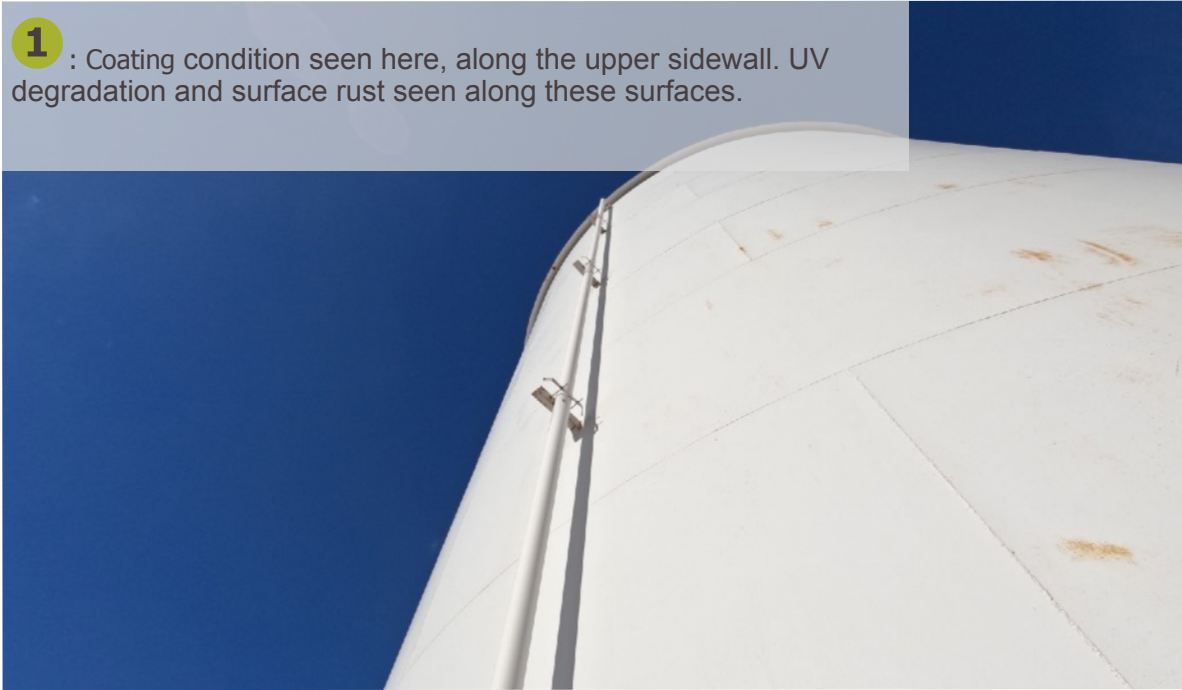
1 : Coating condition seen here, along the upper sidewall. UV degradation and surface rust seen along these surfaces.

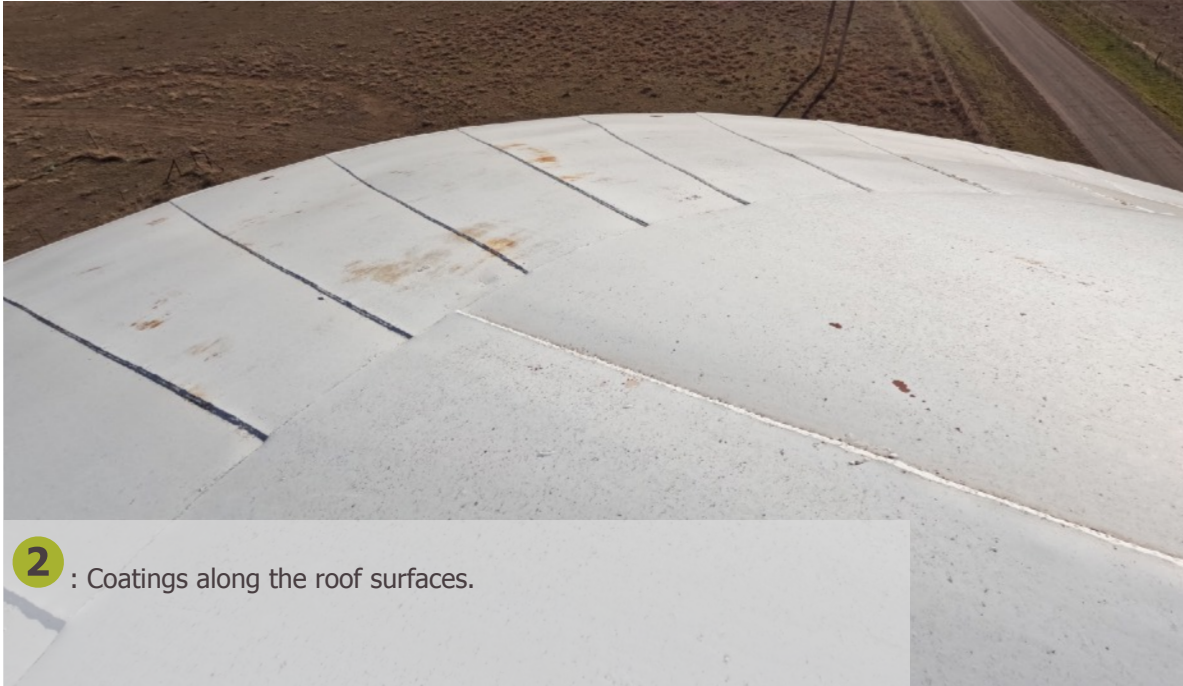
2 : Coatings along the roof surfaces.

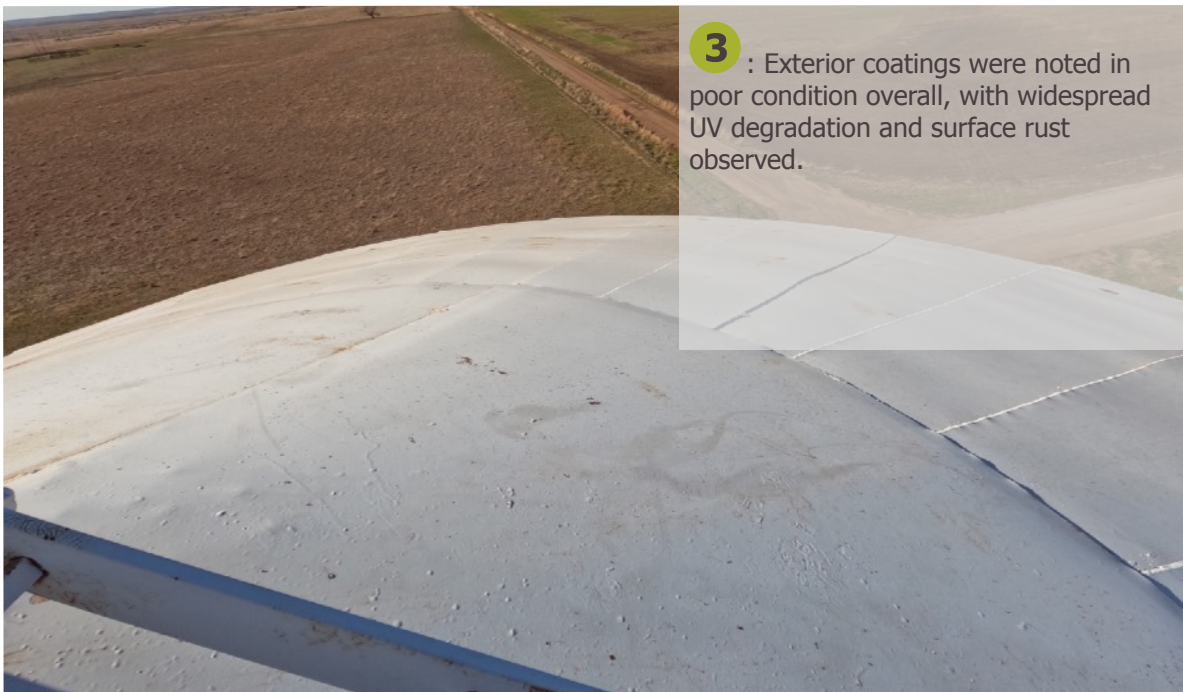
3 : Exterior coatings were noted in poor condition overall, with widespread UV degradation and surface rust observed.

⁴ All coatings applications necessitate, at minimum, a cursory evaluation of existing coatings in effort to determine an appropriate preparation procedure, as there are several factors that are considered when making these procedural determinations. Coating specifications should be obtained by a selected paint manufacturer or engineer.

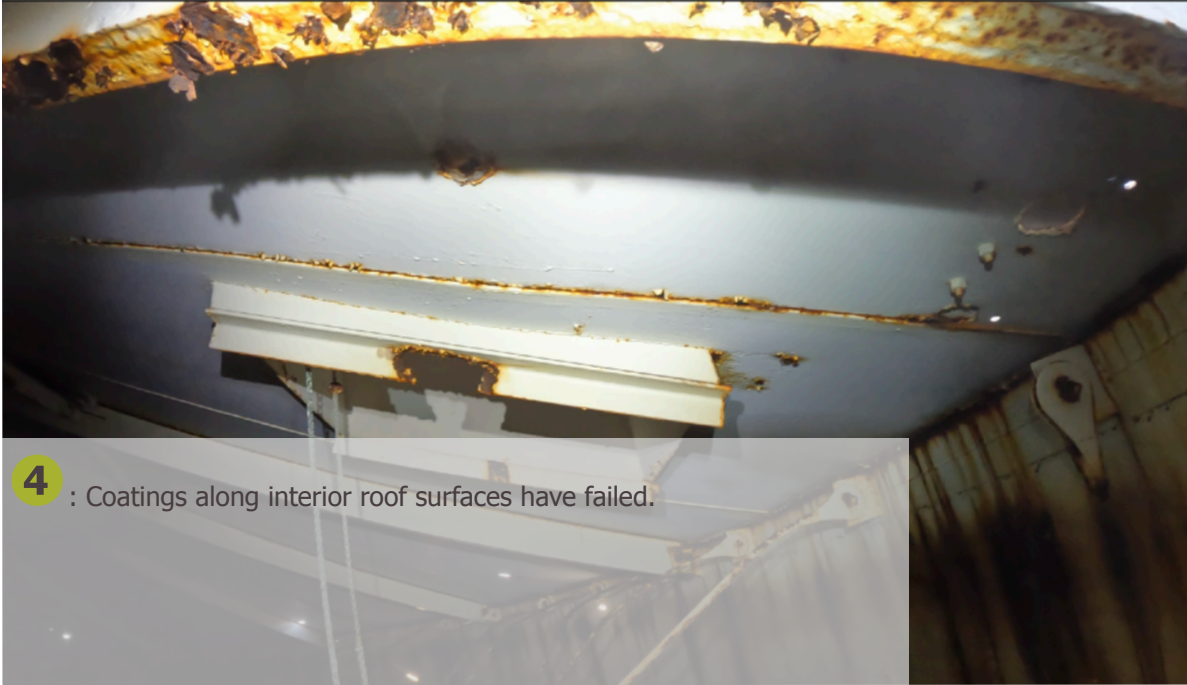
4 : Coatings along interior roof surfaces have failed.

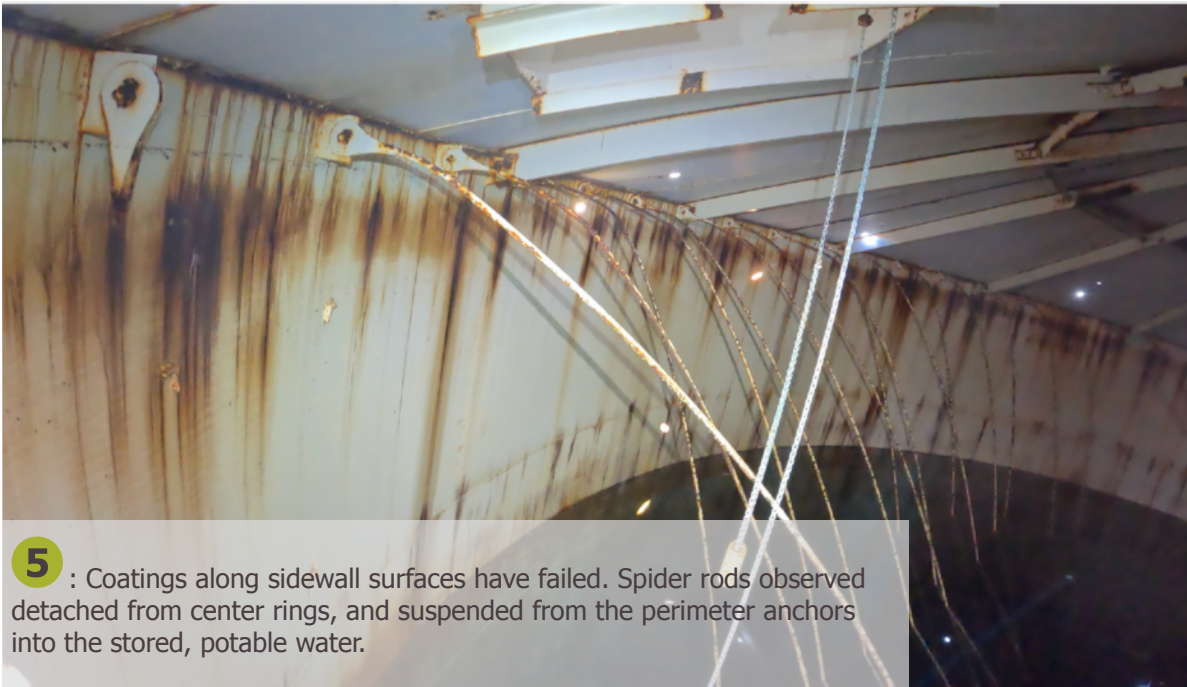
5 : Coatings along sidewall surfaces have failed. Spider rods observed detached from center rings, and suspended from the perimeter anchors into the stored, potable water.

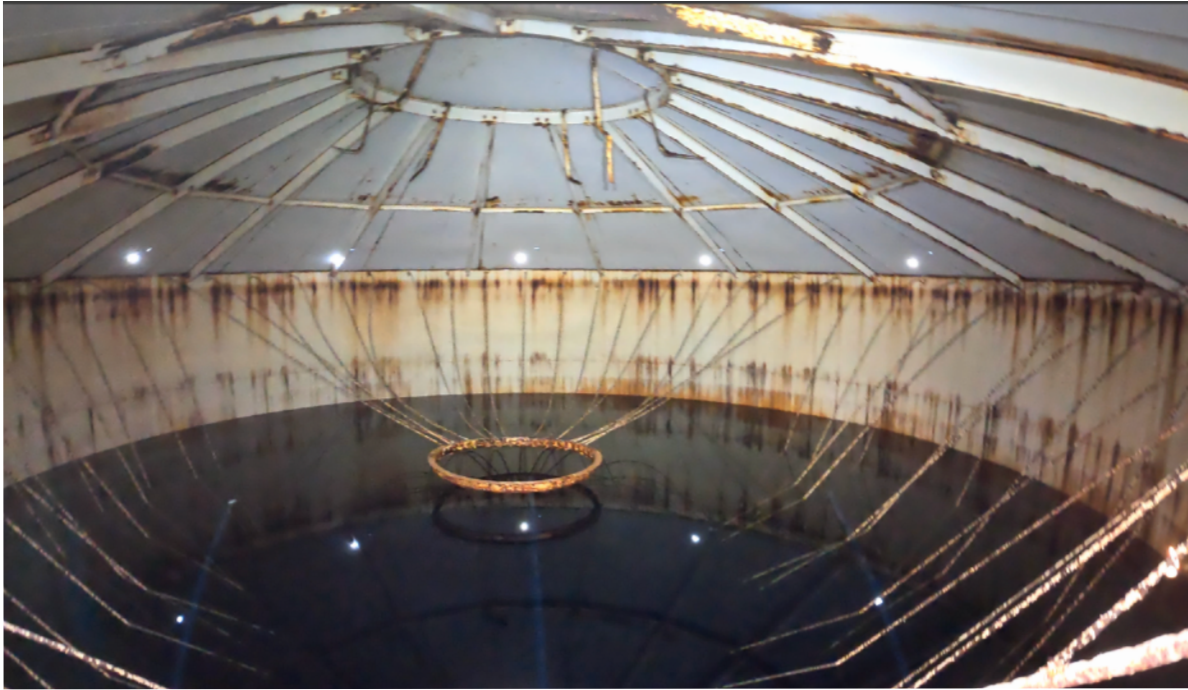
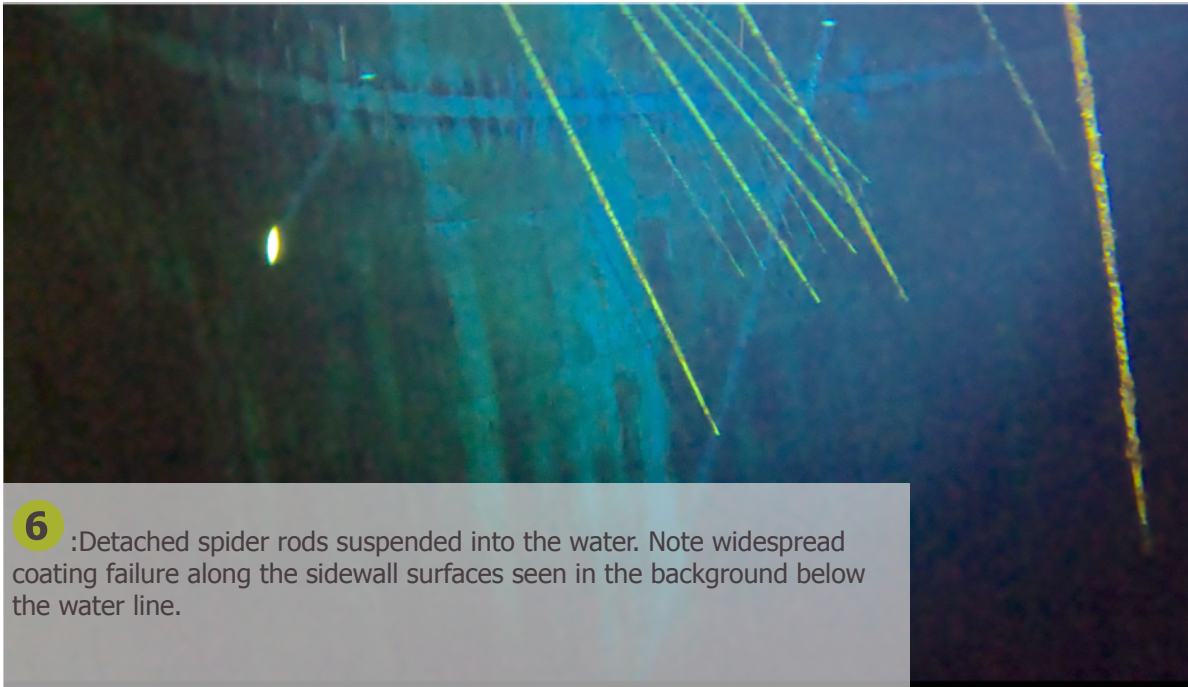
6 :Detached spider rods suspended into the water. Note widespread coating failure along the sidewall surfaces seen in the background below the water line.

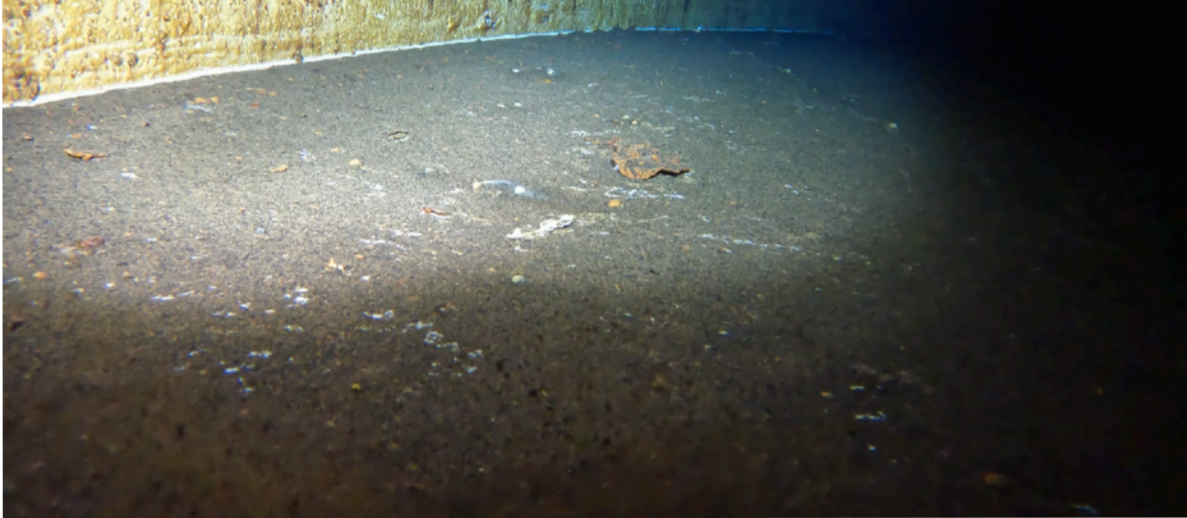
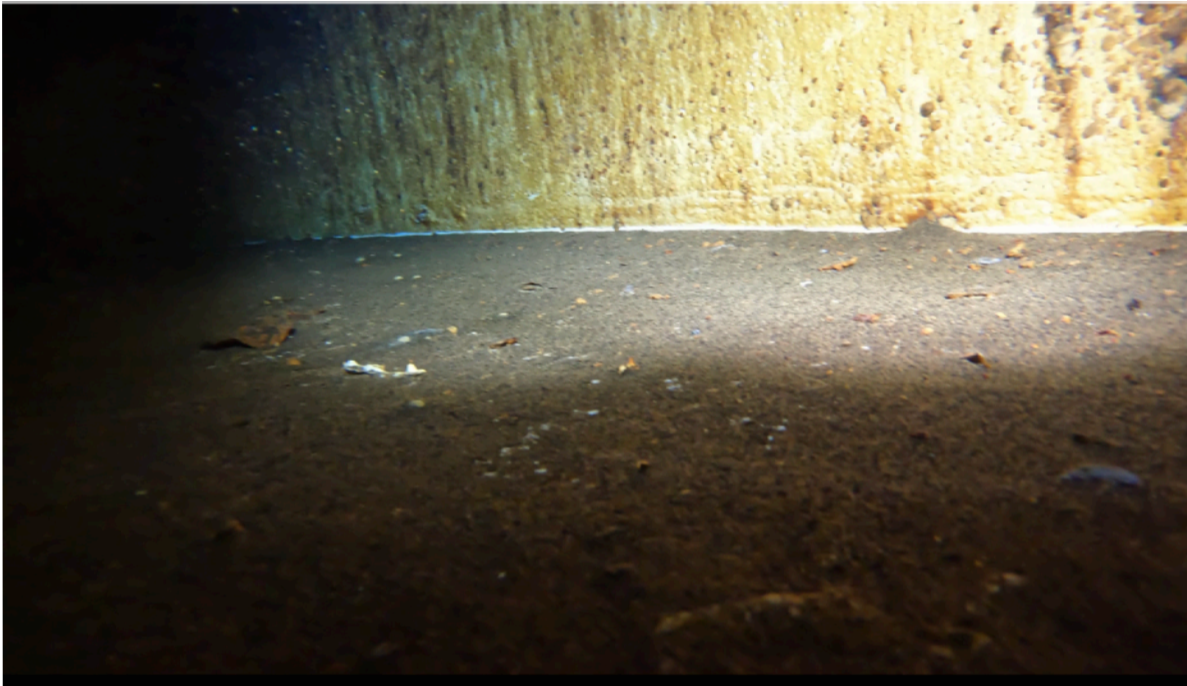
7 : Significant sediment accumulation and unidentified debris observed along the tower's floor. This sediment should be removed in effort to reduce the possibility of disinfection byproduct development.
