FACILITY CONDITION REPORT: 45'X86' - POTABLE WATER TOWER

MANGUM, OK - KERN AVE TOWER

AWWA D100 Potable Water Storage Tank (Location: Mangum, OK - Kern Avenue)

12/14/2024 – Inspector: Alek Gray

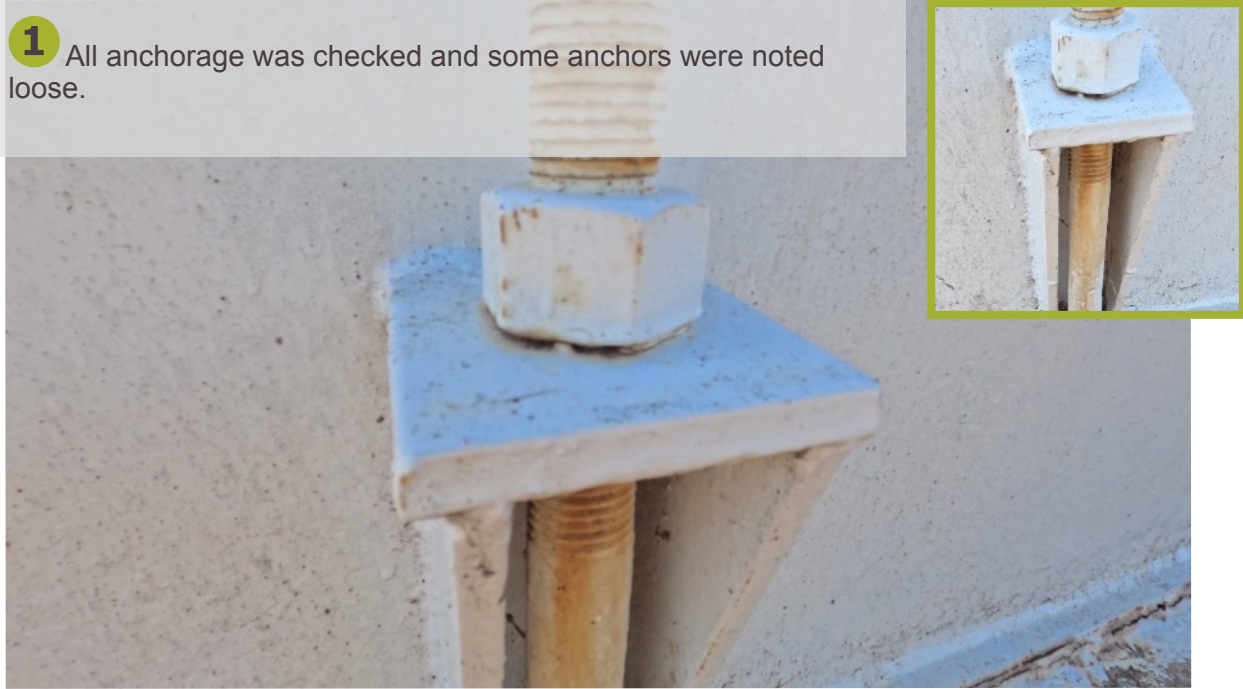
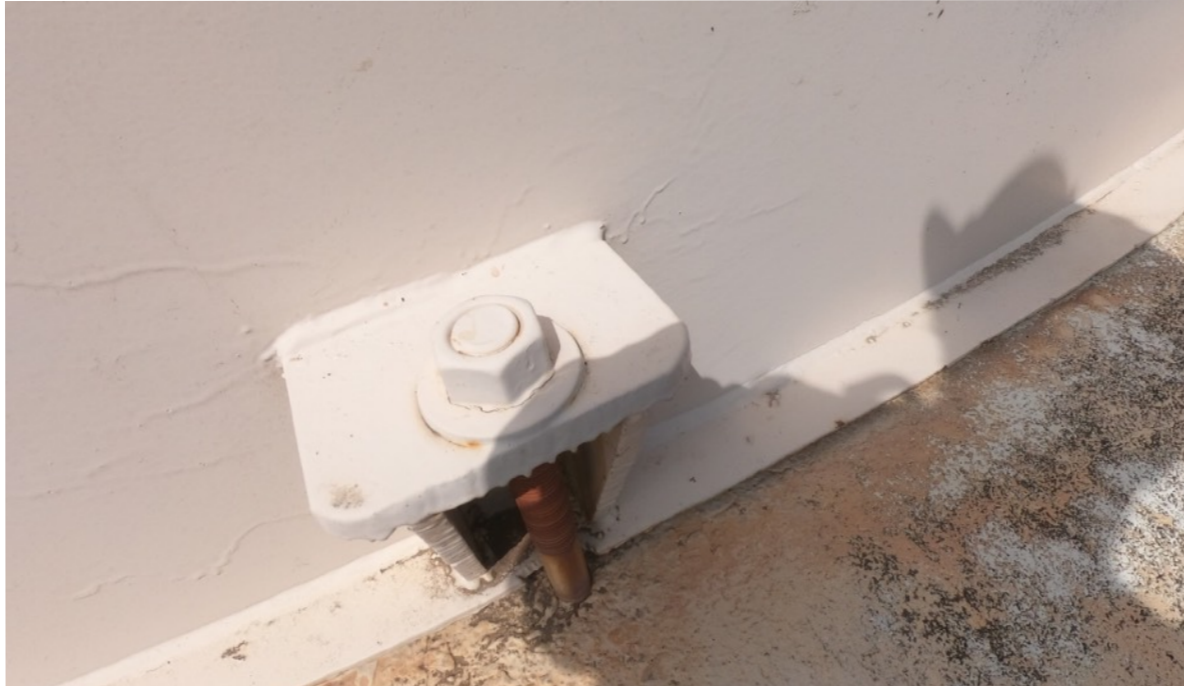
1 All anchorage was checked and some anchors were noted loose.

7. Light cracks were observed along the concrete foundation. These cracks should be sealed to prevent freeze damage.
8. Certain anchors were noted loose and should be properly tightened.

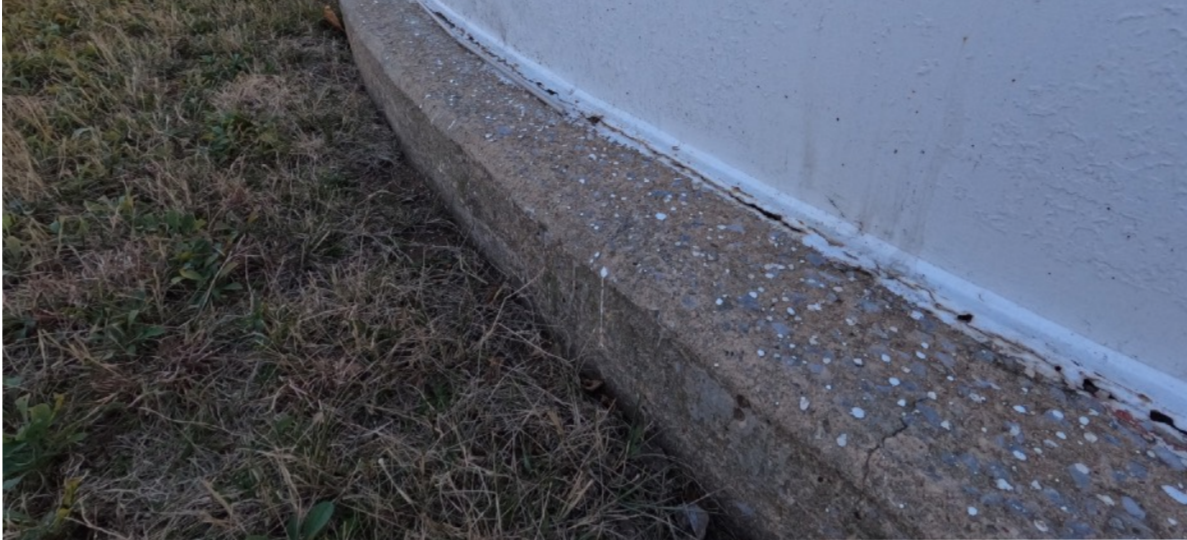
2 Earth around the concrete foundation was noted properly excavated and maintained.

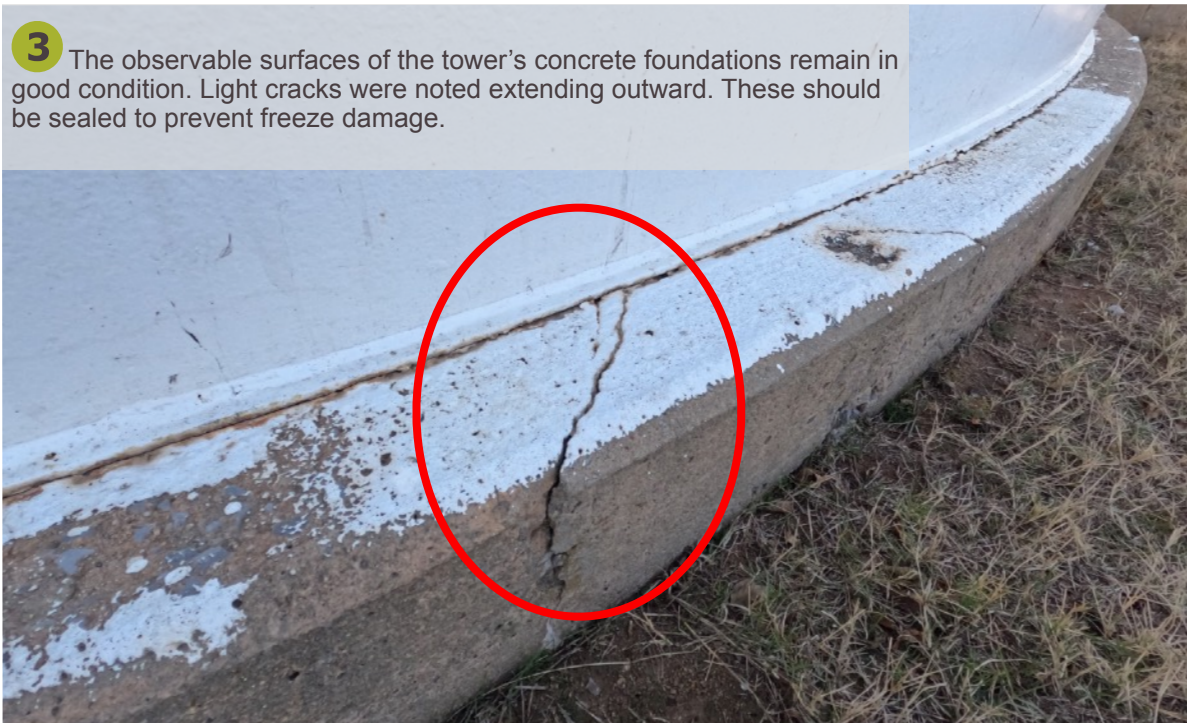
3 The observable surfaces of the tower's concrete foundations remain in good condition. Light cracks were noted extending outward. These should be sealed to prevent freeze damage.

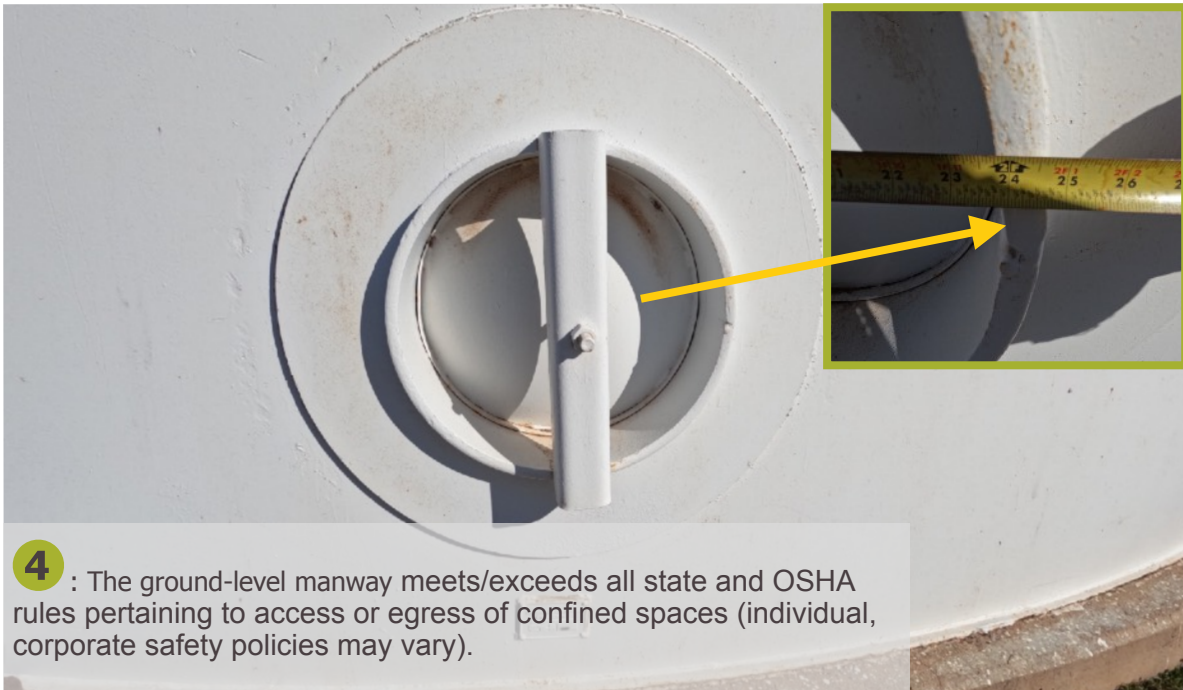
4 : The ground-level manway meets/exceeds all state and OSHA rules pertaining to access or egress of confined spaces (individual, corporate safety policies may vary).

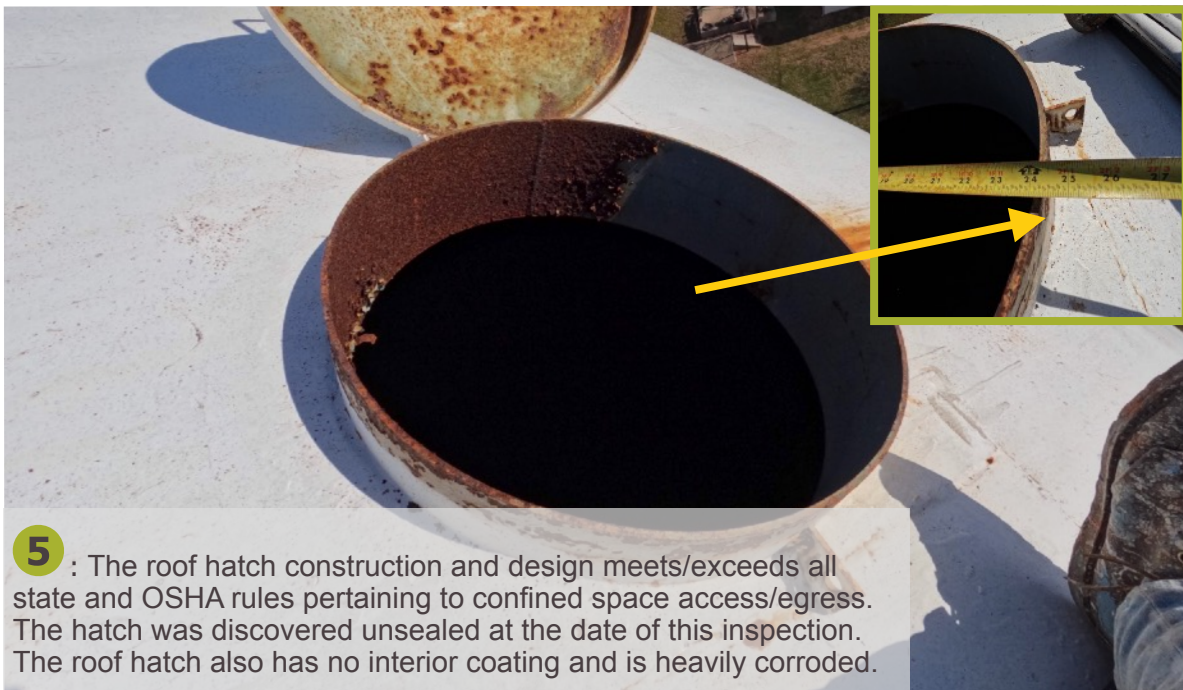
5 : The roof hatch construction and design meets/exceeds all state and OSHA rules pertaining to confined space access/egress. The hatch was discovered unsealed at the date of this inspection. The roof hatch also has no interior coating and is heavily corroded.

4. The exterior, fixed ladder is not equipped with an operable fall-arrest system as required by OSHA.
5. There is no seal along the roof hatch as required by ODEQ.

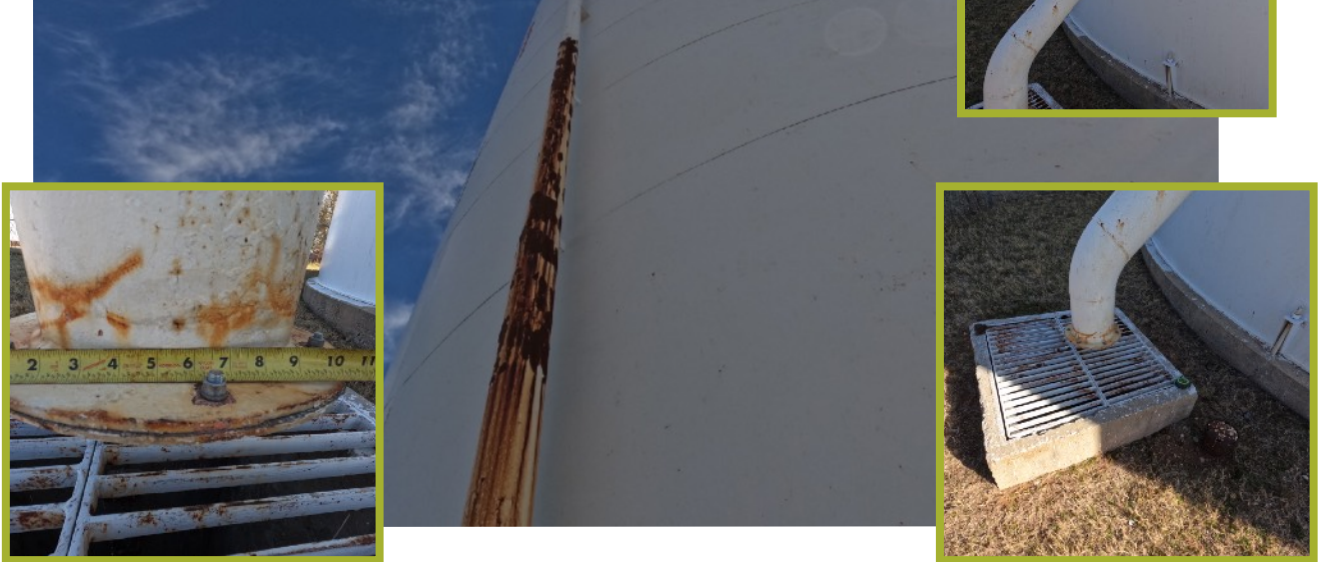
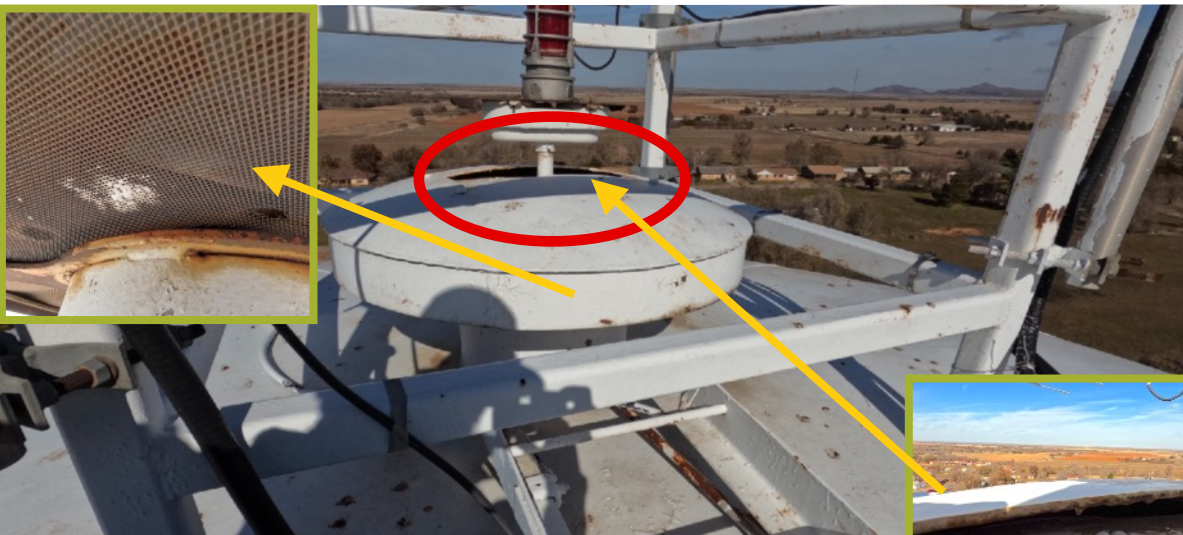
6 :The tower's overflow has an apparent crack (likely from ice damage). This is speculative based on unusually heavy corrosion blistering along this area and stain streaking. The overflow will likely require replacement.

9. The overflow is cracked and requires replacement.

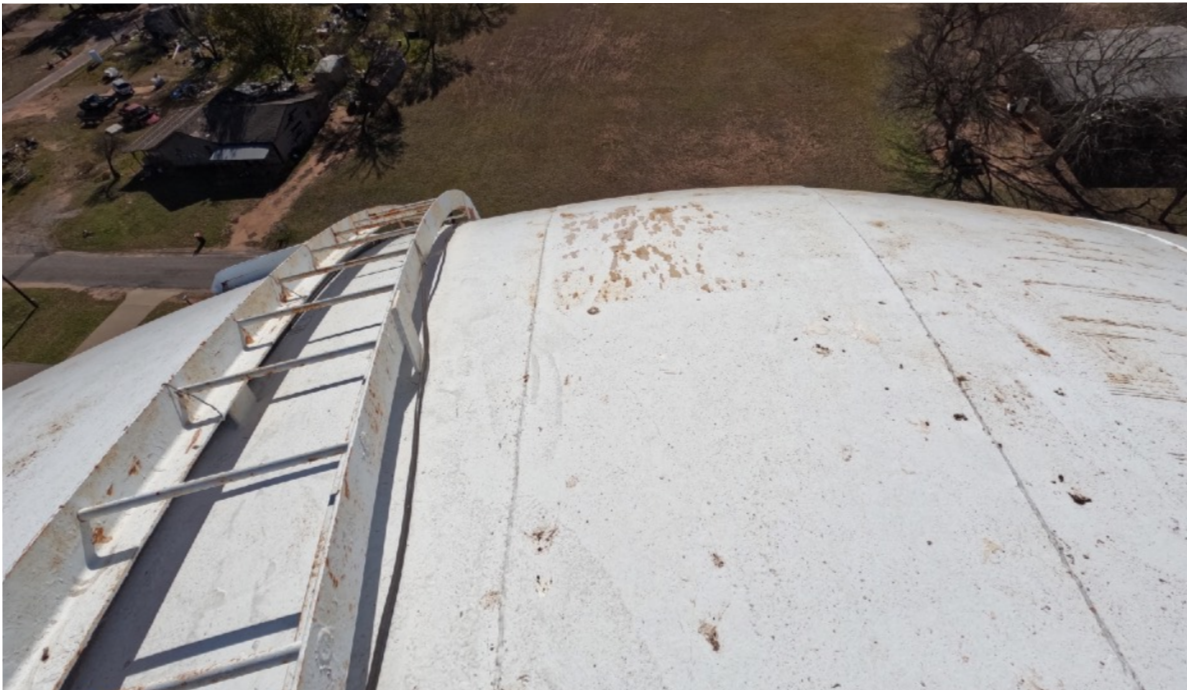
8 :The exterior, fixed ladder was noted in good condition. The exterior ladder is not equipped with an operable fall-arrest system.

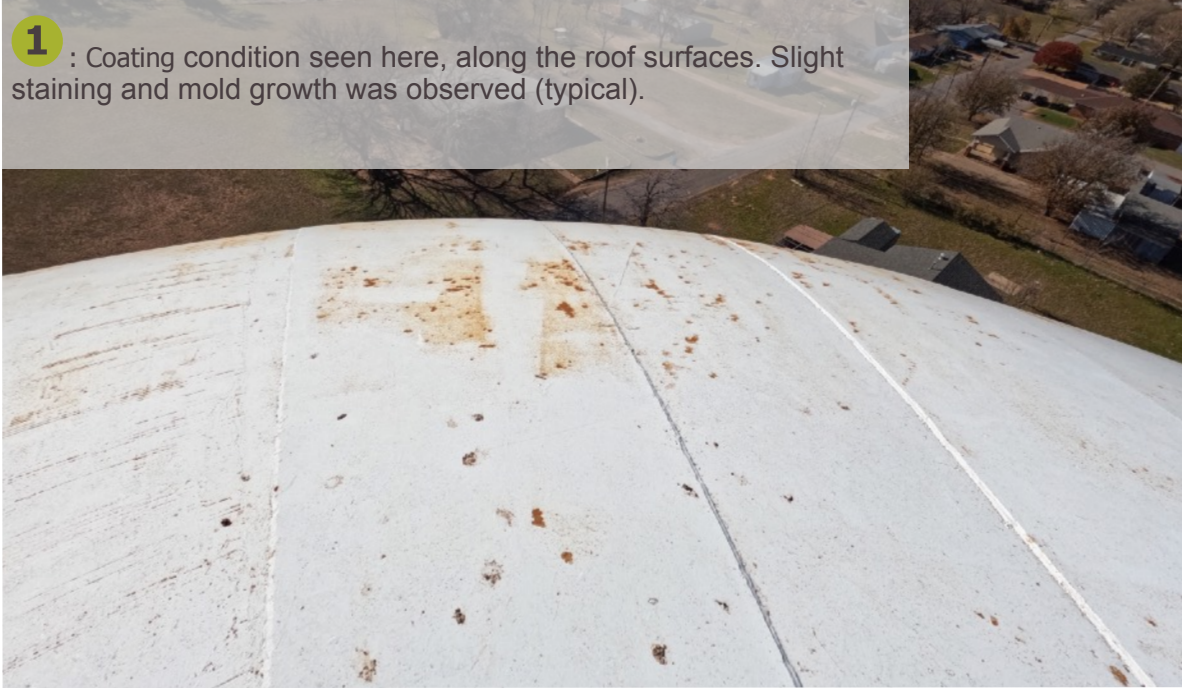
1 : Coating condition seen here, along the roof surfaces. Slight staining and mold growth was observed (typical).

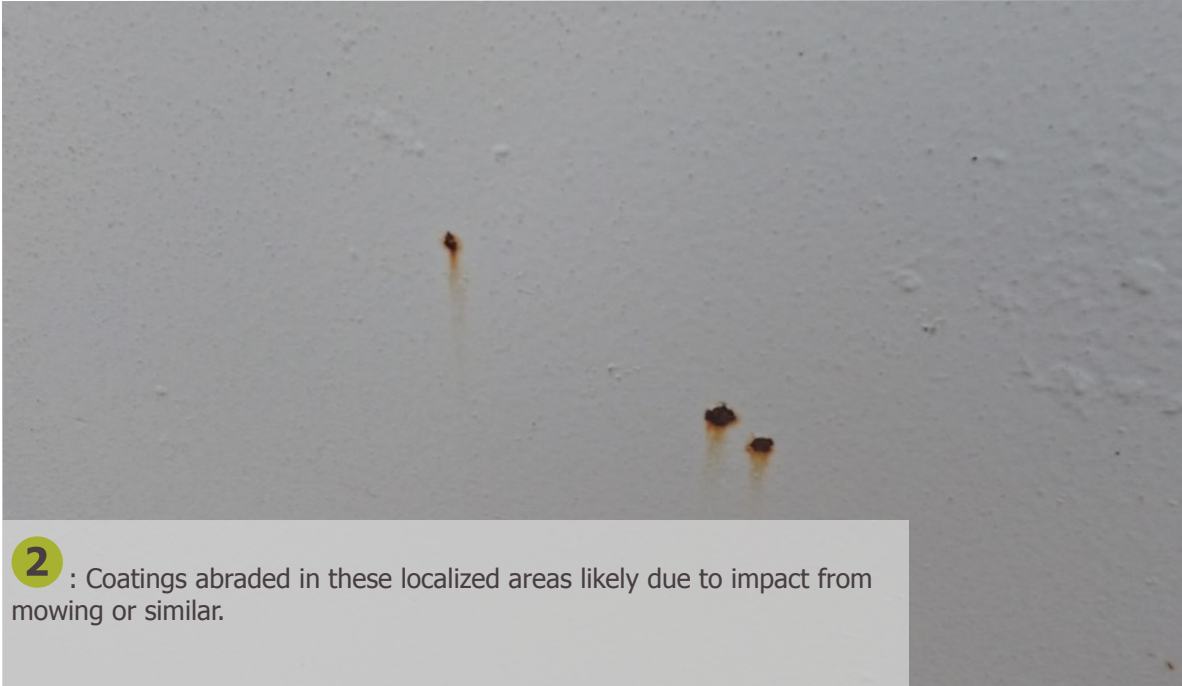
2 : Coatings abraded in these localized areas likely due to impact from mowing or similar.

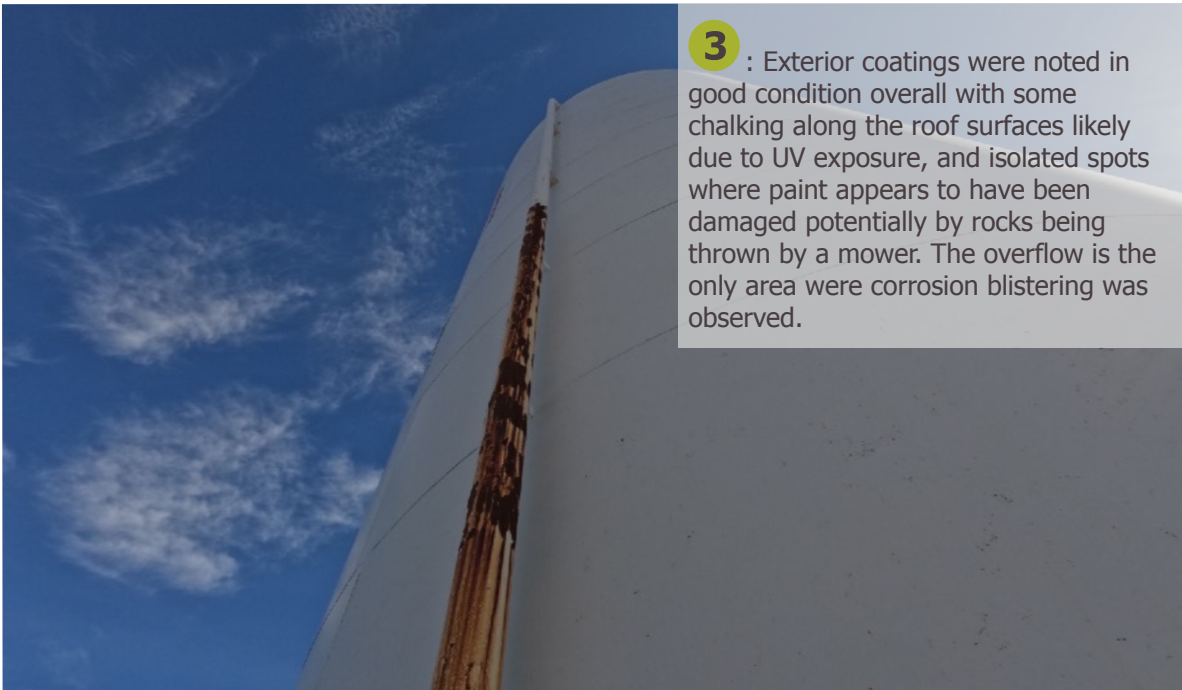
3 : Exterior coatings were noted in good condition overall with some chalking along the roof surfaces likely due to UV exposure, and isolated spots where paint appears to have been damaged potentially by rocks being thrown by a mower. The overflow is the only area where corrosion blistering was observed.

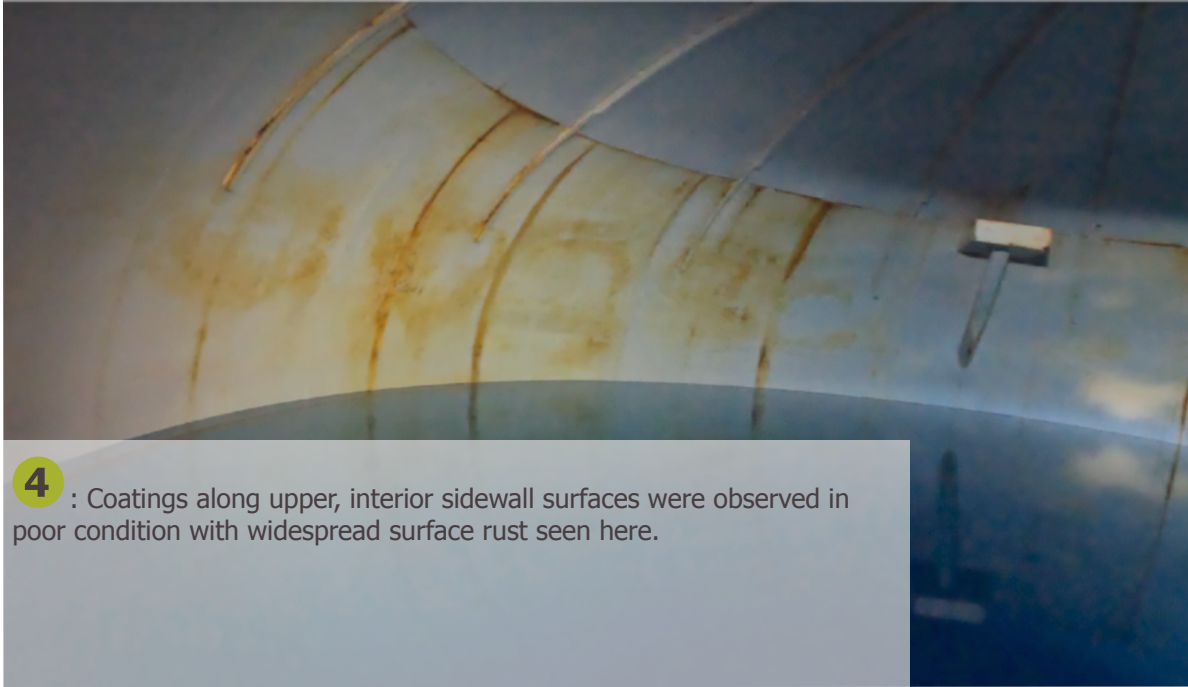
4 : Coatings along upper, interior sidewall surfaces were observed in poor condition with widespread surface rust seen here.

1. The interior coating system was noted in poor condition as widespread surface rust has developed along surfaces above the water line.¹ The roof support structure exhibited significant corrosion blistering. This interior will require renovation.

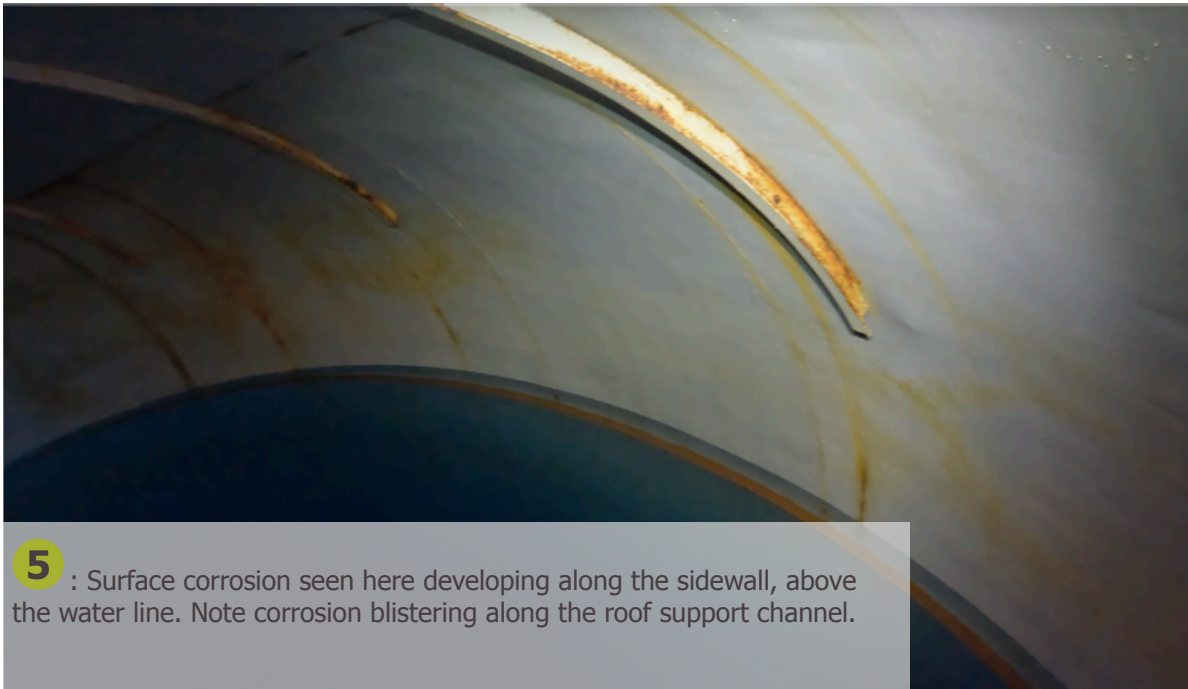
5 : Surface corrosion seen here developing along the sidewall, above the water line. Note corrosion blistering along the roof support channel.
