**FACILITY CONDITION REPORT: 250M CAPACITY - ELEVATED POTABLE WATER TOWER**

**MANGUM, OK - DOWNTOWN TOWER**

Potable Water Storage Tower (Location: Downtown Mangum, OK - Pigg St & Commerce)

12/14/2024 – Inspector: Alek Gray

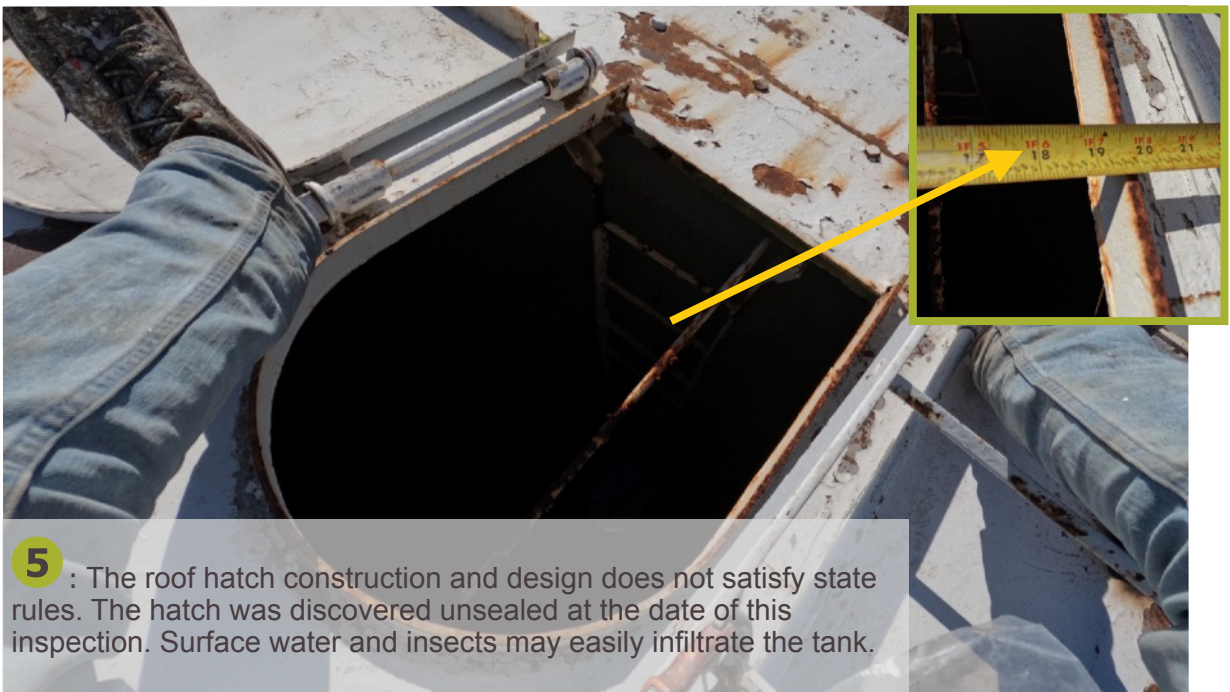
**5** : The roof hatch construction and design does not satisfy state rules. The hatch was discovered unsealed at the date of this inspection. Surface water and insects may easily infiltrate the tank.

5. There is no seal along the roof hatch as required by ODEQ. The roof hatch does not meet ODEQ standards and should be replaced.
6. The tower is equipped with a finial ball on the roof's apex, and this finial ball has been drilled to allow for ventilation. This finial ball should be replaced with a proper vent.

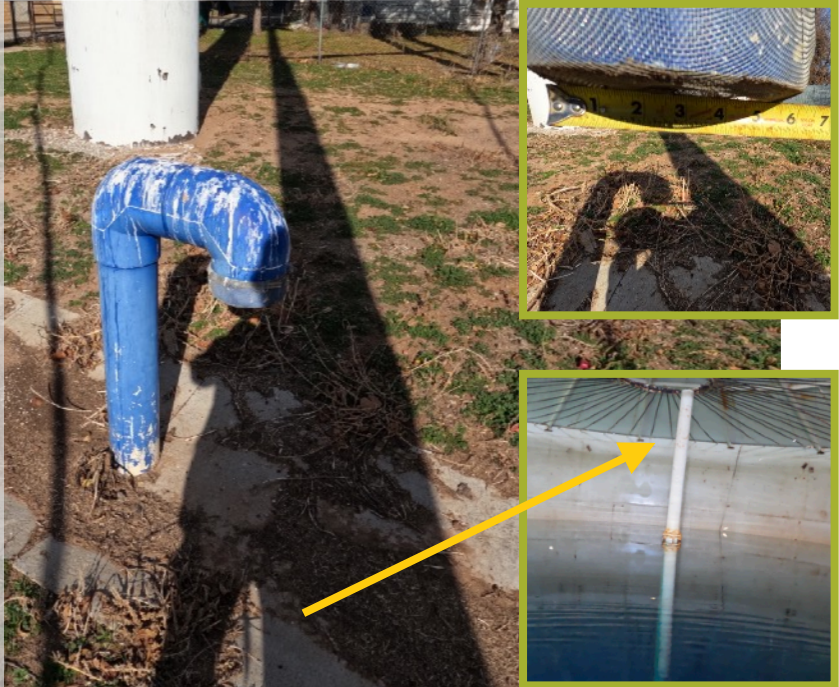
**6** : The tower's 6", interior overflow extends from beneath the ground, and is protected with a screen (see specific standard on the final page).

The overflow extending inside the tank can be seen in the lower inset photograph to the right.

This overflow will likely need to be fully replaced as properly preparing the interior surfaces of the riser behind interior overflow is unlikely.

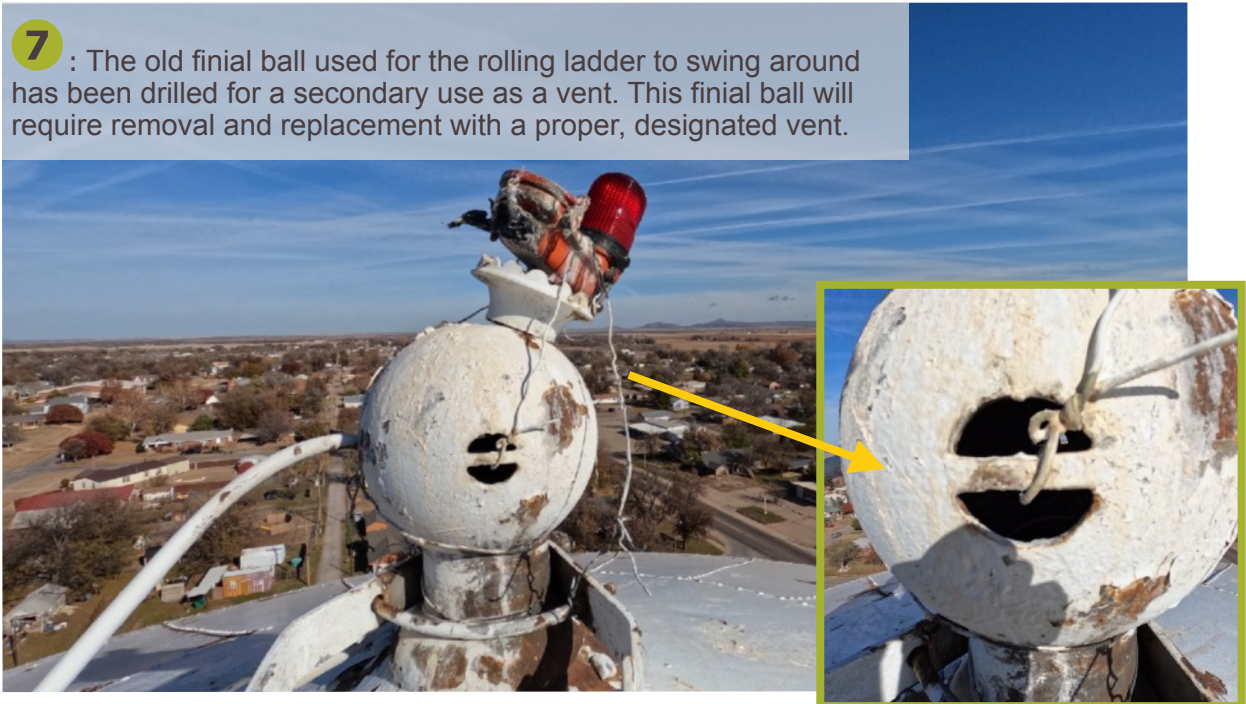
**7** : The old finial ball used for the rolling ladder to swing around has been drilled for a secondary use as a vent. This finial ball will require removal and replacement with a proper, designated vent.

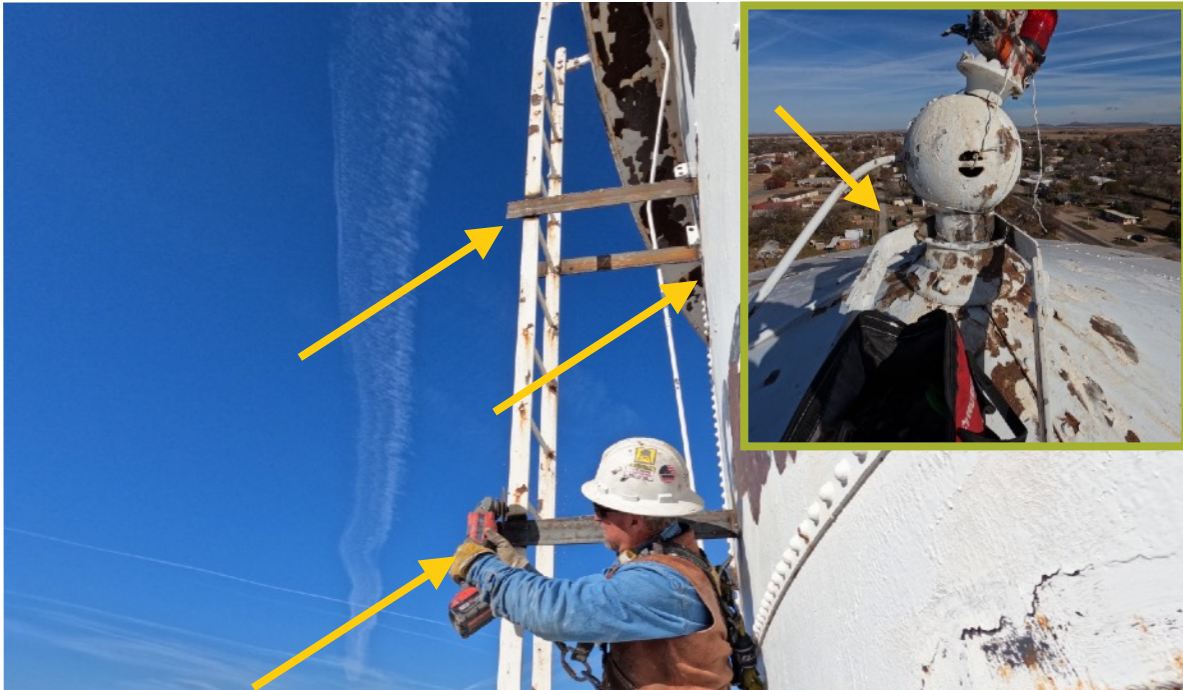
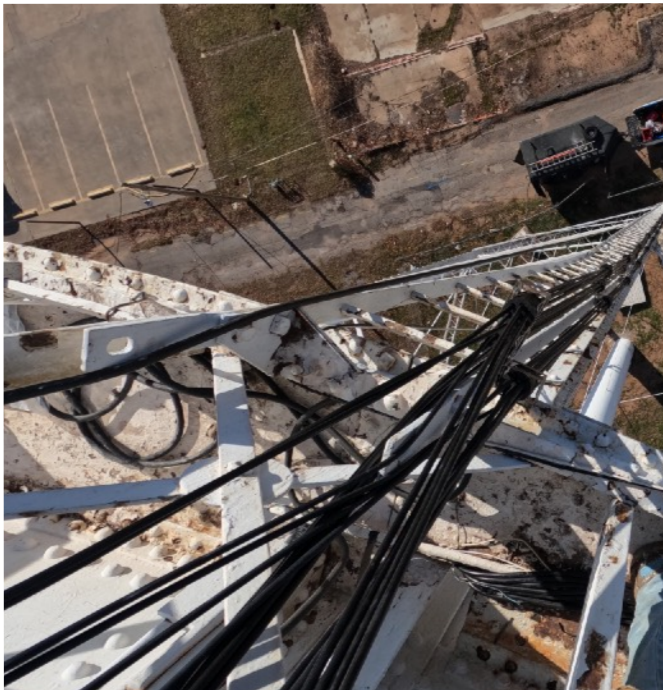
**8** : The exterior, fixed ladders are not equipped with any fall protection system as required by OSHA. Note in the above photograph, temporary repairs being performed by inspection crew. The roof ladder is a rolling ladder. The roof and shell ladders will need to be replaced and/or relocated and properly attached as required (rolling roof ladders are not allowed by OSHA). See photograph of interior ladder on page 13. This interior ladder is unsafe for any use by any personnel!

The leg ladder has been covered in telecom coax. All coax must be removed from the handrail of the ladder. This is seen to the left.

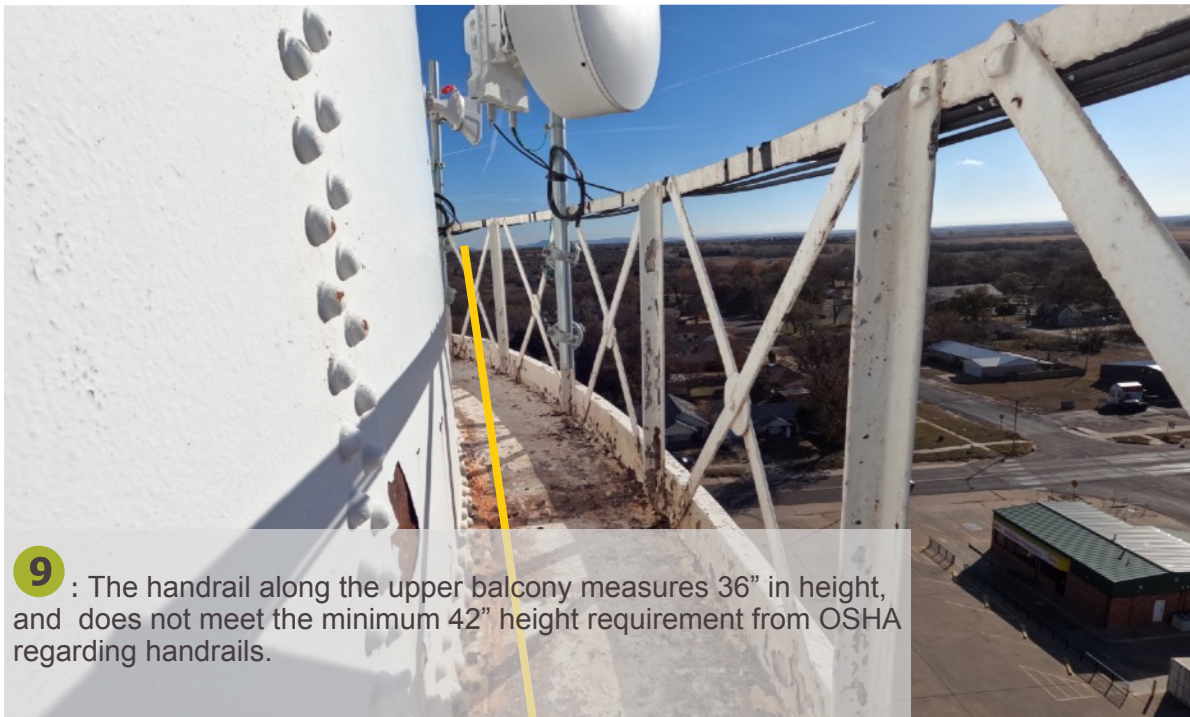
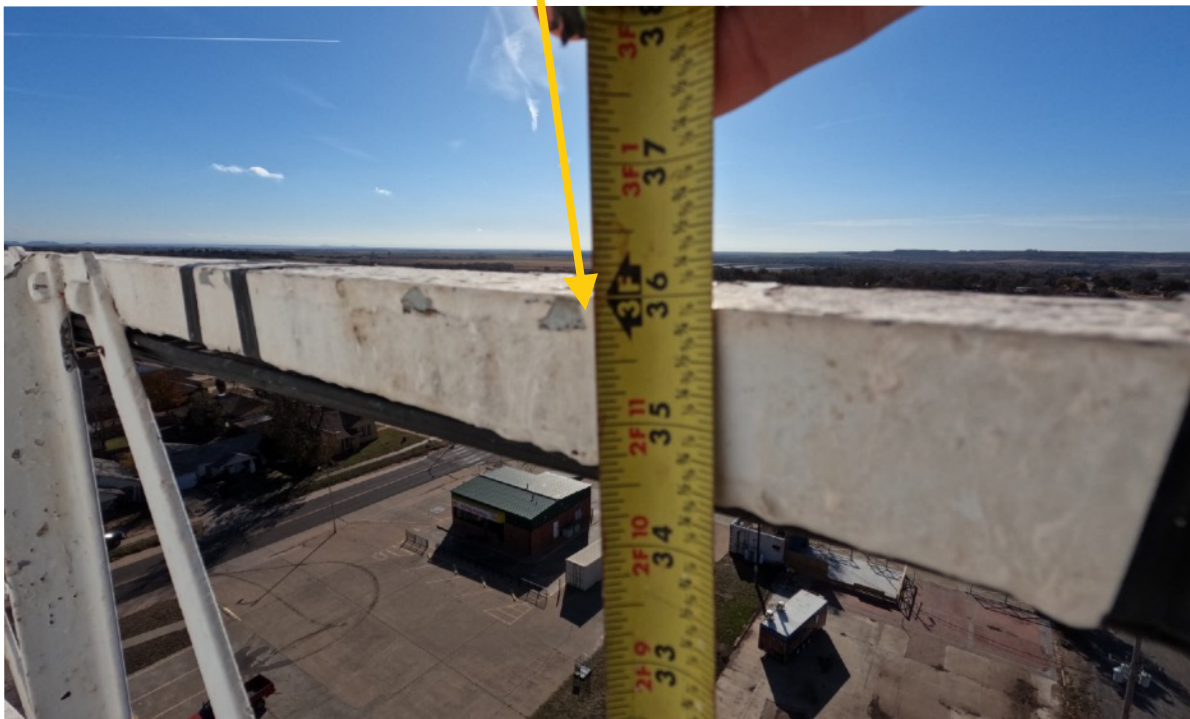
3

<sup>3</sup> On November 18, 2016, OSHA issued a final rule updating its general industry Walking- Working Surfaces standards. In the preamble, the final rule explicitly rescinds STD 01-01-010 and all subsequent letters of interpretation allowing guardrails to have a minimum height of 36 inches. Previously, this interpretation letter (STD 01-01-010) had allowed handrails which were installed before the writing of the current rule to be “grandfathered”.

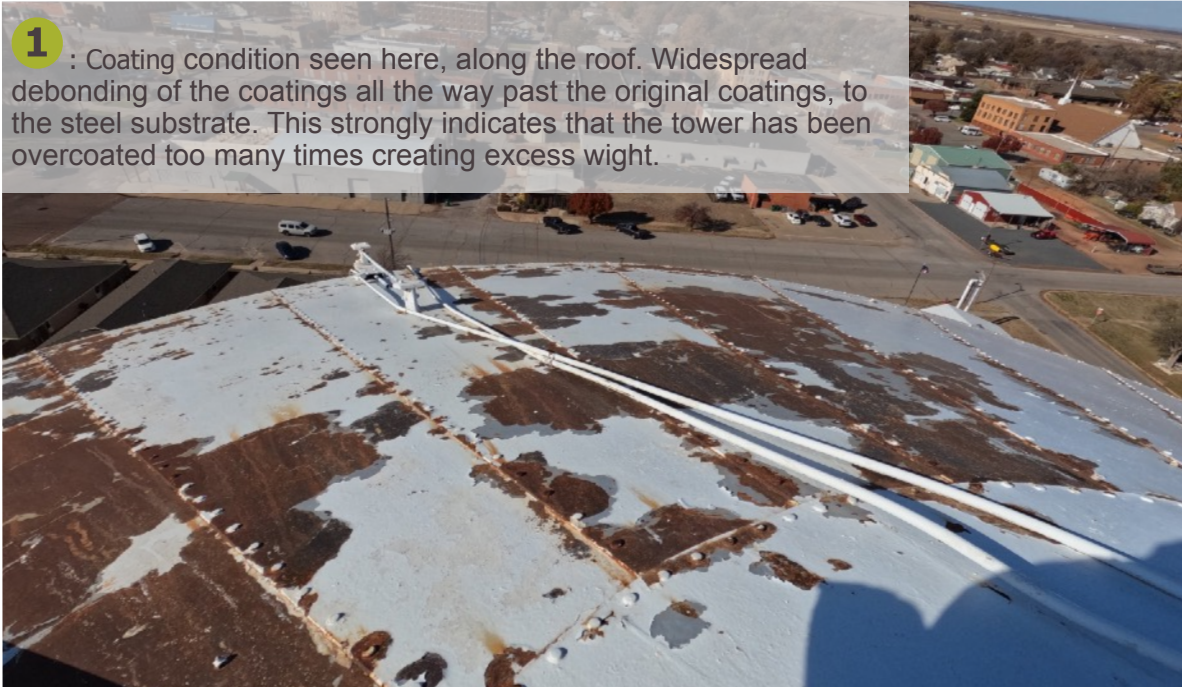
**1** : Coating condition seen here, along the roof. Widespread debonding of the coatings all the way past the original coatings, to the steel substrate. This strongly indicates that the tower has been overcoated too many times creating excess wight.

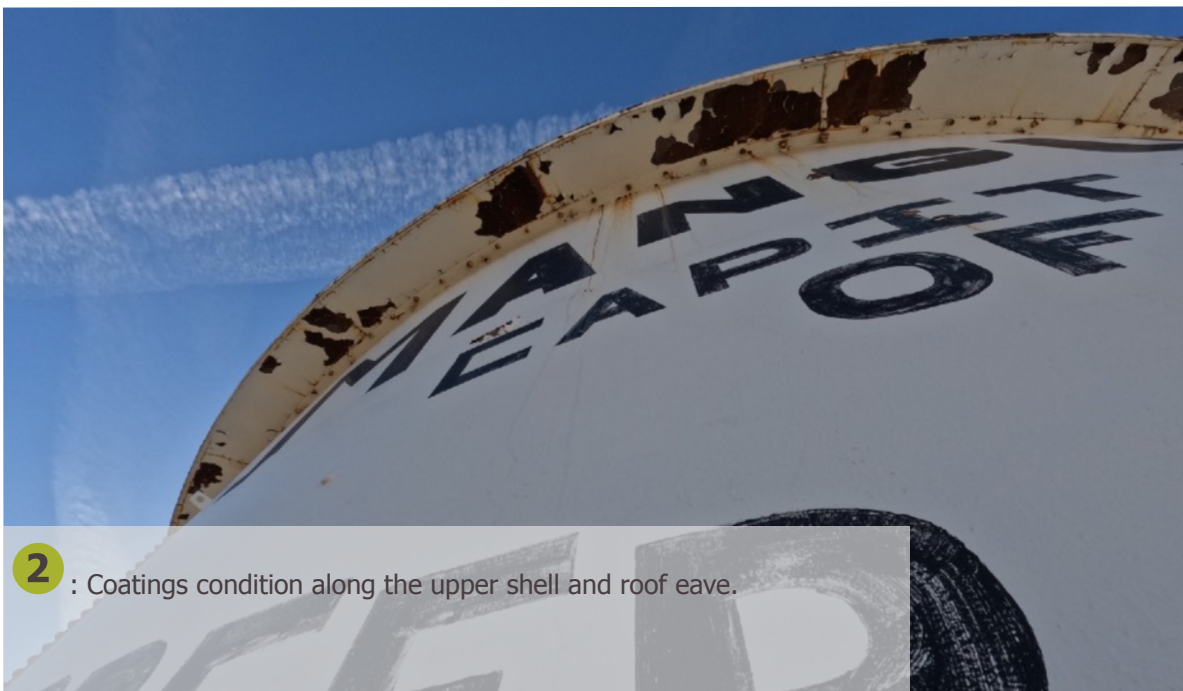
**2** : Coatings condition along the upper shell and roof eave.

<sup>4</sup> All coatings applications necessitate, at minimum, a cursory evaluation of existing coatings in effort to determine an appropriate preparation procedure, as there are several factors that are considered when making these procedural determinations. Coating specifications should be obtained by a selected paint manufacturer or engineer.

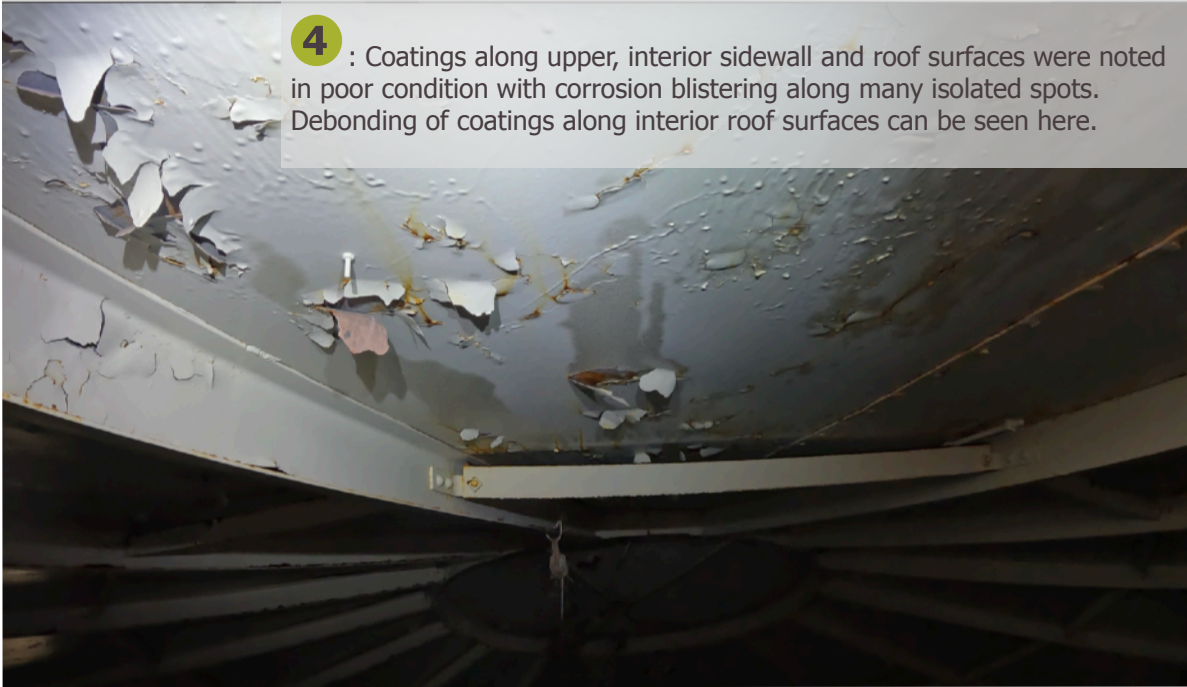
**4** : Coatings along upper, interior sidewall and roof surfaces were noted in poor condition with corrosion blistering along many isolated spots. Debonding of coatings along interior roof surfaces can be seen here.

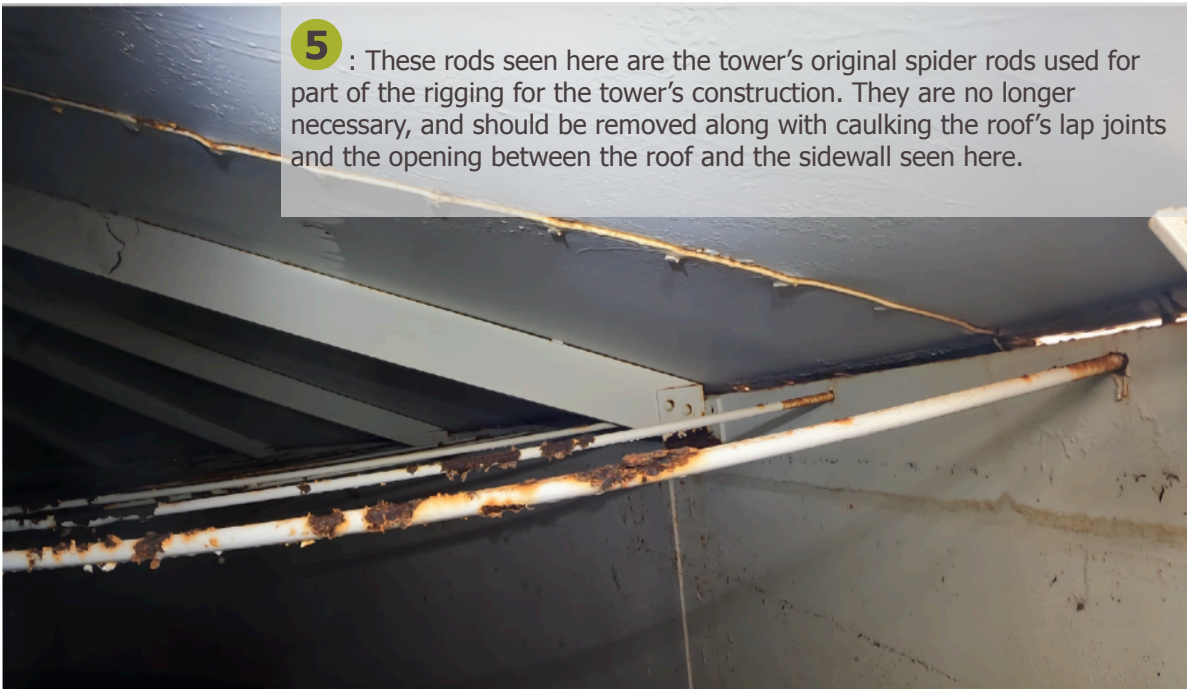
**5** : These rods seen here are the tower's original spider rods used for part of the rigging for the tower's construction. They are no longer necessary, and should be removed along with caulking the roof's lap joints and the opening between the roof and the sidewall seen here.

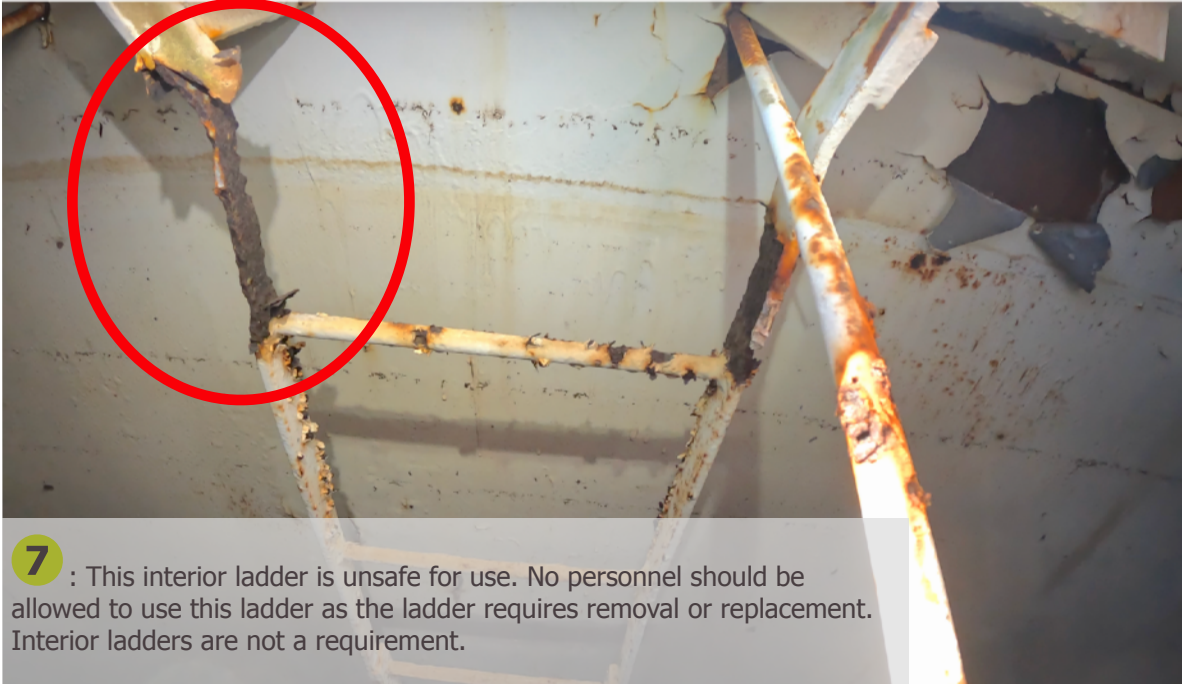
**7** : This interior ladder is unsafe for use. No personnel should be allowed to use this ladder as the ladder requires removal or replacement. Interior ladders are not a requirement.

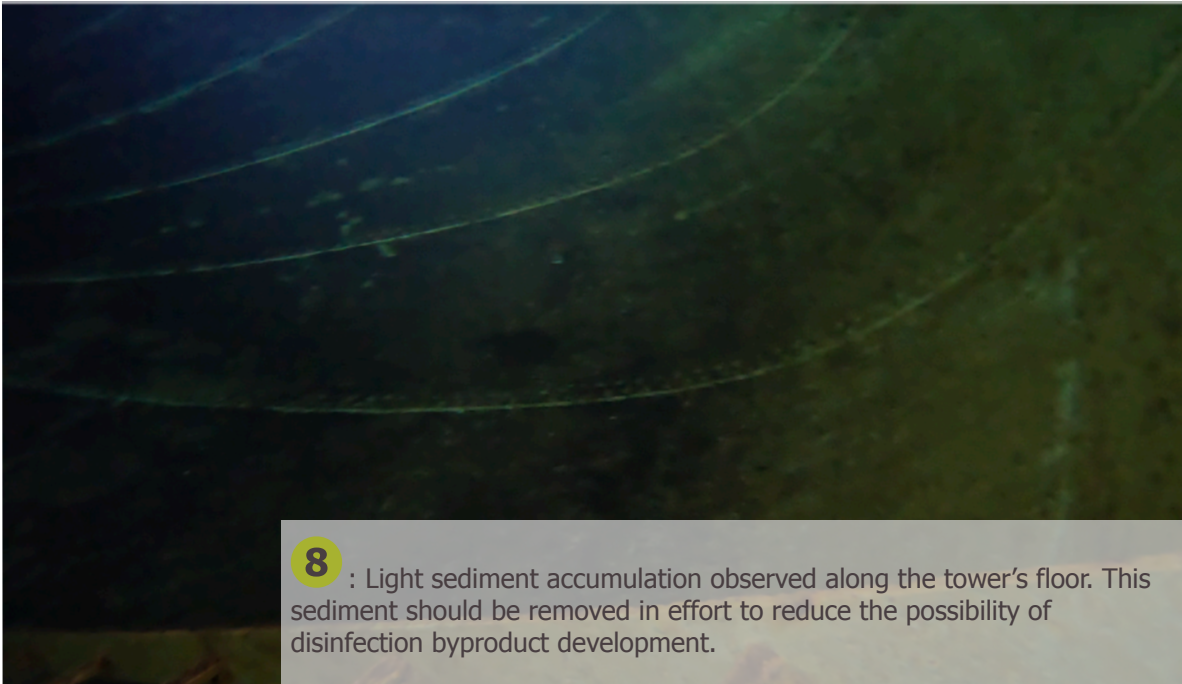
**8** : Light sediment accumulation observed along the tower's floor. This sediment should be removed in effort to reduce the possibility of disinfection byproduct development.
