# 2023 INFLOW & INFILTRATION INVESTIGATIONS PROJECT

## Preliminary Engineering Report

City of Manor  
Public Works Department

April 24, 2023

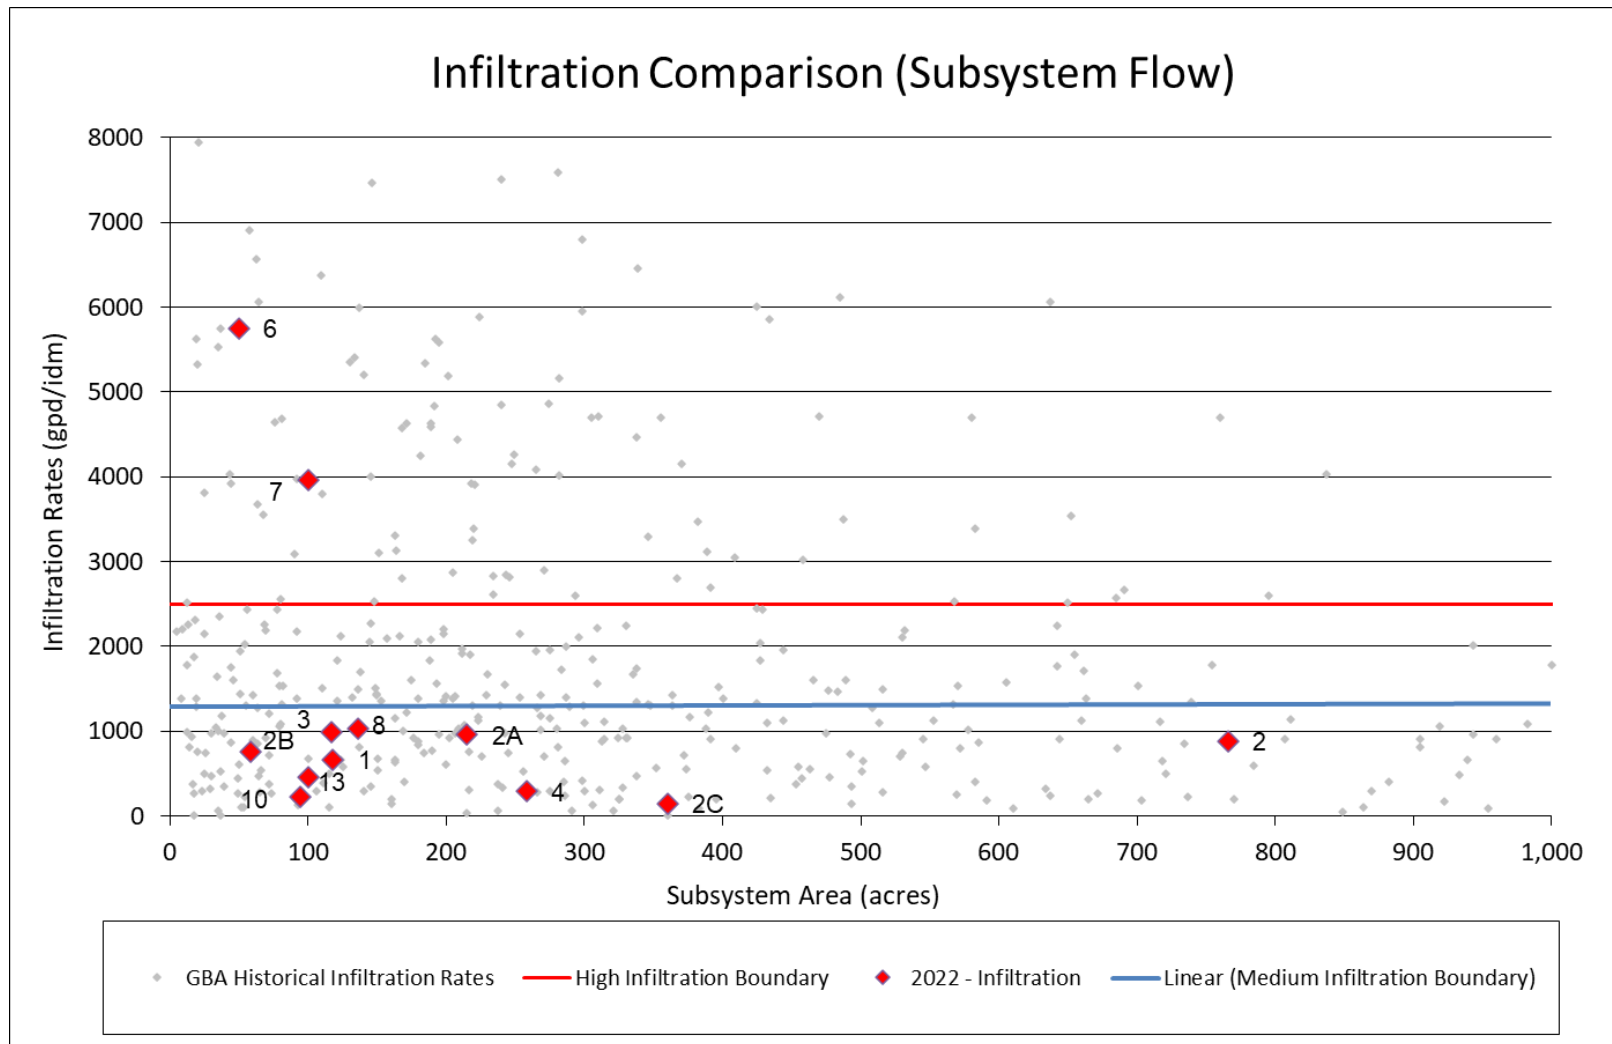
Figure 2-9 – Excessive Infiltration

The infiltration parameters are shown for each subsystem for the flow monitoring period in Table 2-12 and Figure 2-9. Subsystems with excessive infiltration were based on an infiltration rate above 2,500 gpd/IDM. The 2,500 gpd/IDM threshold is based on GBA's historical flow monitoring observations and experience as well as guidelines set forth by the EPA. Two (2) subsystems – Basins 6 and 7 – indicated having excessive infiltration based on an infiltration rate above the 2,500 gpd/IDM for the monitoring period. Coincidentally, these basins also had excessive infiltration rates during the 2021 Fall flow monitoring, and due to this were selected as the "pilot" study areas for this 2022 project.

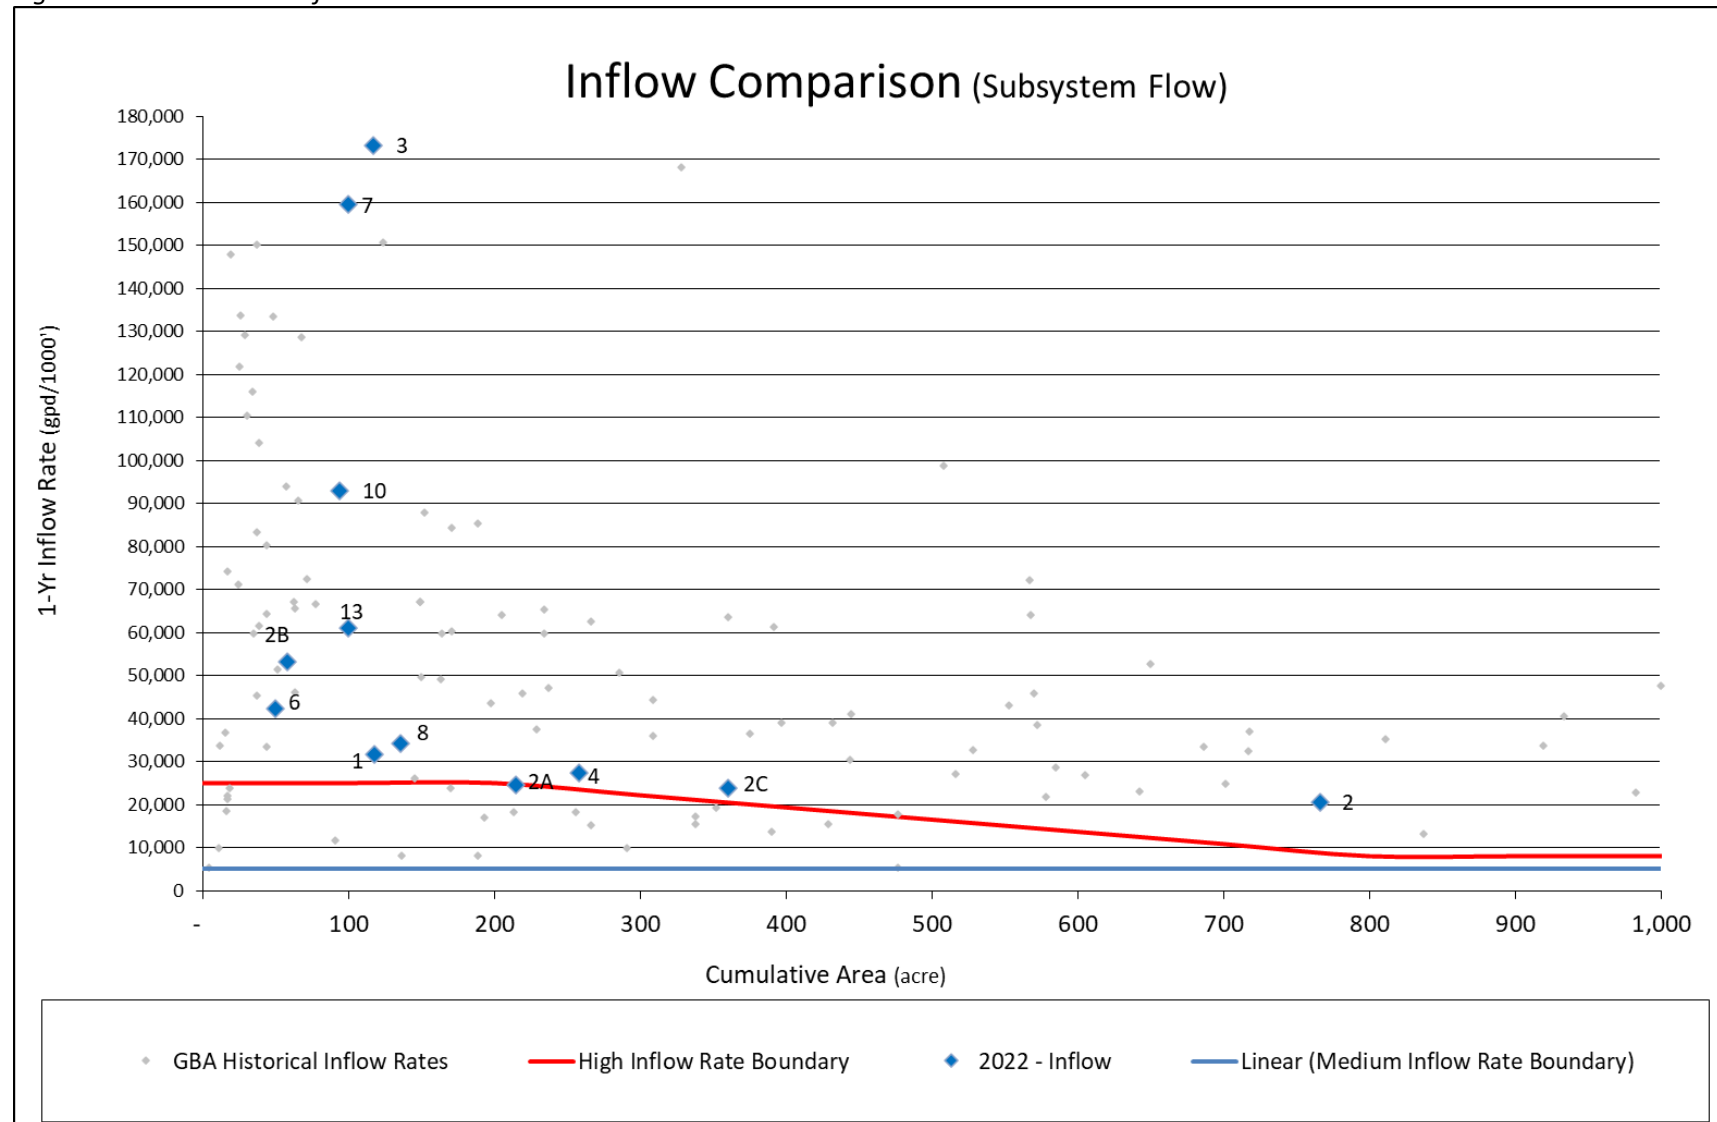
Figure 2-10 – Excessive Inflow

Based on the 2022 Fall flow monitoring results, seven (7) of the twelve (12) basins showed evidence of inflow sources. Inflow is most often associated with system surcharging because it is the result of sources directly tied into the system and causes rain-induced flows to enter the system much quicker than through infiltration sources.

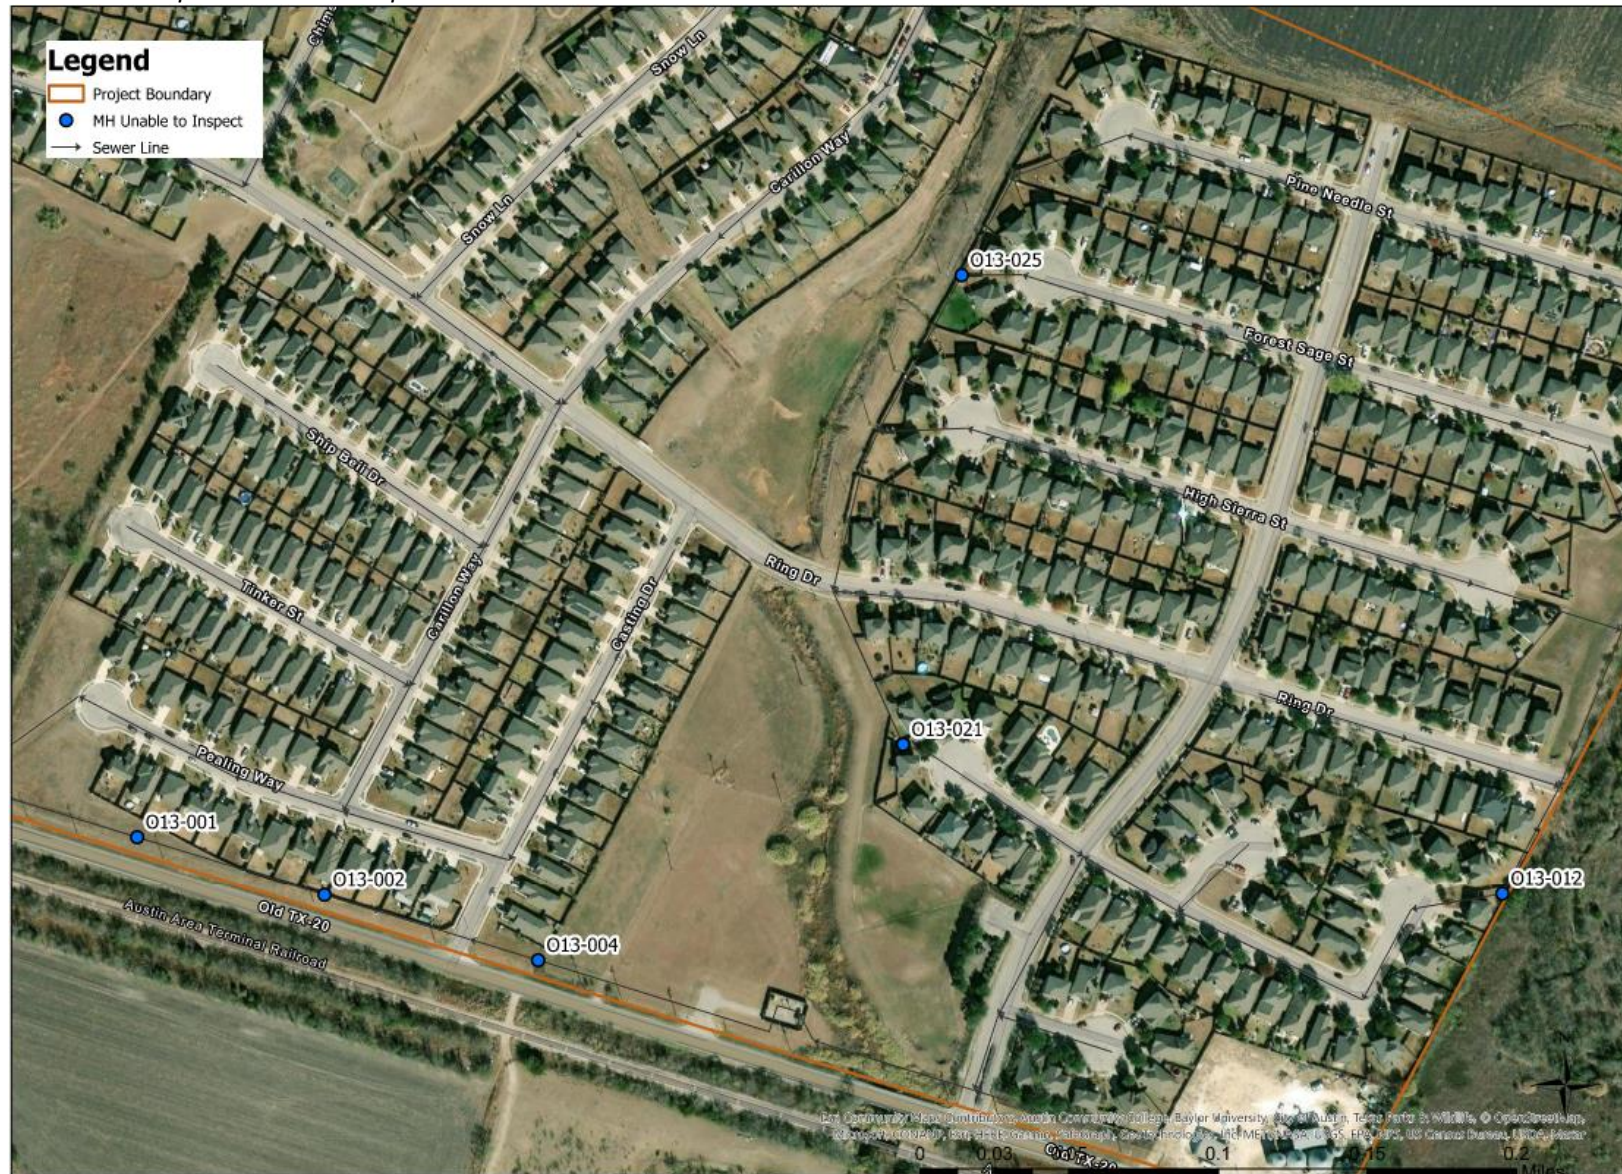
Figure 3-3 – Incomplete Manhole Inspections

There were 137 attempted simple surface inspections, of which six (6) were not able to be fully inspected. Of the incomplete inspections three (3) manholes were located behind fences and could not be accessed, two (2) were not found, and one (1) had a locked cover that the crews could not open. All of these manholes are listed in Table 3-1. The locations of the incomplete inspections are shown on Figure 3-3.

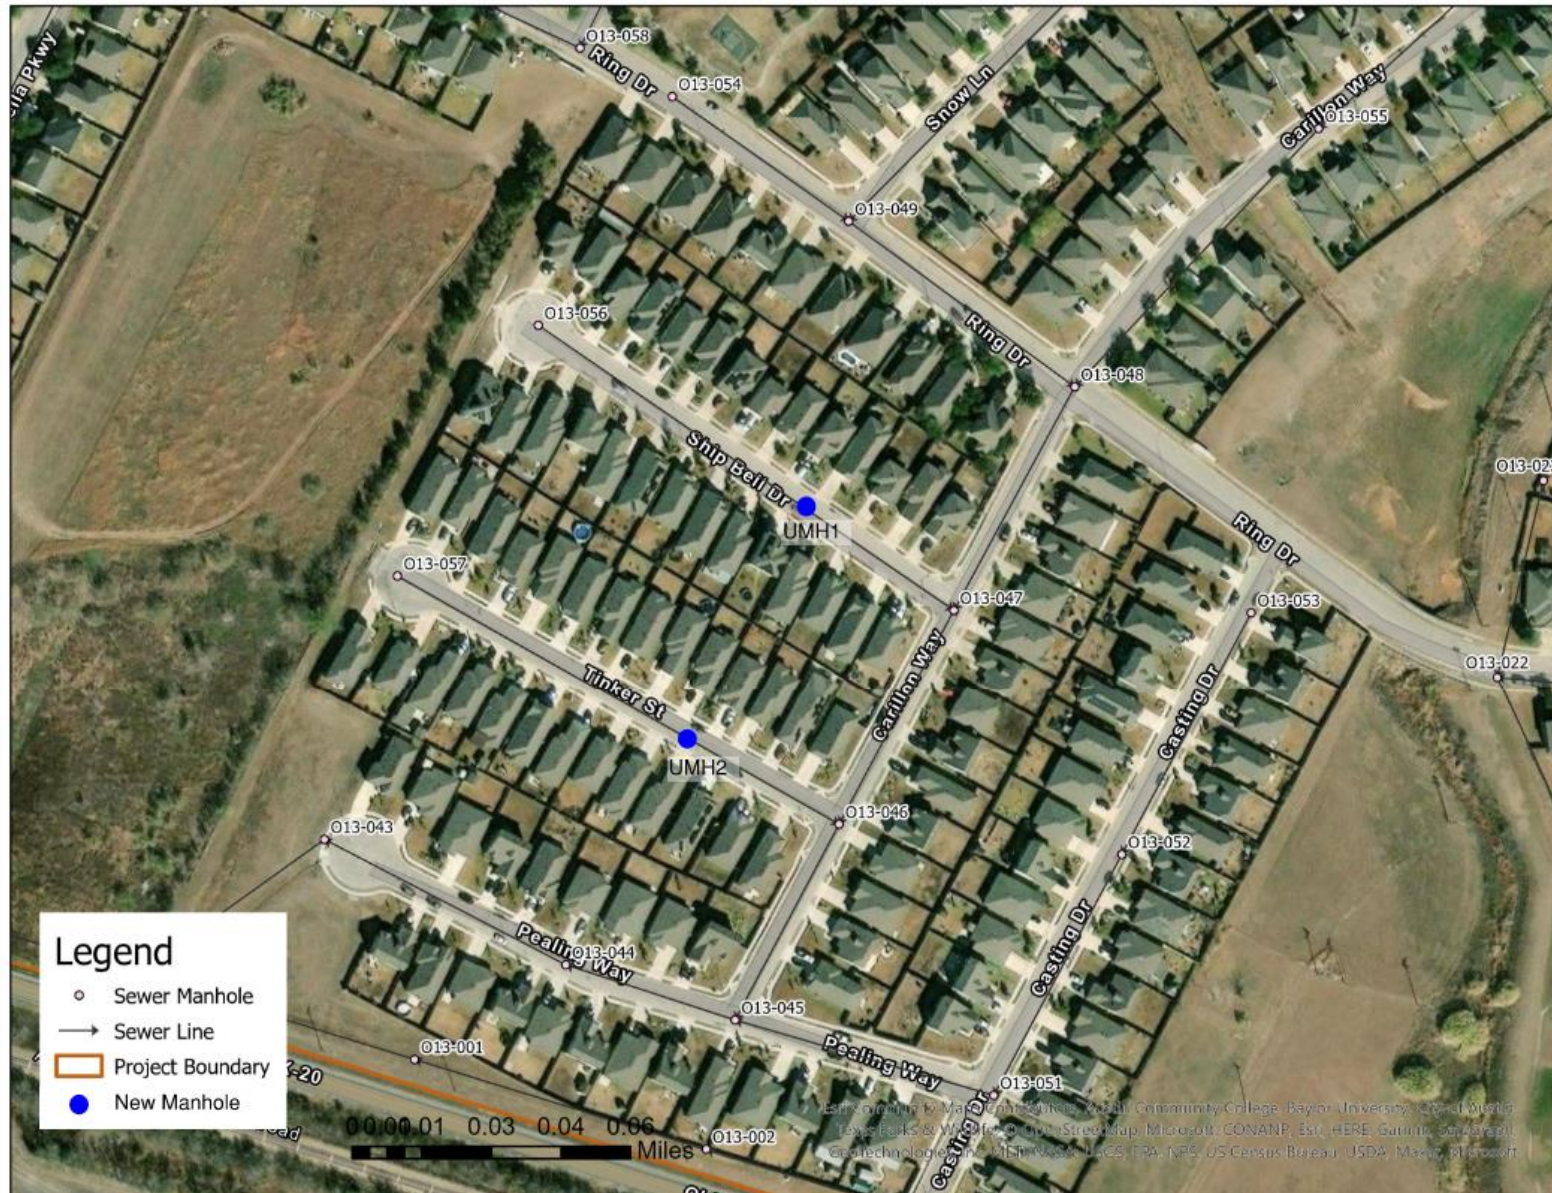
Figure 3-4 – New Manholes Found

Additionally, two (2) new manholes were found during inspections. These are listed in Table 3-2 and shown on Figure 3-4.

MH ID	Condition	Upstream Manhole	Downstream Manhole	Address
UMH-1	0	O13-056	O13-047	13012 Ship Bell Drive
UMH-2	4	O13-057	O13-046	13012 Tinker Street

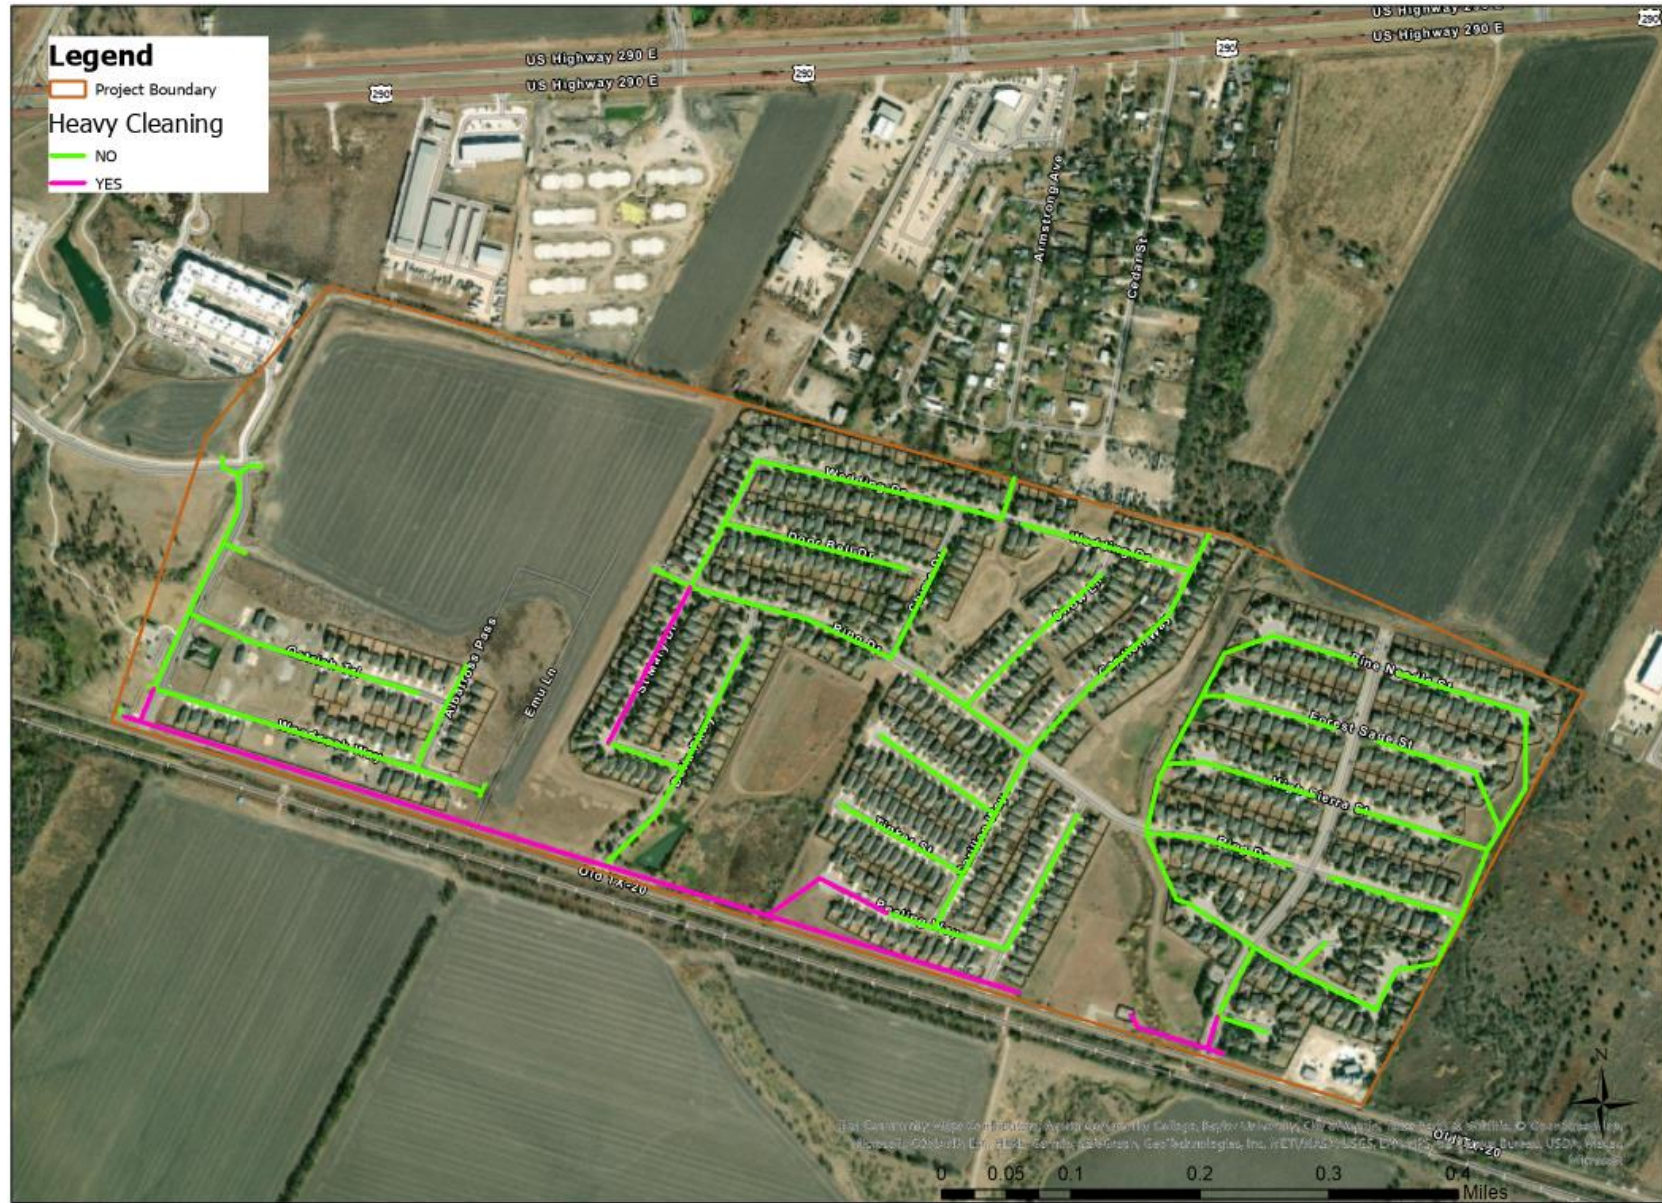
*Figure 4-2 – Heavy Cleaning Lines*

A total of 48.5 hours was spent on heavy cleaning in this targeted Project Area. Most of this time was spent cleaning the 12"-15" lines along Old TX-20. These lines were found to be at least 50% full of silt, rock, and other debris at the time of inspections. It is suspected that the two lift stations located along this trunk line are at least partially responsible for the debris accumulation. The lift station operation cycles were not perfectly calibrated so flows were not always pumped out at the correct intervals and this caused flows to back-up into the sewer lines and debris to settle out.

It was also noted that the two (2) lift stations along Old Hwy 20 (Carriage Hills and Bell Farms Lift Stations) should be cleaned as a follow-up to the work completed during this project. Since not every bit of debris is able to be vacuumed out of the lines at the time of heavy cleaning, it is probably that some debris made its way into the lift stations. Heavy cleaning of the stations will ensure that similar backing up into the system as has been seen before does not happen again.

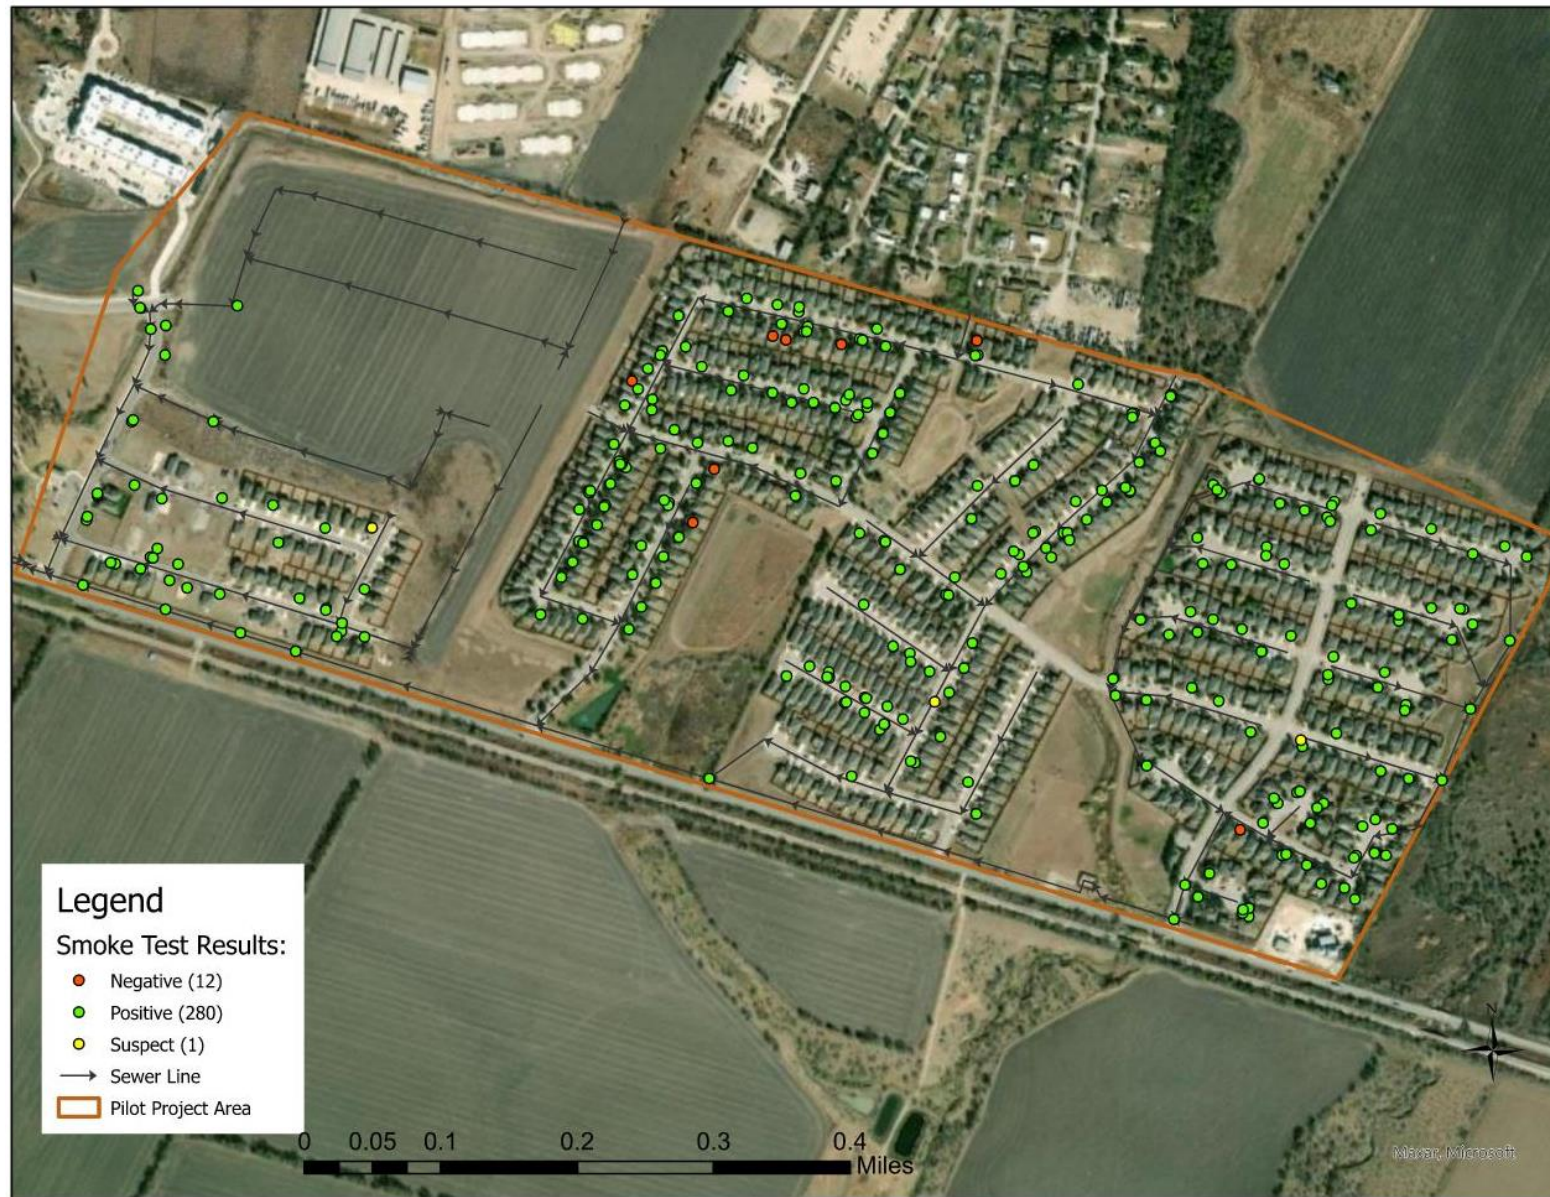
Figure 5-3 – Smoke Testing Results

There were twelve (12) houses that had negative plumbing vent smoke sources. It is suspected that clogs or sags in the laterals were the cause of the smoke not exiting the vent stacks. Table 5-1 shows the properties where vent smoke was not observed.

There were 237 properties with uncapped, broken, or defective cleanouts that should be rehabilitated, out of the 259 total properties with cleanouts present. Although uncapped cleanouts are small in diameter and do not typically introduce a lot of rainfall into the sewer system, they can still pose problems to the system. Foreign objects are often lodged into the cleanouts, and if the top of the cleanout is flush with the surface, it can create a sump scenario that can pool rainfall flow and increase I&I in the system. Appendix D contains the complete list of the 237 defective clean-outs along with recommendations for next steps.

The defects highlighted in blue should be first priority for removal or rehabilitation as they are the most cost effective sources of I&I that can be removed.
