WATER TANK INSPECTION REPORT

CITY OF MANOR, TEXAS

03/10/2023

| TANK NAME: | Intermediate GST | Location: | Parsons St, Manor |

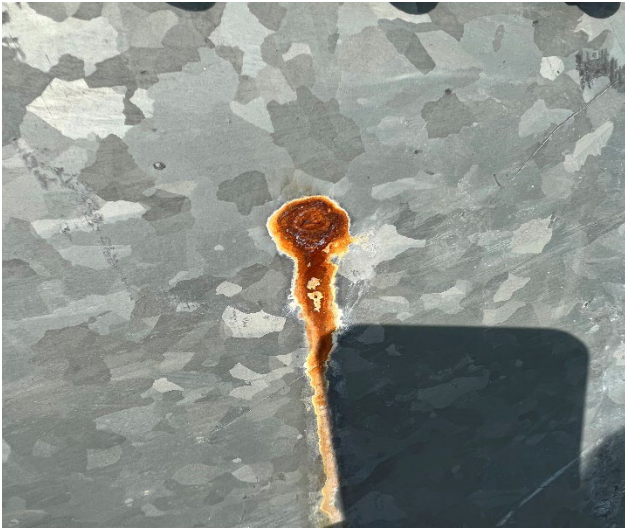
Exterior Coating

Rust pitting noted on exterior plates.

Galvanized: Fair condition with areas of previous leak runs and exterior pitting.

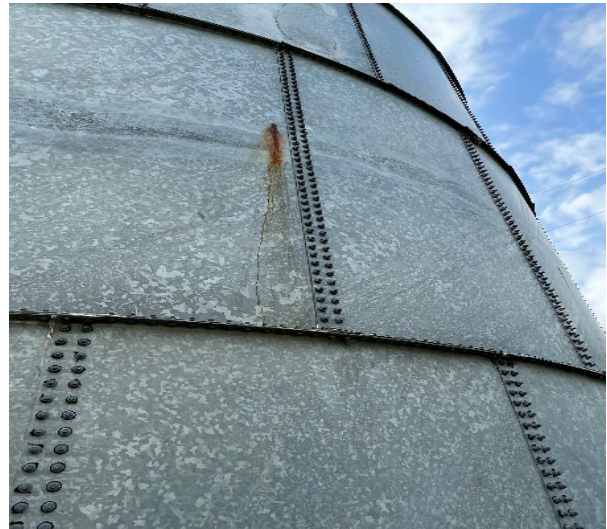
Exterior Coating

Fair condition with areas of exterior leak runs.

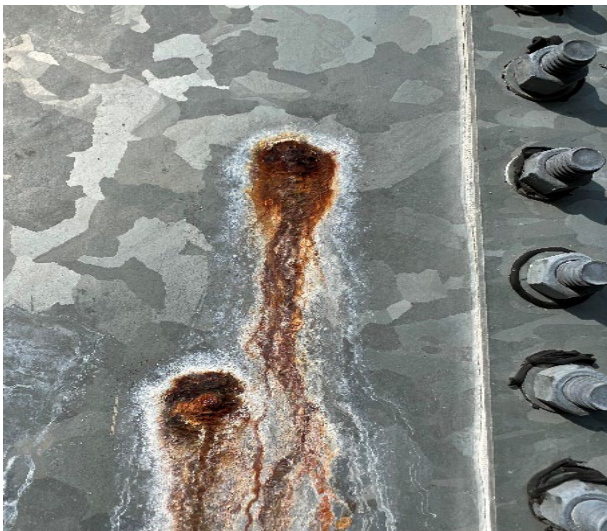
Exterior Coating

Fair condition with areas of exterior protruding rust pits.

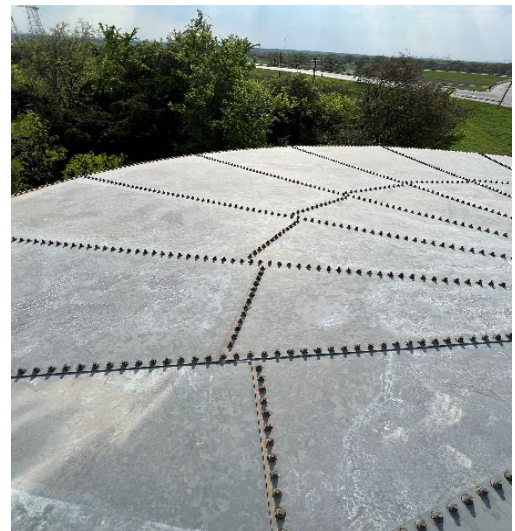
Exterior Coating

Roof shows normal wear. Bolt tracks are in good condition on the exterior.

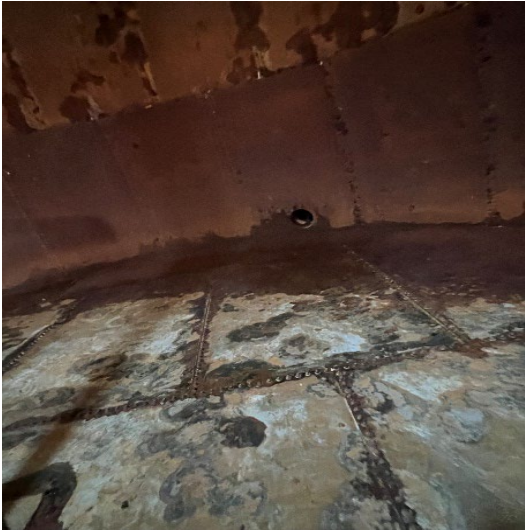
Interior

Floor bolt tracks are degrading. Condition of floor plates are extremely poor.

Galvanized: Poor condition with heavy staining, scattered failures, and pitting. The integrity of the bolt tracks and floor plates are questionable.

Recommendation: Budget for a new welded steel tank.

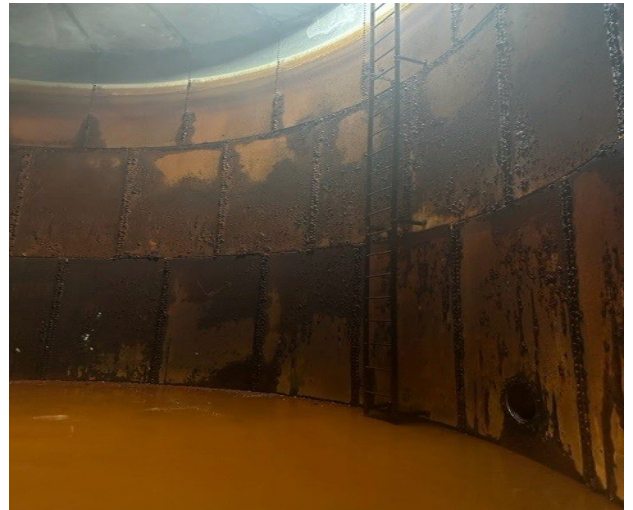
Interior

Heavy rust nodules on the majority of the sidewall bolt tracks.

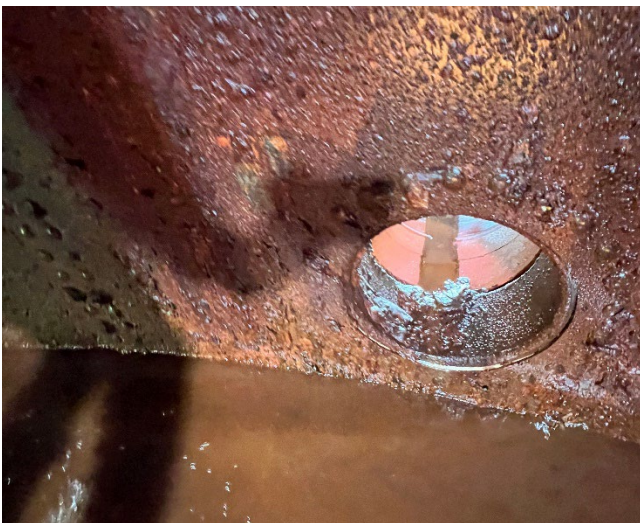
Interior

Walls are heavily stained along with rust nodules present. Tank floor was covered with sediment.

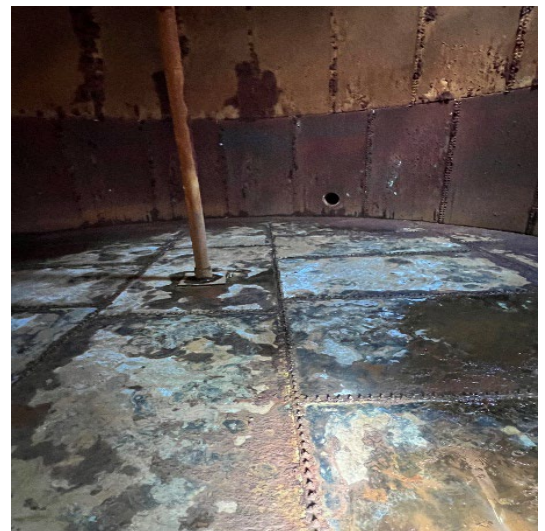
Interior

After tank washout the floor is in poor condition. The integrity of the floor plates and bolt tracks are questionable.

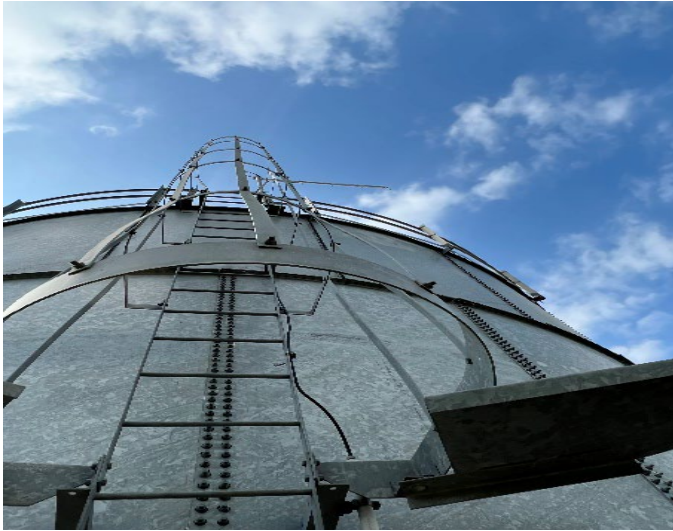
Safety Climb

Ladder cage is in place. No cable climb.

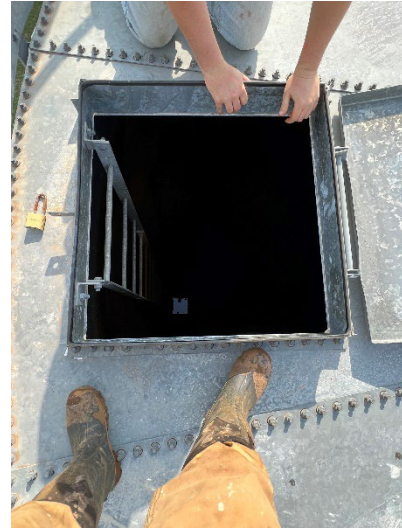
Tank Access

Tank access is proper size and configuration.

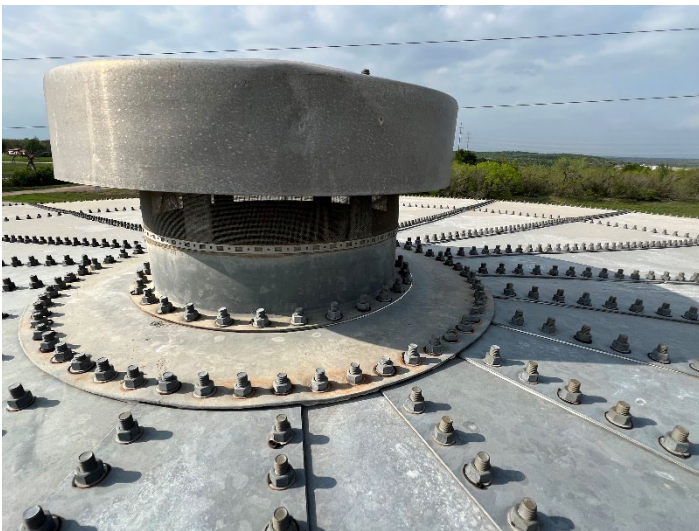
Vent Screen

Non-compliant vent and screen are in place.

Vent is non-compliant TCEQ style.

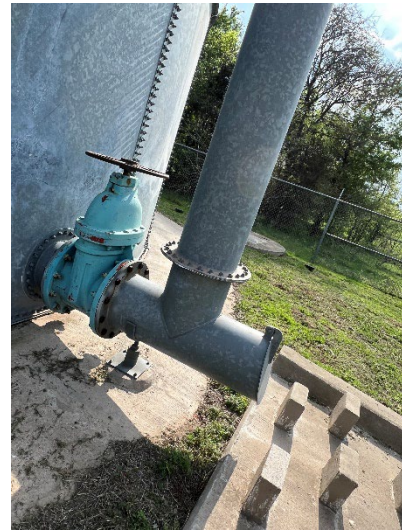
Overflow is in good condition and routed to ground level.
Flapper is in place.

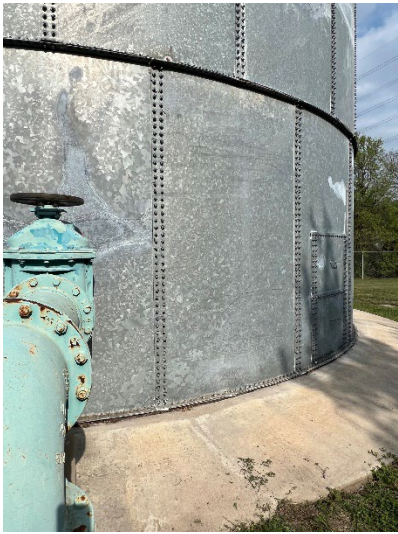
Foundations

Foundation and grout are in good condition, clear of vegetation.

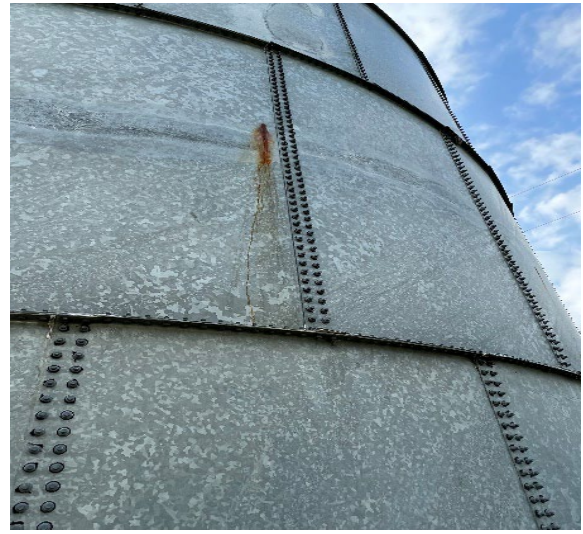
Tank Structure

Tank foundation appears to be in good condition.

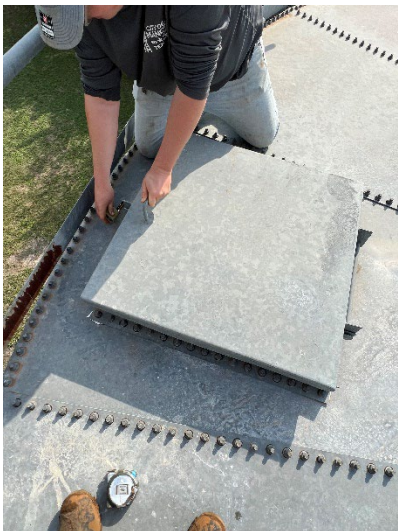
Hatch

Roof man way is in good condition and secured.

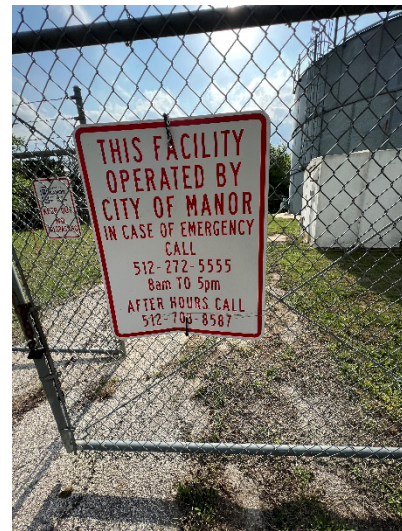
Tank Access

Tank access was secure upon arrival and secure upon completion.
