INSPECTION REPORT

DATE: 3-29-2021
OWNER: L2A LLC
619 Hwy 71 E.
Willmar, MN 56201

PROJECT: 410 Village Drive – To be relocated from
LOCATION: Address to be determined in Marshall
FROM: Ray Henriksen
Building Official
City of Marshall, 56258

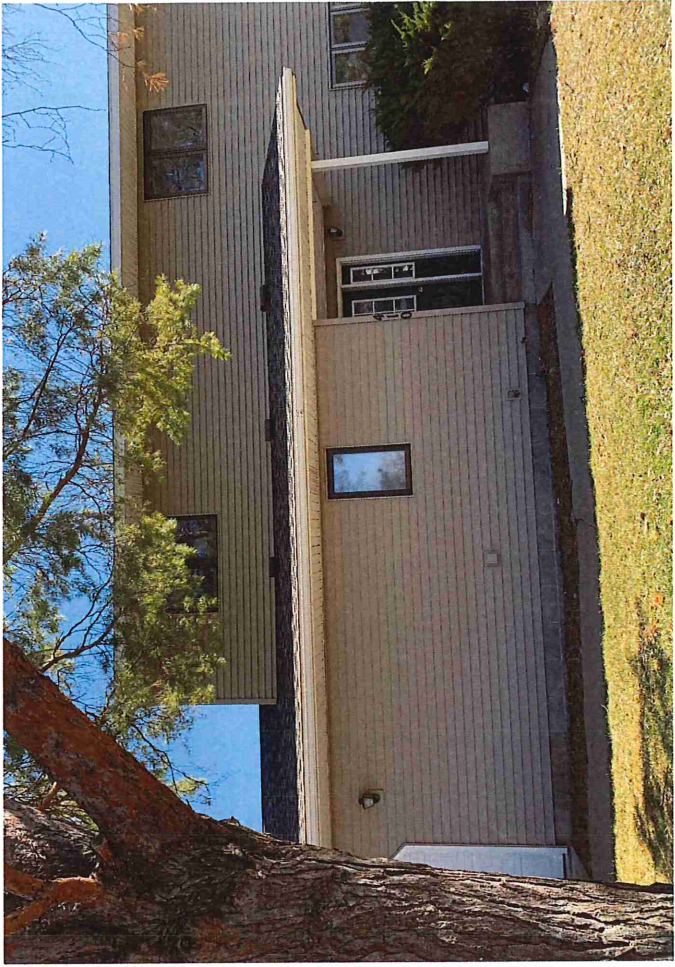
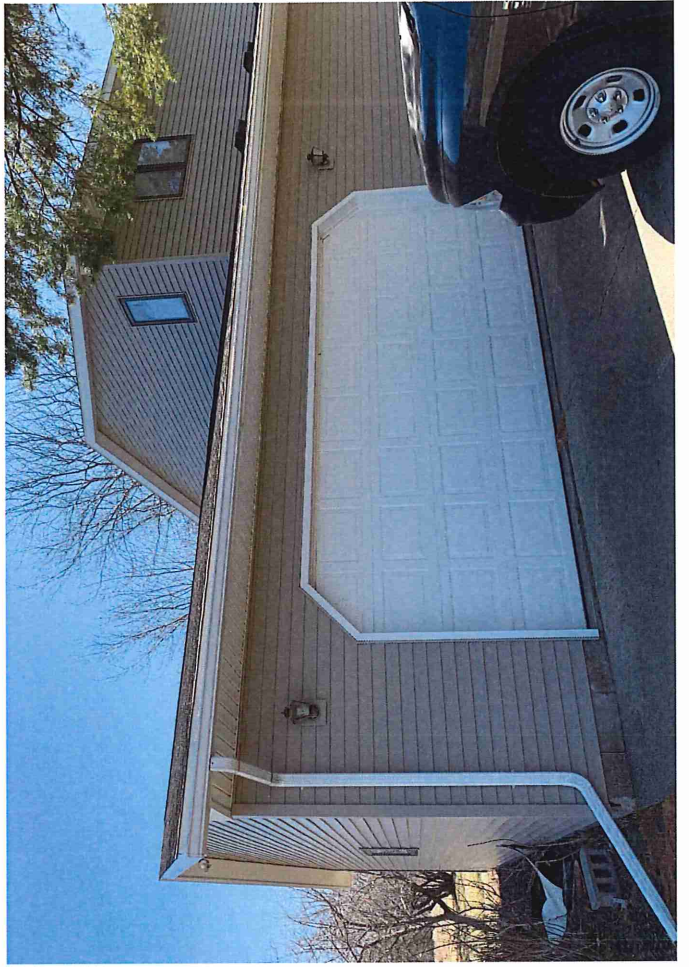
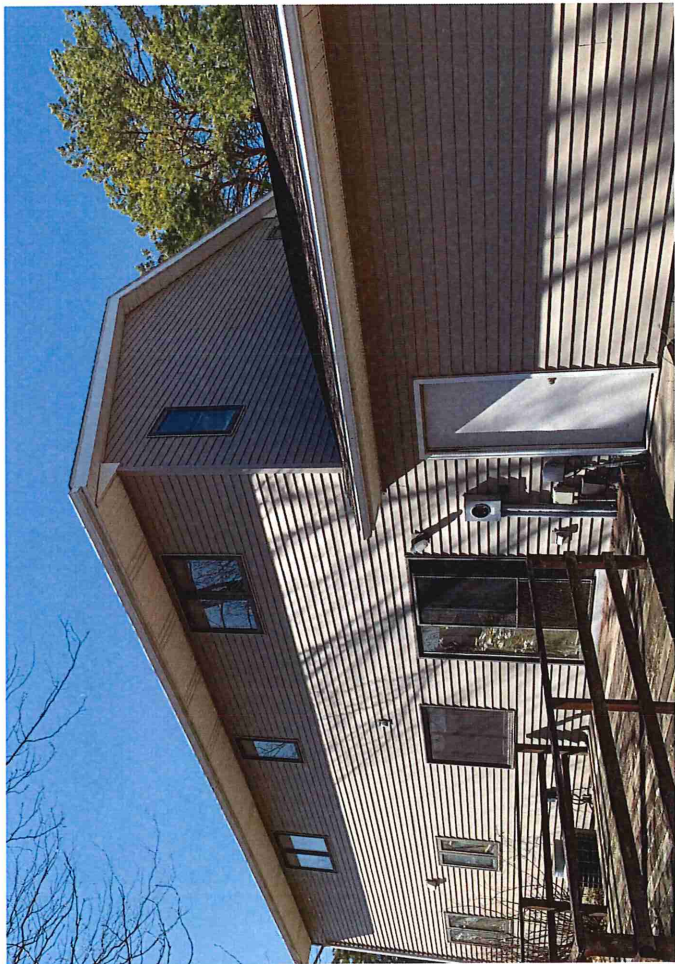
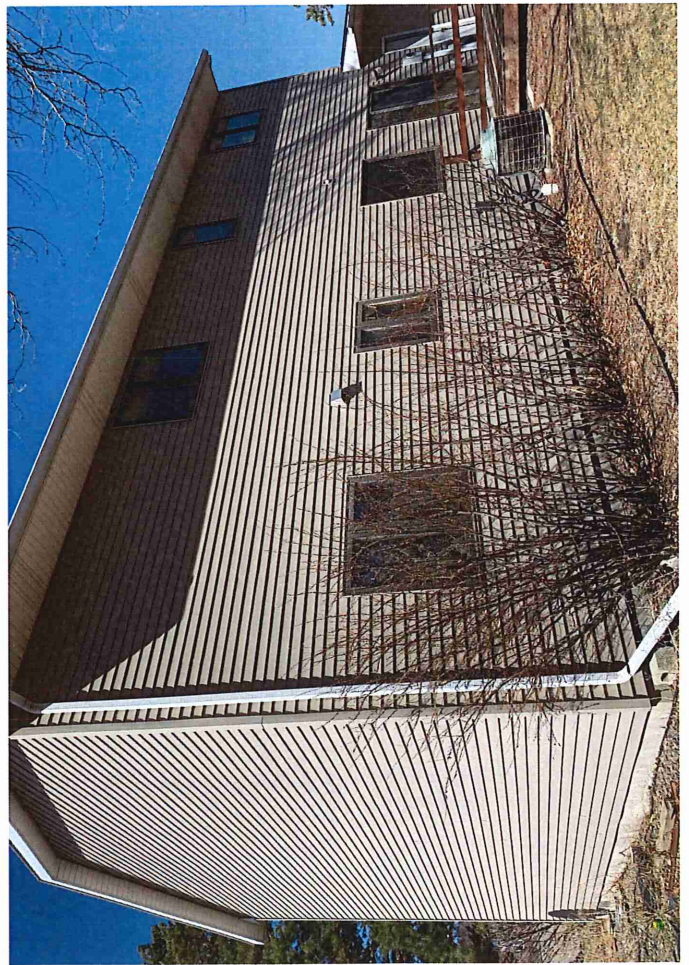
1. Siding is vinyl siding, in good condition.
2. Windows are aged. Interior film is peeling from glazing. See photo of the conditions.
3. Gutters are in good condition
4. Asphalt shingles, age unknown, all roofs are in good shape.
5. Continuous ridge vents used on the garage and dwelling.
6. Garage overhead door is a 2" insulated panel. With wind bracing but no label.
7. Vented soffits.
8. Exterior of windows faded vinyl clad
