March 3, 2025

PROJECT NO. MDBCH24002

RE: LIMITED STORM DAMAGE ASSESSMENT OF "SNACK SHACK" CAFE
15100 GULFVIEW BLVD
MADEIRA BEACH, FL 33708

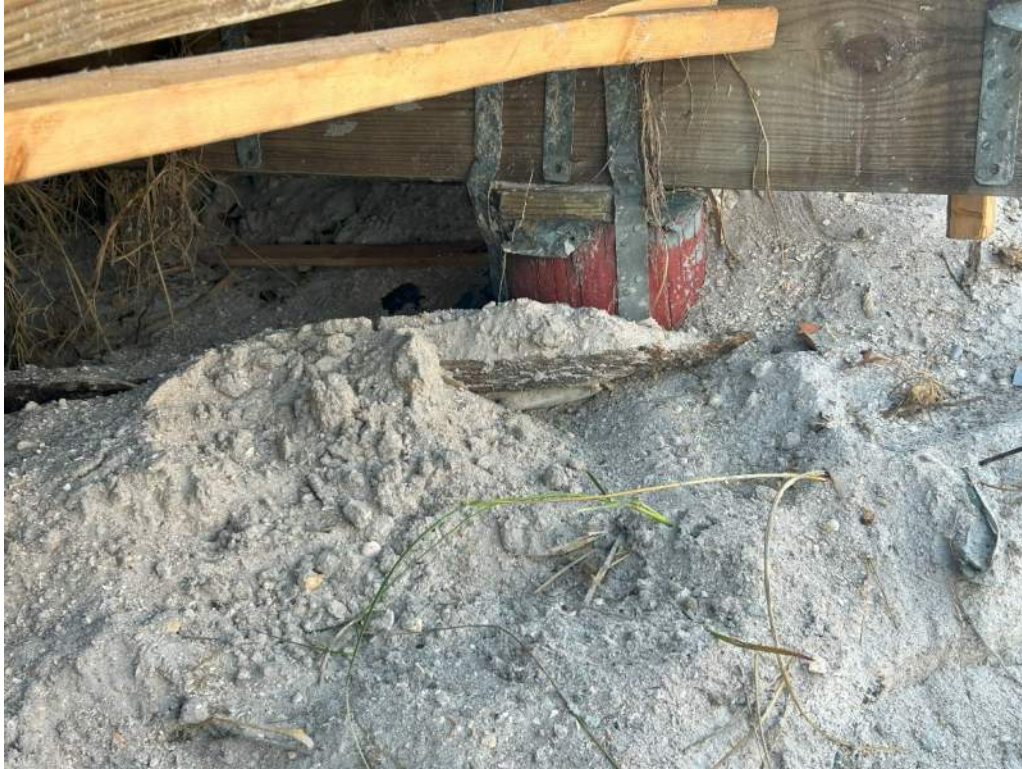
Photo 3 – View of one of the Foundation Piles

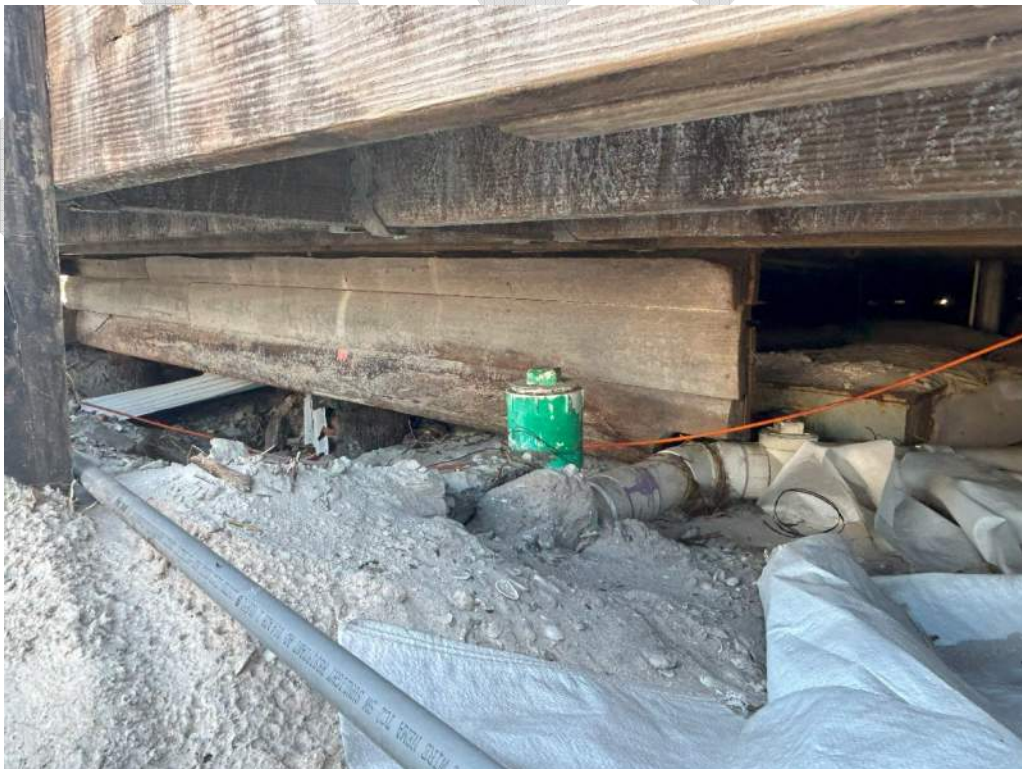
Photo 4 – Partial Underside View of the Wood Structure of the First Floor.

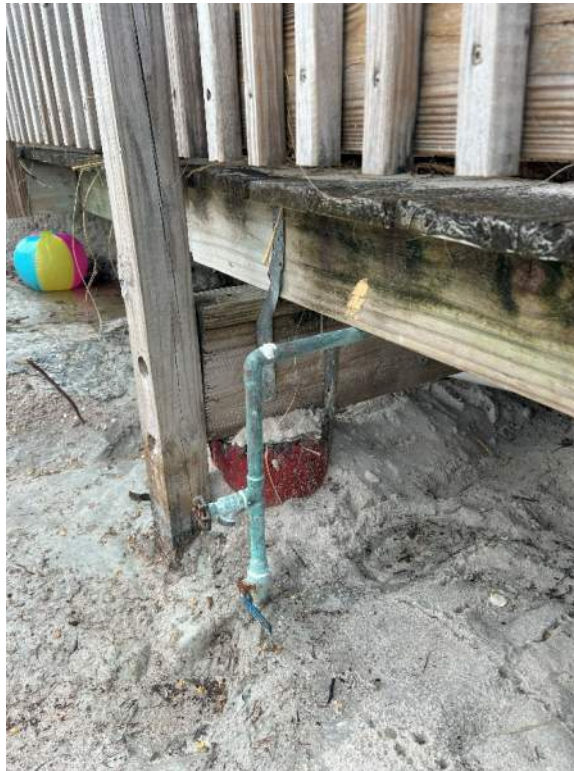
Photo 5 – View of one of the Foundation Piles that support the Perimetral Hallway.

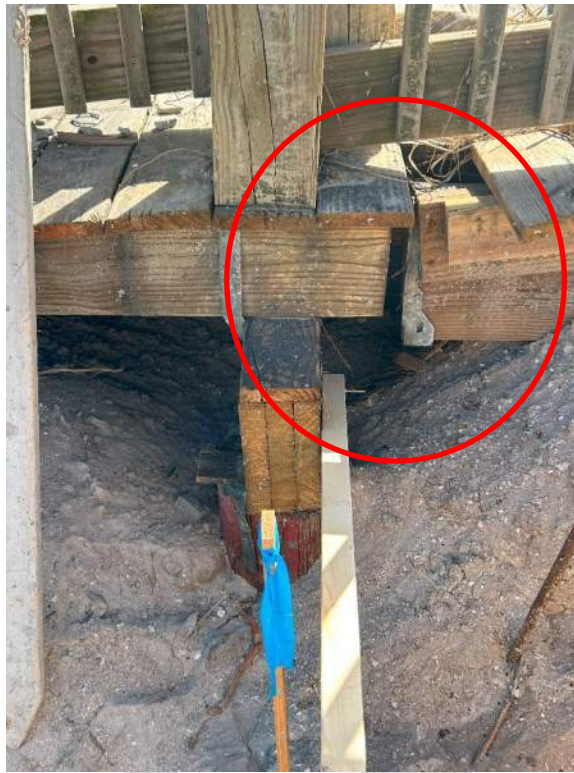
In the northwest corner of the exterior deck the existing **connection failed** due to the impact of the storm surge and on the southeast side of the building, the failure of several of the connections was

Photo 11 – Failed Connection between the Exterior Wood Deck and the Perimeter Corridor.

The reparation of this connections and the replacement of the failed or heavy rusted strapping is recommended and the revision of the temporary repair did it bellow the wooden staircase to the 2nd Floor. (See **Photos 11 – 14 and 56 & SK-3**)

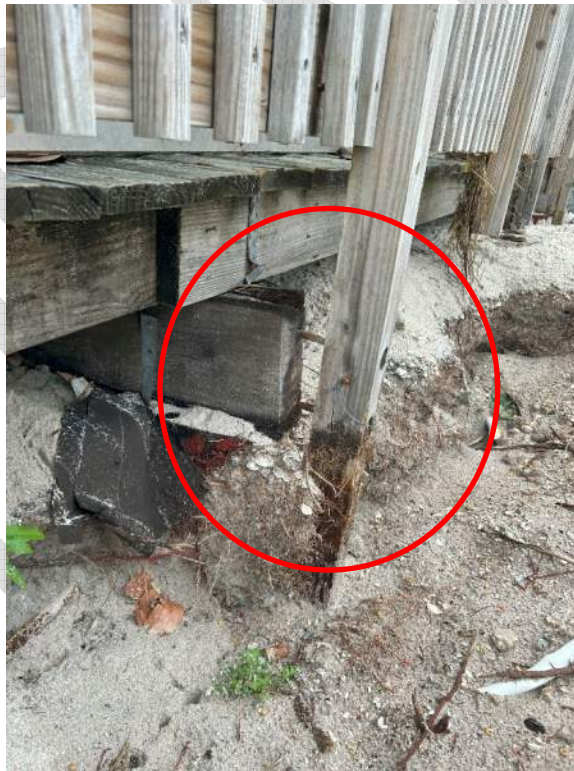
detected where the wooden beams that support the side corridor rest on the foundation piles and at these places the floor is in danger of failure.

Photo 12 – Failed Connection between the Beam that support the Southeastern Perimetral Corridor and the Wood Column that Support its Wooden Handrail (its bottom is rotten).

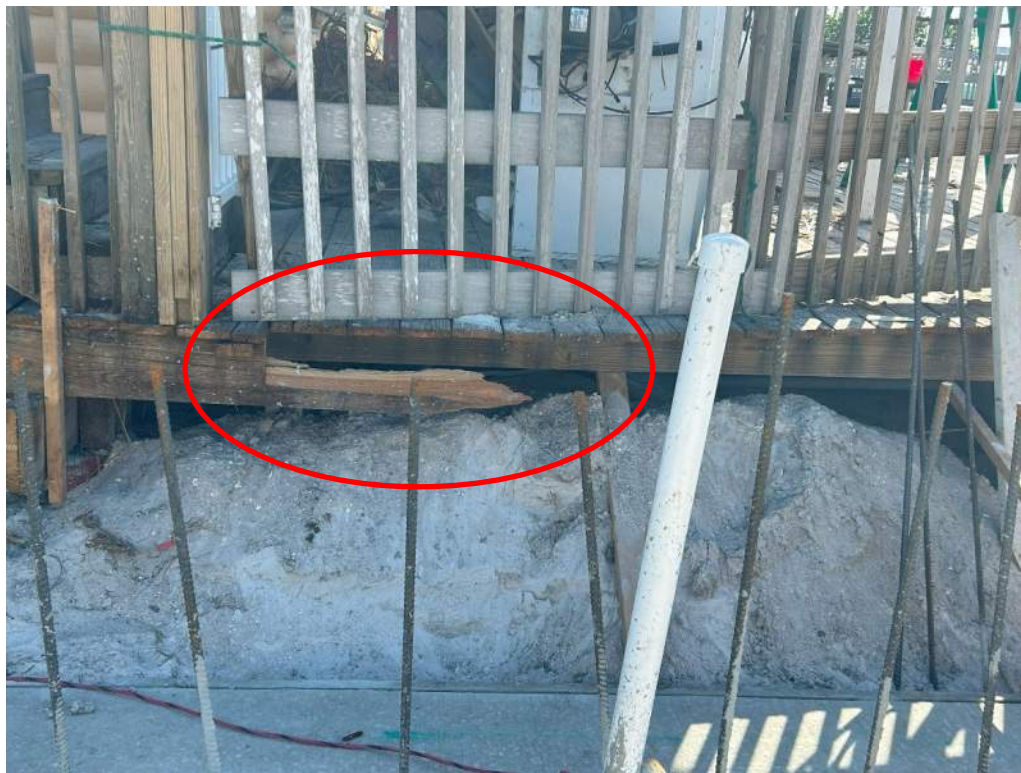
Photo 13 – Broken Exterior Wood Beam at the Outside Deck (in December 2024).

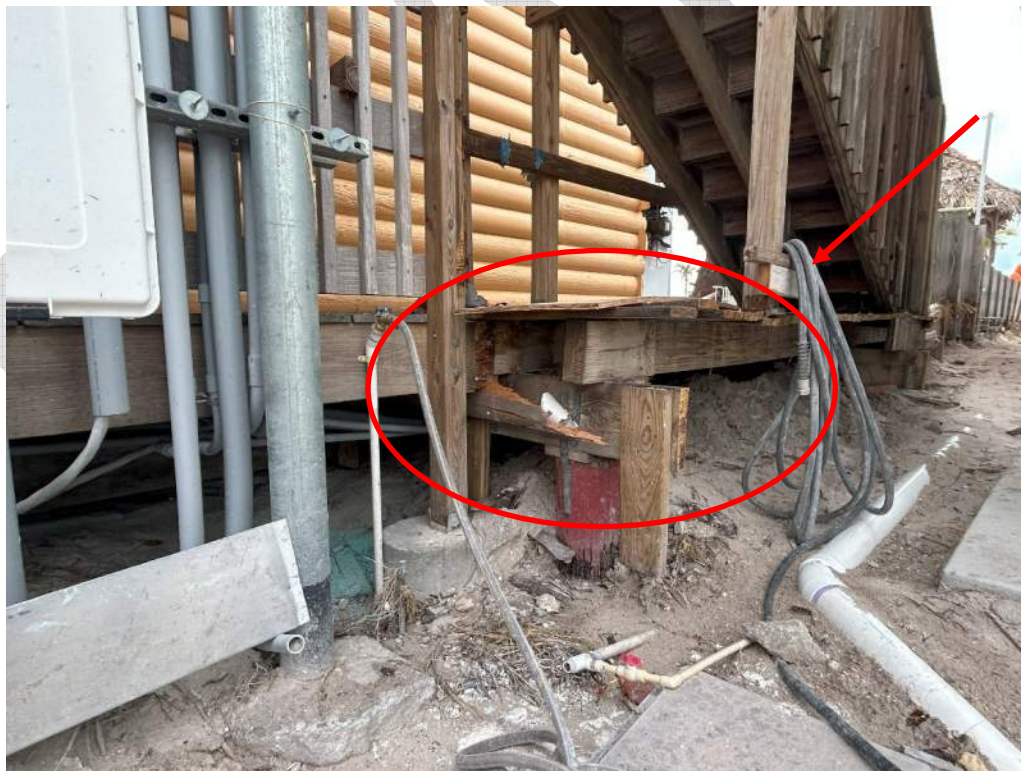
Photo 14 – Broken Exterior Wood Beam at the Outside Deck Repaired in February 2025 BUT Note the Weak Support of the Column that Supports the Staircase.

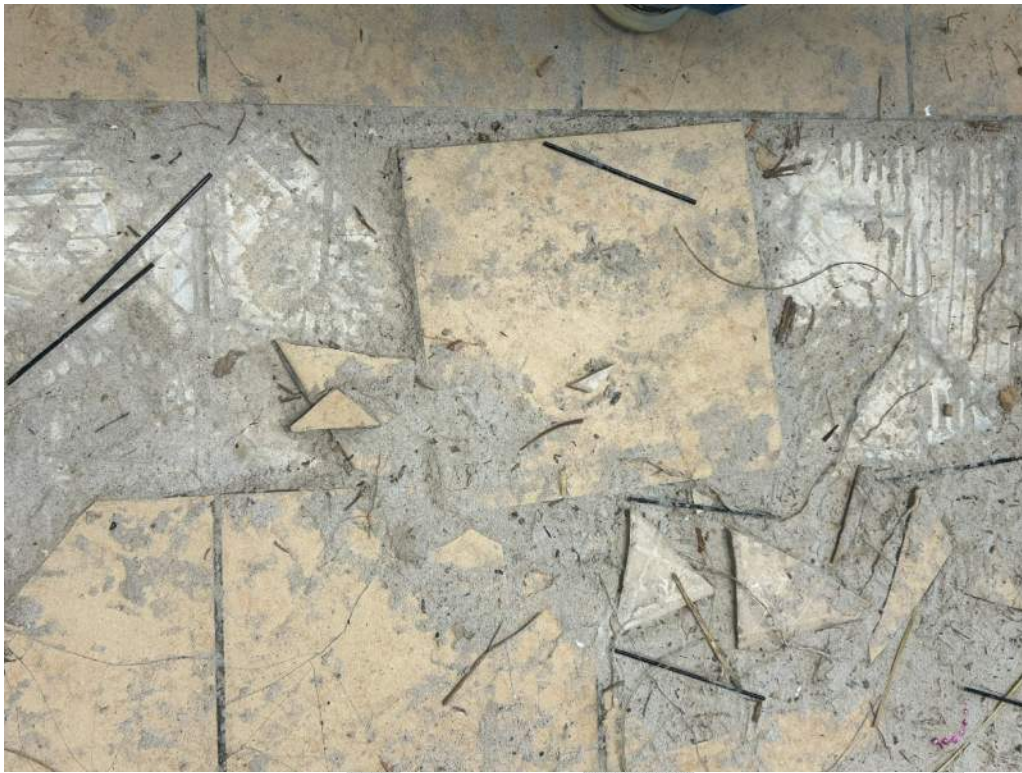
At the time of the inspection, it was still partially covered by sea sand and only the breakage or loose of some areas of the ceramic tiles floor could be seen. There does not appear to be signs of major floor settlement. Once small area of interior was found to be depressed. This may be due to damaged floor joists or hangers. However the removal of sand and interior cleaning of the floor will be required to determine any damage in the floor structure or its connections. On the back porch some of the floorboards were missing. (See **Photos 15 – 16 & SK-3**). These can be replaced in kind.

Photo 15 – Broken Ceramic Tiles at First Floor Deck.

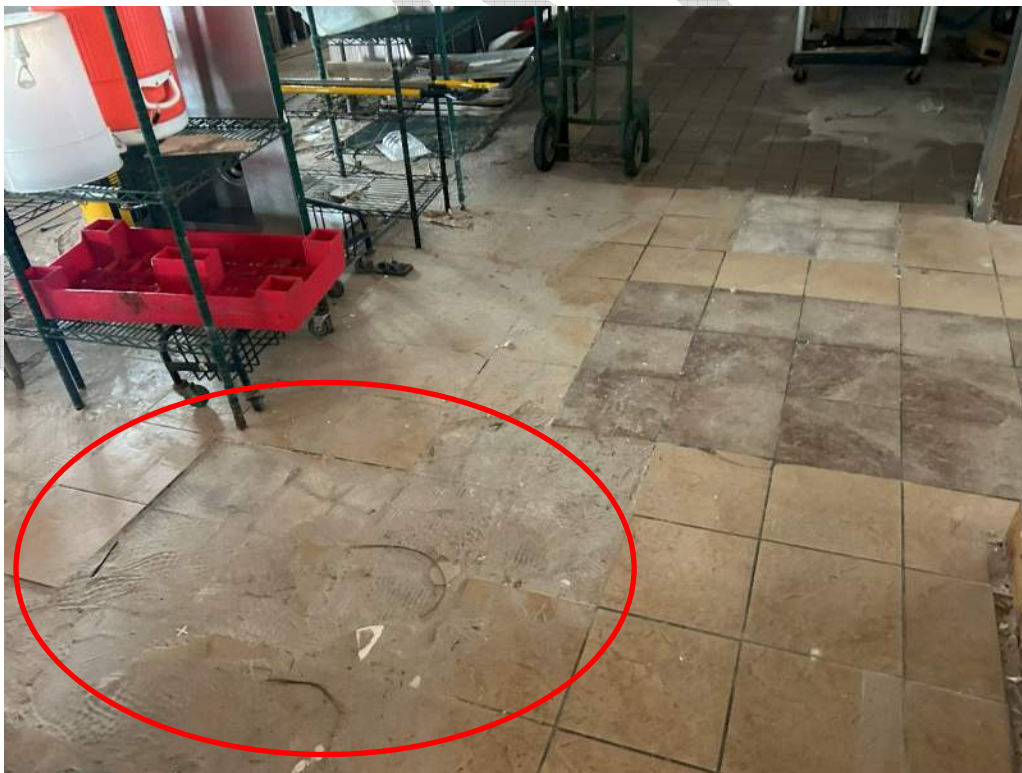
Photo 16 – One of the Areas with Possible Floor Depression

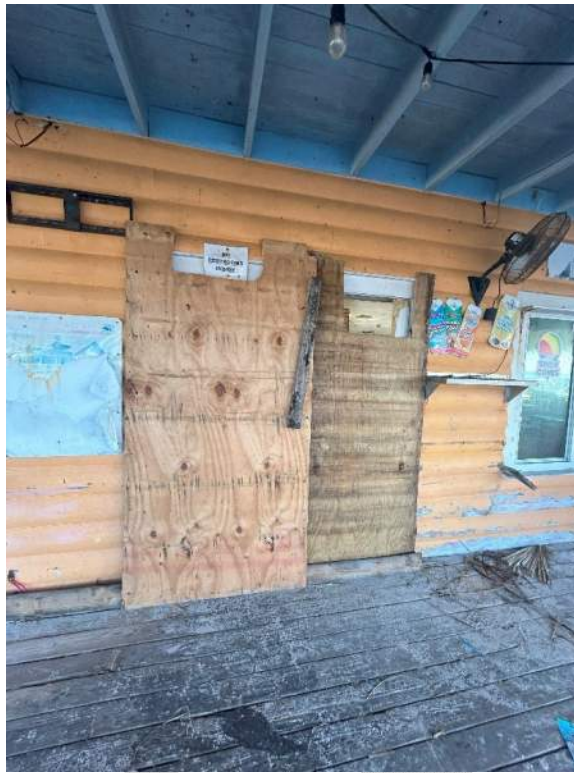
There does not appear to be signs of major readily identifiable displacement of the exterior wood framed walls. Only the **west facing door thresholds was damaged** where the failed doors connected and in the southeast corner of the building there seems to have been a **slight movement of the column** which caused some of the planks that hide it to separate from the impact of the storm surge also two of the glass windows located there are broken as well. (See **Photos 17 - 20 and SK-3**)

Photo 17 – Exterior Door Broken (outside view).

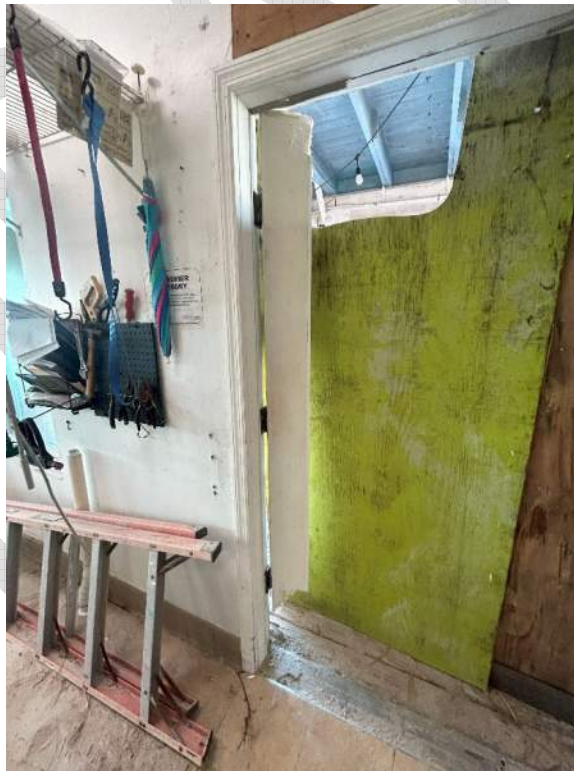
Photo 18 – Exterior Door Broken (inside view).

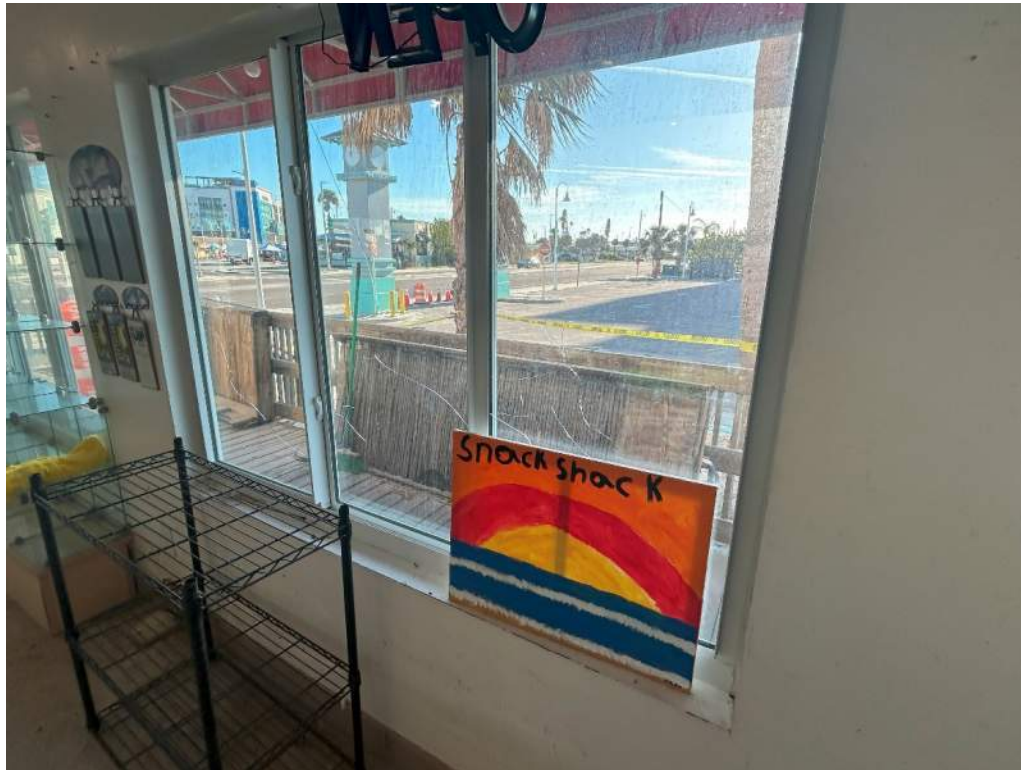
Photo 19 – Impact Glass Window Broken (inside view).

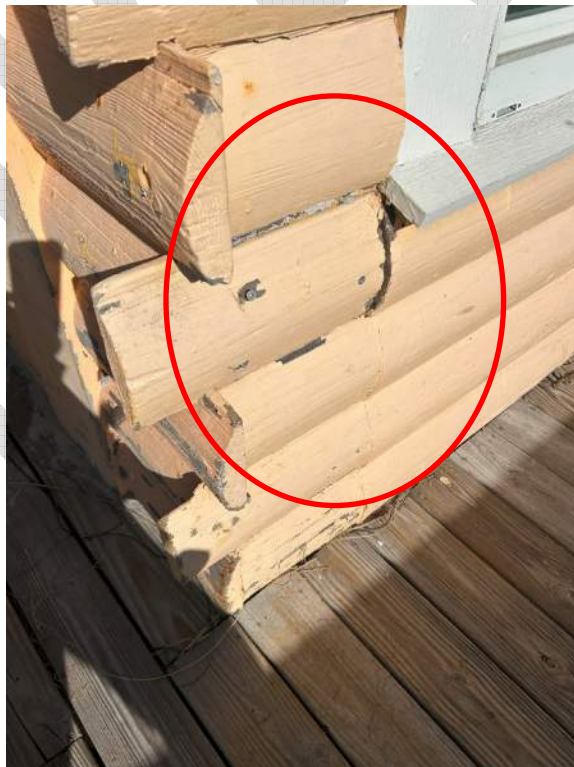
Photo 20 – Minor Signs of Possible Movement in SE Corner of the Building.

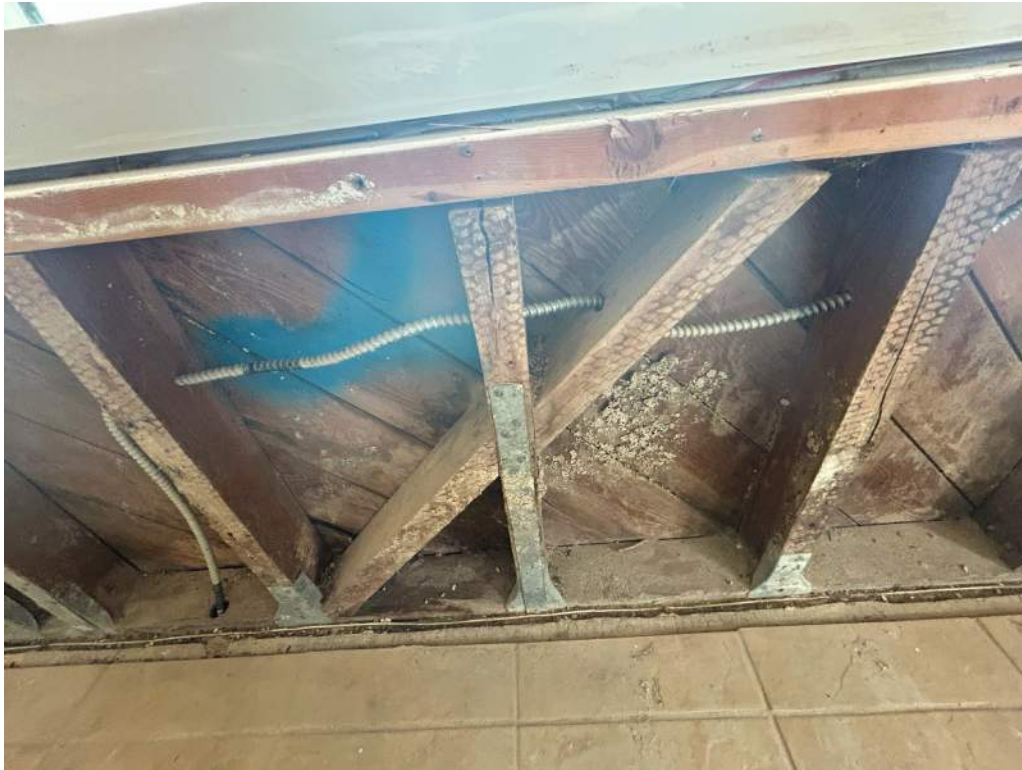
After the removal of interior drywall it was found that in several areas of the perimeter wall, as a result of the systematic penetration of water, the lack of an effective impermeable barrier, especially under the windows, and the fact that in many places the original plywood sheathing were never renewed but only covered with the new ornamental boards, there are many **rotten or broken studs** near the bottom plate of the wooden structure. In other cases, with signs of **termite damage, rusted metal connections**, and in some areas the **original plywood plank is rotten and broken**. (See **Photos 21 -32 and SK-4**)

Photo 21 – Wooden Studs Broken at Exterior Wall Wood Frame.

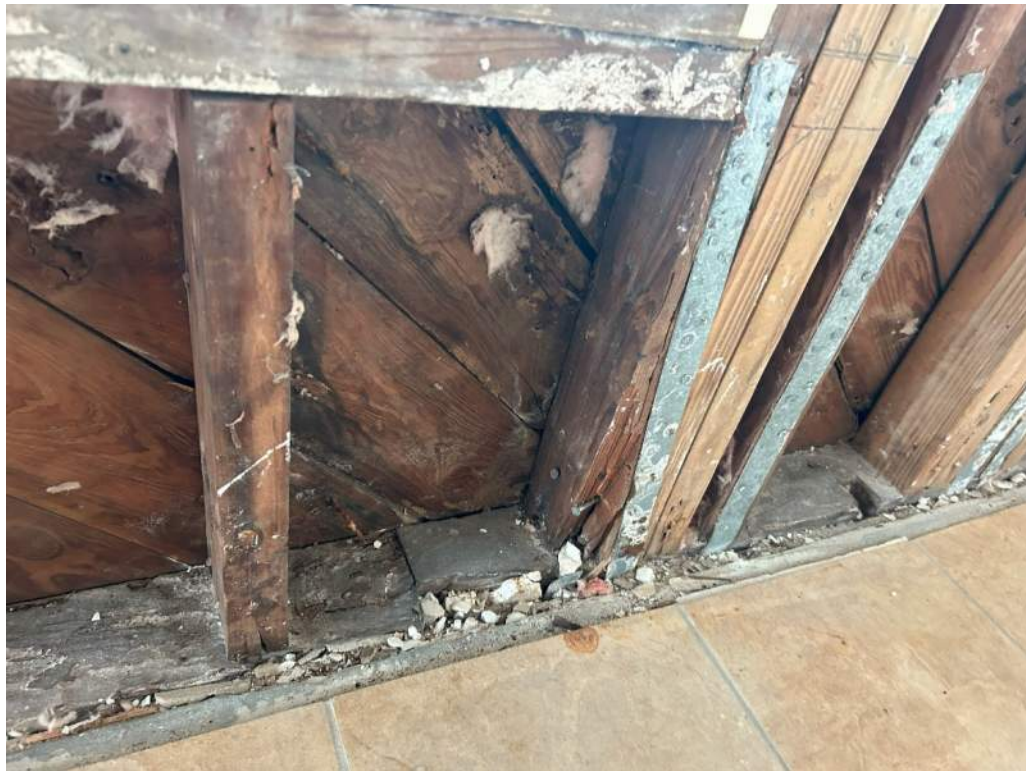
Photo 22 – Wooden Studs Broken and Rotten at Exterior Wall Wood Frame.

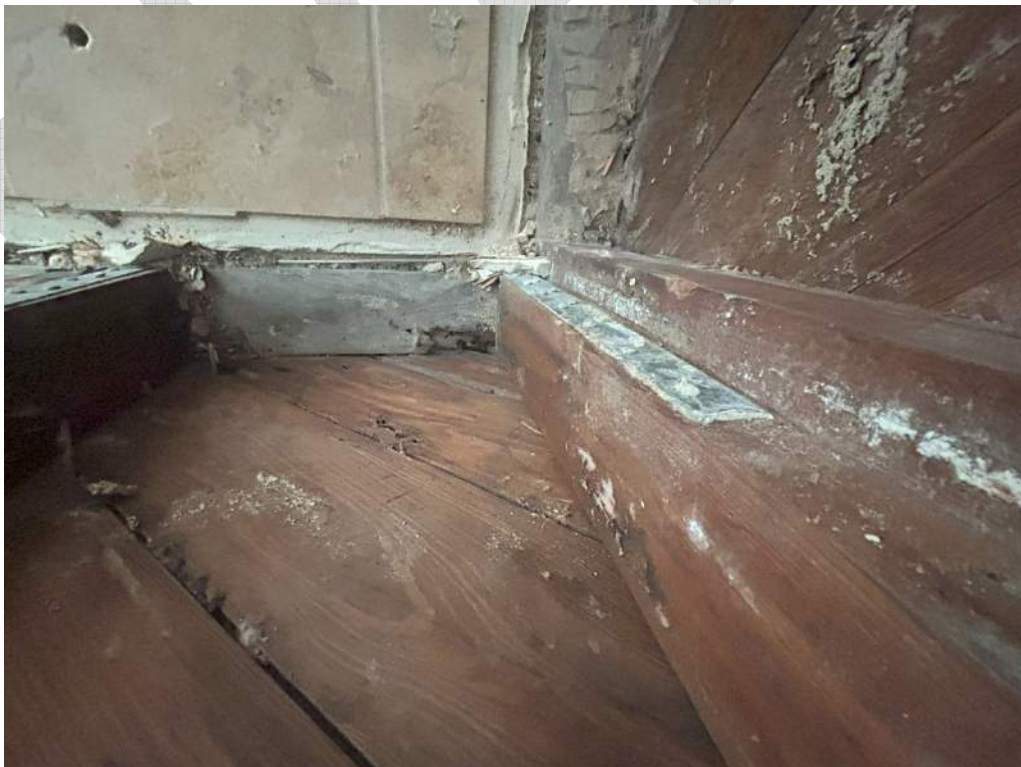
Photo 23 – Wooden Bottom Plate Rutten and Loosen at Exterior Wall Wood Frame.

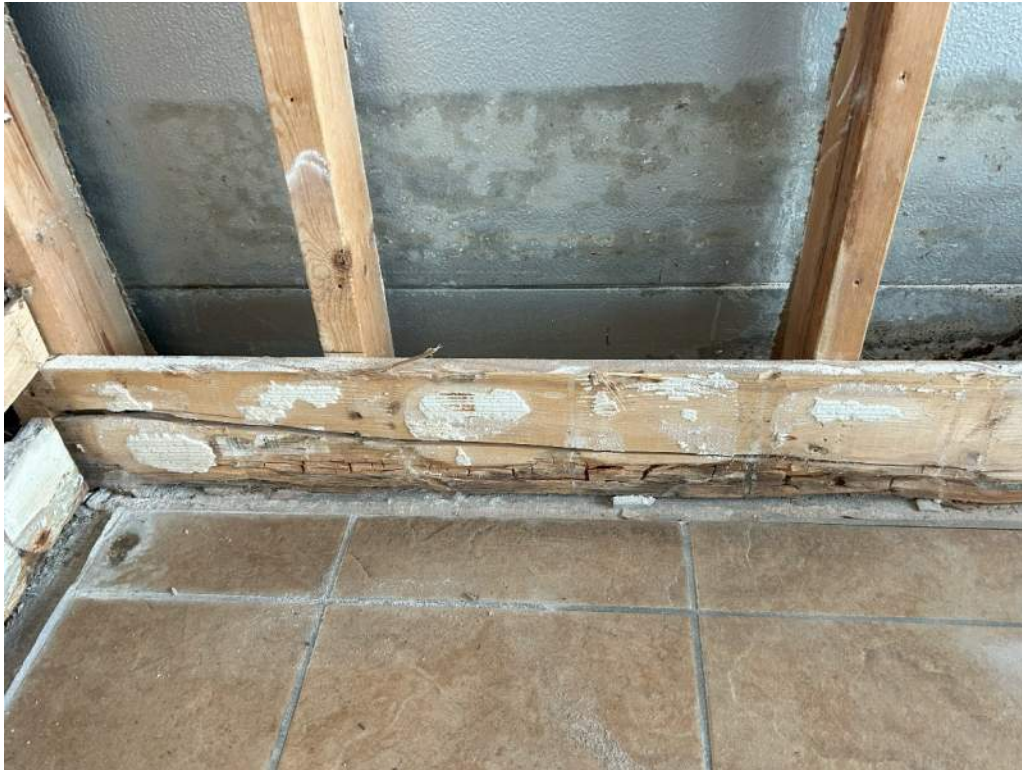
Photo 24 – Wooden Bottom Plate Broken and Rutten at Interior Wall Wood Frame.

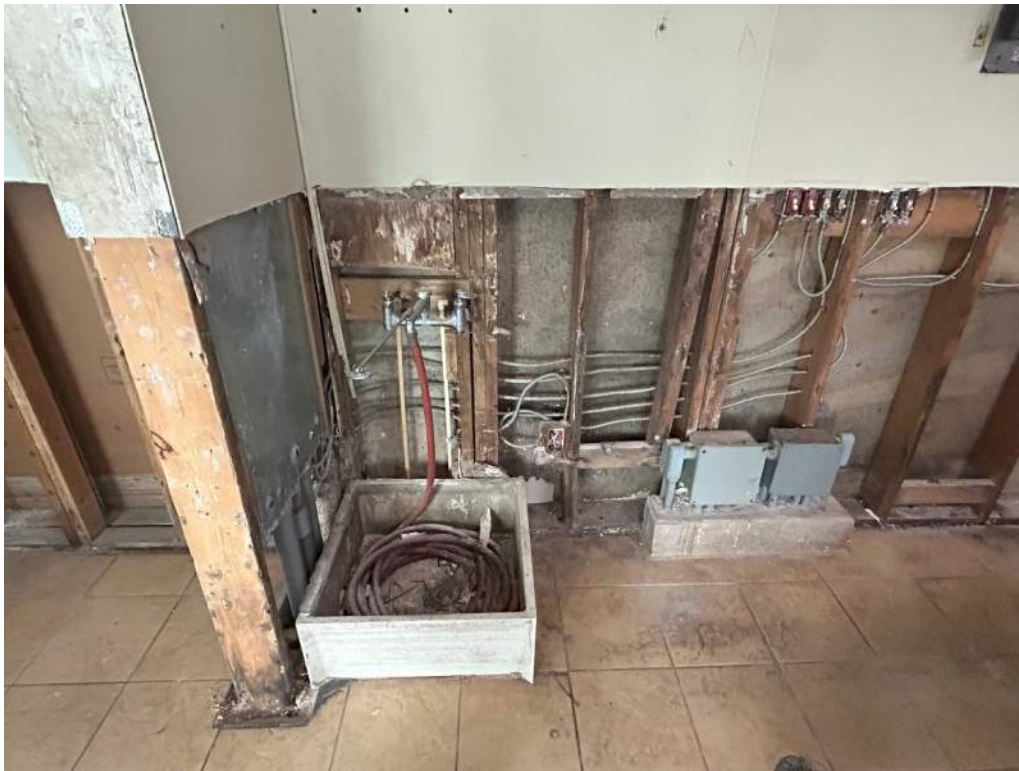
Photo 25 – Broken and Rotten Wood Studs at Interior Wall Wood Frame due to Water Intrusion.

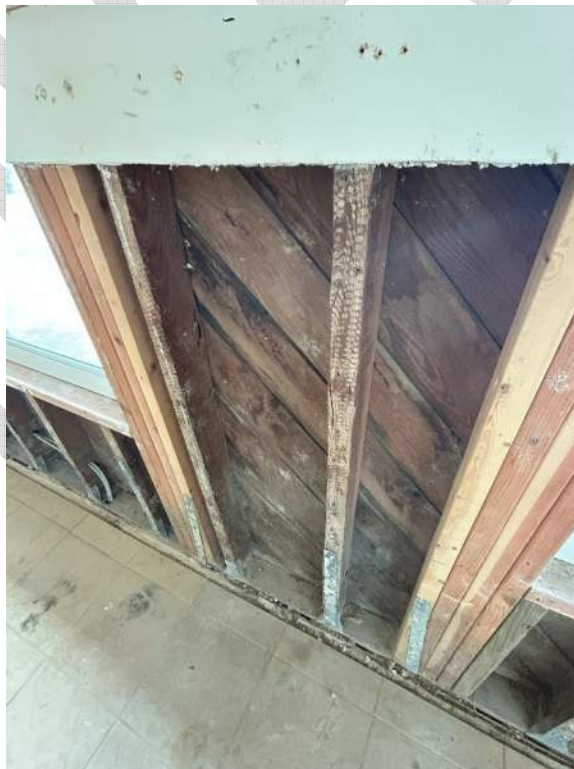
Photo 26 – Signs of Water Intrusion at Exterior Wall Sheathing of the Cabin Wood Frame.

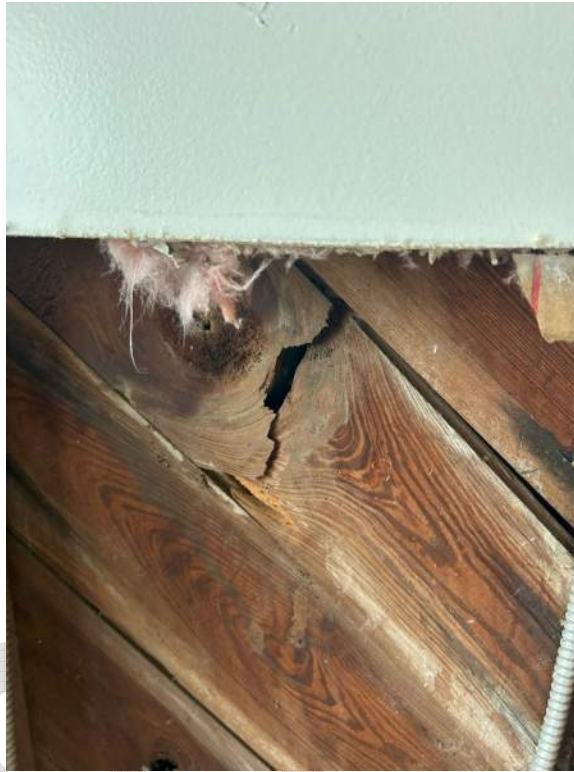
Photo 27 – Broken Wood Board of the Exterior Wall Sheathing of the Cabin Wood Frame.

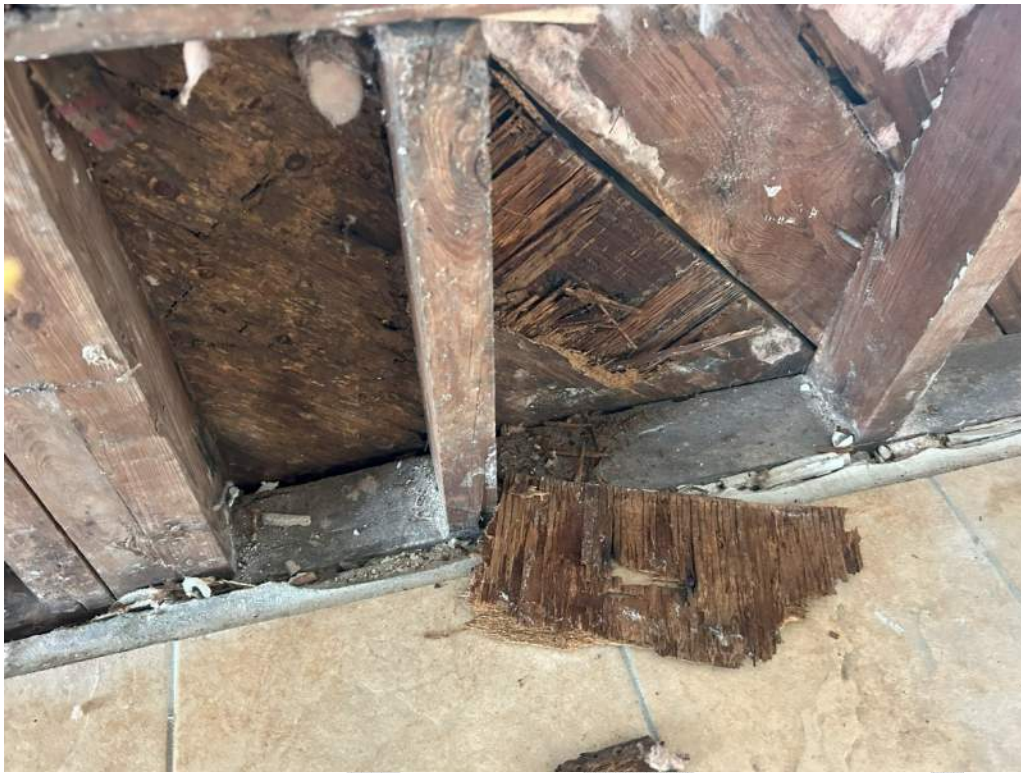
Photo 28 – Broken and Rotten Original Plywood Sheathing of the Exterior Wall of the Cabin due to Water Intrusion and Note the Absence of Steel Connectors.

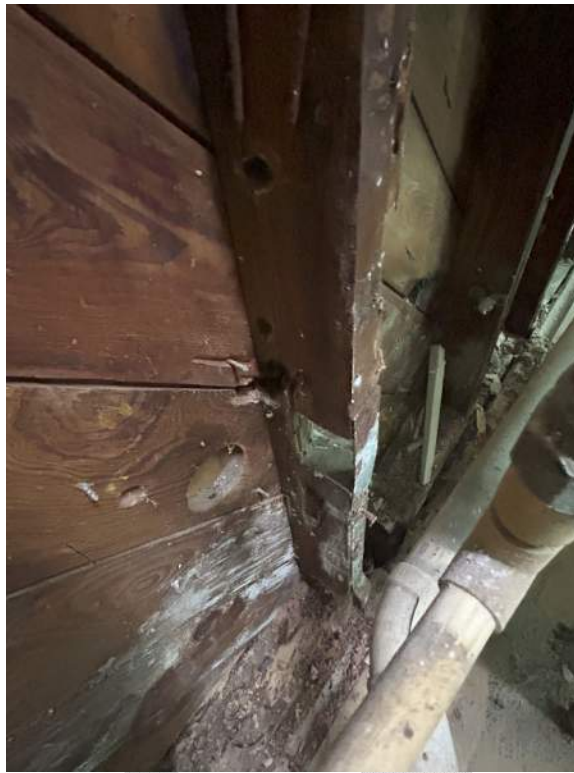
Photo 29 – Termite Damages at Wooden Studs.

It is recommended to have the subject building reviewed by for termites/ insect activity and tree as required prior to completing repairs.

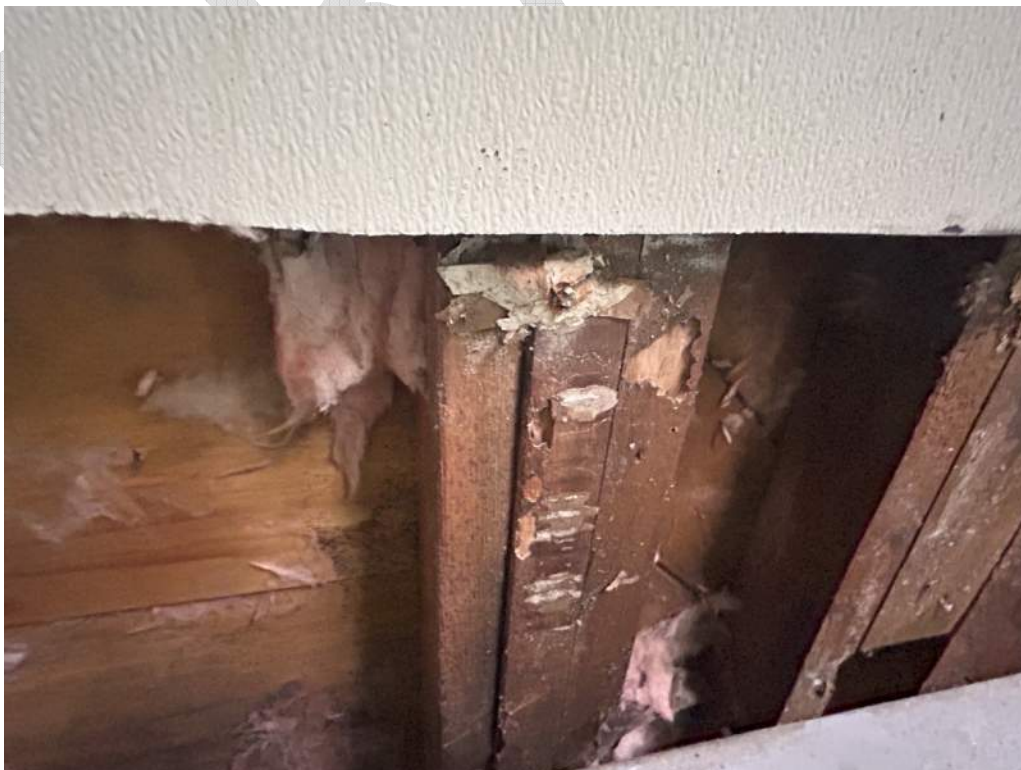
Photo 30 – Termite Damages at Wooden Studs.

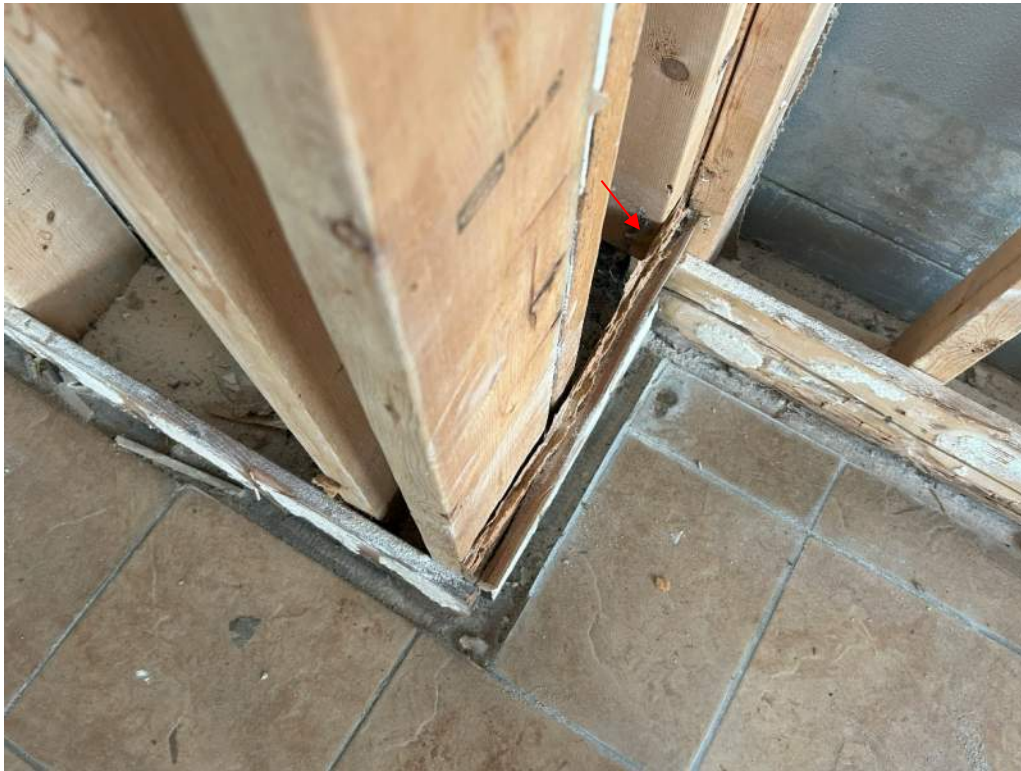
Photo 31 – Termite Damages at Interior Wood Frame.

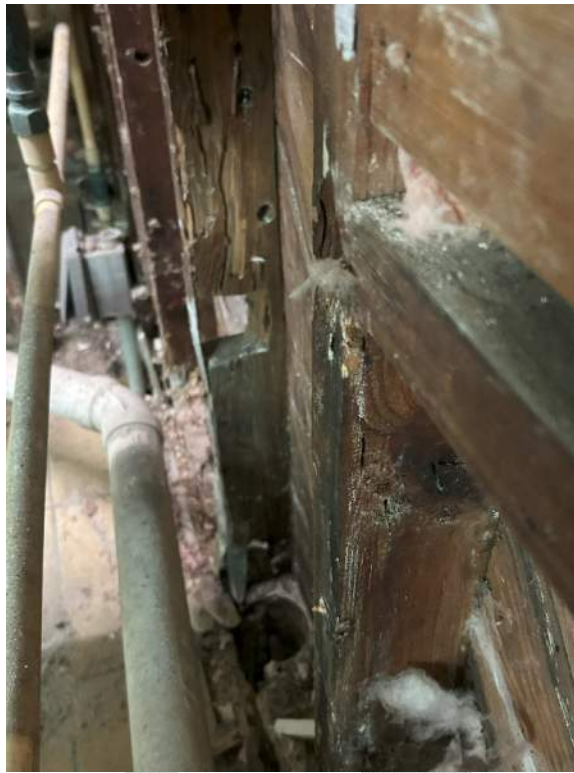
Photo 32 – Termite Damages at Wooden Studs.

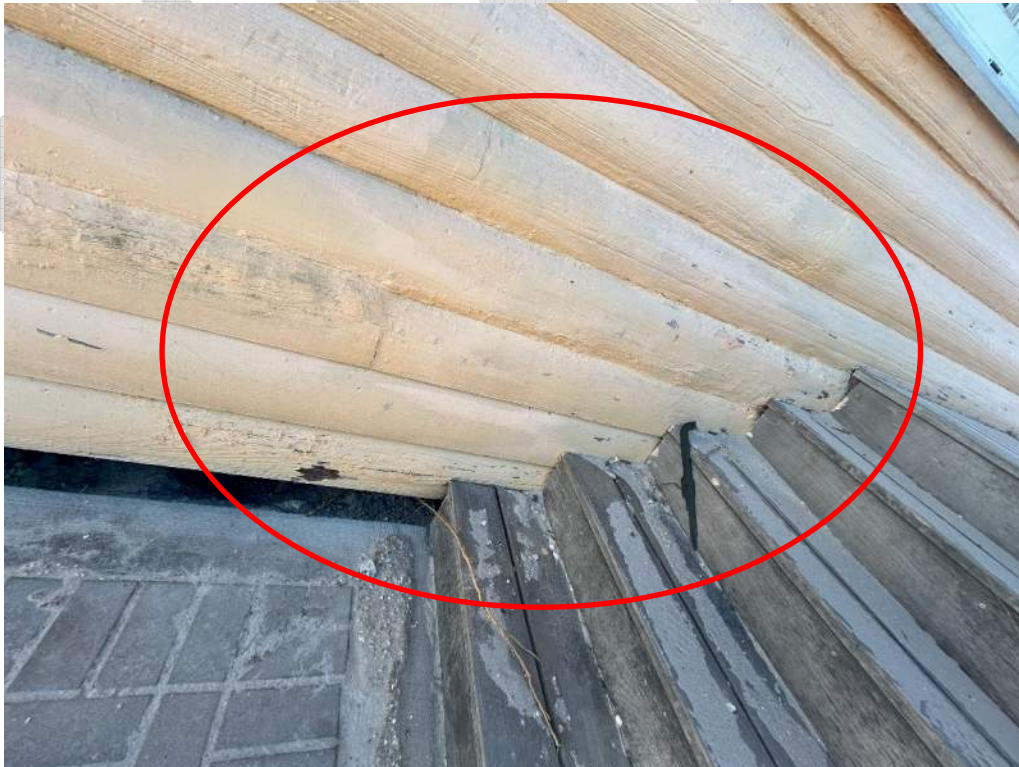
The lower +/- 2 feet of **interior drywall are damaged** by the storm surge and humidity, also some areas of the exterior **wood sidings are rotten**, and exterior **paint coating is damaged**. (See **Photos 33 -34**)

Photo 33 – Damages at Exterior Wooden Sidings.

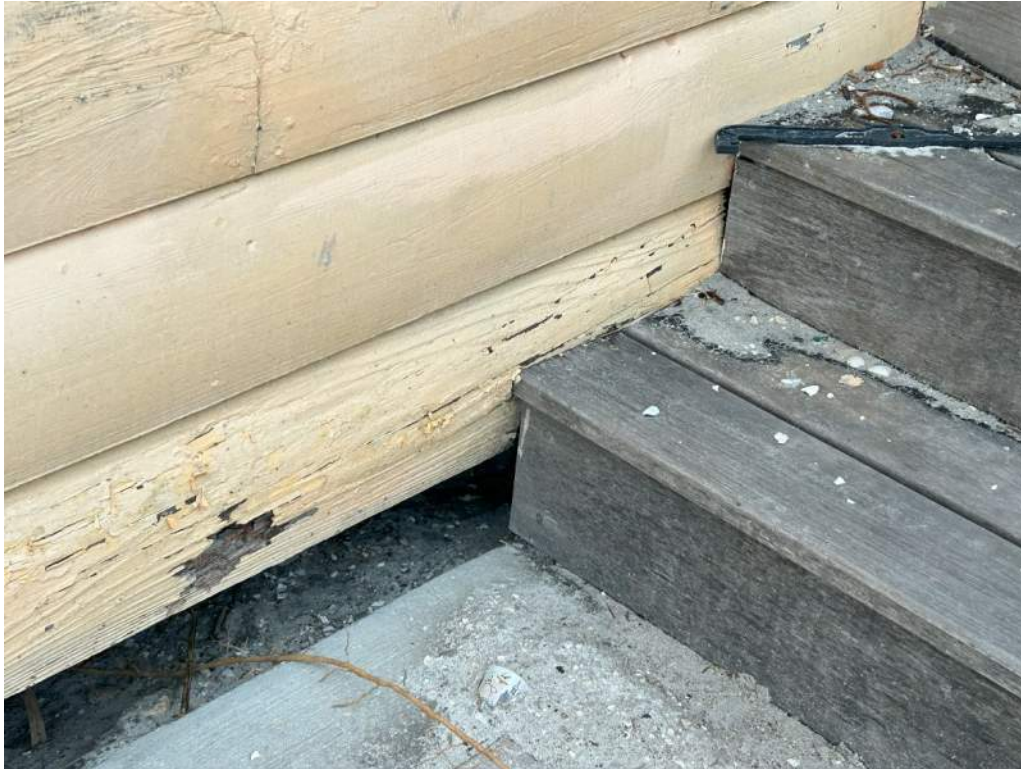
Photo 34 – Damages at Exterior Wooden Sidings.

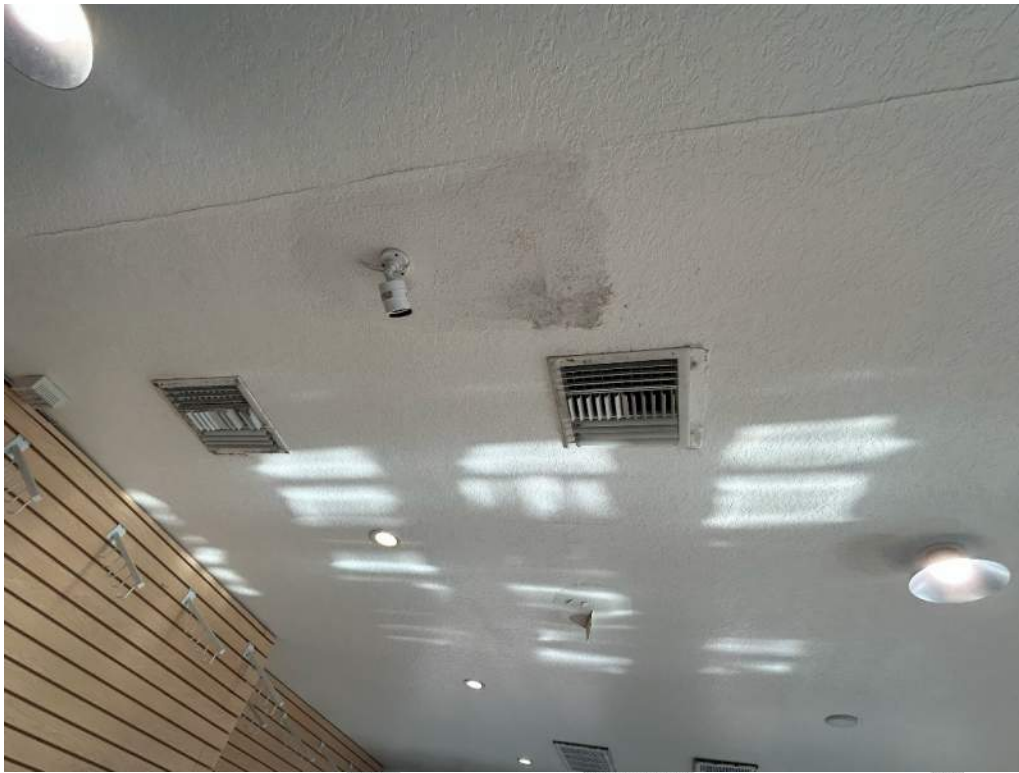
However, in the ceiling of the kitchen preparation area there are **cracks** that may show the excessive deformation of one of the wooden beams that make up the structure of the second level and **multiple signs of water penetration** can be seen on some points of these as well as the **failure of several joints between the plasterboards of the ceiling**, and it is not known whether they also affected any wooden beams.

Photo 35 – Signs of Water Intrusion through the 2nd Floor / Cracks in the Ceiling.

Exploratory removal of some areas of the ceiling and inspection of beams is recommended to determine if floor framing is damaged. It is unclear if the existing wood beams were designed to take the current storage and equipment load. (See **Photos 35 – 38** and **SK-4**)

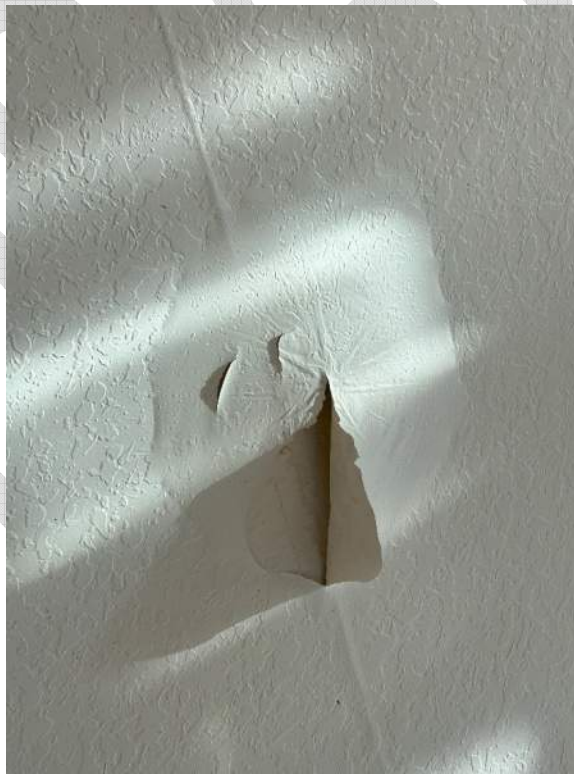
Photo 36 – Signs of Water Intrusion through in the Ceiling

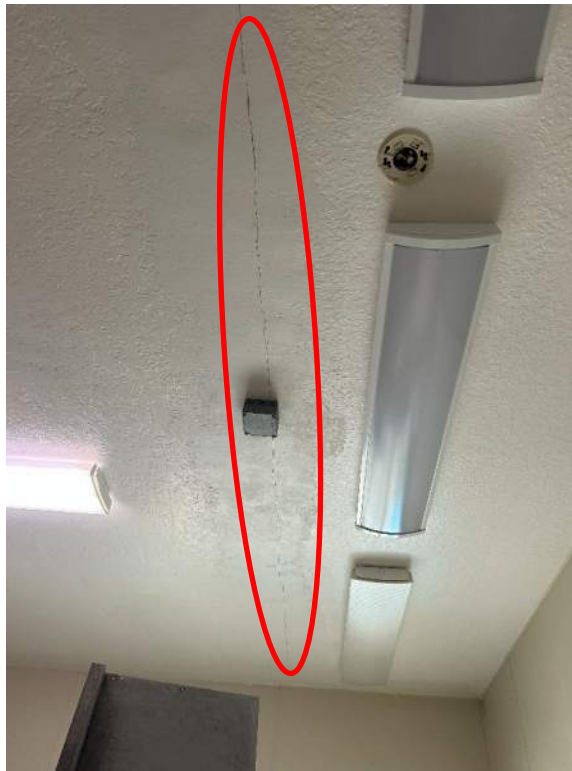
Photo 37 – Signs of Water Intrusion through the Ceiling and Longitudinal Crack in a Wood Truss direction.

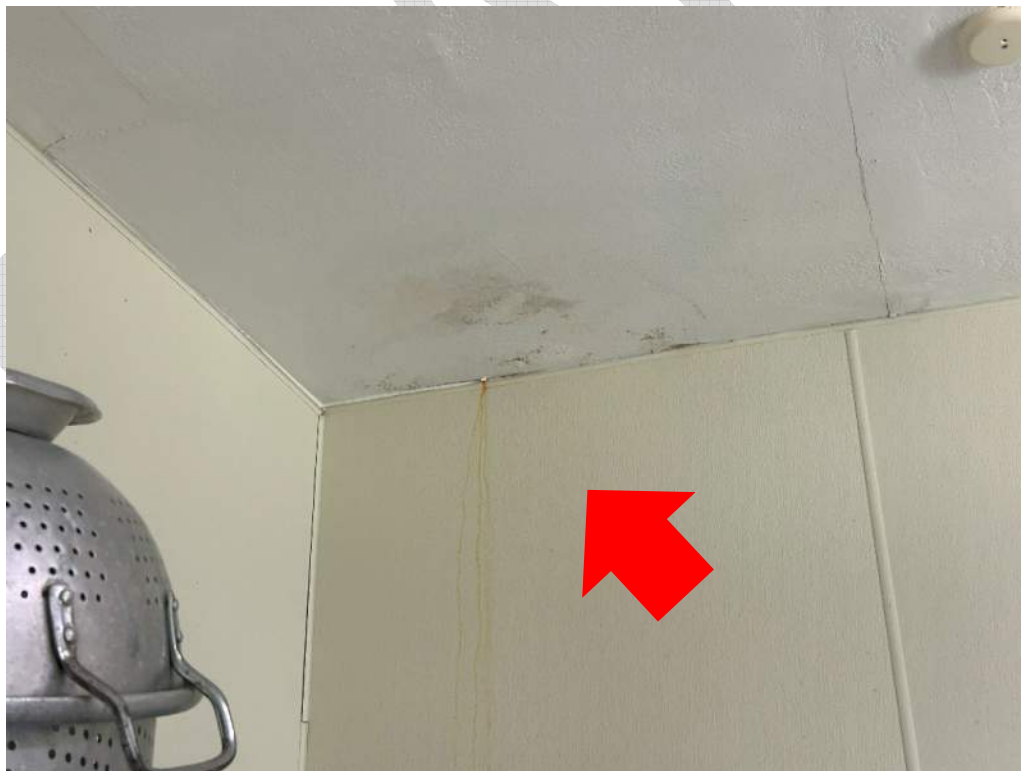
Photo 38 – Signs of Water Intrusion through in the Ceiling.

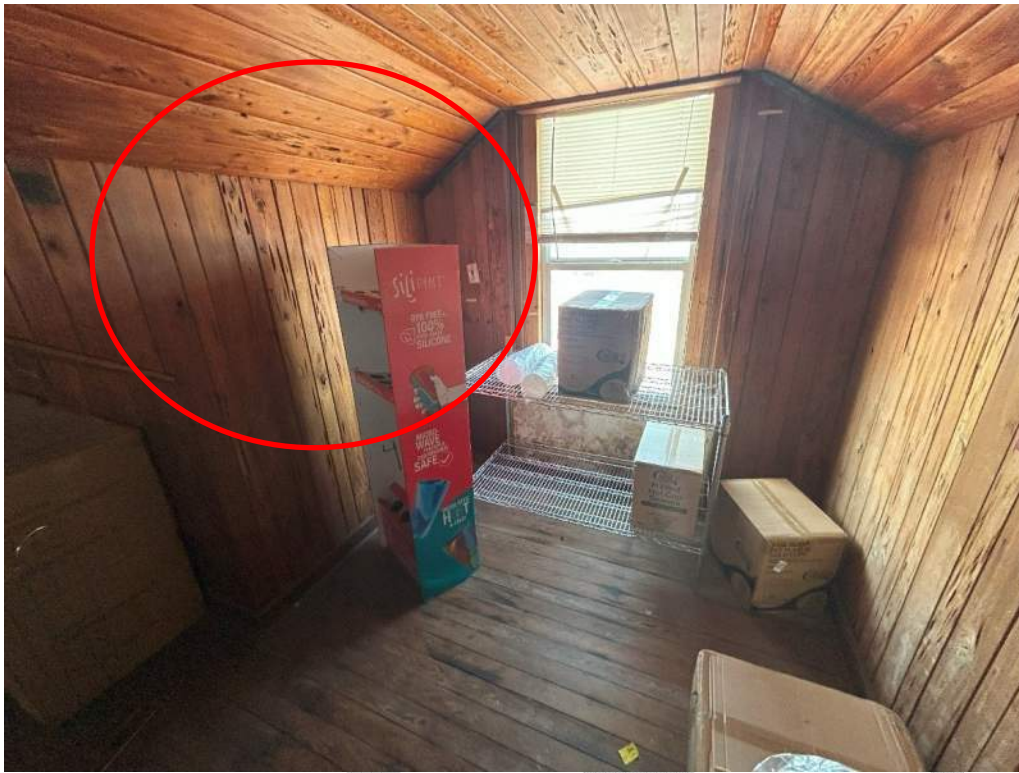
Photo 41 – Interior View of Wood Ceiling of the Attic (see Signs of termites' damages).

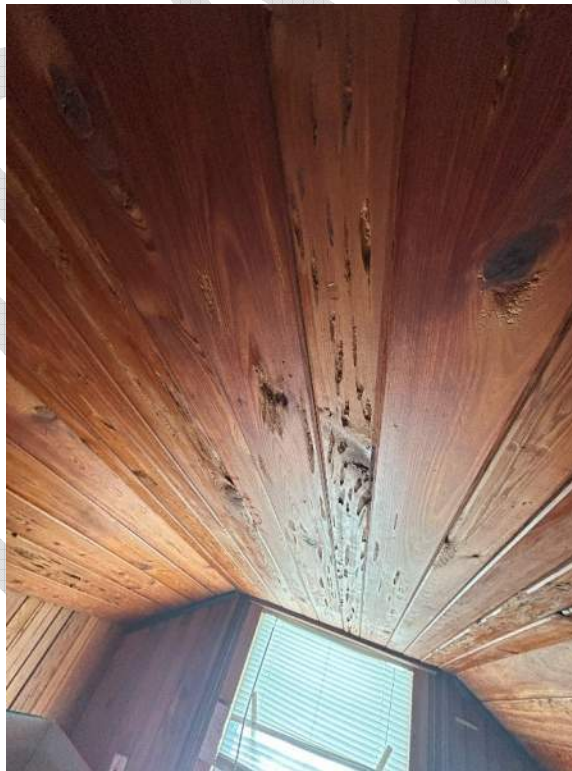
Photo 42 – Termite Damages in Wood Ceiling of the Attic.
