March 3, 2025

PROJECT NO. MDBCH24002

RE: LIMITED STORM DAMAGE ASSESSMENT OF "SNACK SHACK" CAFE
15100 GULFVIEW BLVD
MADEIRA BEACH, FL 33708

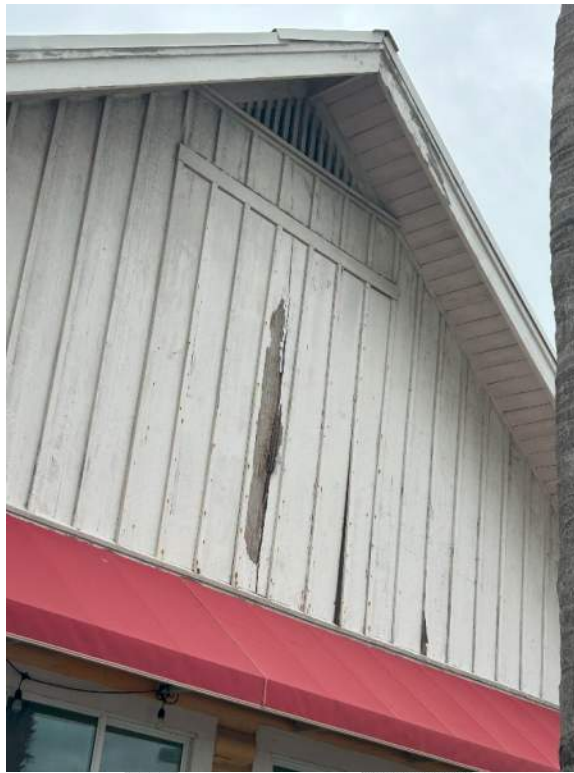
There does not appear to be signs of major readily identifiable displacement of the exterior wood framed walls, but at the southeast façade, where there was originally an opening, **one of its sidings is broken**, apparently due to the impact of the storm wind. The removal of interior wall sheathing will be required to determine the exact reason of the exterior damage and if the wall studs or connections have been affected. (See **Photos 43 – 44** and **SK-3**)

Photo 43 – Exterior Siding Broken at Southeast Façade of 2nd Floor (Attic).

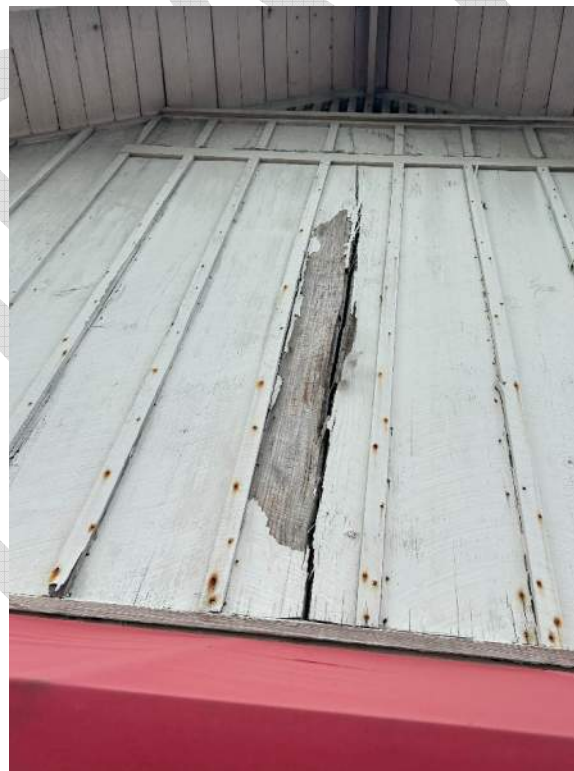
Photo 44 – Close Up View of Exterior Siding Broken at Southeast façade of 2nd Floor (Attic), also Note Wooden Nails Corroded.

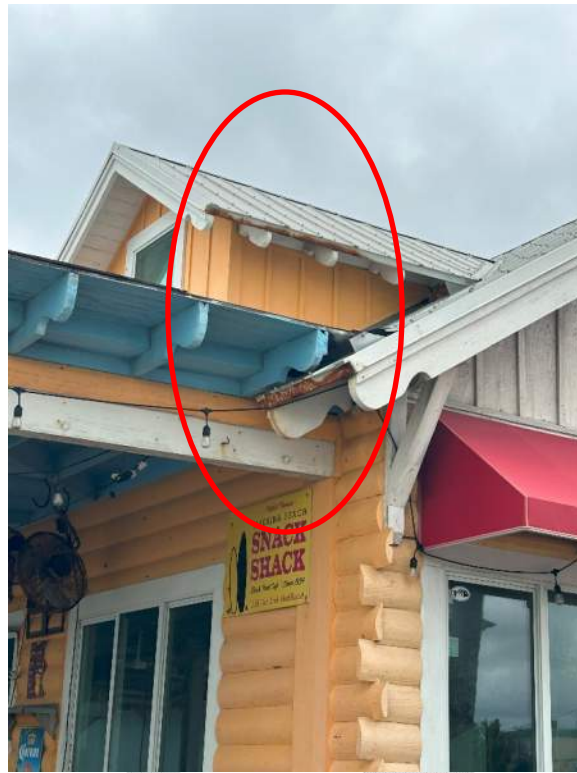
Photo 47 – Corrosion on Metal Roofing Edges.

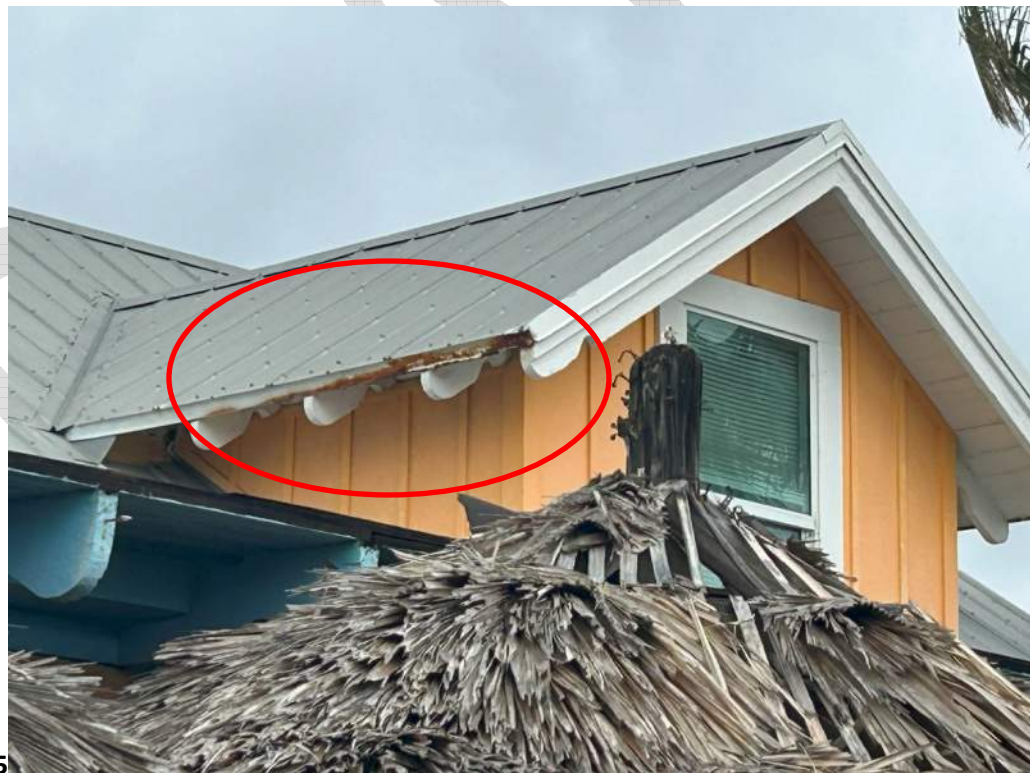
Photo 48 – Corrosion on Metal Roofing Edges.

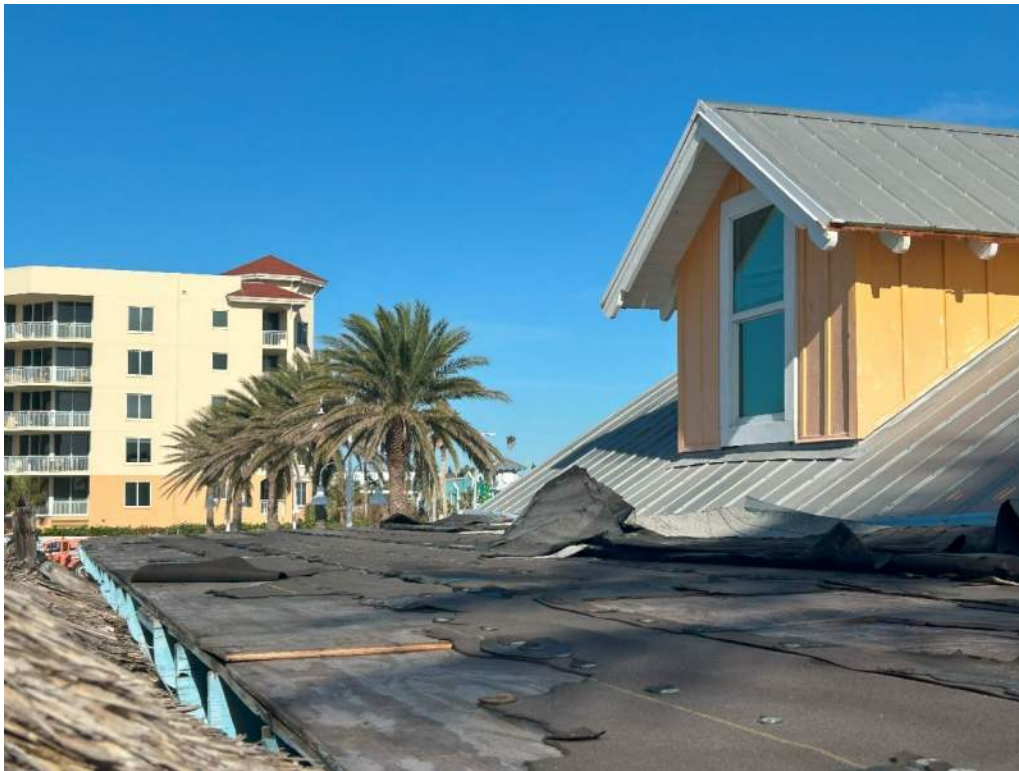
Photo 49 – Outside View of Built-up Roofing Destroyed.

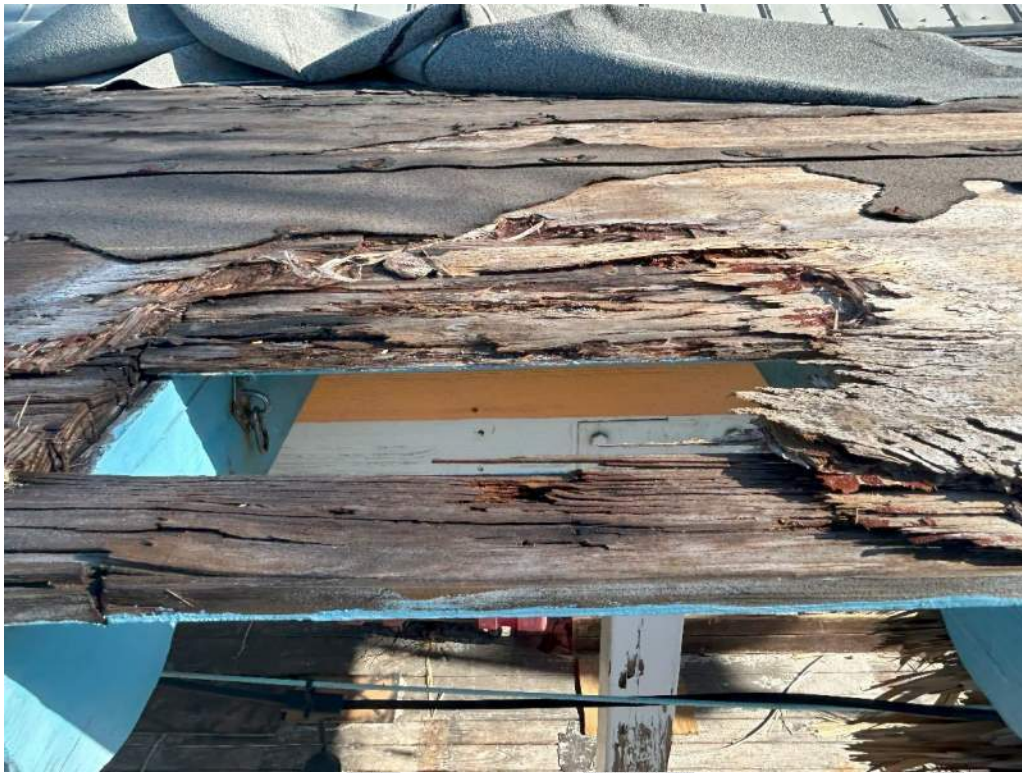
Photo 51 – Back Porch Roof Sheathing Destroyed.

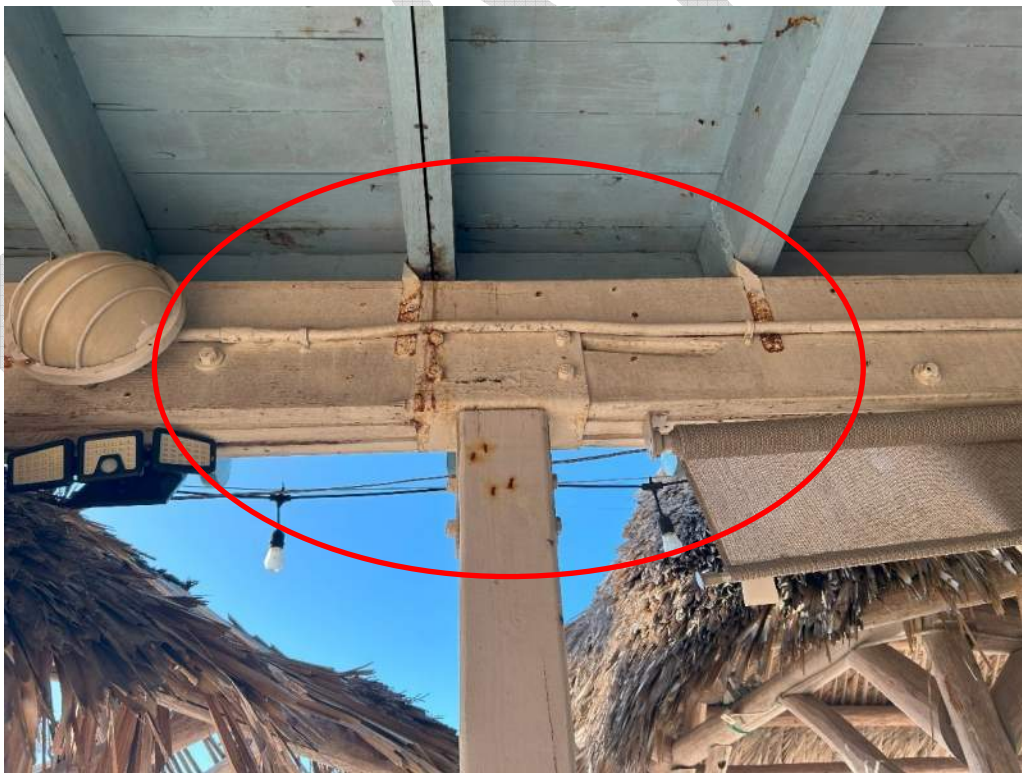
Photo 52 – Corroded Connections at Back Porch Frame.

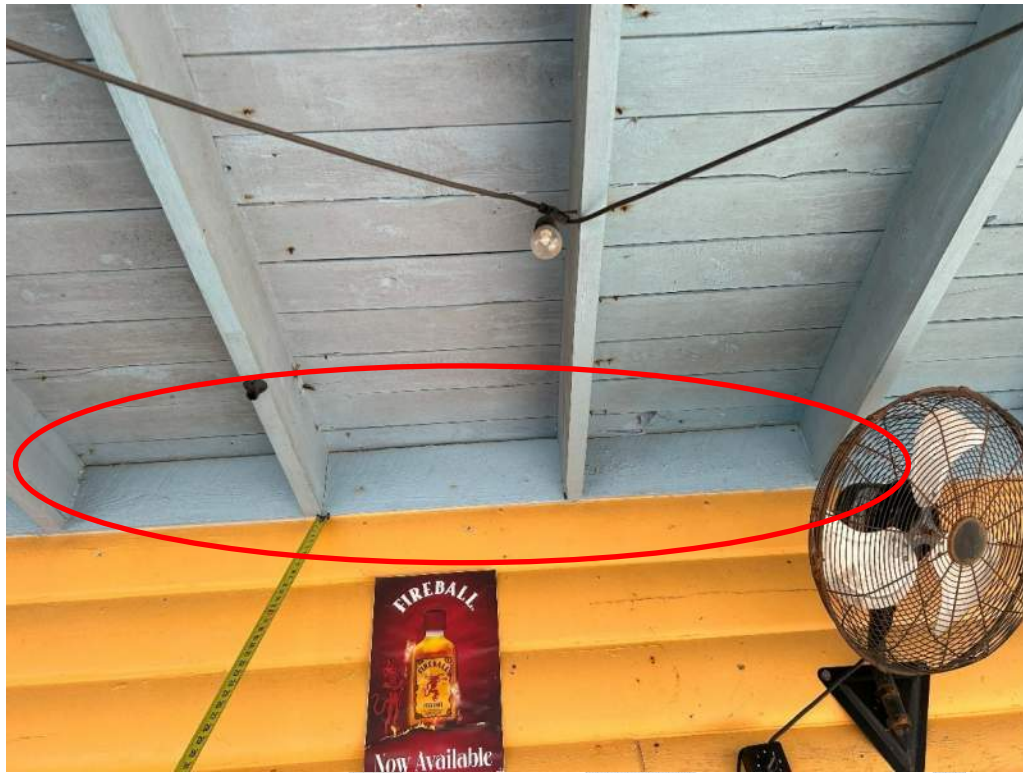
Photo 53 – Lack of Connections in the Roof Structure at Back Porch Frame.

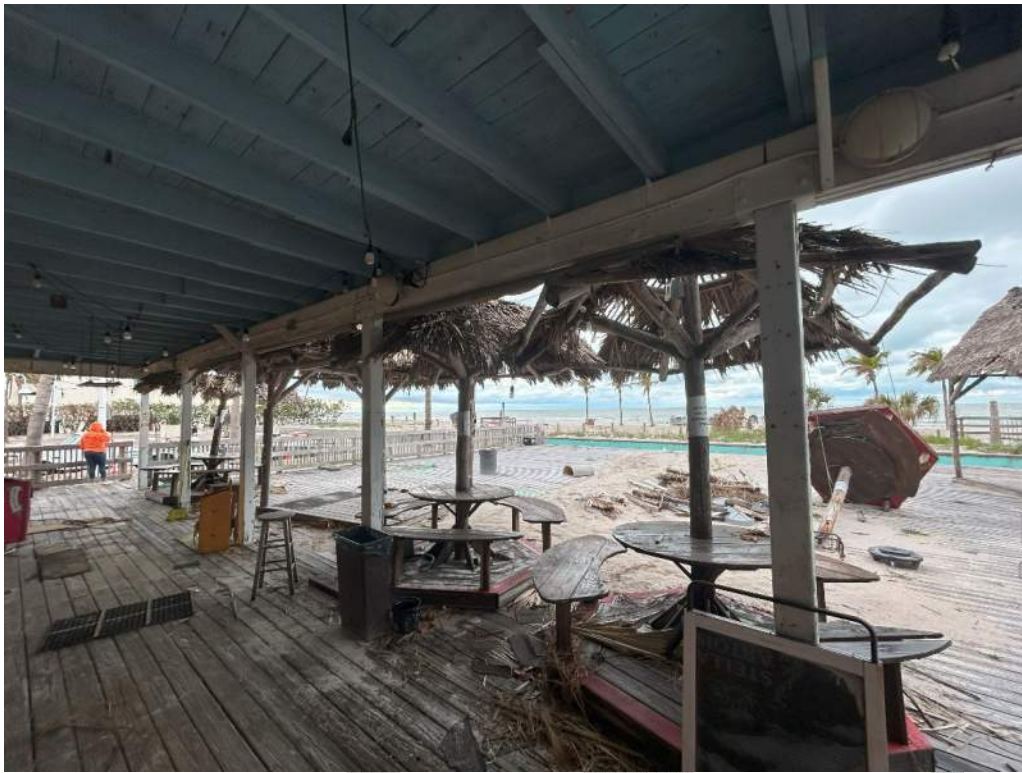
Existing Tiki Huts for sitting on the outside deck were moved for the storm surge from their original location to the building and hit the exterior structure of the back porch. Although no severe damage was seen in the structure, this impact undoubtedly contributed to aggravating the damage to this roof. (See **Photo 2**). Review of the Tiki Huts or the West wood framed deck were not in our scope of work.

Photo 55 – Outside View of the Rear Wood Deck and Back Porch that was Impacted by Outside Tikis.

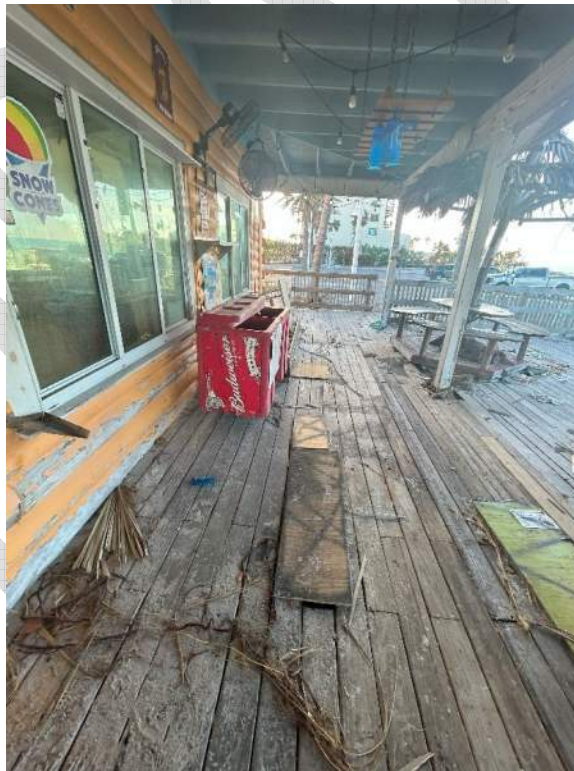
Photo 58 – Wooden Boards Loose at the Back Porch.

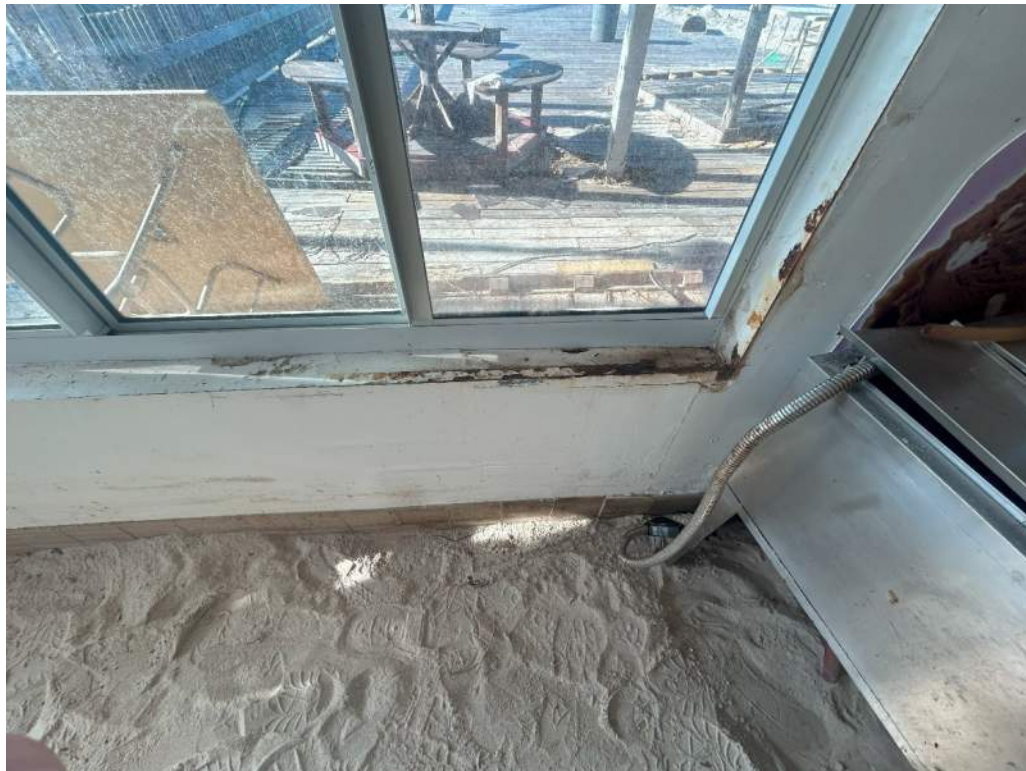
Photo 59 – Corrosion in Metal Corner Beads of Interior Walls.

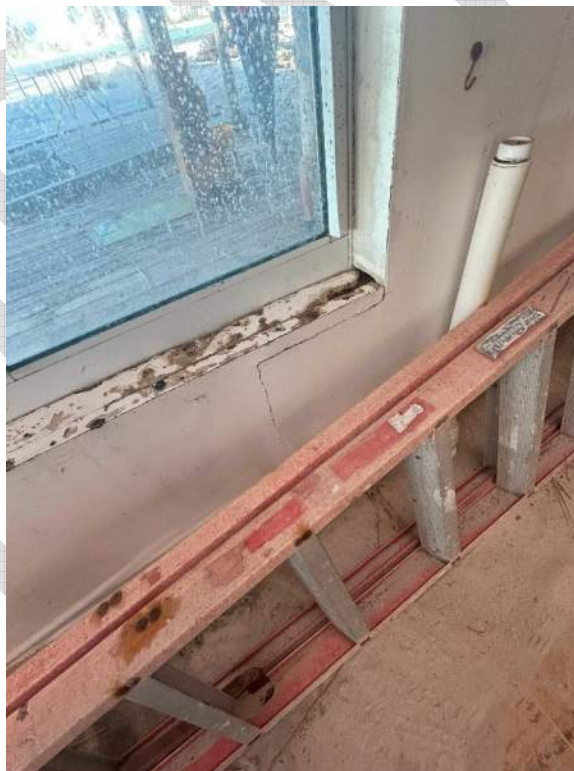
Photo 60 – Several Damages in Interior Walls Finishes.

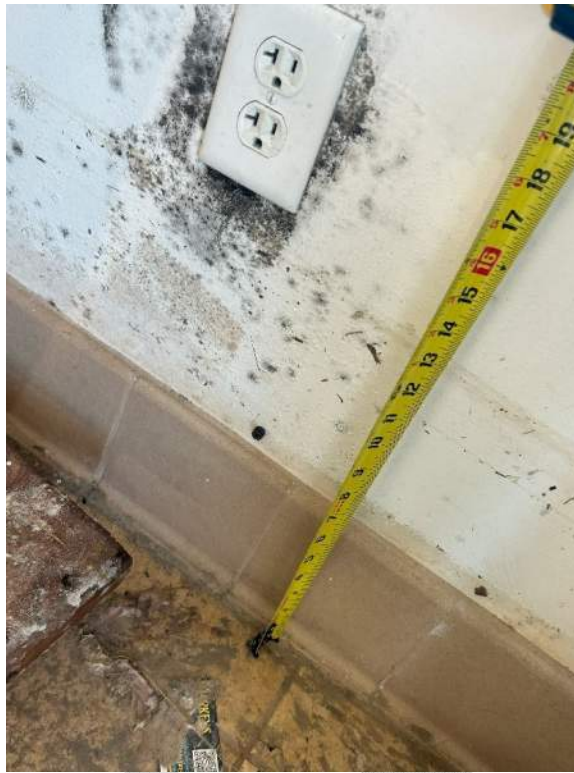
Photo 61 – Signs of Mold and Water Intrusion in the Interior of the Building (14" over finish floor).

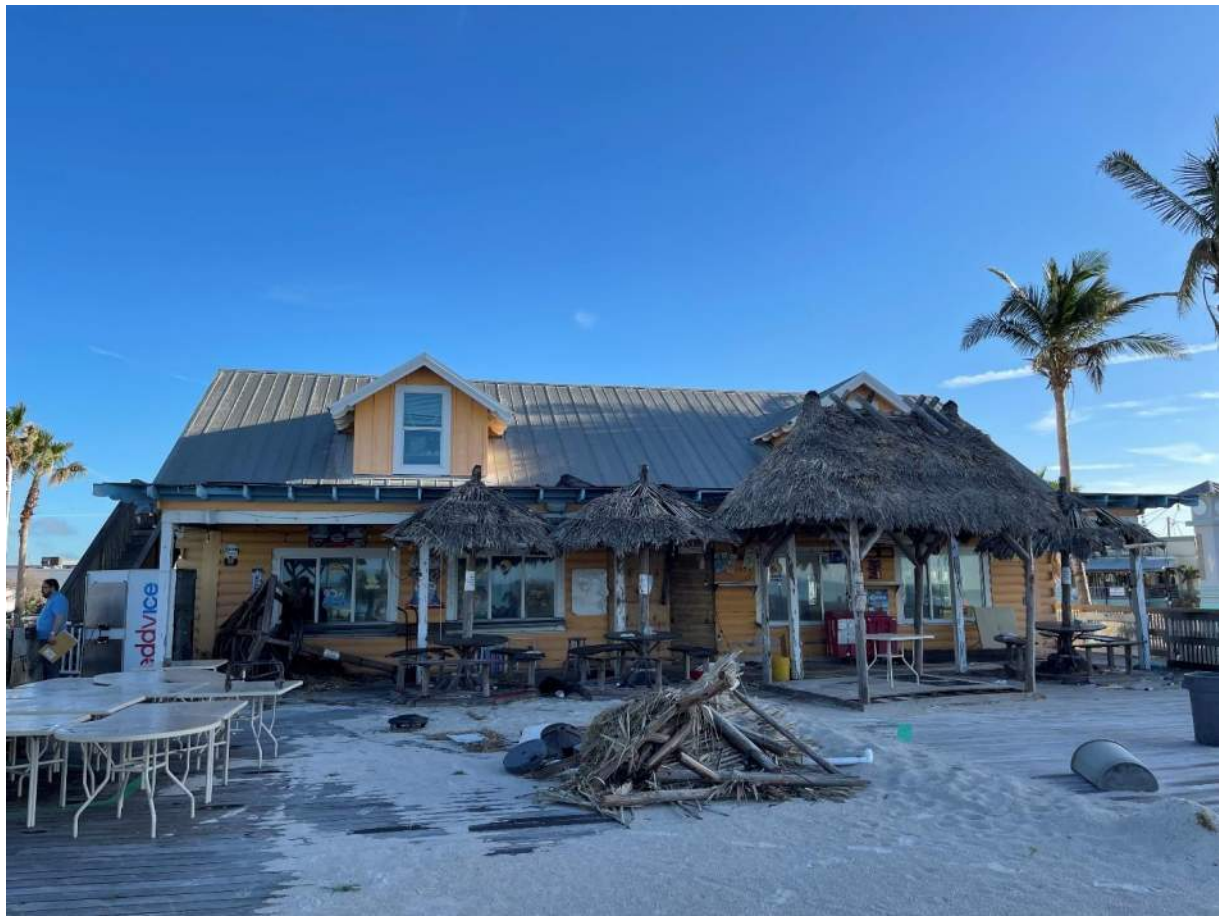
Overall view from exterior deck. damaged tiki huts/seating area.

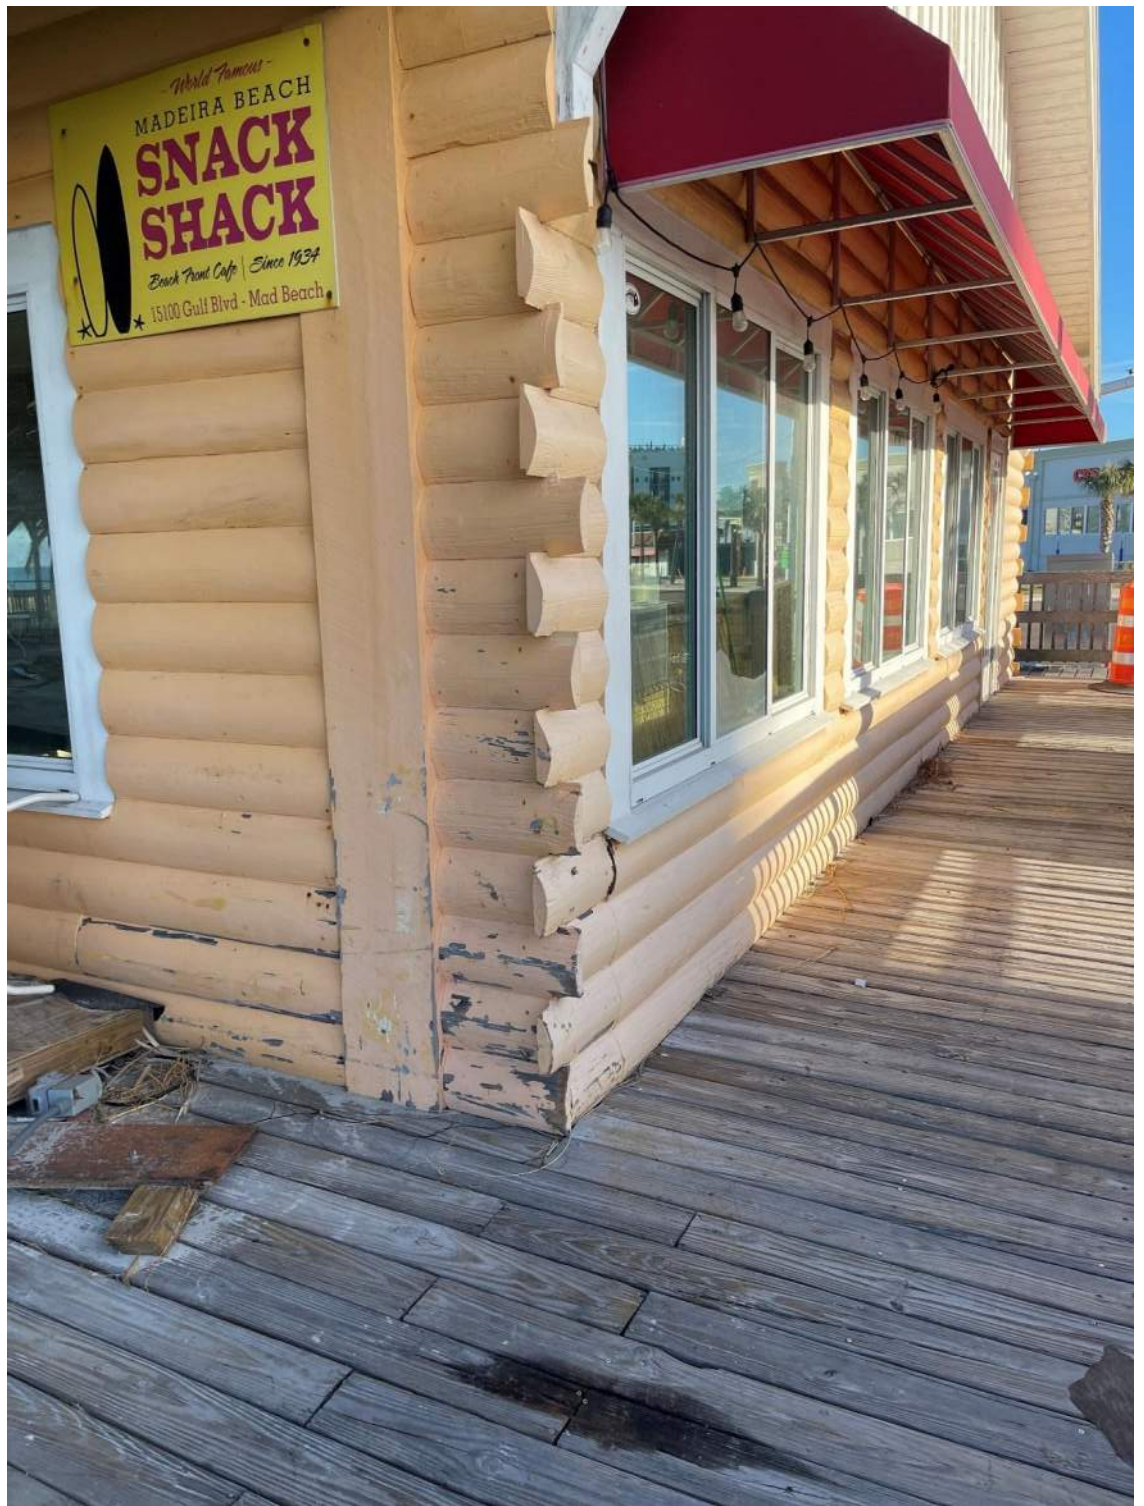
Paint peeling.

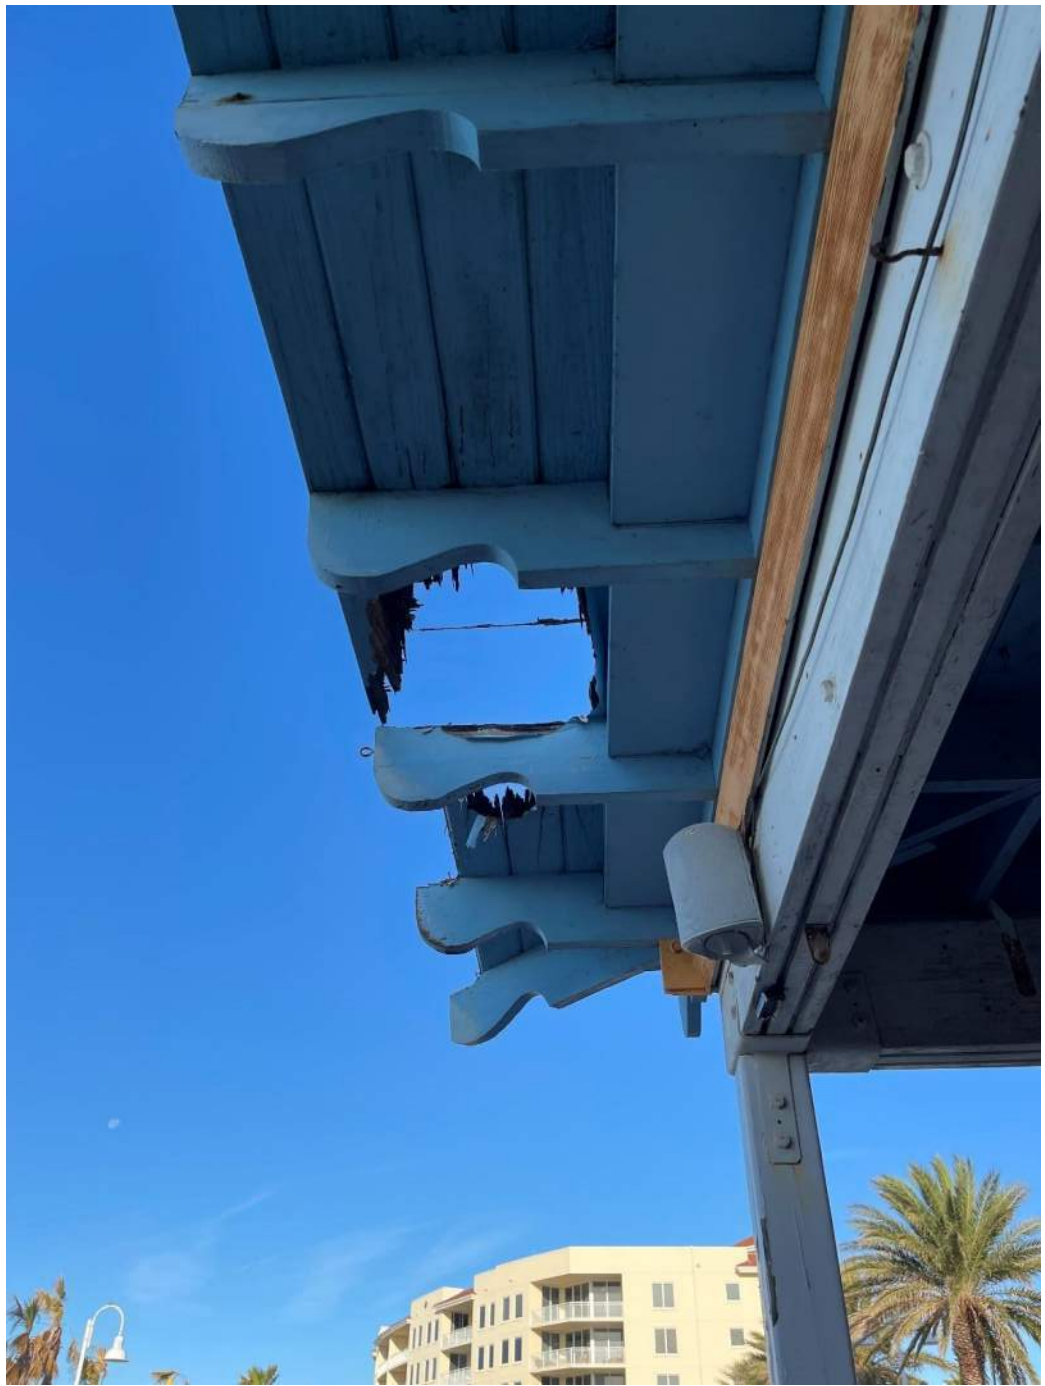
Roof deck damage.

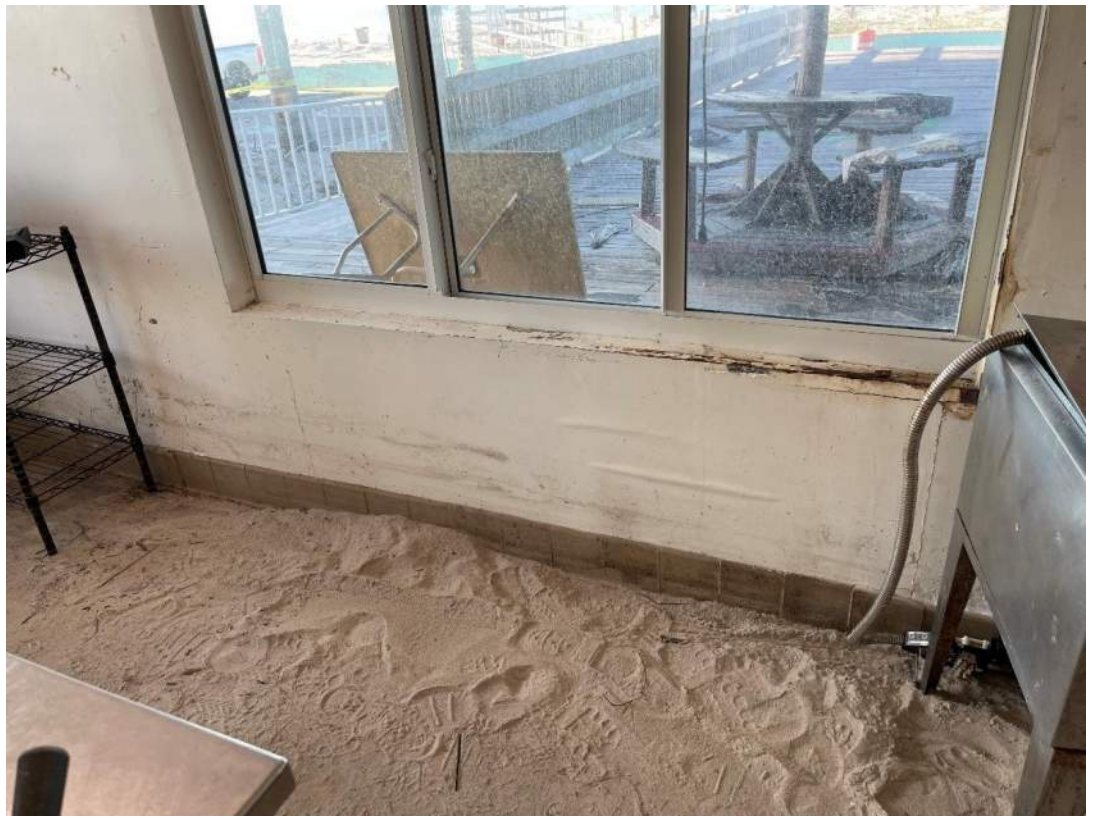
Sand/water intrusion in walls.

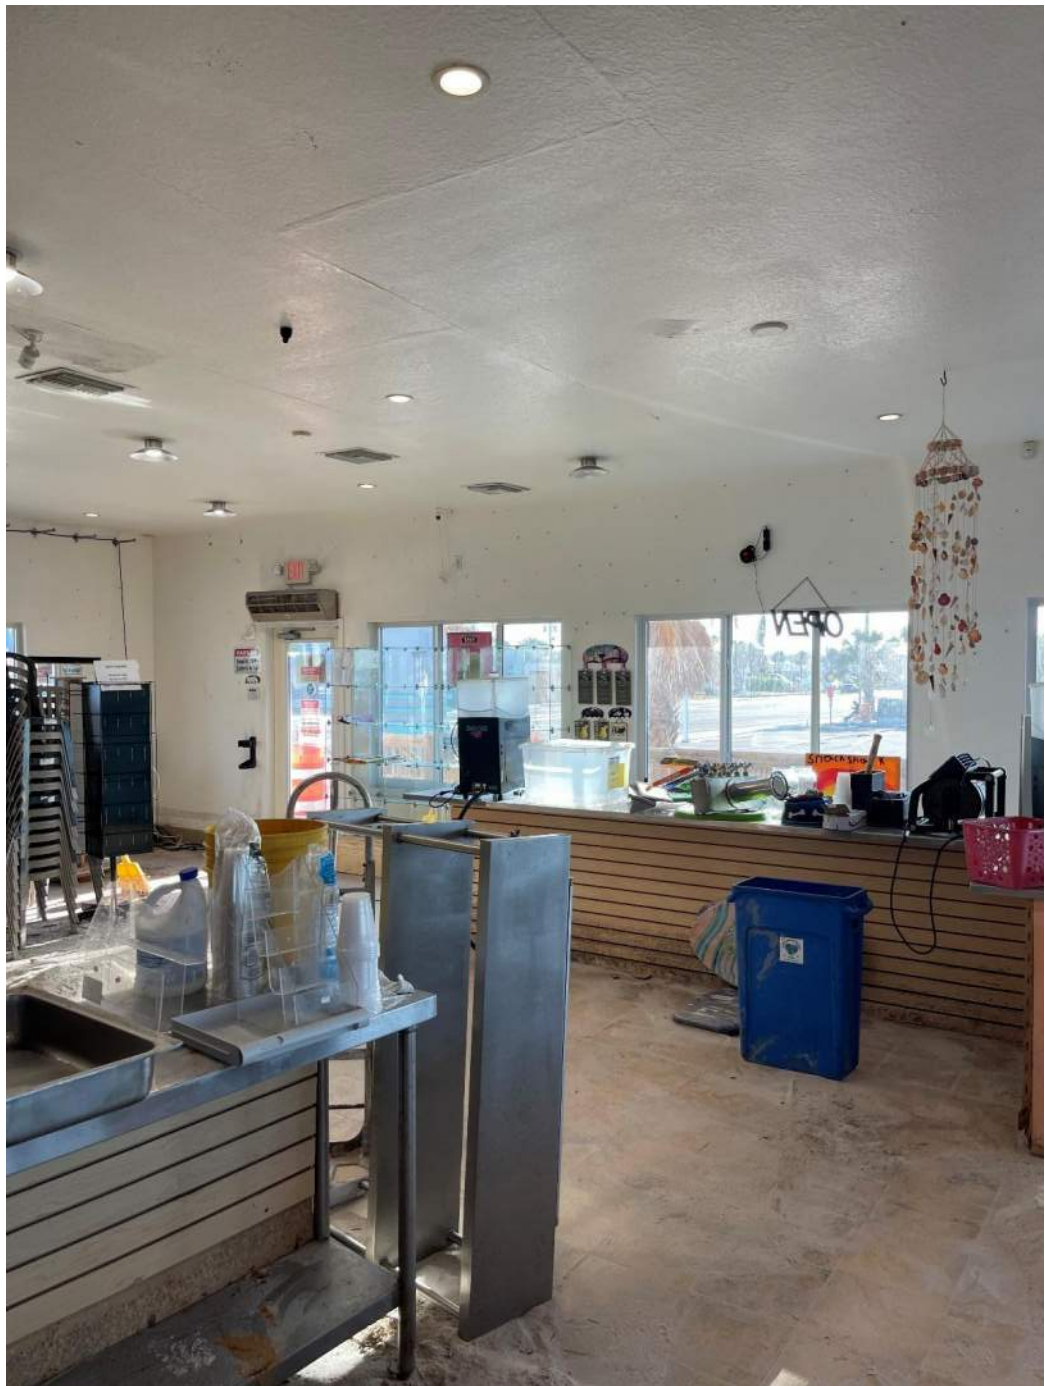
interior/ ceiling cracks and water damage on ceiling.

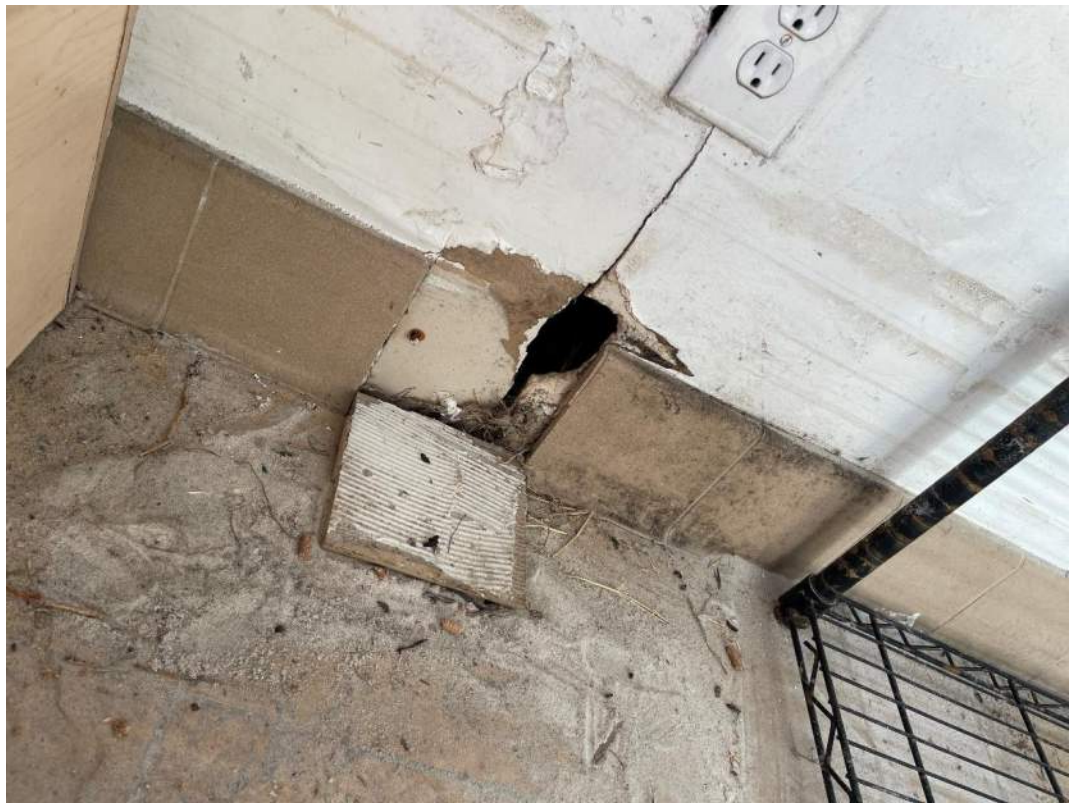
Wall base, hole in wall cavity with water intrusion.

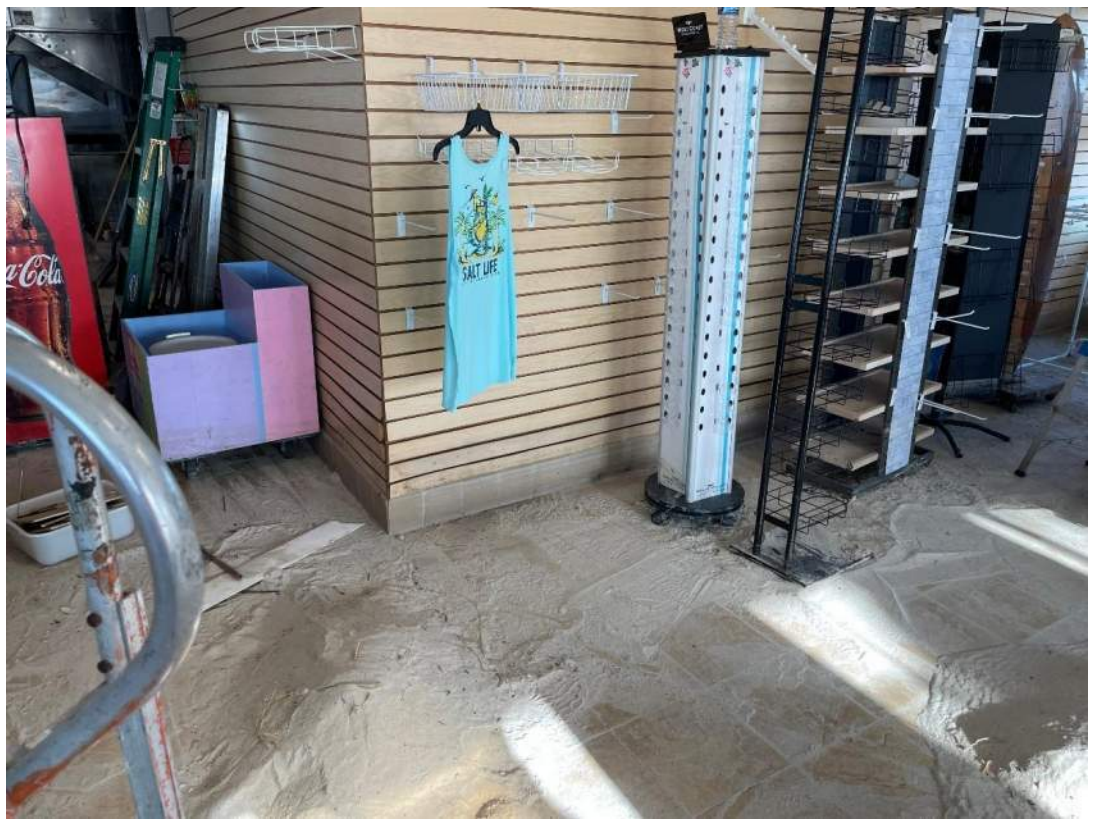
Sand/ flood damage on wood slate wall.

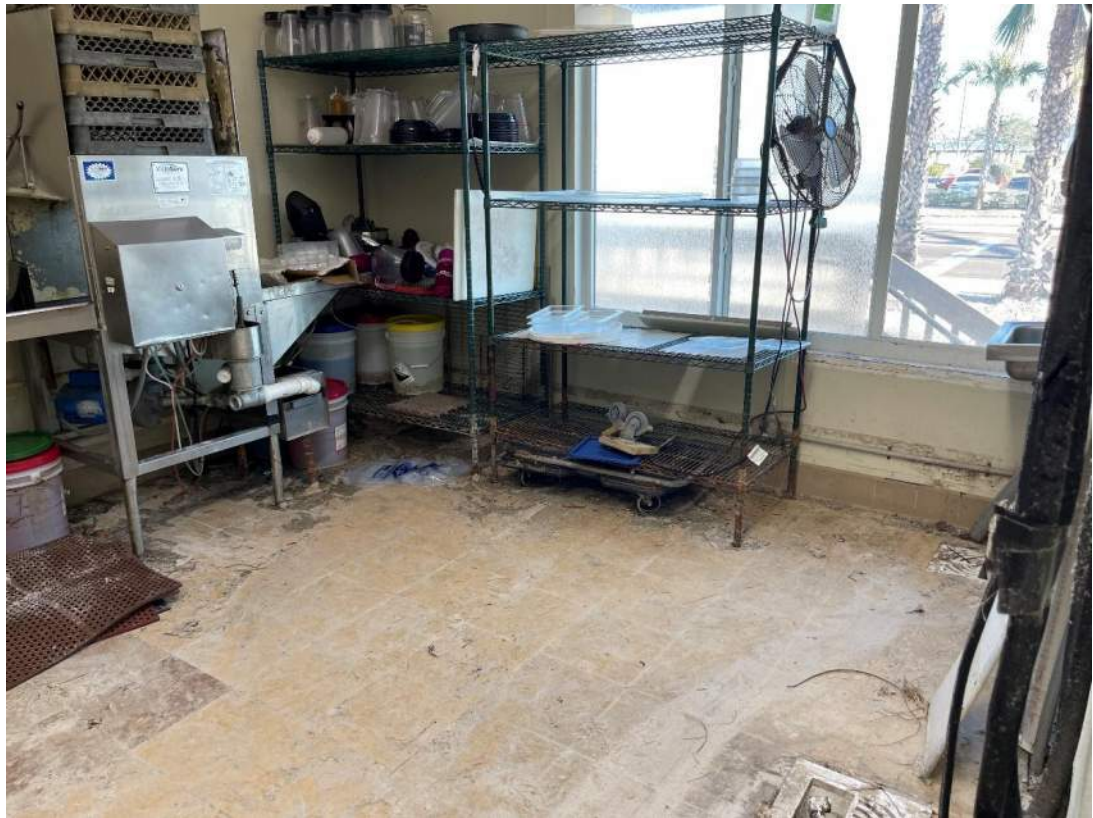
Sand / flood damage , typical throughout

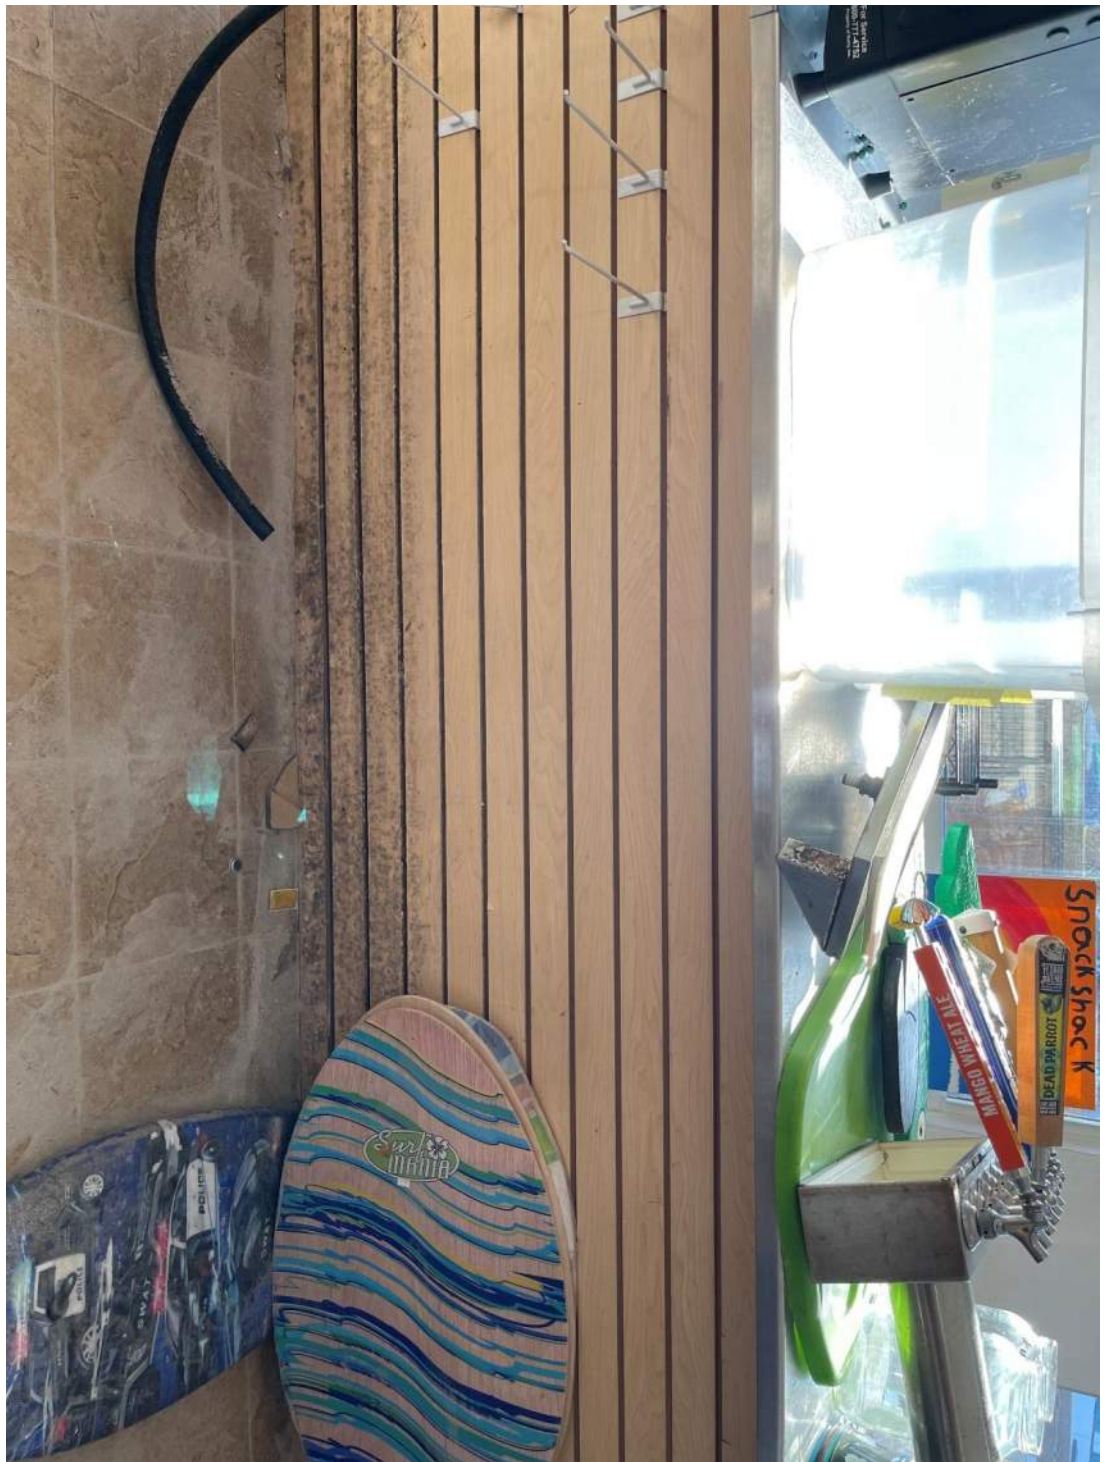
Sales area low wall/wood slate wall damage needs to be replaced.
