July 31, 2025

PROJECT NO. MDBCH25002

**RE: LIMITED STRUCTURAL FLOOD HARDENING STUDY OF MADEIRA BEACH CITY HALL
MADEIRA BEACH CITY HALL RENOVATION & FLOOD HARDENING
300 MUNICIPAL DR.
MADEIRA BEACH, FL 33708**

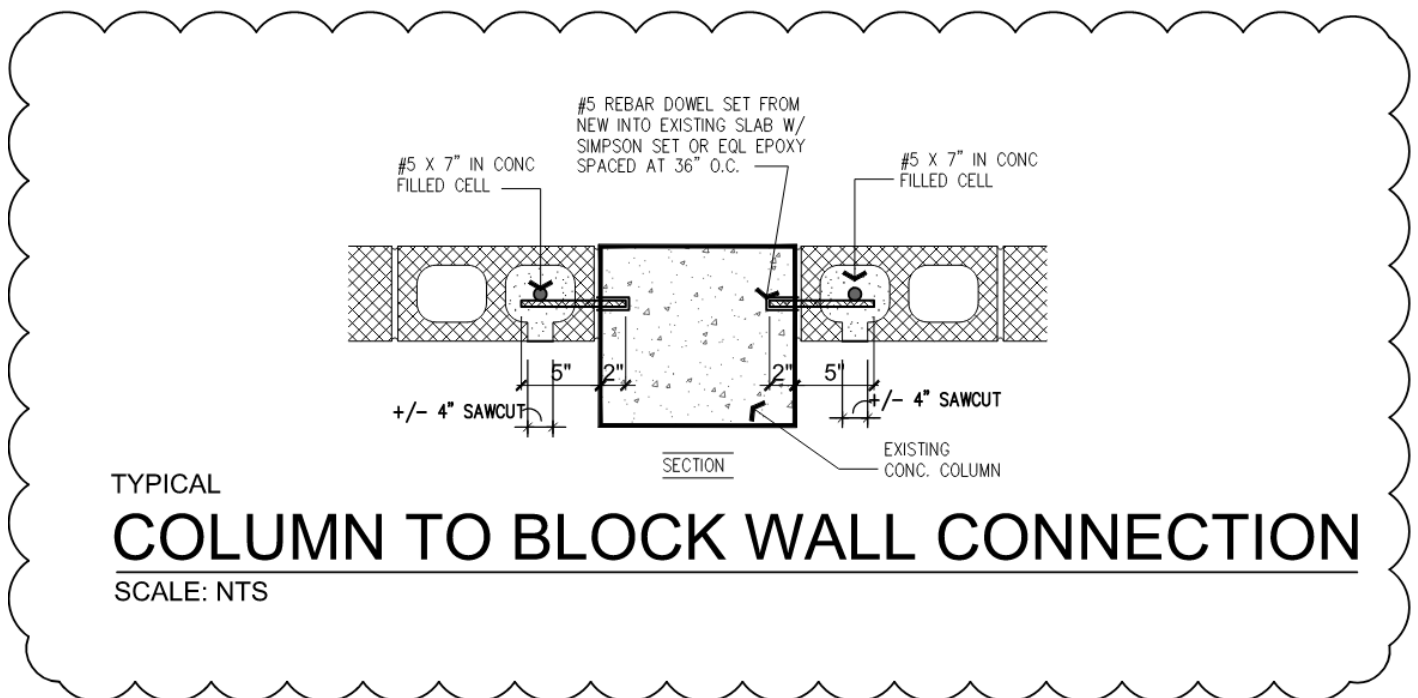
Figure 2 – CMU to Column Connection

Infill wall to existing column connections are specified in the below detail on sheet A-2.0

PAI Comment – Based on Scanning of the structure the exterior columns appear to be tied into the exterior walls by horizontal rebar on 16-inch centers. The rebar is estimated to extend 6 to 8 inches into the wall columns.

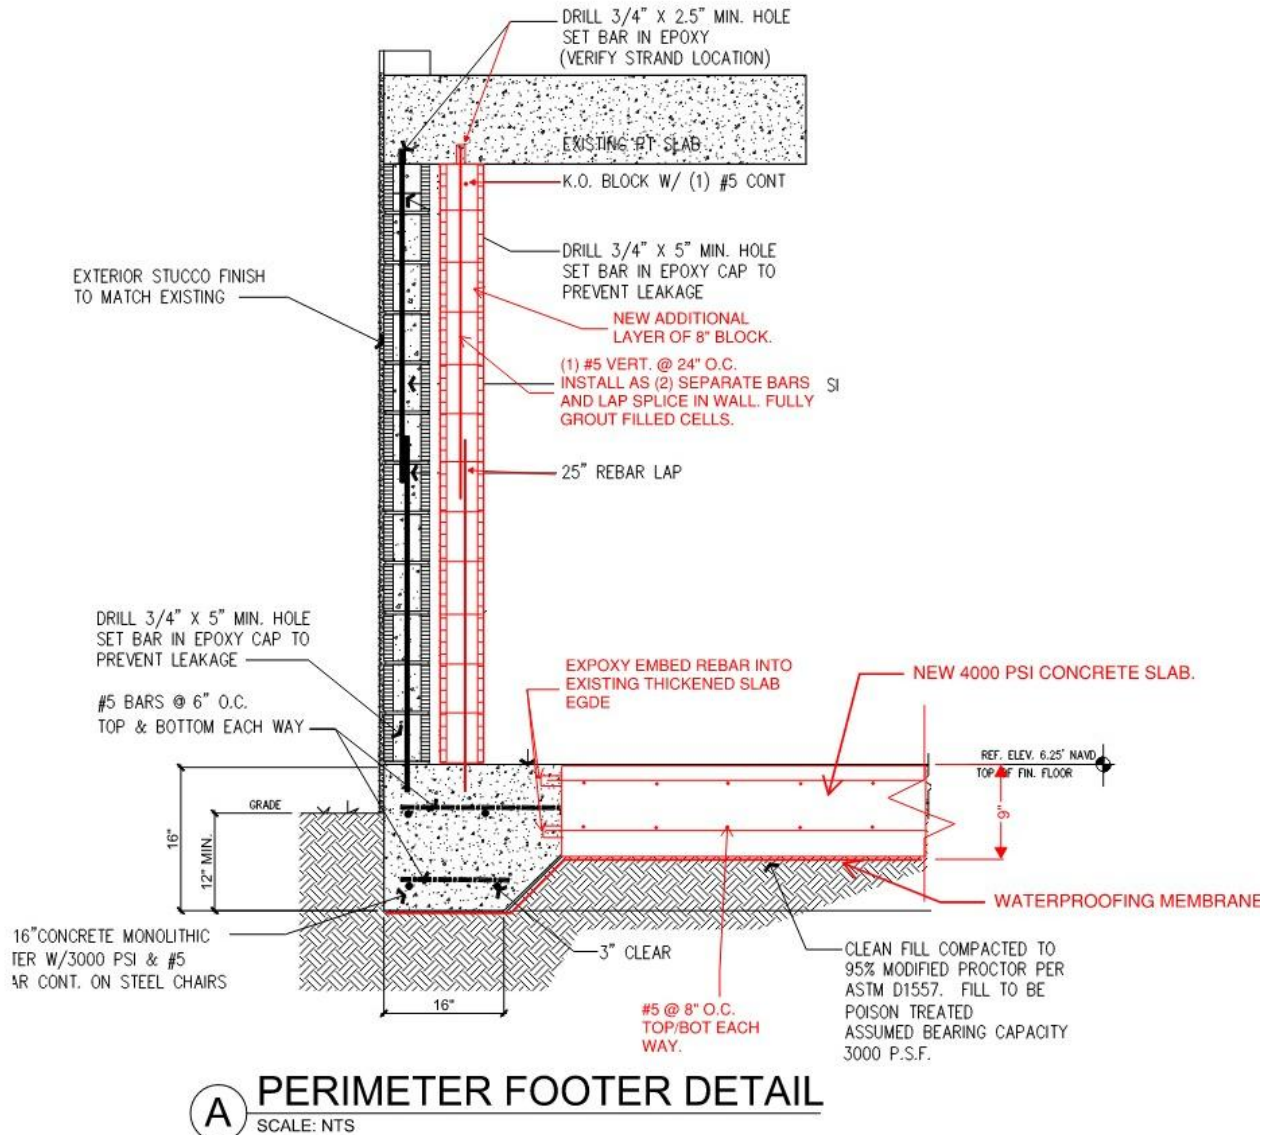
Figure 4 – Sketch of Recommended Repair to Meet Original Code

The conceptual structural hardening details have been included in the below **Figure 4**. The new CMU walls would need to be pinned together with rebar so they can function uniformly under flood loading.

For the exterior walls to meet the existing code requirements for flood loading from the original design a new 2nd 8" CMU walls would need to be constructed and placed behind the face of the existing 8" CMU wall. The new wall would act as 16" CMU wall against the breaking wave force acting on the building. The new wall would satisfy requirements for bending and for deflection. The new wall would need to be reinforced with (1) #5 vertical bar at 24" on center. The rebar would be centered within a filled cell in the wall. For bending stress, the new wall is at 94% capacity. The wall deflection would be 0.06" which is within the required deflection limit of L/360.

The 4" non reinforced slab would need to be removed and replaced with a 9" thick, 2-way mat slab. This new slab would be made from 4000 psi concrete with #5 rebar at 8 inches on center in each direction, for both top and bottom portions of the slab. The slab would be required to be supported by 16" diameter helical piles to resist the uplift forces from buoyance when at flood stage. The piles would be located no more than 12'-0" apart in each direction. A site-specific geotechnical testing, including Standard Penetration Testing (SPT) borings, would be required to determine the type, depth and size of piles to be installed below the new structural slab.

All window and door openings would also need to have new flood panels installed as well. The original flood panels do not appear to have a NOA associated with them and may have been site built without engineering.

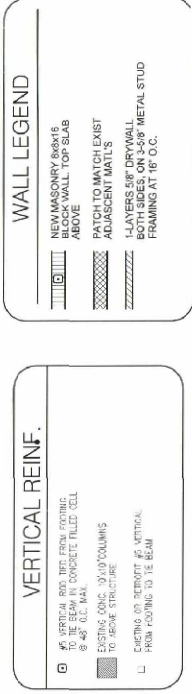
FIGURE 1
SITE MAP
SHOWING RESULTS
OF GEOPHYSICAL
INVESTIGATION

Column Reinforcement: The exterior columns appear to be tied into the exterior walls by horizontal rebar on 16-inch centers. The rebar is estimated to extend 6 to 8 inches into the walls (Figure 1)

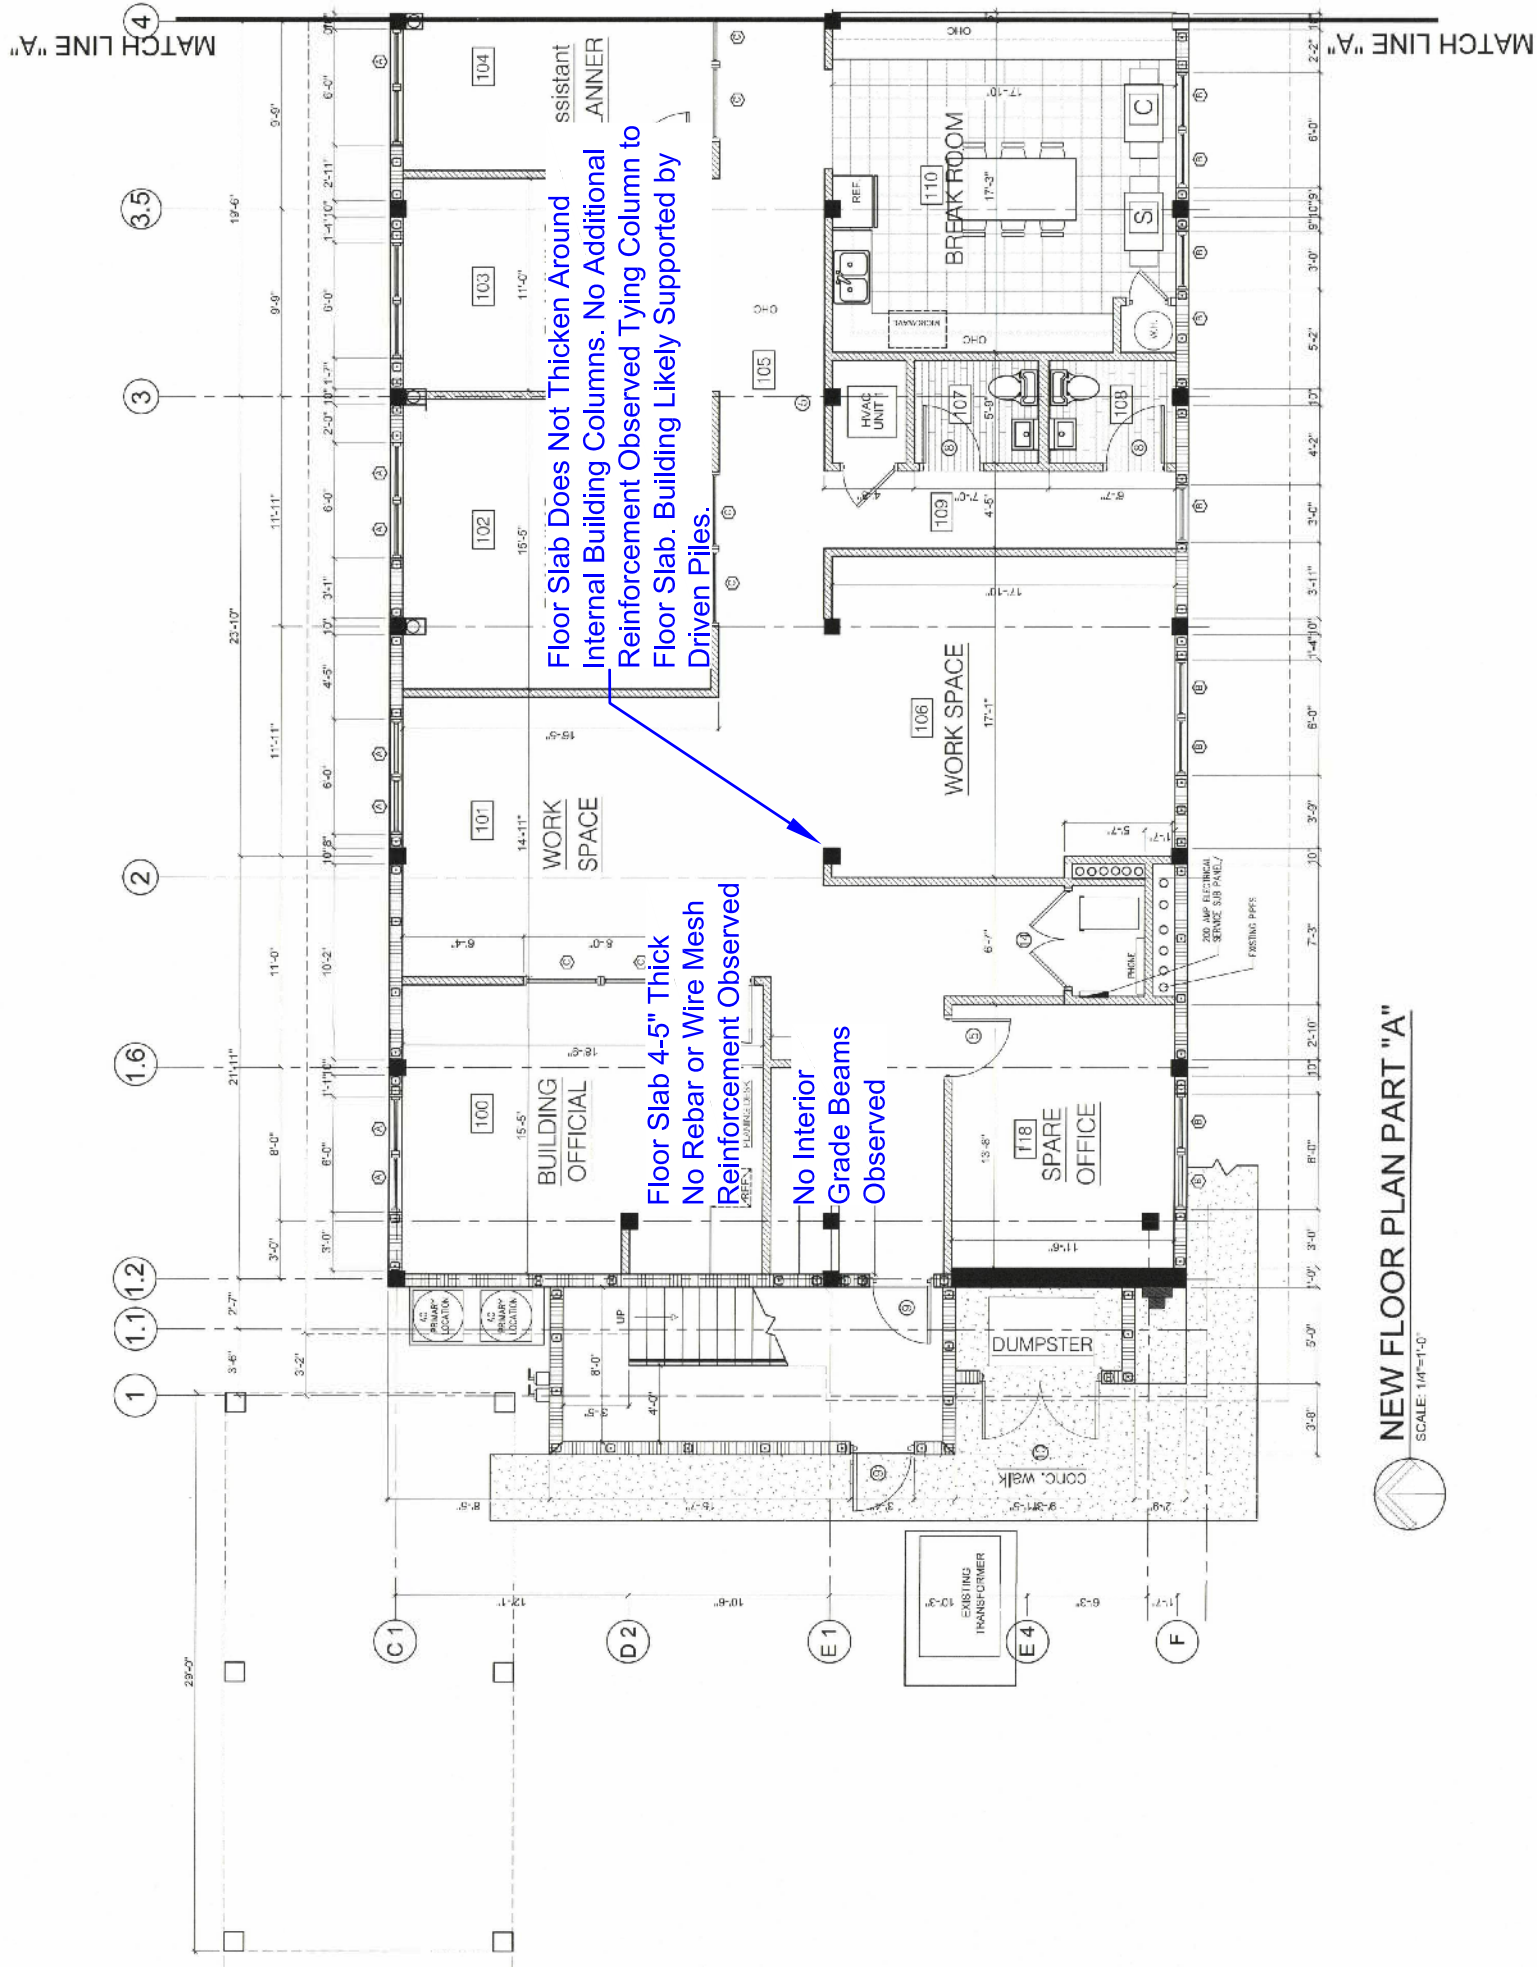
Floor Slab: The floor slab is 4 to 5 inches thick. No wire mesh or rebar mat reinforcement was observed in the slab (Figure 2).

Interior Grade Beams: No interior grade beams were observed (Figure 2).

Interior Column Foundations: The interior columns of the structure are independent of the slab. No rebar reinforcement or thickening of the slab was observed near the columns. No indication of an underlying spread footer that would have supported the columns was observed (Figure 2). It is suspected that the columns are driven piles.

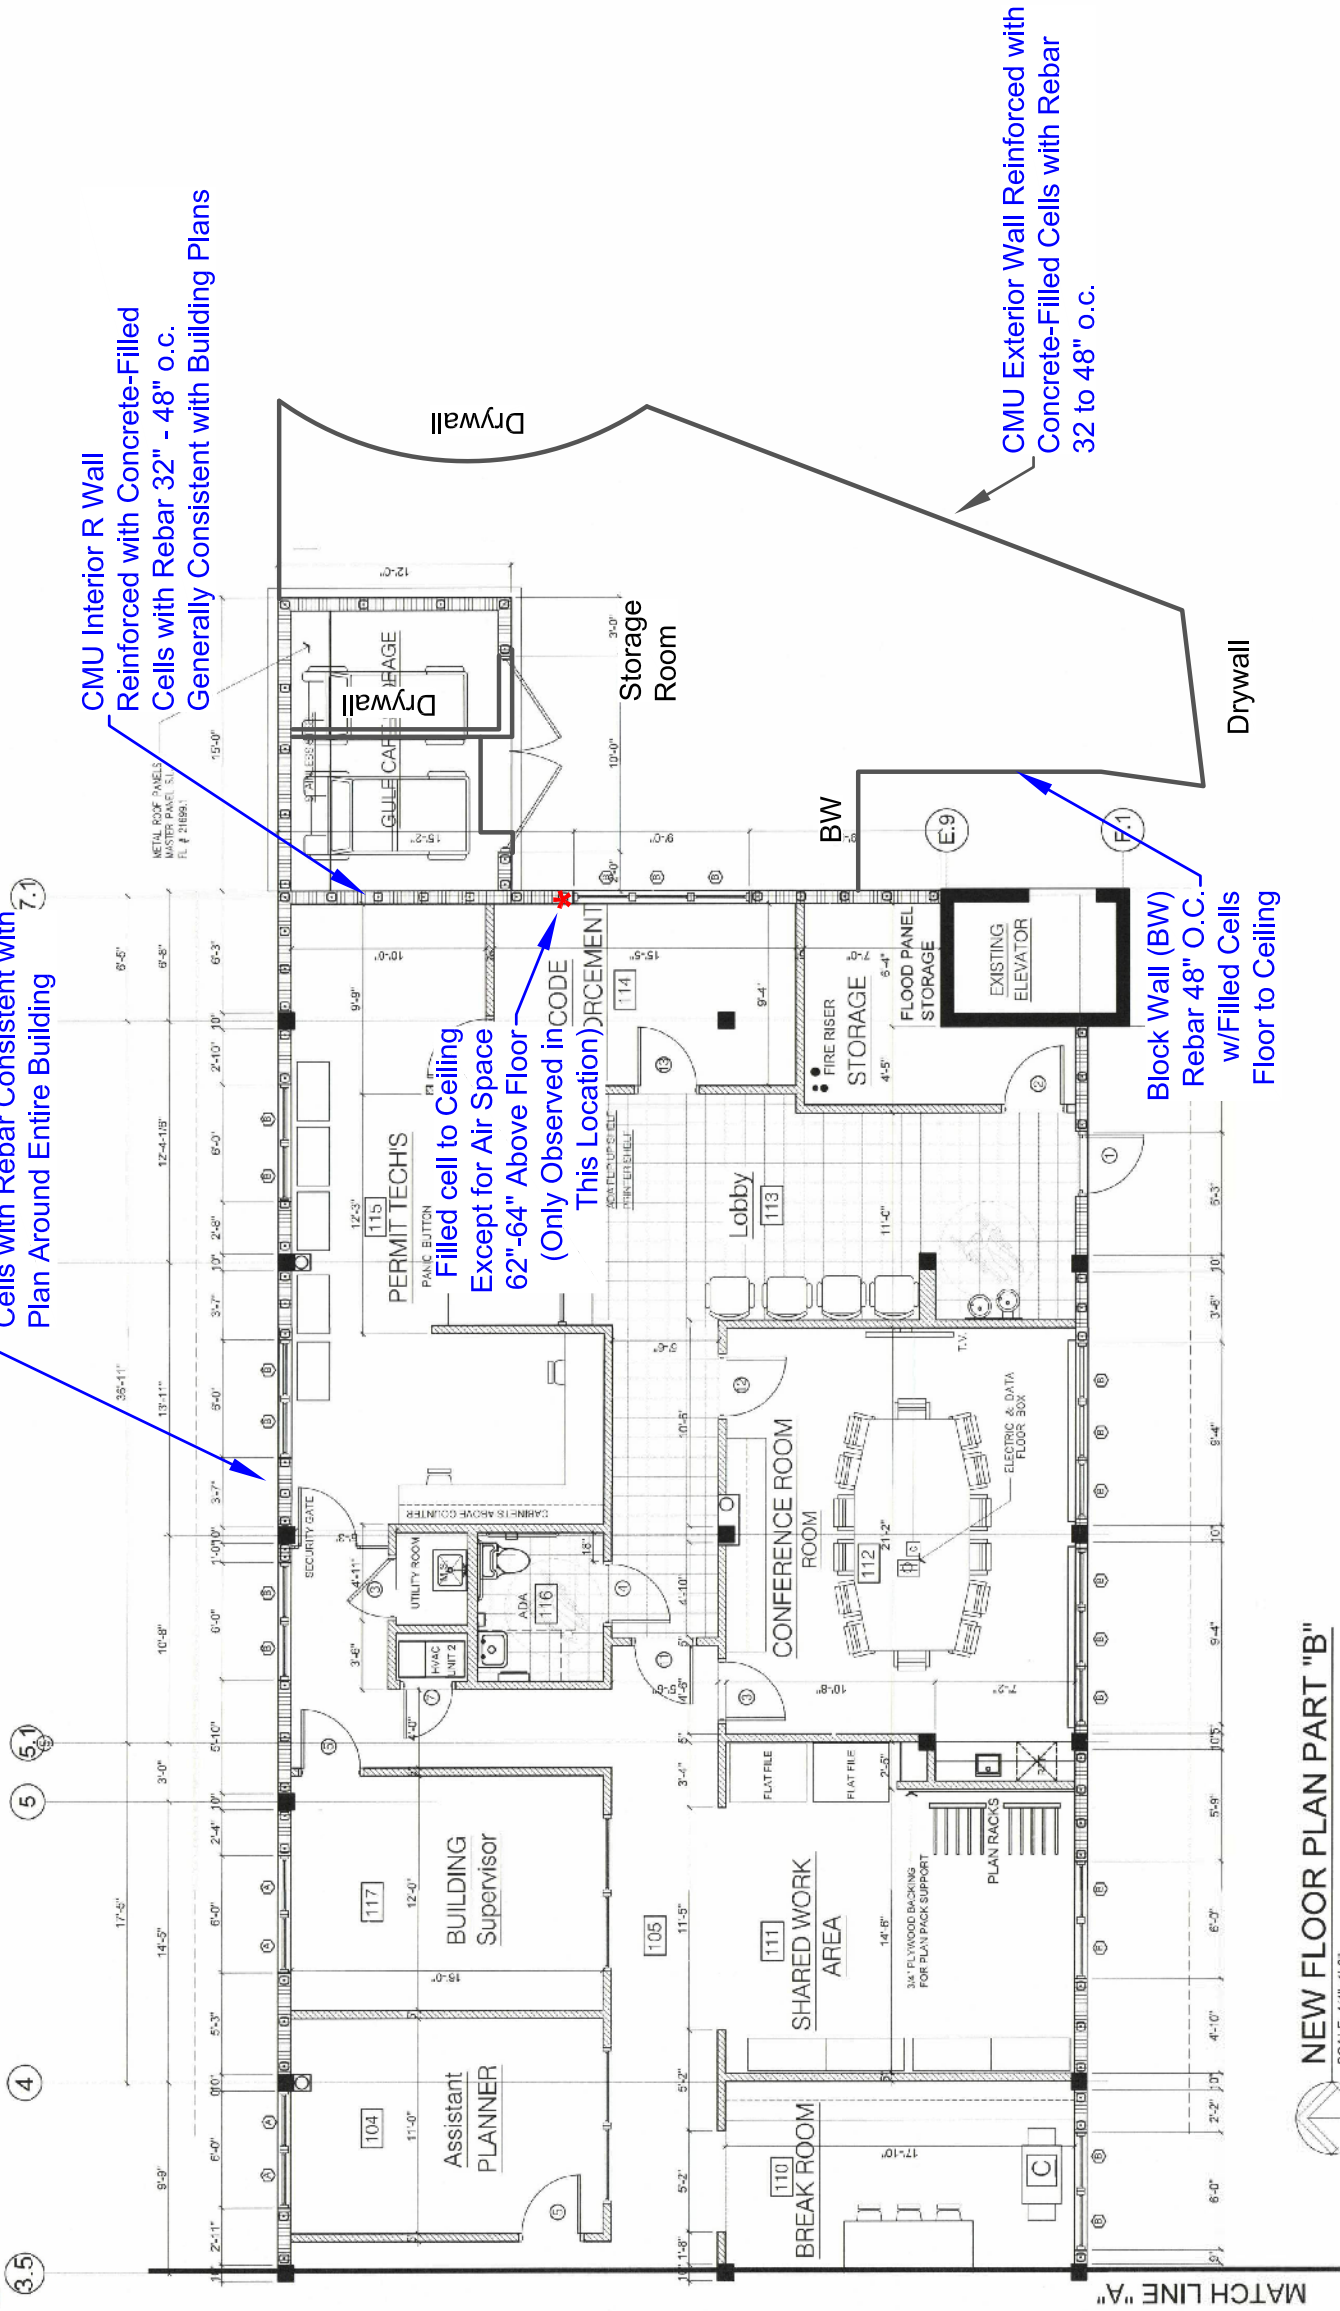
FIGURE 3
SITE MAP
SHOWING RESULTS
OF GEOPHYSICAL
INVESTIGATION

Exterior CMU Wall Reinforcement: Concrete filled cells with rebar reinforcement were observed within the exterior walls. The location the reinforced filled cells corresponds very well with the existing building plans including in the areas around the windows and doors (Figure 3)

Interior CMU Wall Reinforcement: Concrete filled cells with rebar reinforcement were observed within the interior CMU walls. The reinforced cells were 32 to 48 inches on-center. One gap in the vertical filled cells was observed in the eastern portion of the building. This gap extended from the floor to a height of 62 to 64 inches above the floor. Concrete was present in the column above this elevation. No other gaps were observed in the scanned interior CMU walls of the building. The location the reinforced filled cells corresponded reasonably well with the existing building plans (Figure 3).

CMU Exterior Walls in Eastern Portion of the Building: Rebar reinforced filled cells were observed on 32 to 48 inches on center (Figure 3).
