Limited Visual Crawlspace Inspection Madeira Beach Snack Shack

Project No. MDBCH25003

Issue Date: March 18, 2026

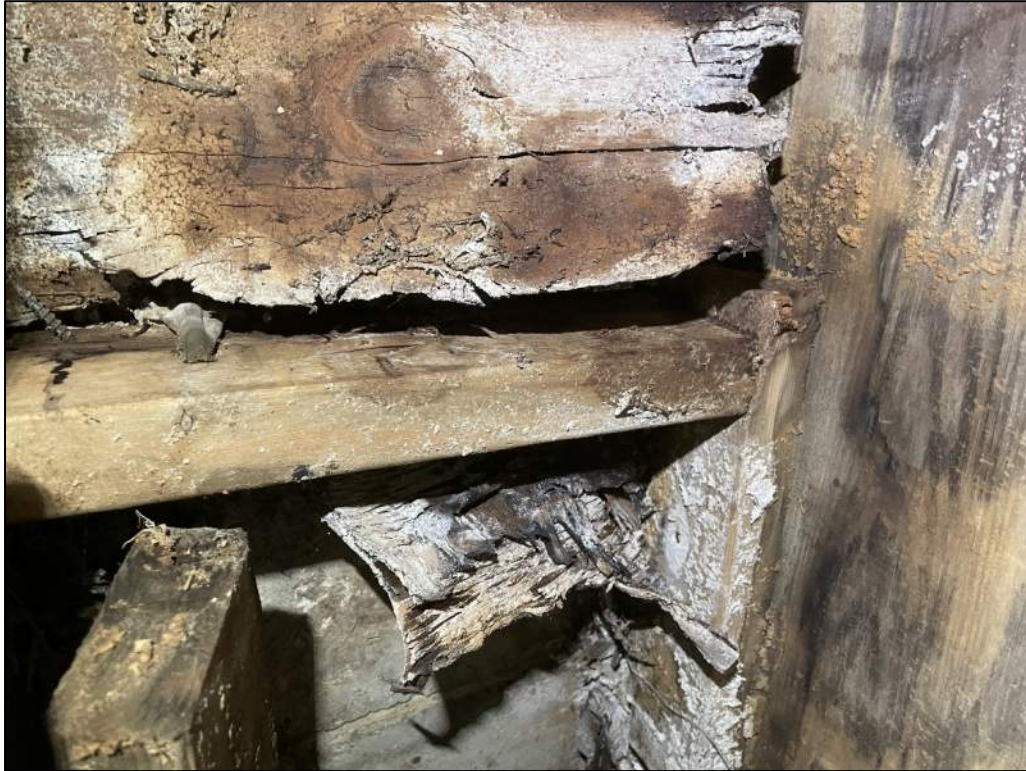
- a) Approximately 450 square feet (SF) of the existing $\frac{3}{4}$ " plywood subfloor was found to be damaged or completely detached and failed, exposing the floor finish underlayment (thin-set mortar or equivalent). These sections of subfloor is currently a **Dangerous Condition** as defined by Section 202 of the Florida Existing Building Code (FBCE). It is recommended that access be restricted above these areas until repairs can be made. One area of damaged or failed subfloor is below the existing cooler and may need to be removed to properly repair the subfloor in the area. The subfloor is recommended to be replaced in kind with $\frac{3}{4}$ " structural I APA Span Rated sheathing fastened at the edges 8" O.C. staggered with 8d ring shank nails.

Photo 1 – Damaged or Failed Subfloor

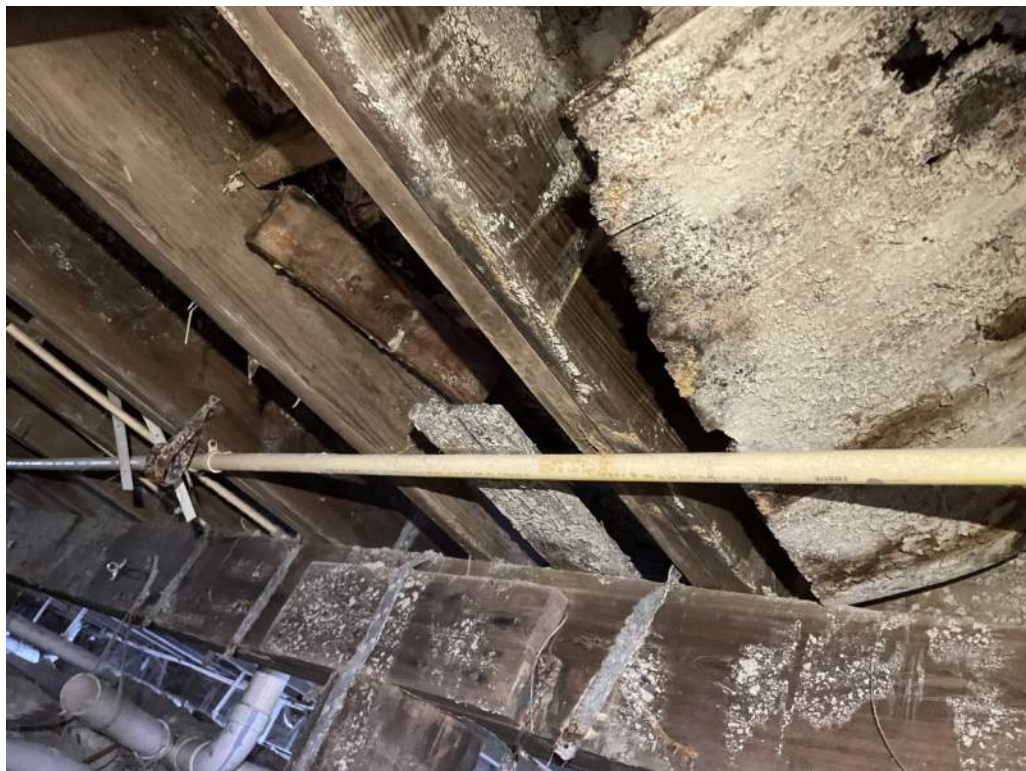
Photo 2 – Damaged or Failed Subfloor

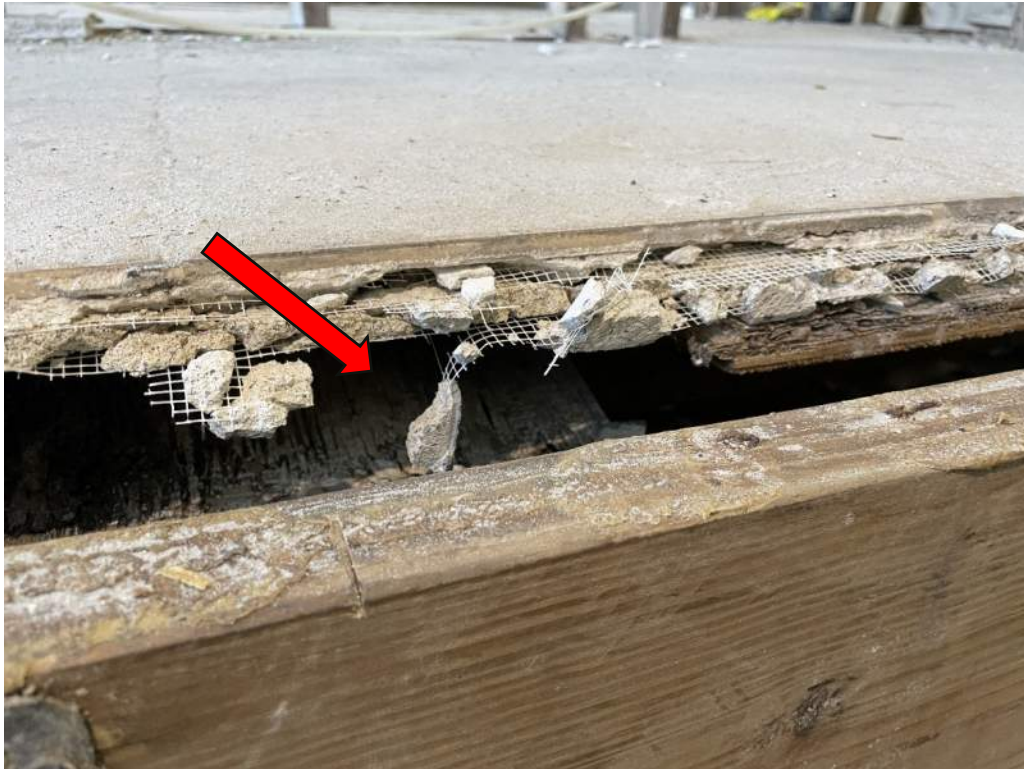
Photo 3 – Damaged or Failed Subfloor

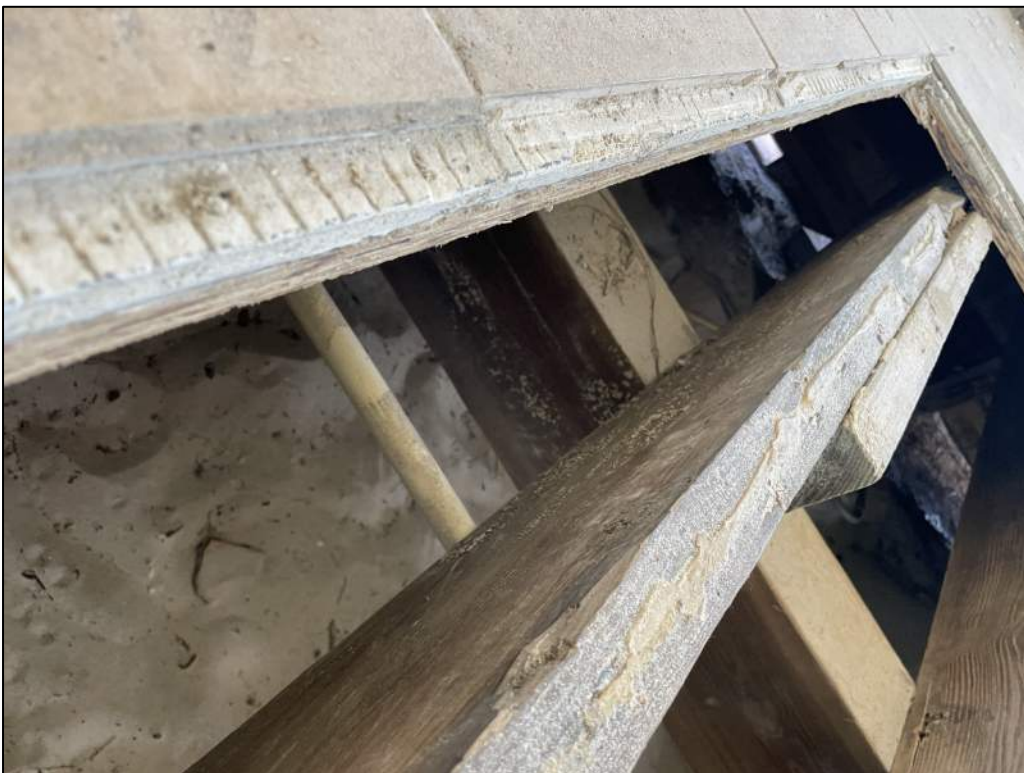
- a) No damages were observed to the joists at the time of this limited site visit. Concealed damages to the joists may be revealed during the removal of the subfloor. New joists may need to be sistered to existing joists if cross section loss is discovered. Approximately 5% - 10% of the ~16" twist straps were observed to have heavy pitting or corrosion and are recommended to be replaced. New straps can also be added to supplement any

damaged straps. This is typical throughout the crawlspace. Overall, the joists were observed to be in stable condition.

Photo 4 – Floor Joists

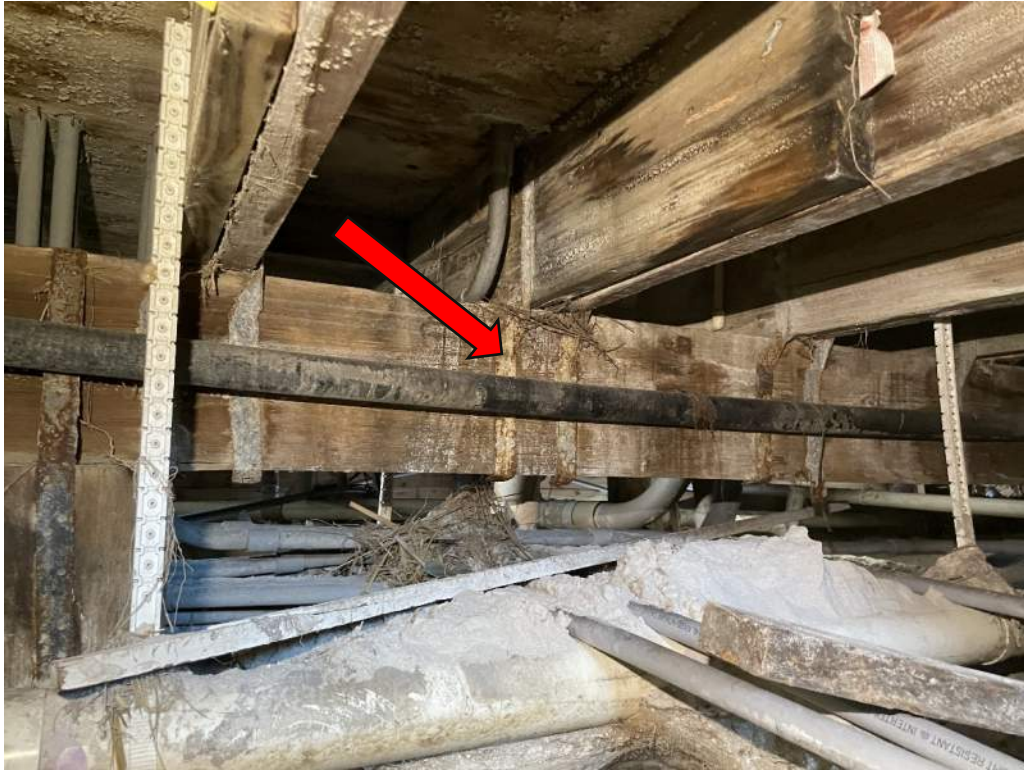
Photo 5 – Floor Joist Strap Corrosion

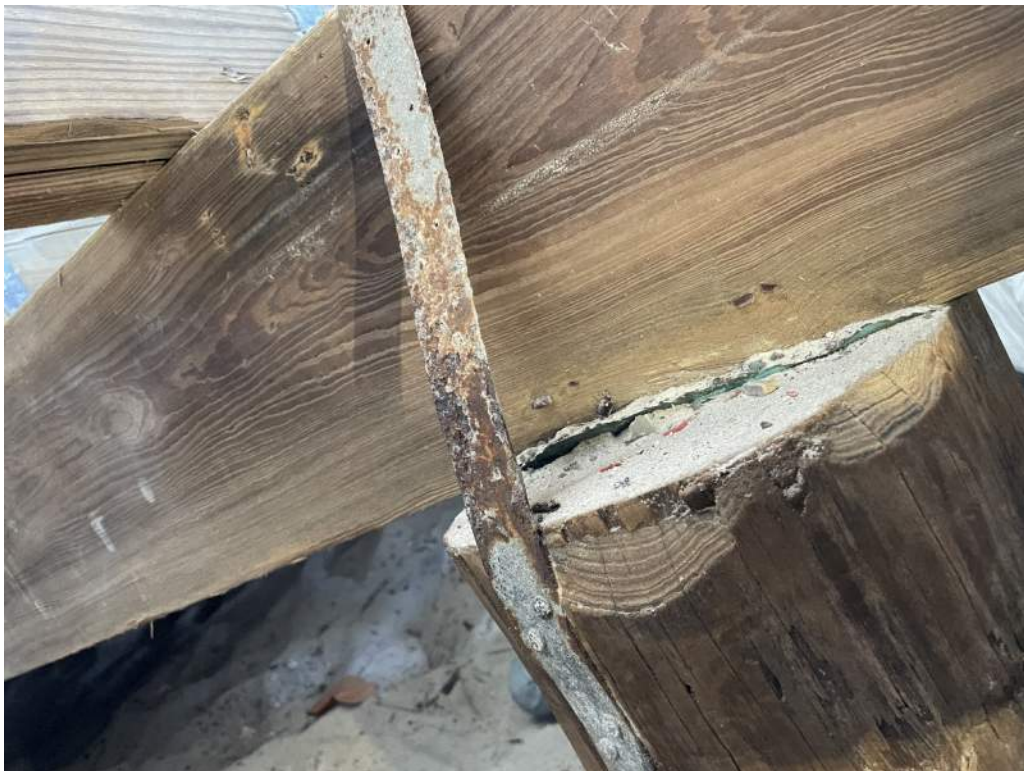
- a) No damages were observed to the beams at the time of this limited site visit. Approximately 1% - 2% of the ~45" twist straps were observed to have heavy pitting or corrosion and are recommended to be replaced. New straps can also be added to supplement any damaged straps. This is typical throughout the crawlspace. Overall, the beams were observed to be in stable condition.

Photo 6 – Beam Strap Corrosion

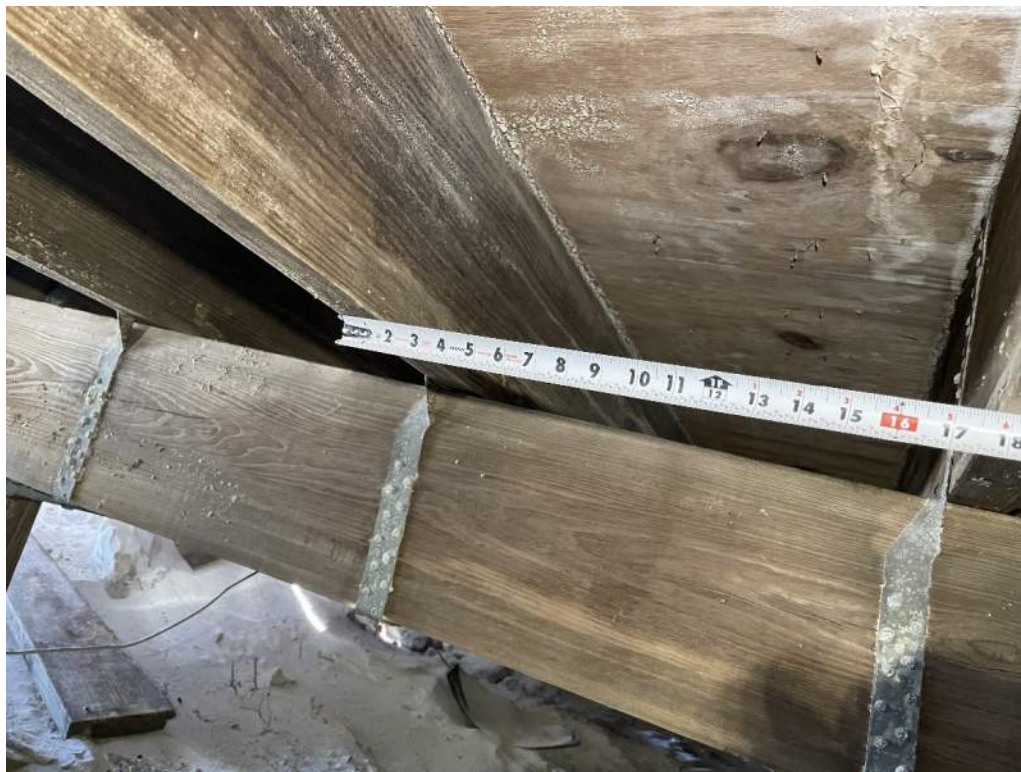
Photo 7 – Floor Beam

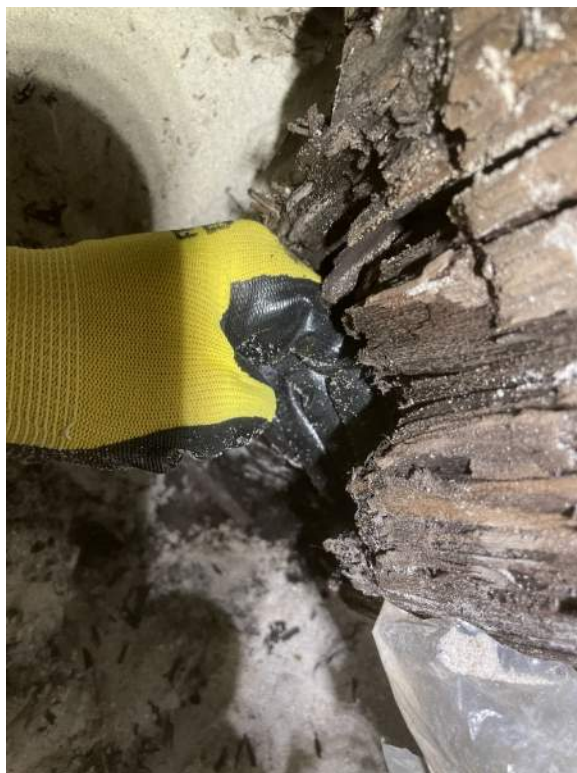
- a) (2) timber piles were observed to have approximately 5% - 10% cross section loss. The surrounding framing was not observed to be deflecting or in distress due to the loss of capacity of the pile. It is recommended that these timber piles be replaced in kind or repair in place with splices.

Photo 8 – Timber Pile Cross Section Loss

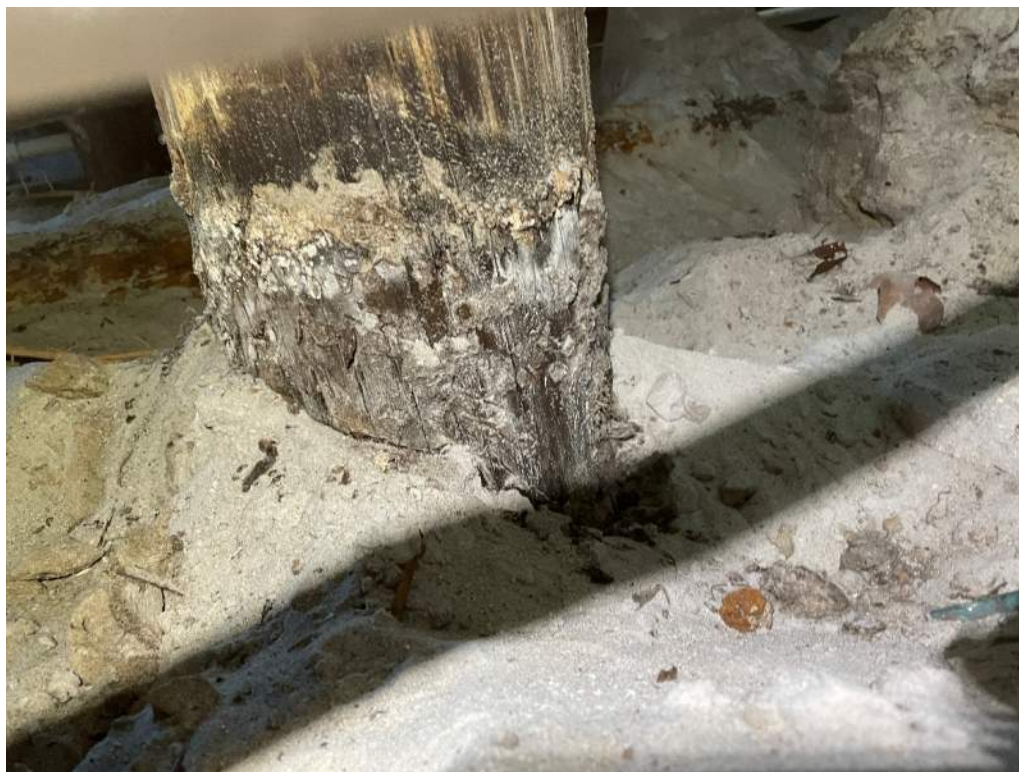
Photo 9 – Timber Pile Cross Section Loss

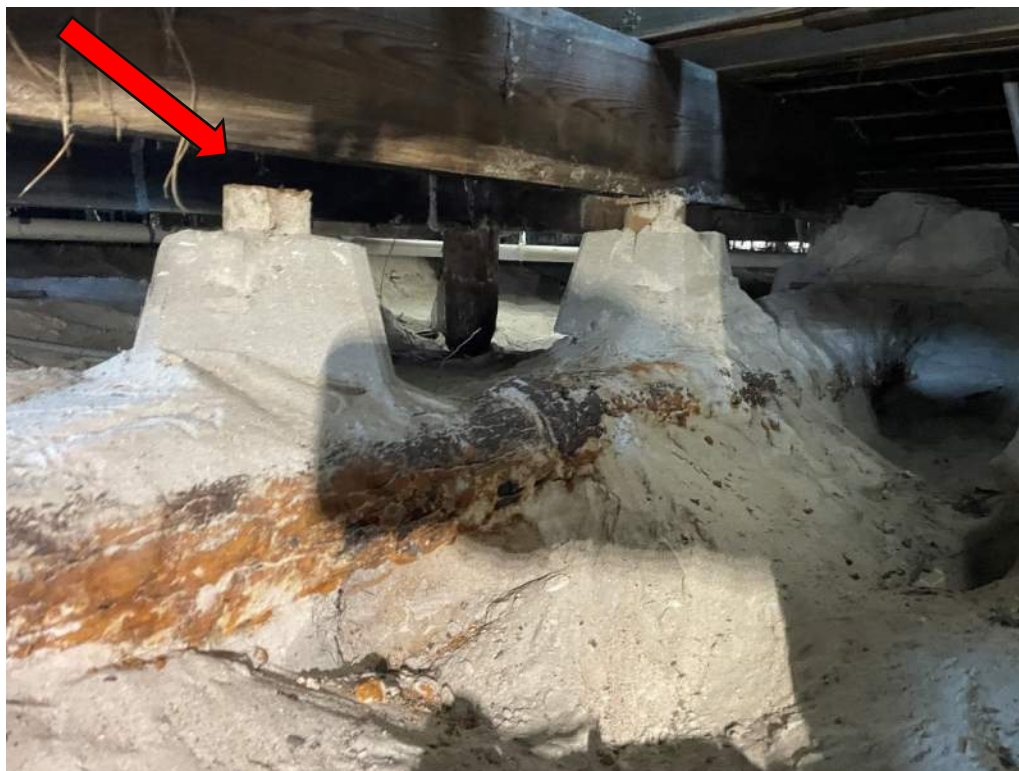
- a) A previous retrofit of concrete piers, 4x4 wood posts and 2x10 beams was observed to be in the crawl space. A 2x10 was also observed to be sistered to an original 10x6 beam. The concrete piers were observed to be undermined with minimal amounts of bearing on grade, and some 4x4 posts were observed to be detached from the beams. It is recommended to remove the concrete piles, beams and posts, as there is no evidence of these components being necessary to reinforce the existing framing.

Photo 10 – Previous Retrofit with Detached Post

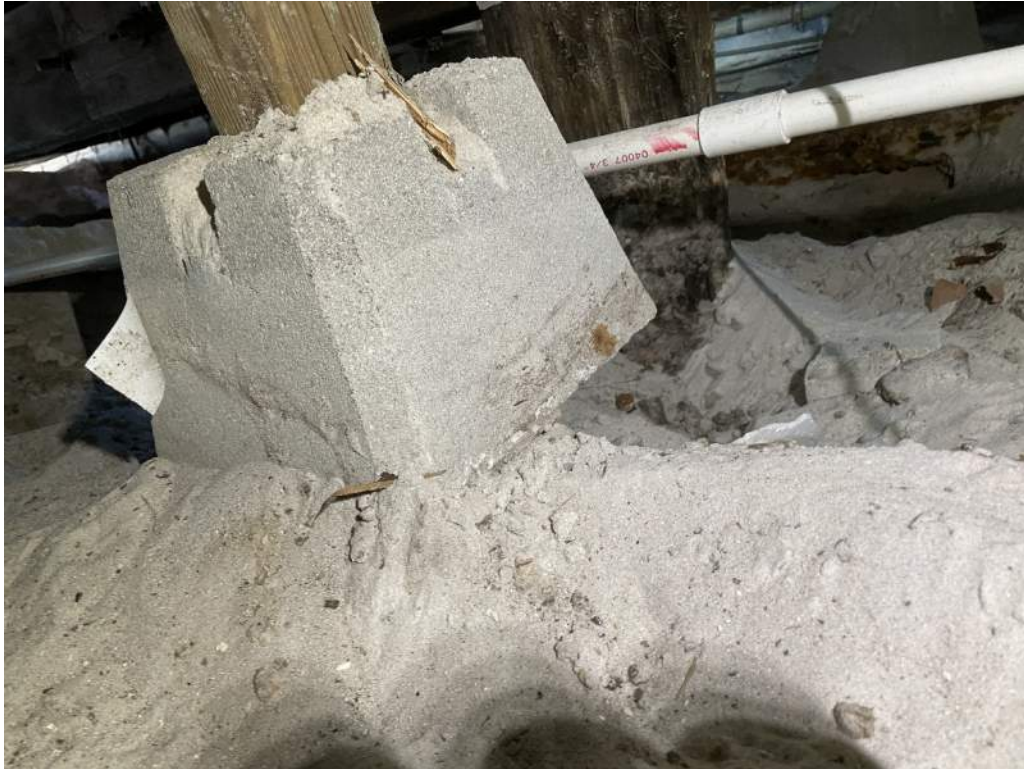
Photo 11 – Previous Retrofit Pier with Minimal Bearing on Grade

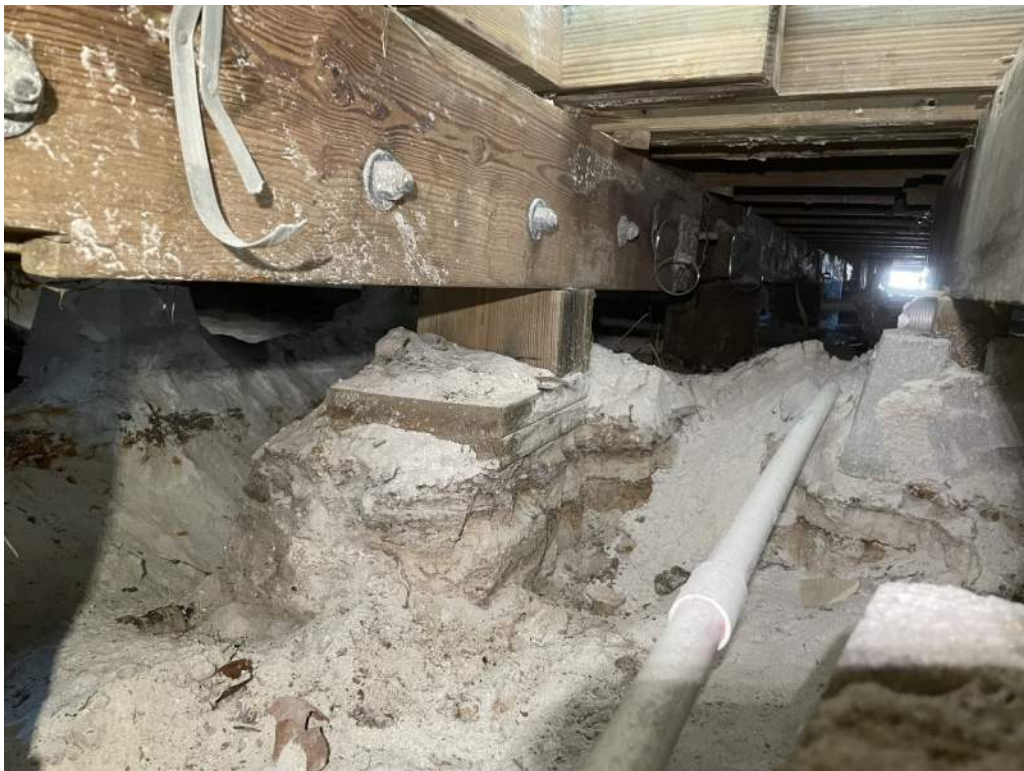
Photo 12 – Previous Retrofit of Sistered Beam
