Non-Development Tree Permit Activity Report January 2023 By Andy Crossett

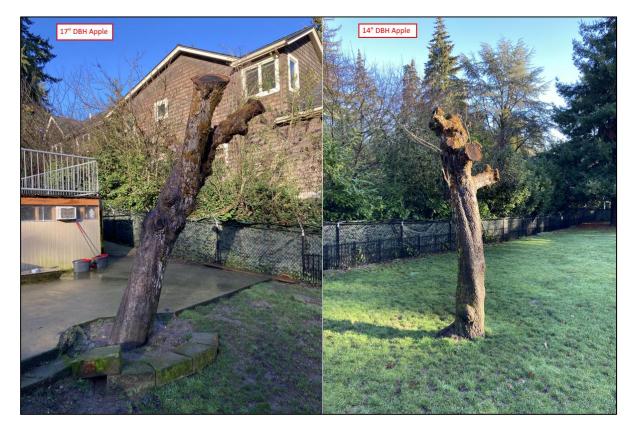
3244 EPR – 1 17" DBH apple and 1 14" DBH apple

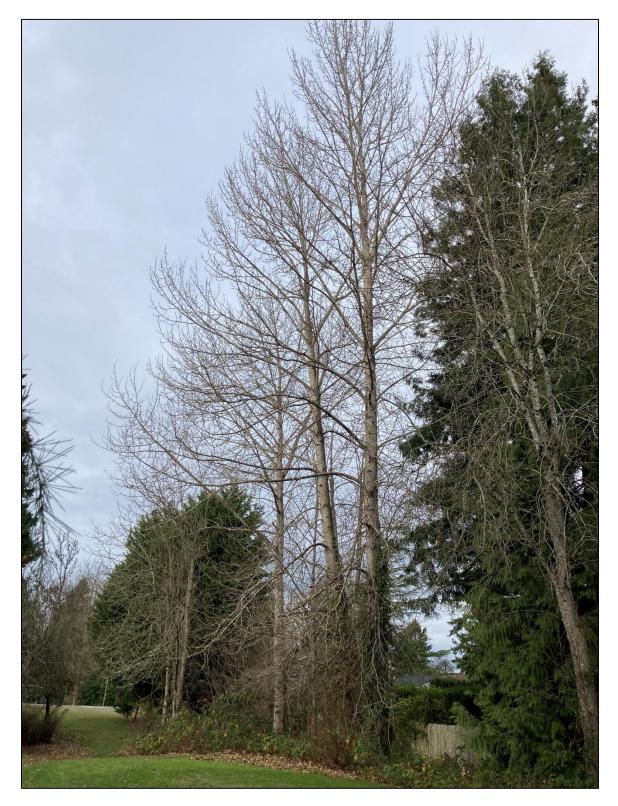
2451 79th Ave NE – 3 ROW Cottonwood. Resident doesn't like the deciduous nature of the trees. Trees are in good condition. "Low" risk.

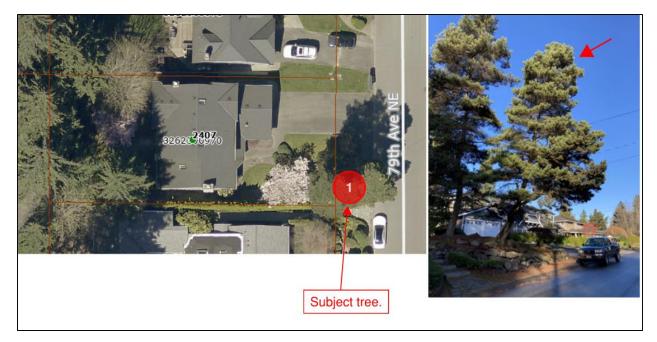
2403 79th Ave NE – "High" Risk ROW shore pine.

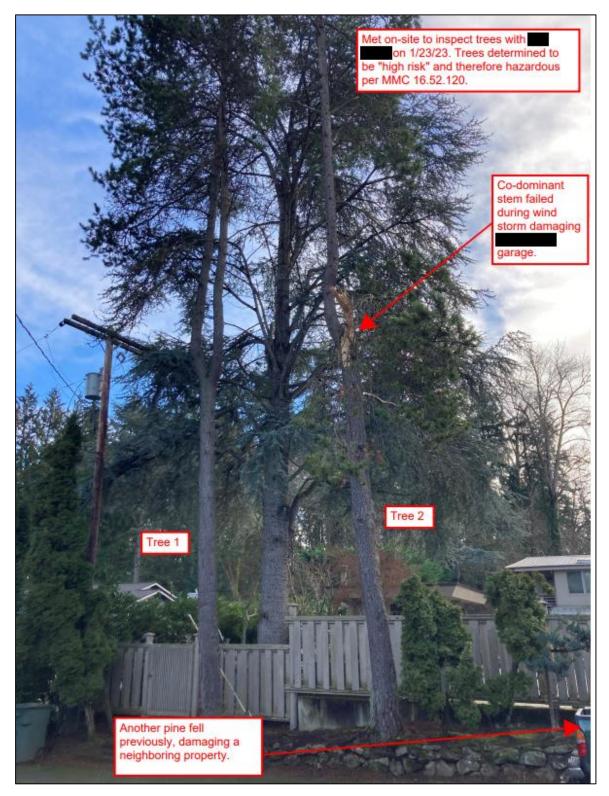
3217 78th Place NE – Originally 3 trees. One tree fell, another tree lost a codominant top, and the last tree is in similar shape to the fallen trees.

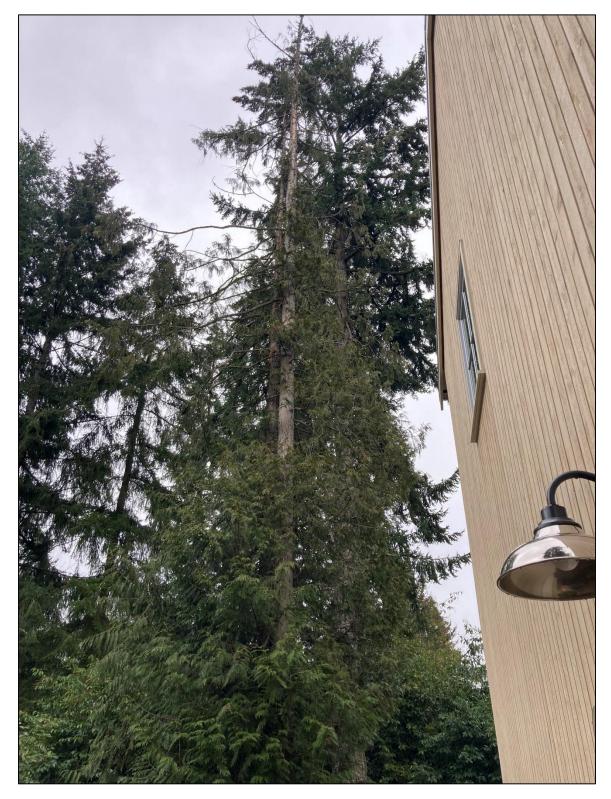
2230 Evergreen Point Rd – Attrition due to poor tree protection during construction. First tree is a western red cedar with severe crown dieback. Decline is likely associated with root disturbances.

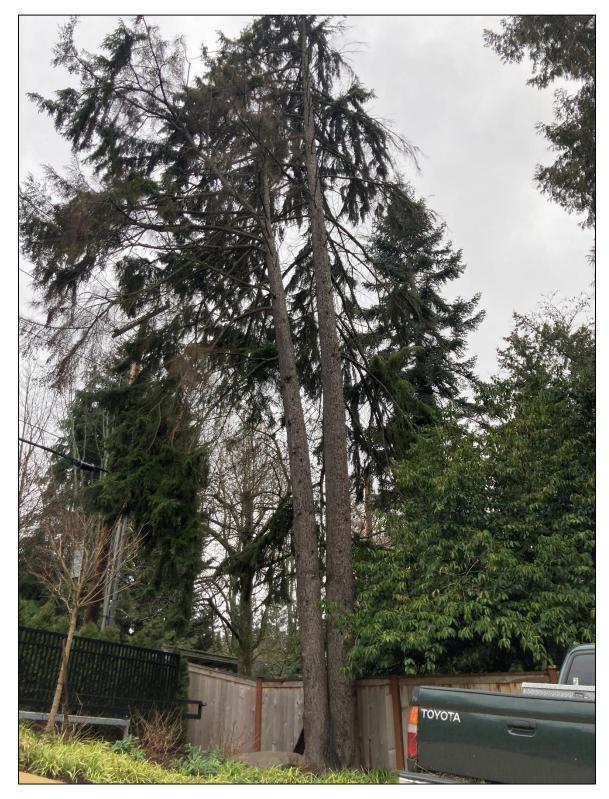
This hemlock is in poor condition with tip/branch dieback. Low vitality and crown dieback like this is often associated with construction damage. As a result, tree is now "high" risk. Resident is aware and has agreed to remove the tree. Permit submitted on 2/2/23. In review now.

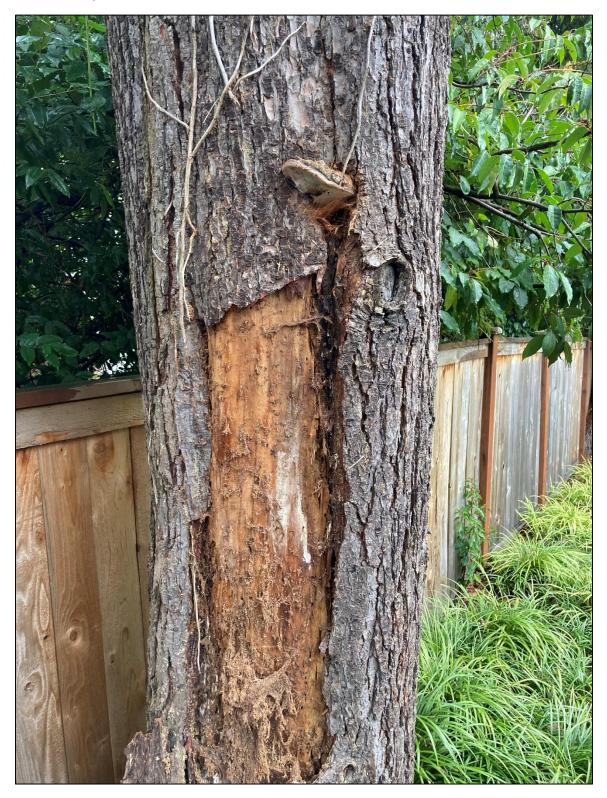
The lower trunk of the hemlock. Note the bracket fungus (Fomitopsis sp.) or "mushroom" growing on the damaged trunk. This indicates that the interior wood is compromised and very weak. Damage like this often starts with accidental trunk strike by an excavator bucket.
