# CITY OF MEDINA

**Date:** November 8, 2021  
**To:** Honorable Mayor and City Council  
**Via:** Michael Sauerwein, City Manager  
**From:** Steven R. Wilcox, Development Services Department Director  
**Subject:** Development Services Department Monthly Report

October 18, 2021

Subject: City of Medina City Hall Indoor Air Quality Consulting  
501 Evergreen Point Road  
Medina, WA

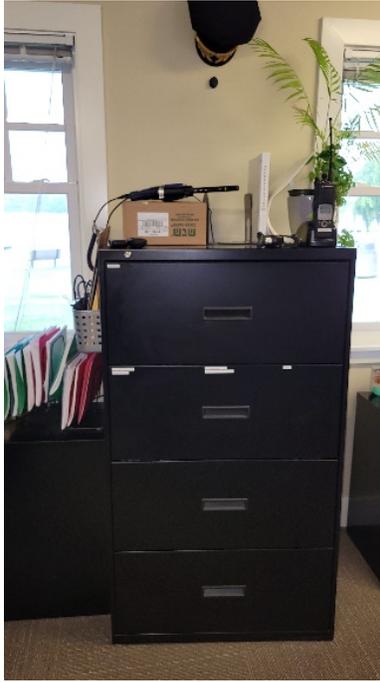
Photograph 1. First floor: Police Department office, location of indoor air quality monitor.

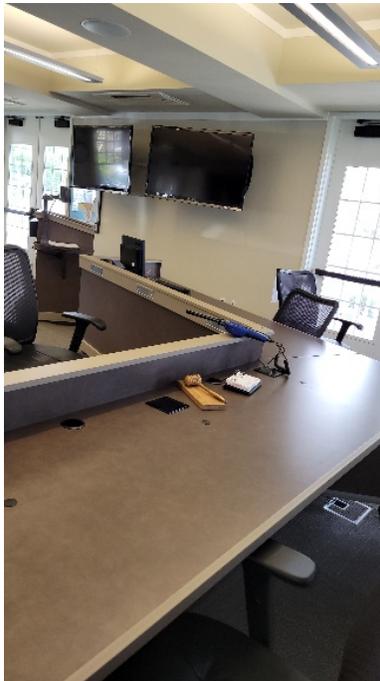
Photograph 2. Second floor: Council chamber, location of indoor air quality monitor.

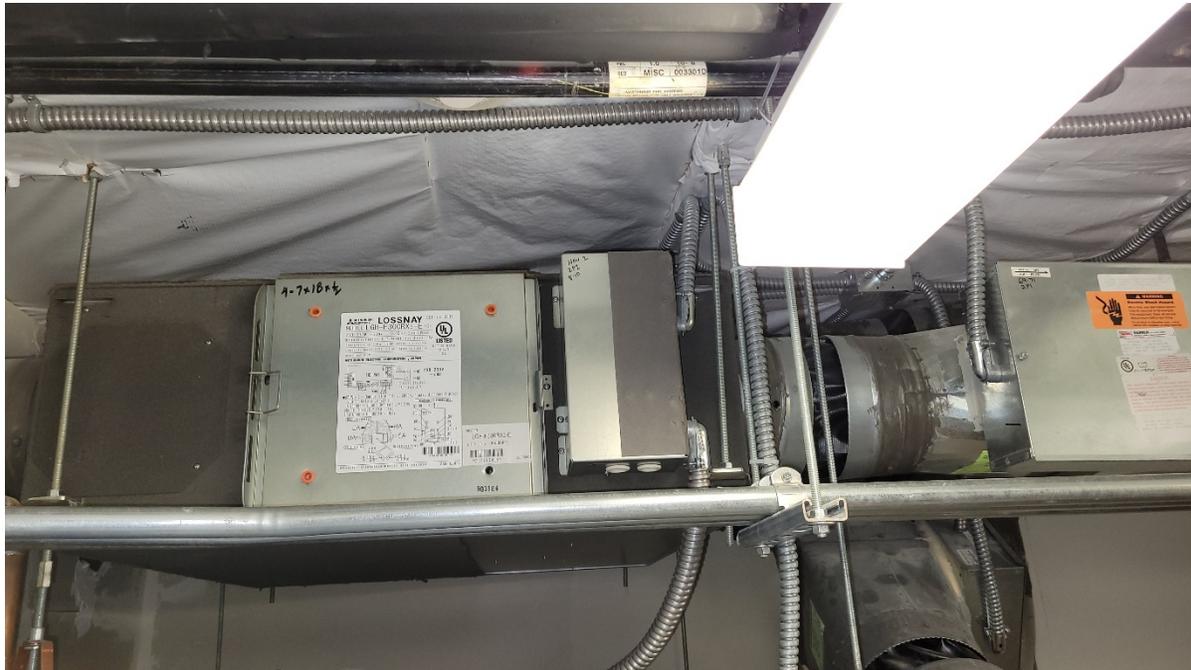
Photograph 3. Third floor: Lossnay energy recovery ventilator unit.

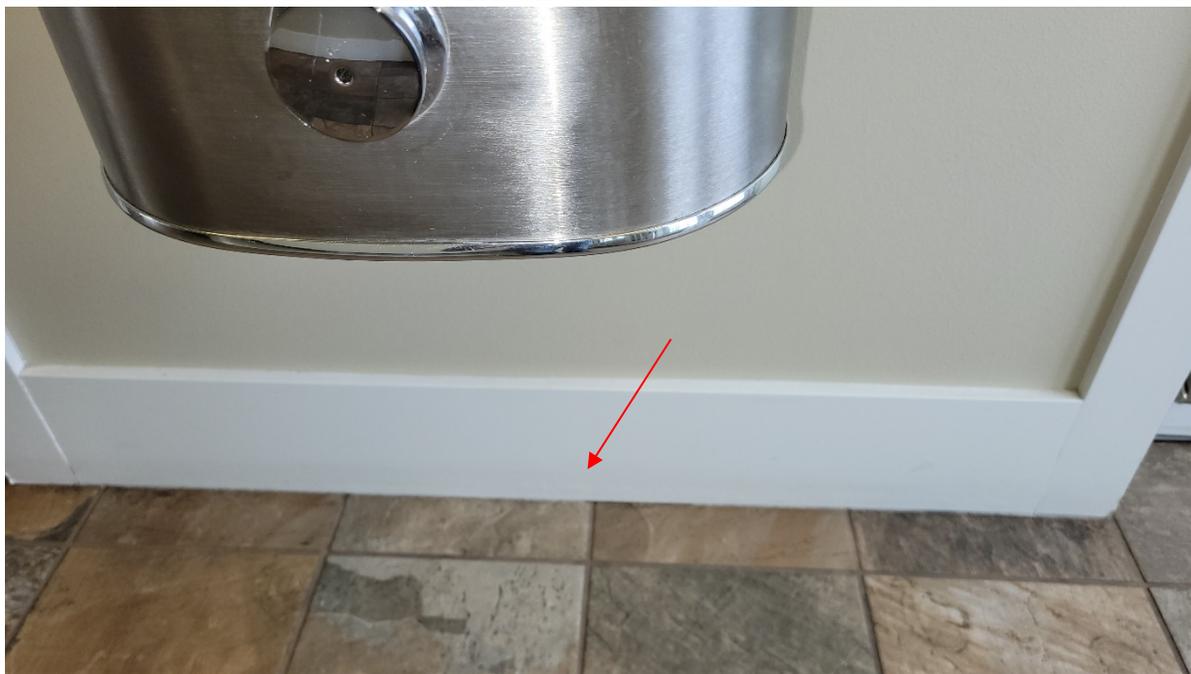
- Limited areas of swollen MDF baseboard were observed on the west wall of the Council chamber on the second floor;
- Limited areas of swollen MDF baseboard were observed under the water fountain in the lobby on the second floor;
- Less than 1 square foot of swollen baseboard was observed on the north wall of Michael Sauerwein's office on the third floor;
- No excess moisture was detected in any of the assessed areas; and
- No SVG was observed on exposed surfaces.

Photograph 4. Hall water cooler on the second floor: slight swelling of base board (red arrow).

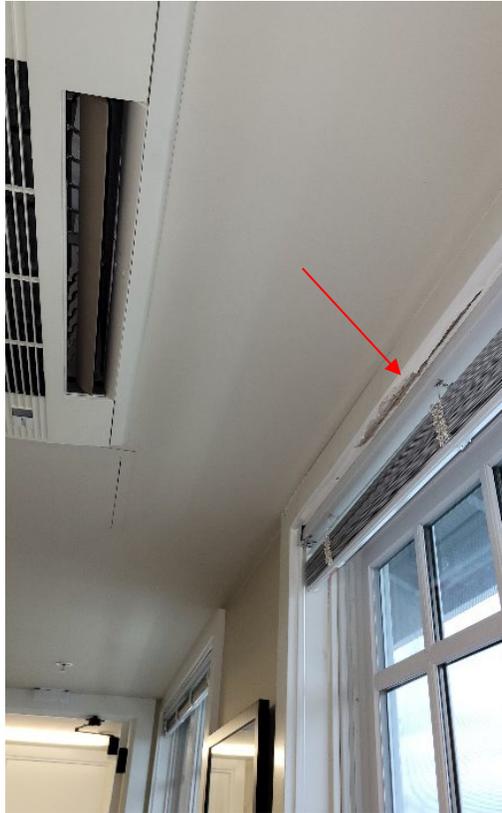
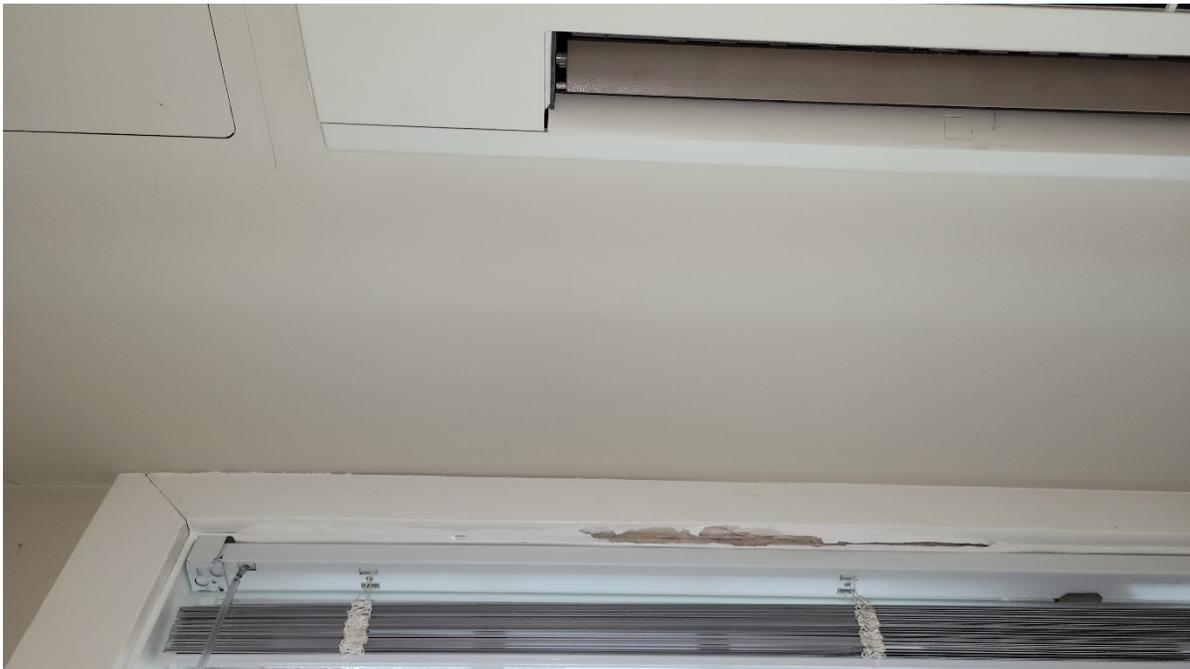
- Limited areas of swollen MDF baseboard, delaminated paint, caulk, and MDF window trim were observed on the north wall of the second-floor staff only area;

- Delaminated paint, caulk, and swollen MDF decorative trim were likely caused by moisture from condensation on exterior windows, presumably due to the individual indoor HVAC units.

- There could be limited quantities of mold growth contained in the wall cavities affected by moisture observed in the staff-only area the second floor, but no exposures are expected unless the moisture-affected building materials are disturbed.
- No excess moisture was detected in accessible, assessed building materials.

Photograph 5. Staff-only area on the second floor, north wall: delaminated paint and swollen decorative window trim.

Photograph 6. Detail of area in Photograph 5.

Wood recommends that the drywall affected by delaminated paint or concealed by swollen MDF decorative trim be assessed for mold growth after hours when the space is not occupied. The work should be conducted using dust controls such as, but not limited to:

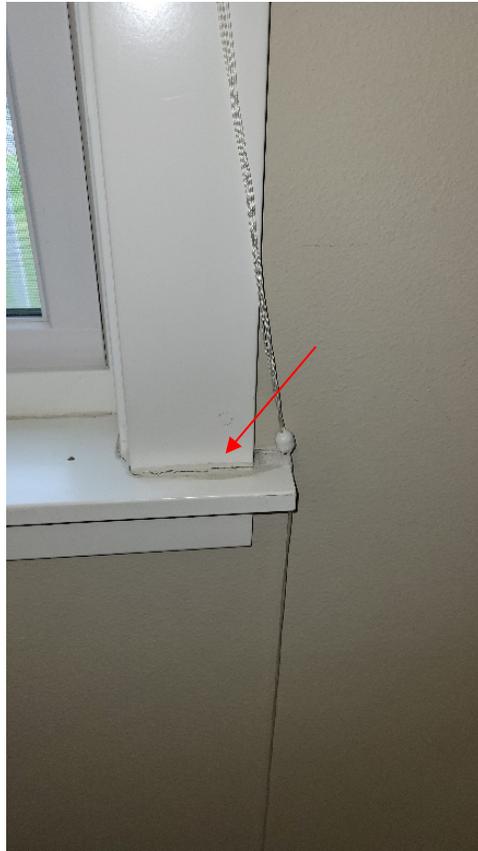
Photograph 7. Staff-only area on the second floor: swollen decorative window trim (red arrow).

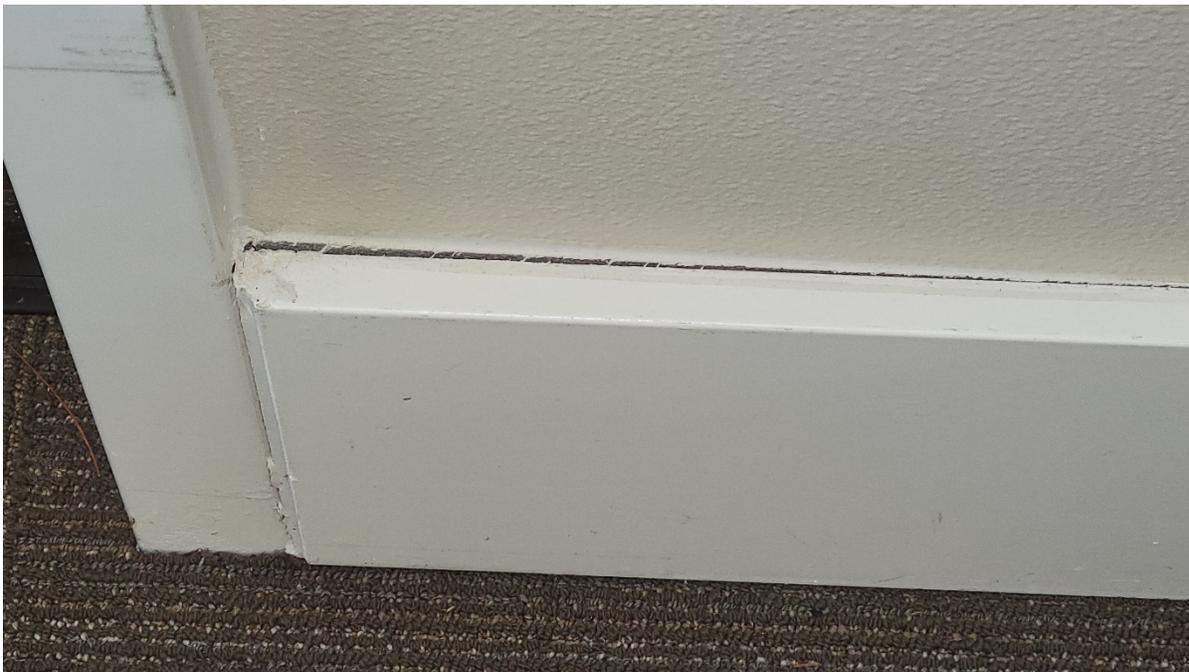
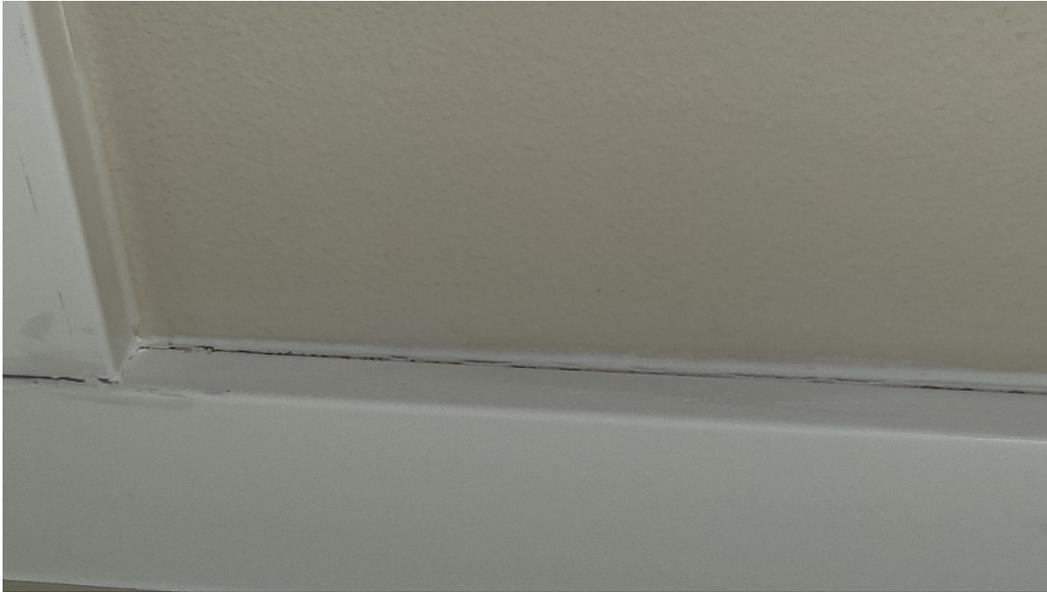
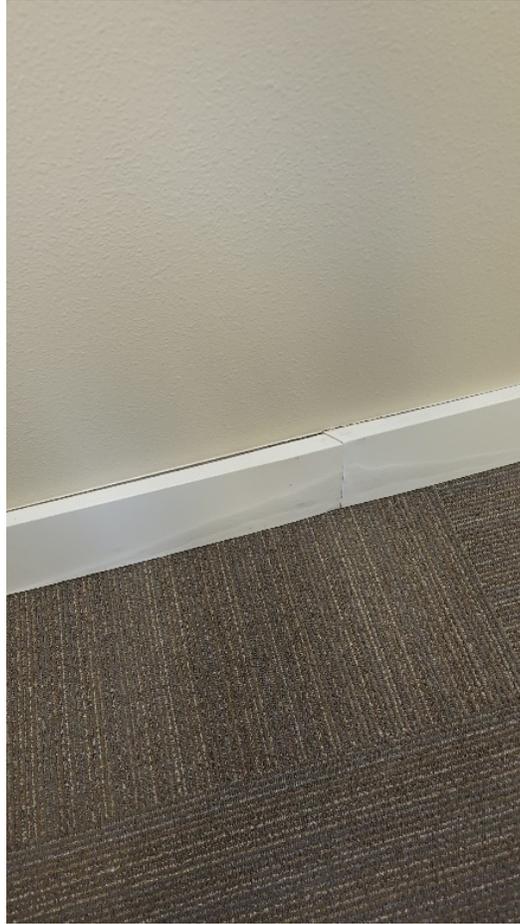
- Swollen MDF baseboard in Mr. Sauerwein's office on the third floor, the staff-only area on the second floor, and the Council chamber were likely related to localized condensate pump or related HVAC unit failures, which Wood understands have been repaired.

Photograph 8. Council chamber on the second floor, west wall: swollen baseboard.

Photograph 9. Council chamber on the second floor, west wall: swollen baseboard trim, presumably from moisture impacts.

Photograph 11. Detail of area in Photograph 8.

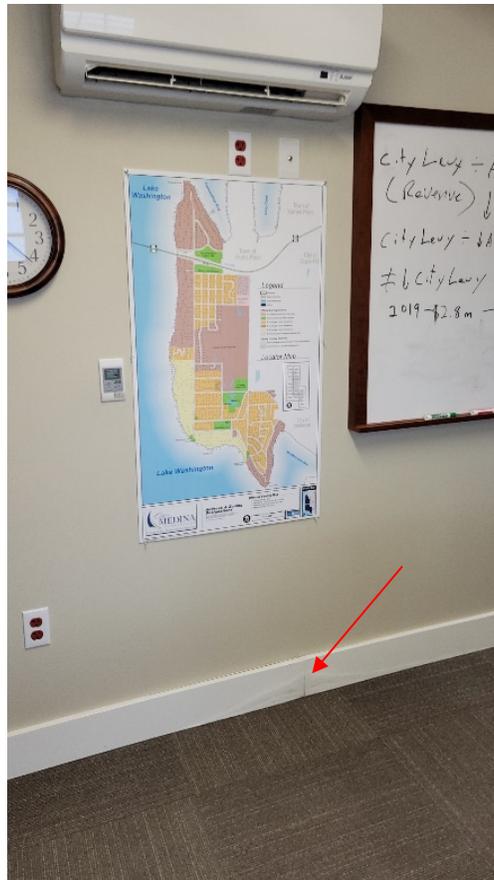
Photograph 10. Michael Sauerwein's office on the third floor: swollen baseboard (red arrow).
