Public Works Building Facility Conditions Assessment

AB6402 | February 6, 2024

Public Works Building: Facility Conditions Assessment Findings

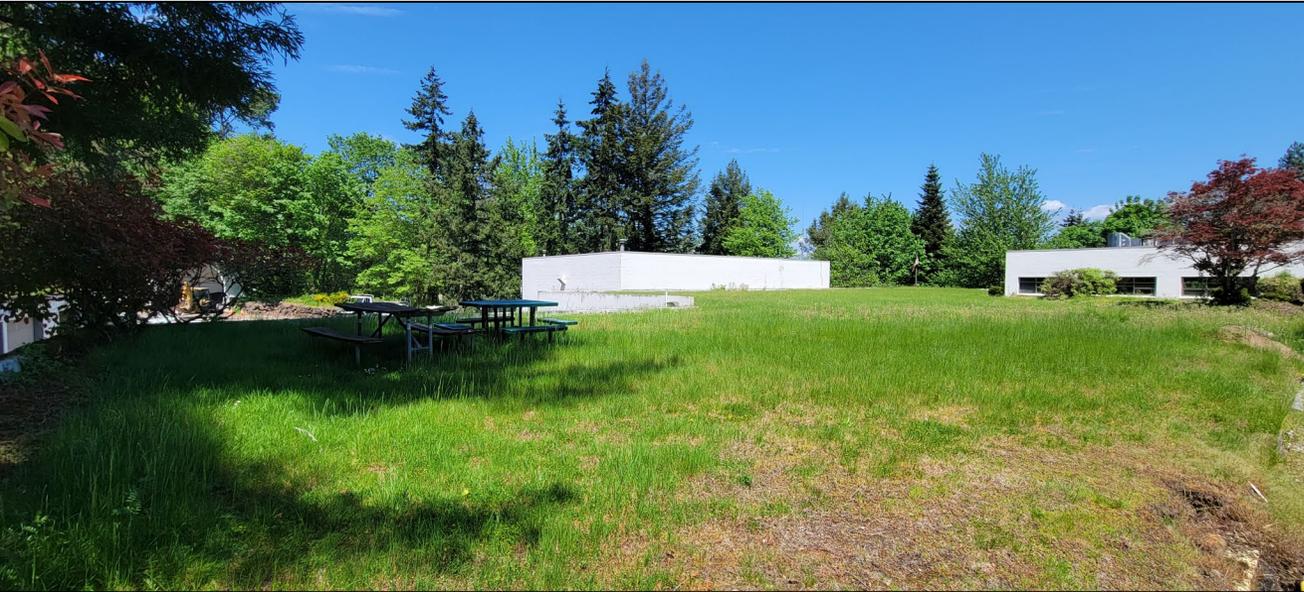
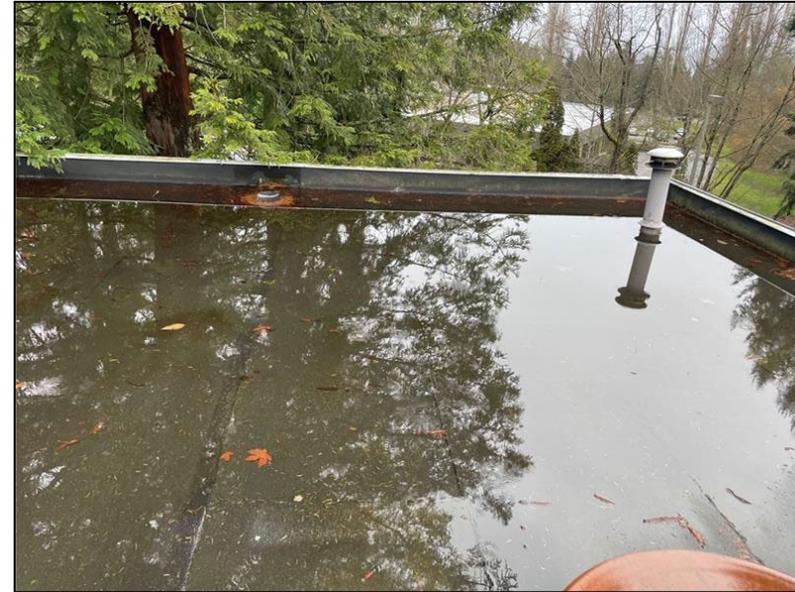
Roofing and Water Intrusion

- The roofing membrane under the green roof is compromised and failing. This covers the warehouse and operations spaces.
- The flat roofs over the administrative offices and the mechanic's shop are not properly drained, resulting in standing water.

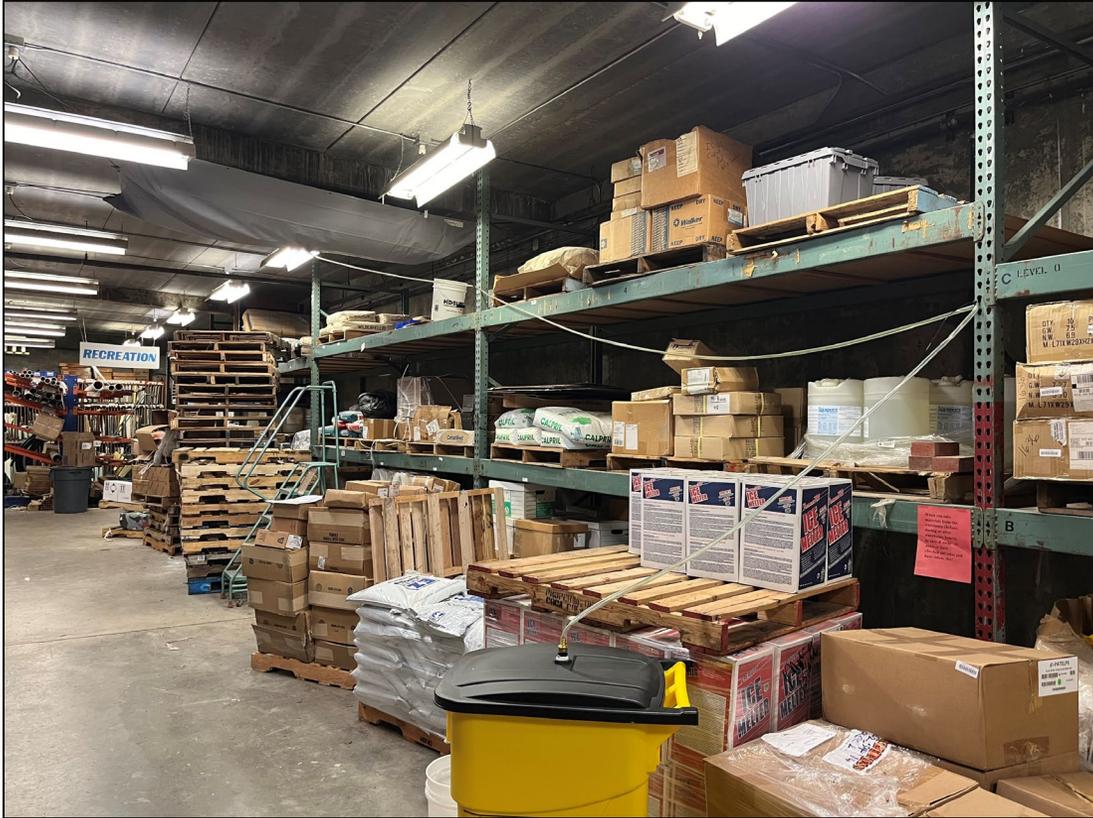
Leak collection system in warehouse

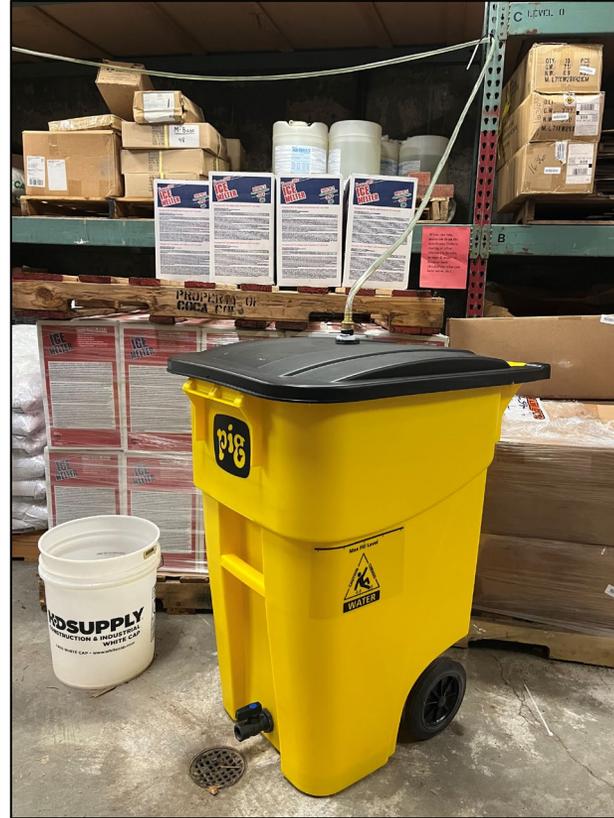
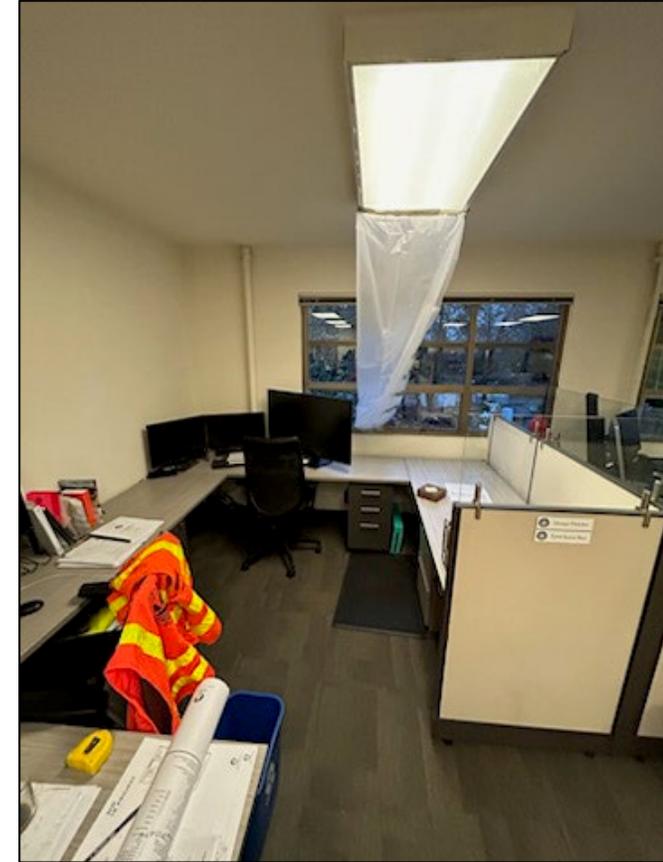
Leak above desks in administration offices

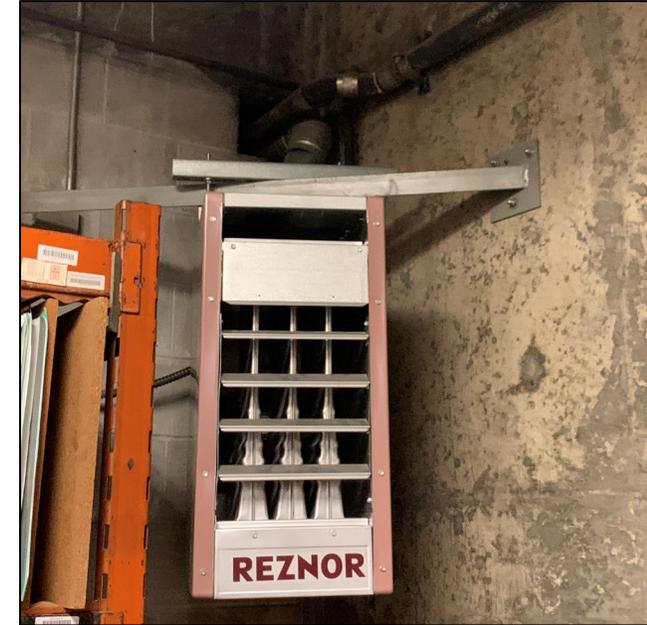
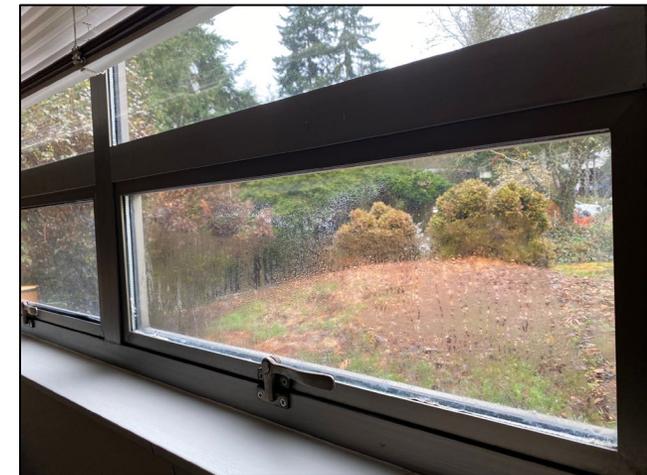
Heating, Cooling & Ventilation

- There is no cooling in the lower level of the building, where the operations teams work.
- The HVAC system on the upper level is at the end of its useful life.
- There is lack of adequate ventilation to address vehicle exhaust, the welding hood, and the fluid storage room.
- The exterior walls are concrete block with minimal insulation value.
- The aluminum-framed windows are not insulated and the double panes are unsealing.

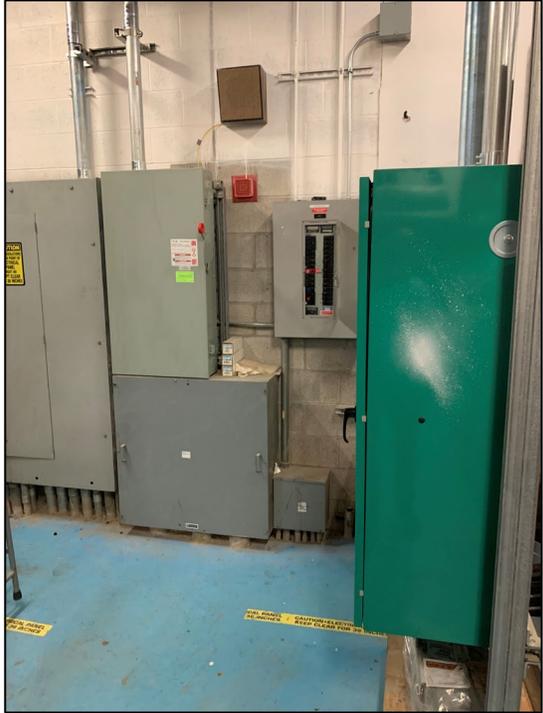
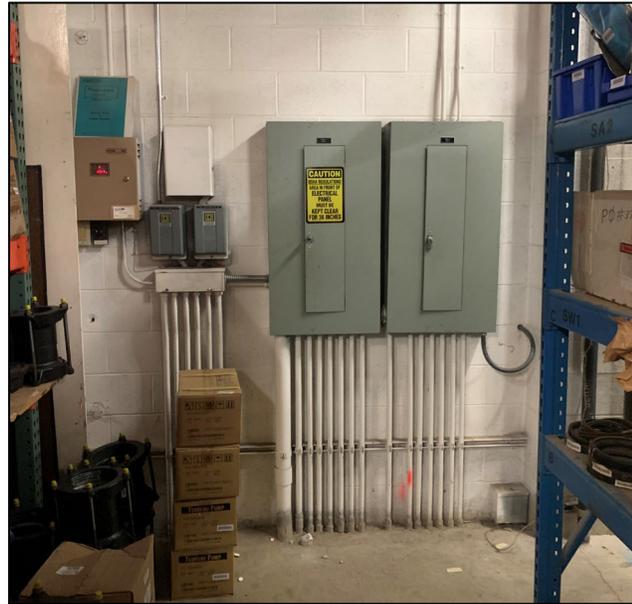
Electrical Service & Distribution

- The electrical panels and distribution system must be replaced to meet code and current uses (planned for 2025-2026).
- There is not enough electrical capacity currently, circuits are tripping regularly.
- Before the HVAC and lighting system improvements can be undertaken, the electrical system must be addressed.

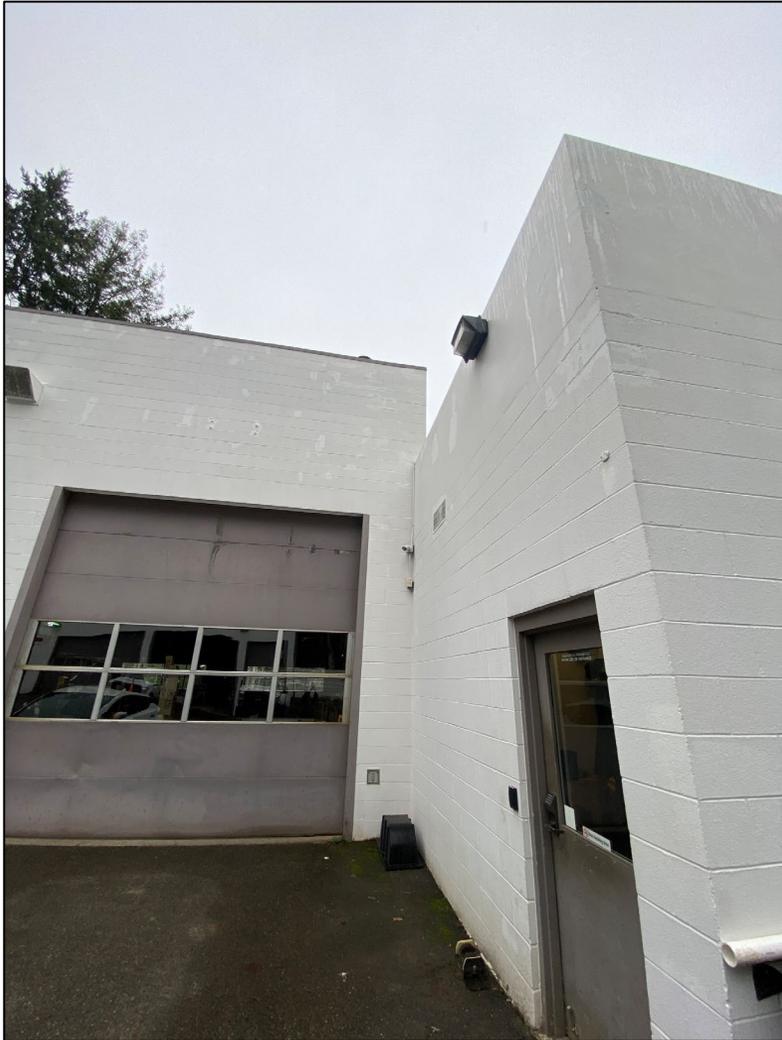
Structural Deficiencies

- The Public Works Building was not designed to meet the seismic resilience required for a building that must operate as an essential facility following an earthquake.
- ASCE 41-17 seismic evaluation found that existing building structure is inadequate to remain operational as a Seismic Risk Category II building.
- Public Works' operations facility should meet Seismic Risk Category III or IV to ensure that it can perform essential functions following a seismic event.

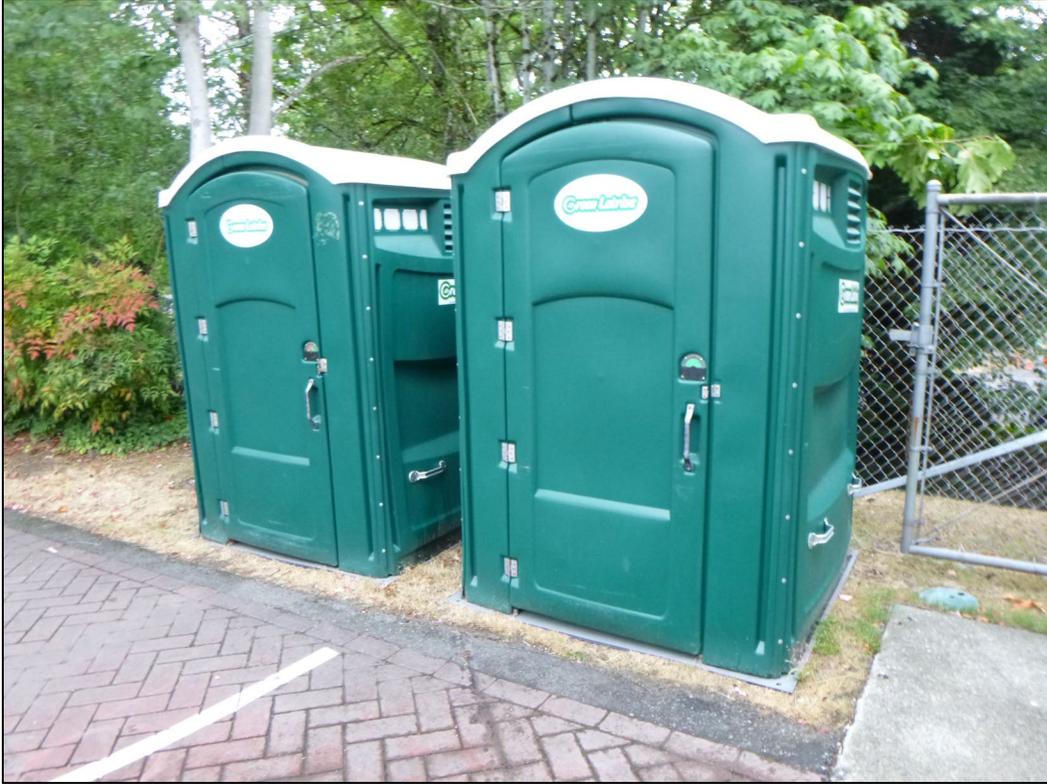
Insufficient Restroom Capacity

- The Public Works Building only has 5 restroom stalls, which is insufficient for current staffing needs. Two portable toilets are on-site to meet needs.
- There are no restrooms on the second floor of the building.

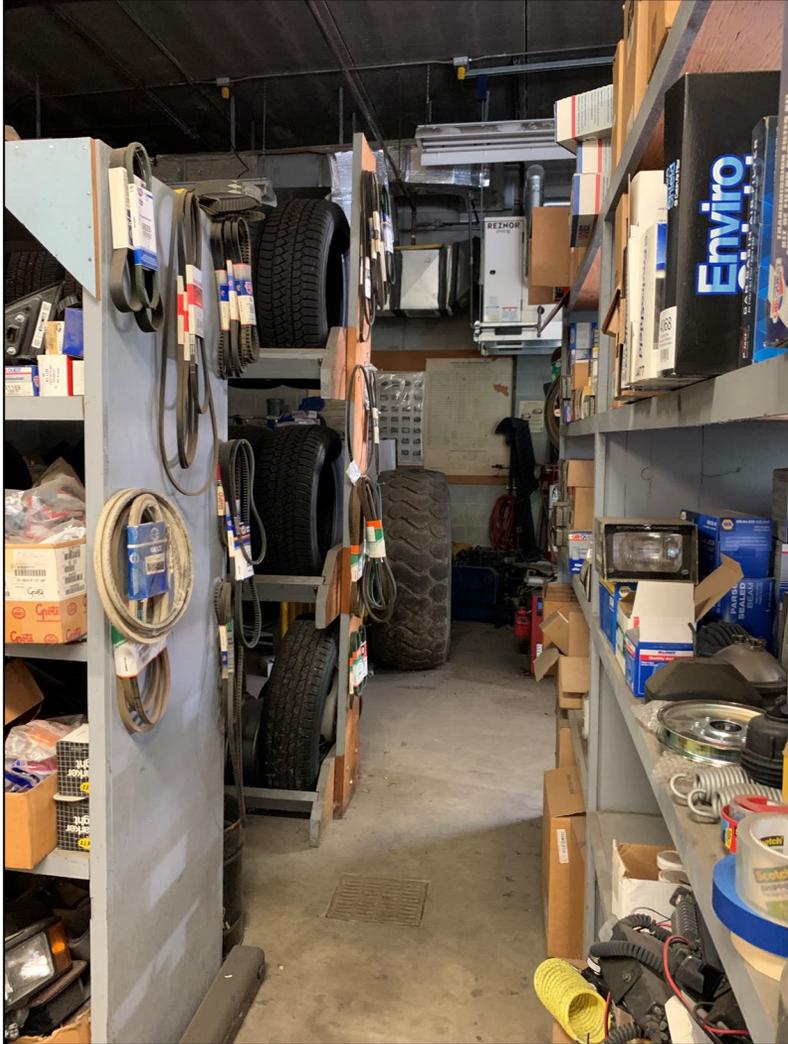
Fire Suppression System

- The building does not have a fire suppression system.
- The existing system is comprised of fire/heat **detection** only.
- This is of particular concern in the Mechanic's Shop and Warehouse where flammable materials and liquids are stored.

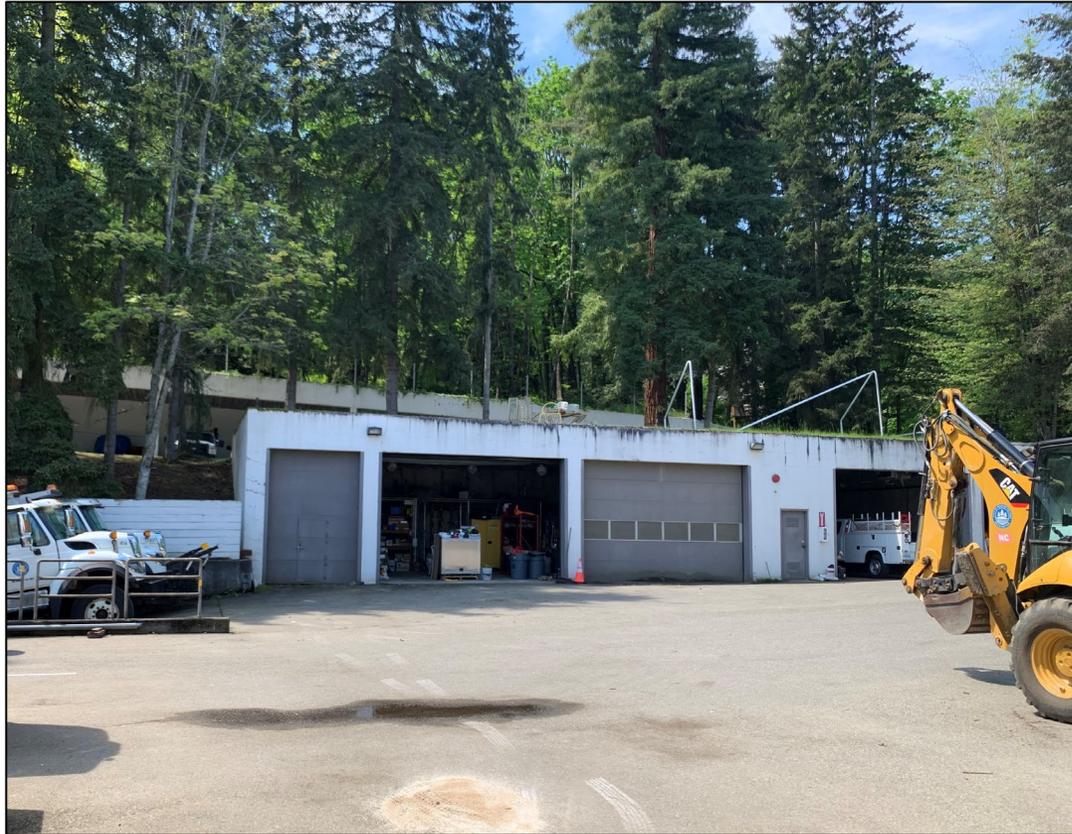
Fall Protection Railings

- Accessible roofs on top of the Public Works Building and outbuildings have no railing system to protect against falls.
- Several of these areas are used for material storage (benches, holiday displays, plants, etc.)
- A railing system must be installed on all edges to meet code requirements (to be installed in 2024).

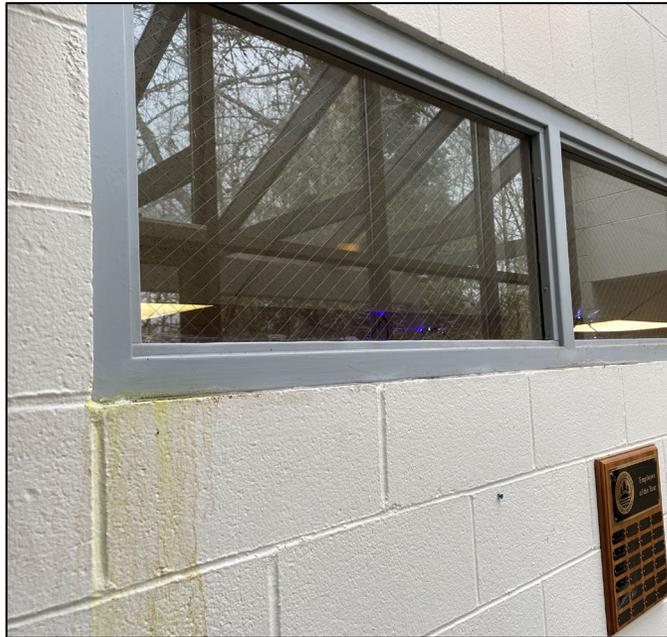
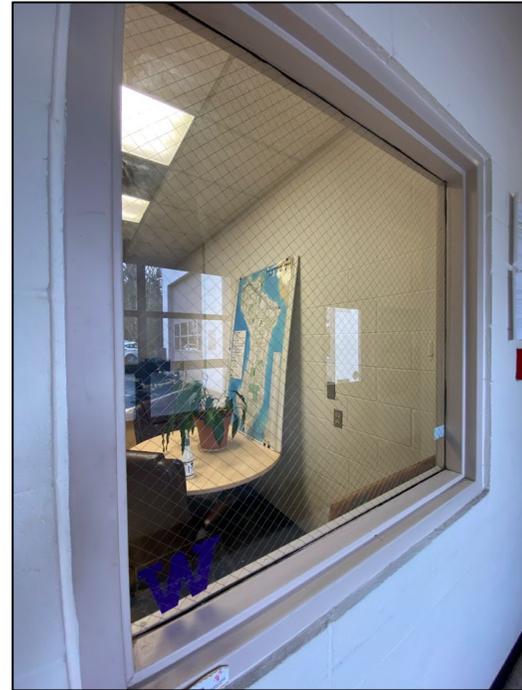
Wired Glass

- The glass installed on the interior windows and doors includes wired glass, which is now considered a potential safety hazard.
- Wire mesh weakens the glass and creates jagged glass shards when broken.
- The windows will be covered with a protective film to contain glass if broken (to be installed in 2024).
