PRELIMINARY REPORT

City of Mercer Island

Public Works Building Report

September 22, 2023

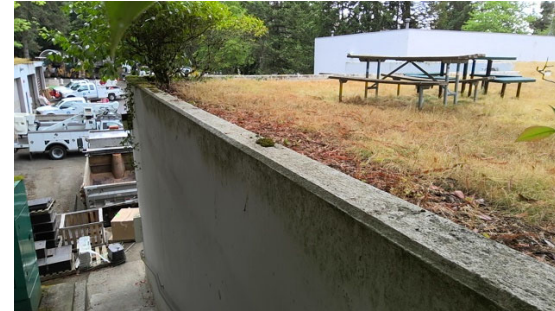
Deficient Material: Fall Guard

Green roofs on public works building are accessible, but have no perimeter fall restraint guard railings at the leading edges over the yard and ground below on the west, north, and east sides.

Install perimeter safety guard rail system.

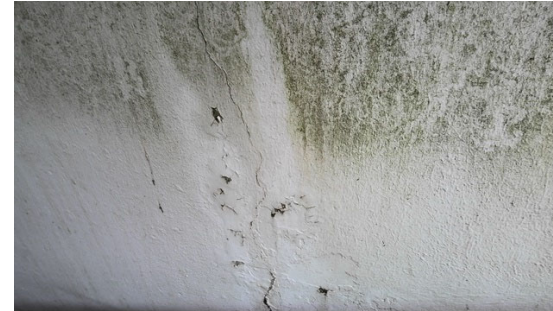
Deficient Material: Exterior Walls

Some peeling paint and cracks in west and north exterior of warehouse walls.

Strip paint, seal cracks, and repaint.

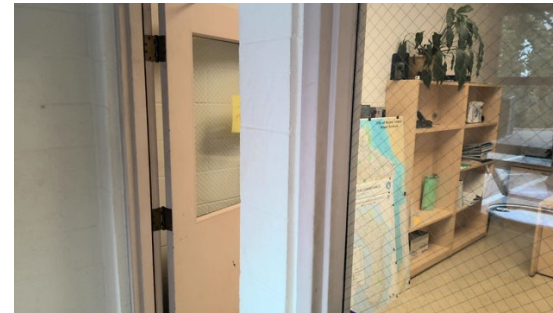
Deficient Material: Wire Glass

Wire glass in rated doors and internal windows. Wire glass is now known as a safety hazard and liability.

Remove existing wire glass and retrofit with modern rated safety glazing.

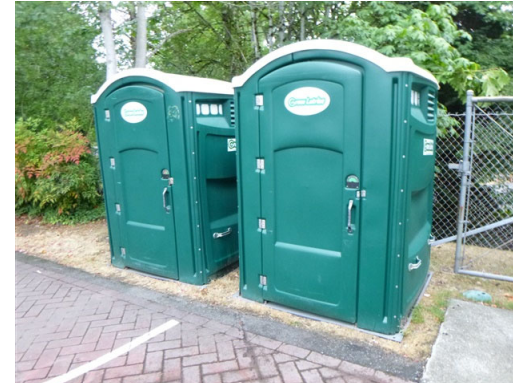
Deficient Material: Restrooms

Insufficient restroom facilities, with two porta potties currently in use on a temporary basis.

Expand permanent restroom capability to replace the current porta potties.

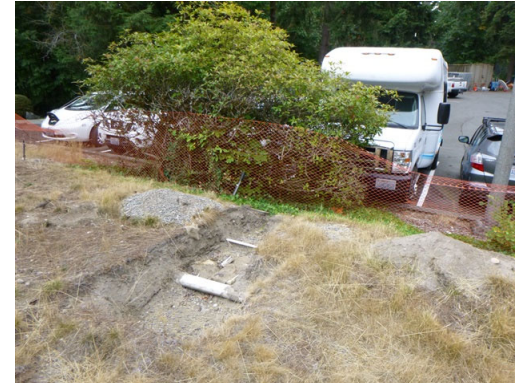
Deficient Material: Roof Drain

Aged and failing low green roof under-drains and undersized high-roof drains, contributing to roof leaks.

Replace the low green roof under-drain system and increase high-roof drains from 2-inch to 4-inch, all in conjunction with new roof covering.

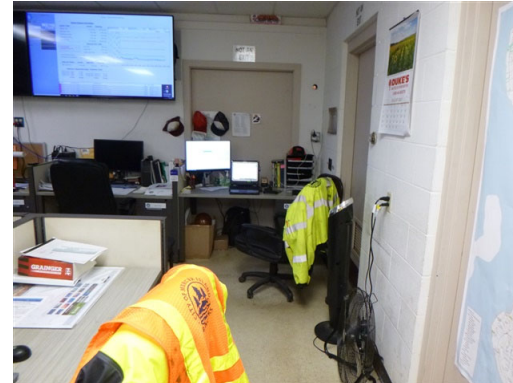
Deficient Material: Cooling

Heat and vent HVAC system for former shop area now used for office area for public works staff, resulting in hot uncomfortable working conditions.

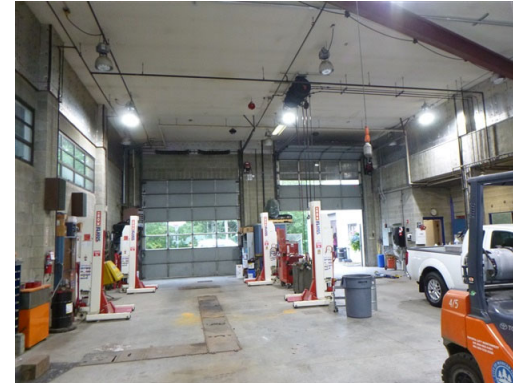
Deficient Material: HVAC System

Aged HVAC throughout with multiple spaces including minimal light industrial heat and vent HVAC systems with insufficient heat, no cooling, and marginal or no ventilation for office use. Odors build up in some spaces, potentially toxic to staff, especially over time. No apparent ventilation at all for some spaces, such as the warehouse area. The former machine shop and repurposed carpenter shop (now groundskeeping) HVAC system was completely off during the site visit, with significant pesticide and/or fertilizer odors present. No general ventilation for the vehicle repair garage (only the abandoned engine exhaust system).

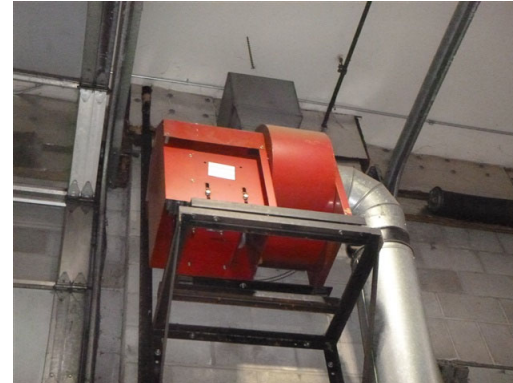
Deficient Material: Engine Exhaust

Fully service and restore vehicle engine exhaust system to operational condition.

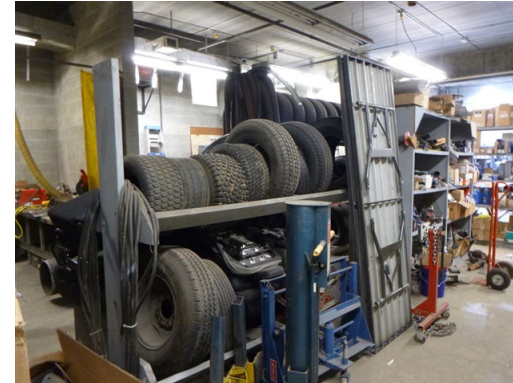
Deficient Material: Shop Equipment

Renew, replace, or repurpose aged, obsolete, and abandoned shop and other specialized equipment.

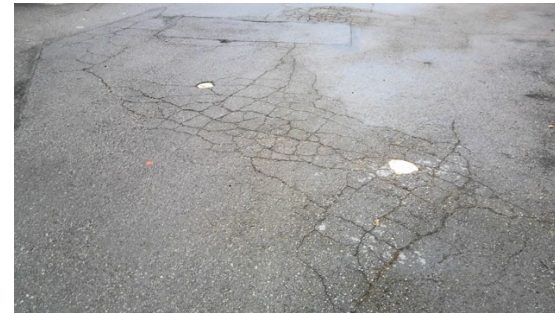
Deficient Material: Asphalt Paving

Patch asphalt, fill and seal cracks, and fog coat to prolong system life.
