**MERCER ISLAND PARKS
OVERWATER STRUCTURES ASSESSMENT**

DRAFT REPORT

May 30, 2014

OAC Services, Inc.

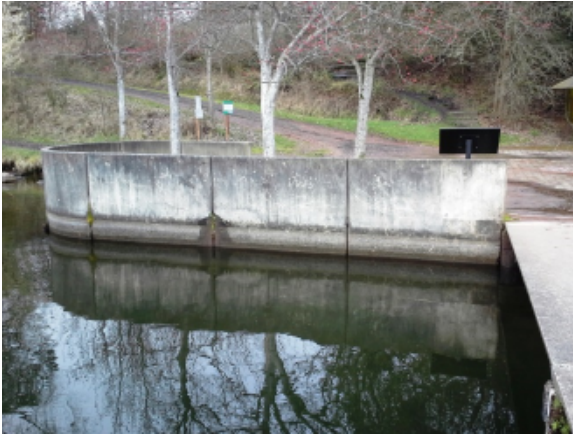
Photo 1A – Concrete bulkhead

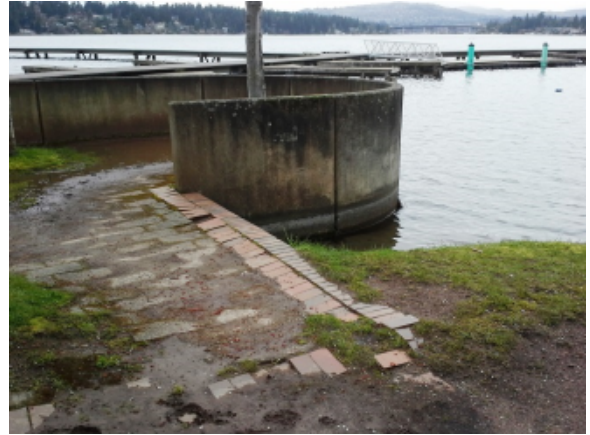
Photo 2A – Brickwork adjacent to bulkhead

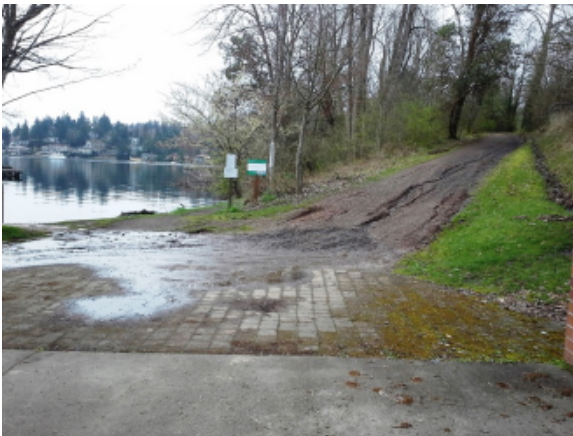
1B	Gravel maintenance road/trail	Heavily rilled; erosion of soil from inclined road has resulted in deposition of mud and accumulation of standing water on brick surface behind S. end of bulkhead.	Uncontrolled runoff on inclined surface of maintenance road; a portion of the runoff appears to be due to emergent seepage (springs) in the road.	4	4	2	7	Exceeded	Periodic regrading of the road and frequent removal of the mud from behind the bulkhead.	\$1,000 per event	Construction of check dams/water bars on road; installation of a trench drain at the toe of the slope.	\$10,000 - \$15,000
2	Natural shoreline [approx 975 ft. of shoreline]	Generally good; trail paralleling shoreline very muddy.	Muddy condition of trail due to accumulation of runoff, possibly with some emergent seepage.	7	7	7	9	20+	Build up surface of trail with cedar chips underlain by filter fabric.	\$5,000 - \$10,000	Build up surface of trail with crushed rock underlain by filter fabric.	\$10,000 - \$15,000

Photo 3A – Gravel maintenance road

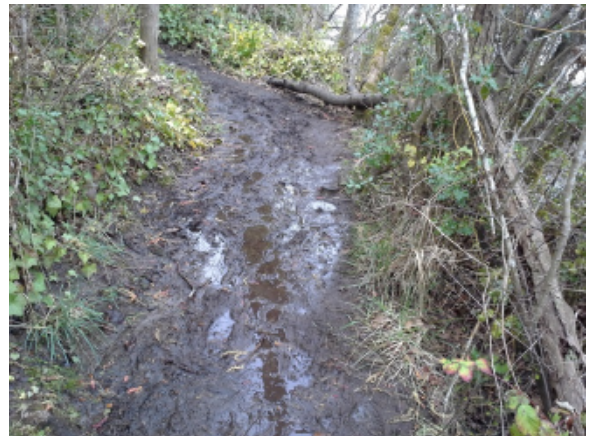
Photo 4A – Trail along shoreline

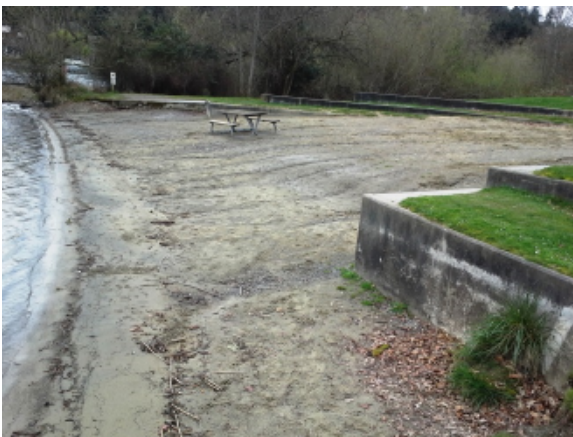
3	Swim beach [approx 85 ft. of shoreline]	Beach appears to be constructed of imported sand placed on till. Heavy rilling of surface of beach. Concrete steps/retaining walls at head of beach in good condition.	Rilling on beach due to erosion from runoff. The source of much of the runoff appears to be emergent seepage (springs).	6	6	6	10	N/A	Regrade surface of beach/import additional sand.	\$5,000	Installation of interceptor/finger drains to control seepage.	\$10,000 - \$15,000

Photo 5A – Swim beach

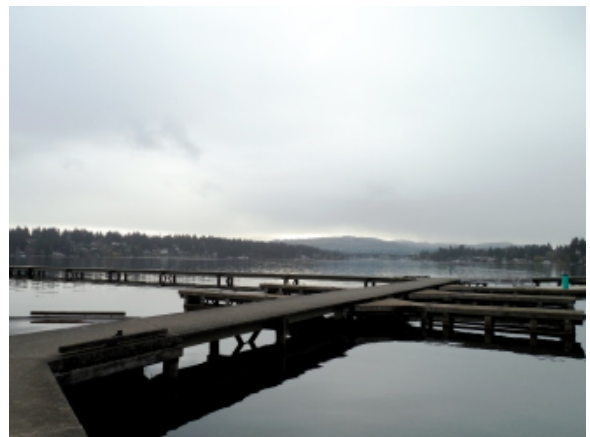
Photo 6A – Large pier

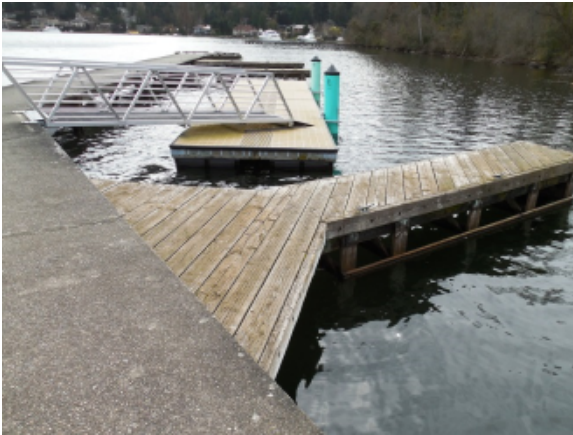
Photo 7A – Pier finger and gangway

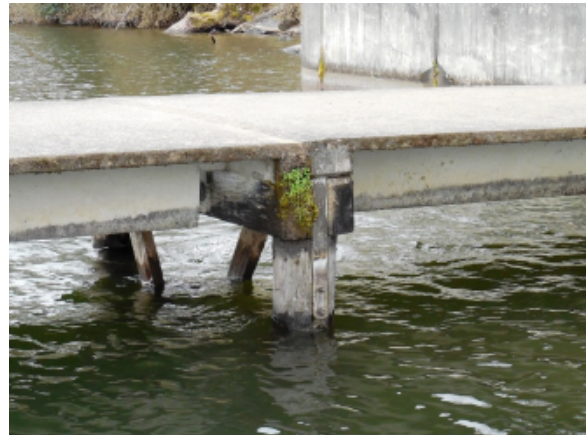
Photo 8A – Typical pier construction

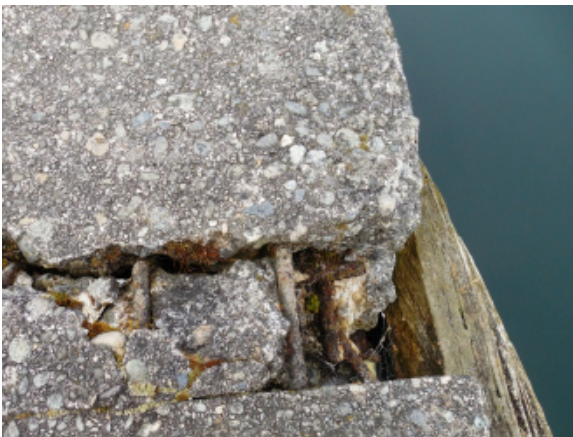
Photo 9A – Deteriorated pier slab

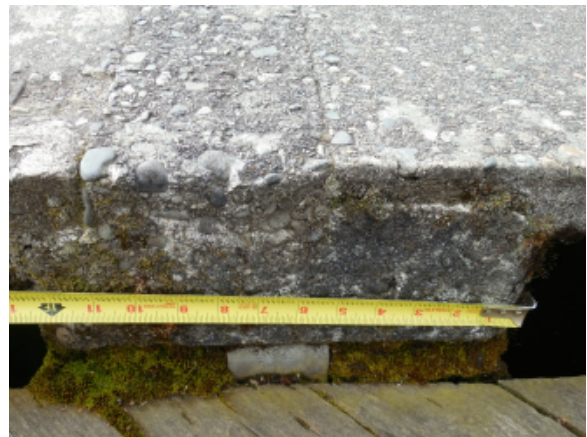
Photo 10A – Pier slab over support

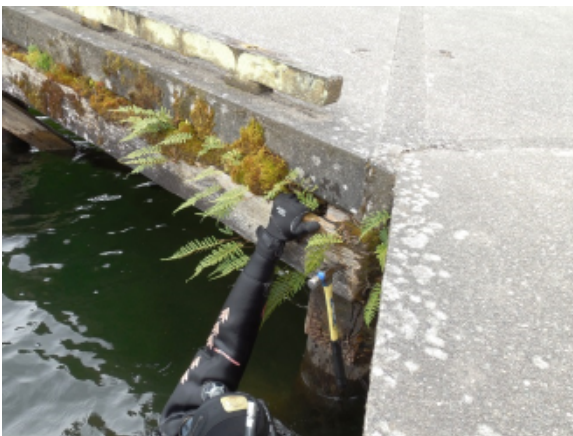
Photo 11A – Moss / vegetation at pier edge

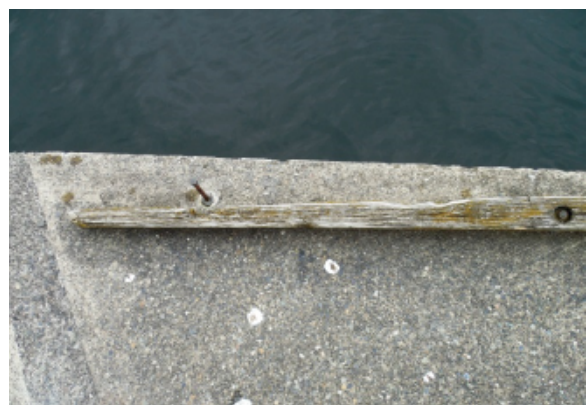
Photo 12A – Deteriorated / loose bull rail

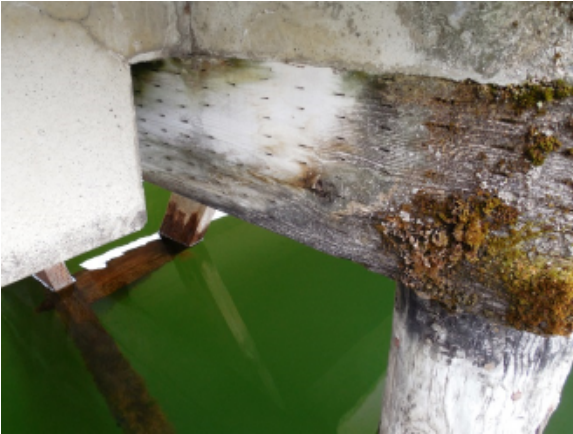
Photo 13A – Treated cap beam at pile

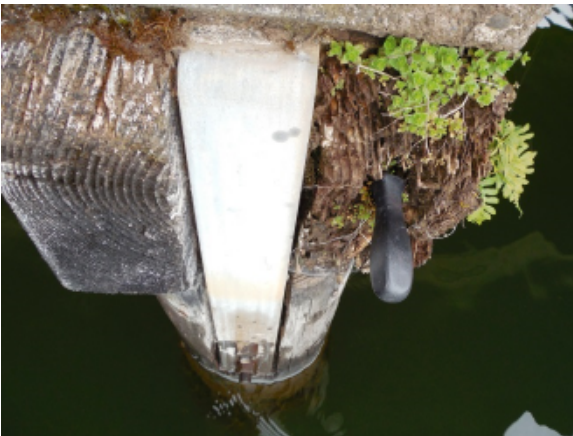
Photo 15A – Deteriorated cap beam end

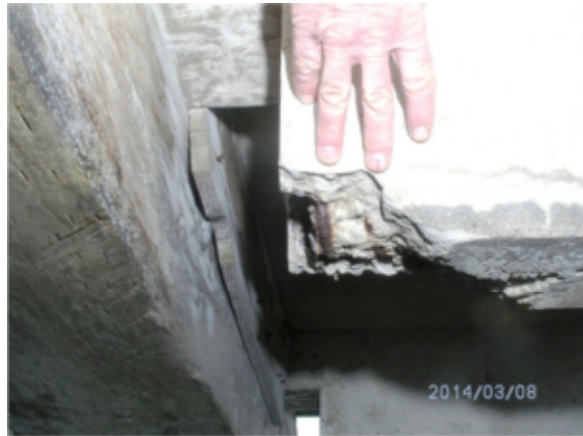
Photo 16A – Spalling at underside of precast "T"

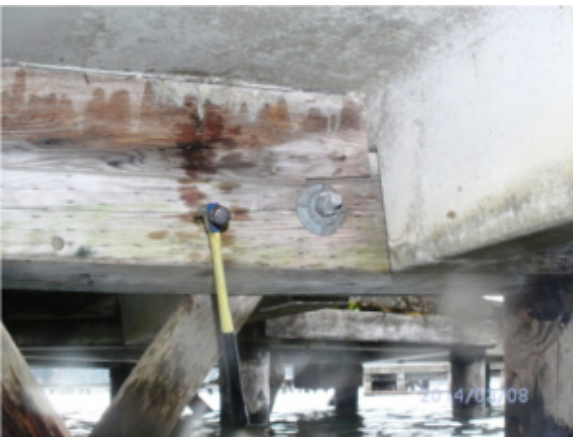
Photo 17A – Precast "T" and timber cap beam

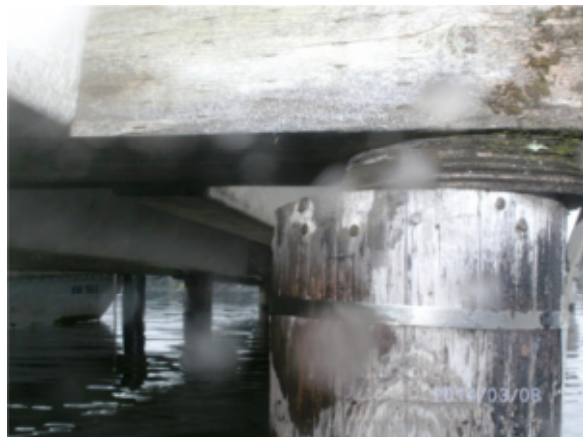
Large Pier Substructure	Substructure consists of treated timber cap beams (with non-treated wood shims); creosote treated timber piles and timber bracing. Diver reports the following: With exception of one location, piles are in good condition. Problems exist with decayed wood shims between caps and piles, and decayed cap ends. Bracing is loose and connection hardware loose corroded at some locations.	age weathering wood decay steel corrosion wave action	5	5	N/A	7	2 - 4	Pile splice allowance + allowance to repair decayed cap beams, shims and bracing in-place.	\$65,000 - \$85,000	Provide allowance in budget for additional similar mitigation procedures in 10 - 15 years.	\$50,000
5	Small Pier Superstructure	Construction and condition same as large pier - see notes above							Allowance for repair of deteriorated concrete and wood rails.	5,000 - \$10,000	Provide allowance in budget for additional similar mitigation procedures in 10 - 15 years.	\$10,000

Photo 18A – Plywood shims between cap and pile

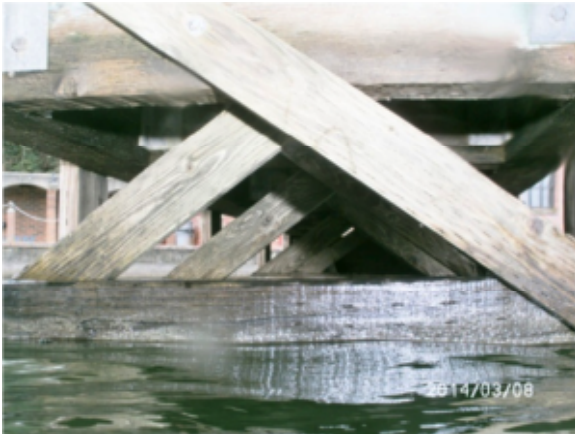
Photo 19A – Diagonal bracing

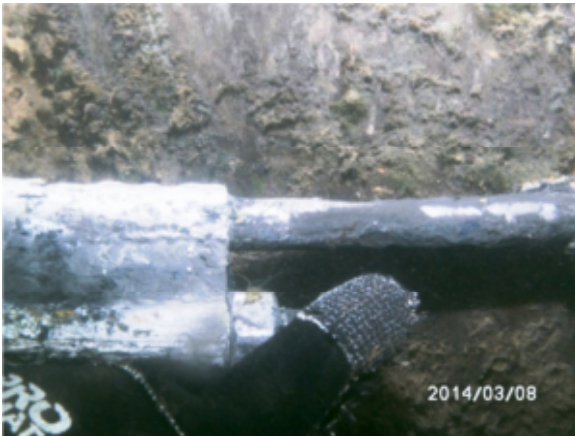
Photo 21A – Stripped / corroded connector

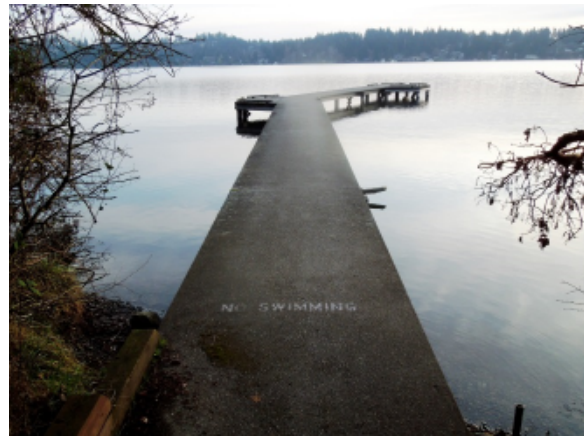
Photo 22A – Small pier

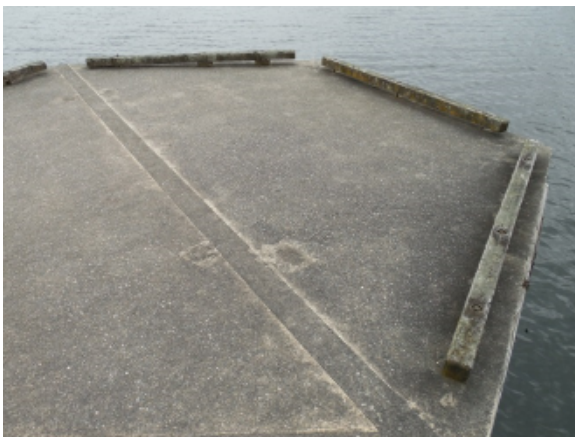
Photo 23A – Platform at end of small pier

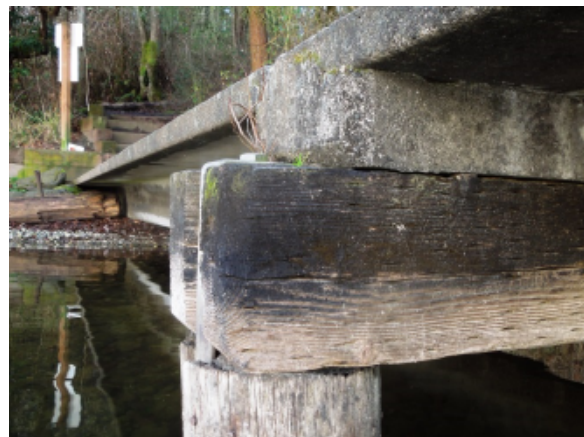
Photo 24A – Pile cap to pile connection (small pier)

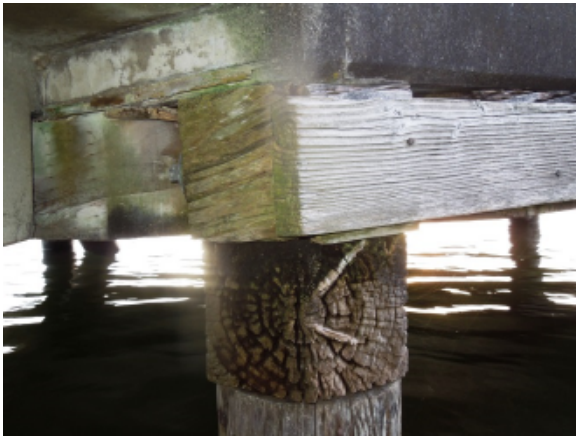
Photo 25A – Deteriorated cap beam (small pier)

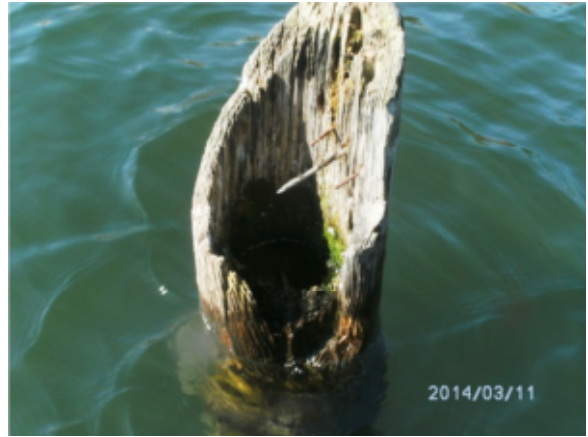
Photo 26A – Deteriorated mooring pile
