Luther Burbank Pier Renovation and Upgrade Grant

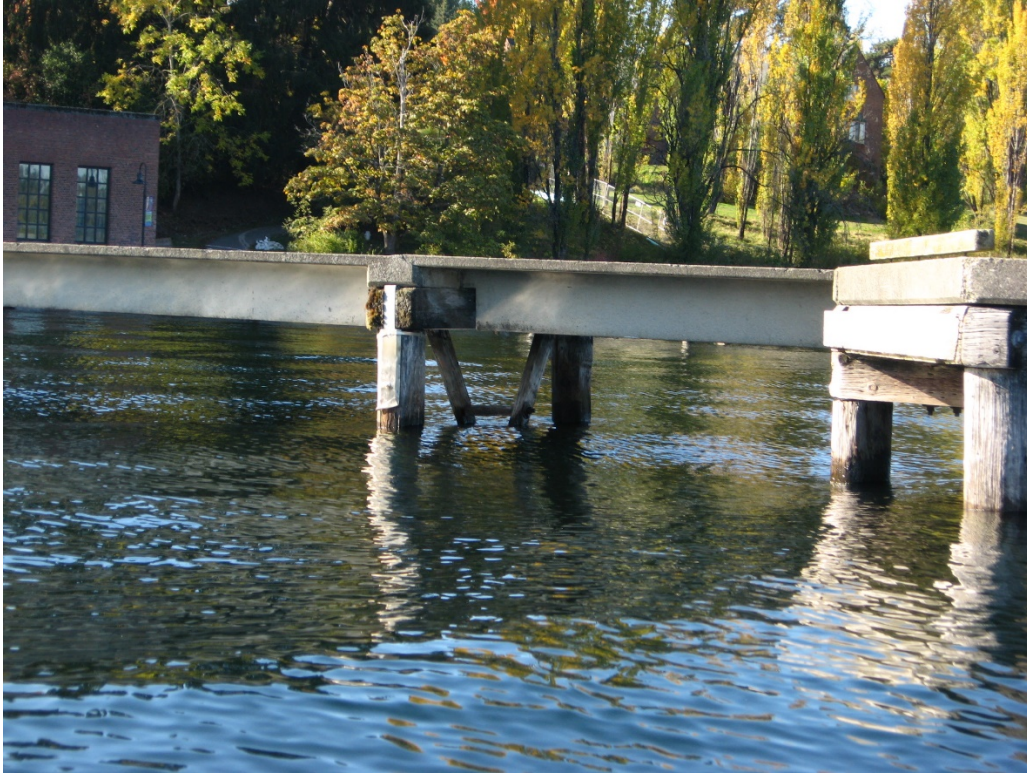
Figure 1: Profile view of pier showing concrete panel and wood cap beam construction

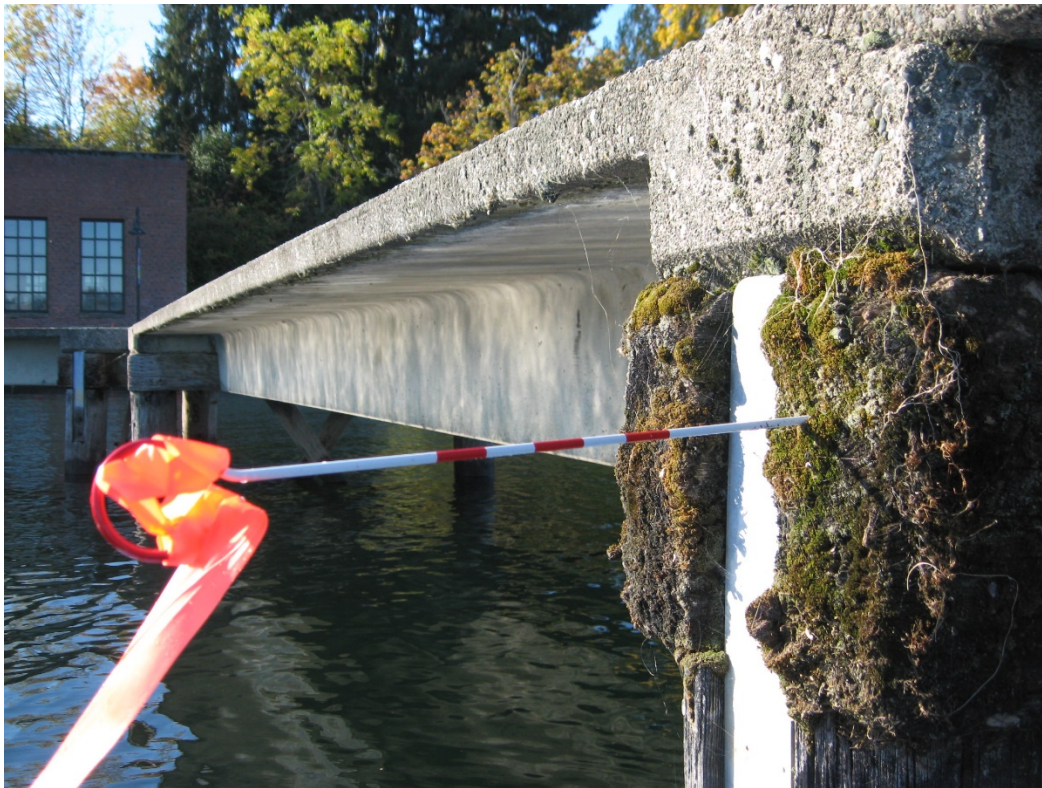
Figure 2: Detail of cap beam illustrating typical rot condition
