## PUBLIC WORKS FACILITY SEISMIC RETROFITS PROJECT CLOSEOUT CONSTRUCTION PHOTOS

**AB6901 | EXHIBIT 2 | GRADE BEAM INSTALLATION AT MECHANIC GARAGE DOORS**

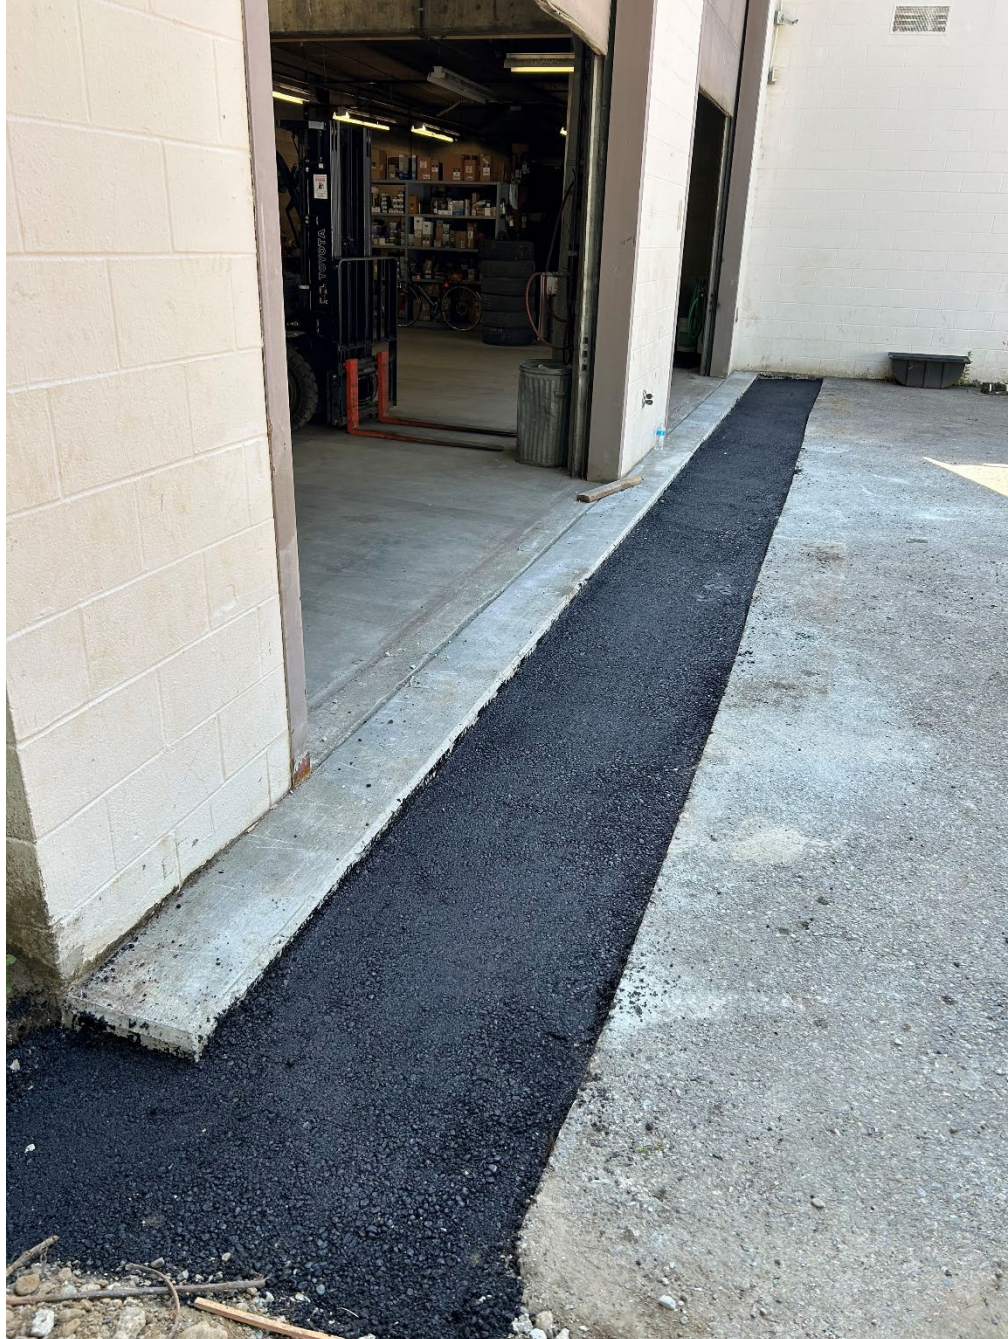
**AB6901 | EXHIBIT 2 | GRADE BEAM COMPLETE AT MECHANIC GARAGE DOORS**

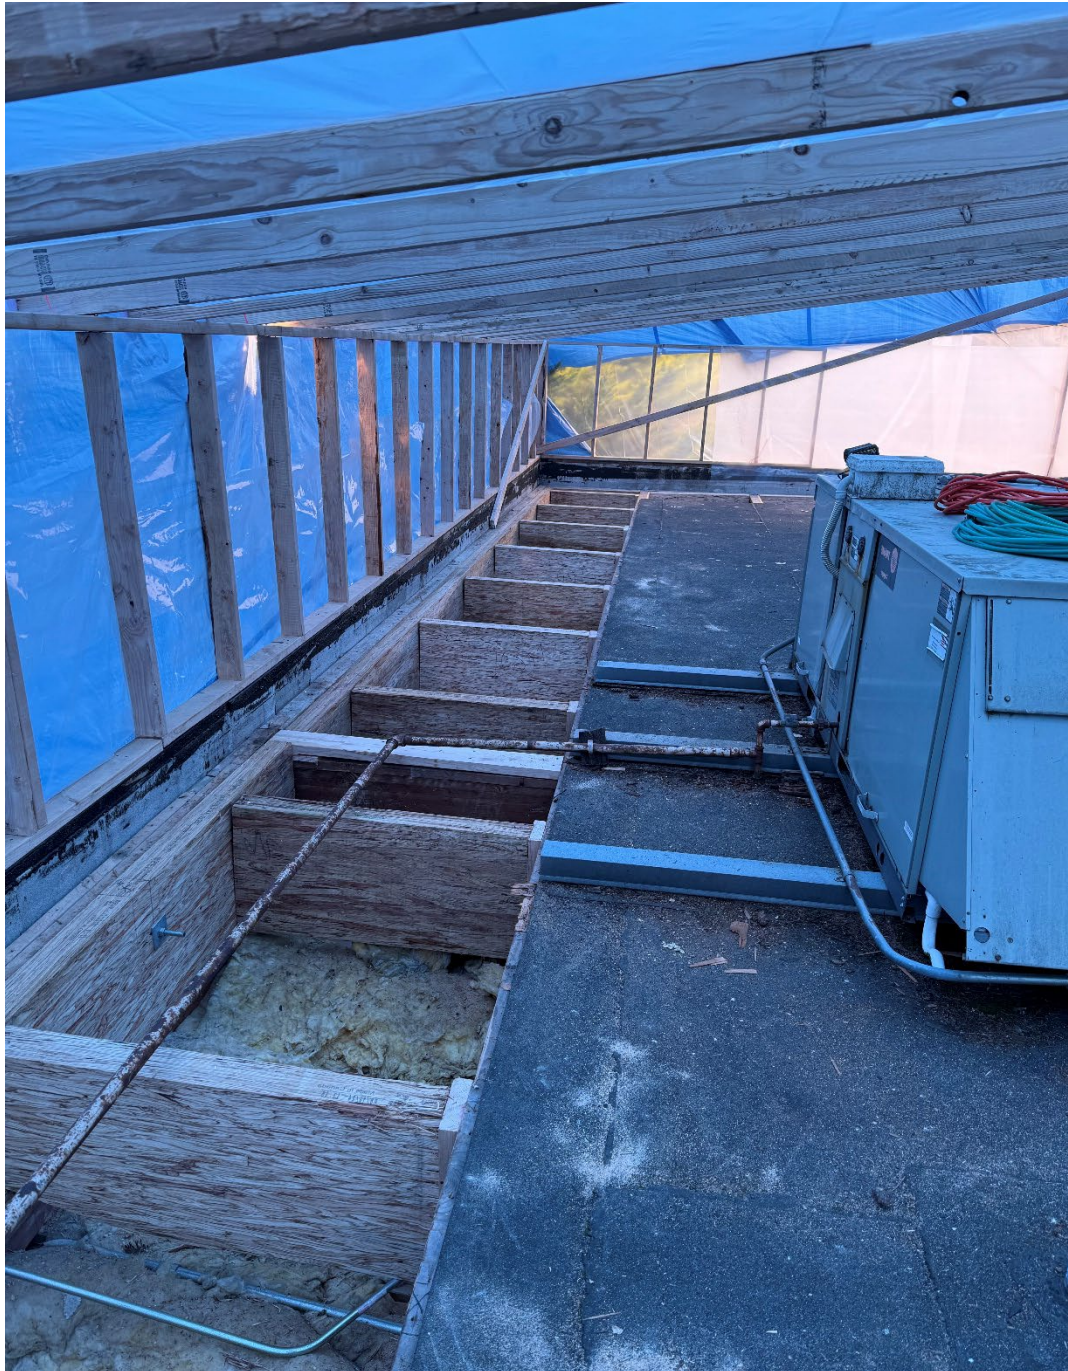
**AB6901 | EXHIBIT 2 | UPPER ROOF REINFORCEMENT**

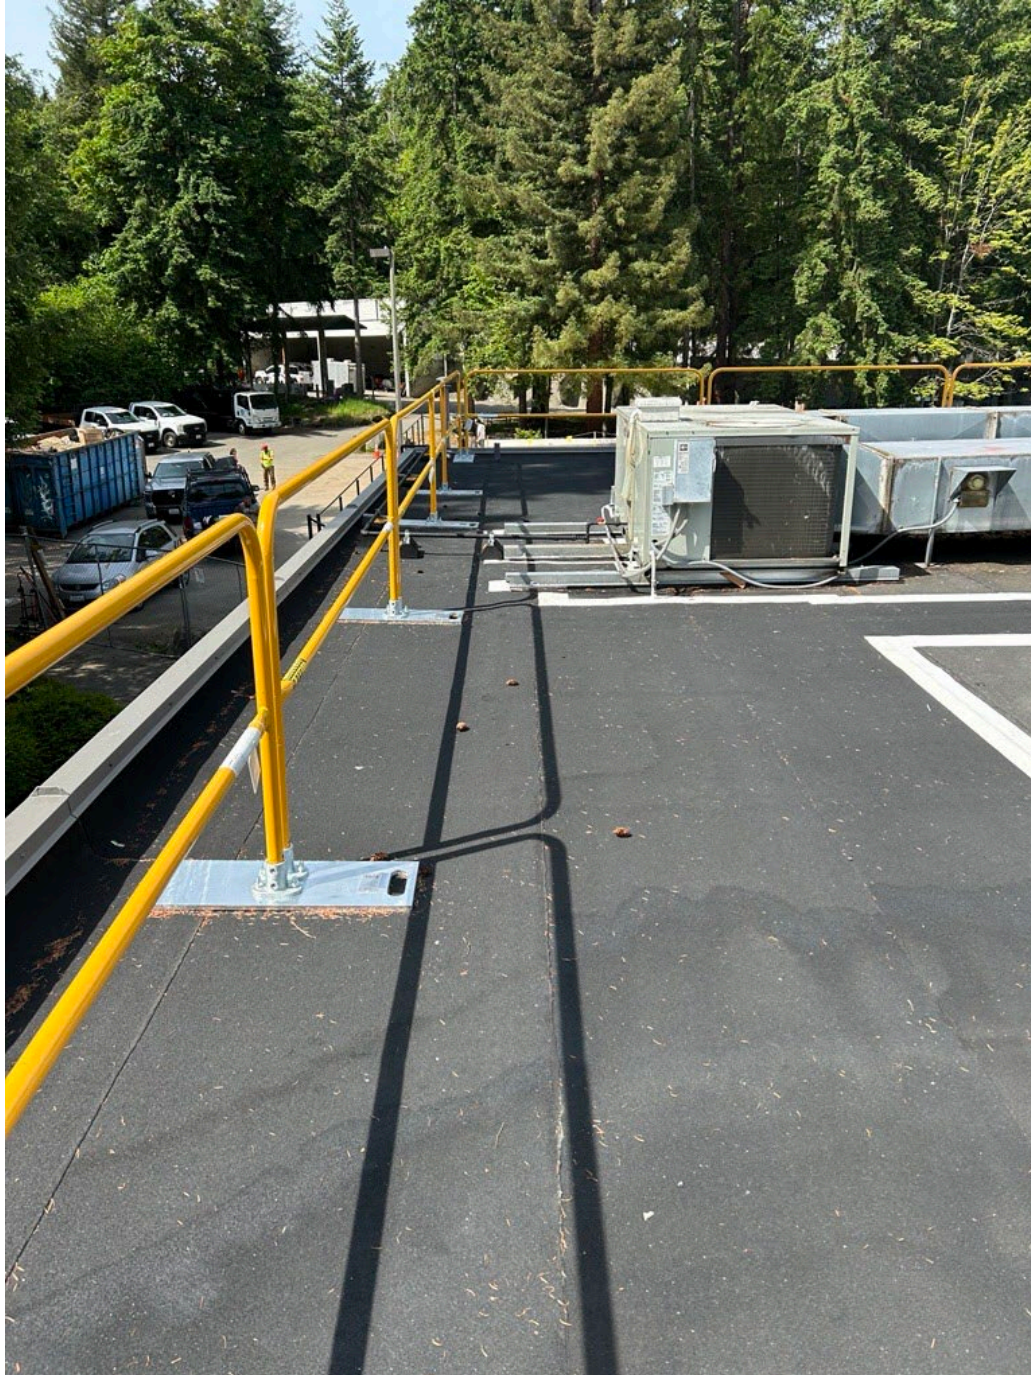
**AB6901 | EXHIBIT 2 | FALL PROTECTION**

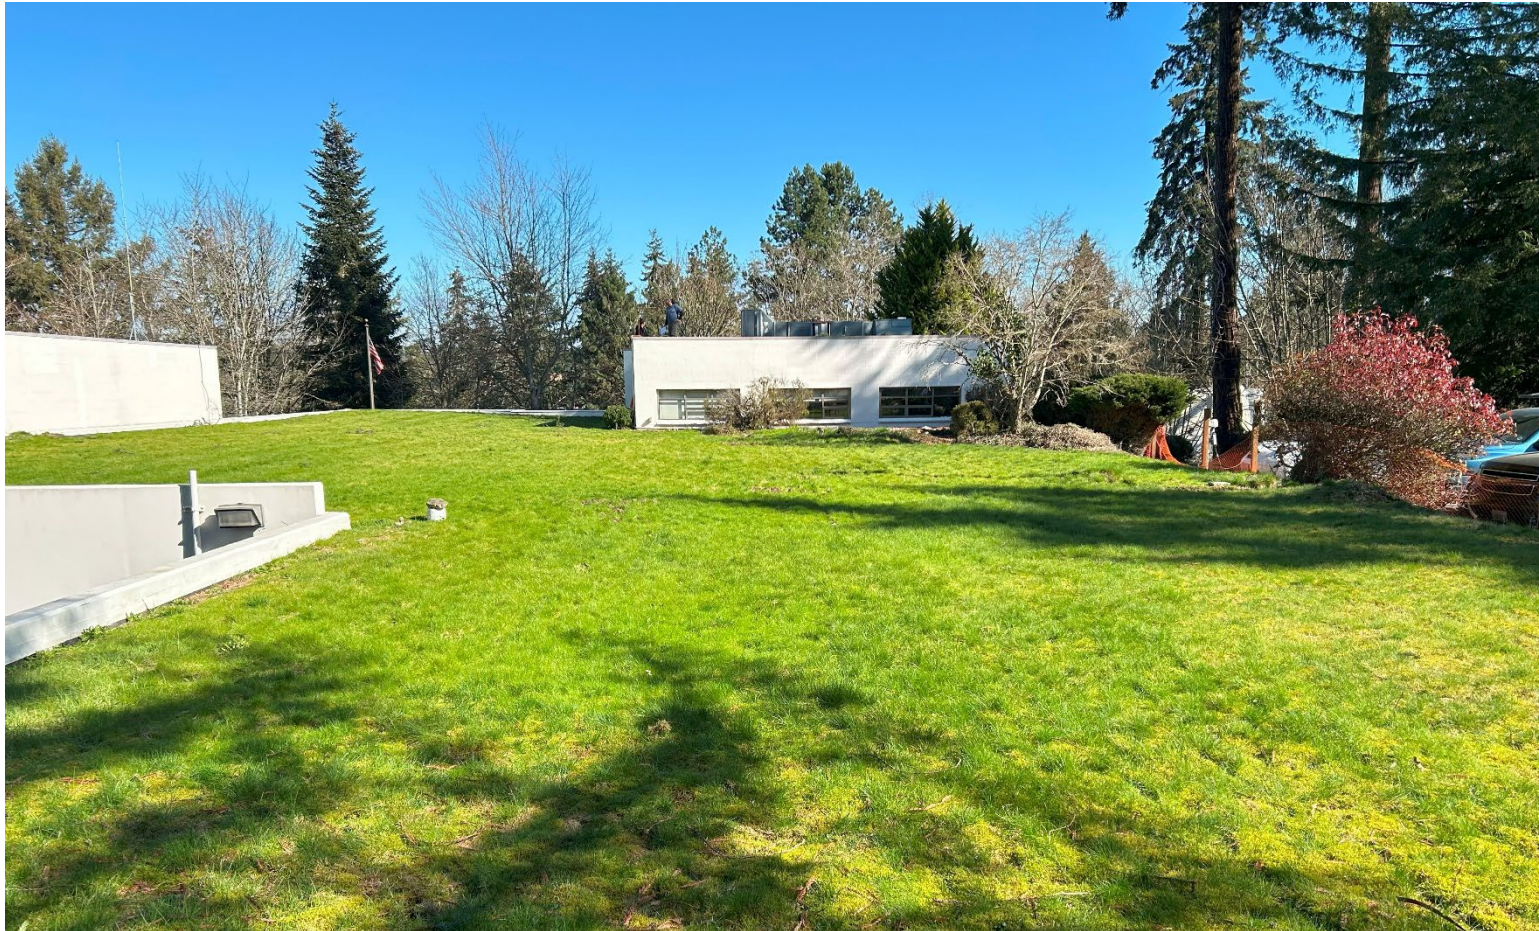
**AB6901 | EXHIBIT 2 | EXISTING OVERBURDENED GREEN ROOF**

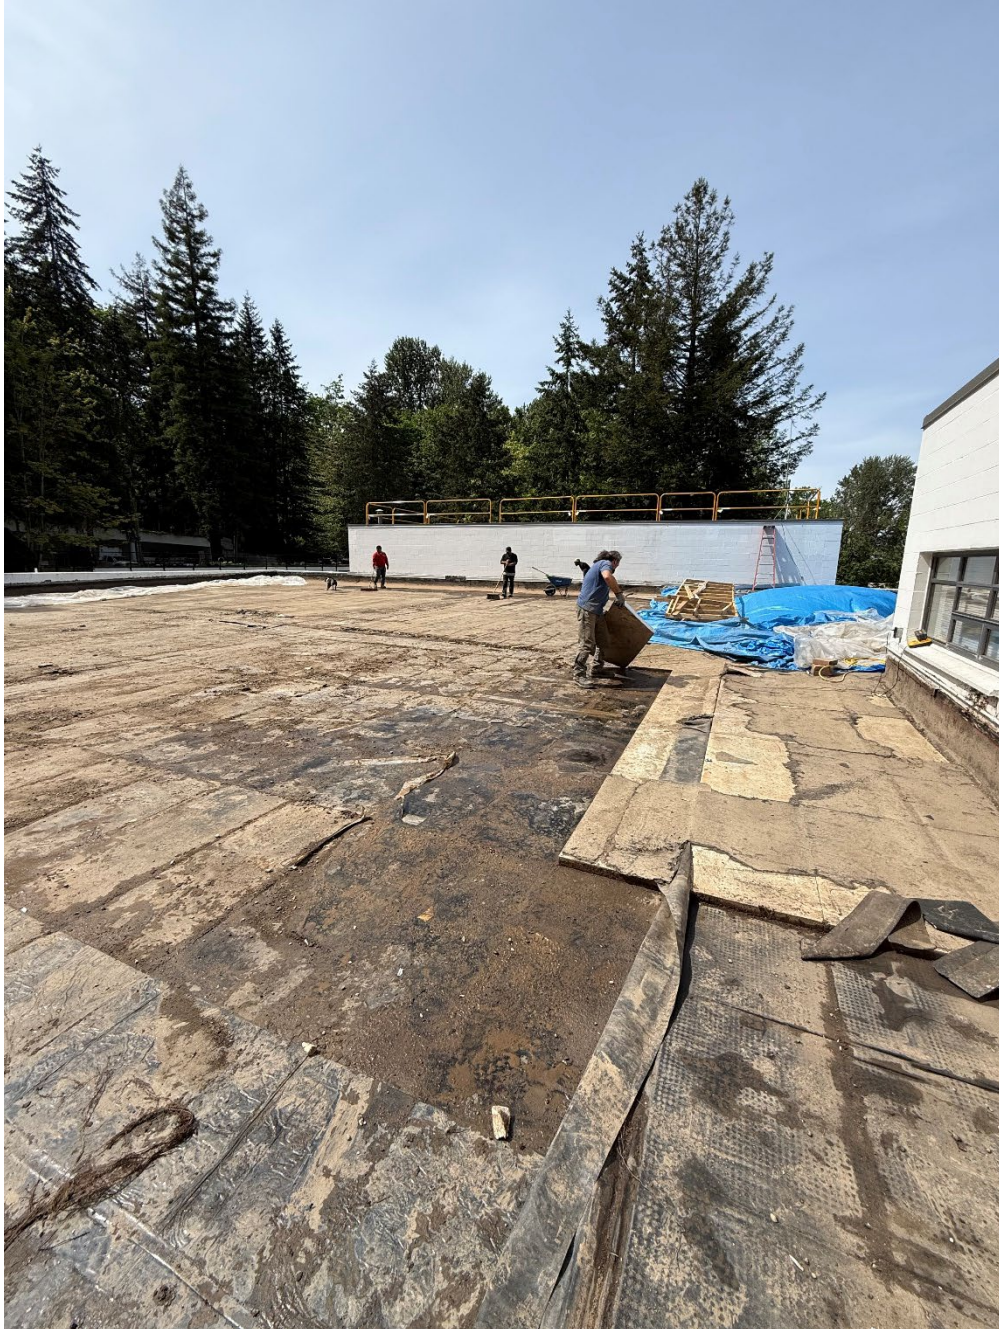
**AB6901 | EXHIBIT 2 | GREEN ROOF ASSEMBLY REMOVAL**

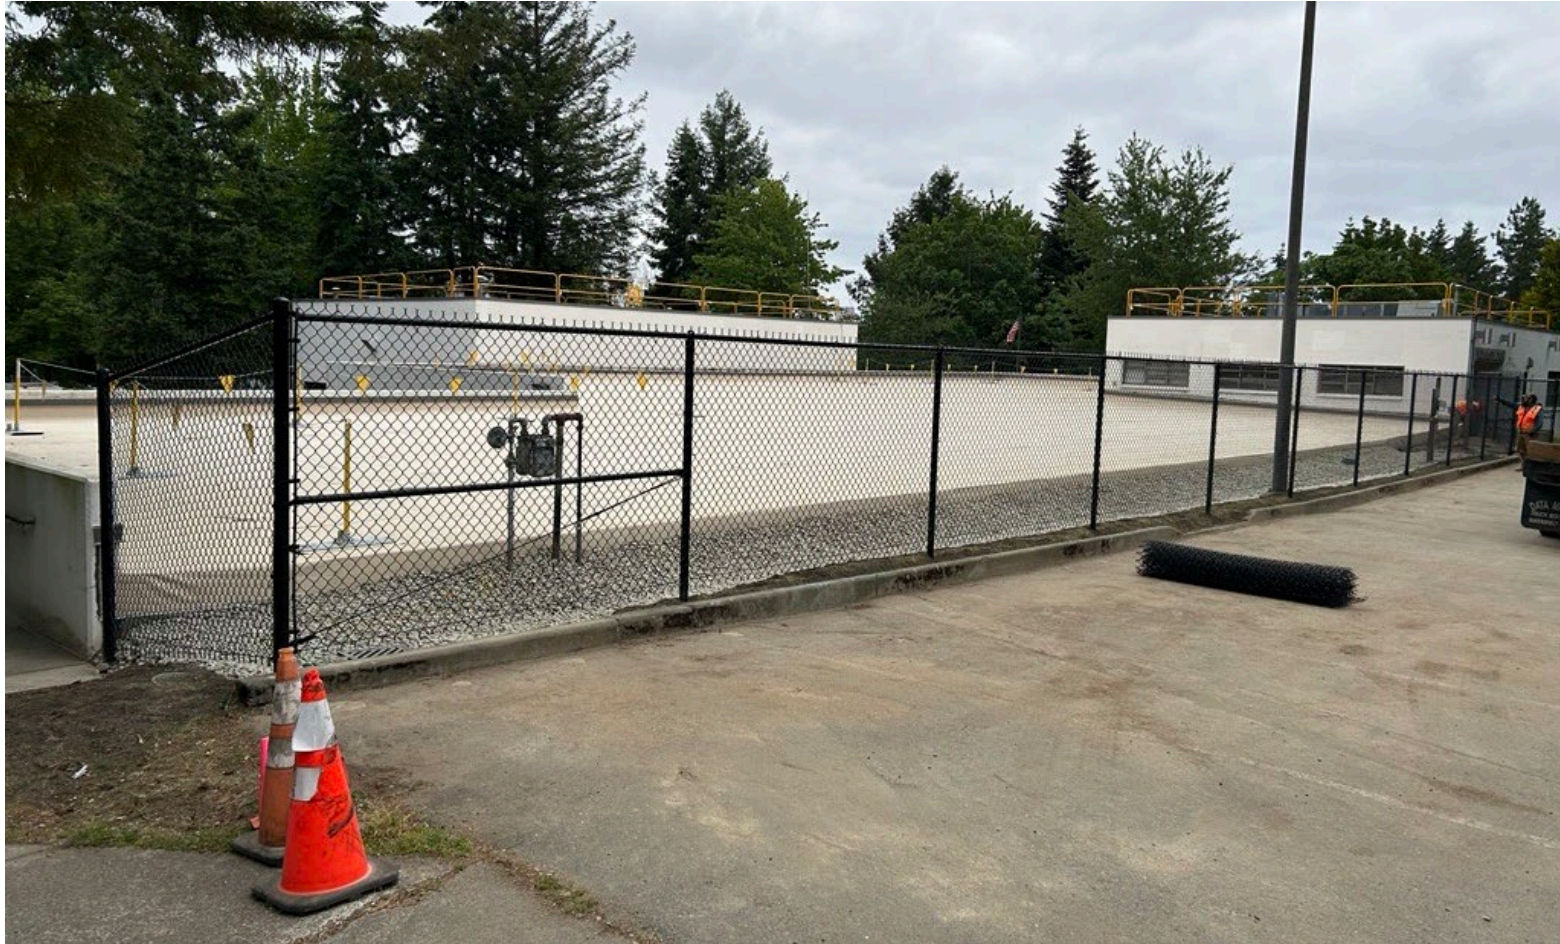
**AB6901 | EXHIBIT 2 | SINGLE PLY ROOFING MEMBRANE, DRAINAGE SWALE AND FALL PREVENTION**

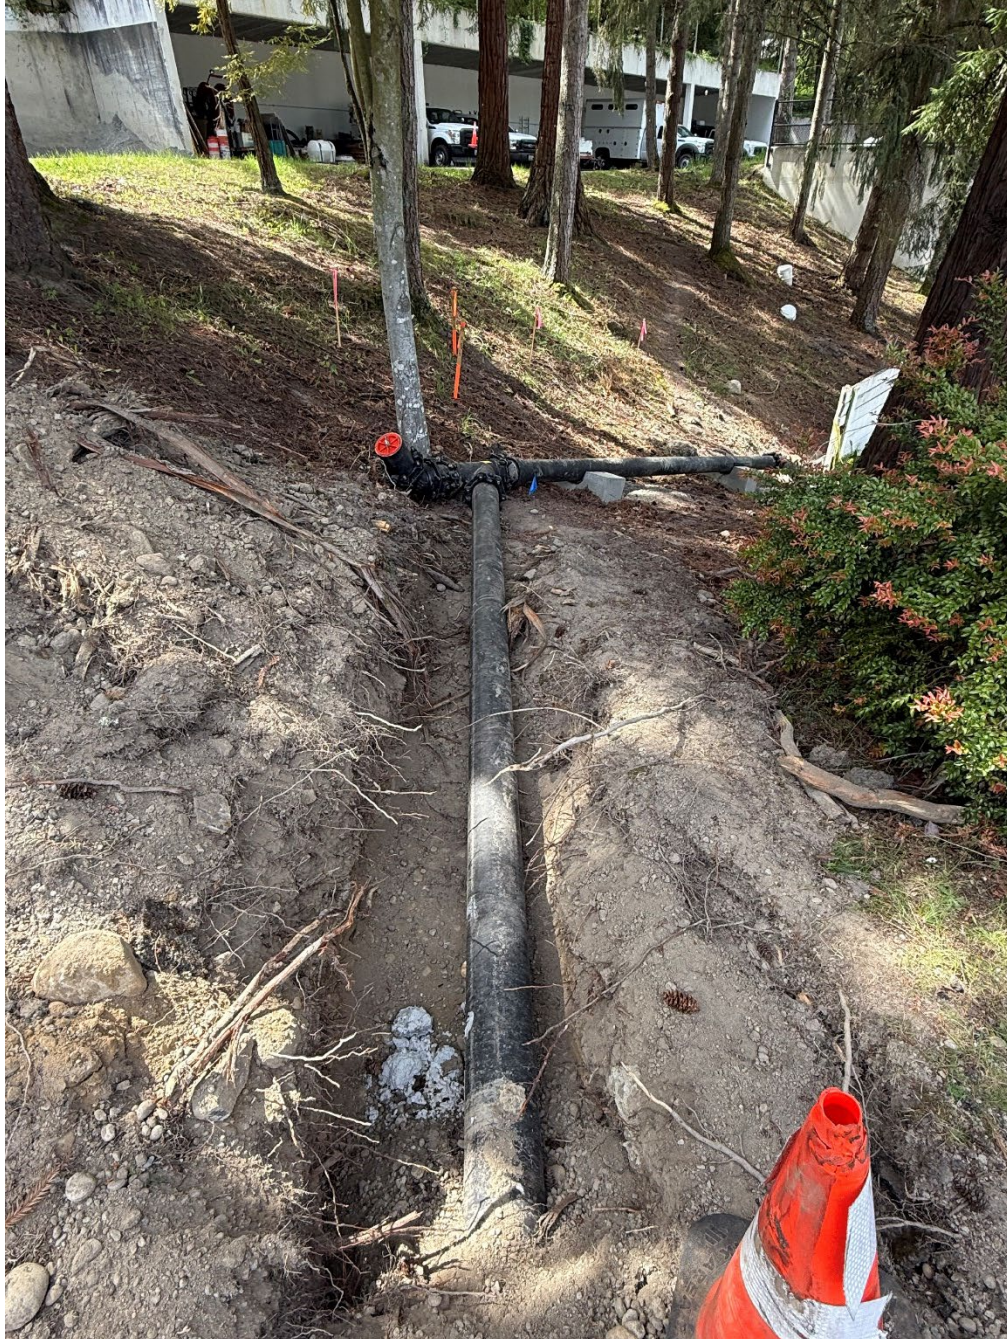
**AB6901 | EXHIBIT 2 | STORM DRAINAGE INSTALLATION**

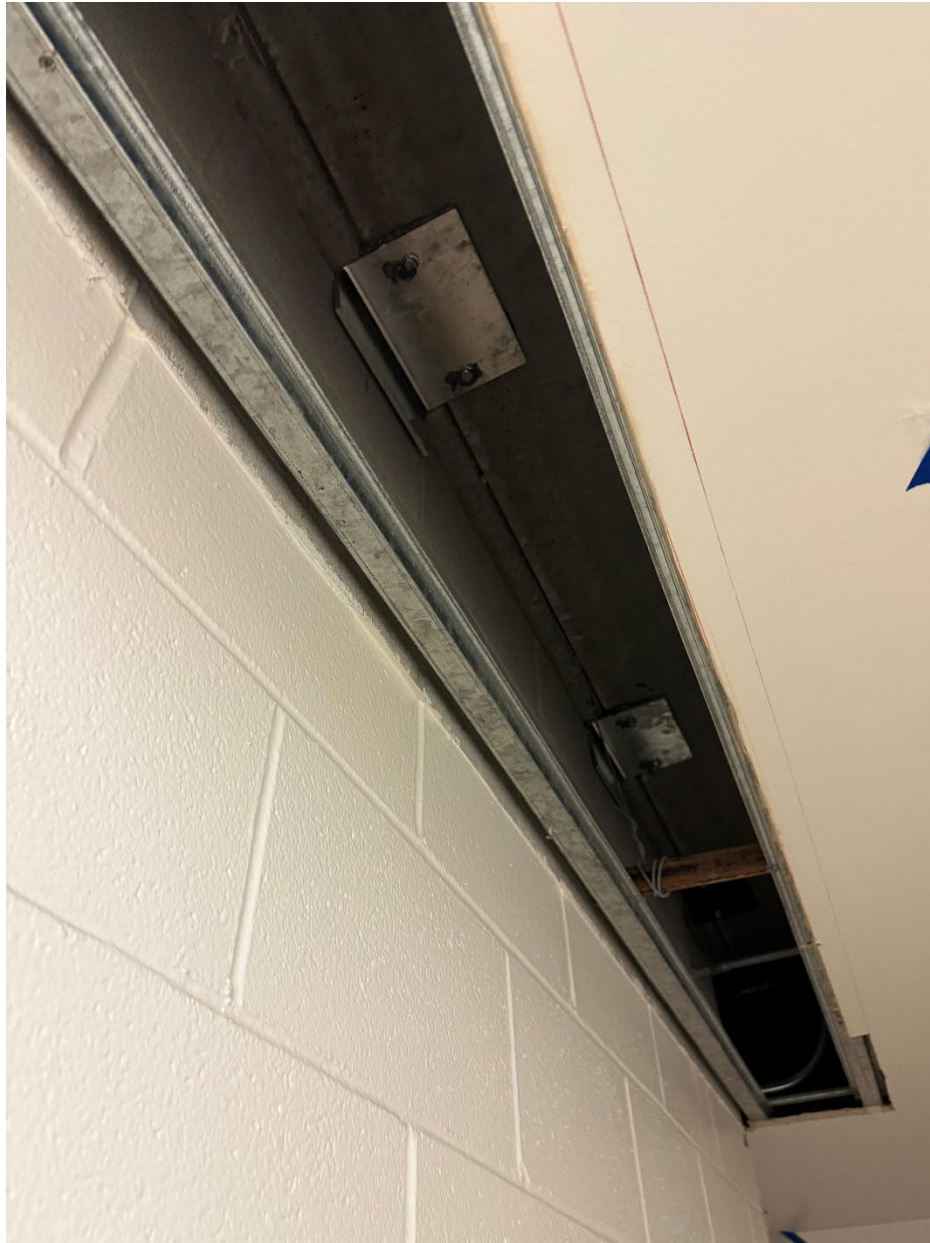
**AB6901 | EXHIBIT 2 | BRACING AT INTERIOR CONCRETE MASONRY UNIT WALL**
