# City Hall Facility Review

City Council Study Session  
April 7, 2026

# Executive Findings

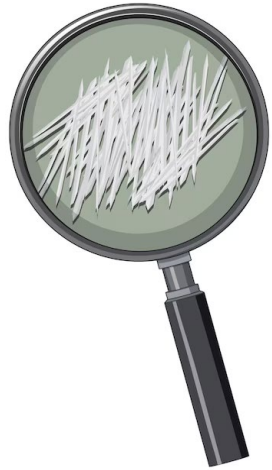
**Non-Airborne Asbestos**  
identified throughout  
the building

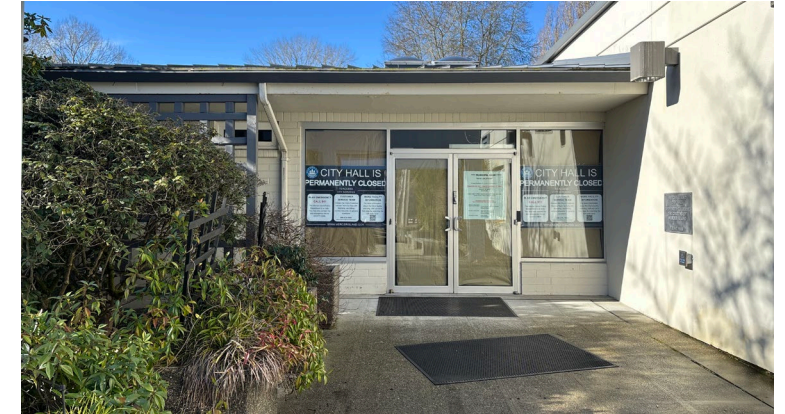
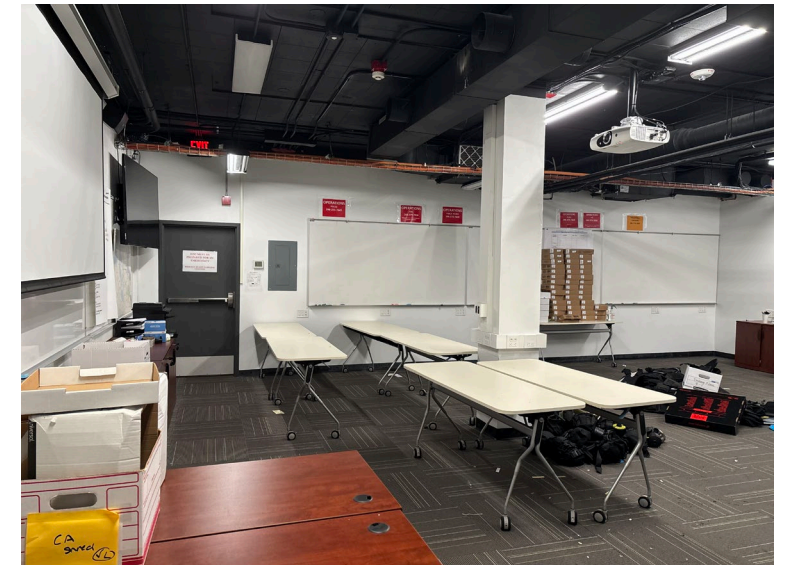
- **No automatic sprinkler system**
- **No accessible egress pathway** at the Basement Level of the building
- **Fire separations** between occupancies unable to be verified and most-likely not compliant with current building code standards
- **Lack of signage** for wayfinding and emergency egress
- **Non-Airborne Asbestos** identified in several building elements listed below. If these elements were to break or become disturbed that would present additional challenges to occupancy:
  - Misc. vinyl flooring tile
  - Misc. mastic and residual black mastic
  - Fire-rated wood doors
  - Concealed pipe insulation
  - Window putty
  - Ductwork insulation and lining

- New automatic sprinkler system
- Abatement/removal of non-airborne asbestos materials
- Complete space reconfiguration for Police & EOC occupancy

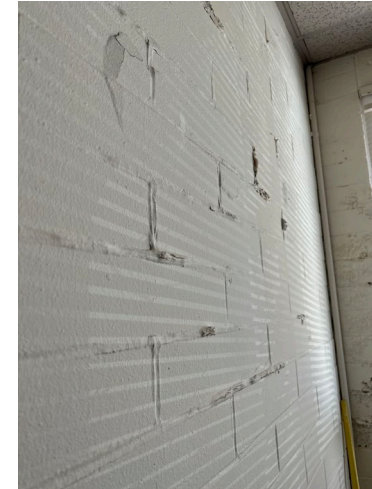
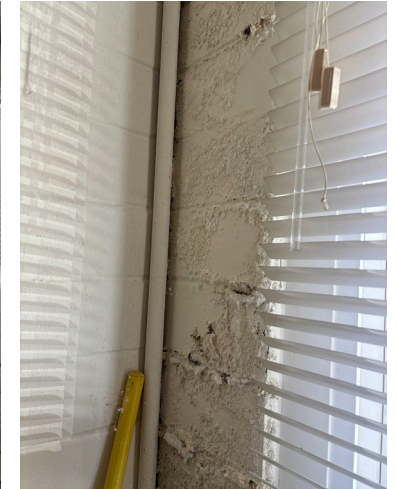
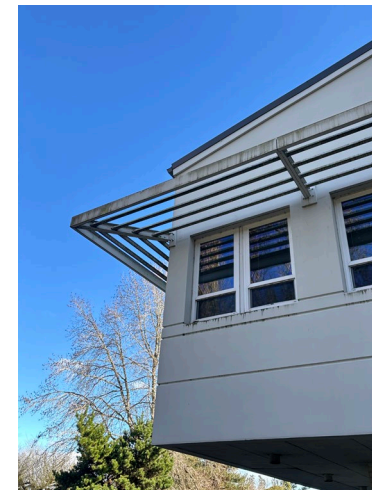
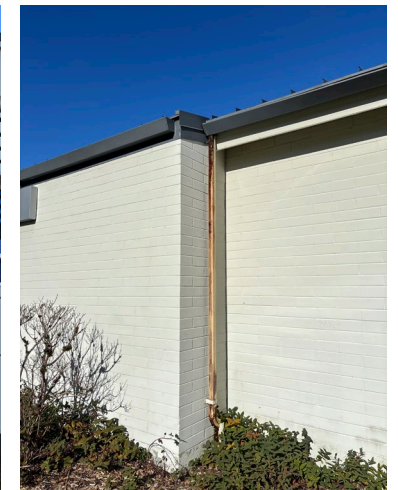
- **Moisture intrusion** at numerous existing CMU (concrete masonry unit) block walls and interior gypsum wallboard (typical interior) walls leading to **breakdown of wall construction**
- **Mildew, mold, and rust** along the exterior building facades
- Discoloration from **water damage** at ceilings throughout the building
- Flashing/weatherproofing of the window and door openings, wall joints, and roof edges **does not meet current standards** and is providing additional areas for water intrusion and leakage
- Overall, **under-insulated exterior wall and roof assemblies** which do not comply with current energy code standards

- Full exterior enclosure replacement:
  - Waterproofing measures at basement walls
  - Wall framing improvements with rigid insulation; new windows, exterior doors, and flashing
  - New standing seam metal roofing with insulation

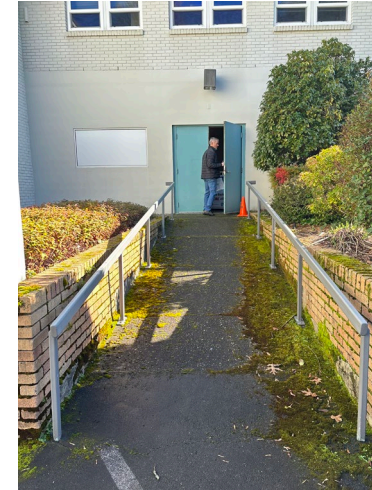
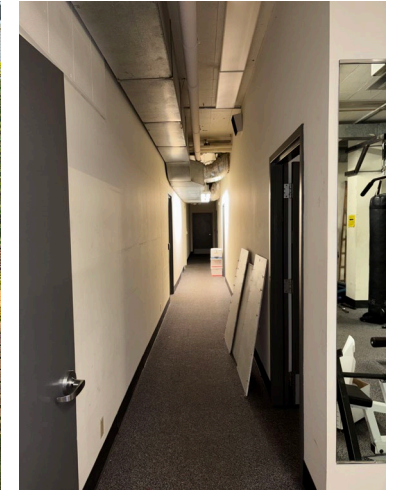
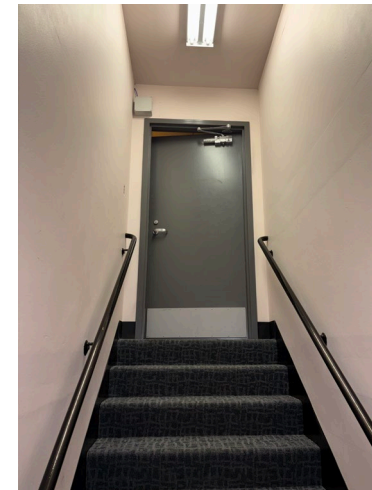
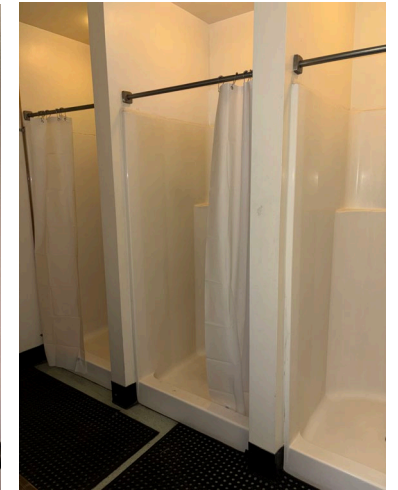
- Stairway treads and ramp slopes, landings, guardrails and handrails **do not comply** with current building code and accessibility standards
- **No accessible egress path** via elevator or wheelchair path to lower level
- **No ADA accessible toilets, showers, or lockers** which comply with current accessibility standards

- Addition of an elevator and replacement of existing stairs and ramp
- Addition of ADA compliant restrooms and fixtures

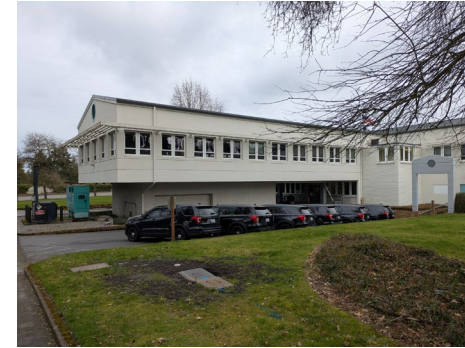
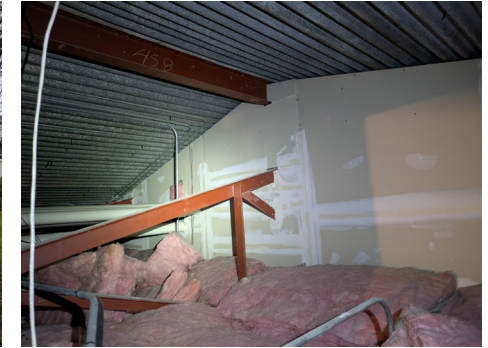
- Existing masonry shear walls are likely **not grouted or reinforced**
  - These shear walls do not provide enough capacity to meet the demands during a seismic event either for in-plane or out-of-plane forces
- Truss seats likely **do not provide adequate out-of-plane wall anchorage** for the top of masonry walls
- Unknown extent of fastening of the metal roof deck to the steel trusses and to adjacent sections of deck - these **connections may be overstressed** when subjected to earthquake forces
- Unlikely that roof construction can withstand diaphragm chord forces
- The type of connection(s) between the roof diaphragm and masonry shear walls make an **incomplete lateral load path**

- Micropile deep foundations
- Supplemental footings for seismic upgrade
- Shotcrete of existing masonry shear walls with new reinforcement to increase the flexural and shear strength
- Reinforce joist seat connections to strengthen out-of-plane connection of existing masonry walls
- Adding new diaphragm fastening or replacing the metal roof deck to provide adequate diaphragm capacity
- New steel angles or channels welded between the trusses to act as diaphragm chord members
- Additional steel channels, wide flange shapes, etc. to act as collector elements

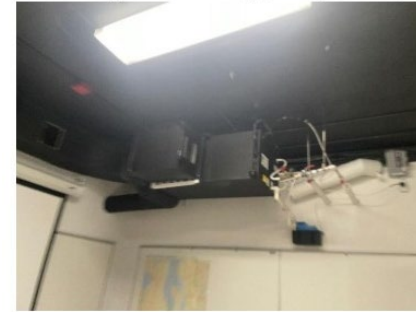
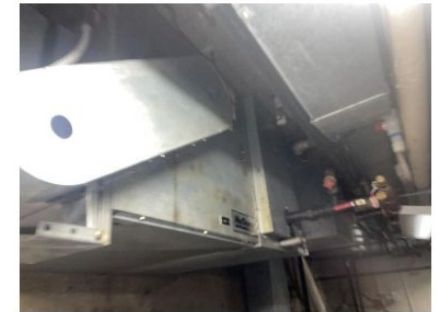
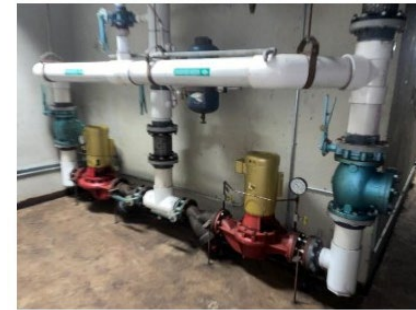
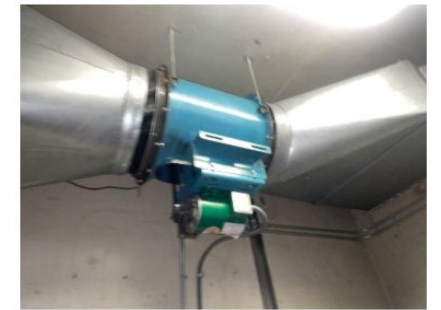
- The two primary air handlers appear to be original and are well past their useful service life
- The existing heat pump units are all at or nearing the end of their anticipated useful service life though they look to have likely been replaced or installed around the 2000's, rather than being original
- The boiler and cooling tower were likely installed or replaced at the same time as the heat pumps; nearing the end of their useful service life
- The pumps for the condenser loop are original to the loop

- Remove and install new mechanical systems that meet current energy code
- Remove and install new supporting infrastructure (piping and ductwork)
- Install direct digital control system for system control and monitoring

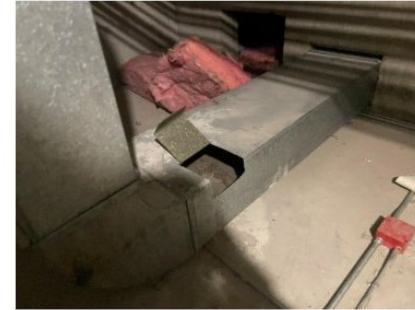
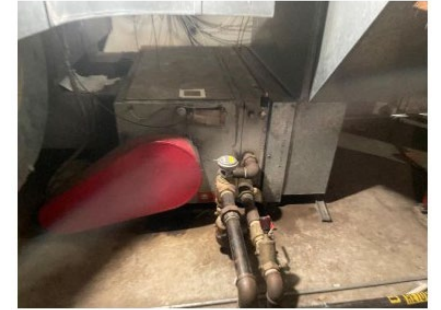
- Ductwork was found to **include asbestos** lining/insulation

- The hydronic piping serving all the heat pumps was installed in PVC. **PVC is not appropriate** for this type of installation and is showing signs of sagging/warping

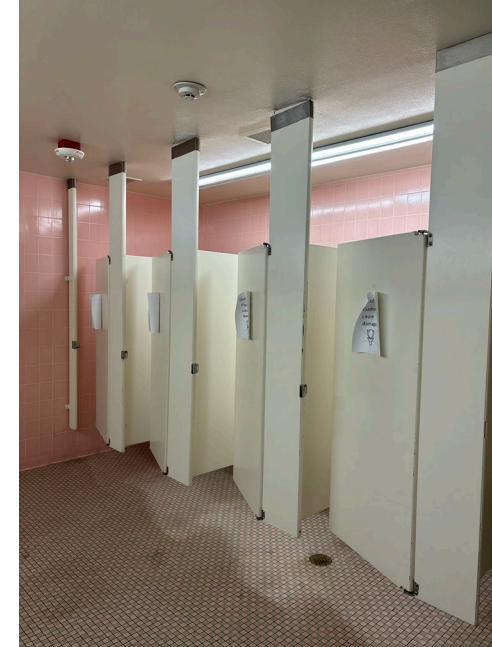
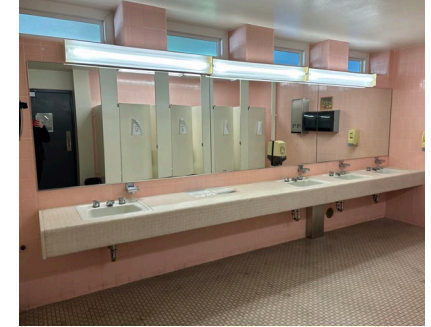
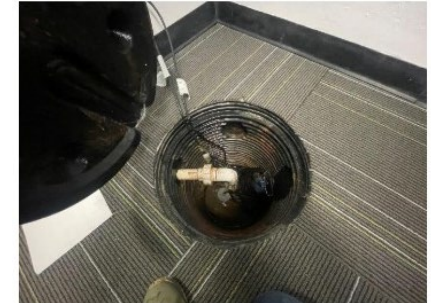
- **Inadequate number of plumbing fixtures** for occupancy of building
- There are **no accessible water closets/toilets, lavatories, showers, or lockers** which meet current ADA accessibility standards

- Replacement of the electric water heaters with heat pump technology
- Provide ADA accessible restrooms
- Provide additional plumbing fixtures to adequately serve occupancy of the building
- Install modern low-flow plumbing fixtures
- Replace ground water sump pump within basement level
- Wholesale re-piping of the domestic water system for programmatic changes

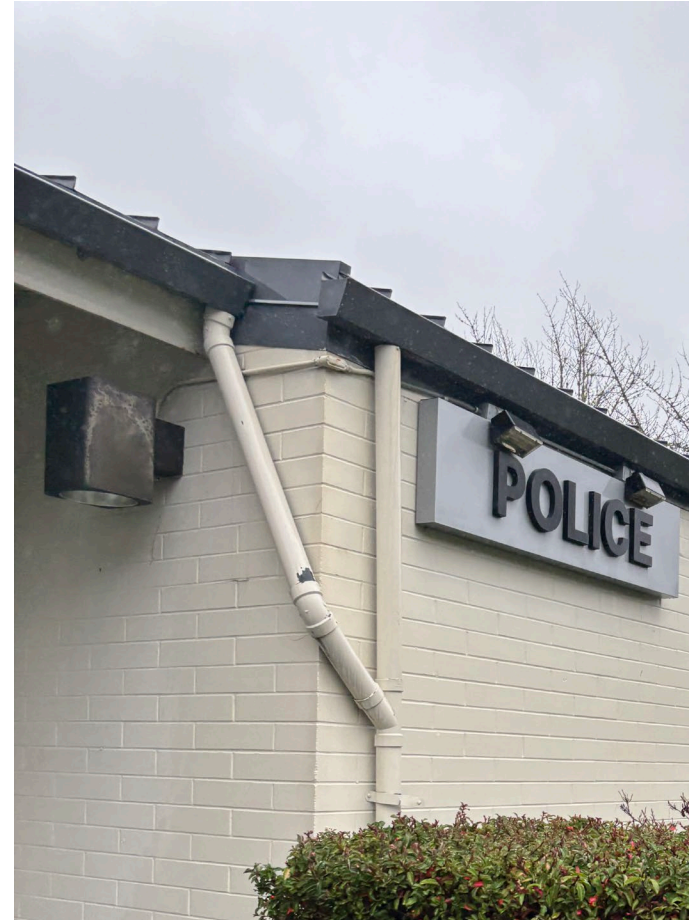
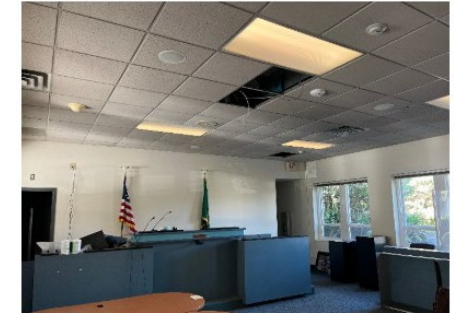
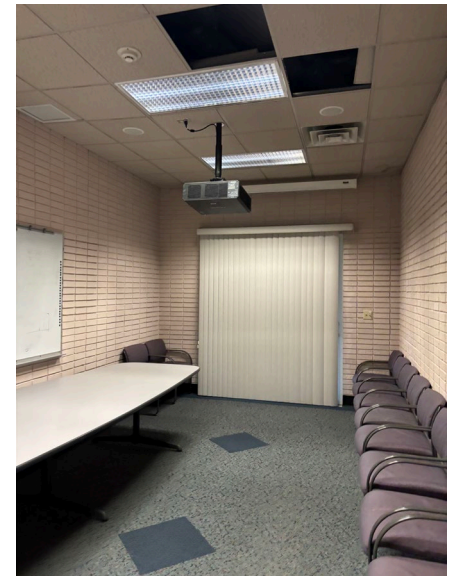
- **Non-compliance** with current Washington State Energy Code
- Aging ballasts and **lamp failures**
- Reduced lighting quality
- **High energy consumption** lighting fixtures
- Lack of occupancy and daylight controls
