City Hall Facility Review

April 7, 2026 City Council Meeting

AB 6891

A breakdown of the City Hall Building Assessment

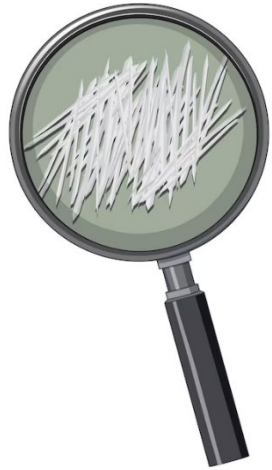
Non-Airborne Asbestos
identified throughout
the building

Removal of Non-Airborne Asbestos

Preparation + Abatement of non-airborne asbestos throughout building:

- Demolition of all mechanical systems
- Demolition of all ceiling and flooring
- Demolition of doors and windows
- Demolition of select wall, floor, and roof construction

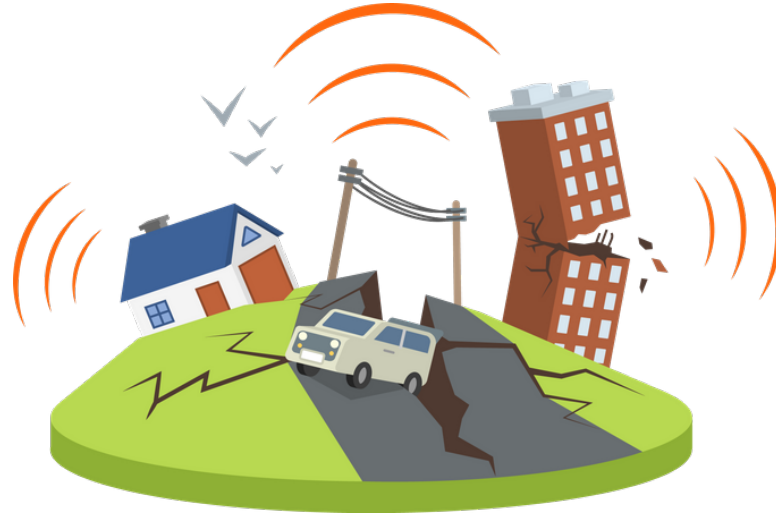
Seismic deficiency of the existing building
structure + inability to meet Seismic
Category IV requirements for essential
facilities

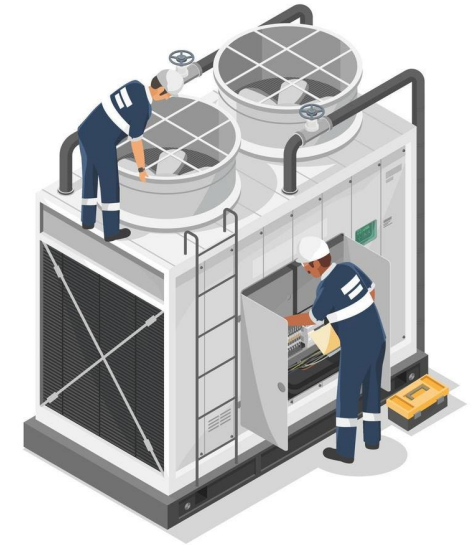
Mechanical & electrical systems
are at **end-of-service-life**

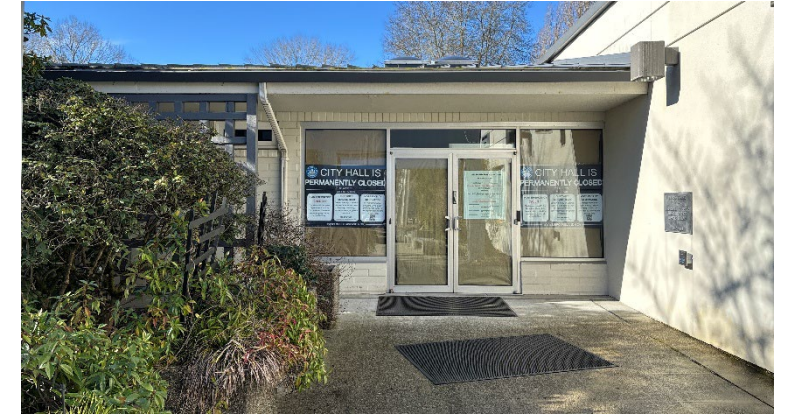
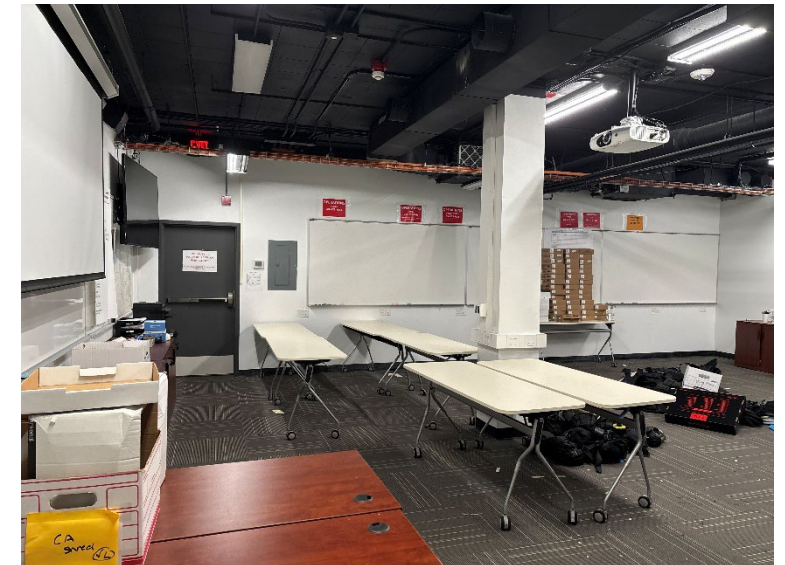
Building life safety & egress not up to current building code standards:

- **No automatic sprinkler system**
- **No accessible egress pathway** at the Basement Level of the building
- **Fire separations** between occupancies unable to be verified and most-likely not compliant with current building code standards
- **Lack of signage** for wayfinding and emergency egress
- **Non-Airborne Asbestos** identified in several building elements listed below. If these elements were to break or become disturbed that would present additional challenges to occupancy:
 - Misc. vinyl flooring tile
 - Misc. mastic and residual black mastic
 - Fire-rated wood doors
 - Concealed pipe insulation
 - Window putty
 - Ductwork insulation and lining

Building life safety & egress updates:

- New automatic sprinkler system
- Abatement/removal of non-airborne asbestos materials
- Complete space reconfiguration for Police & EOC occupancy

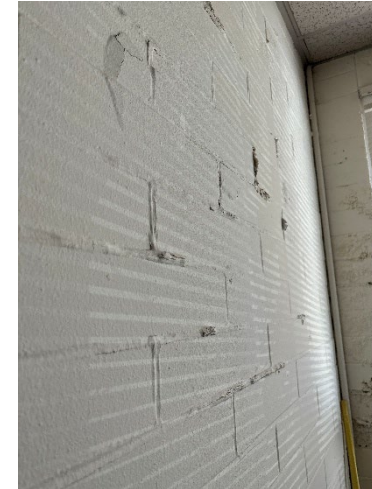
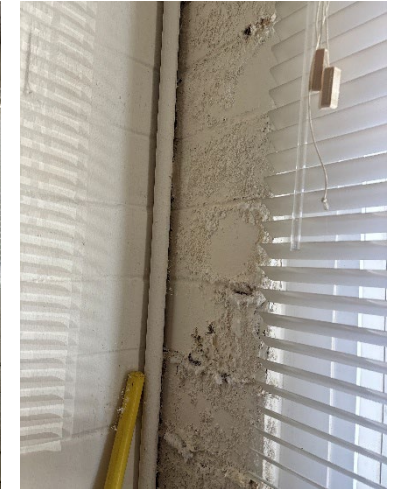
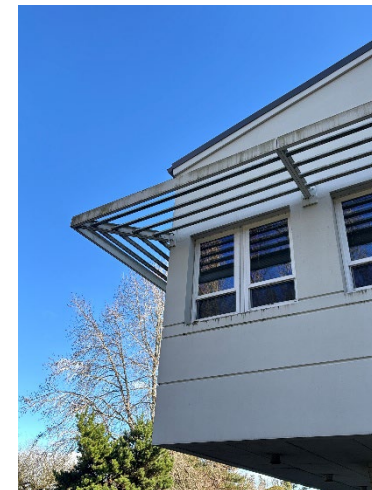
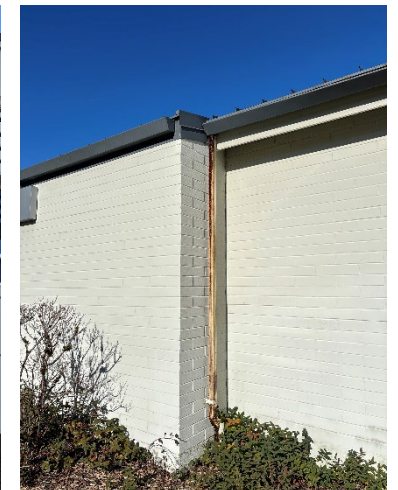
Building envelope deficiencies and non-compliance with current energy code:

- **Moisture intrusion** at numerous existing CMU (concrete masonry unit) block walls and interior gypsum wallboard (typical interior) walls leading to **breakdown of wall construction**
- **Mildew, mold, and rust** along the exterior building facades
- Discoloration from **water damage** at ceilings throughout the building
- Flashing/weatherproofing of the window and door openings, wall joints, and roof edges **does not meet current standards** and is providing additional areas for water intrusion and leakage
- Overall, **under-insulated exterior wall and roof assemblies** which do not comply with current energy code standards

Building envelope updates:

- Full exterior enclosure replacement:
 - Waterproofing measures at basement walls
 - Wall framing improvements with rigid insulation; new windows, exterior doors, and flashing
 - New standing seam metal roofing with insulation

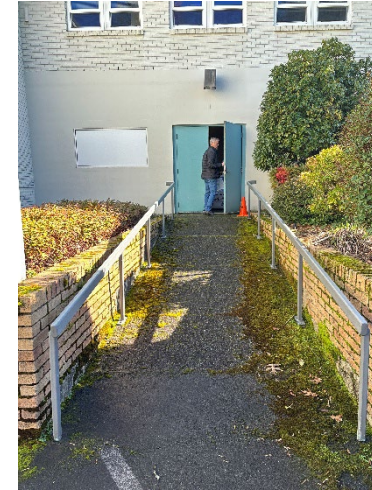
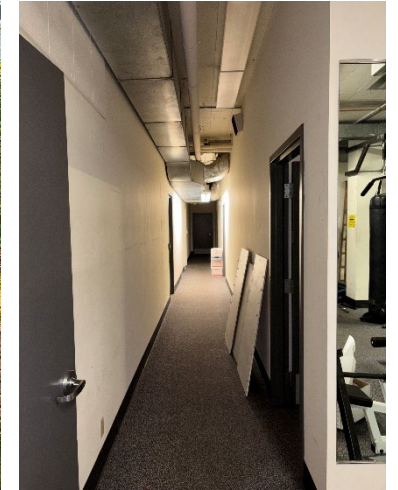
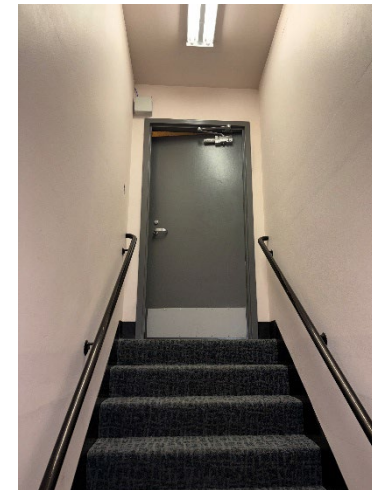
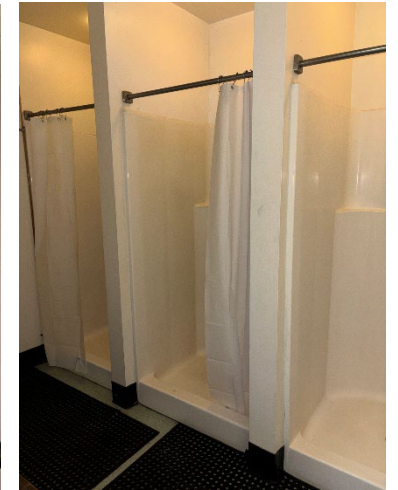
Accessibility restrictions:

- Stairway treads and ramp slopes, landings, guardrails and handrails **do not comply** with current building code and accessibility standards
- **No accessible egress path** via elevator or wheelchair path to lower level
- **No ADA accessible toilets, showers, or lockers** which comply with current accessibility standards

Accessibility updates:

- Addition of an elevator and replacement of existing stairs and ramp
- Addition of ADA compliant restrooms and fixtures

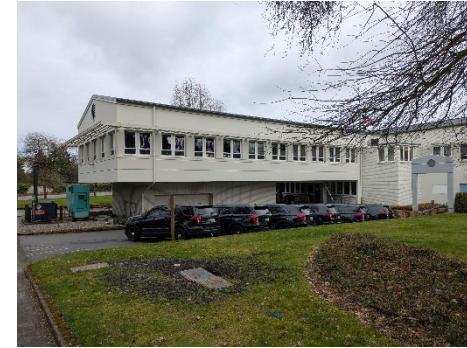
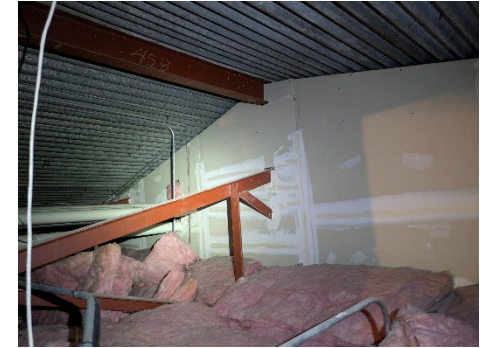
Seismic Deficiencies – structural components :

- Existing masonry shear walls are likely **not grouted or reinforced**
 - These shear walls do not provide enough capacity to meet the demands during a seismic event either for in-plane or out-of-plane forces
- Truss seats likely **do not provide adequate out-of-plane wall anchorage** for the top of masonry walls
- Unknown extent of fastening of the metal roof deck to the steel trusses and to adjacent sections of deck - these **connections may be overstressed** when subjected to earthquake forces
- Unlikely that roof construction can withstand diaphragm chord forces
- The type of connection(s) between the roof diaphragm and masonry shear walls make an **incomplete lateral load path**

Seismic Remediation:

- Micropile deep foundations
- Supplemental footings for seismic upgrade
- Shotcrete of existing masonry shear walls with new reinforcement to increase the flexural and shear strength
- Reinforce joist seat connections to strengthen out-of-plane connection of existing masonry walls
- Adding new diaphragm fastening or replacing the metal roof deck to provide adequate diaphragm capacity
- New steel angles or channels welded between the trusses to act as diaphragm chord members
- Additional steel channels, wide flange shapes, etc. to act as collector elements

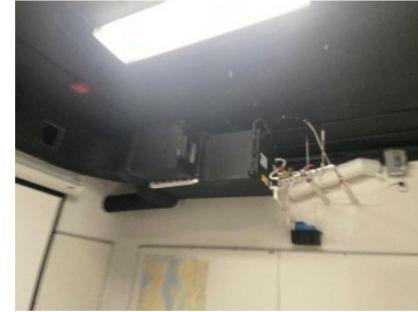
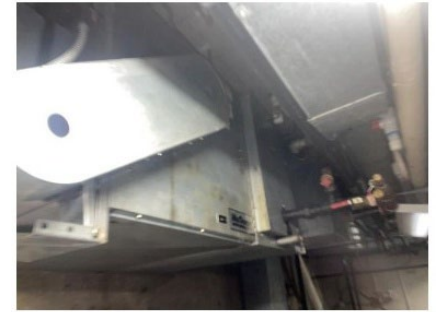
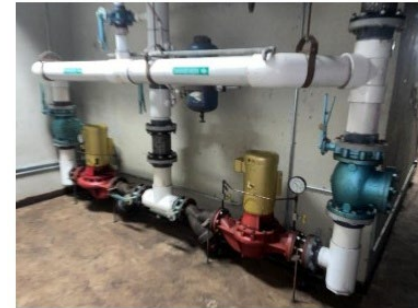
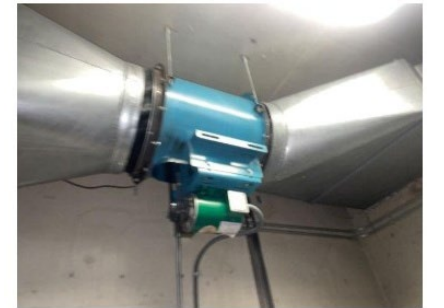
Generally, all the mechanical systems are at or nearing the end of their useful service life:

- The two primary air handlers appear to be original and are well past their useful service life
- The existing heat pump units are all at or nearing the end of their anticipated useful service life though they look to have likely been replaced or installed around the 2000's, rather than being original
- The boiler and cooling tower were likely installed or replaced at the same time as the heat pumps; nearing the end of their useful service life
- The pumps for the condenser loop are original to the loop

Due to the near or at end-of-life condition observed for the majority of the systems AND the poor condition of the supporting infrastructure (piping and ductwork), it would not be recommended that any of these systems be retained for reuse as part of a renovation

- Remove and install new mechanical systems that meet current energy code
- Remove and install new supporting infrastructure (piping and ductwork)
- Install direct digital control system for system control and monitoring

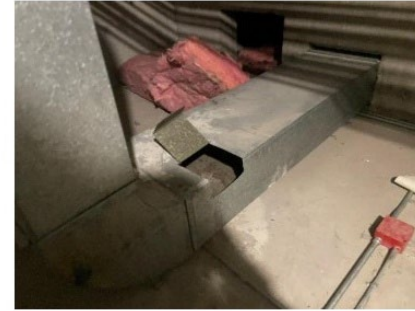
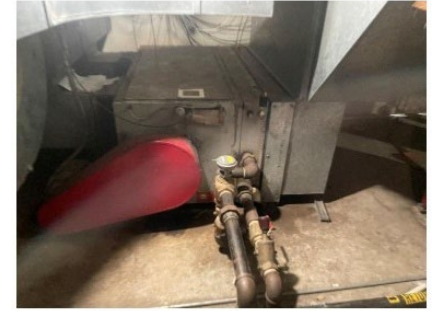
Non-airborne asbestos:

- Ductwork was found to **include asbestos** lining/insulation

Installation errors:

- The hydronic piping serving all the heat pumps was installed in PVC. **PVC is not appropriate** for this type of installation and is showing signs of sagging/warping

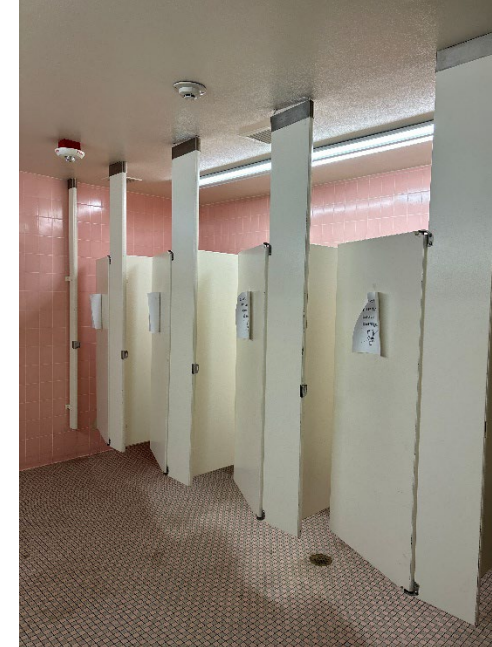
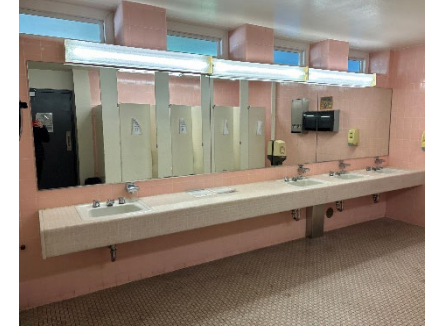
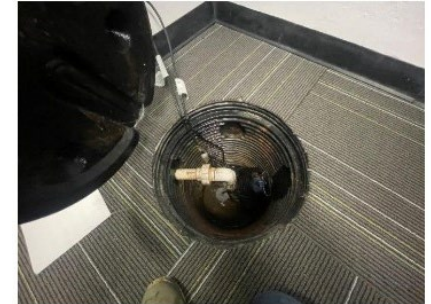
Generally, all the systems are at or nearing the end of their useful service life; additional concerns include:

- **Inadequate number of plumbing fixtures** for occupancy of building
- There are **no accessible water closets/toilets, lavatories, showers, or lockers** which meet current ADA accessibility standards

- Replacement of the electric water heaters with heat pump technology
- Provide ADA accessible restrooms
- Provide additional plumbing fixtures to adequately serve occupancy of the building
- Install modern low-flow plumbing fixtures
- Replace ground water sump pump within basement level
- Wholesale re-piping of the domestic water system for programmatic changes

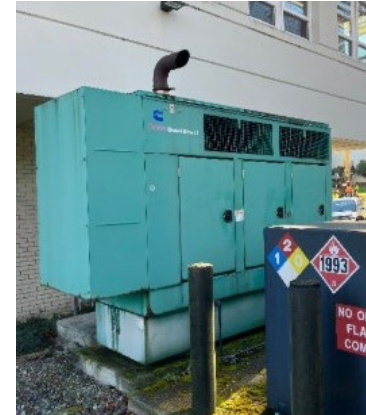
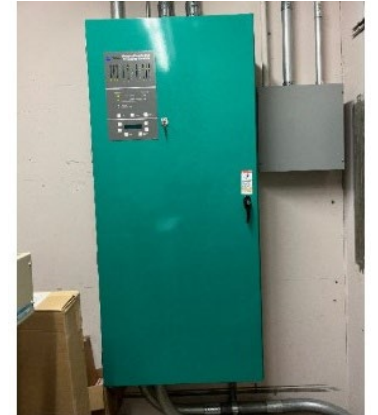
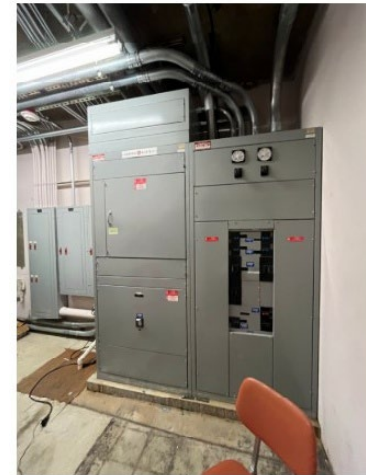
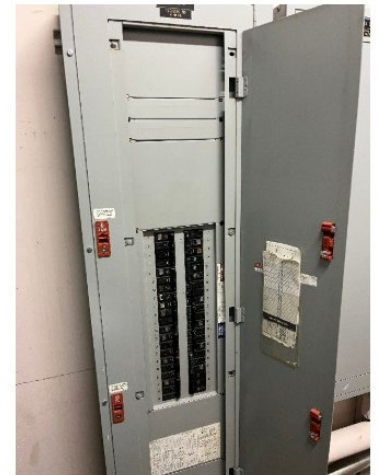
Generally, all the systems are at or nearing the end of their useful service life; major power system concerns include:

- Aging protective devices and bus components
- Limited availability of replacement parts
- Increased probability of failure due to age
- Absence of modern monitoring and metering capabilities
- Elevated arc flash risk relative to modern equipment
- Breaker failure under fault conditions
- Nuisance tripping
- Obsolete breaker models with limited availability
- Inaccurate or outdated panel schedules
- Limited spare capacity

The electrical infrastructure at the City Hall / Police Station facility is largely at or beyond its intended service life, particularly the primary power distribution systems dating from the 1988 renovation. Renovation work required:

- Full replacement of branch panelboards is recommended
- Feeder conductors should be evaluated and replaced where insulation condition or capacity limitations are identified
- Updated panel schedules and labeling should be provided as part of modernization
- Generator replacement should be planned within approximately five years, with evaluation of increased capacity for resiliency
- The ATS may remain in service if compatible with replacement equipment
- A comprehensive LED retrofit is recommended. The upgrade should include occupancy sensors, daylight controls where applicable, and improved lighting levels in operational police areas
- A security systems audit is recommended to evaluate modernization opportunities and integration with future infrastructure improvements

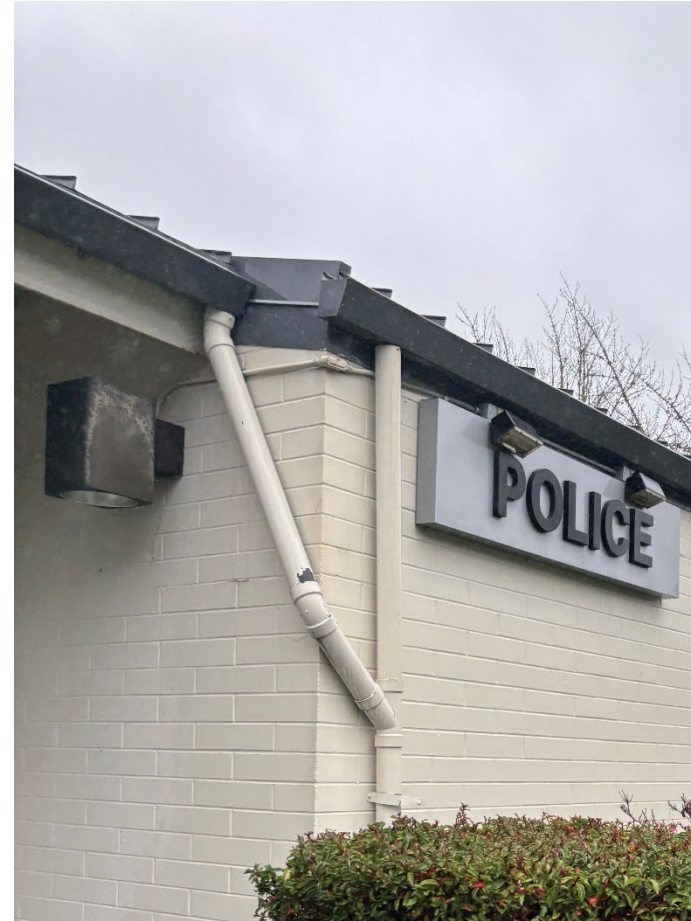
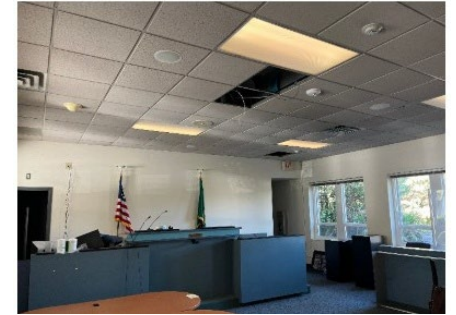
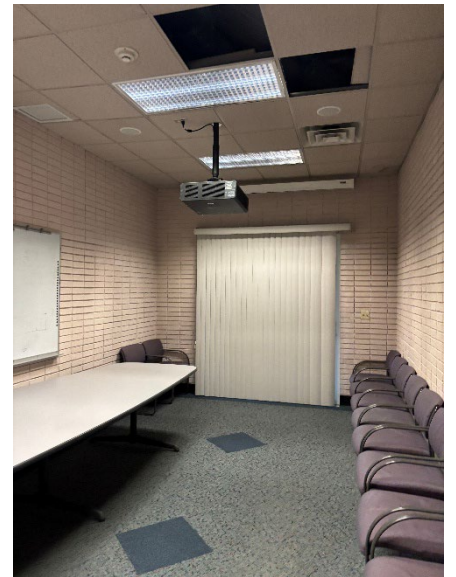
Lighting system deficiencies:

- **Non-compliance** with current Washington State Energy Code
- Aging ballasts and **lamp failures**
- Reduced lighting quality
- **High energy consumption** lighting fixtures
- Lack of occupancy and daylight controls
