# AB 6308 City Hall Closure Update

Mercer Island City Council | July 18, 2023

# Overview & Purpose

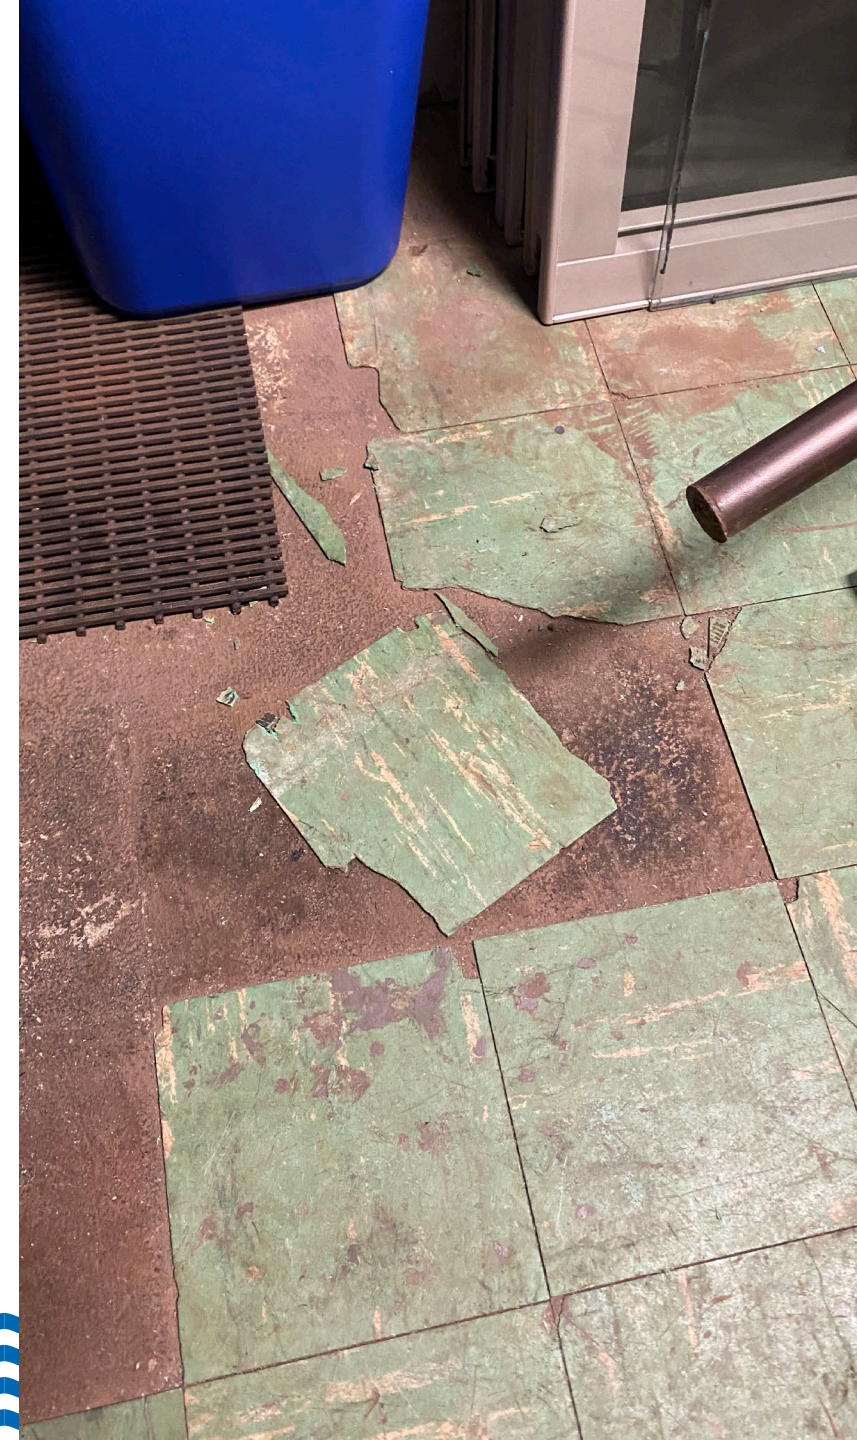
- Broken tiles and tile adhesive in the basement Mechanical Room of City Hall were identified as possibly containing asbestos.
- The tiles were discovered by a staff person while inspecting the Mechanical Room and may have been in that condition for some time.
- Same-day tests confirmed that both the tiles and adhesive contained asbestos.
- The Mechanical Room also contains an air handling unit for the City Hall HVAC system.
- City Hall was immediately closed to further investigate.

**Picture:** Broken tiles in Mechanical Room

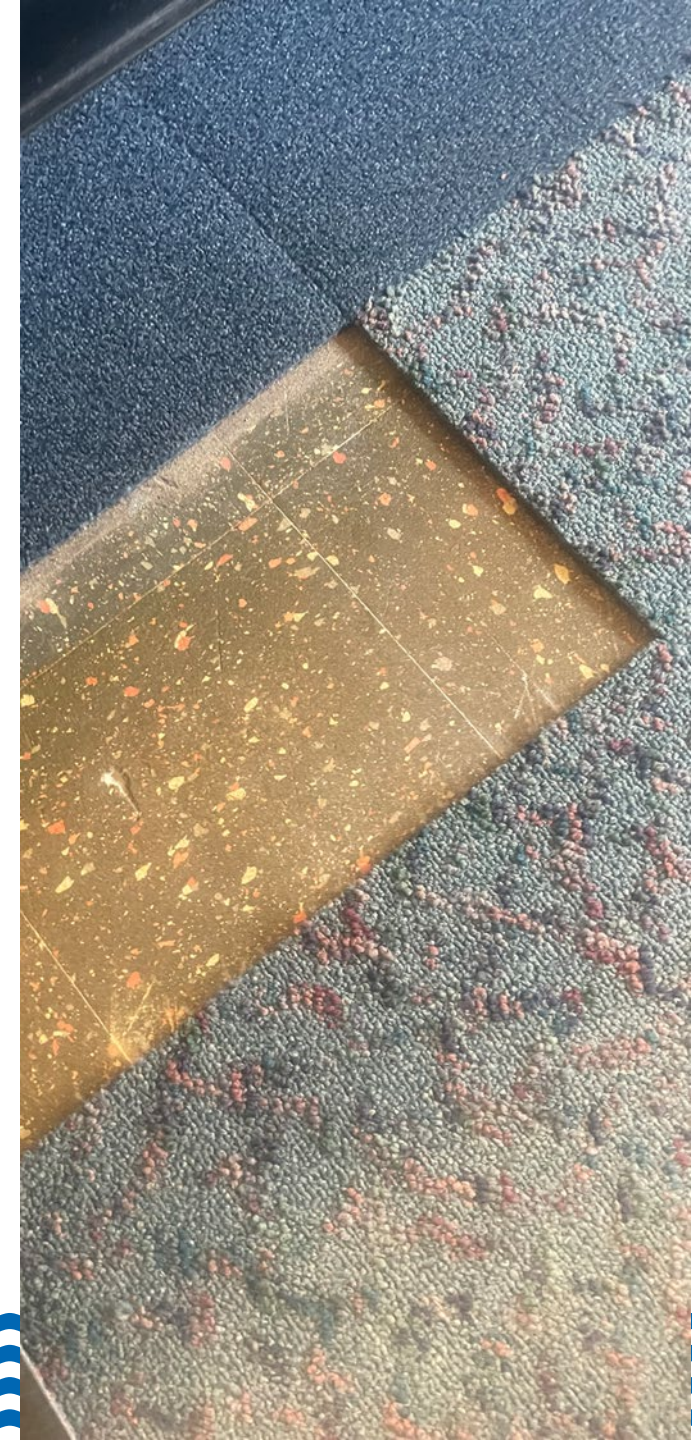
- The asbestos abatement contractor performed an initial building walk through.
- Additional floor tiles on the Main Floor of City Hall also tested positive for asbestos. These tiles are intact, undisturbed, and under carpet tiles, and do not present an immediate hazard. However, they will require abatement in the event of a renovation involving the floor plate in the areas where present.
- The contractor conducted initial air quality testing throughout the building; there were no positive tests for airborne asbestos.

**Picture:** Asbestos-containing tiles under carpet floor tiles on first floor of City Hall.

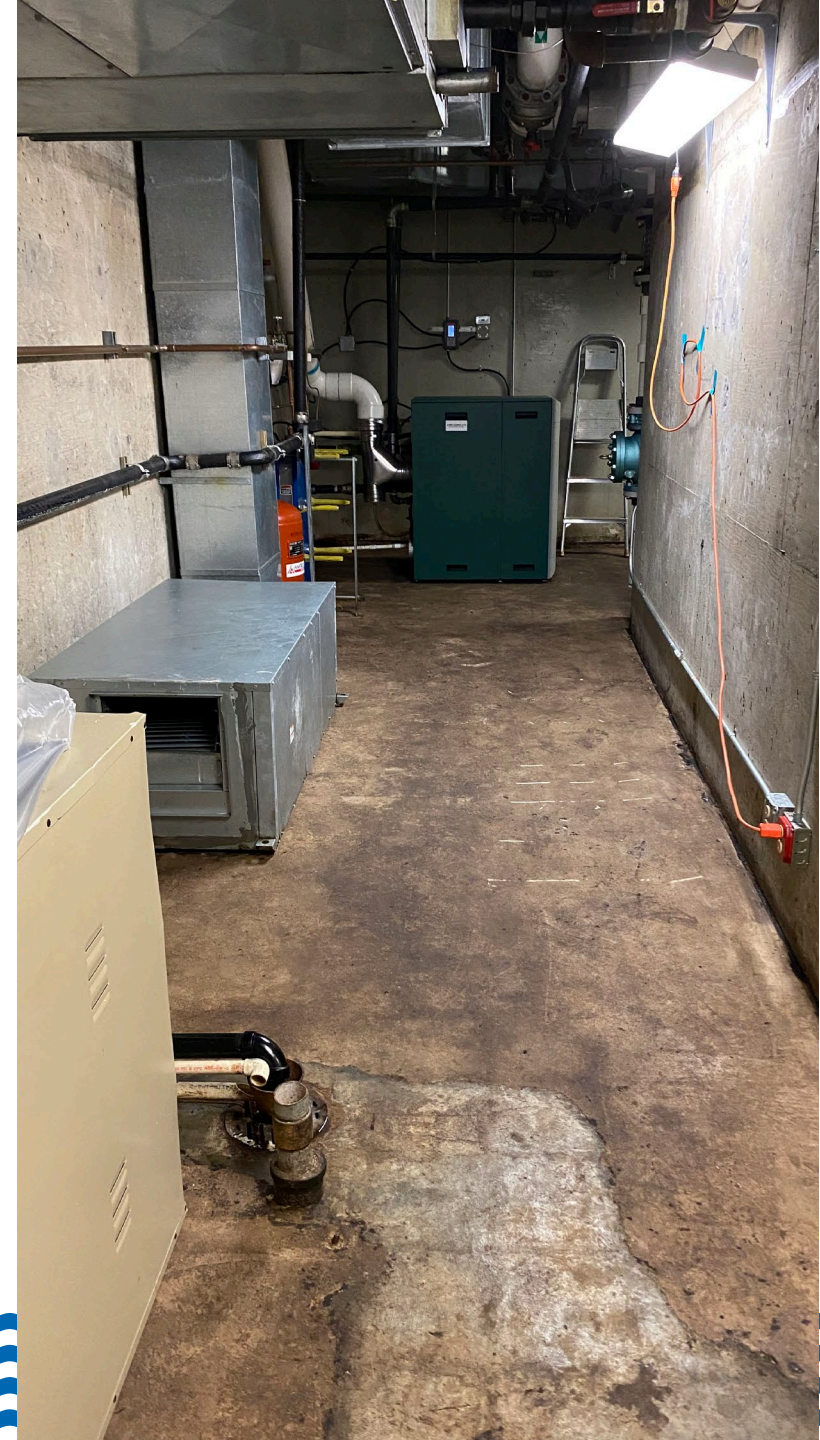
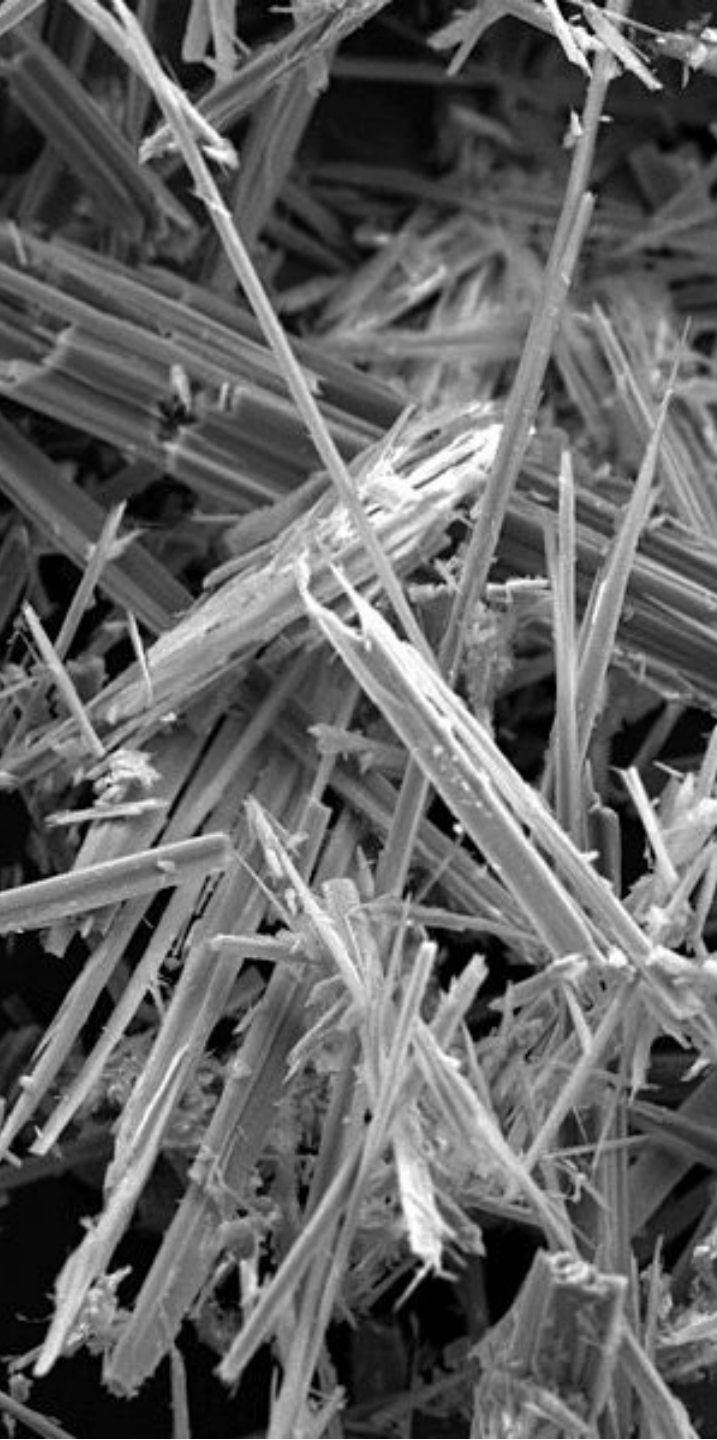
- Boiler room flooring materials abated (pictured)

**Picture:** Basement mechanical room post-abatement.

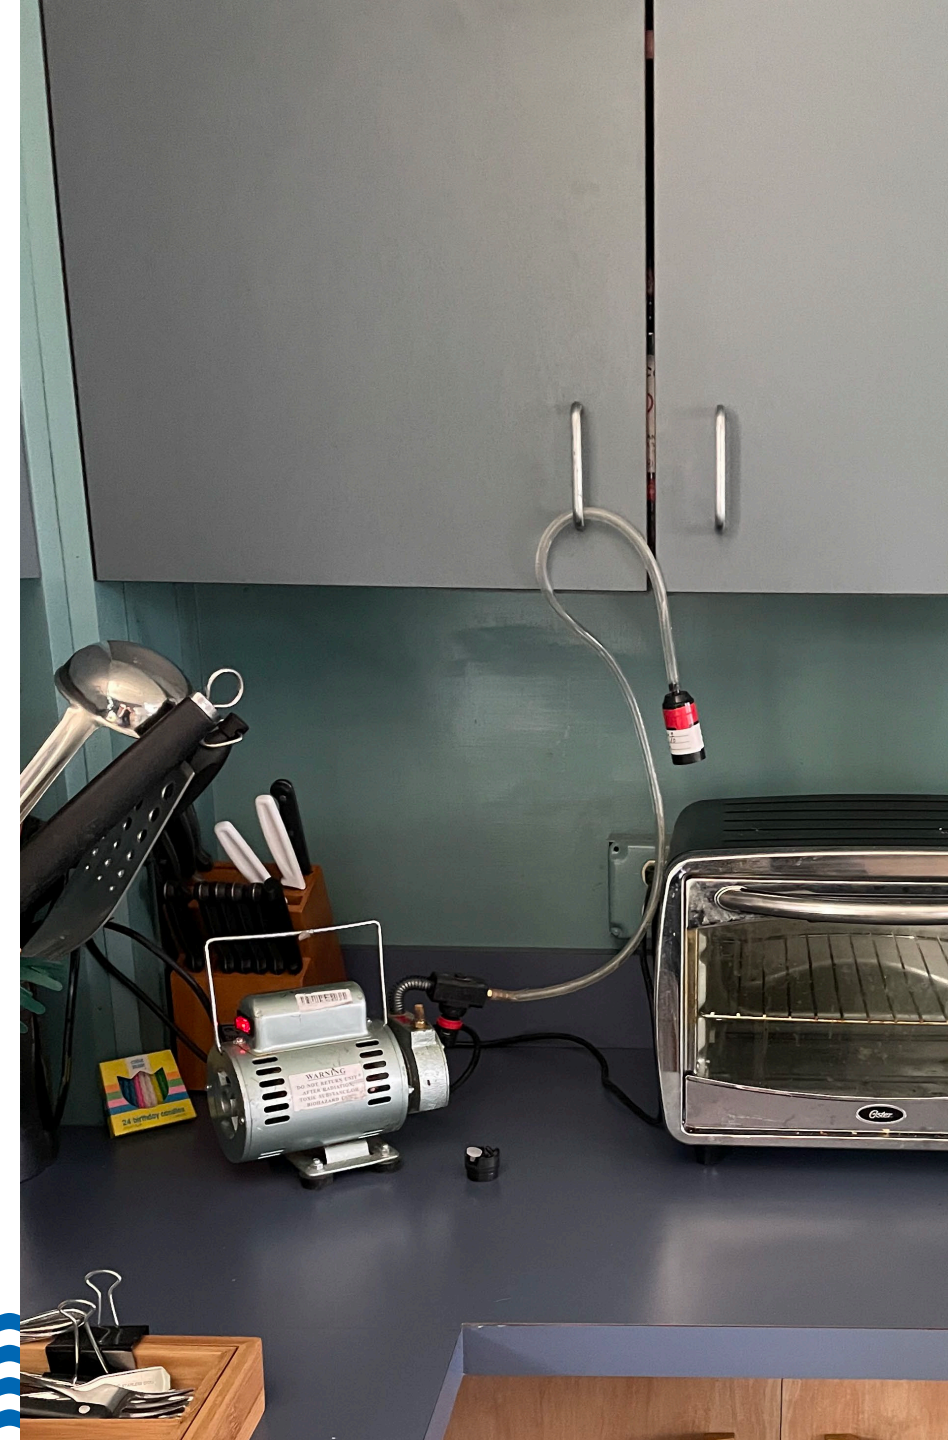
- No asbestos fibers were identified in any air testing samples.

**Picture:** Air sampling performed in City Hall kitchen.

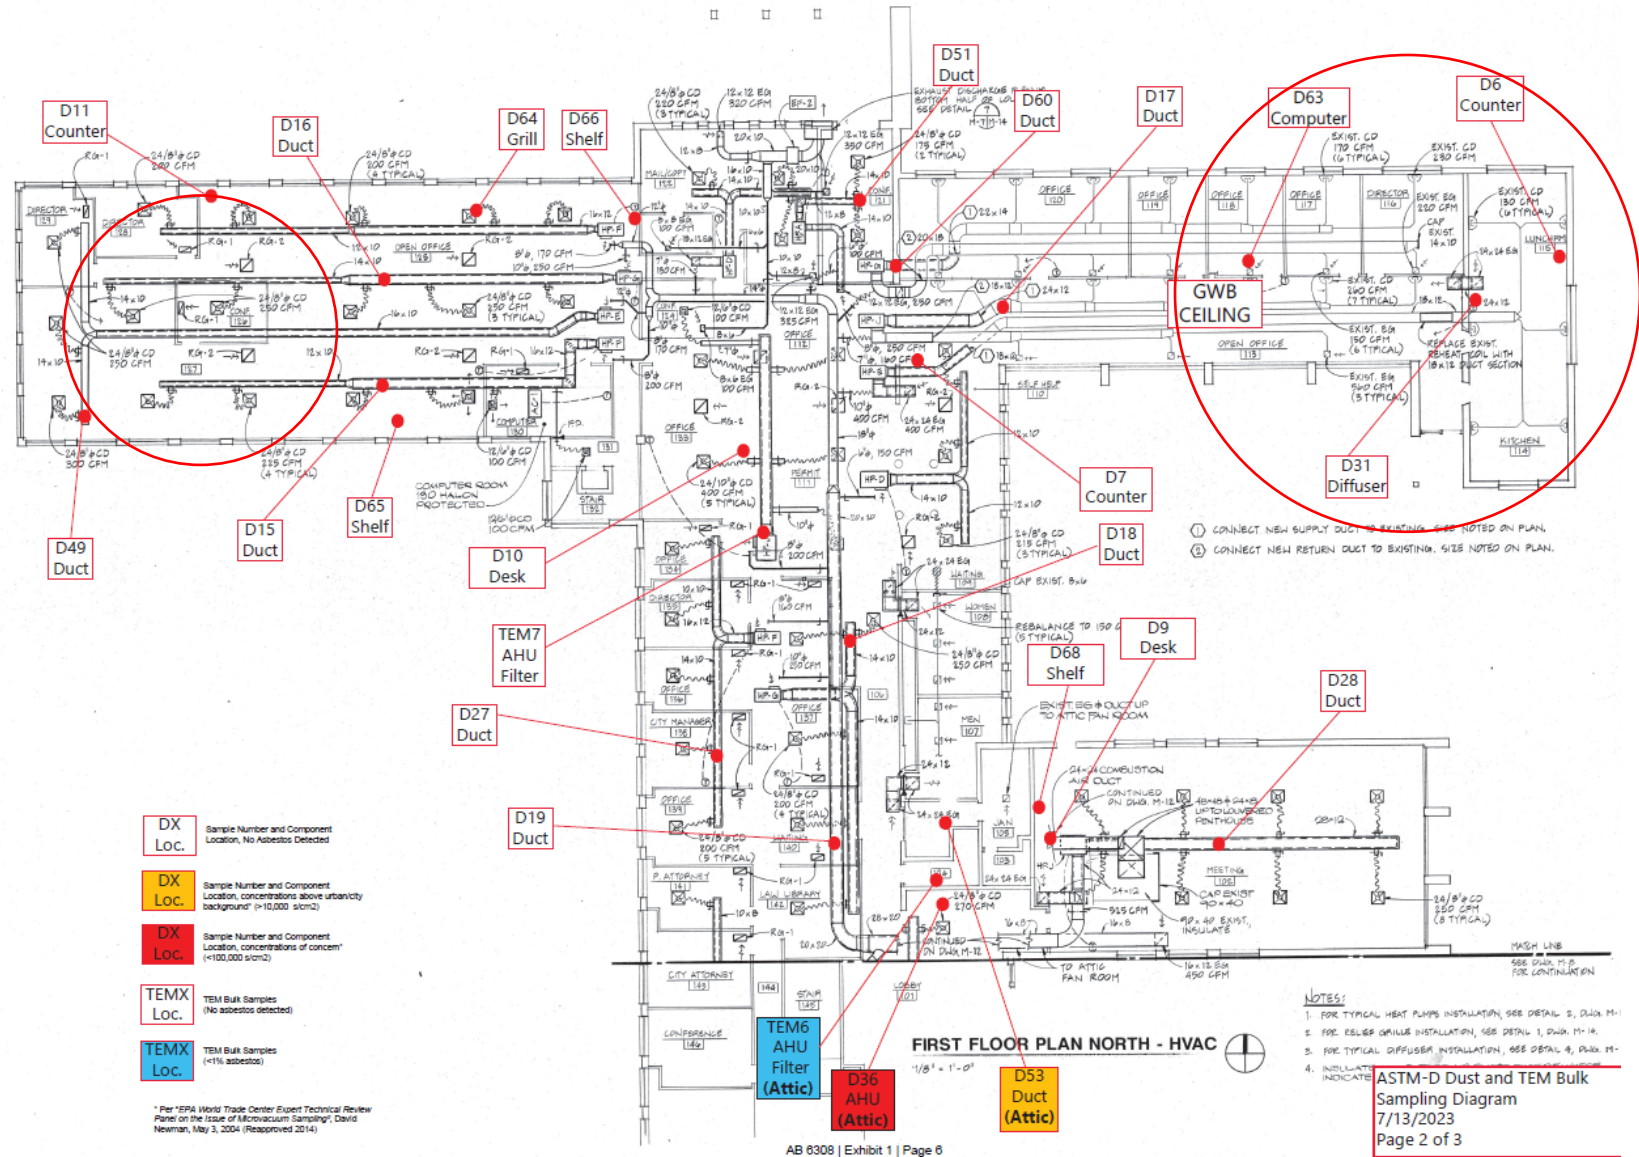
# Sampling Diagram: First Floor, North

- Area includes CPD, Finance, City Manager, and Municipal Court.
- Area around Municipal Court had several positive tests:
  - White: No asbestos detected
  - Orange: Dust >10,000 s/cm<sup>2</sup>
  - Red: Dust >100,000 s/cm<sup>2</sup>
  - Blue: Bulk sample with a positive detection
- Ceiling construction in northeast and northwest corners of building limited access for duct sampling.

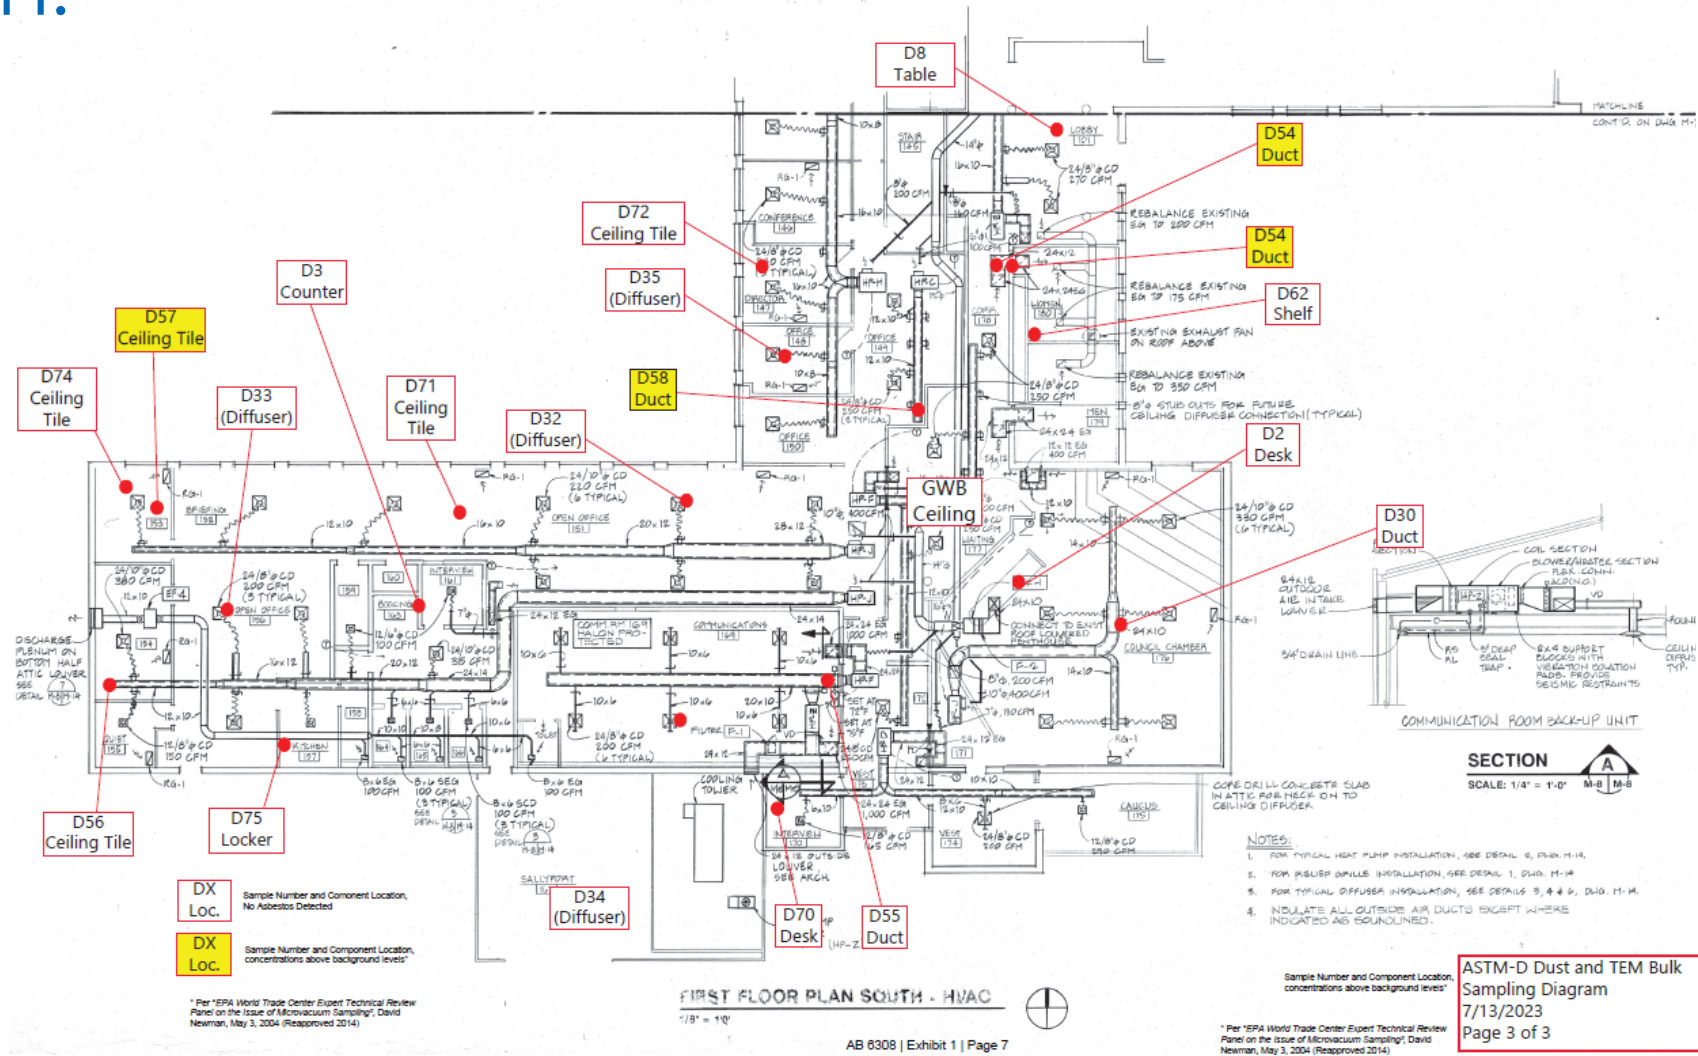
# Sampling Diagram: First Floor, South

- Area includes Police Department and Council Chambers
- Several positive dust samples:
  - White: No asbestos detected
  - Yellow: Dust <math>< 10,000 \text{ s/cm}^2</math>

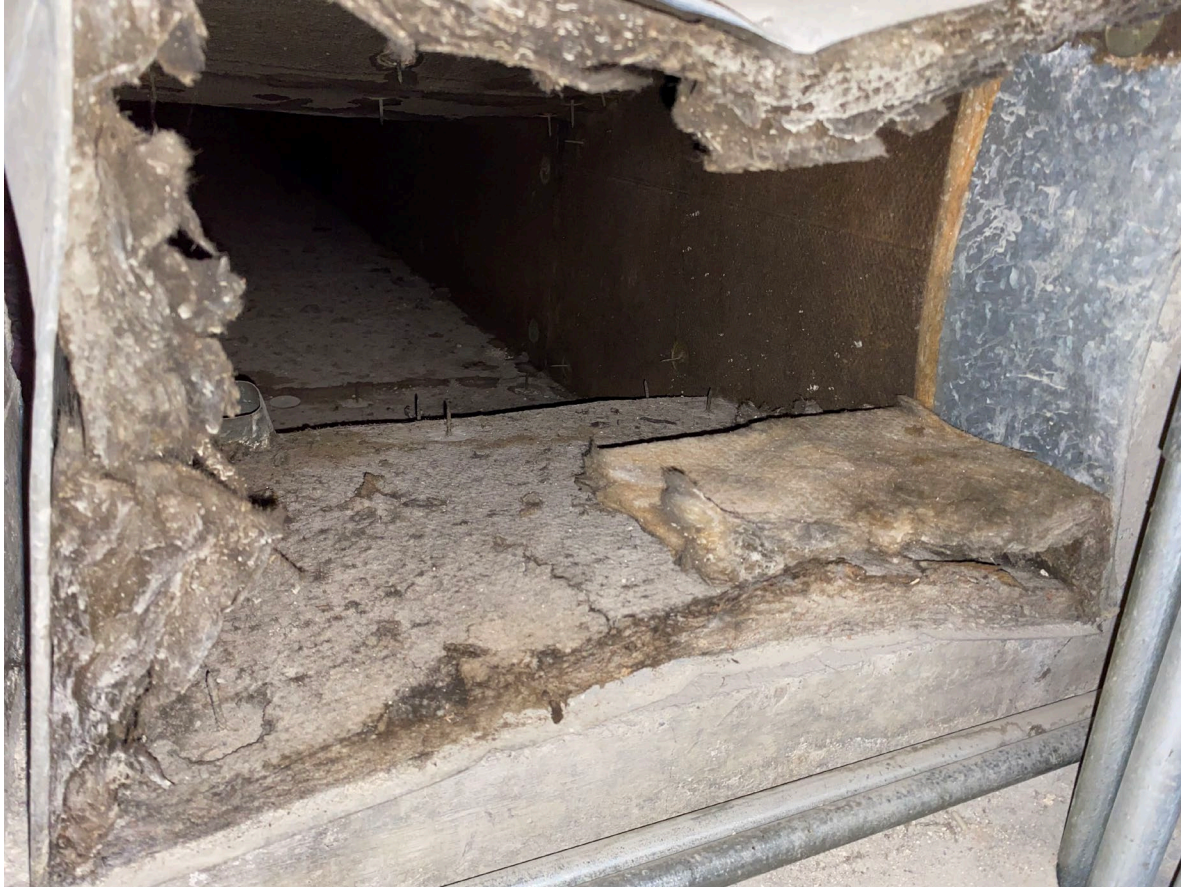
**Picture:** Example of lined duct in attic mechanical room.

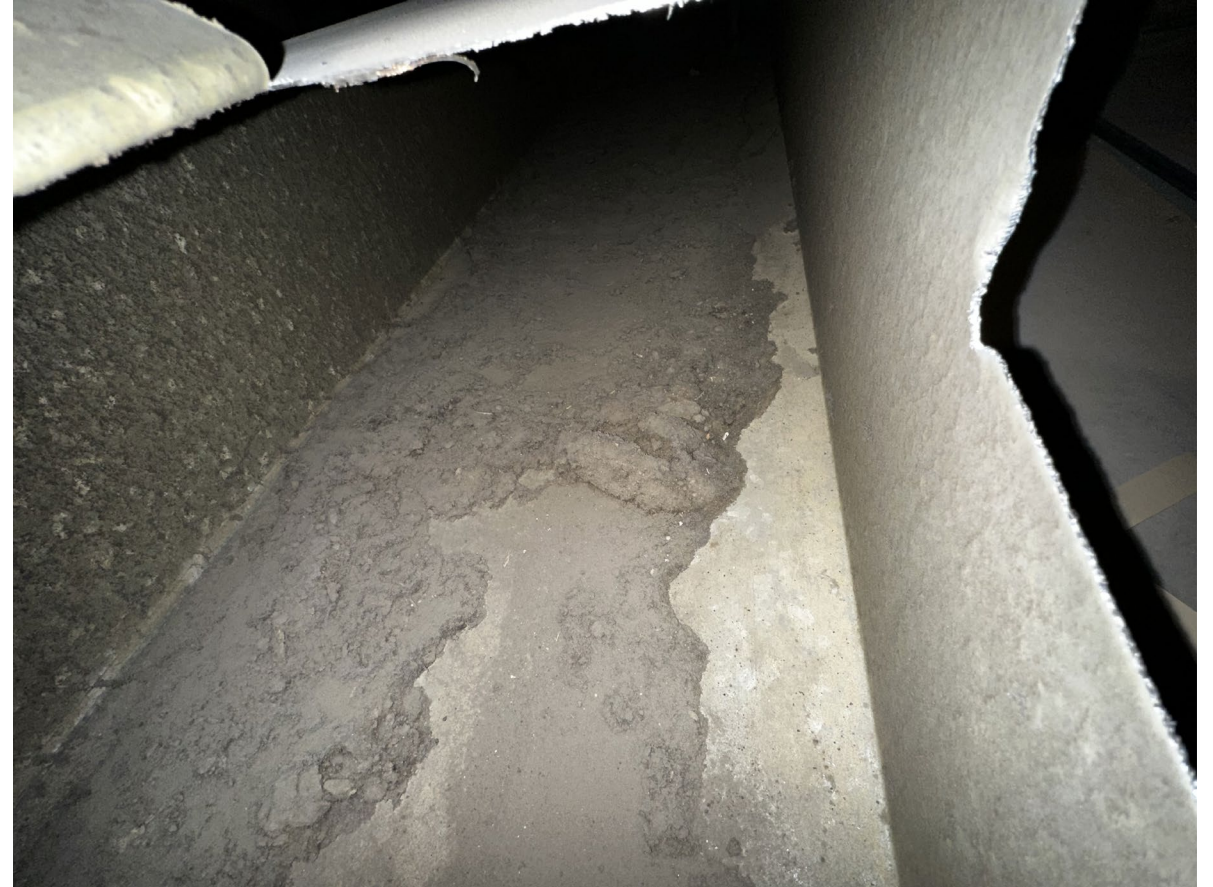
**Picture:** Dust build-up in an unlined duct in the attic mechanical room (sample D53).

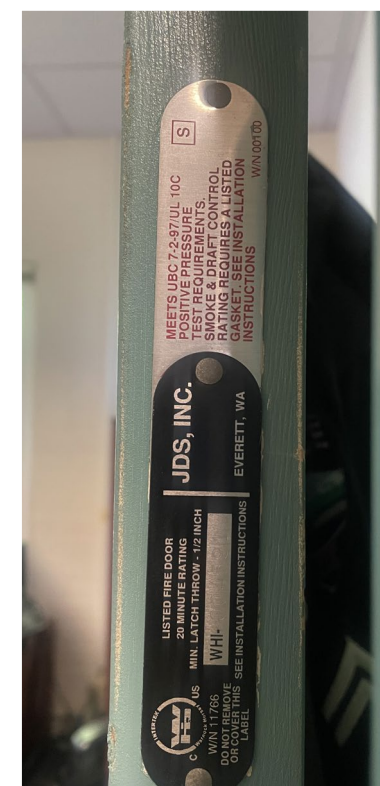
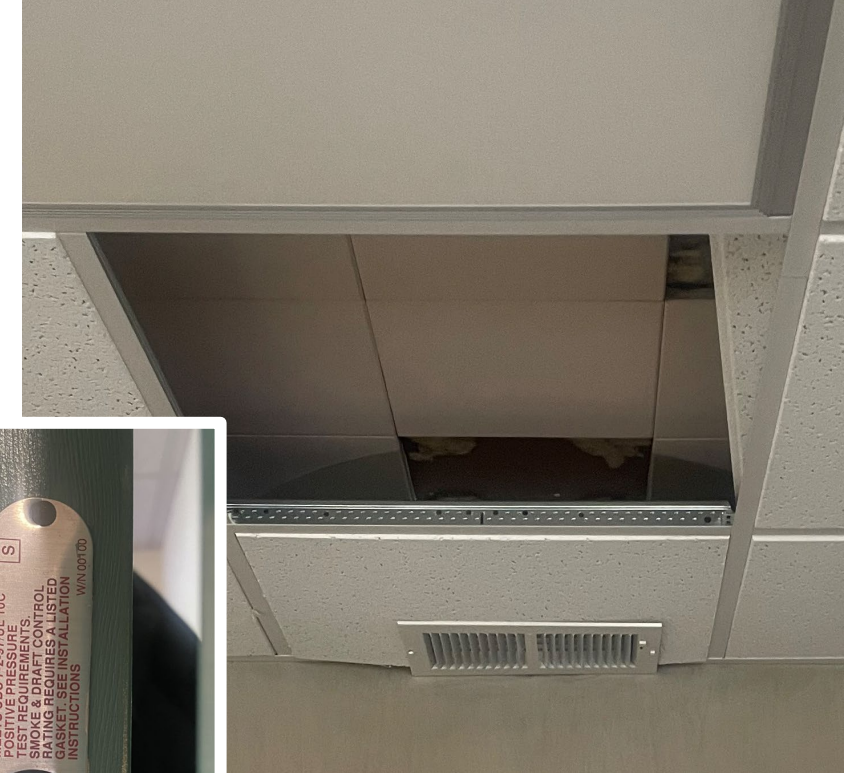
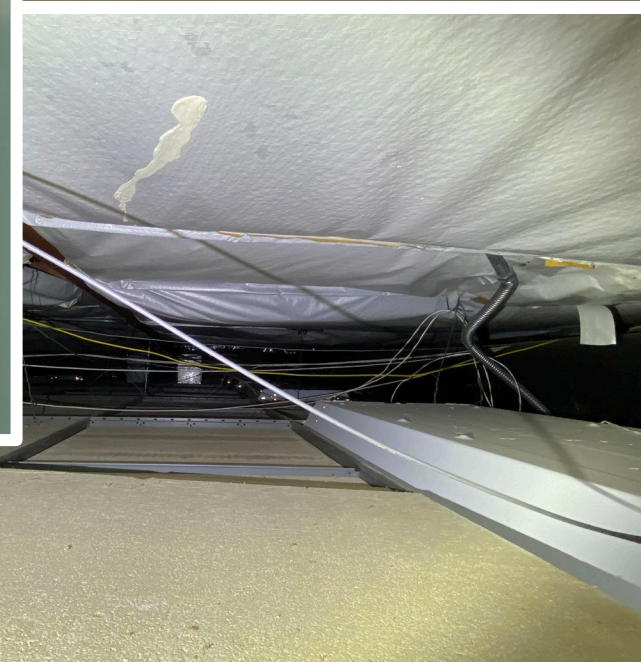
- A Good Faith Inspection surveys all potential asbestos-containing materials in a building.
- The investigation of City Hall was limited by access issues in the ceiling and attic (pictured).
- This work included 77 additional bulk samples.

- 13\* samples were positive, including:
  - Three types of flooring (additional 20,000 sq ft)
  - Flooring adhesive
  - Window putty
- 31 interior fire doors visually identified as asbestos-containing\* (pictured)
