City of Mercer Island

Public Works Building Report

September 19, 2023

Prepared by MENG Analysis, September 2023

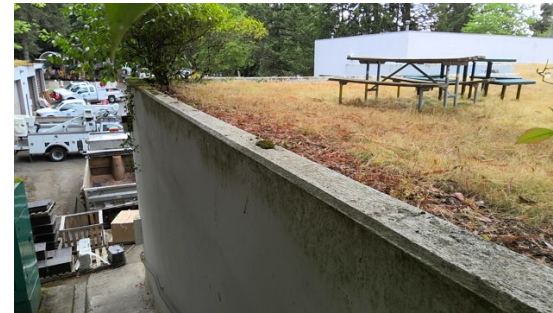
Deficient Material: Fall Guard

Green roofs on public works building are accessible, but have no perimeter fall restraint guard railings at the leading edges over the yard and ground below on the west, north, and east sides.

Install perimeter safety guard rail system.

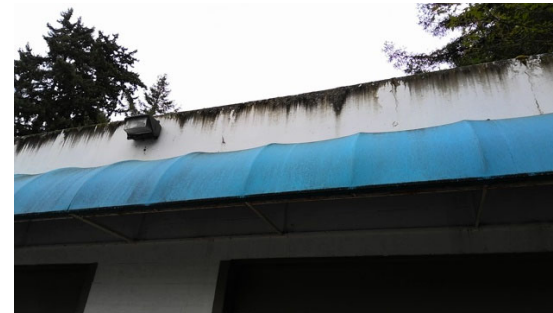
Deficient Material: Exterior Walls

Moss, lichen, and algae growth. Exterior walls are in need of cleaning.

Clean all exterior walls.

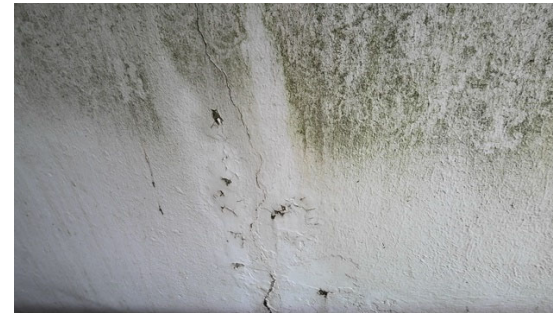
Deficient Material: Exterior Walls

Some peeling paint and cracks in west and north exterior of warehouse walls.

Strip paint, seal cracks, and repaint.

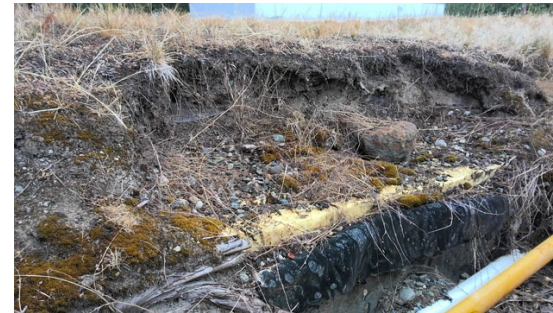
Deficient Material: Membrane Roofing

Membrane below green roof is leaking and at end of life. Built-up asphalt roof over vehicle maintenance garage and admin are at expected end of life.

Replace all roofing. At built-up asphalt roof areas, remove roofing (verify condition of insulation), add rigid insulation to meet or exceed current code (taper at parapet edges for transition), and install new roofing. At green roofing, remove soil medium (per G2050 Landscaping), remove existing insulation and membrane roofing, and install new rigid insulation and new membrane roofing. Install new green roof per G2050 Landscaping.

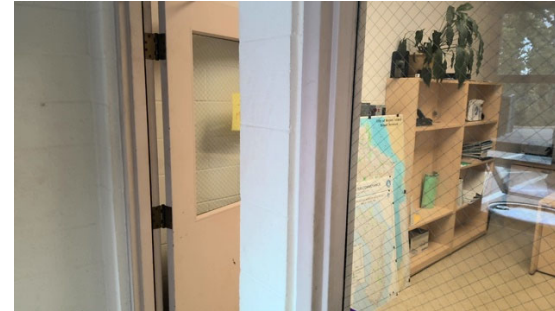
Deficient Material: Wire Glass

Wire glass in rated doors and internal windows. Wire glass is now known as a safety hazard and liability.

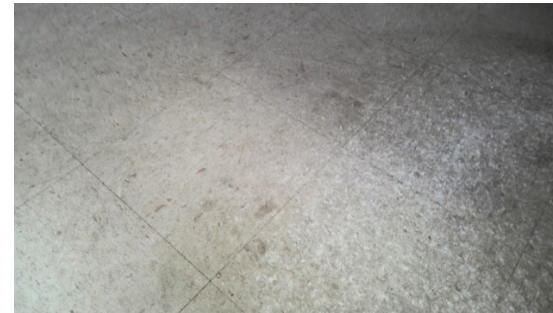
Deficient Material: Vinyl Composition Tile

VCT flooring worn, stained, and nearing end of life. Some seams separated from moisture intrusion.

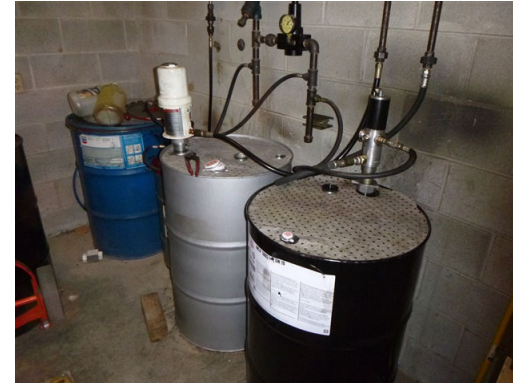
Deficient Material: Shop Fluids

Shop fluids room has no observed ventilation and opens directly into the open office area.

Renew shop fluids system and especially the room to provide direct outside access, isolation from office areas, code-required ventilation, electrical divisional classification if required by shop fluid hazard level, and one to two additional pumped fluids as needed by the shop crew for efficient and safe operation.

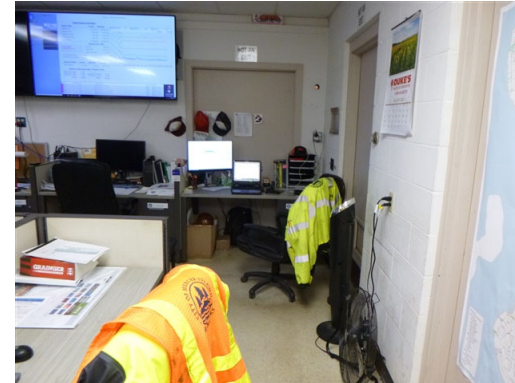
Deficient Material: Cooling

Heat and vent HVAC system for former shop area now used for office area for public works staff, resulting in hot uncomfortable working conditions.

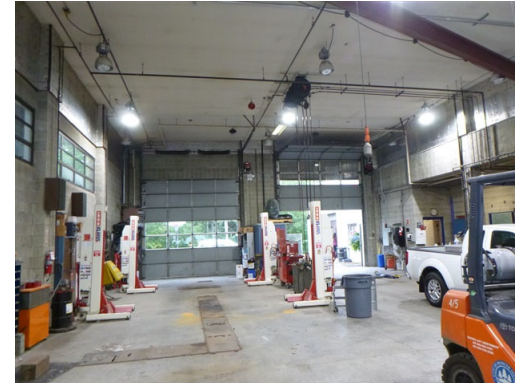
Deficient Material: HVAC System

Aged HVAC throughout with multiple spaces including minimal light industrial heat and vent HVAC systems with insufficient heat, no cooling, and marginal or no ventilation for office use. Odors build up in some spaces, potentially toxic to staff, especially over time. No apparent ventilation at all for some spaces, such as the warehouse area. The former machine shop and repurposed carpenter shop (now groundskeeping) HVAC system was completely off during the site visit, with significant pesticide and/or fertilizer odors present. No general ventilation for the vehicle repair garage (only the abandoned engine exhaust system).

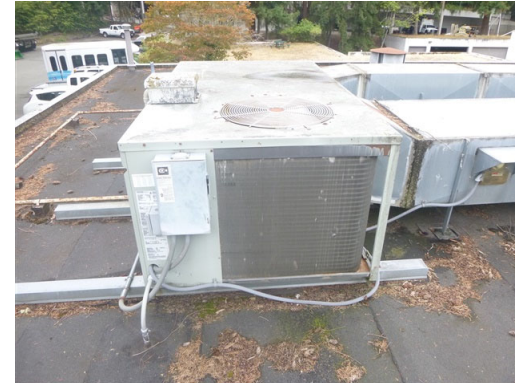
Deficient Material: Rooftop Units

Upper level office area rooftop gas-pack units is aged (2001) and near end of life - could completely fail at any time.

Budget to replace immediately upon failure.

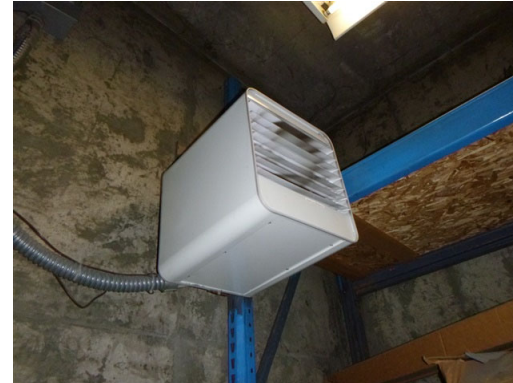
Deficient Material: Unit Heaters
Multiple aged electric duct and unit heaters.

Remedial Action:
Budget to replace immediately upon failure.

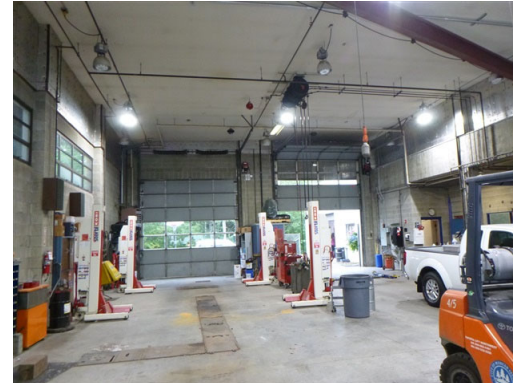
Deficient Material: Fire Sprinkler
No fire sprinkler system.

Remedial Action:
Install fire sprinkler system, including any specialty coverage, such as for tire rack, flammable or combustible liquid, and high-pile combustible storage areas.

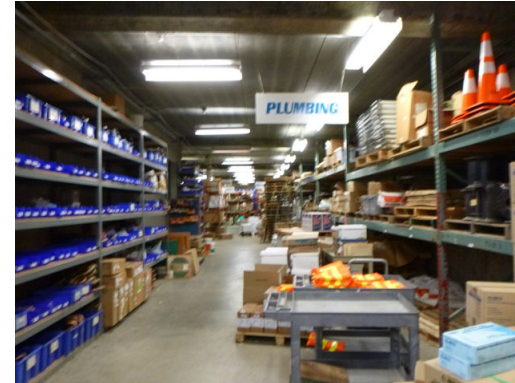
Deficient Material: Lighting

Most areas with original fluorescent lighting fixtures with manual control, poor lighting, and failed ballasts and lamps.

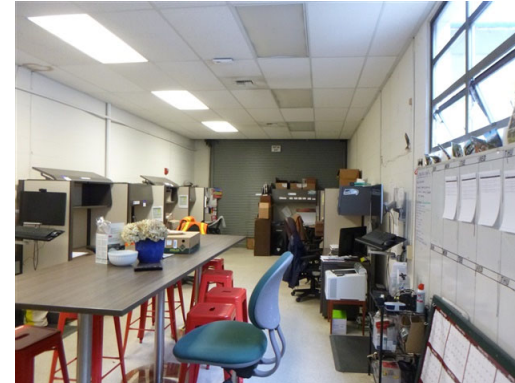
Deficient Material: **Wiring and Devices**

Aged wiring and devices, insufficient hardwired distribution at shop and storage areas converted to office area, minimal ground fault protection, and aged and failing switches and receptacles throughout.

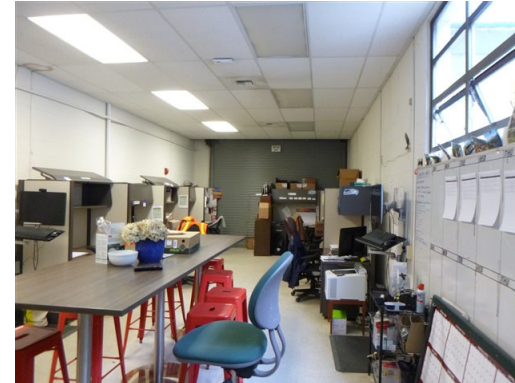
Deficient Material: Fire Alarm
Multiple painted-over and failing detectors.

Remedial Action:
Replace damaged detectors.

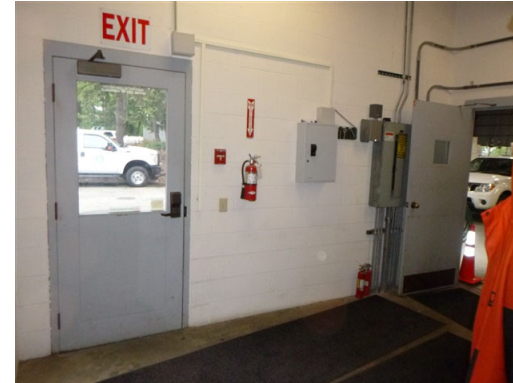
Deficient Material: Emergency lighting

Despite generator, there are no lighted exit signs, and no observed continuously-on egress pathway lighting fixtures.

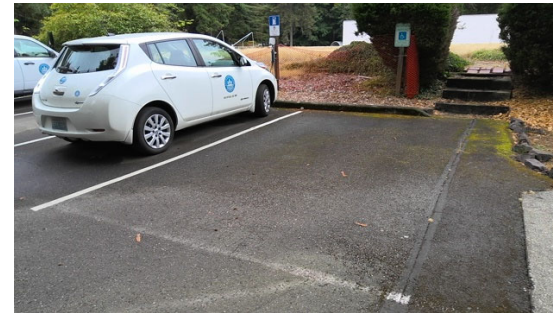
Deficient Material: Asphalt Parking

Asphalt surface weathering, some areas with faded paint striping, ADA stall missing ADA paint symbol and access aisle paint striping.

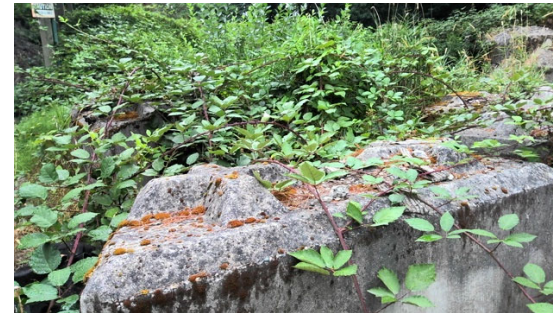
Deficient Material: Invasive Species

Perimeter and stream side underbrush contains a significant amount of invasive blackberry and English ivy. Blackberries encroaching on material storage. Ivy noted climbing trees.

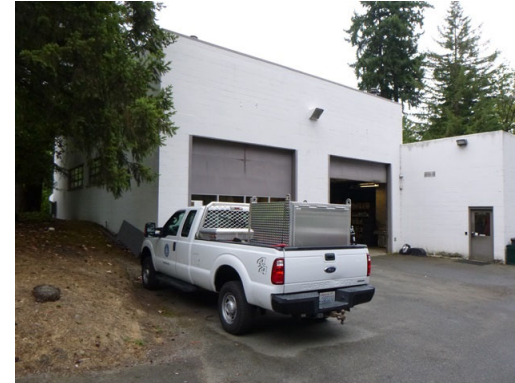
Deficient Material: Oil Water Separator

No oil/water separator observed for vehicle repair shop floor drains.

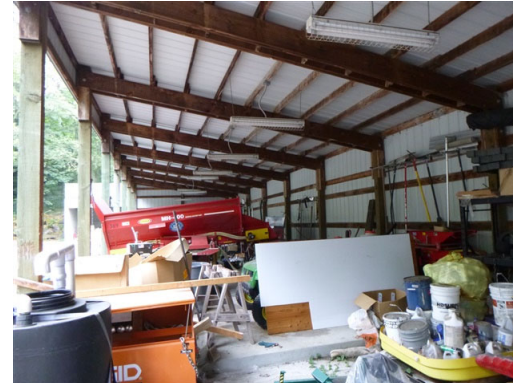
Deficient Material: Out-building lighting

Aged, inefficient, broken, or damaged lighting at most the permanent out buildings.

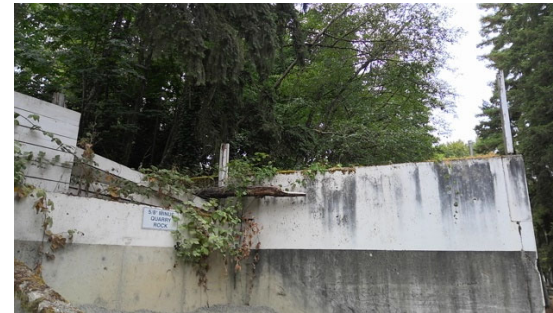
Deficient Material: Screen Fence

Wood screen walls on upper concrete storage bays have been damaged by falling trees and some are completely missing.

Remove or replace screen walls.
