City of Mercer Island

Public Works Building Report

September 19, 2023

Prepared by MENG Analysis, September 2023

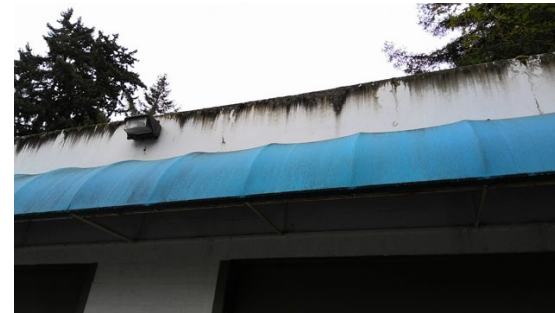
Deficient Material: Exterior Walls

Moss, lichen, and algae growth. Exterior walls are in need of cleaning.

Clean all exterior walls.

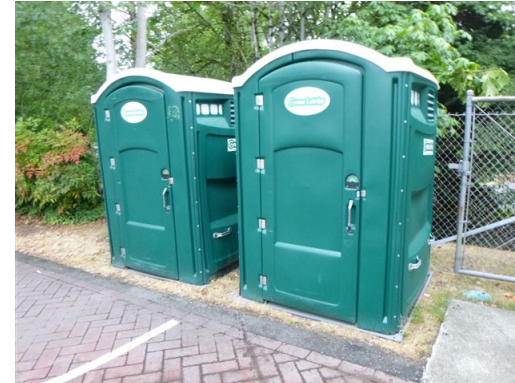
Deficient Material: Restrooms

Expand permanent restroom capability to replace the current porta potties.

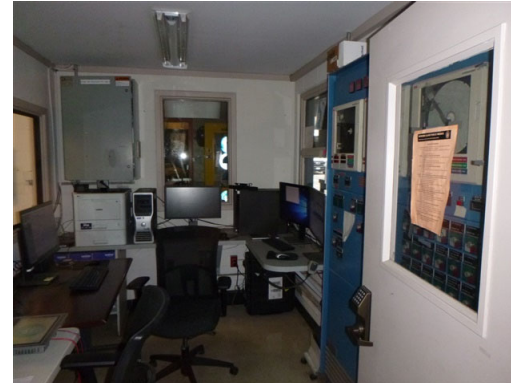
Deficient Material: Communications Cooling

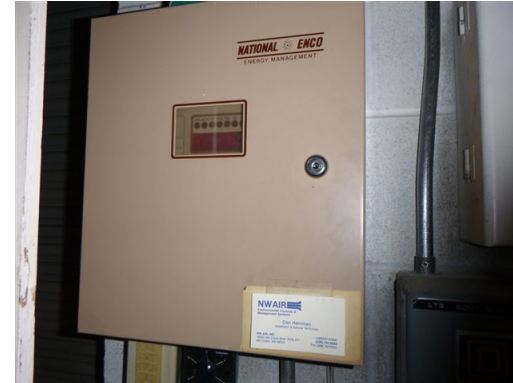
Deficient Material: HVAC Controls

Replace with city standard DDC system to include remote monitoring by the facilities department.

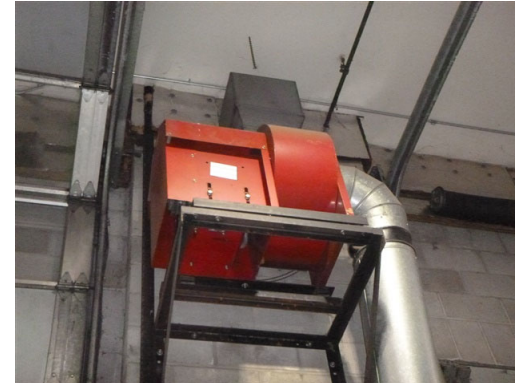
Deficient Material: Engine Exhaust

Fully service and restore vehicle engine exhaust system to operational condition.

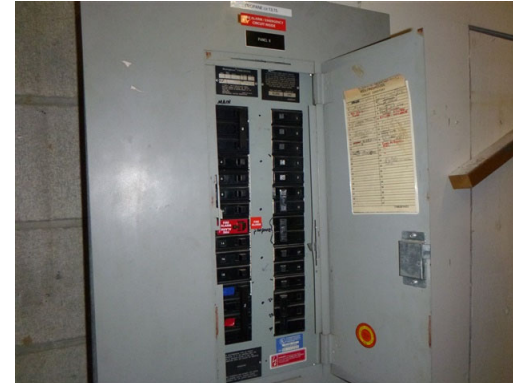
Deficient Material: Electrical Distribution

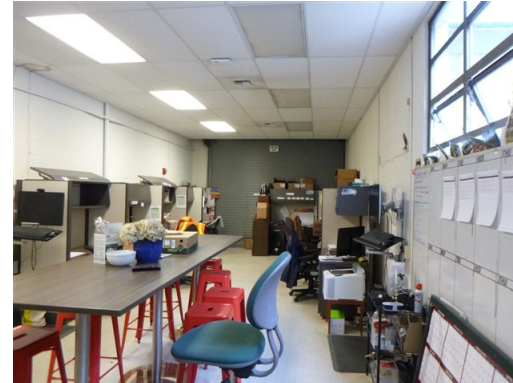
Deficient Material: Fire Alarm
Multiple painted-over and failing detectors.

Remedial Action:
Replace damaged detectors.

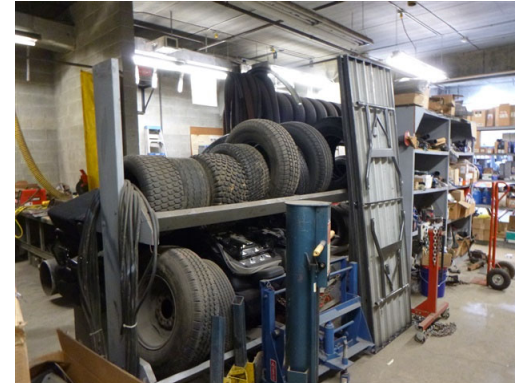
Deficient Material: Shop Equipment

Renew, replace, or repurpose aged, obsolete, and abandoned shop and other specialized equipment.

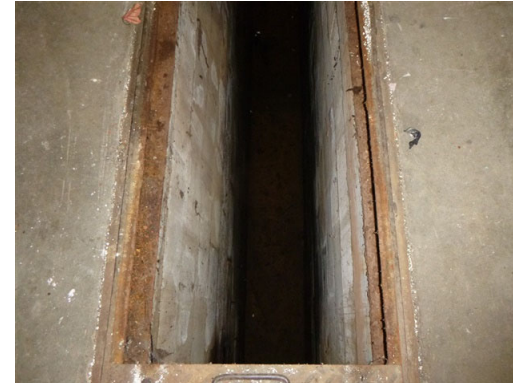
Deficient Material: Vehicle shop pit & lift

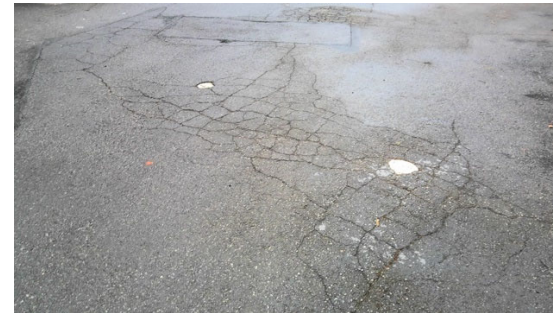
Deficient Material: Asphalt Paving

Patch asphalt, fill and seal cracks, and fog coat to prolong system life.

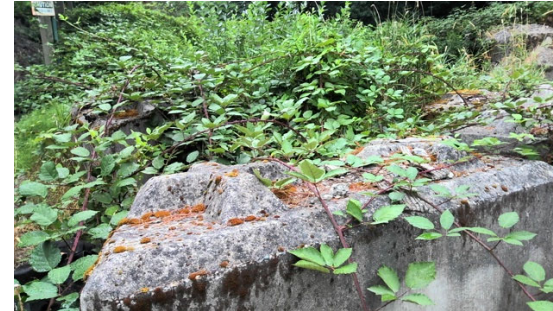
Deficient Material: Invasive Species

Perimeter and stream side underbrush contains a significant amount of invasive blackberry and English ivy. Blackberries encroaching on material storage. Ivy noted climbing trees.

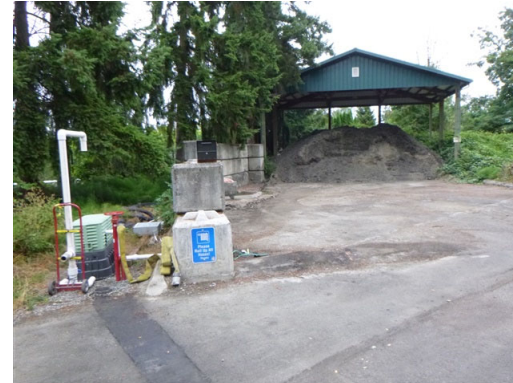
Deficient Material: Decant facility

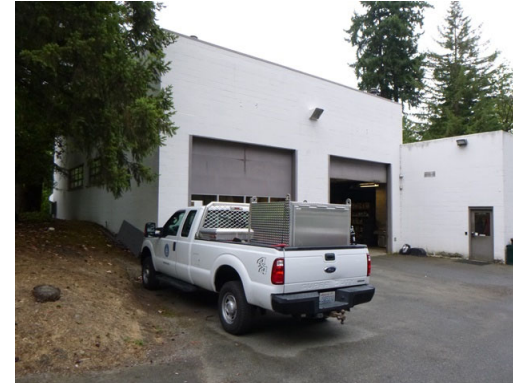
Deficient Material: Oil Water Separator

No oil/water separator observed for vehicle repair shop floor drains.

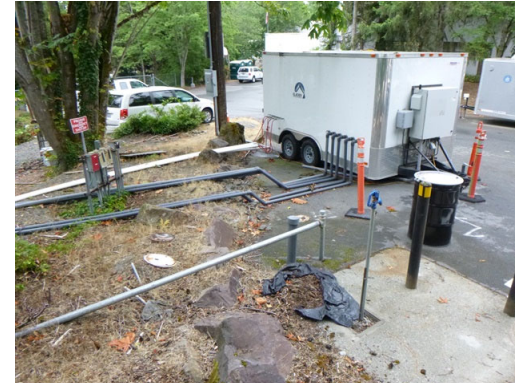
Deficient Material: Subsurface Soil

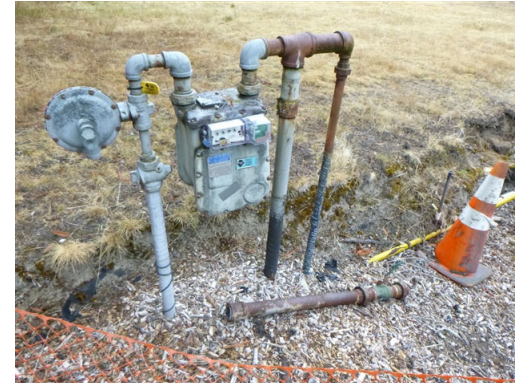
Deficient Material: Gas Service

Relocate and replace meter and install per current Puget Sound Energy and applicable code.

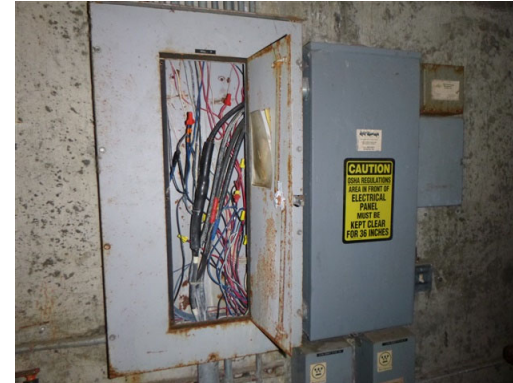
Deficient Material: Electrical Service

Replace the campus electrical service and upgrade from 150 kVA to 300 kVA to support current and future loads, plus likely switch over from gas to electric heat to comply with climate action plan requirements and provide electric vehicle charging. Provide engineered power to permanent out buildings including all four concrete covered storage buildings and the two pole barn buildings, plus general upper and lower service yard process and support equipment and out buildings.

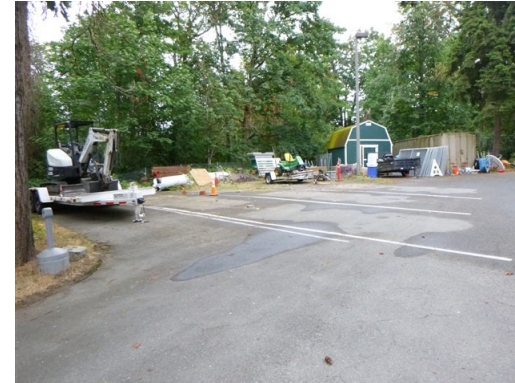
Deficient Material: Outside lighting

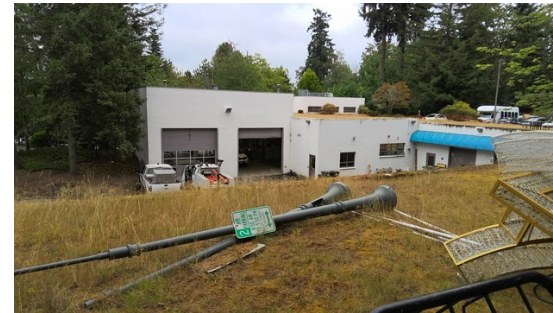
Deficient Material: Fall Restraint
