Public Works Building Facility Conditions Assessment Follow-Up

AB 6477 | May 21, 2024

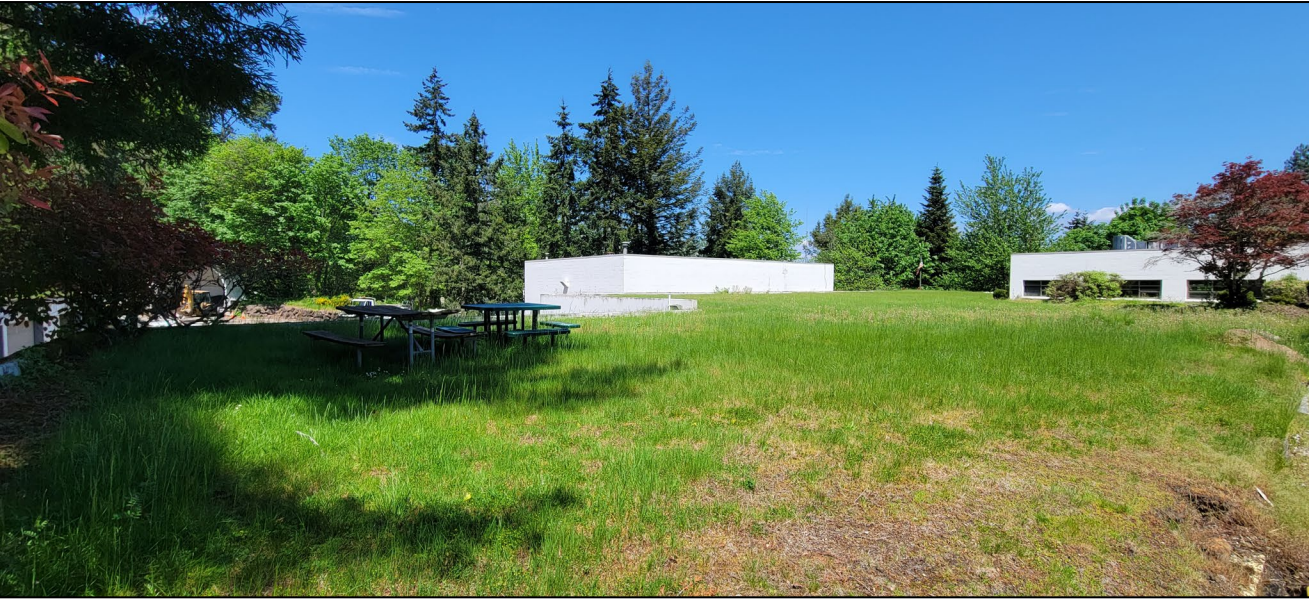
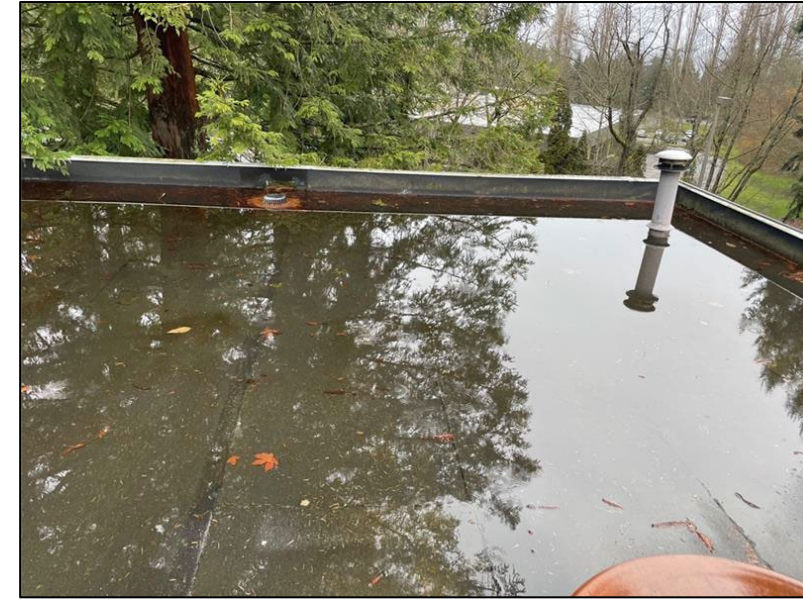
Roofing and Water Intrusion

- The roofing membrane over the warehouse and operations spaces is more than 10 years beyond end-of-life and leaking profusely.
- The flat roofs over the administrative offices and the mechanic's shop are not properly sloped, resulting in standing water.

- The roof leaks need to be addressed to extend the life of the building and provide reasonable workspace for City staff.
- In the development of the roof replacement scope of work, structural deficiencies were also identified. (More on that later.)
- The existing green roof soil must be removed in order to address the roof leaks and structural concerns.

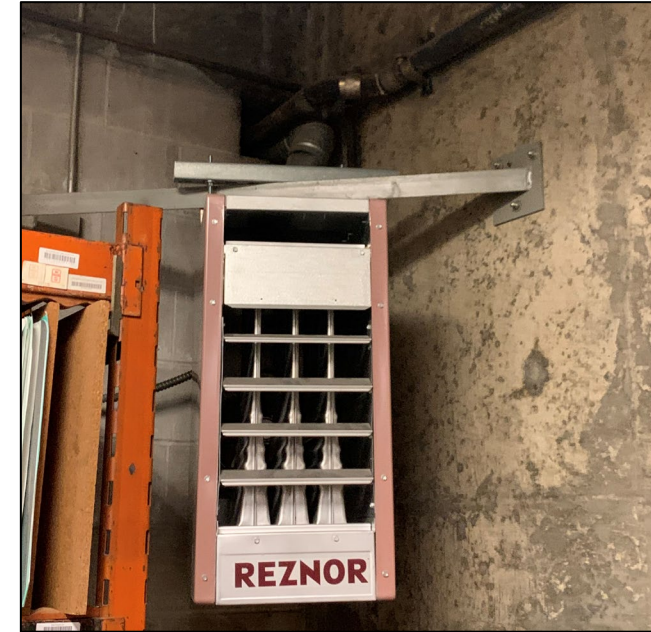
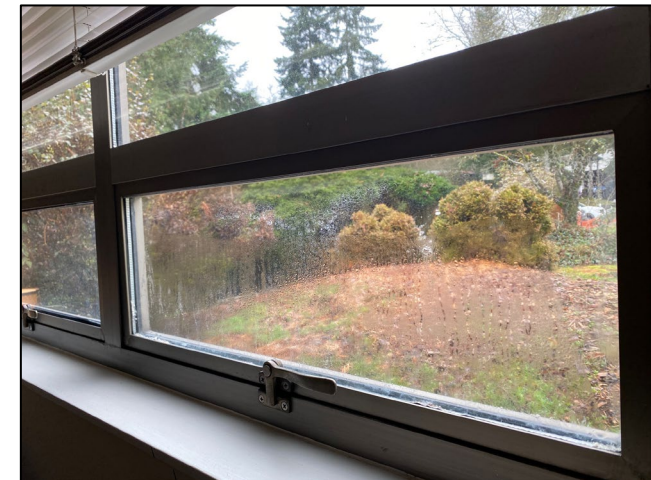
Heating, Cooling & Ventilation

- There is no cooling in the lower level of the building where the operations teams work.
- The HVAC system on the upper level is at the end of its useful life.
- There is a lack of adequate ventilation to address vehicle exhaust, the welding hood, and the fluid storage room.
- The exterior walls are concrete block with minimal insulation value.
- The aluminum-framed windows are not insulated and the double panes are unsealing.

- The existing engine exhaust system is now operational.
- Air quality monitors have been installed throughout the building.
- Installing a new HVAC system would likely cost hundreds of thousands of dollars and require extensive electrical modifications. Given the building's short-term expected occupancy, we are not proceeding with this recommendation.
- The existing HVAC systems will be run to failure and components replaced or repaired if necessary.

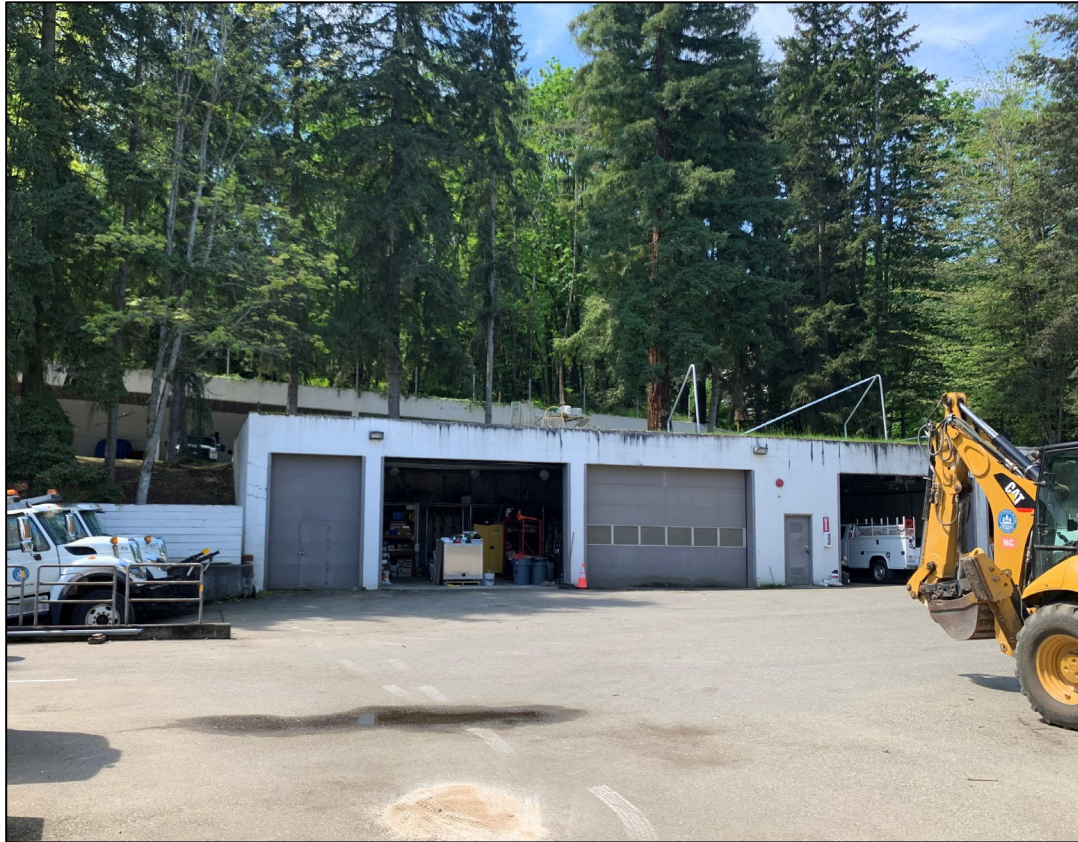
Fall Protection Railings

- Accessible roofs on top of the Public Works Building and outbuildings have no railing system to protect against falls.
- Several of these areas are used for material storage (benches, holiday displays, plants, etc.)
- A railing system must be installed on all edges to meet code requirements.

- Include fall restraint guards at the Public Works building and select outbuildings.
- This project will be completed this year.

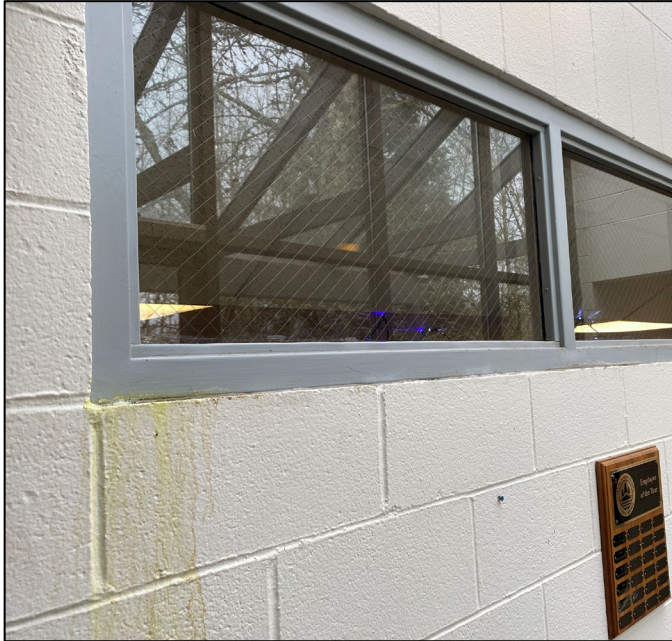
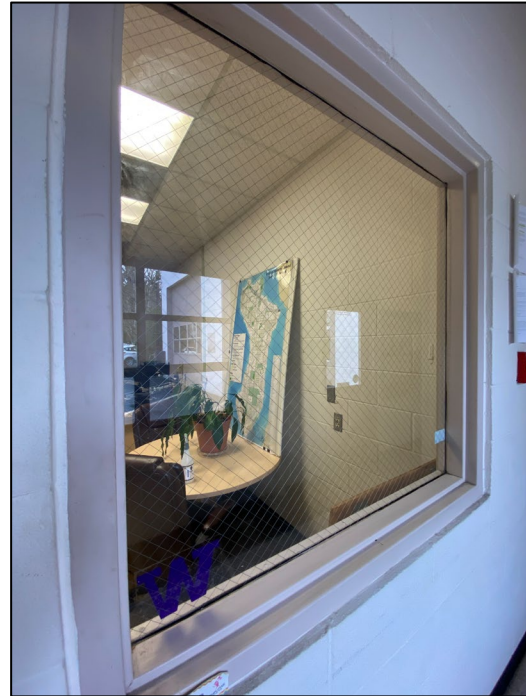
Wired Glass

- The glass installed on the interior windows and doors includes wired glass, which is now considered a potential safety hazard.
- Wire mesh weakens the glass and creates jagged glass shards when broken.
- The windows can be covered with a protective film to contain glass if broken.

- Given the expected lifespan of the building, the windows will be treated with a safety film to prevent shattering rather than being replaced.
- This work will be completed this year.

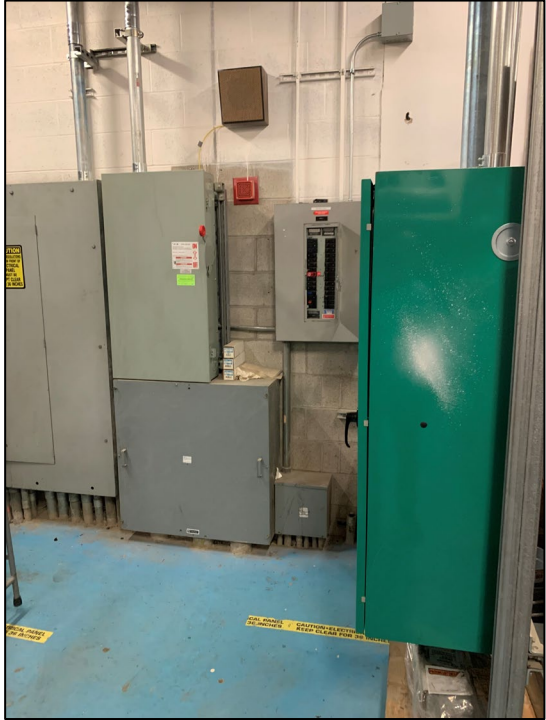
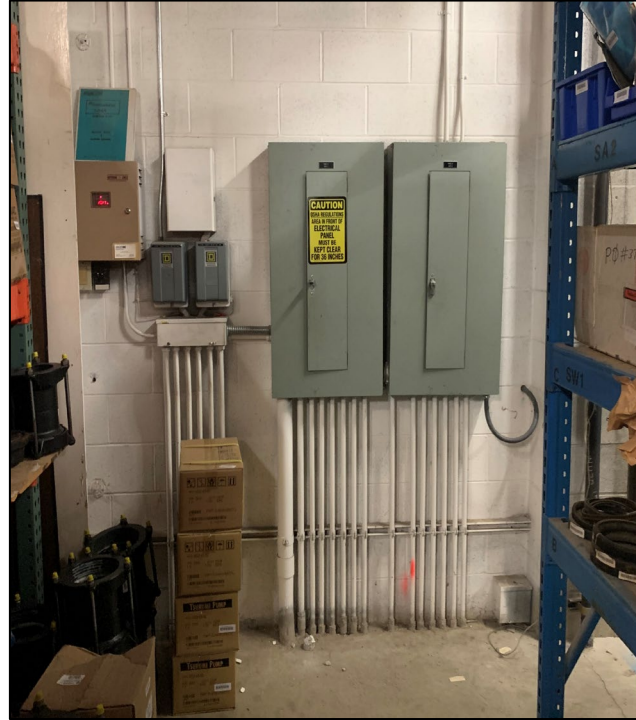
Electrical Service & Distribution

- There is not enough electrical capacity currently, circuits are tripping regularly.
- The electrical system must be assessed and updated before any modifications can be made to the HVAC or lighting systems.

- The findings of the FCA include a recommendation to engage an electrical contractor to fully review the existing system and develop a work package to address observed deficiencies and code-based upgrades.
- If long-term occupancy of this building was anticipated, the electrical panels and distribution system should be replaced.
- Due to the expected short-term occupancy, we are not moving forward with this recommendation.
- Operational changes have been made to distribute the loads that were causing breakers to trip.

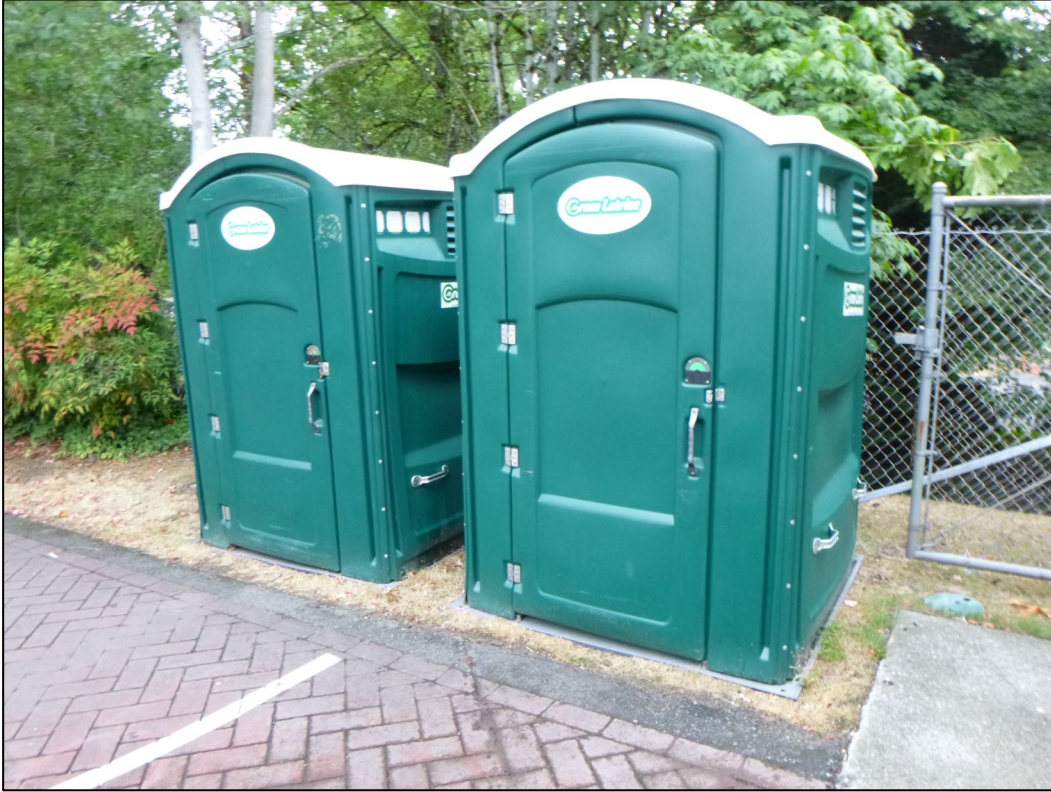
Insufficient Restroom Capacity

- The Public Works Building only has 5 restroom stalls, which is insufficient for current staffing needs as determined per WAC 296-800-23020.
- Two portable toilets are on-site to meet needs.
- There are no restrooms on the second floor of the building.

- Staff will continue to provide on-site portable restrooms to address the capacity needs for the current workforce.

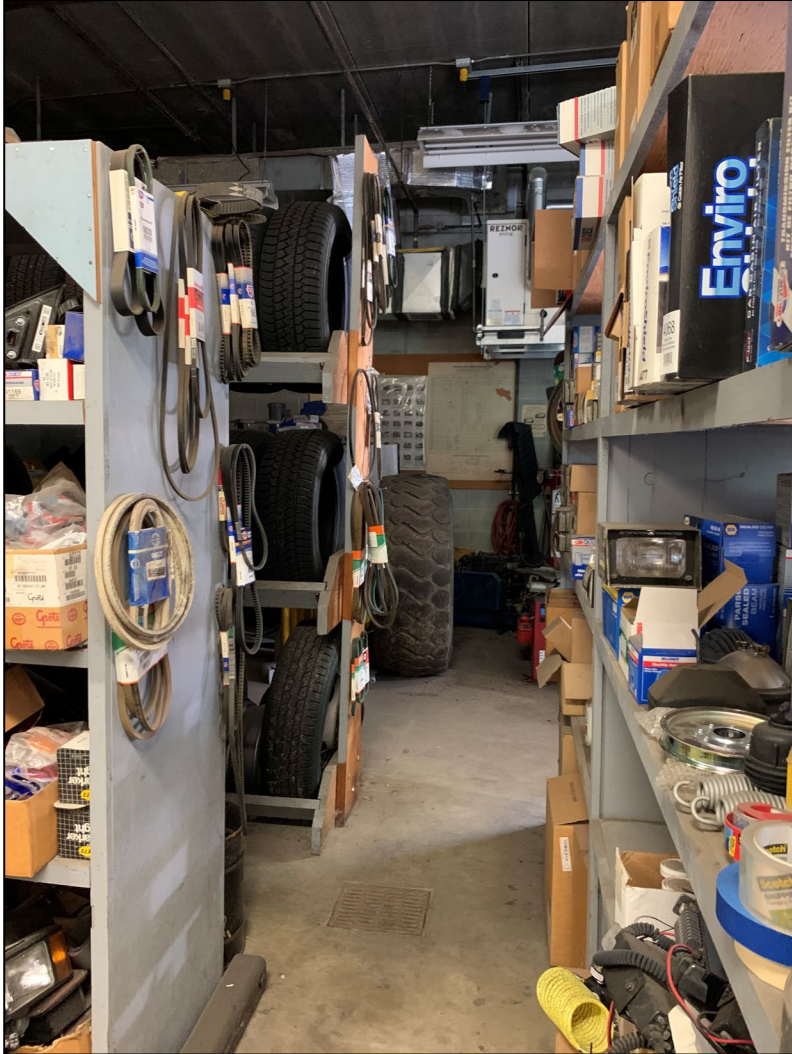
Fire Suppression System

- The building does not have a fire suppression system.
- The existing system is comprised of fire/heat detection only.
- This is of particular concern in the Mechanic's Shop and Warehouse where flammable materials and liquids are stored.

- The existing fire suppression system meets the code requirements for this building.
- Additional fire extinguishers have been procured for the facility.

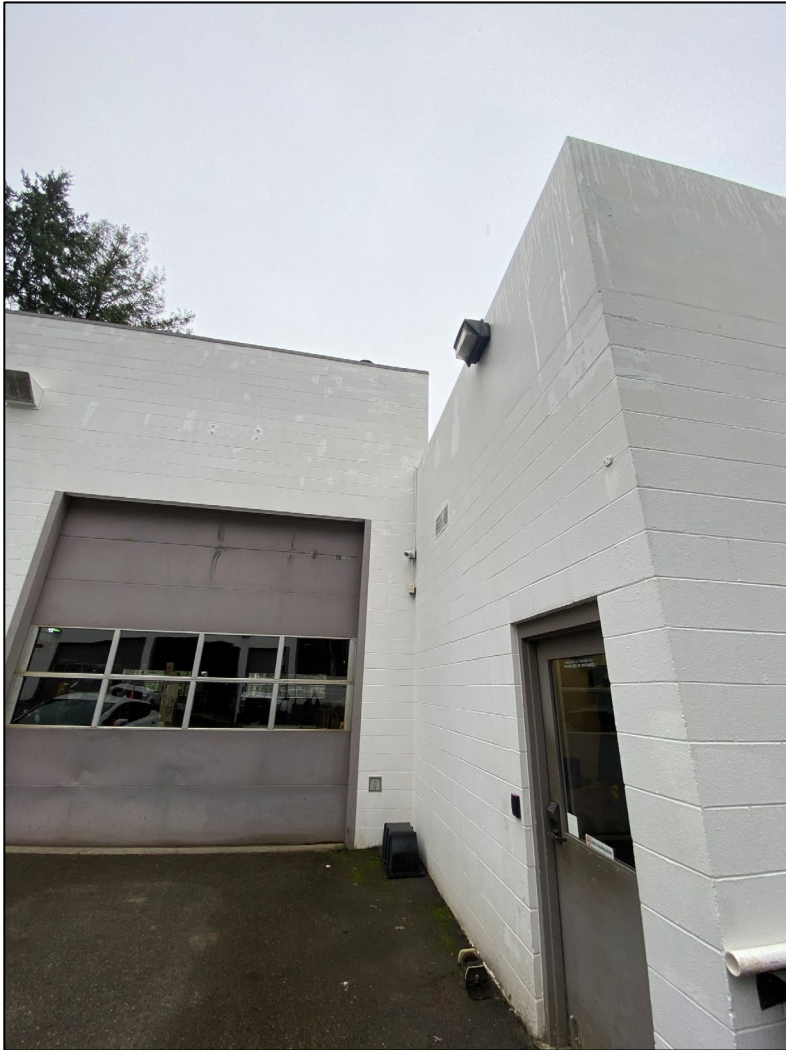
Structural Deficiencies

- The Public Works Building was not designed to meet the seismic resilience required for a building that must operate as an essential facility following an earthquake.
- ASCE 41-17 seismic evaluation found that the existing building structure is inadequate to remain operational as a Seismic Risk Category II building.
- A standalone Public Works' operations facility should meet Seismic Risk Category III or preferably Category IV to ensure that it can perform essential functions following a seismic event.

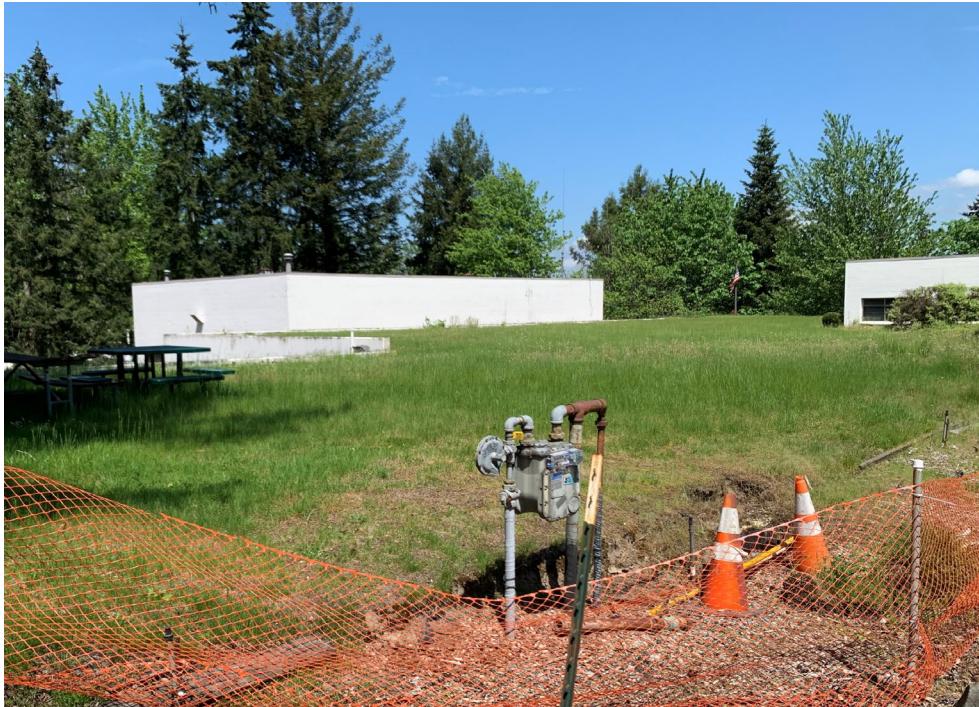
Roofing and Walls

- The weight of the green roof's soil and vegetation must be addressed as soon as possible to reduce weight on the structure and allow for membrane replacement.
- The existing shear walls are adequate only if the green roof and soil on the roof is completely removed.

- Remove all of the green roof soil to reduce the weight on the structure. Remove roof decking material as needed to install seismic retrofits. Install new, short-term roof system.
- Install anchoring between the walls and the wood diaphragms at the second-floor office and high-bay garage roofs.
- Install a subsurface concrete-grade beam along the exterior at each end of the high-bay garage doors.
- Brace the internal non-bearing CMU walls to protect against potential collapse.

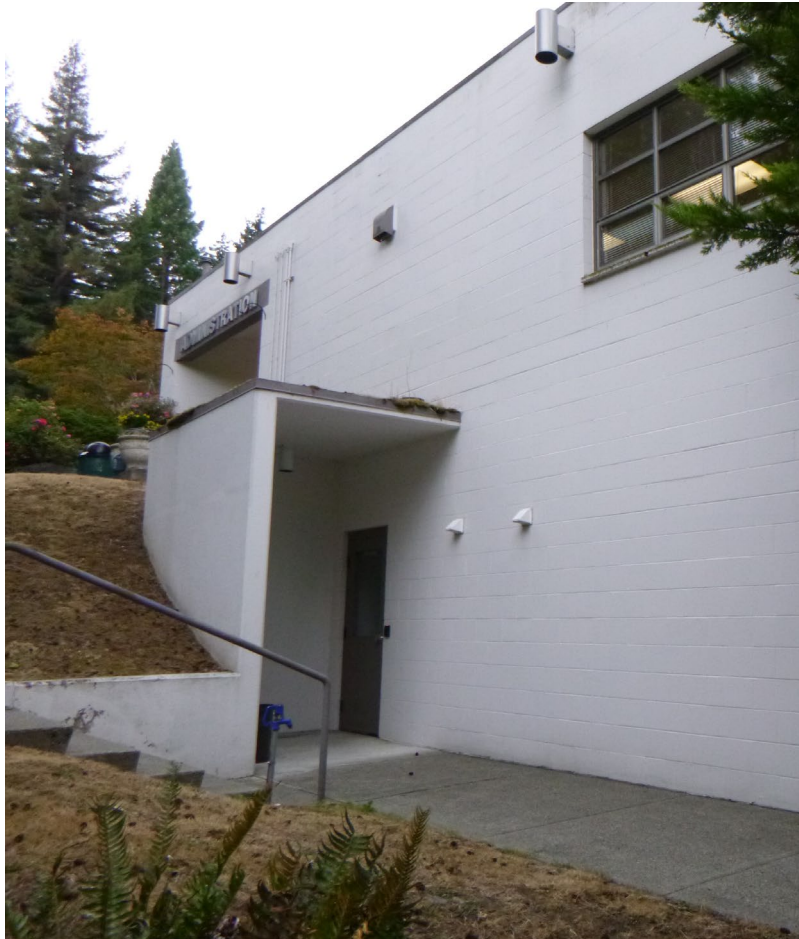
Wall Anchoring

- There is no evident anchoring between the walls and the wood diaphragms at the two higher roofs: the office and the high-bay garage.
- The connection between the wood-framed roofs and the exterior walls is inadequate and must be retrofitted now, even with short-term occupancy.

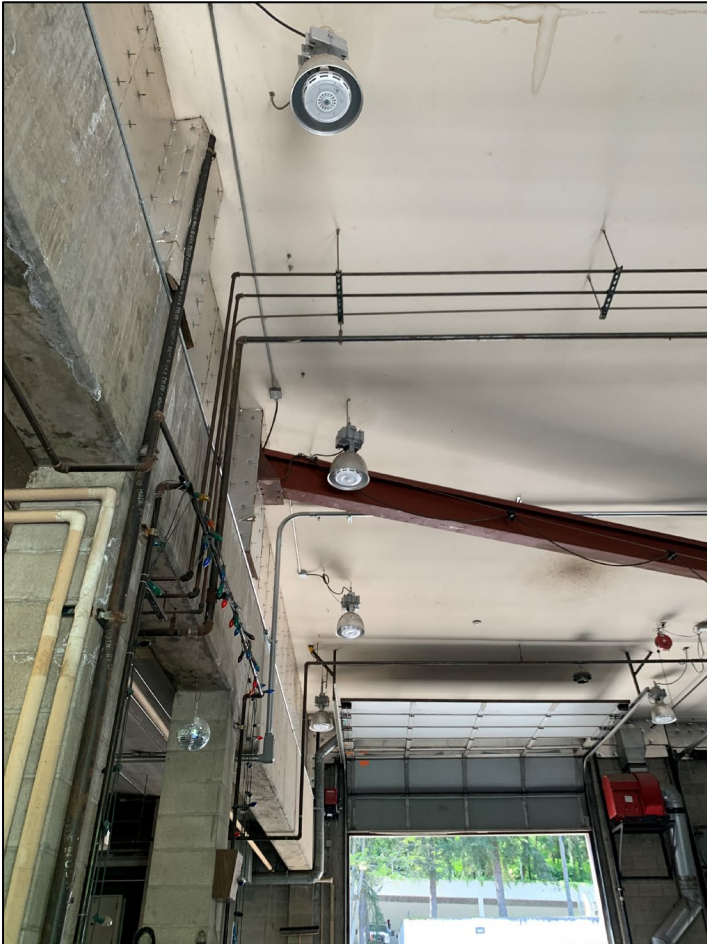
High-Bay Doors and CMU Walls

- Inadequate foundations along the high-bay doors on both the east and west sides.
- The building has numerous unbraced interior Concrete Masonry Unit (CMU) walls. It is unclear if these are secured to the roof.
