Title: **3003 77<sup>th</sup> Ave Project – Mercer South Park Project  
Street and Landscape Trees  
Level 2 Basic Tree Risk Assessment  
3003 77<sup>th</sup> Ave SE  
Mercer Island, Washington**

Prepared for: Ryan Companies US Inc.  
Attn: Marc Gearhart  
110 110 Ave NE  
Bellevue, Washington 98004

Date: May 13, 2020

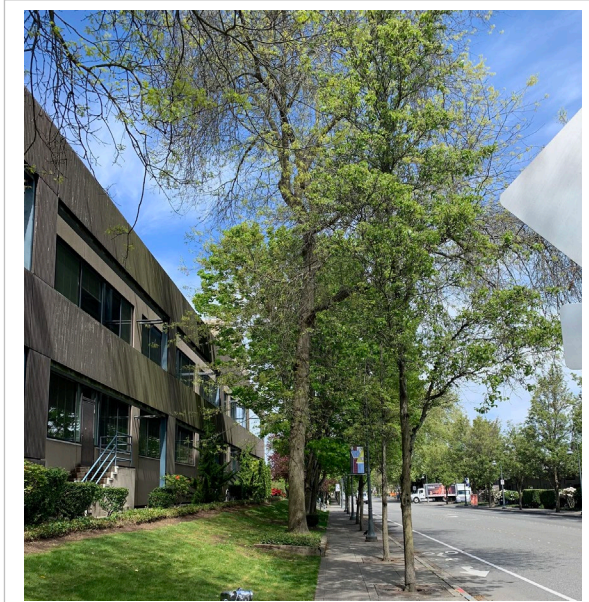
**Photo 1. These are the healthy larger trees on private property (left) and smaller street trees (right) on the west side of 77<sup>th</sup> Ave SE in Mercer Island. The viewer is looking north.**

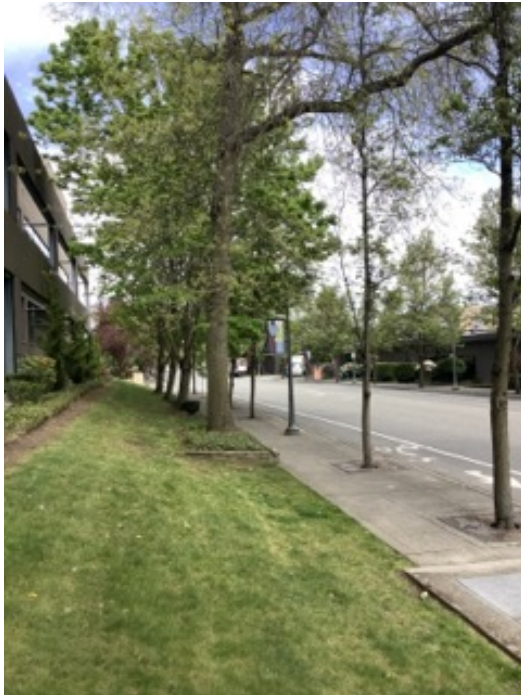
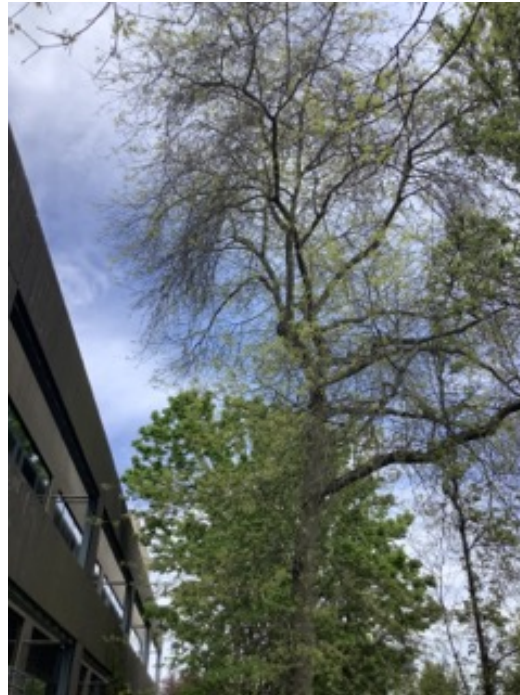
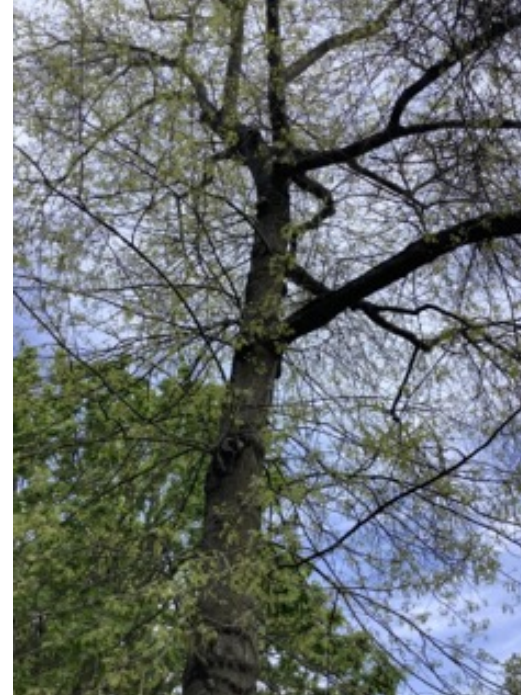
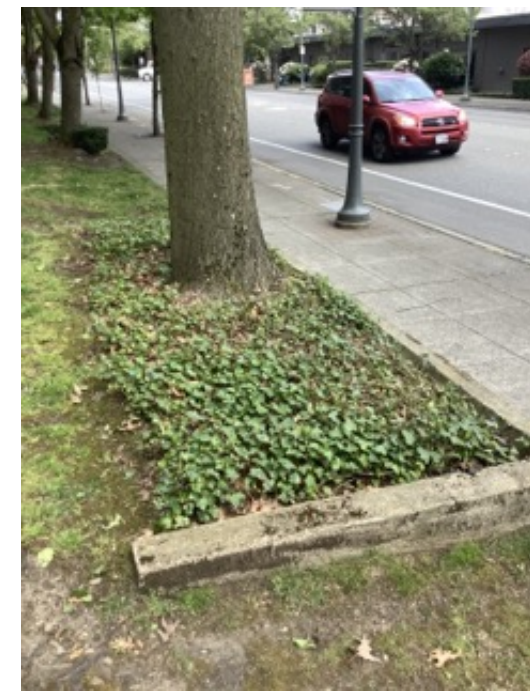
Tree	Species	DBH (in)	Drip Avg (ft)	CRZ (ft)	Vigor	Structure	Risk	Pres. Cat/Value	Recommendations
141	Red oak <i>Quercus rubra</i>	23.1, (23.1)	16.4	23.1	Fair	Fair to Good	Low	Unknown  Medium	
<b>Notes / Defects</b>	The tree is approximately 18 feet to the building exterior shell. It is in good condition and there are no structural defects. There is some moderate twig dieback in the crown.								<b>Dripline (ft)</b> <b>N</b> 16 <b>S</b> 17.5 <b>E</b> 16 <b>W</b> 16

Leveling the slope down to the grade of the sidewalk is in direct conflict with retaining trees #141, #142, #143, and #144. Remove the property trees and replace on-site at a ratio of 2:1. Submit a Development Tree Removal Permit with the City, showing the location of replacement tree plantings on a site map. Also complete a tree inventory of all significant trees on the property demonstrating that at least 30 percent of trees are retained.

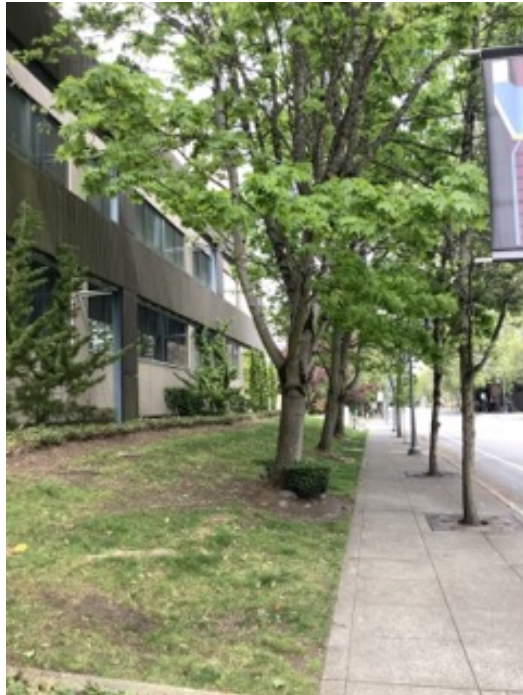
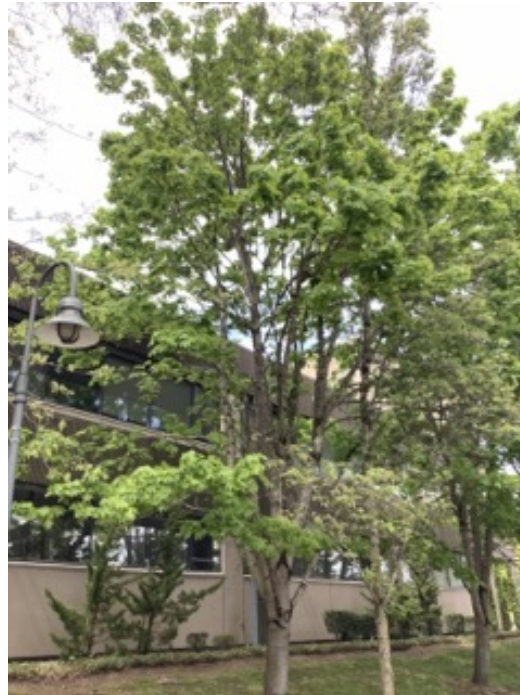
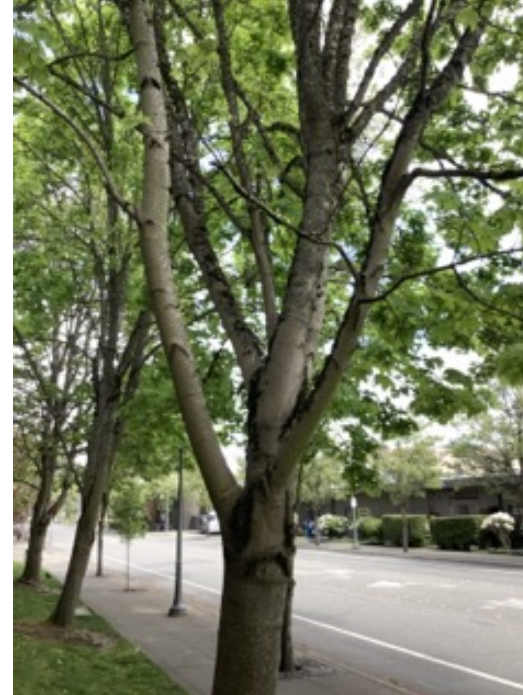
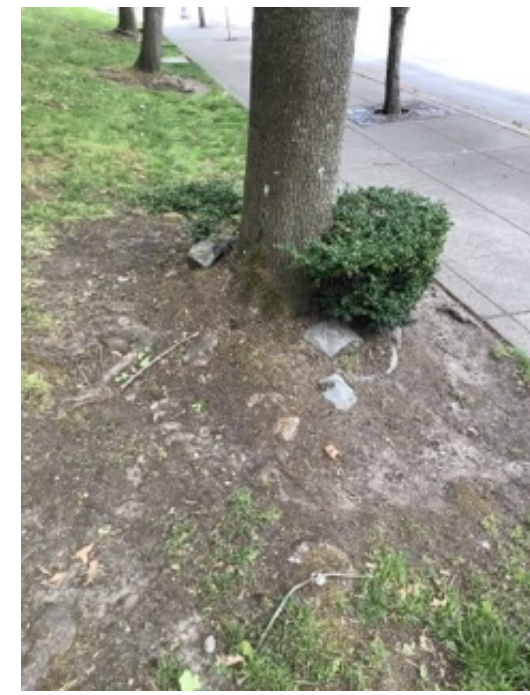
Tree	Species	DBH (in)	Drip Avg (ft)	CRZ (ft)	Vigor	Structure	Risk	Pres. Cat/Value	Recommendations
142	Norway maple <i>Acer platanoides</i>	15.7, (15.7)	16.0	15.7	Good	Good	Low	Unknown  Medium	
<b>Notes / Defects</b>	The tree has a full crown and no structural defects. There are a few large surface roots visible in the bare ground around the base of the tree.								<b>Dripline (ft)</b> <b>N</b> 16 <b>S</b> 16 <b>E</b> 16 <b>W</b> 16

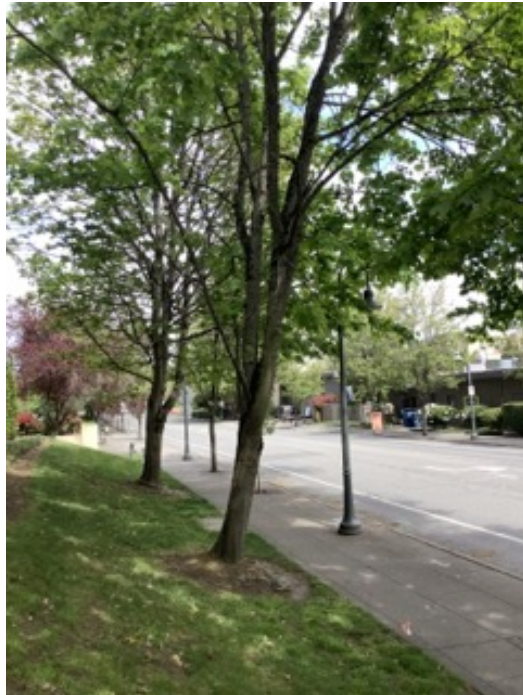
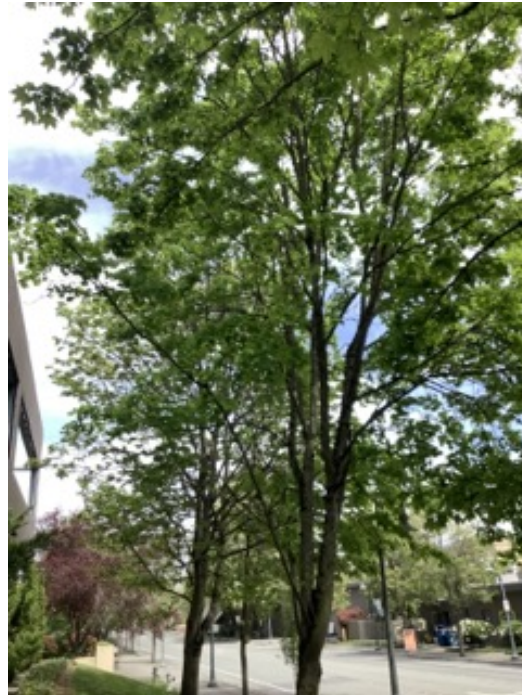
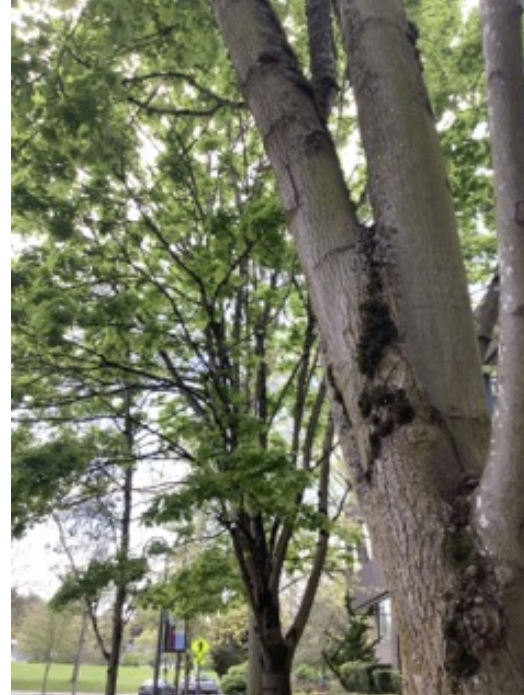
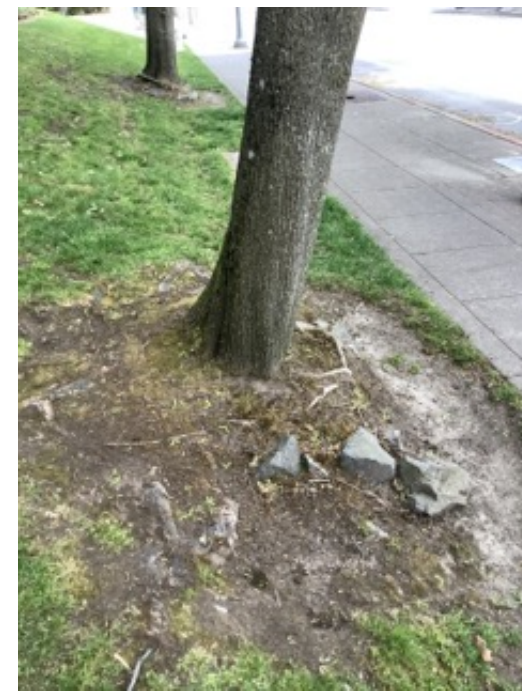
Tree	Species	DBH (in)	Drip Avg (ft)	CRZ (ft)	Vigor	Structure	Risk	Pres. Cat/Value	Recommendations
143	Norway maple <i>Acer platanoides</i>	15, (15)	14.0	15.0	Good	Fair to Good	Low	Unknown  Medium	
<b>Notes / Defects</b>	The tree is leaning slightly towards the street. One codominant stem closest to the street has a weak union that could be managed to reduce risk. The planting area looks like it was originally bounded by some structures that have been removed to open up the space for roots to grow.								<b>Dripline (ft)</b> <b>N</b> 14 <b>S</b> 14 <b>E</b> 14 <b>W</b> 14

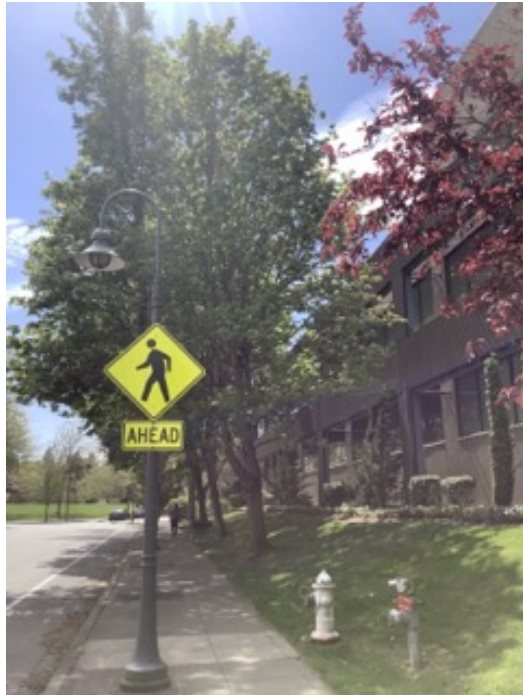
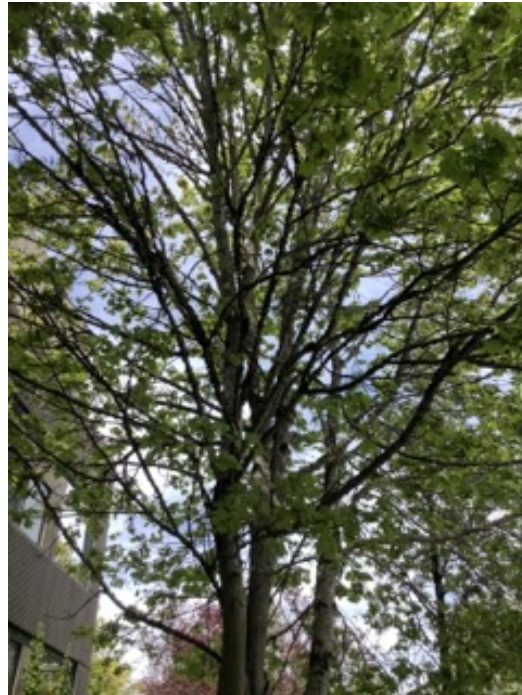
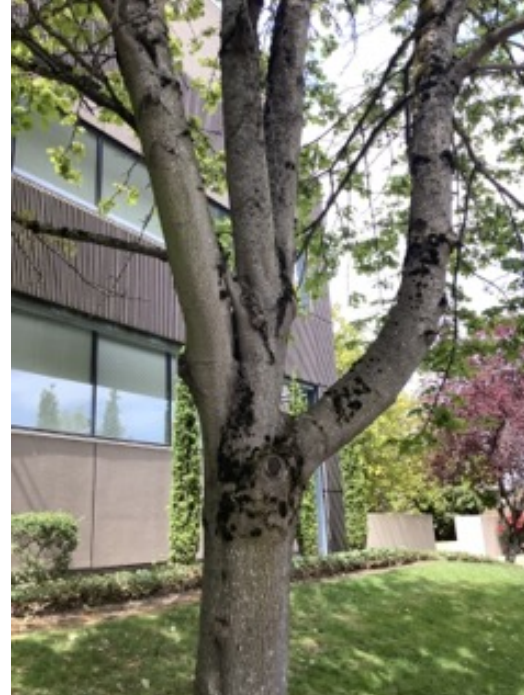
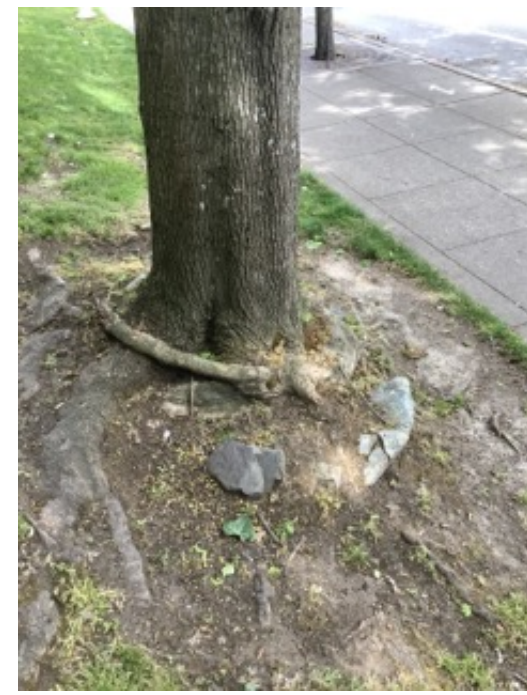
Tree	Species	DBH (in)	Drip Avg (ft)	CRZ (ft)	Vigor	Structure	Risk	Pres. Cat/Value	Recommendations
144	Norway maple <i>Acer platanoides</i>	17.5, (17.5)	19.3	17.5	Fair	Good	Low	Unknown  Medium	
<b>Notes / Defects</b>	There is a 2-foot girdling root on the southwest side of the trunk flare. There is some twig dieback in the crown and foliage development is delayed compared to other trees in the group. The tree has a large, full crown.								<b>Dripline (ft)</b> <b>N</b> 19 <b>S</b> 19 <b>E</b> 21 <b>W</b> 18

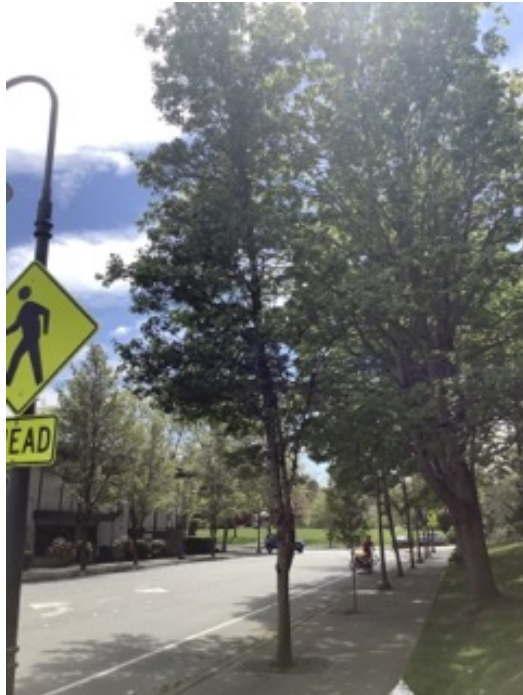
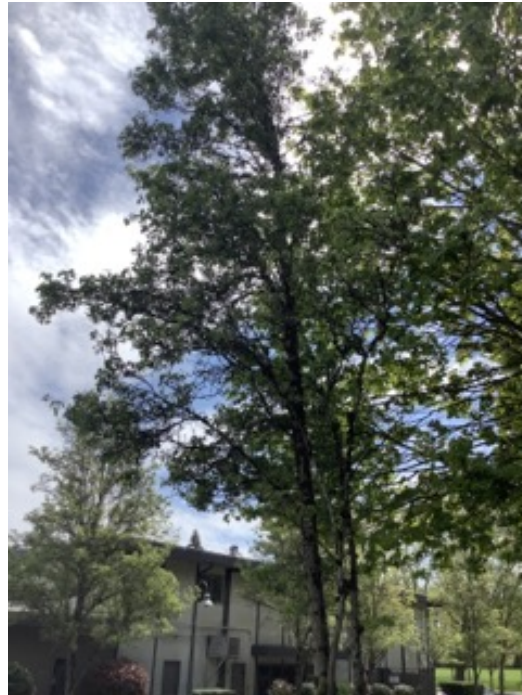
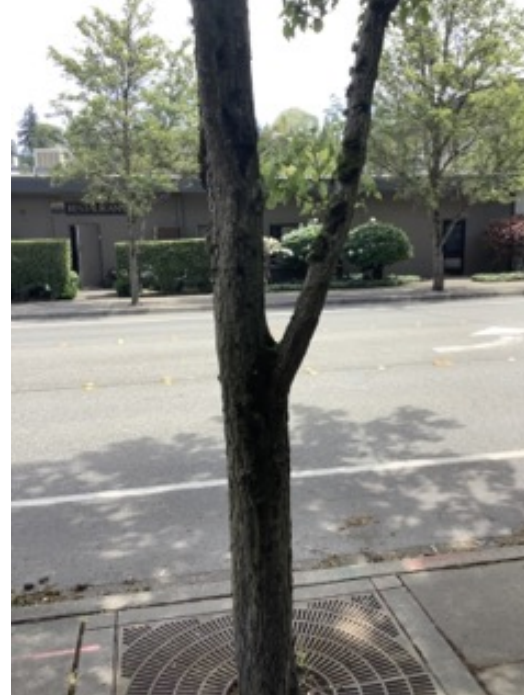
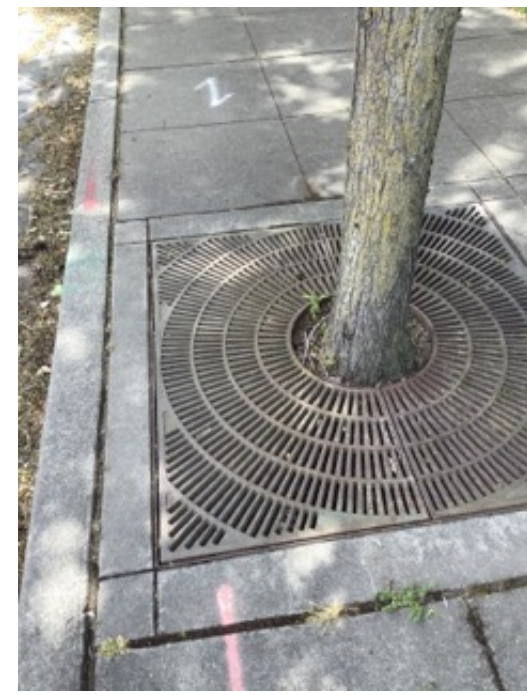
Tree	Species	DBH (in)	Drip Avg (ft)	CRZ (ft)	Vigor	Structure	Risk	Pres. Cat/Value	Recommendations
145	Callery pear var. <i>Prunus calleryana</i> var.	7, (7)	6.0	7.0	Good	Good	Low	Unknown  Low	
<b>Notes / Defects</b>	The tree is tall and it has a narrow crown for its species. The growth form is most likely a result of competition with the adjacent larger maple trees and pruning for street clearance.								<b>Dripline (ft)</b> <b>N</b> 6 <b>S</b> 6 <b>E</b> 6 <b>W</b> 6

Retain all the street trees for the purposes of the development project. Because of their relatively small critical root zones under the sidewalk, they have a high likelihood of survival with tree protection measures implemented during construction. Submit a tree protection plan to the City that meets the standards described in City Code 19.10.080, including a site map with tree protection measures marked on it. General tree protection guidelines are attached.

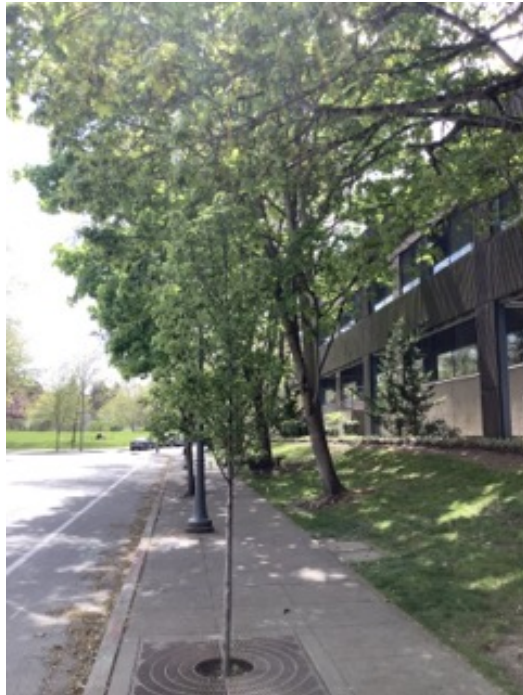
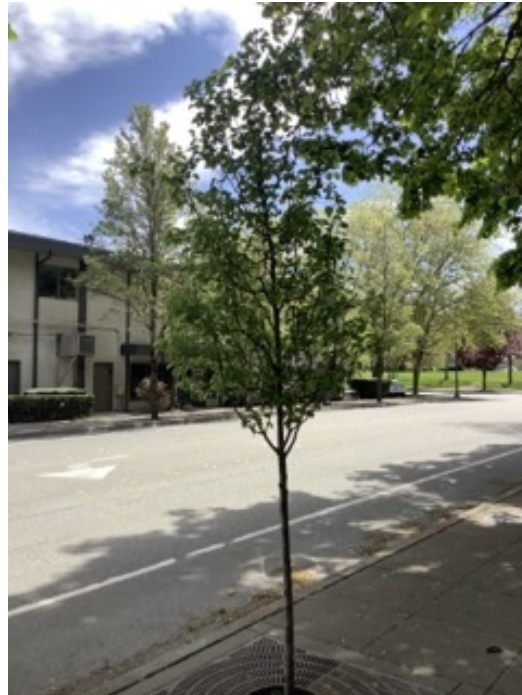
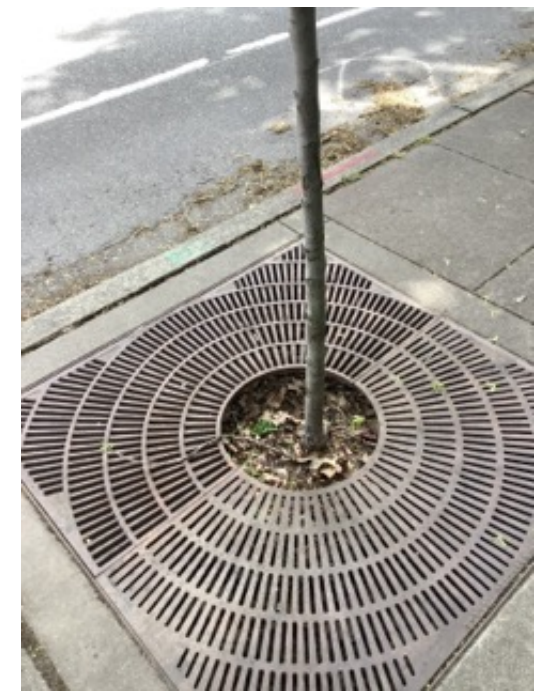
Tree	Species	DBH (in)	Drip Avg (ft)	CRZ (ft)	Vigor	Structure	Risk	Pres. Cat/Value	Recommendations
146	Callery pear var. <i>Prunus calleryana</i> var.	1.2, (1.2)	2.0	1.2	Good	Good	Low	Unknown  Low	
<b>Notes / Defects</b>	This is a newly planted tree growing under the crown of an adjacent maple tree.								<b>Dripline (ft)</b> <b>N</b> 2 <b>S</b> 2 <b>E</b> 2 <b>W</b> 2

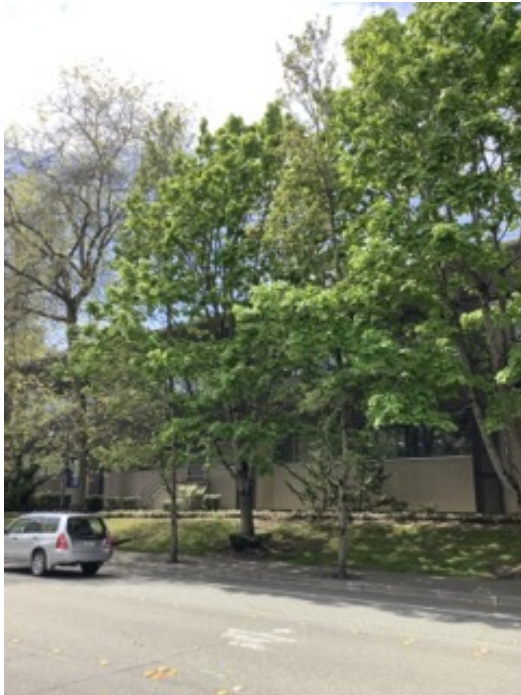
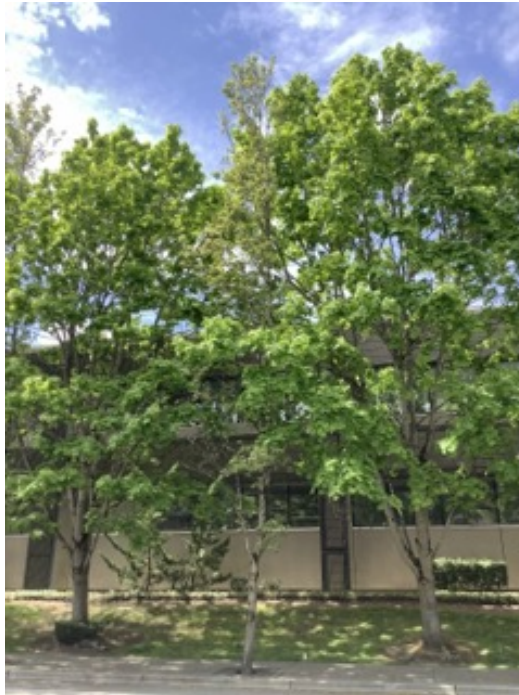
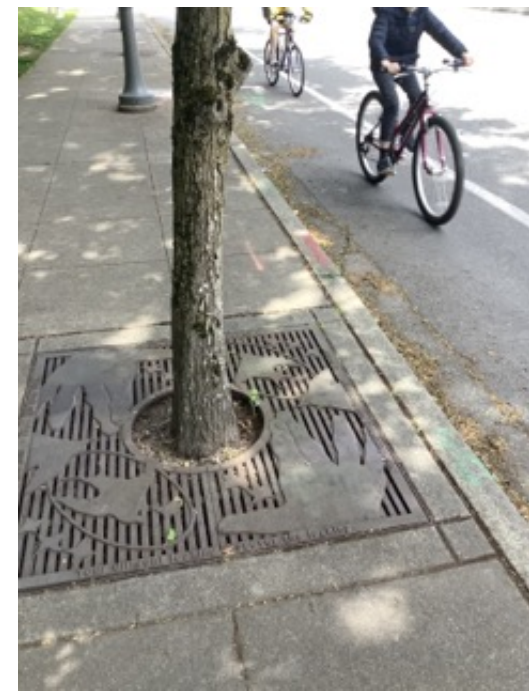
Tree	Species	DBH (in)	Drip Avg (ft)	CRZ (ft)	Vigor	Structure	Risk	Pres. Cat/Value	Recommendations
147	Callery pear var. <i>Prunus calleryana</i> var.	6.5, (6.5)	3.8	6.5	Poor to Fair	Fair	Low	Unknown  Low	
<b>Notes / Defects</b>	The tree has a tall and narrow crown growing up through the maple tree next to it. There is substantial twig dieback and very few scaffold branches.								<b>Dripline (ft)</b> <b>N</b> 4 <b>S</b> 4 <b>E</b> 7 <b>W</b> 0

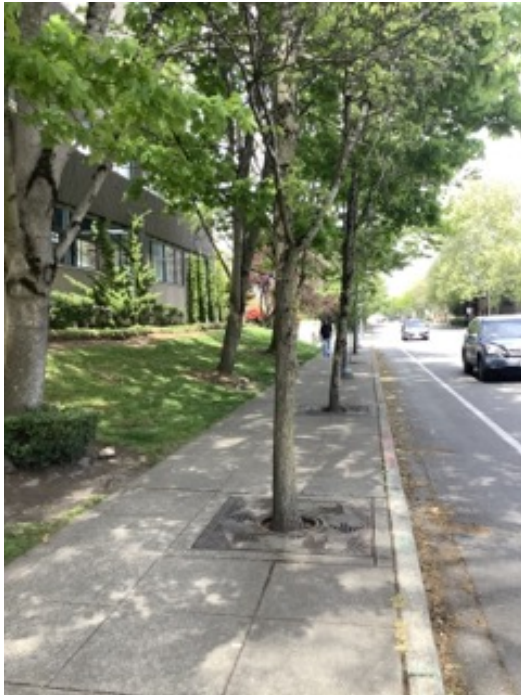
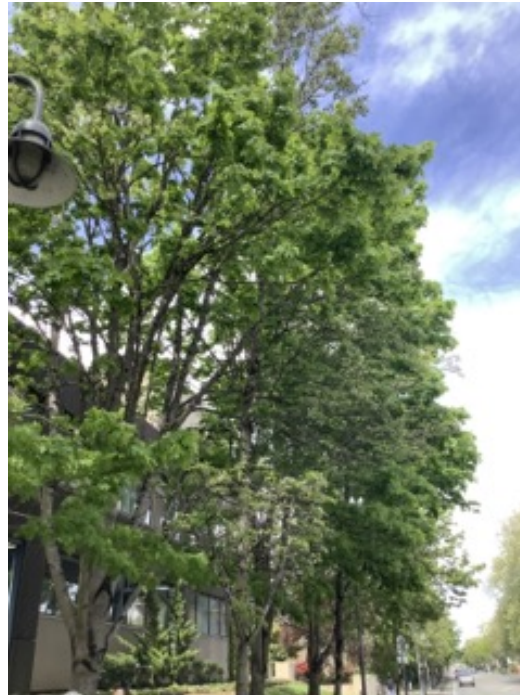
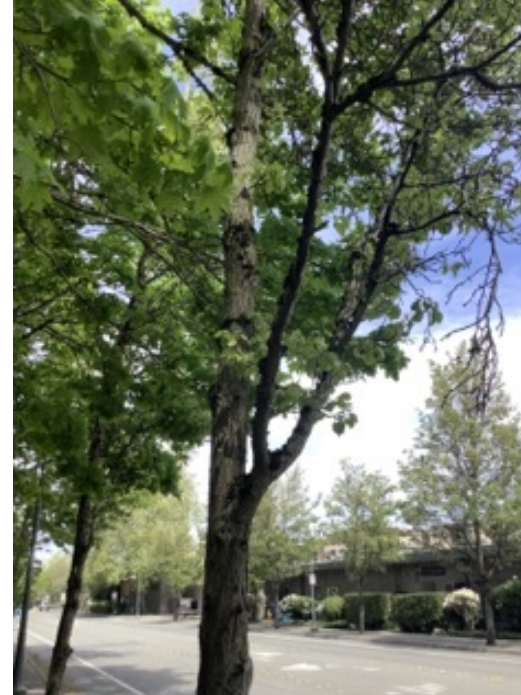
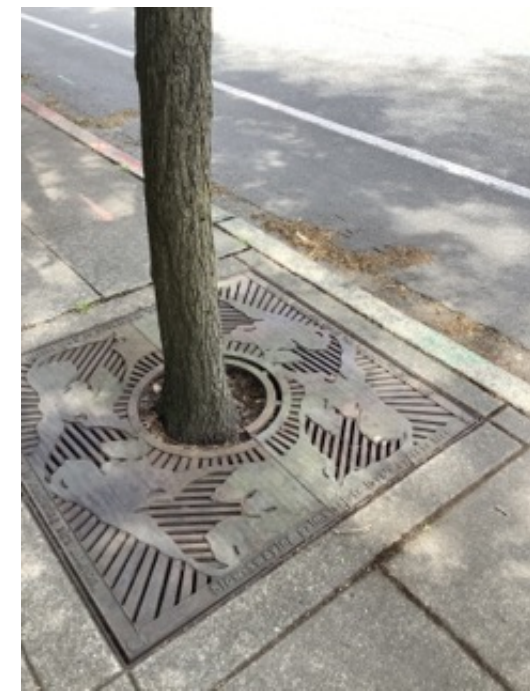
Tree	Species	DBH (in)	Drip Avg (ft)	CRZ (ft)	Vigor	Structure	Risk	Pres. Cat/Value	Recommendations
148	Callery pear var. <i>Prunus calleryana</i> var.	6.7, (6.7)	5.0	6.7	Poor to Fair	Fair	Low	Unknown  Low	
<b>Notes / Defects</b>	The tree has a tall and narrow crown growing through the crown of a maple tree next to it. The pear crown is asymmetrical towards the street.								<b>Dripline (ft)</b> <b>N</b> 4 <b>S</b> 8 <b>E</b> 8 <b>W</b> 0

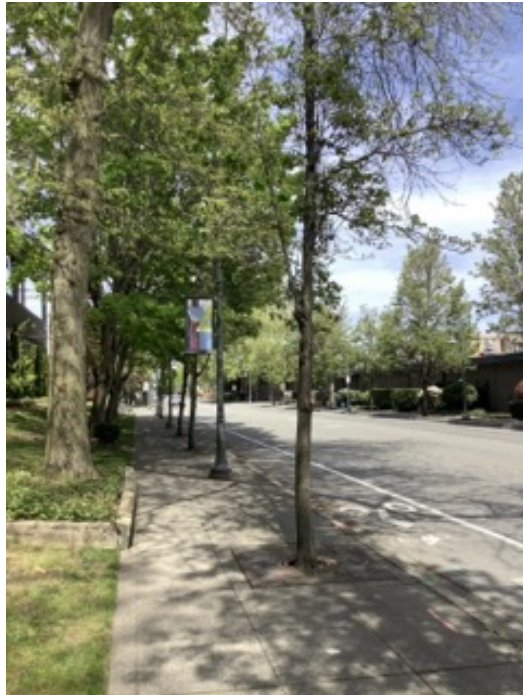
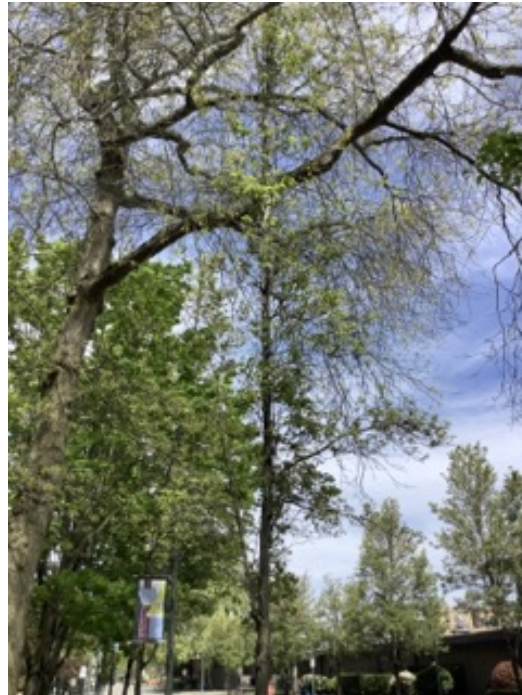
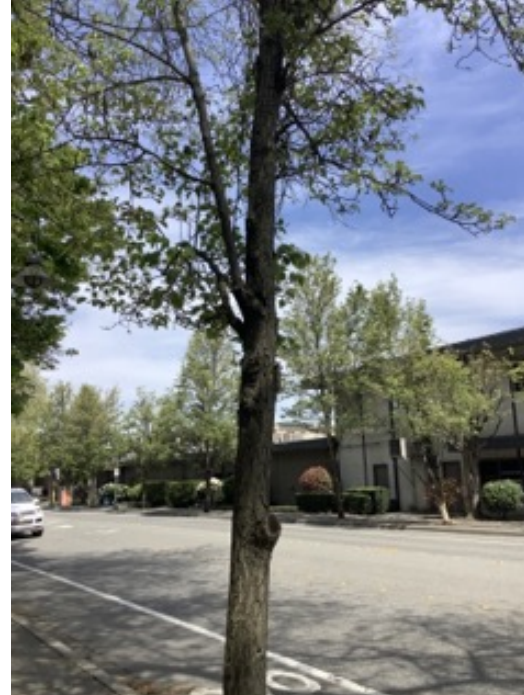
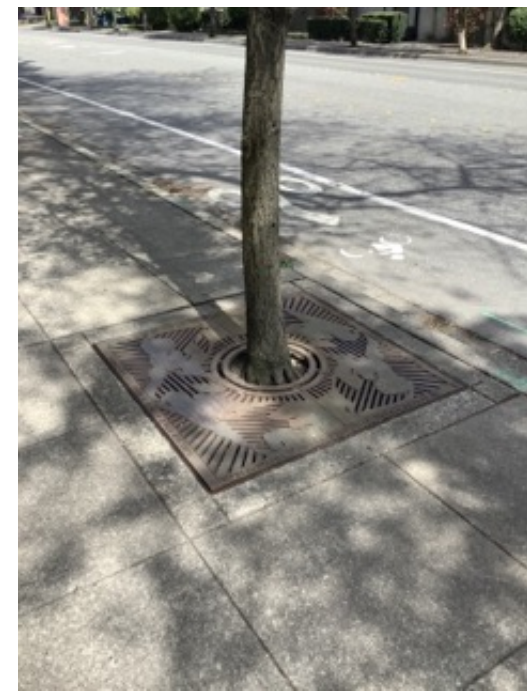
Tree	Species	DBH (in)	Drip Avg (ft)	CRZ (ft)	Vigor	Structure	Risk	Pres. Cat/Value	Recommendations
149	Callery pear var. <i>Prunus calleryana</i> var.	5.7, (5.7)	5.0	5.7	Fair	Fair	Low	Unknown  Low	
<b>Notes / Defects</b>	The tree has a tall and narrow crown growing upward through the oak tree crown next to it.								<b>Dripline (ft)</b> <b>N</b> 5 <b>S</b> 5 <b>E</b> 5 <b>W</b> 5

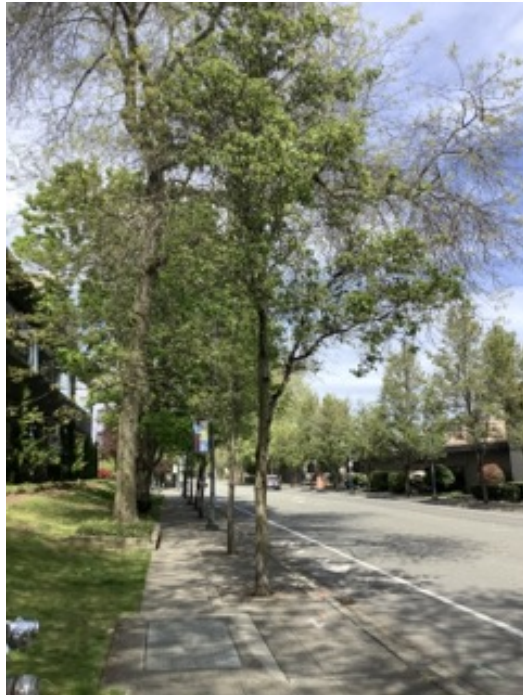
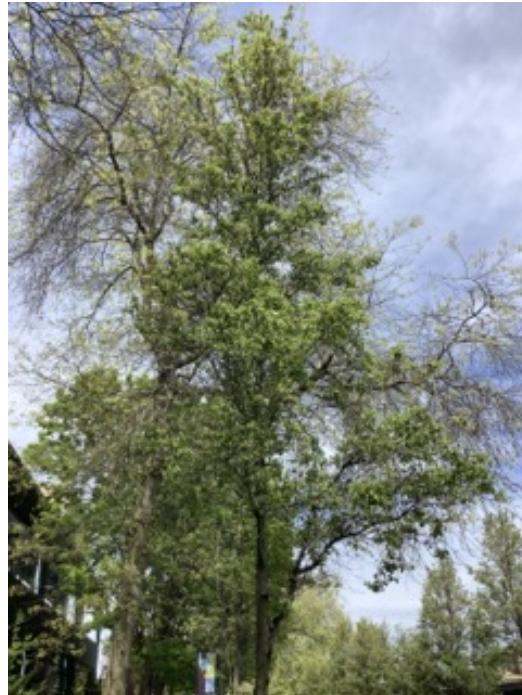
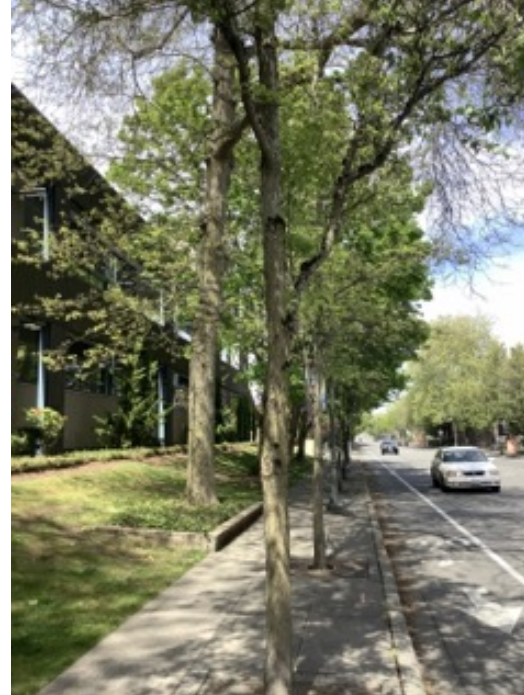
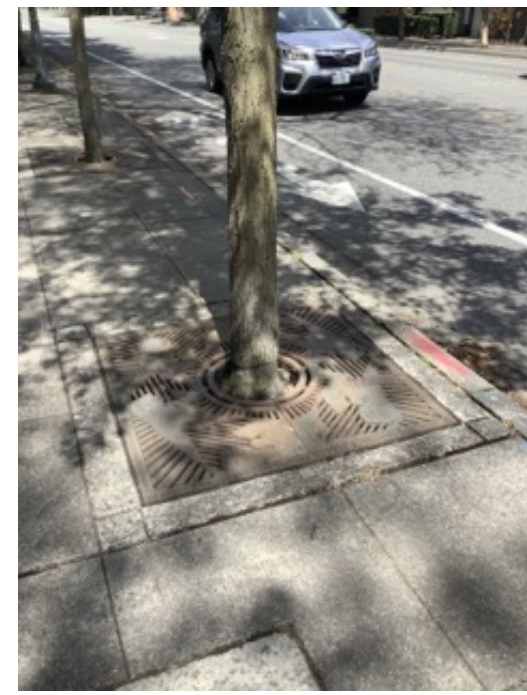
Tree	Species	DBH (in)	Drip Avg (ft)	CRZ (ft)	Vigor	Structure	Risk	Pres. Cat/Value	Recommendations
150	Callery pear var. <i>Prunus calleryana</i> var.	7.5, (7.5)	6.5	7.5	Good	Fair to Good	Low	Unknown  Low	
<b>Notes / Defects</b>	The tree is leaning slightly and has an asymmetrical crown towards the street. The trunk is slightly swollen at the base at what looks to be a root grafting scar.								<b>Dripline (ft)</b> <b>N</b> 2 <b>S</b> 9 <b>E</b> 9 <b>W</b> 6
