City of Mercer Island

# ADA Transition Plan

2022

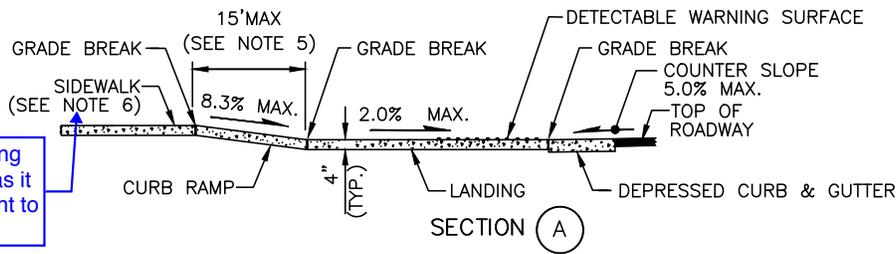
Recommend removing reference to note 6 as it doesn't seem relevant to the sidewalk.

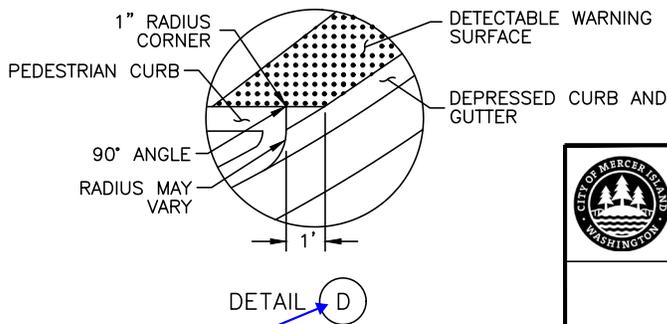
Suggest changing to "B".

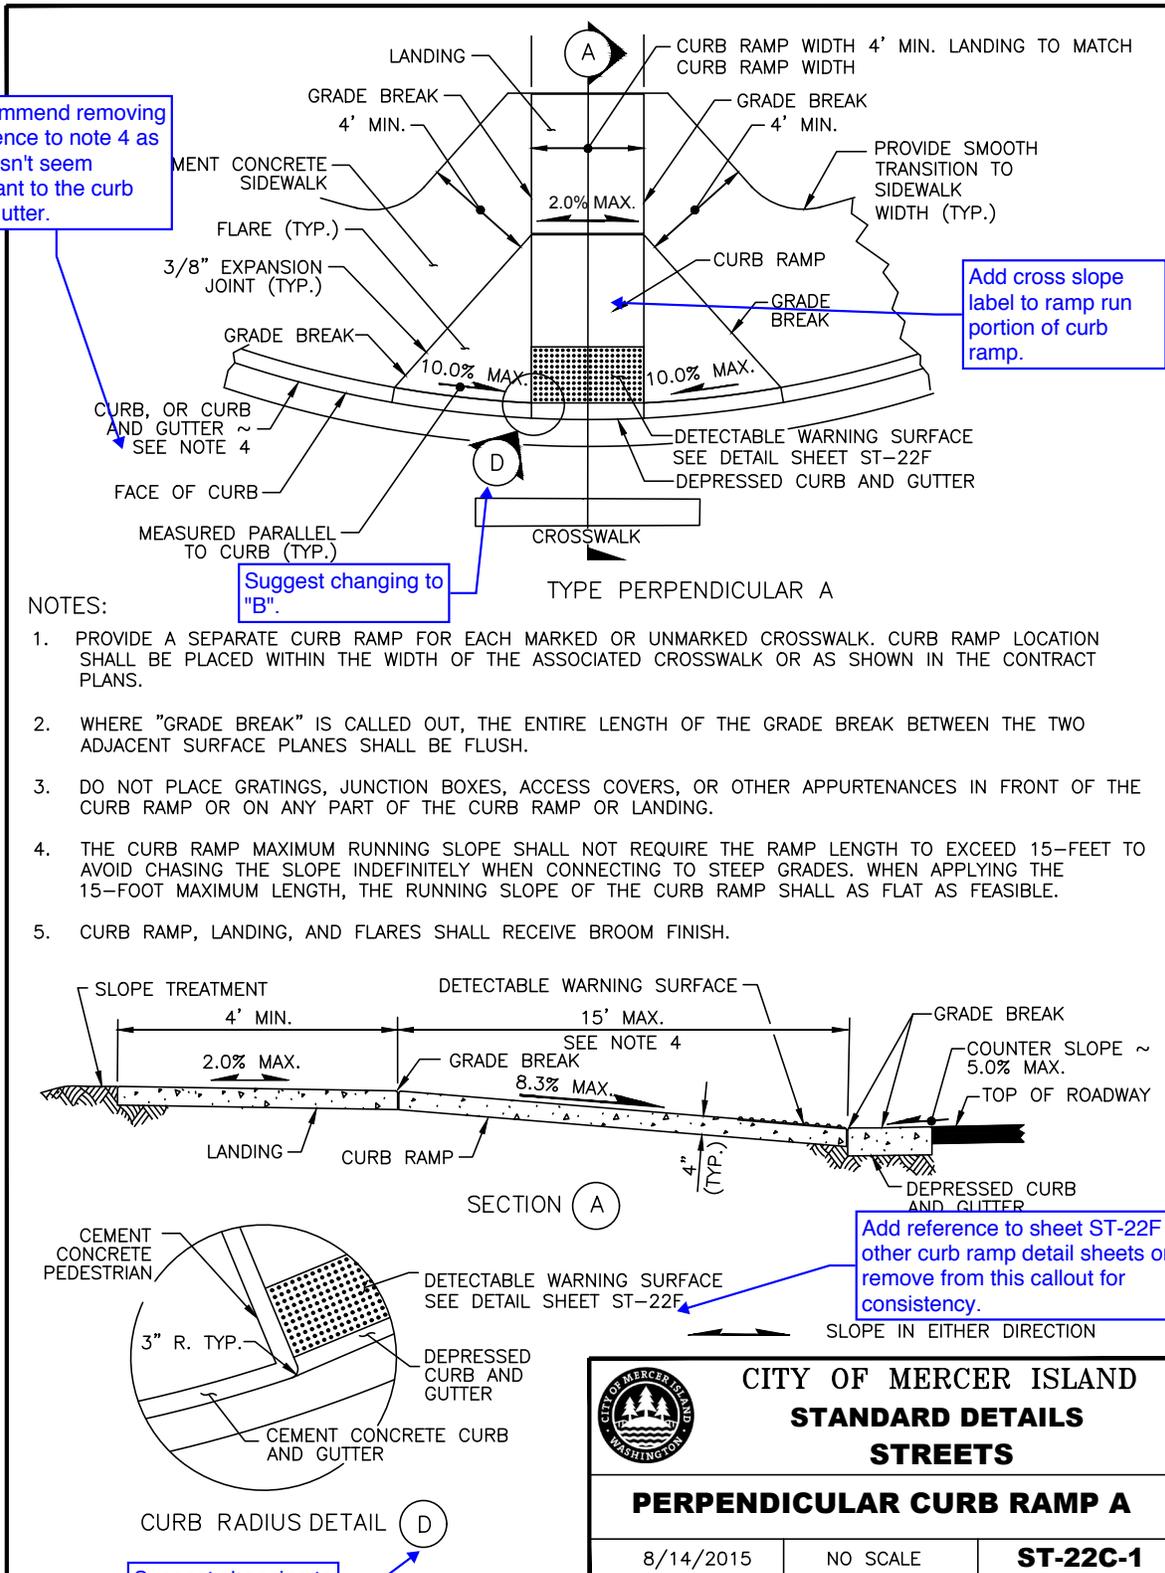
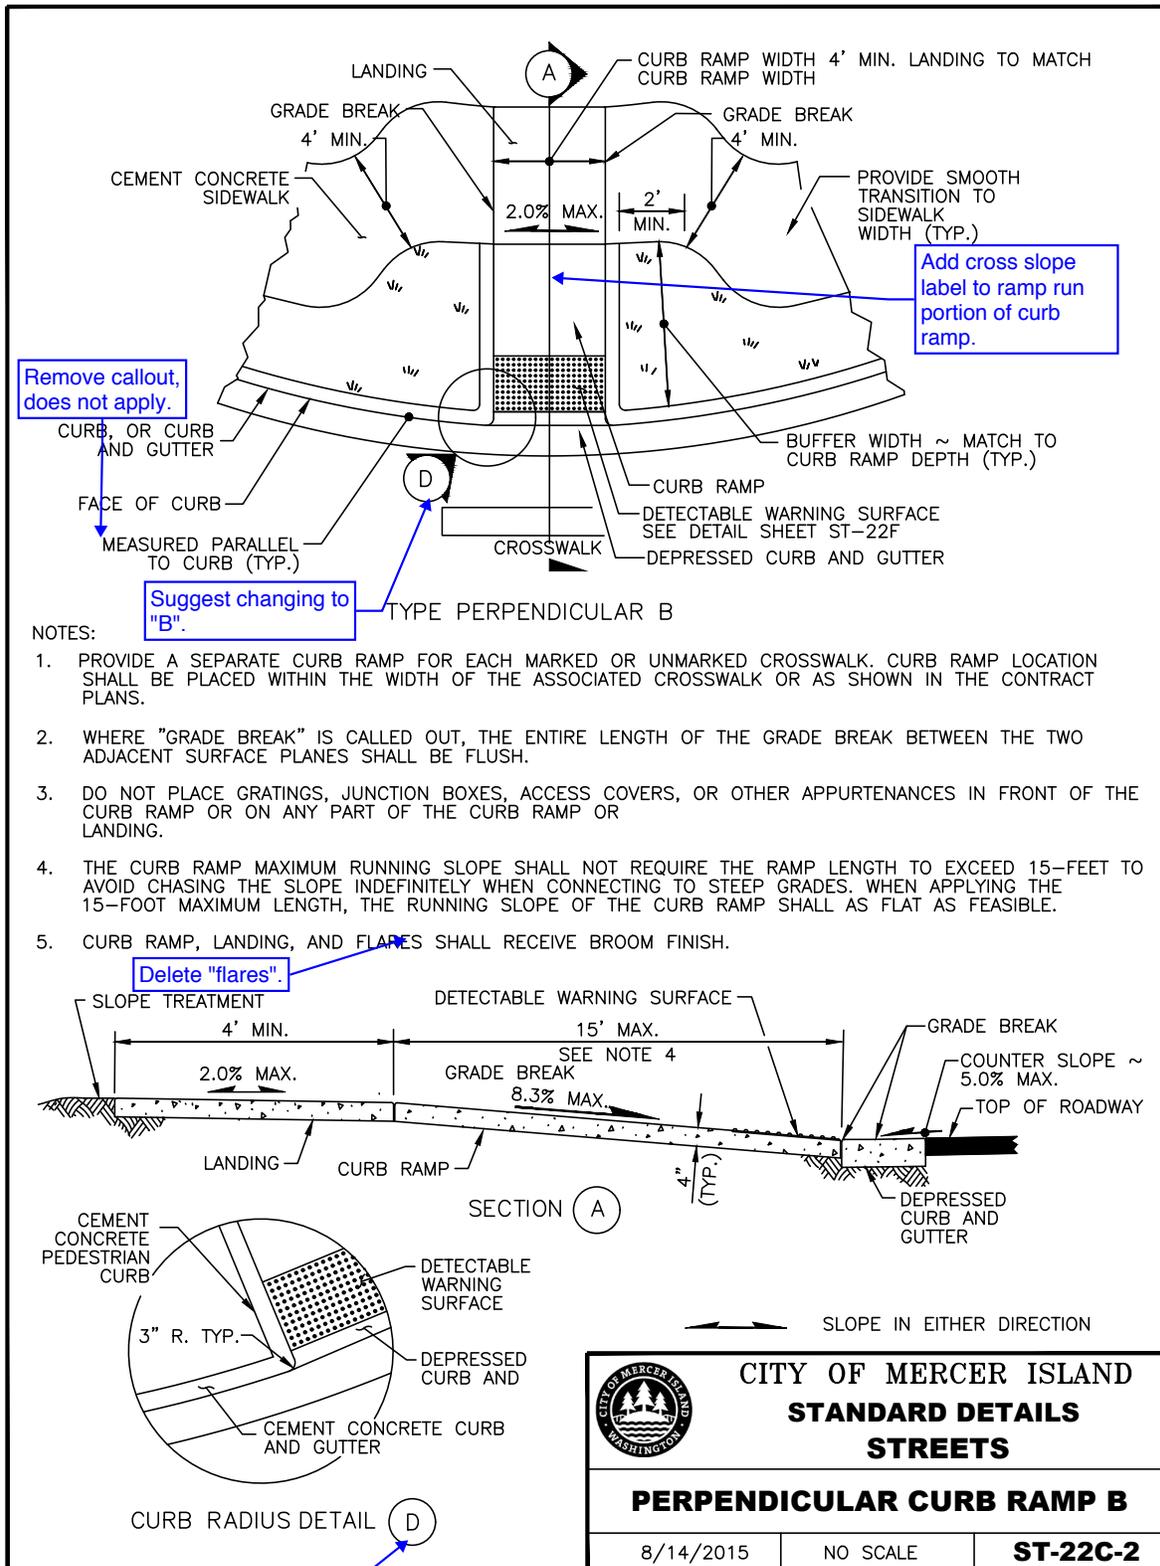
Add reference to Detail Sheet ST-22F to callout to match other curb ramp detail sheets.

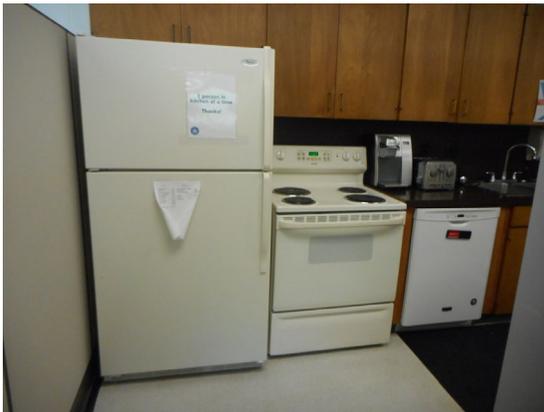
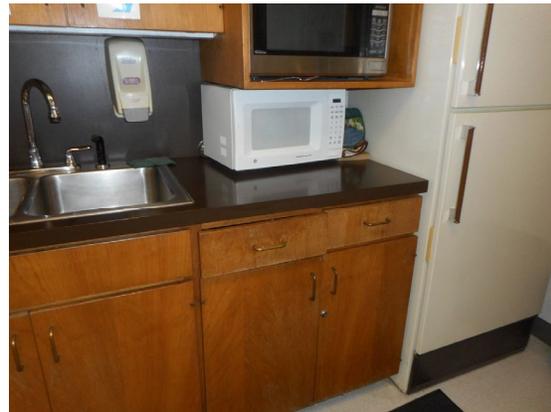
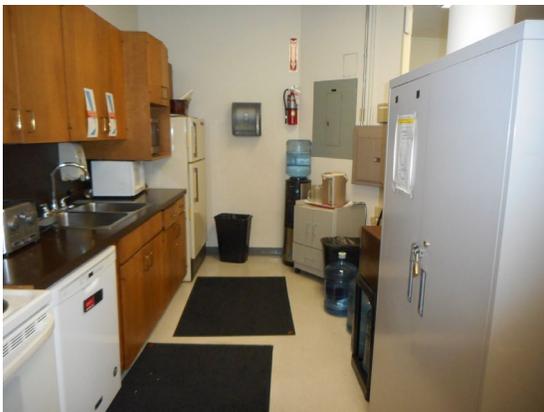
**Maintenance Building**

- Upper Left: Kitchen range has controls that require a reach over the burners. Kitchens with cooktops require an adjacent work surface with knee & toe space.
- Upper Right: Sink is 36" AFF (34" max. required). Outlets and switches mounted above countertop are not accessible for a side reach due to countertop height & depth.
- Lower Left: Metal cabinets and water bottles block the required turn-around space. Paper towel dispenser and fire extinguisher are mounted too high.

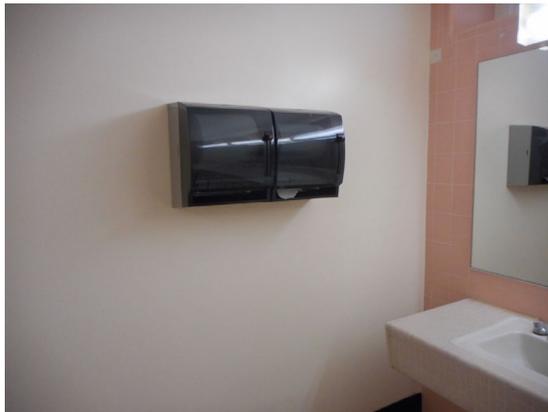
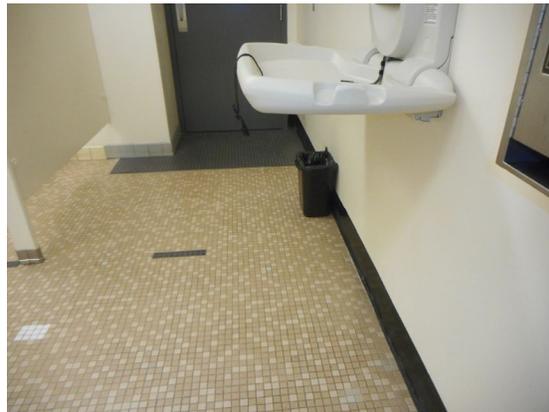
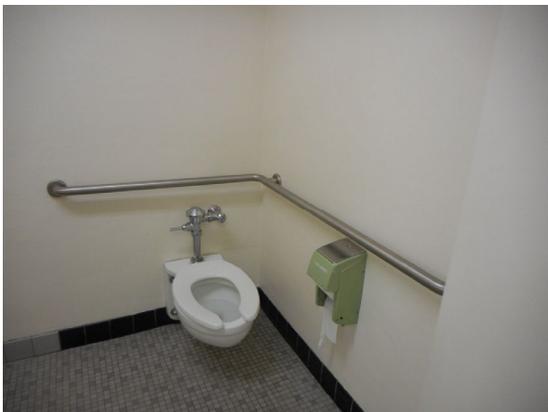
**City Hall**

- Upper Left: Dispensers present protruding object hazard, requiring relocation or permanent barrier located below.
- Upper Right: Baby changing tables require relocation due to height.
- Lower Left: Wheelchair accessible toilets are required to be 16" min. - 18" max. from side wall. Relocation required at some toilets.

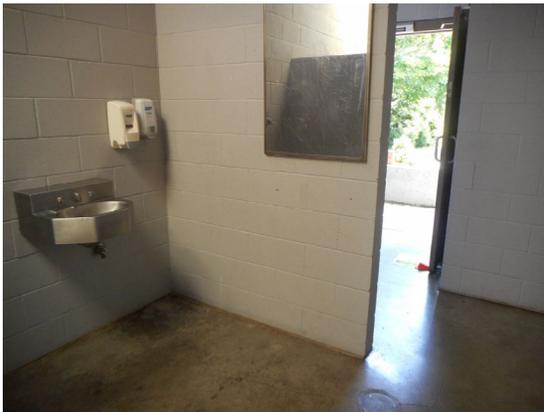
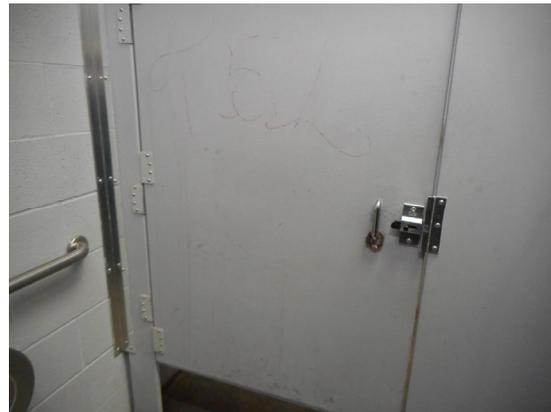
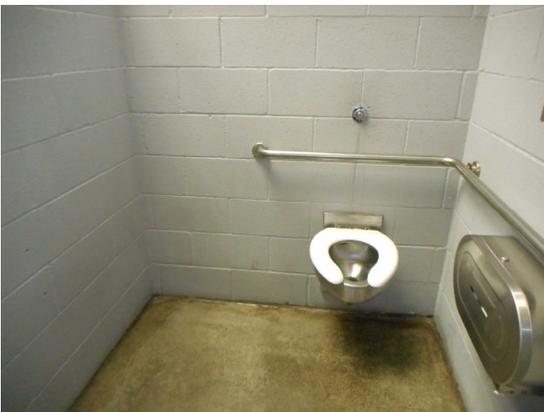
**Aubrey Davis Park**

- Upper Left: Mirrors in both restrooms by Feroglia Fields should be relocated to above sinks at 40" max. AFF.
- Upper Right: Doors are located on wrong side of accessible stalls at restrooms by Feroglia Fields and should be relocated.
- Lower Left: Flush control in Women's restroom by Feroglia Fields should be repaired or replaced due to operation difficulty.

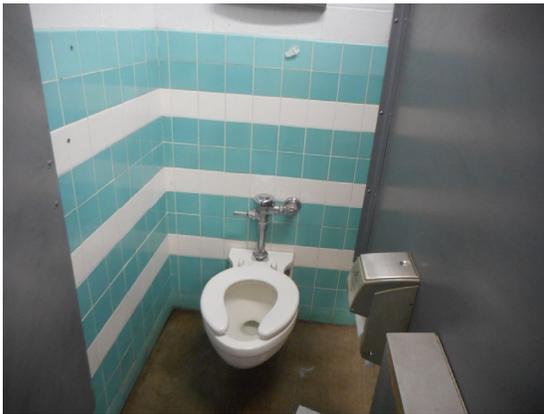
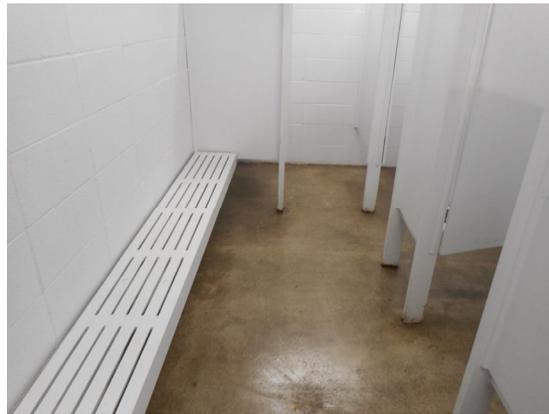
**Groveland Beach Park**

Upper Left: Restrooms are substantially non-compliant. Accessible stall in the Women's restroom is too small, grab bars are missing, flush control is incorrectly located. The Men's restroom lacks a turn-around.

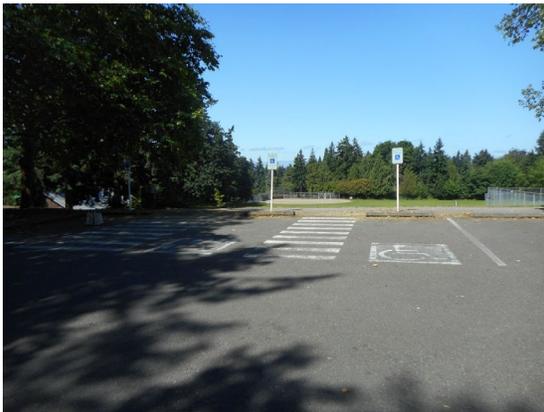
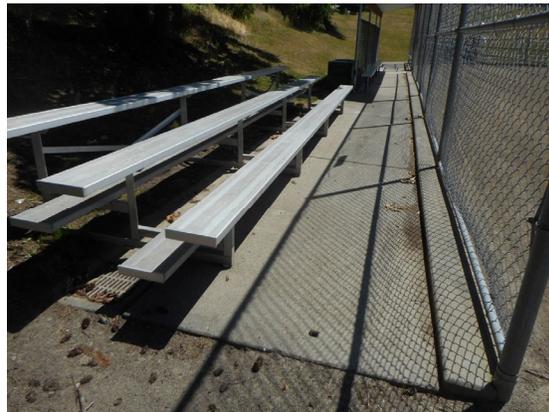
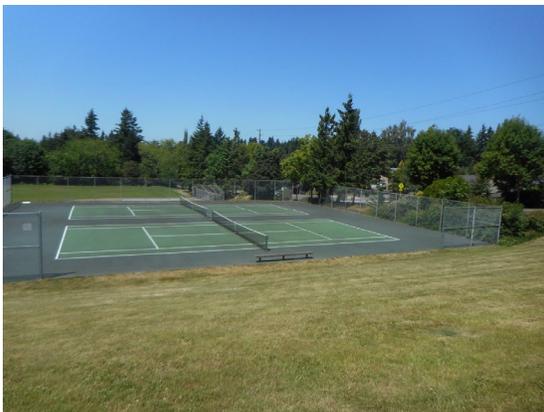
**Homestead Park**

- Upper Left: Parking signs are mounted too low. Bottom to be 60" min. above paving.
- Upper Right: Bleachers require wheelchair seating (with signage).
- Lower Left: Tennis courts lack an accessible route.

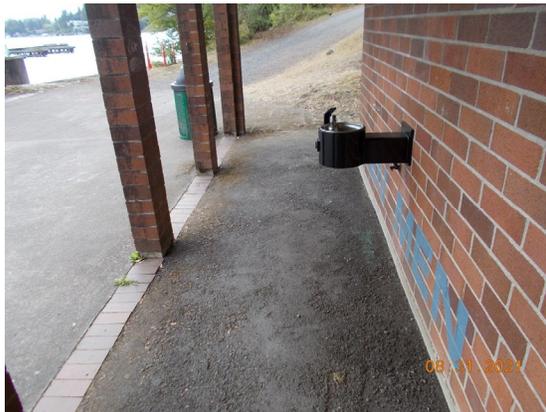
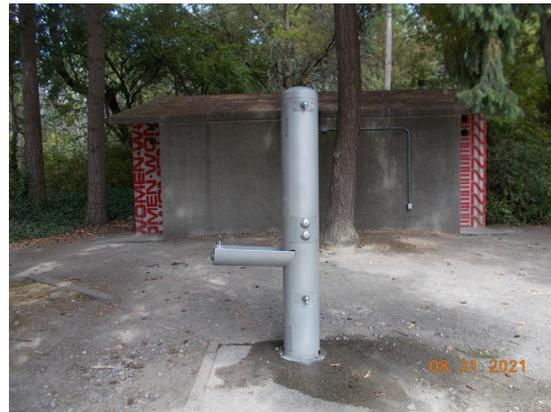
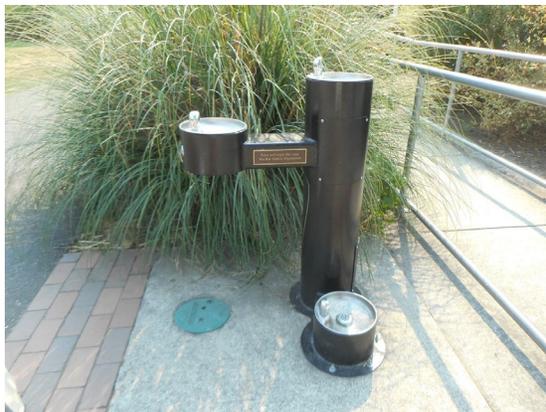
**Luther Burbank Park**

- Upper Left: Only low level drinking fountain is provided near old boiler room. Hi-low drinking fountain required.
- Upper Right: Drinking fountain with foot rinse and shower lacks a high level drinking fountain.
- Lower Left: The hi-low fountain near the tennis courts has a clear floor space with excessive slope that affects the height of the fountain, resulting in a protruding object hazard.

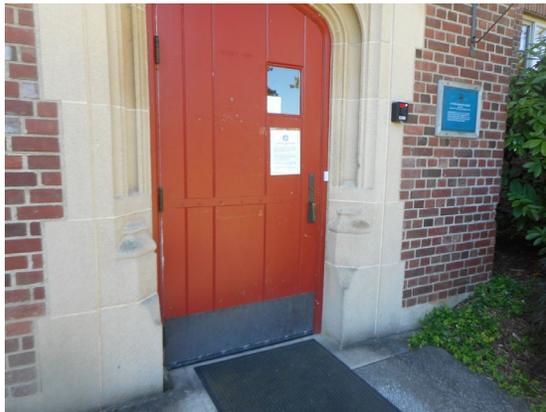
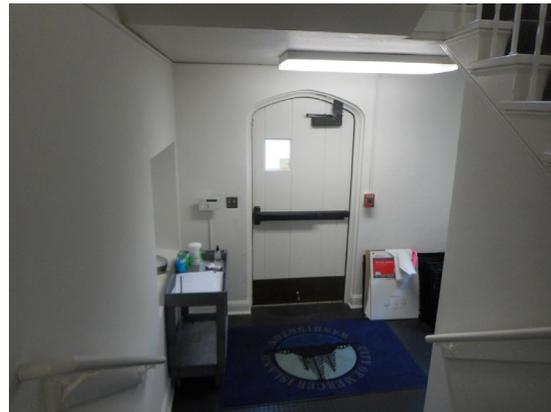
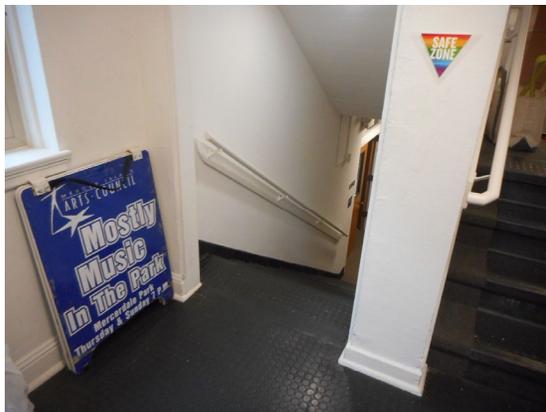
**Luther Burbank Park Administration Building**

Upper Left: North entry door is recessed 12" from brick façade. To preserve historic doorway, power operator would be required.

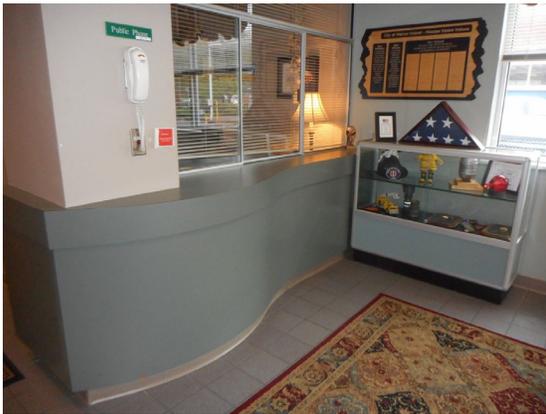
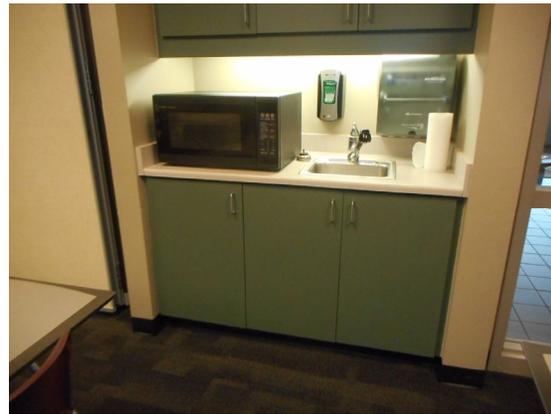
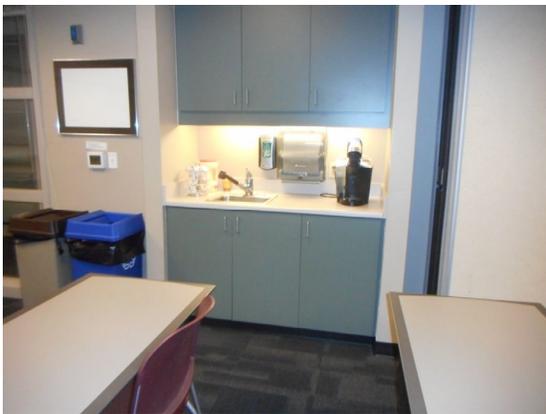
**Main Fire Station #91**

- Upper Left: Service counter accommodates clear floor space, but curved configuration prevents a parallel approach.
- Upper Right: Meeting room has a movable partition divider, separating it into 2 rooms. Each of these rooms has a wet bar with a sink at 36" AFF. Sinks are required to be 34" max. AFF.
- Lower Left: See above.

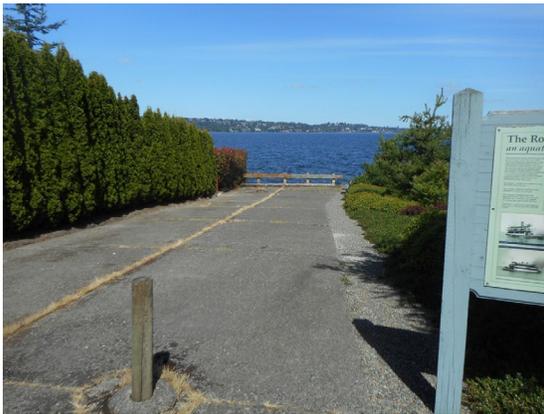
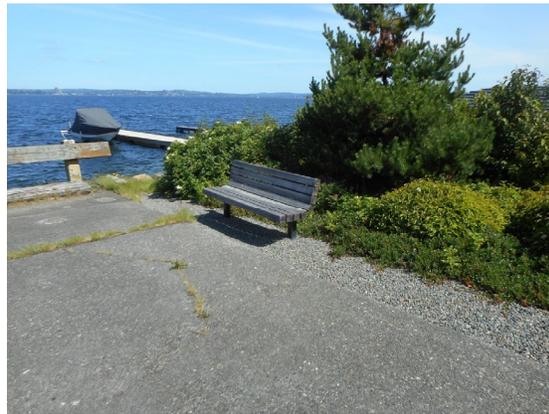
**Roanoke Landing**

- Upper Left: Roanoke Landing. I
- Upper Right: The bench requires an adjacent clear floor space (concrete pad) at one end. Loose gravel is adjacent to each side of the bench.
