Mercer Island Pipeline Shutdown

What Happened, Lessons Learned, Next Steps

April 2023

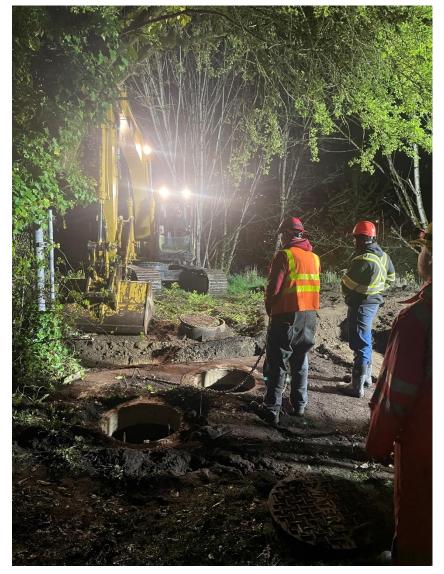
Valve vault before excavation

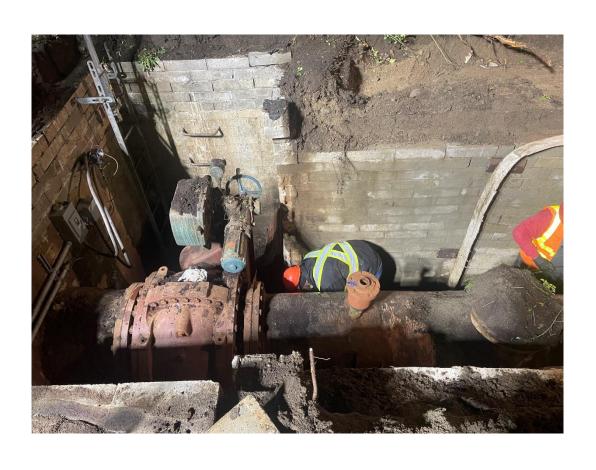
Valve vault after concrete lids removed

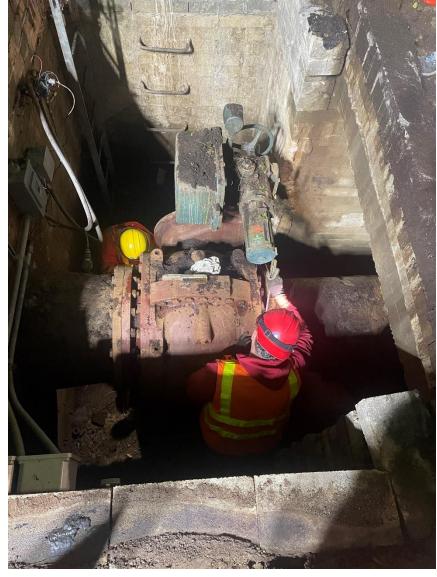
- Valve at SE 120th Ave did not open on Tuesday morning
- Took crews several hours to diagnose that actuator was OK, gearing was OK – valve body and stem were not moving
- It's a ball valve without a bypass line no way to provide even a little water around it if it fails
- We had opened and closed that valve twice in 2022, no issues

24-in ball valve that stuck closed

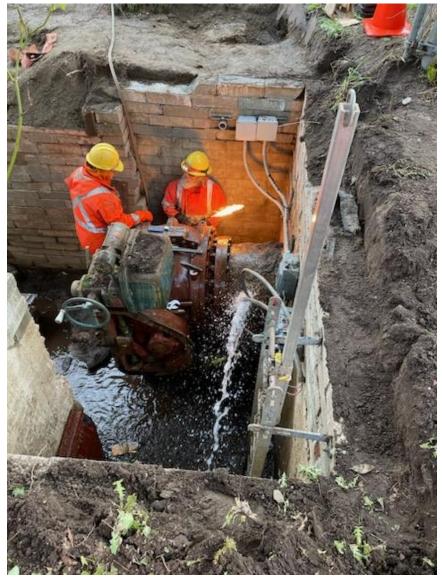
Removing 24-in ball valve

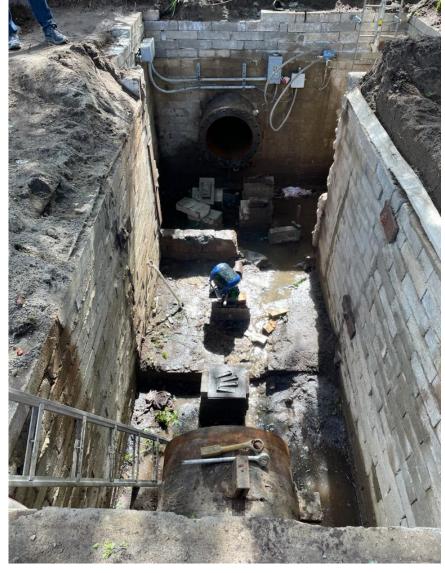
Vault cleared

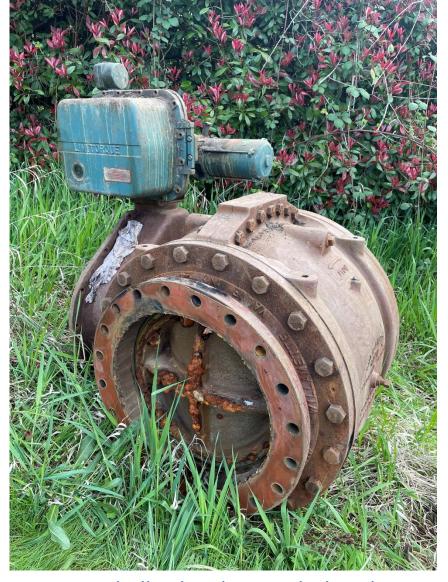
24-in ball valve that stuck closed

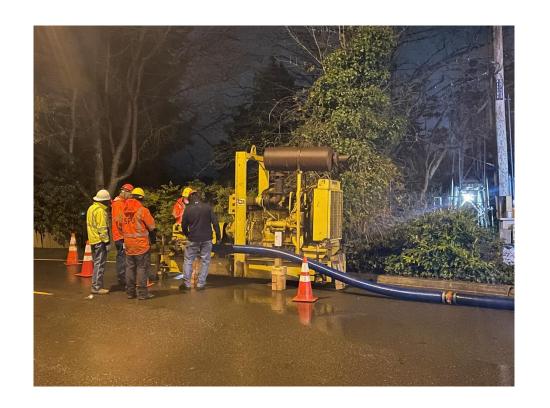
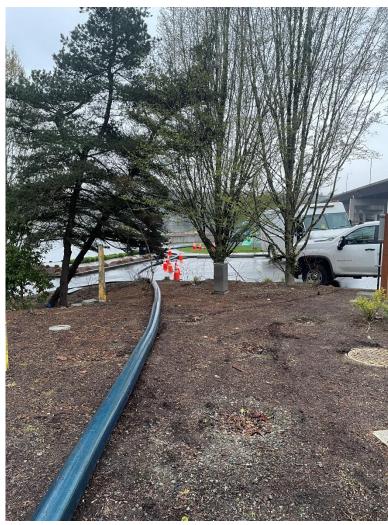
- The bypass pumping required too much water from Bellevue Enatai – decreased their system pressure too low
- The pumping required higher discharge pressure than the discharge hose could tolerate
 - Required 175 psi; at about 150 psi the discharge hose tends to fail at couplings
- Need to plan a better bypass plan for next time, as a contingency plan

Bypass pumping setup from Bellevue Enatai to Mercer Island

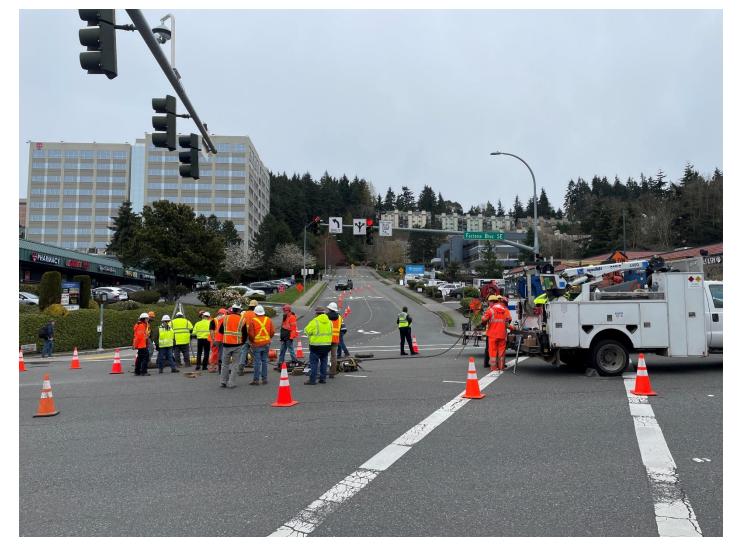
- Opening the valve at Factoria:
 - Valve closed smoothly for shutdown
 - Opened about 30 turns out of about 300 and stopped moving
- Also a ball valve, no bypass line around it
- Crews scrambled to take the valve apart enough to find the piece that had stripped a gear, turn the valve by hand and lock it open in place
- We had opened and closed that valve previously, but only down to 50% closed; last exercised about 10 years ago
- Valve exercising program needs attention

Valve that opened to 10% then froze is in the middle of the intersection in Factoria

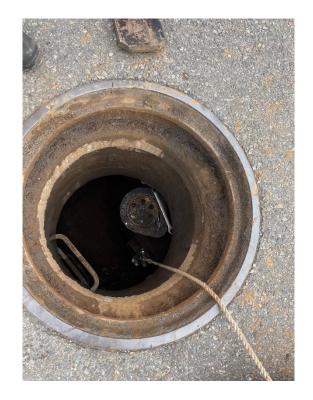
Exposed gear at top of valve

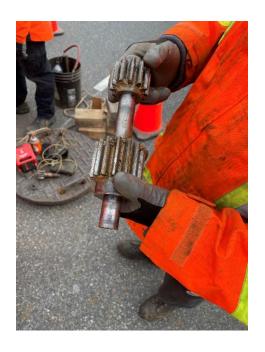
Shear pin broke - top shaft gear came loose (by design to protect gears from damage)

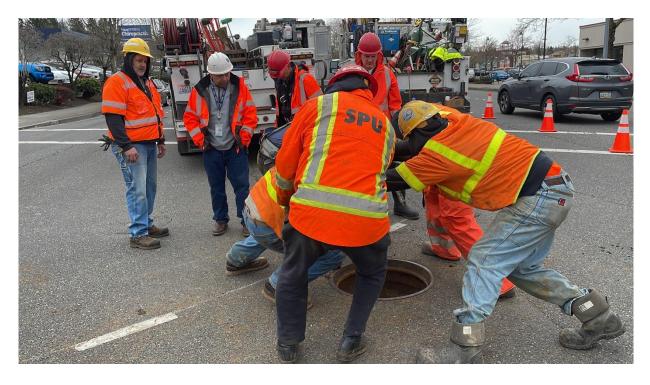
Crews manually turning the valve using a t-wrench attached to the top valve gear
