Mercer Island Pipeline Shutdown

What Happened, Lessons Learned, Next Steps

April 2023

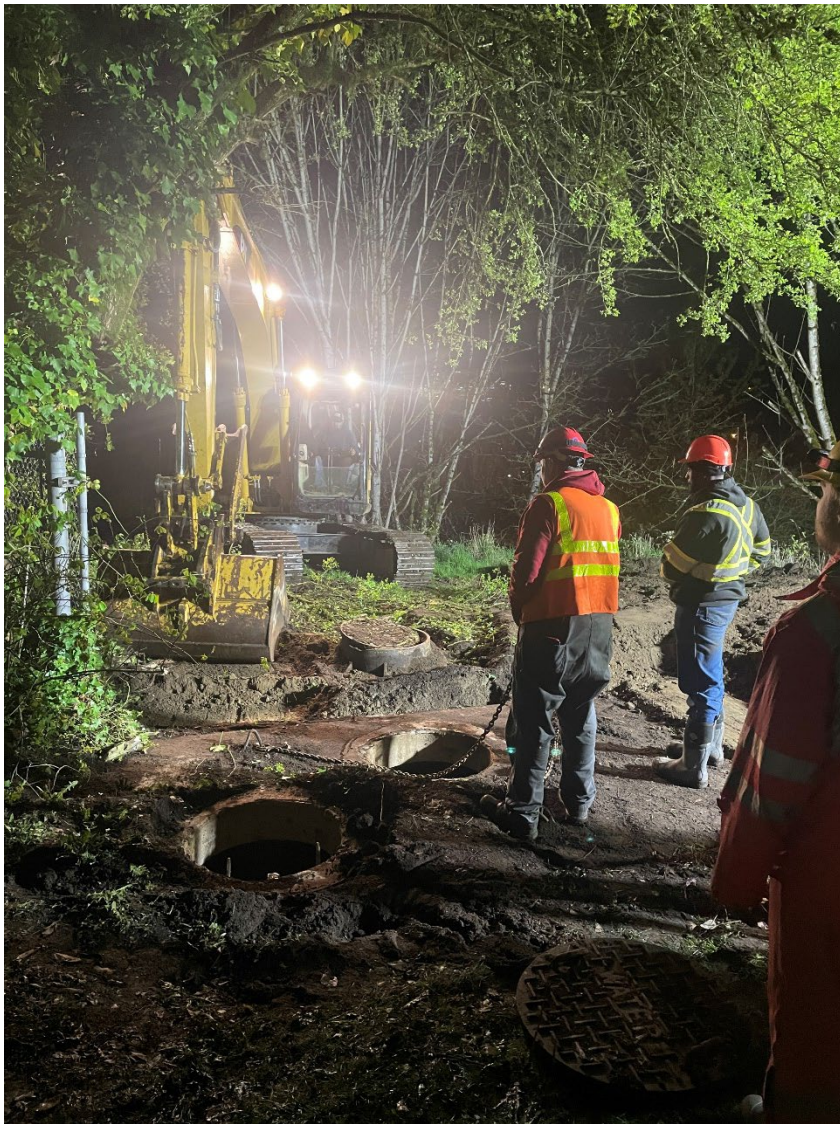
Valve vault before excavation

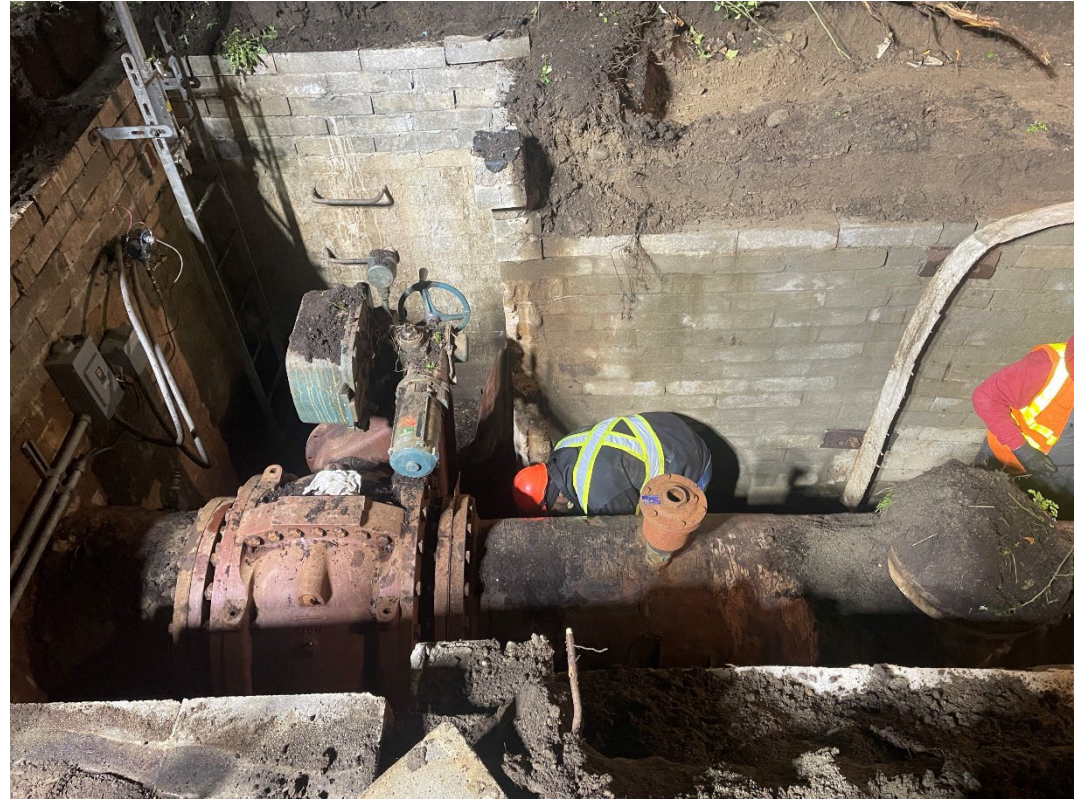
Valve vault after concrete lids removed

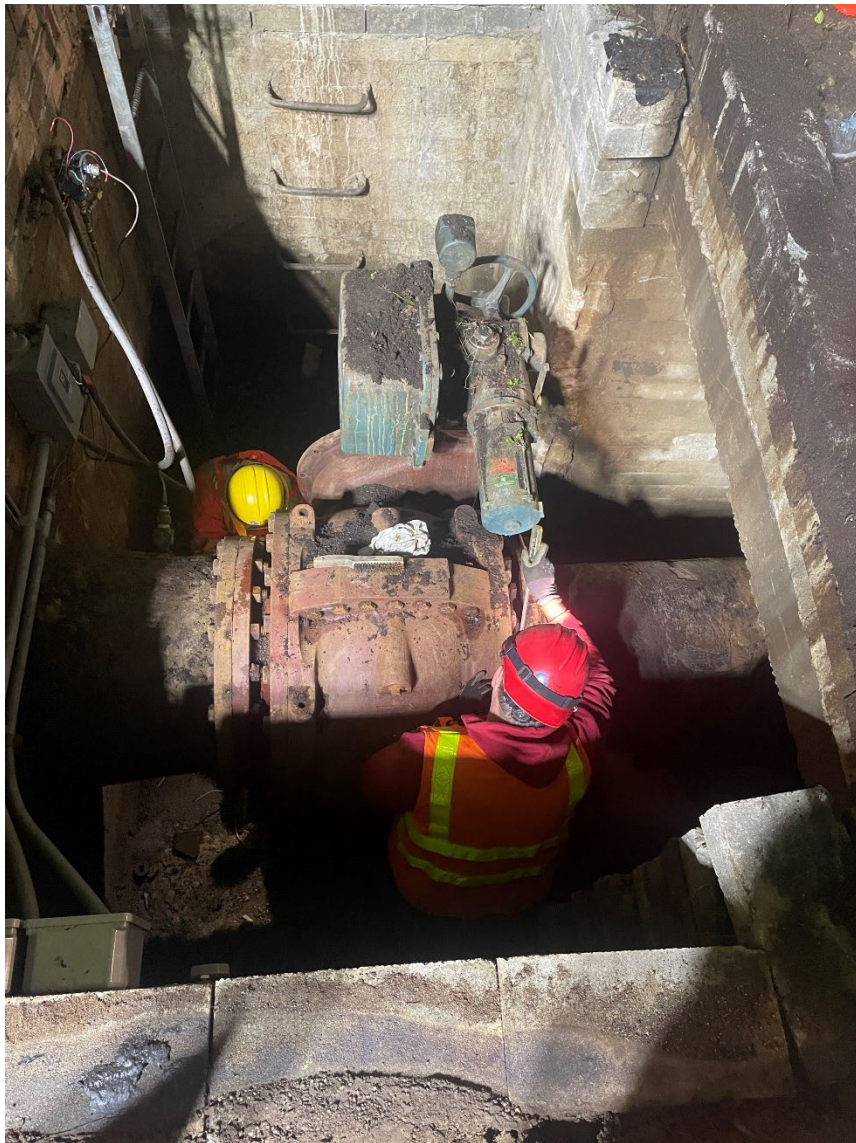
- Valve at SE 120th Ave did not open on Tuesday morning
- Took crews several hours to diagnose that actuator was OK, gearing was OK – valve body and stem were not moving
- It's a ball valve without a bypass line – no way to provide even a little water around it if it fails
- We had opened and closed that valve twice in 2022, no issues

24-in ball valve that stuck closed

- Plan A: close upstream valve at Factoria, dig up and remove the vault lids, remove valve, replace with another valve
- Plan B: provide some bypass pumping from Bellevue at Enatai to Mercer Island

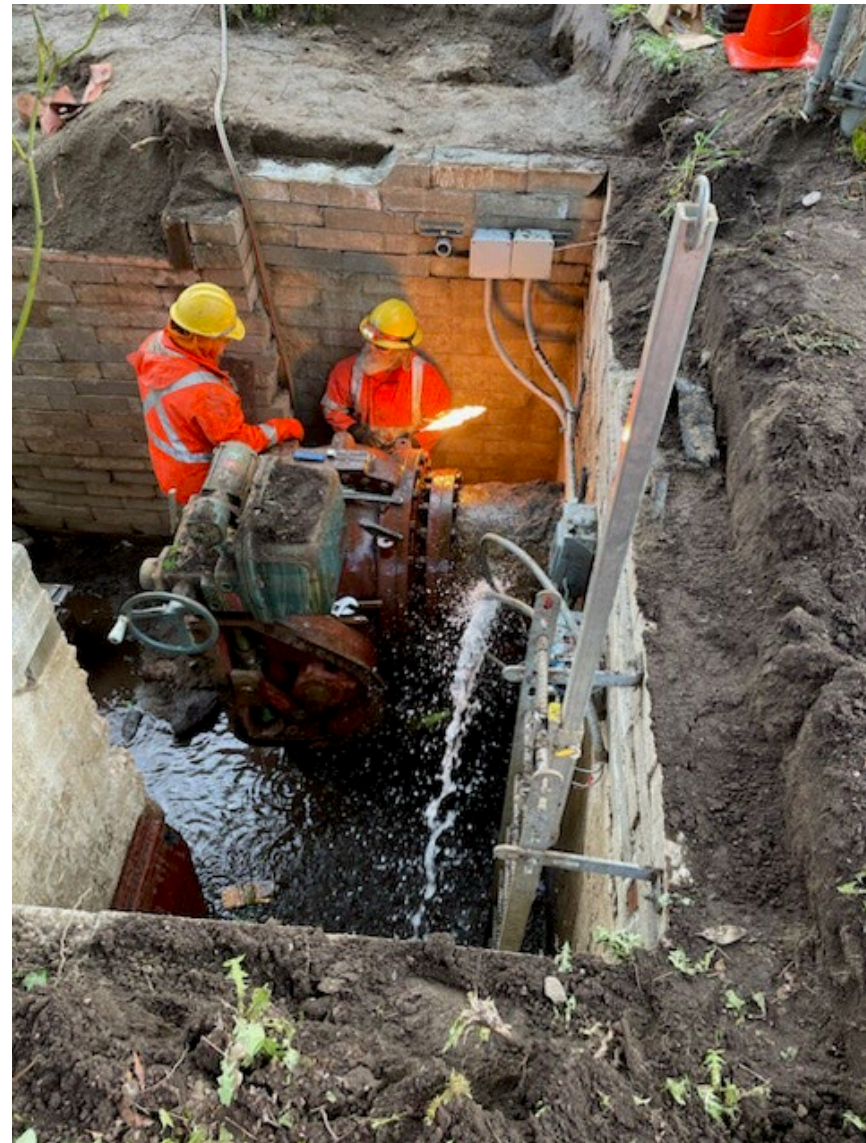
Removing 24-in ball valve

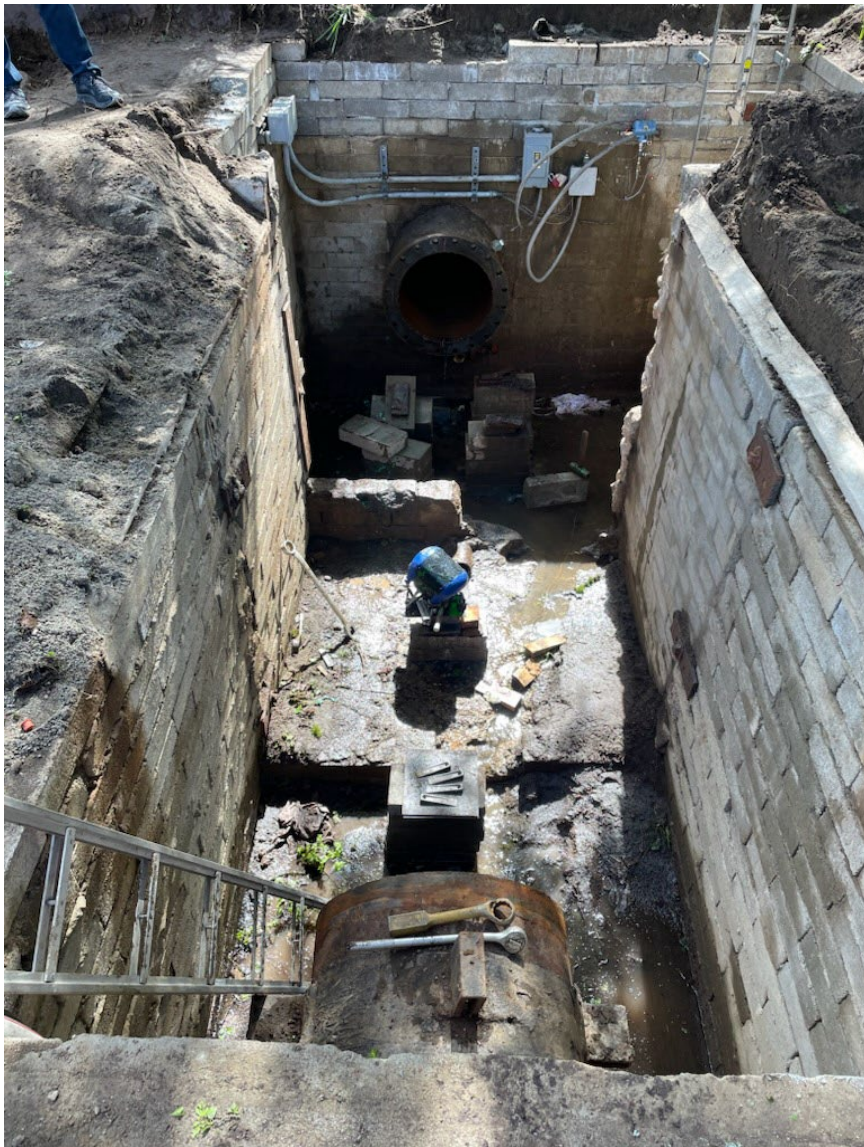
Vault cleared

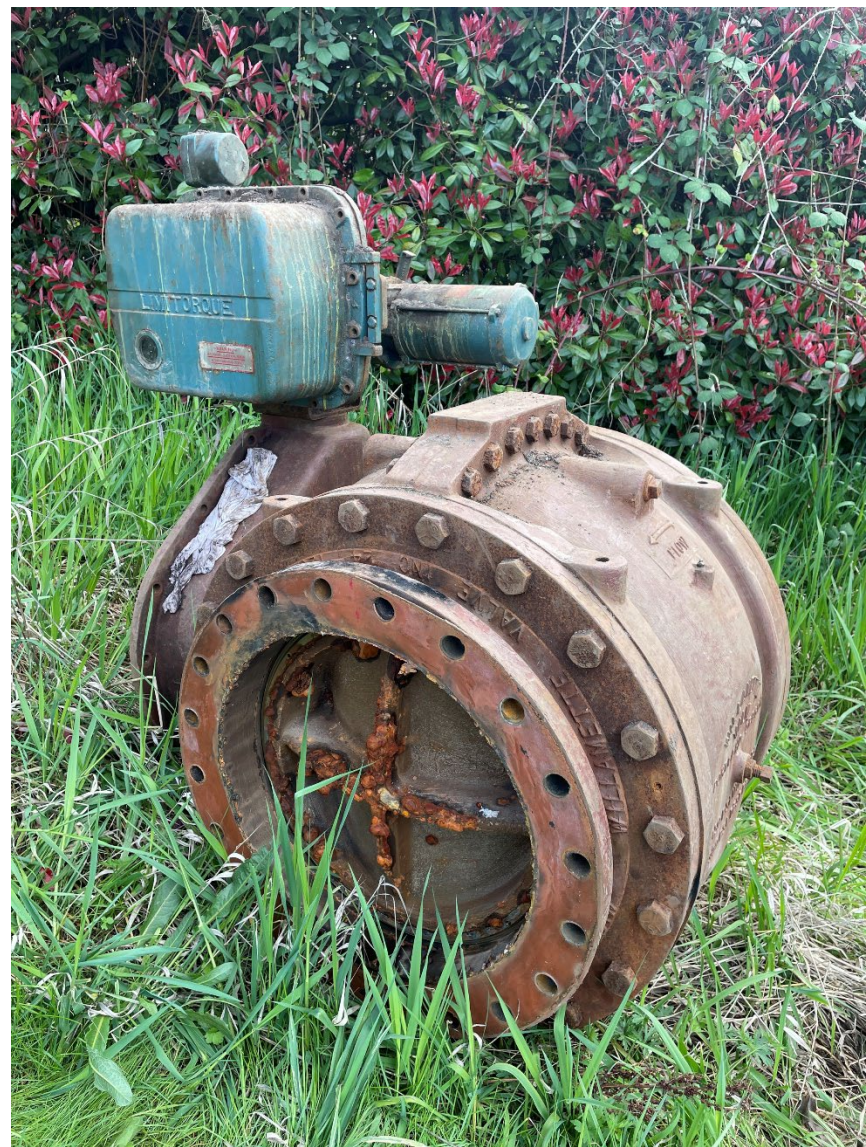
24-in ball valve that stuck closed

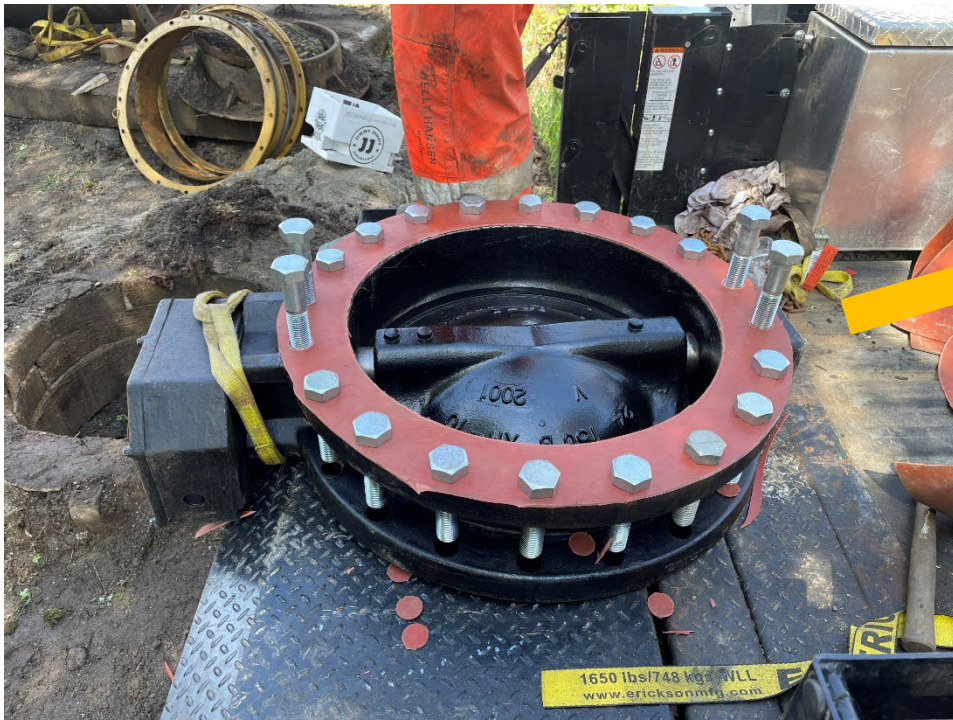
Replacement 24-in butterfly valve

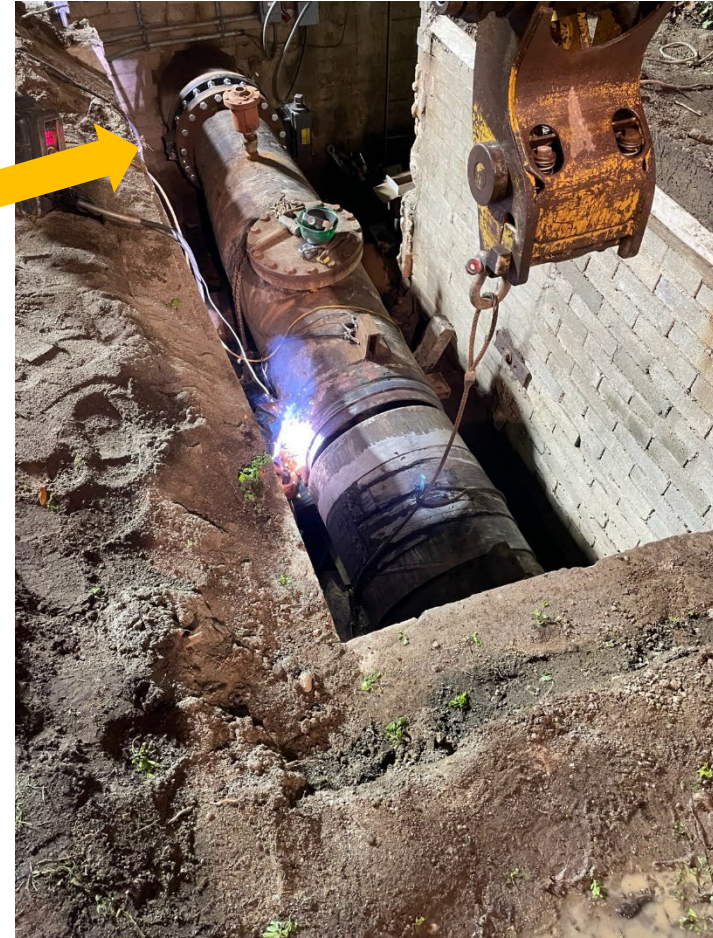
Replacement 24-in butterfly valve in place and piping welded back together

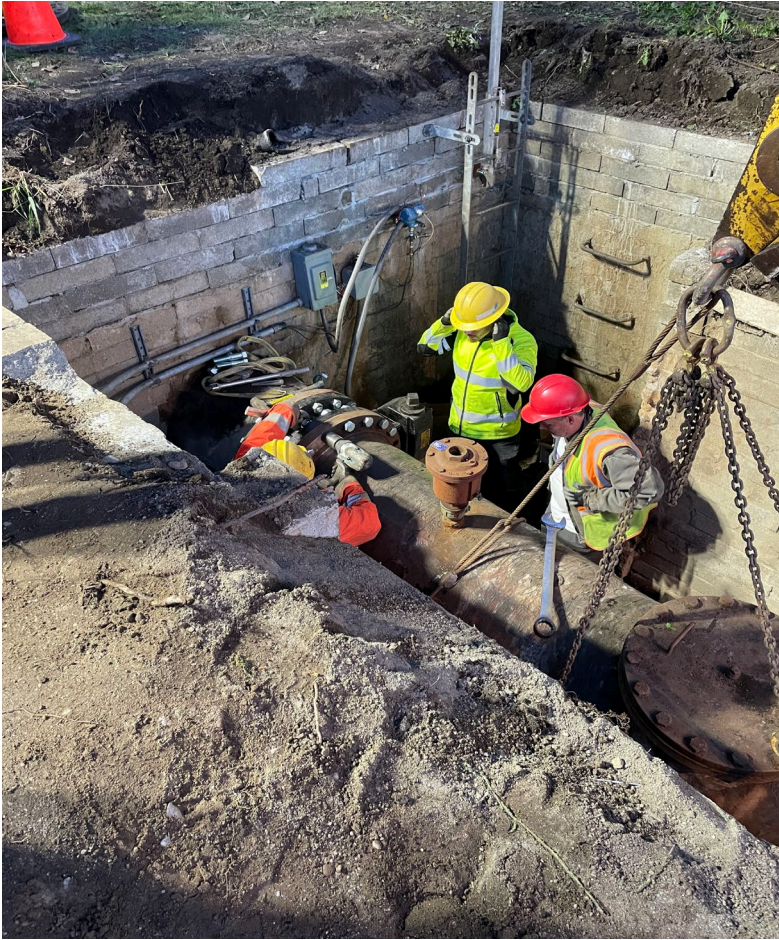
Re-assembly with 24-in butterfly valve

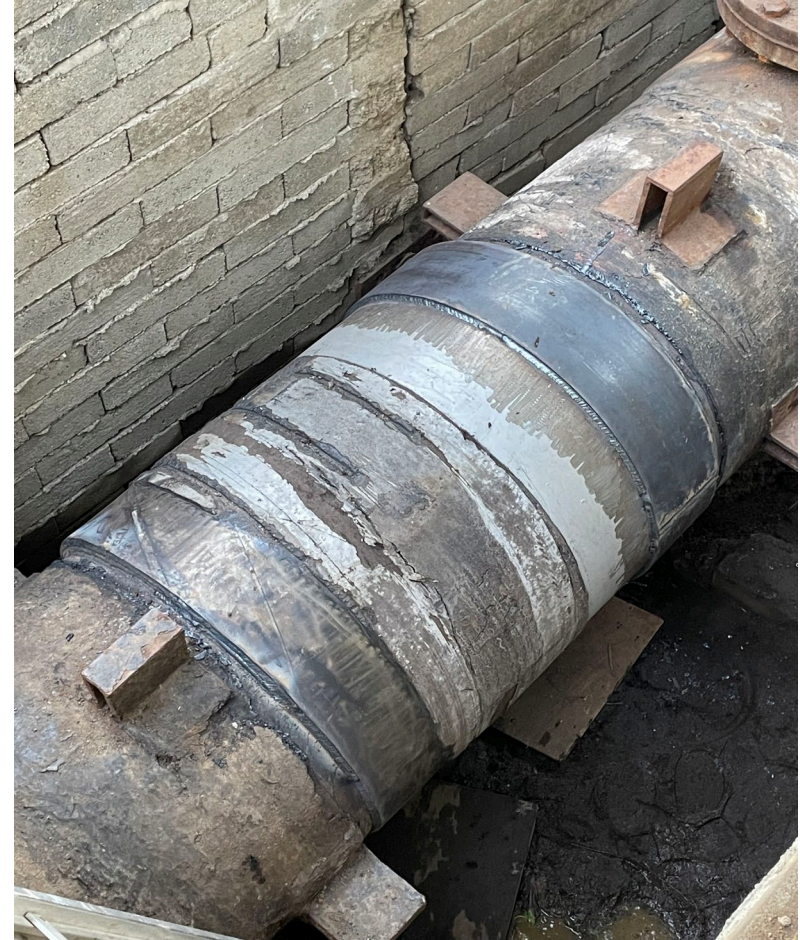
Final welding complete

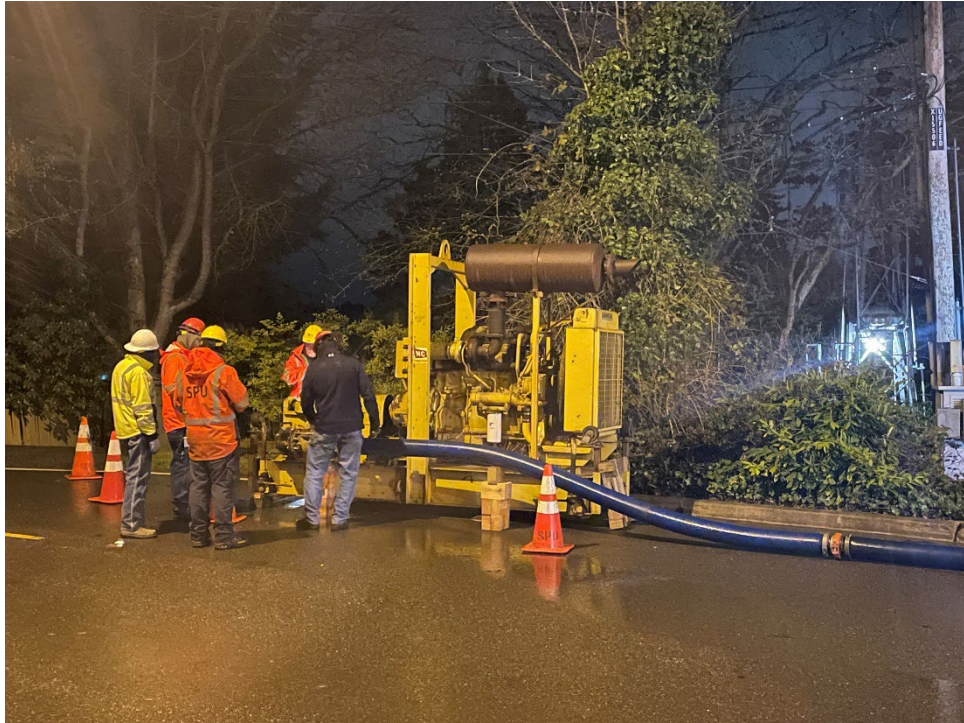
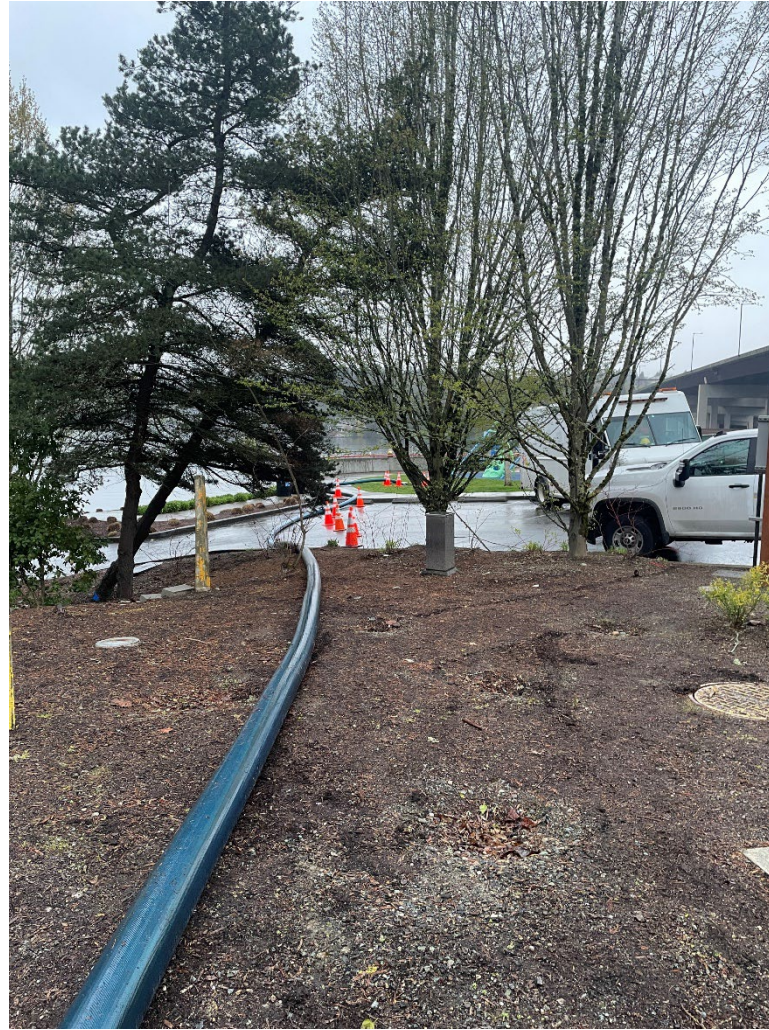
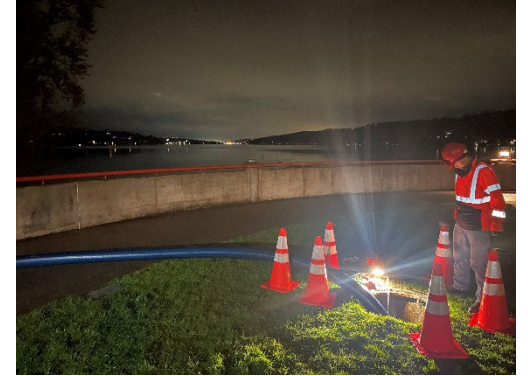
- The bypass pumping required too much water from Bellevue Enatai – decreased their system pressure too low
- The pumping required higher discharge pressure than the discharge hose could tolerate
 - Required 175 psi; at about 150 psi the discharge hose tends to fail at couplings
- Need to plan a better bypass plan for next time, as a contingency plan

Bypass pumping setup from Bellevue Enatai to Mercer Island

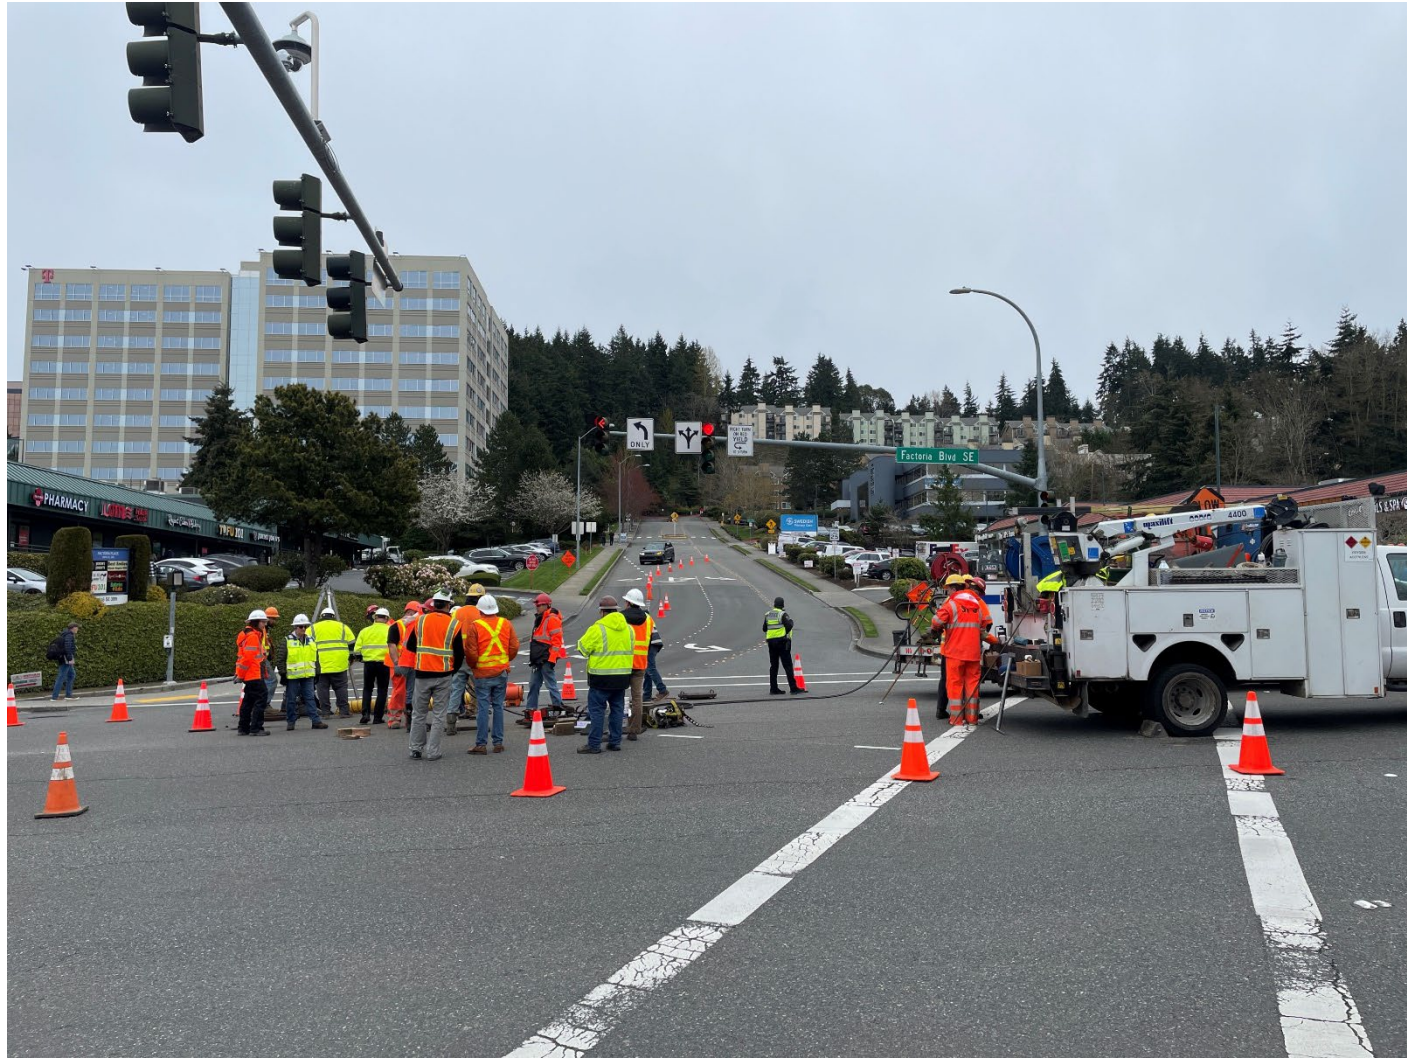
- Opening the valve at Factoria:
 - Valve closed smoothly for shutdown
 - Opened about 30 turns out of about 300 and stopped moving
- Also a ball valve, no bypass line around it
- Crews scrambled to take the valve apart enough to find the piece that had stripped a gear, turn the valve by hand and lock it open in place
- We had opened and closed that valve previously, but only down to 50% closed; last exercised about 10 years ago
- Valve exercising program needs attention

Valve that opened to 10% then froze is in the middle of the intersection in Factoria

- Develop options for long-term improvements to review with Mercer Island and Cascade
 - Consider adding bypasses around valves without them – and upsize to use for minor water supply as well as equalizing pressure around the valves
 - Consider redundancy throughout this pipeline section – one of the few spots in the water system without redundancy
 - Consider what to do about the valve at Factoria – needs replacing; can it be moved out of the intersection?
 - Consider what to do about the valve at SE 120th – OK as is, needs a bypass installed
 - Ball valve with remote control was in case of slough pipeline failing from settlement; that concern has gone away
- Order and stock spare valves, especially for large valves without redundancy
- Look at our valve exercising and maintenance protocols, especially for large valves with no redundancy

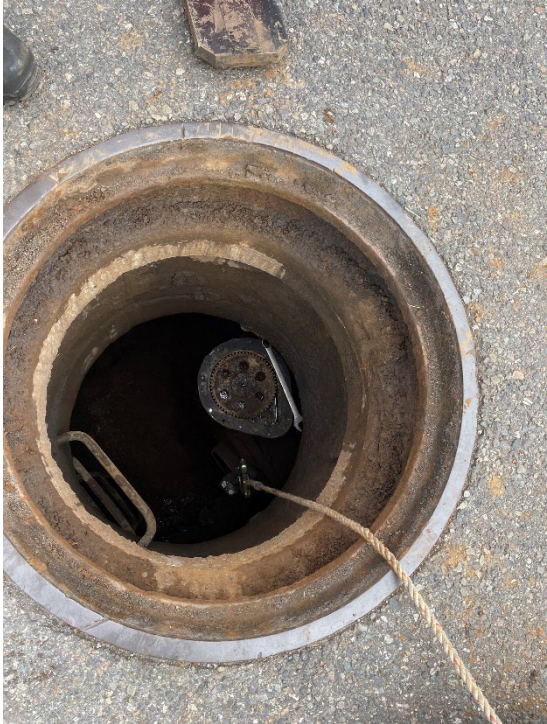
Exposed gear at top of valve

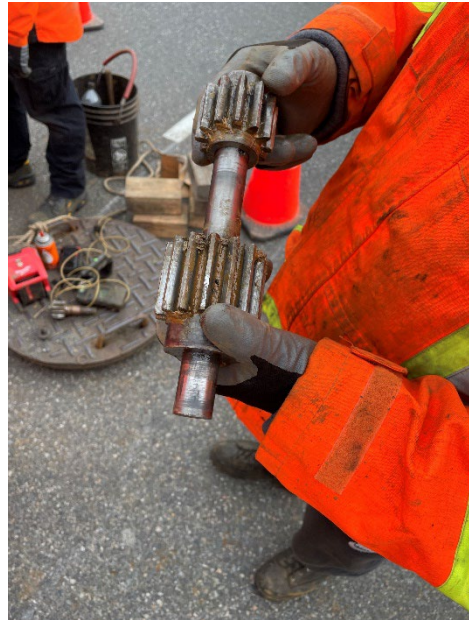
Shear pin broke - top shaft gear came loose (by design to protect gears from damage)

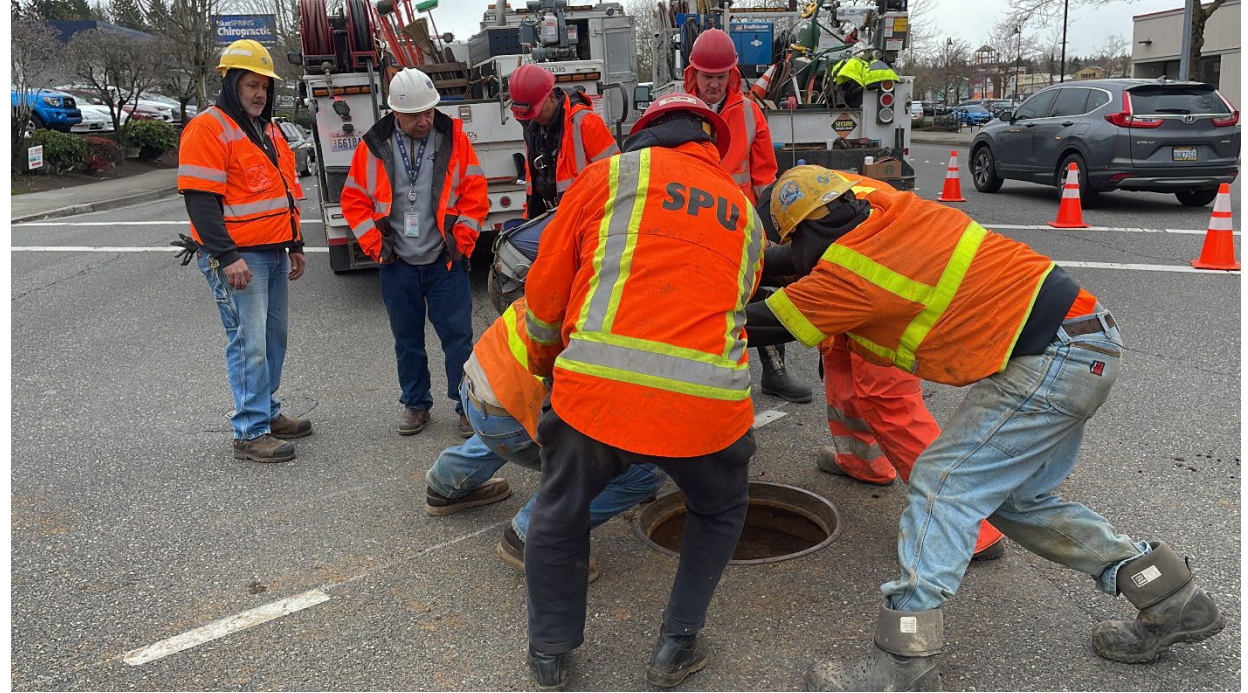
Crews manually turning the valve using a t-wrench attached to the top valve gear
