**ARBORIST REPORT
2885 78th Ave SE.
Mercer Island, WA**

January 16th, 2020

2885 78th Ave SE

Date of Field Examination: **January 8th, 2020**

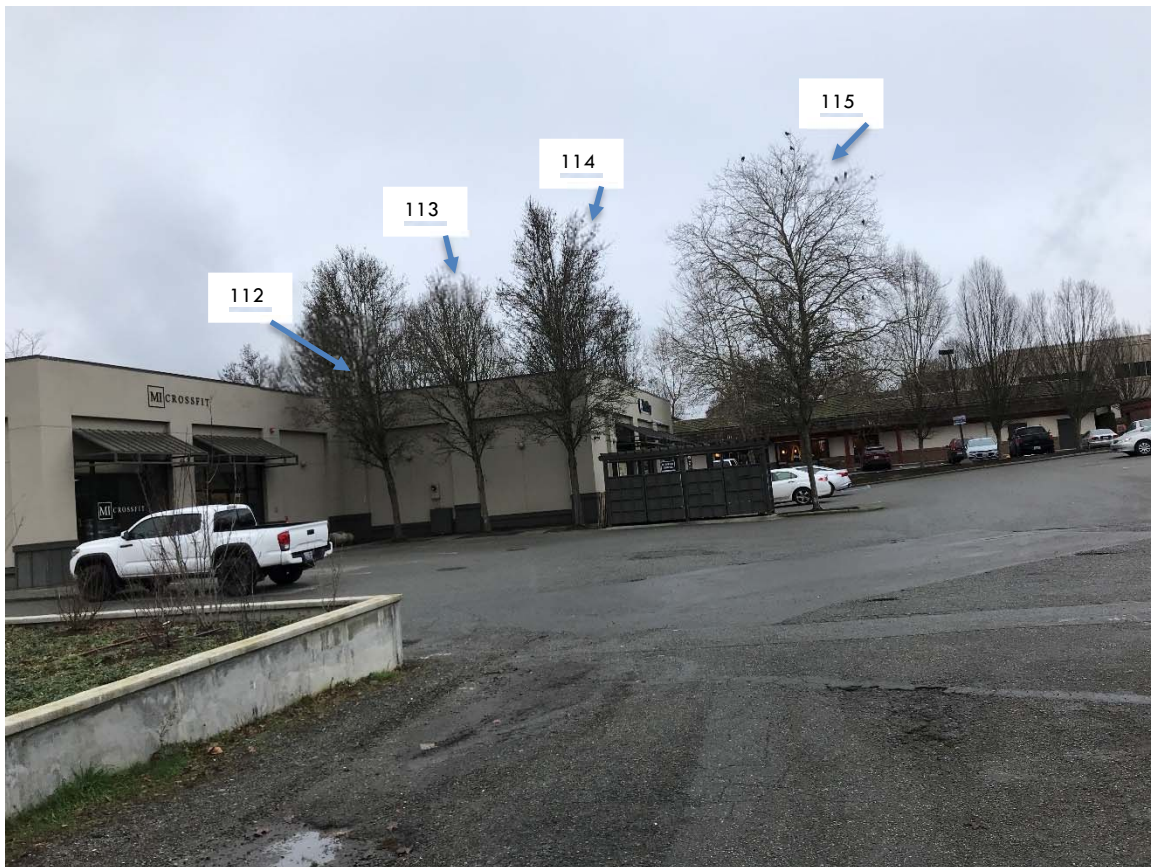
Trees #101, 102, 112, 113, 114, and 115 are flowering pears (*Pyrus caleriana*) planted in the northwest portion of the property as perimeter trees around the building at 2750 SE 77th St. These range in size from 6 - 9.6 inches in diameter at 4.5 feet above grade (DBH). None of these are considered 'Large' trees by the City of Mercer Island.

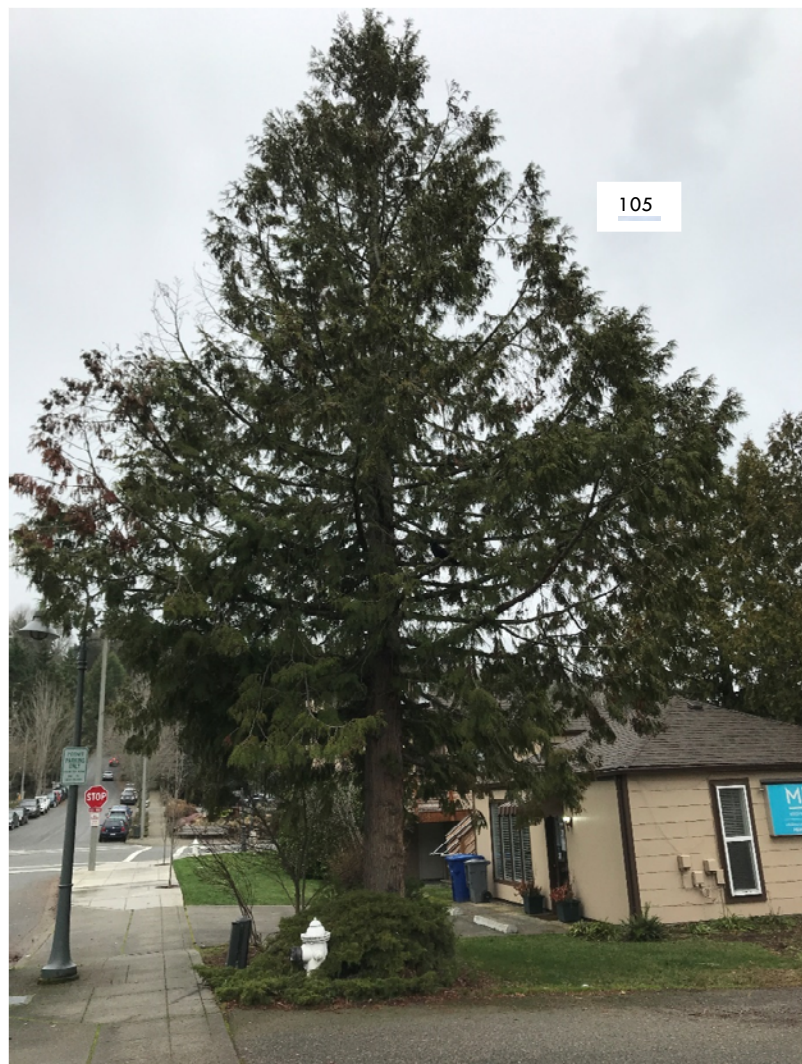
Trees #103 and 104 are flowering cherries (*Prunus* sp.) with DBHs of 10 and 7 inches respectively. These trees have been apparently neglected as they are in declining condition with dead material in their canopies and are surrounded by invasive blackberry and ivy. #103 is considered a 'Large' tree by The City.

Tree #105 is a western red cedar with a DBH of 22 inches growing near the southwest edge of the subject property bordering what is identified as the Bitney Parcel. This tree is in good condition, but shows some stress in the canopy with somewhat thin foliage.

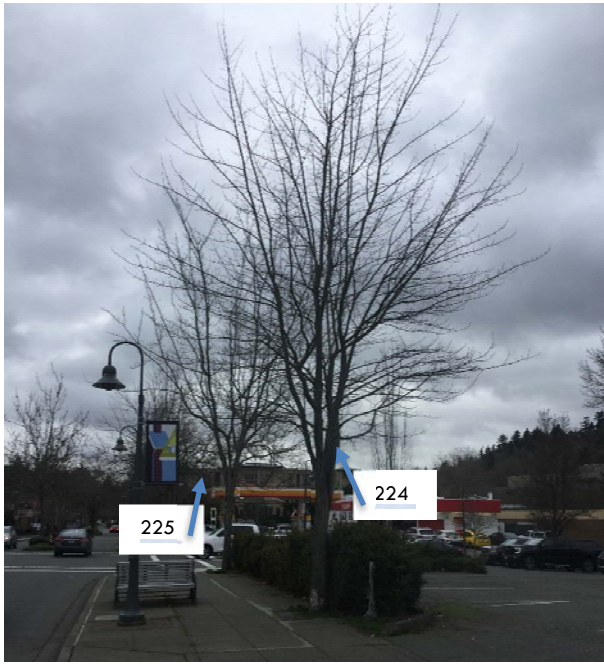
Trees #219-229, 234, 235, and 236 along the right of way (ROW) on the west, south, and east sides of the subject parcel have been approved for removal by Mercer Island Design Commission on January 22nd 2019. These trees would be in the middle of the sidewalk in the proposed condition, in conflict with current town center streetscape standards.

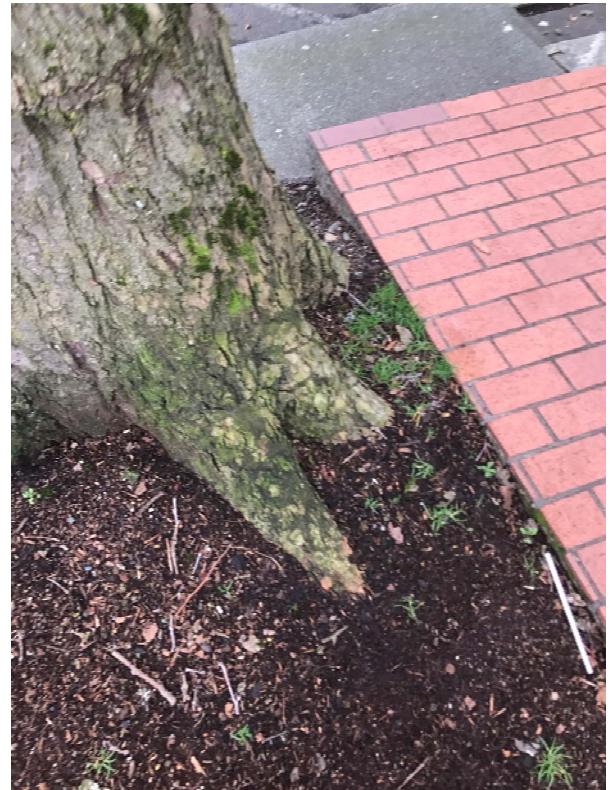
Trees #207 and 217 are 'Large' London planes (*Platanus x. acerifolia*) growing near the north property line. The critical root zone of #217 (14 inch DBH) extends approximately two feet into an area planned for a 'suspended' concrete pavement system. #207 (23.1 inch DBH) is located near, or possibly on the property line and has large surface roots which are disrupting the walkway and steps immediately to its west.

Expanding the adjacent planting areas around #203 and 204 and avoiding soil disturbance in this area will minimize the impacts to these trees. The concrete steps joining the brick path to the north will likely need to be replaced, and a new concrete path is proposed within the critical root zone of #207. There are large structural roots in the area of the steps. A diagram showing removal and replacement of these steps should be developed to instruct crews of the process for completing this work without damaging the structural roots.

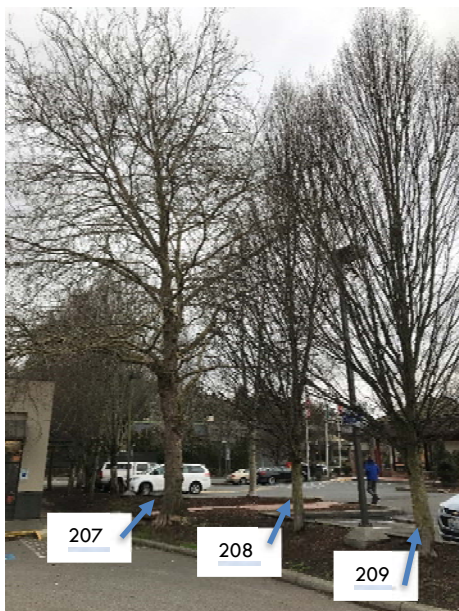
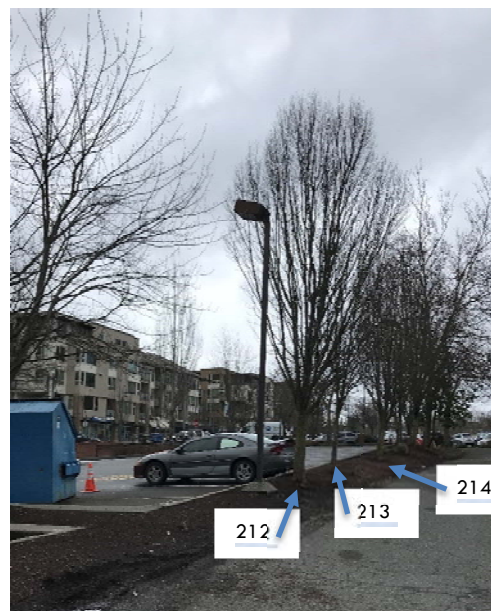
The remainder of the trees north of the subject property are European hornbeam (*Carpinus betulus*). This species is commonly planted in urban settings as it is fairly tolerant of development pressures. These trees are in good condition and are unlikely to have significant roots which extend to into the development area to the south.

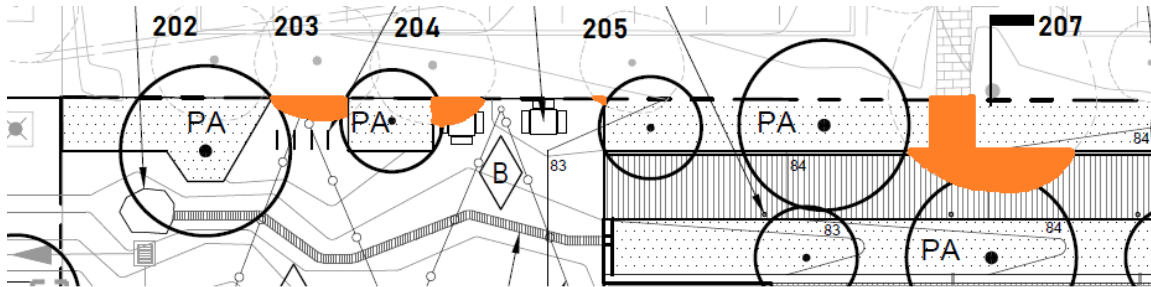
The proposed re-development is extensive and will not allow for tree retention within the subject property lines. The right of ways on the west, south, and east perimeters will be redesigned and the street trees will be replaced per current Town Center Streetscape standards. The priority for tree retention are the trees north of the subject property. A six foot wide planting area is proposed along the majority of this property line. Ground disturbance in this area including any trenching for utilities, or compaction caused by heavy equipment traffic or materials storage shall be prohibited in this area. Pavement installation is proposed within the critical root zones of trees #203, 204, and 207 as shown in orange on the diagram below.
