## Presentation on the Existing Condition of the Public Works Building

City Council Study Session  
May 5, 2026

AB 6920

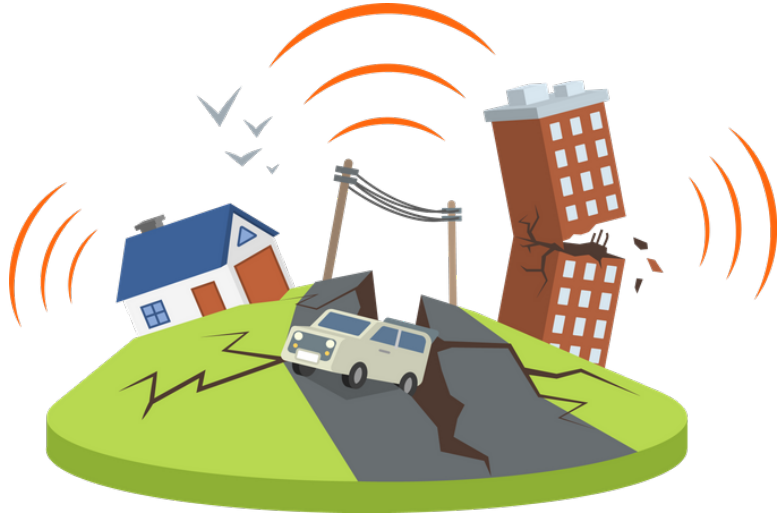
**Seismic deficiency** of the existing building structure and inability to meet Risk Category III

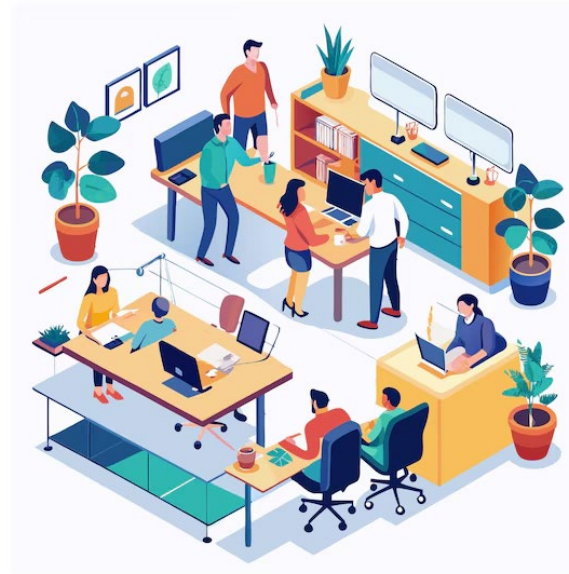
Existing building **cannot support programmatic needs** of office occupancy as-is

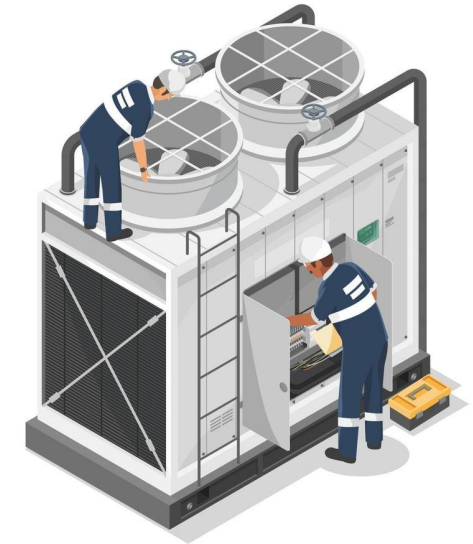
Mechanical & electrical systems are at **end-of-service-life**

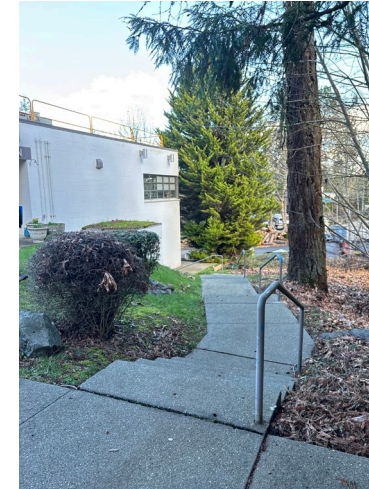
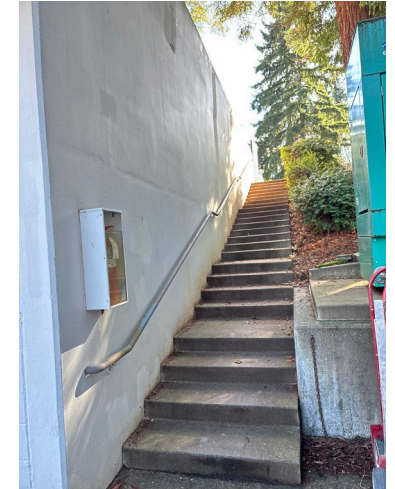
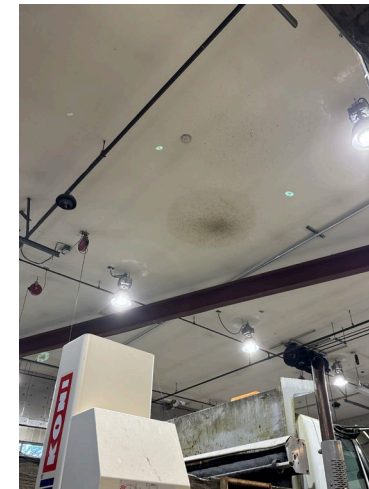
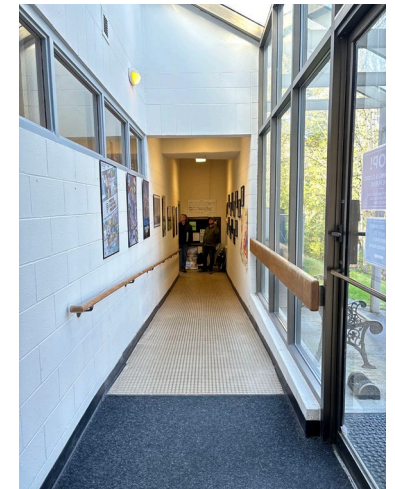
**Building life safety & egress not up to current building code standards:**

- **No automatic sprinkler system**
- **No wheelchair accessible egress pathway** from the second floor to the street.
- **Fire separations** between occupancies un-identifiable or non-complaint.
- **Lack of signage** for wayfinding and emergency egress.

- New **automatic sprinkler system**
- Complete space reconfiguration for final occupancy

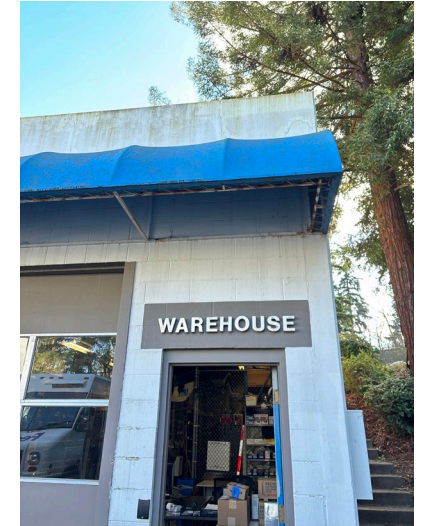
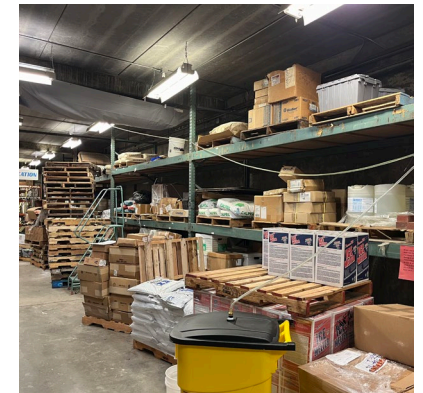
## Building envelope deficiencies and non-compliance with current energy code:

- **Moisture intrusion issues** at roof and wall joints.
- **Flashing/weatherproofing** of the window and door openings, wall joints, and roof edges **does not meet current standards.**
- **Under-insulated exterior wall and roof assemblies** which do not comply with current energy code standards.
- **Low thermal comfort for occupants;** heating and cooling systems not sufficient or operational.

- Full exterior enclosure **insulation upgrades:**
  - Below-grade waterproofing and insulation
  - Insulation for exterior wall assemblies
  - New blown-in insulation at truss cavities
  - Insulated windows and exterior doors

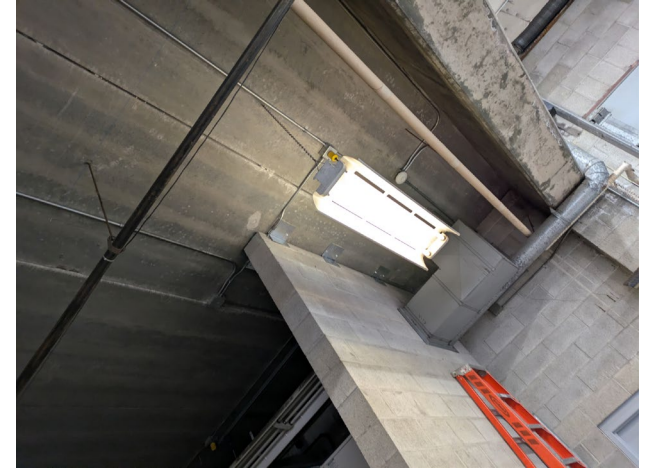
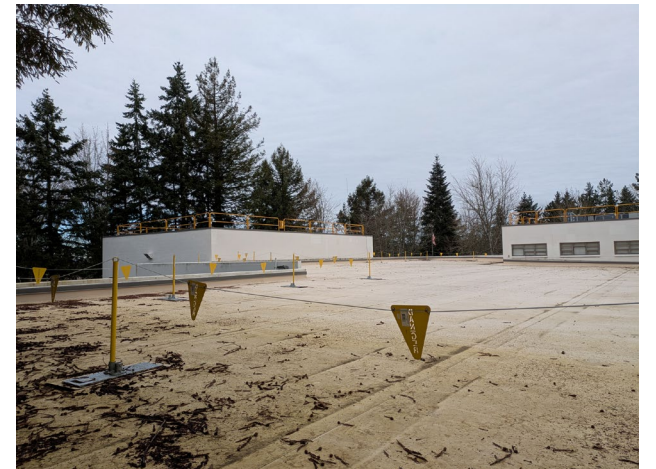
**Some seismic upgrades completed during the 2023 voluntary renovation work include:**

- Installation of **additional foundation support** / grade beams in the vehicle maintenance Bays.
- Additional **lateral bracing** at the top of non-structural masonry walls.
- **Removal of green roof** on the lower roof.
- Additional **top of structural masonry wall anchorage** usings new ledgers, straps, and post-installed anchors.
- New **diaphragm nailing for the existing roof sheathing** around the edges of both upper roofs.

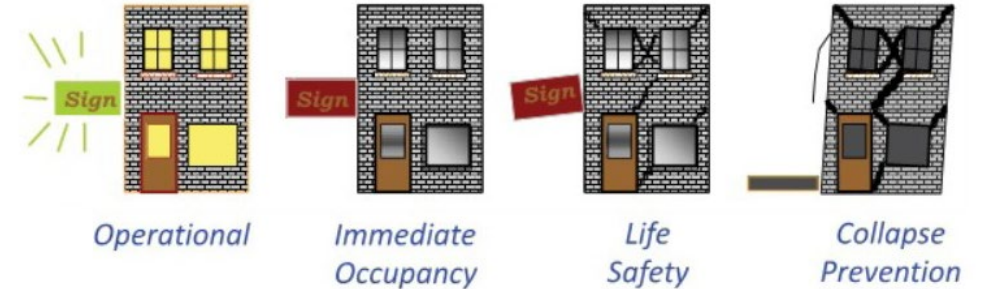
The voluntary renovation work completed **did not constitute a full seismic upgrade, Risk Category II or minimum recommended retrofit.**

The remaining seismic deficiencies include:

- Torsional effects from the shear wall layout resulting in **shear walls being overstressed.**
- **Foundation deficiencies below the shear walls** resulting from these torsional effects.
- **Inadequate connections** between the roof diaphragms and shear walls.

- Providing **additional support to shear walls with shotcrete / concrete.**
- **Foundation upgrades** at the upgraded shear walls.
- **Increased diaphragm nailing** at the roof plywood sheathing.
- **Strengthening the connections** between the top of masonry wall and the roof joists.

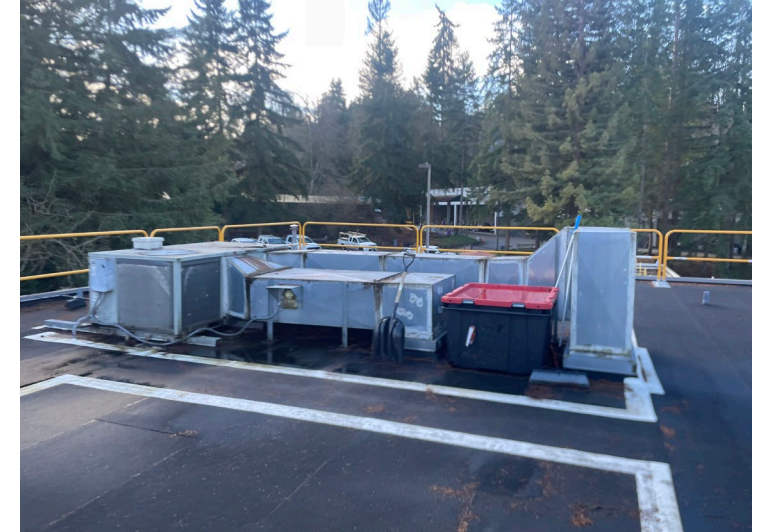
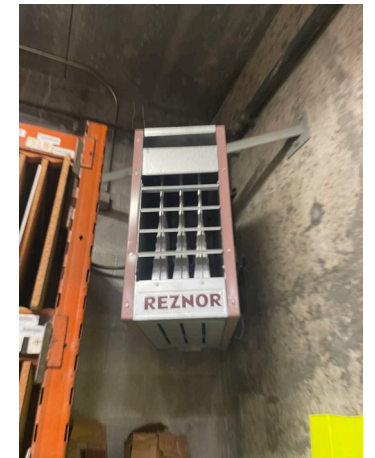
- The HVAC system is a mix of **gas fired unit heaters, one gas fired and one electric furnace, exhaust fans and a gas pack rooftop unit.**
- There is **cooling at the second floor.**
- There is a **vehicle exhaust extraction system and an exhaust fan** installed in the shop.
- **Limited Direct Digital Control (DDC)** is provided via central controller.

Generally, all the mechanical systems are at or nearing the end of their useful service life; additionally:

- HVAC systems appear original and would require **full replacement** to improve performance and meet industry standards.
- The **warehouse and shop space ventilation equipment** should be evaluated and updated to meet current standards.
- The Server room does not have necessary cooling.

- **Replace existing systems** with newer/modern systems.
- A new **dedicated outside air system (DOAS)** should be provided for all the office type occupancies.
- Thermal control for offices should include a variable refrigerant flow (VRF) system, to **allow zone by zone control**.
- Shop and warehouse spaces should be provided with **ventilation and radiant heat**.
- The **shop area should include products of combustion sensors (CO/NOx)** which tie into the associated ventilation system and generate an alarm if levels exceed exposure limits.
