Presentation on the Existing Condition of the Public Works Building

City Council Study Session
May 5, 2026

AB 6920

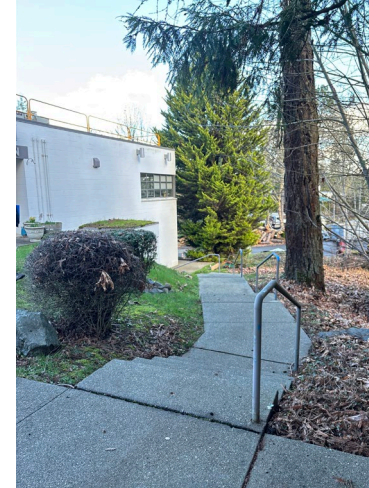
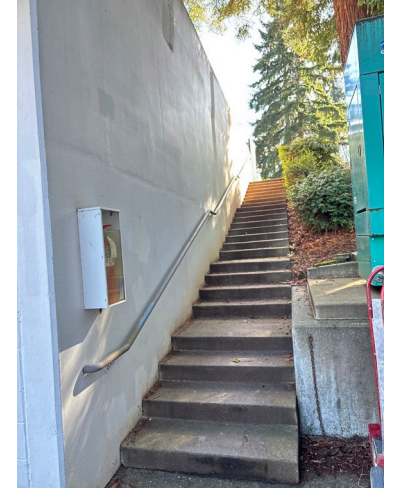
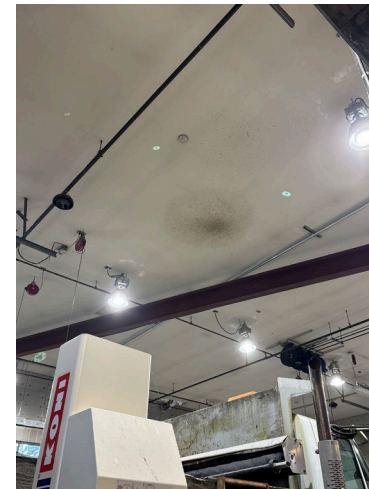
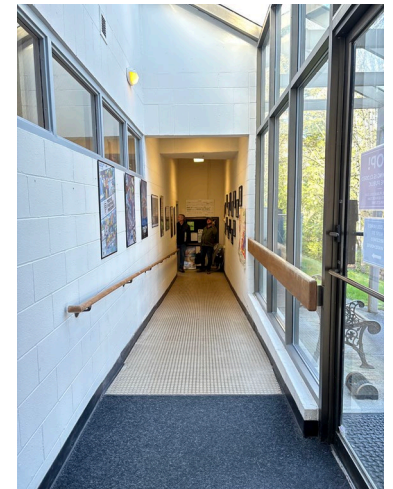
Building life safety & egress not up to current building code standards:

- **No automatic sprinkler system**
- **No wheelchair accessible egress pathway** from the second floor to the street.
- **Fire separations** between occupancies un-identifiable or non-complaint.
- **Lack of signage** for wayfinding and emergency egress.

Building life safety & egress updates:

- New **automatic sprinkler system**
- Complete space reconfiguration for final occupancy

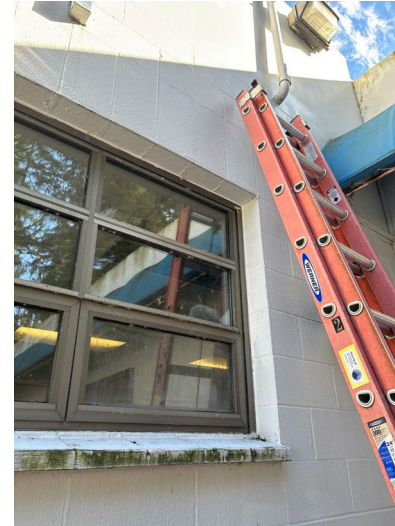
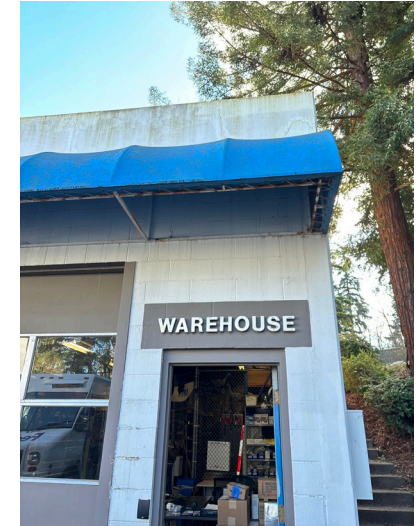
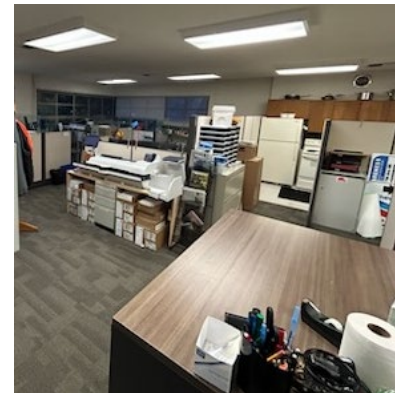
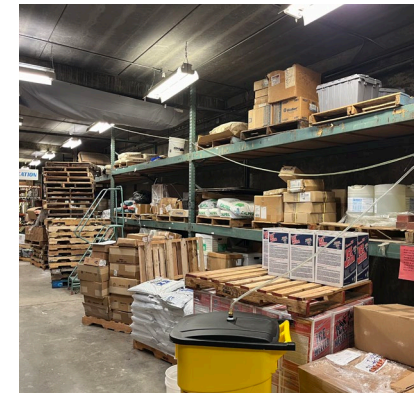
Building envelope deficiencies and non-compliance with current energy code:

- **Moisture intrusion issues** at roof and wall joints.
- **Flashing/weatherproofing** of the window and door openings, wall joints, and roof edges **does not meet current standards.**
- **Under-insulated exterior wall and roof assemblies** which do not comply with current energy code standards.
- **Low thermal comfort for occupants;** heating and cooling systems not sufficient or operational.

Building envelope updates:

- Full exterior enclosure **insulation upgrades:**
 - Below-grade waterproofing and insulation
 - Insulation for exterior wall assemblies
 - New blown-in insulation at truss cavities
 - Insulated windows and exterior doors

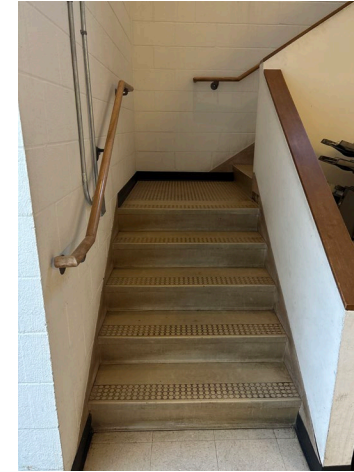
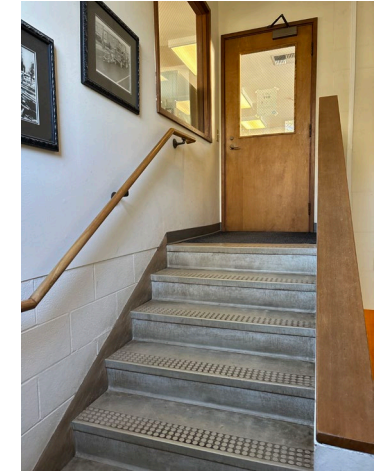
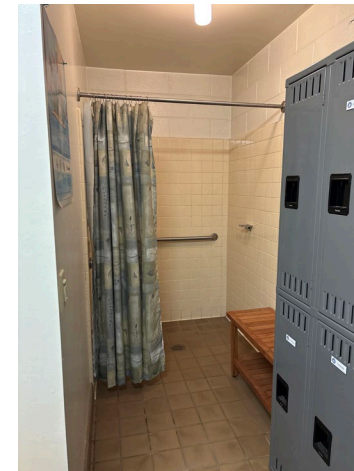
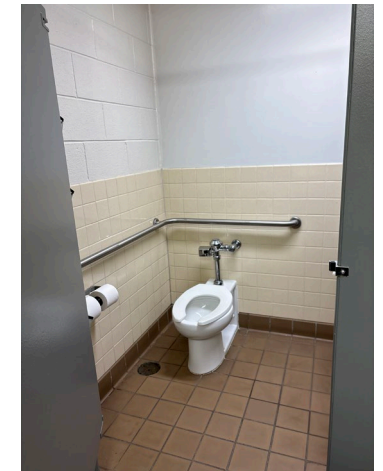
Accessibility restrictions:

- **Guardrails and handrails do not comply** with current building code and accessibility standards.
- **No interior wheelchair accessible path** via elevator or wheelchair path from the first floor to the second floor.
- **ADA accessible toilets, showers, and lockers need modifications to comply** with current accessibility standards.
- **Door hardware, countertops, and Breakroom equipment and fixtures do not comply** with current accessibility standards.

Accessibility updates:

- **Upgrade of existing stairs and ramp**
- Addition of **ADA compliant restrooms** and fixtures

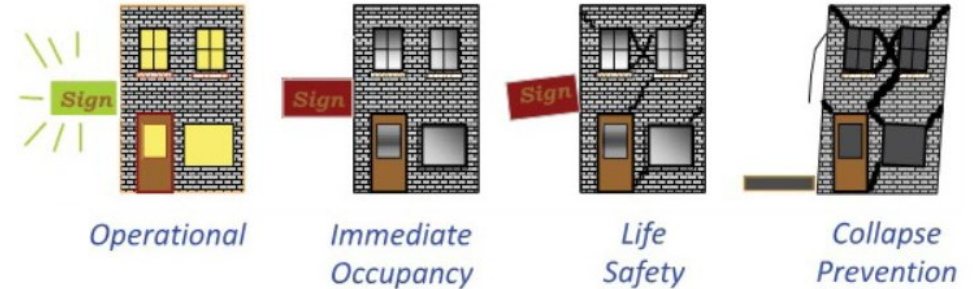
The voluntary renovation work completed **did not constitute a full seismic upgrade, Risk Category II or minimum recommended retrofit.**

The remaining seismic deficiencies include:

- Torsional effects from the shear wall layout resulting in **shear walls being overstressed.**
- **Foundation deficiencies below the shear walls** resulting from these torsional effects.
- **Inadequate connections** between the roof diaphragms and shear walls.

Seismic remediations to meet Seismic Category III include:

- Providing **additional support to shear walls with shotcrete / concrete.**
- **Foundation upgrades** at the upgraded shear walls.
- **Increased diaphragm nailing** at the roof plywood sheathing.
- **Strengthening the connections** between the top of masonry wall and the roof joists.

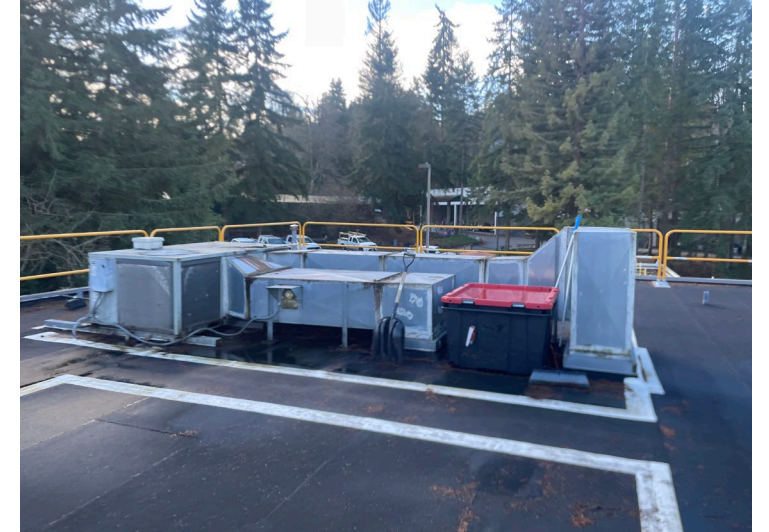
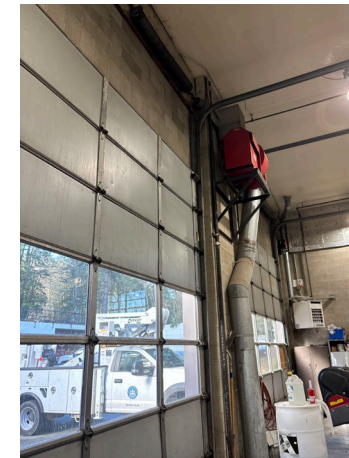
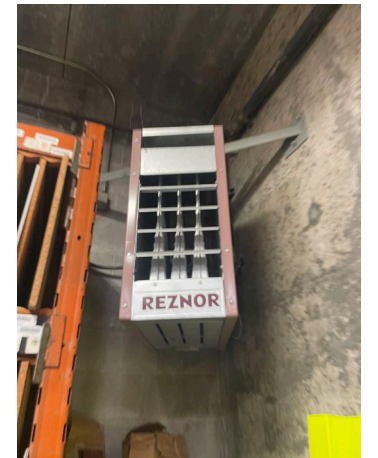
General:

- The HVAC system is a mix of **gas fired unit heaters, one gas fired and one electric furnace, exhaust fans and a gas pack rooftop unit.**
- There is **cooling at the second floor.**
- There is a **vehicle exhaust extraction system and an exhaust fan** installed in the shop.
- **Limited Direct Digital Control (DDC)** is provided via central controller.

Generally, all the mechanical systems are at or nearing the end of their useful service life; additionally:

- HVAC systems appear original and would require **full replacement** to improve performance and meet industry standards.
- The **warehouse and shop space ventilation equipment** should be evaluated and updated to meet current standards.
- The Server room does not have necessary cooling.

A full mechanical system replacement is recommended, including:

- **Replace existing systems** with newer/modern systems.
- A new **dedicated outside air system (DOAS)** should be provided for all the office type occupancies.
- Thermal control for offices should include a variable refrigerant flow (VRF) system, to **allow zone by zone control**.
- Shop and warehouse spaces should be provided with **ventilation and radiant heat**.
- The **shop area should include products of combustion sensors (CO/NOx)** which tie into the associated ventilation system and generate an alarm if levels exceed exposure limits.

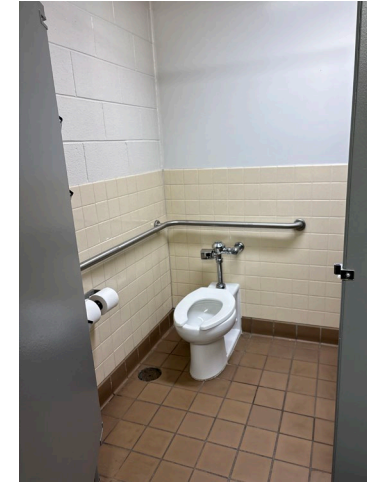
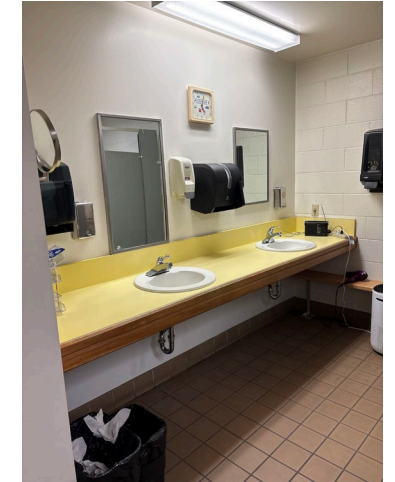
- The facility is served by an **electric water heater.**
- **All restrooms are located on the first floor.**
- Plumbing fixture count:
 - Women's – 2 toilets, 2 sinks, 1 shower
 - Men's – 5 toilets/urinals, 3 sinks, 3 showers
- Piping materials - **domestic water piping is copper; drainage, waste, and vent piping is cast iron.**
- The existing **1988 air compressor is abandoned-in-place; a new air compressor was installed around 2023.**

- **The electric water heater is at or nearing the end of its useful service life.**
- There is an **inadequate number of plumbing fixtures (women's)** for occupancy of building.
- **Trap primers are not present** in the existing plumbing systems.

- **Replacement of the electric water heater** with heat pump technology.
- Provide **additional and modern of restroom plumbing fixtures** with low flow products to meet energy code.
- **Reuse the existing domestic and drainage piping and provide additional piping** for new restroom plumbing fixtures.
- **Remove the abandoned-in-place air compressor** should be removed to free up space.
- **Retain and provide additional air compressor connect drops** and reels for the building as needed.
