IDAHO HISTORIC SITES INVENTORY FORM

PROPERTY NAME Eggers/Moore barnyard FIELD# 01-19779
STREET 820 S. Black Cat Rd. RESTRICT
CITY Meridian VICINITY COUNTY CD 1 COUNTY NAME Ada
SUBNAME BLOCK SUBLOT ACRES LESS THAN
TAX PARCEL S1215325420 UTMZ 11 EASTING 544200 NORTHING 4826930 7291
TOWNSHIP 3 N S N RANGE 1 E W W SECTION 15 NW 1/4 SW 1/4
QUADRANGLE Meridian 7.5 OTHERMAP 1917 Ada Co. Land Ownership Intermt. Map Co.
SANBORN MAP SANBORN MAP# PHOTO# Roll 14: 13-25

PROJ/RPT TITLE I-84 Widening Addendum SVY DATE 03-09-07 SVY LEVEL Intensive
ITD Project No. A010, Key No. 10459
 RECORDED BY J. Theisen, B. Joyce PH 208-939-1022 ADDRESS Bionomics Environmental Inc.
Boise, Idaho

Site Photos
AD-1 Eggars/Moore Farm
March 2007

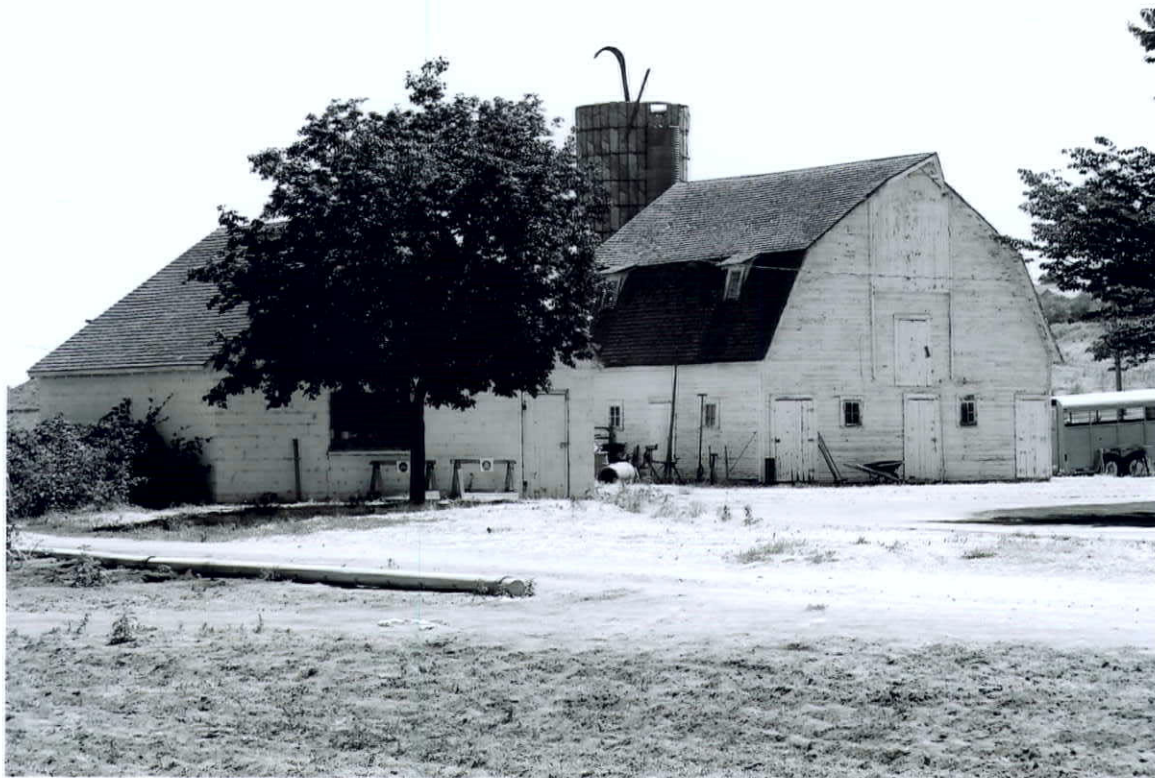
COMMENTS Rare double-silo granary. Silos made of interlocking vertical concrete staves with iron hoops. Two and one-half story silo has same construction as dairy barn. 1917 - Hockett??

IHSI # 01-19779
Eggers/Moore barnyard - double-silo
granary
View facing E
8/2007
2007 City of Meridian Impact
Area Reservey

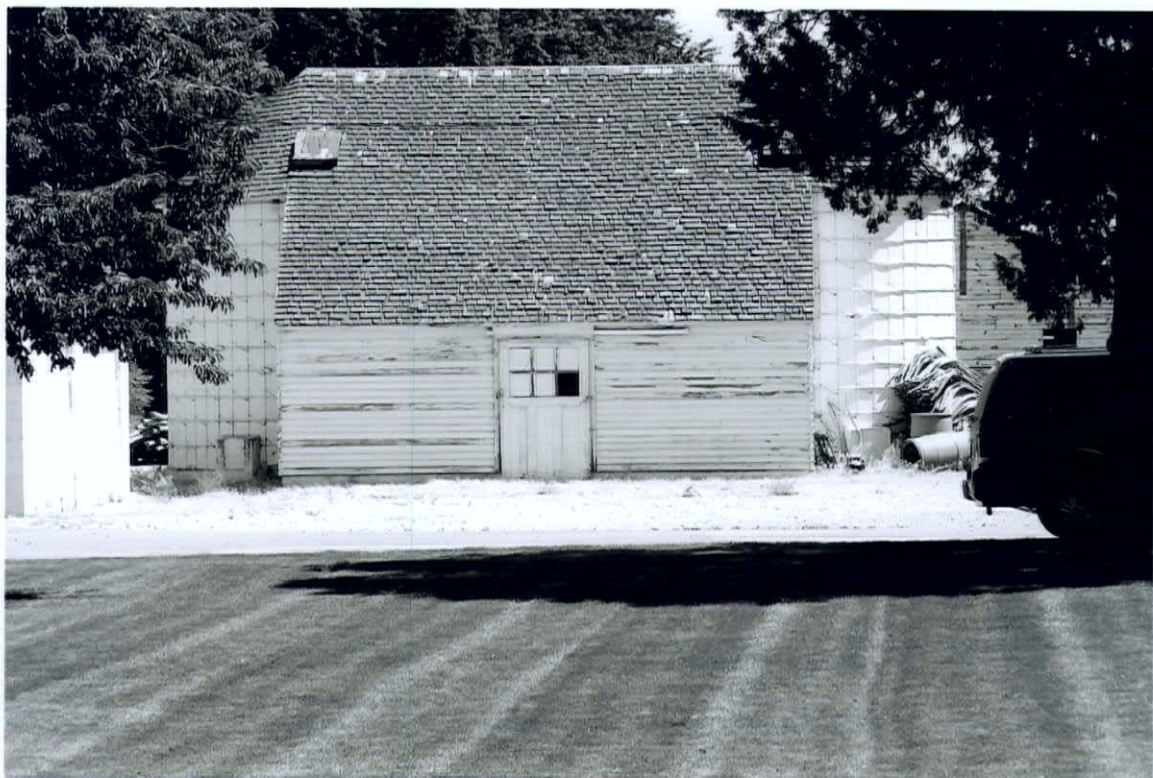
IHSI # 61-19779
Eggers/Moore barnyard - over-view
View facing SE
8/2007
2007 City of Meridian Impact
Area Reservey

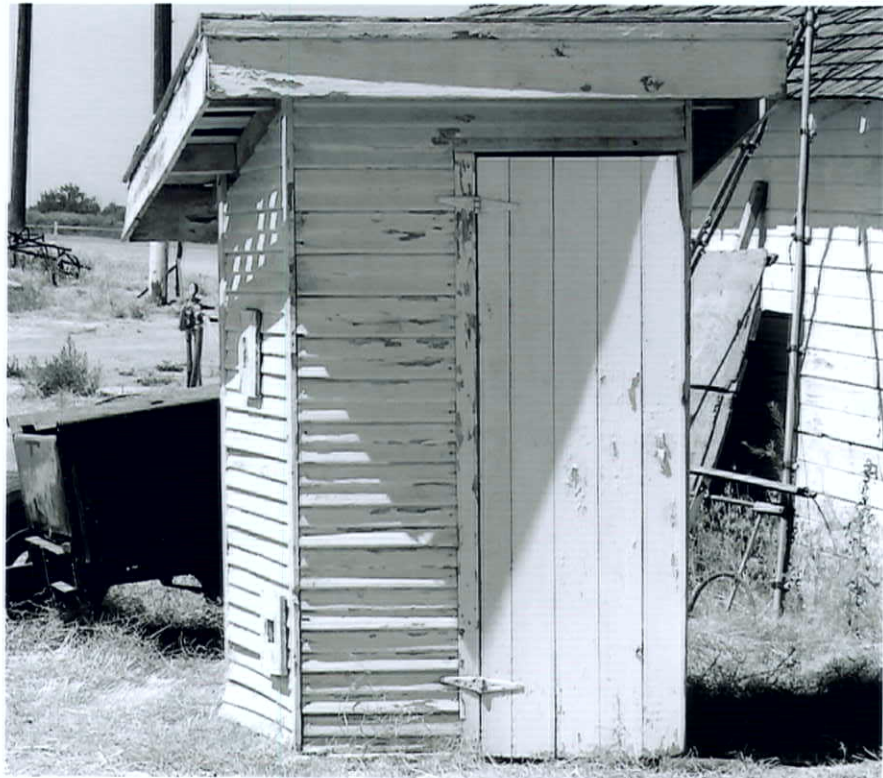
WPA outhouse

13. Outhouse
 This outhouse is a WPA built privy, as reported by the Arrowrock Group (2001). This is a deluxe model of privy. It has a concrete foundation and venting. The small building has a square plan and a shed style roof with cedar shingles. The exterior is wood painted white.
 The east elevation has one flush, swing open door. There is one vent opening at the north and west elevations and two vent openings at the south elevation.
 The outhouse is in good to condition, it retains its historic integrity, and it is important because it is associated with the WPA. The building is individually eligible and contributes to the eligibility of the historic farm site as a whole.

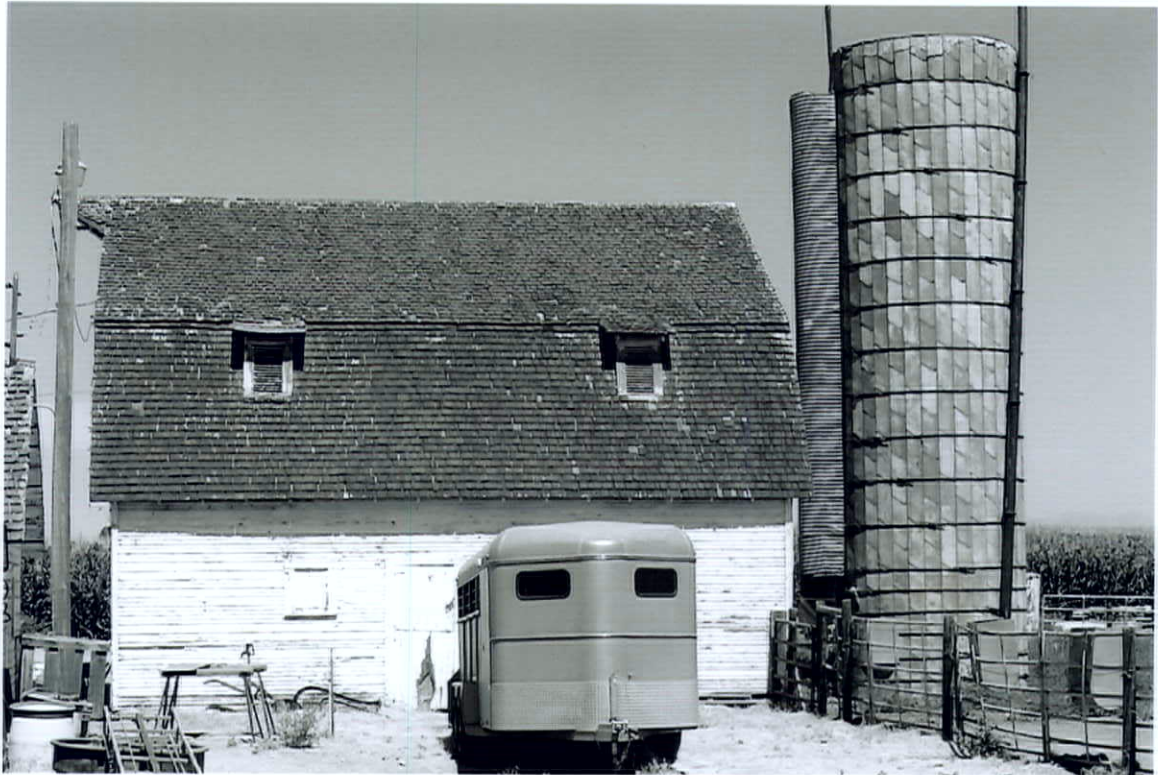
barn, silos

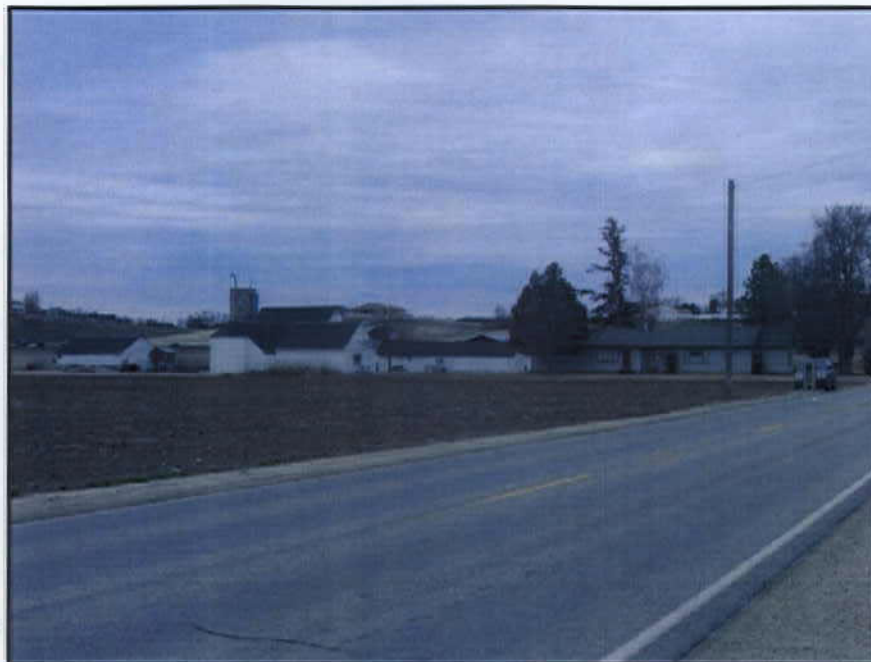
Overall Condition
 The condition of the property is excellent; it is well kept and clean. The buildings have been maintained and cared for through the years. The oldest buildings are the barn and the silos which are in good condition for being almost 90 years old, and they are still in use on the farm today. The historic buildings, with the exception of the house, have retained their original location, design, setting, materials, workmanship, feeling, and association.

Overview looking southeast at Eggars/Moore Farm.

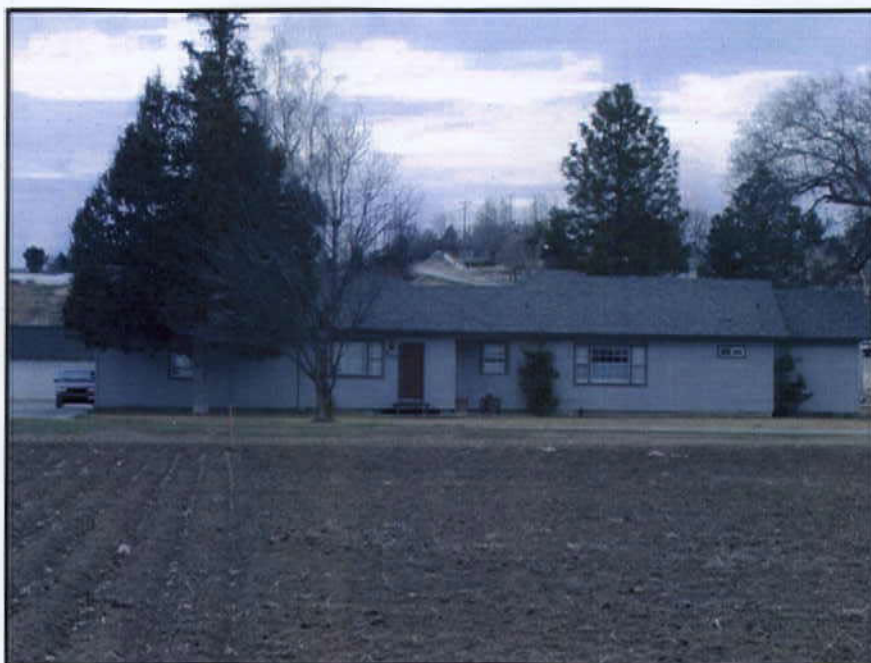
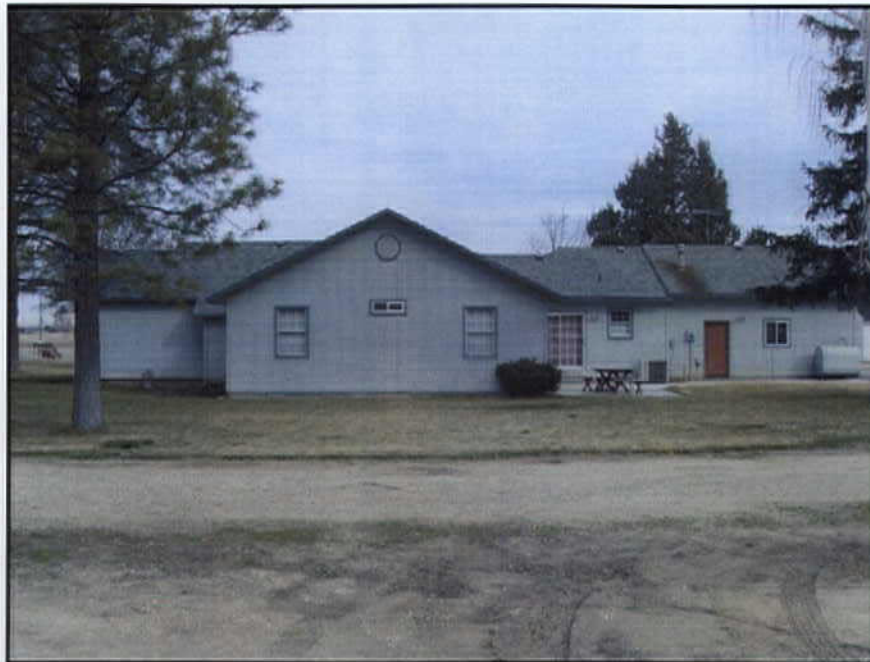
The house is in good condition, but because of the modern additions and extensive changes including the exterior, roofing, and windows, this building does not contribute to the eligibility of the site as a whole.

View looking south at the north elevation of No.1 house.

View looking north at the south elevation of No.1 house.

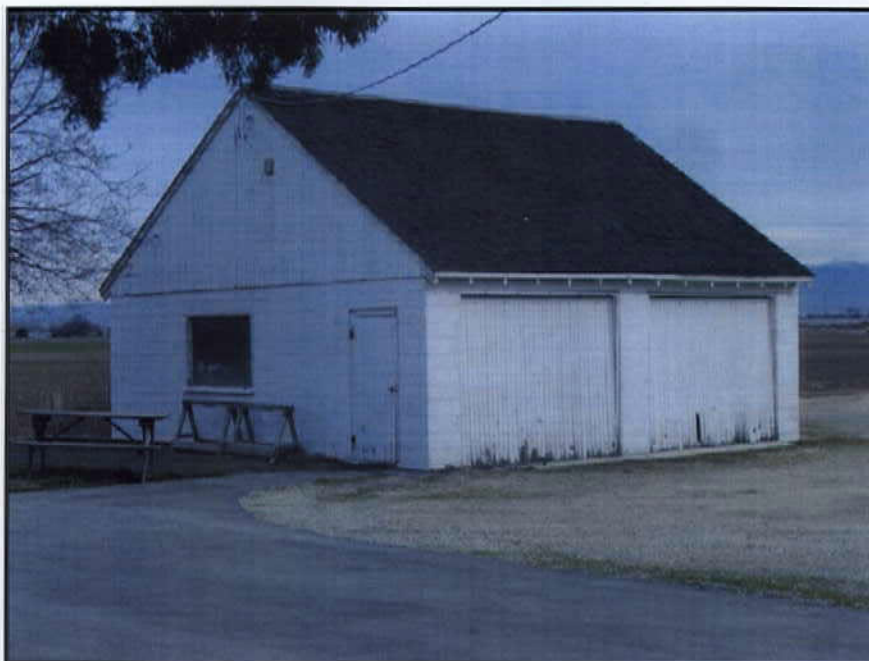
This building is in good to fair condition. The original construction materials and style are intact and the building has retained its historic integrity. The concrete block shop contributes to the eligibility of the historic site as a whole.

View looking northeast at the south and west elevation of No. 2 shop.

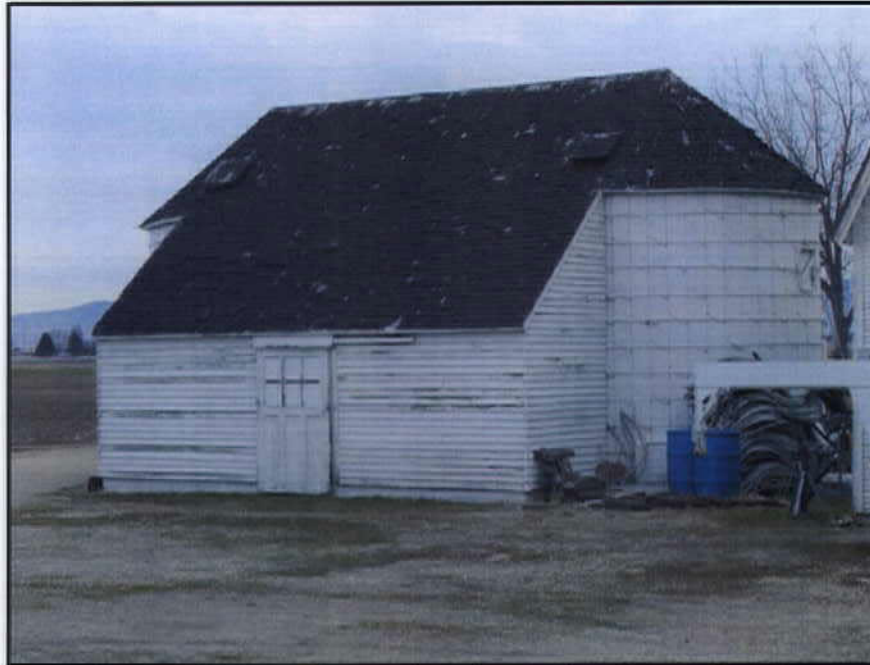
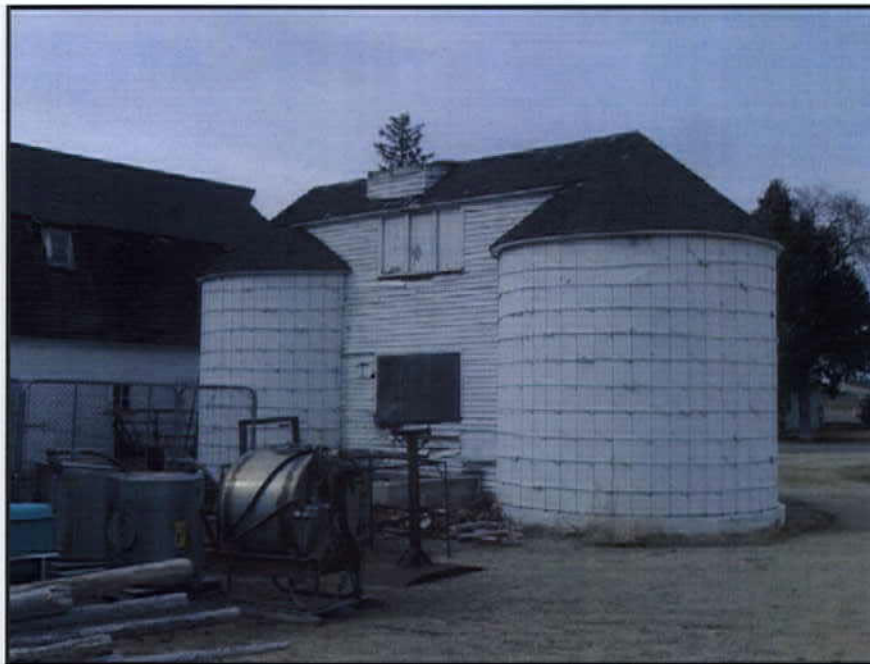
The unique building is in good condition and has retained its historic integrity. The granary with its double silo is individually eligible and contributes to the eligibility of the historic site as a whole.

View looking northeast at the south and west elevations of No. 3 granary.

View looking southwest at the north and east elevations of No. 3 granary.

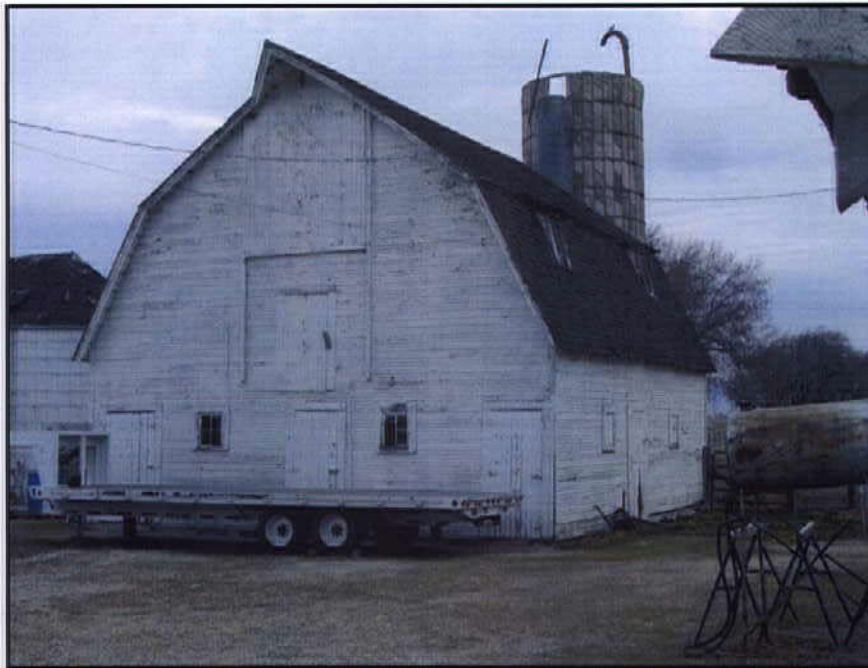
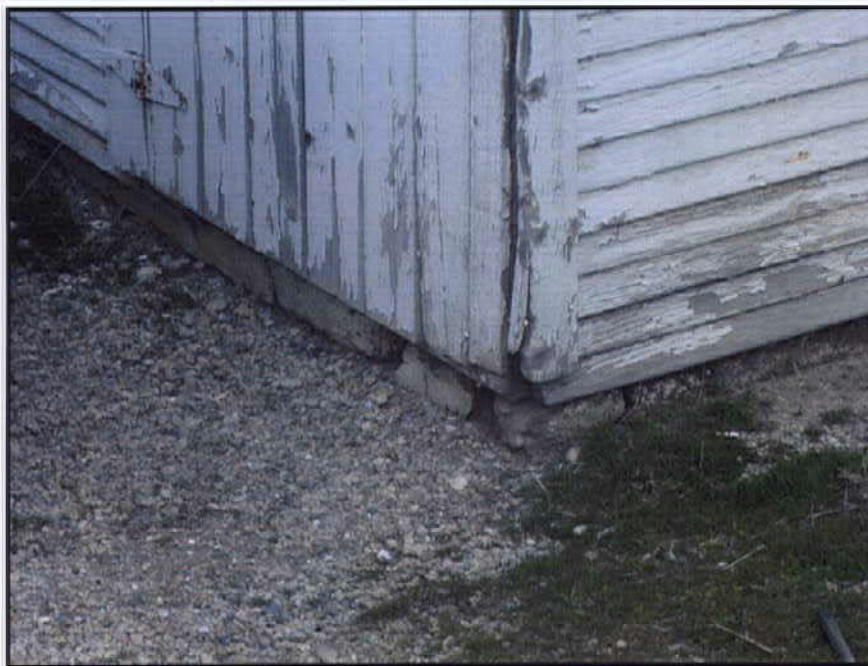
The barn is in good condition and has retained its historic integrity. It is individually eligible and contributes to the eligibility of the site as a whole.

View looking northeast at the south and west elevations of No. 4 barn.

Close-up view of southwest corner of No. 4 barn,
showing the use of quarried stone for the foundation.

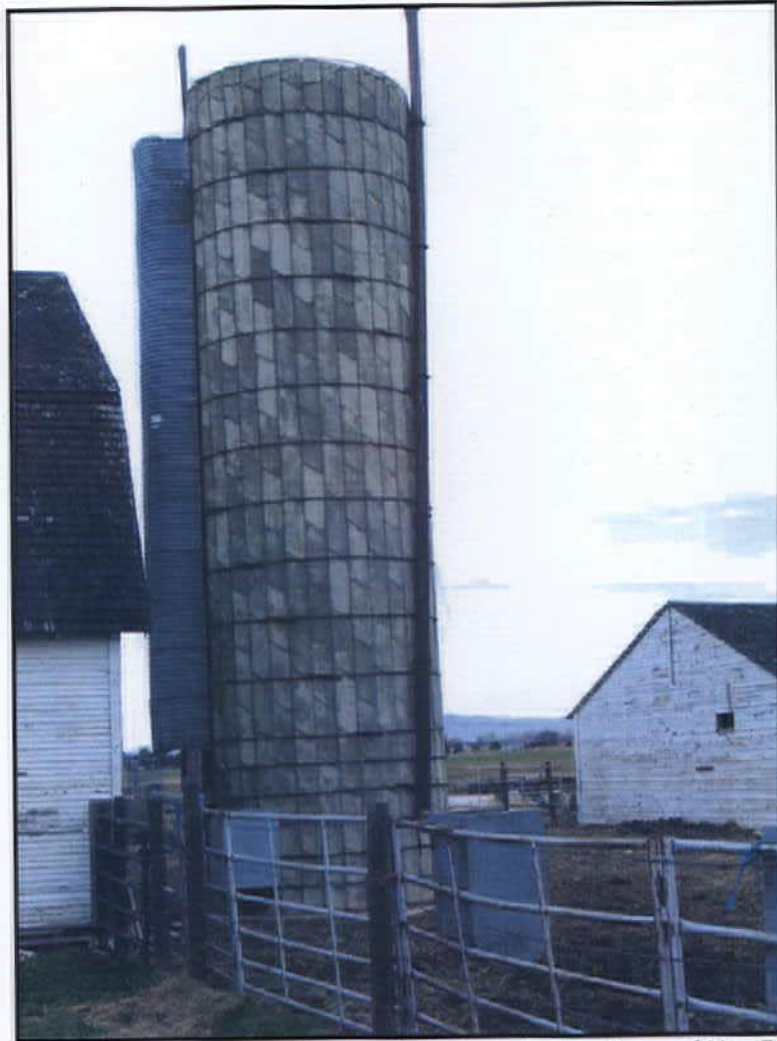
The silo is in good condition and it has retained its historic integrity. It is individually eligible and contributes to the eligibility of the site as a whole.

View looking northeast at the south and west elevations of No. 5 silo.

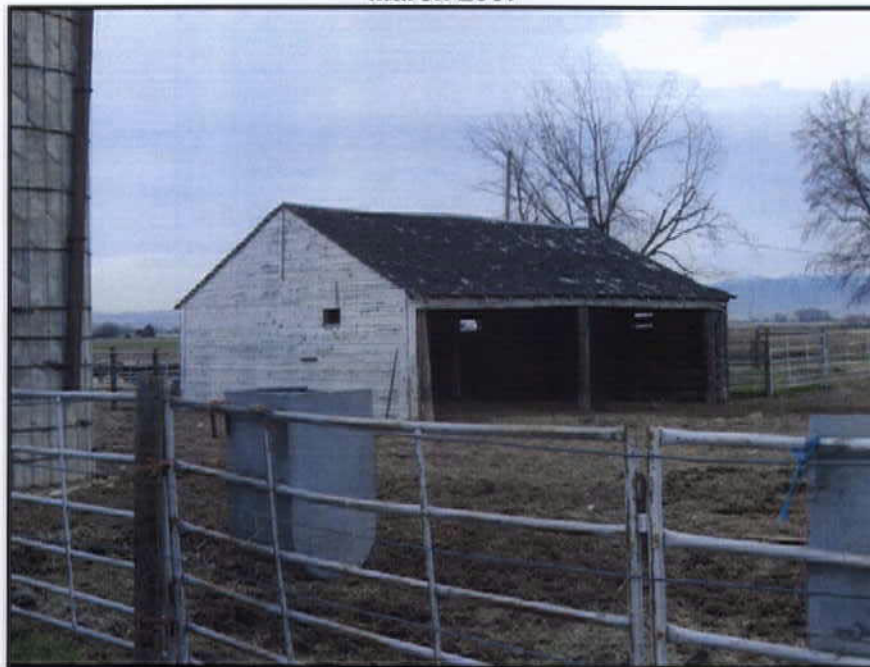
The horse shelter is in good condition and has retained its historic integrity. This building contributes to the eligibility of the site as a whole.

View looking northeast at the south and west elevations of No. 6 horse shelter.

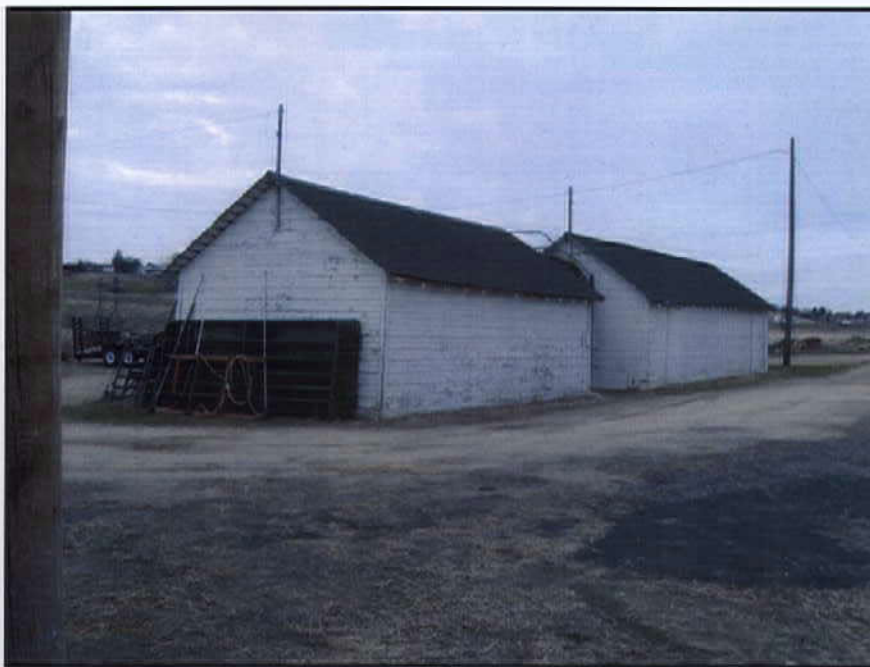
The shed is in good condition and it has retained its historic integrity. This building contributes to the eligibility of the site as a whole.

The shed is in good to fair condition and has retained its historic integrity. This building contributes to the eligibility of the site as a whole.

View looking southwest at the north and east elevations of No. 7 west shed and No. 9 east shed. The west shed may have been used for a mint still at one time.

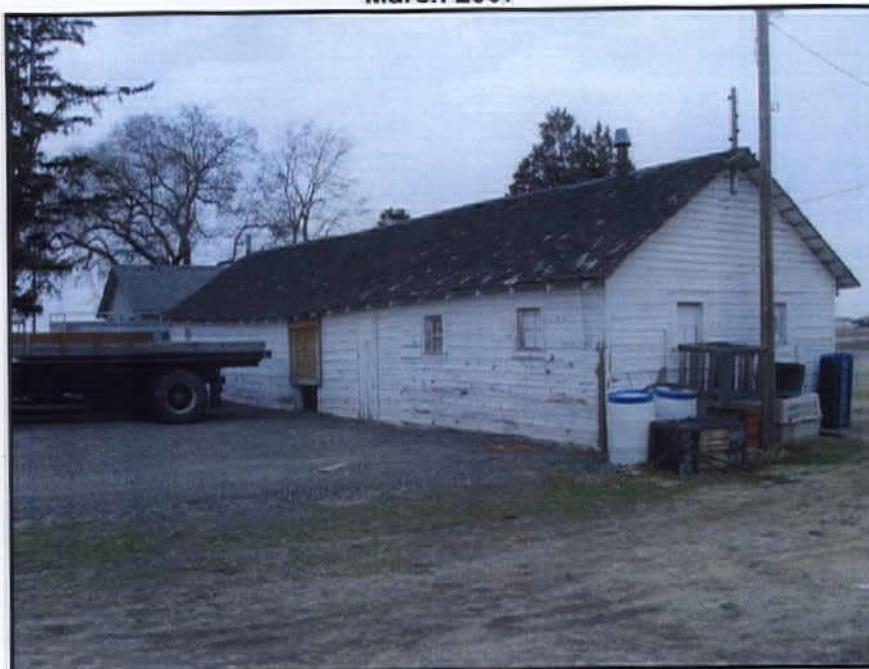
The long shed is in good condition and has retained its historic integrity. This building contributes to the eligibility of the site as a whole.

View looking northwest at the south and east elevation of No. 8 long shed.

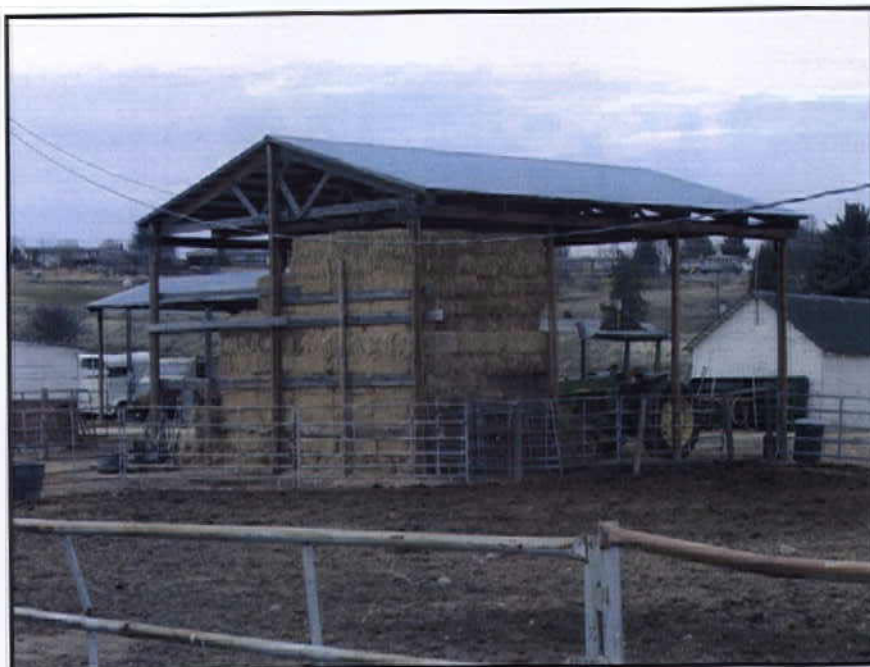
The pole barn is in good condition. Because it is not historic, it does not contribute to the eligibility of the historic site as a whole.

View looking southwest at the north and east elevations of No.10 pole shed.

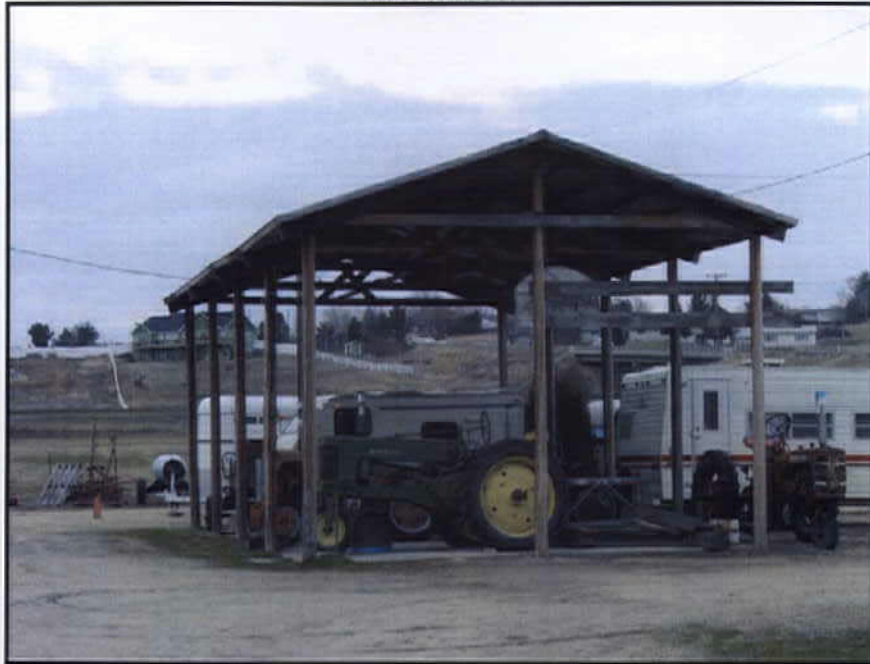
11. Wood Shed
 The wood shed is not historic. This building has a rectangular plan and is constructed of wood beams. It is open on all sides and has a corrugated metal roof. This open building has a concrete pad.
 The wood shed is in good condition. Because it is not historic, it does not contribute to the eligibility of the historic site as a whole.

View looking southwest at the north and east elevations of No.11 wood shed.

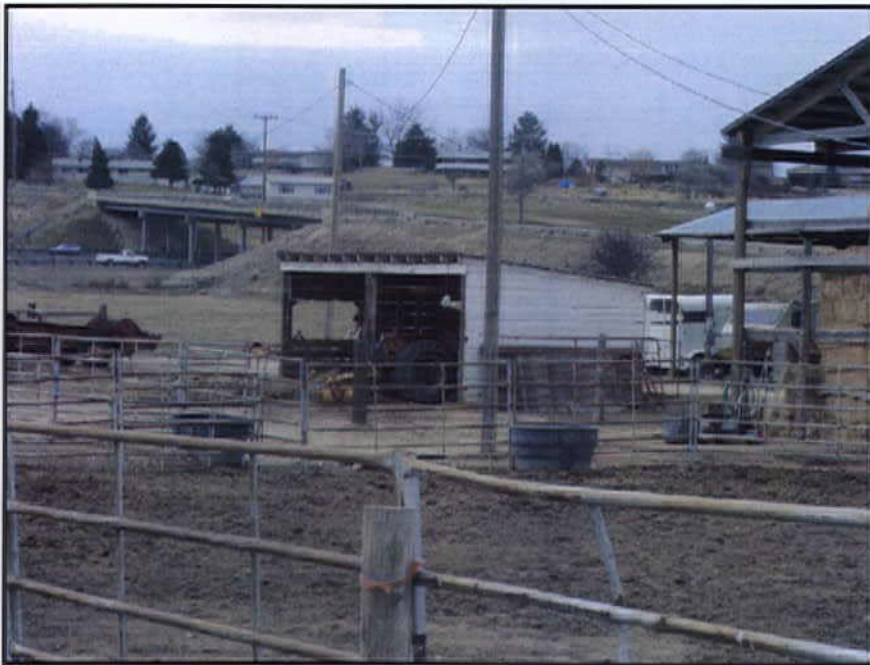
12. Loafing Shed
 The small loafing shed has a rectangular plan and is constructed of wood with a wood exterior painted white. It has a shed style roof with metal roofing and a dirt floor.
 The north elevation has no doors or windows. The south and west elevations have portions of the wall broken out. The east elevation is open.
 The loafing shed is in good condition. This building contributes to the eligibility of the site as a whole.

View looking southwest at the north and east elevation of No.12 loafing shed.

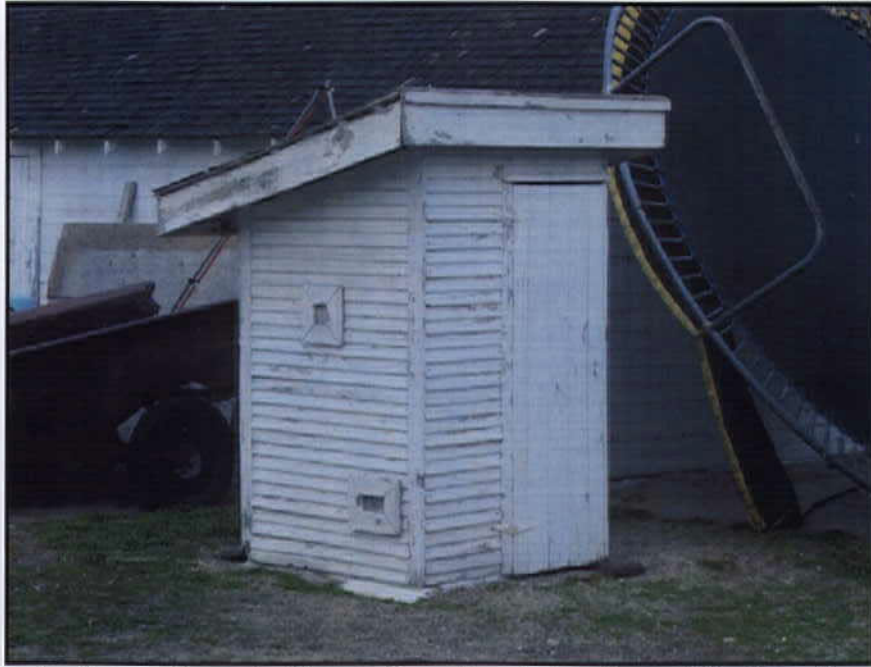
View looking northwest at the south and east elevations of No.13 outhouse.

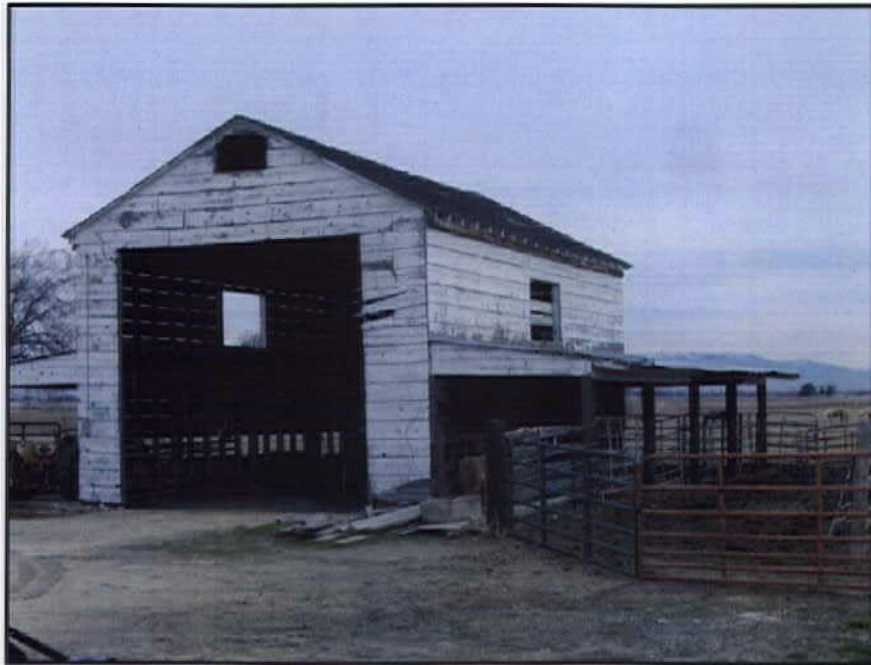
14. Feeder Barn
 The feeder barn is two stories tall with a dirt floor. It has a rectangular plan with a front gable roof and cedar shingles. There is a lean to roof built on at the first floor around the north, east, and south elevations which has metal roofing. There is a concrete pad on the ground around the north, east, and south elevations. The exterior is wood painted white and there is missing exterior wood around three sides of the building at equal height, about four feet above the ground surface. This condition is assumed to be from horses chewing on the wood.
 At the west elevation is a large bay door that fills up nearly the two stories. There is an open vent in the west elevation gable. The north, south, and east elevations have rectangular openings for windows or for venting.
 The barn is in good condition. This building contributes to the eligibility of the site as a whole.

View looking northeast at the south and west elevations of No.14 feeder barn.
