**SUMMARY REPORT OF A
LIMITED FORENSIC EVALUATION**

**MICANOPY TOWN HALL
MICANOPY, ALACHUA COUNTY, FLORIDA**

GSE PROJECT NO. 17318

Subject: Summary Report of a Limited Forensic Evaluation
Micanopy Town Hall
Micanopy, Alachua County, Florida
GSE Project No. 17318

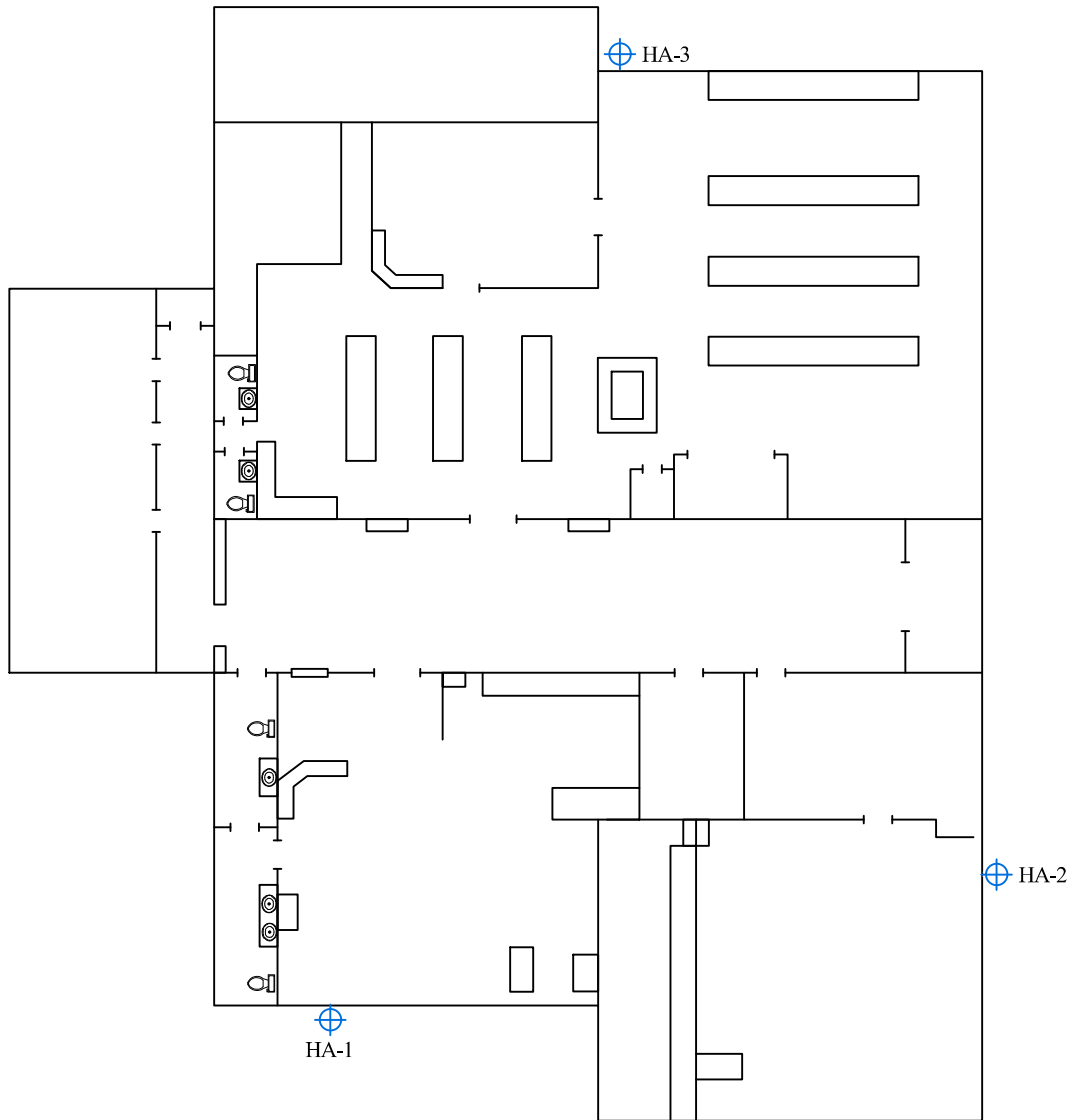
FIGURE
 2

Cracking and separation damage were noted on both the interior and exterior of the building. Figure 2 illustrates the overall layout and observed representative damage to the interior and exterior of the building.

The auger borings were performed in accordance with ASTM D1452. The borings were performed with hand auger equipment that was rotated into the ground in a manner that reduces soil disturbance. After penetrating to the required depth, the auger was retracted and the soils collected on the auger flights were field classified and placed in sealed containers. Representative samples of each stratum were retained from the auger boring. Results from the auger borings are provided in Section 5.1. The auger boring locations are indicated on Figure 2.

Three (3) hand auger borings were performed at the site around the perimeter of the building. The selected boring locations considered the damage to the building and relative floor elevation survey. The soil boring locations are shown on Figure 2. Descriptions for the soils encountered are based on visual observations of the recovered soil samples and the laboratory testing performed. Stratification boundaries between the soil types should be considered approximate, as the actual transition between soil types may be gradual. The complete boring logs are provided in Section 8.1. The key to soil classifications is provided in Section 8.3.

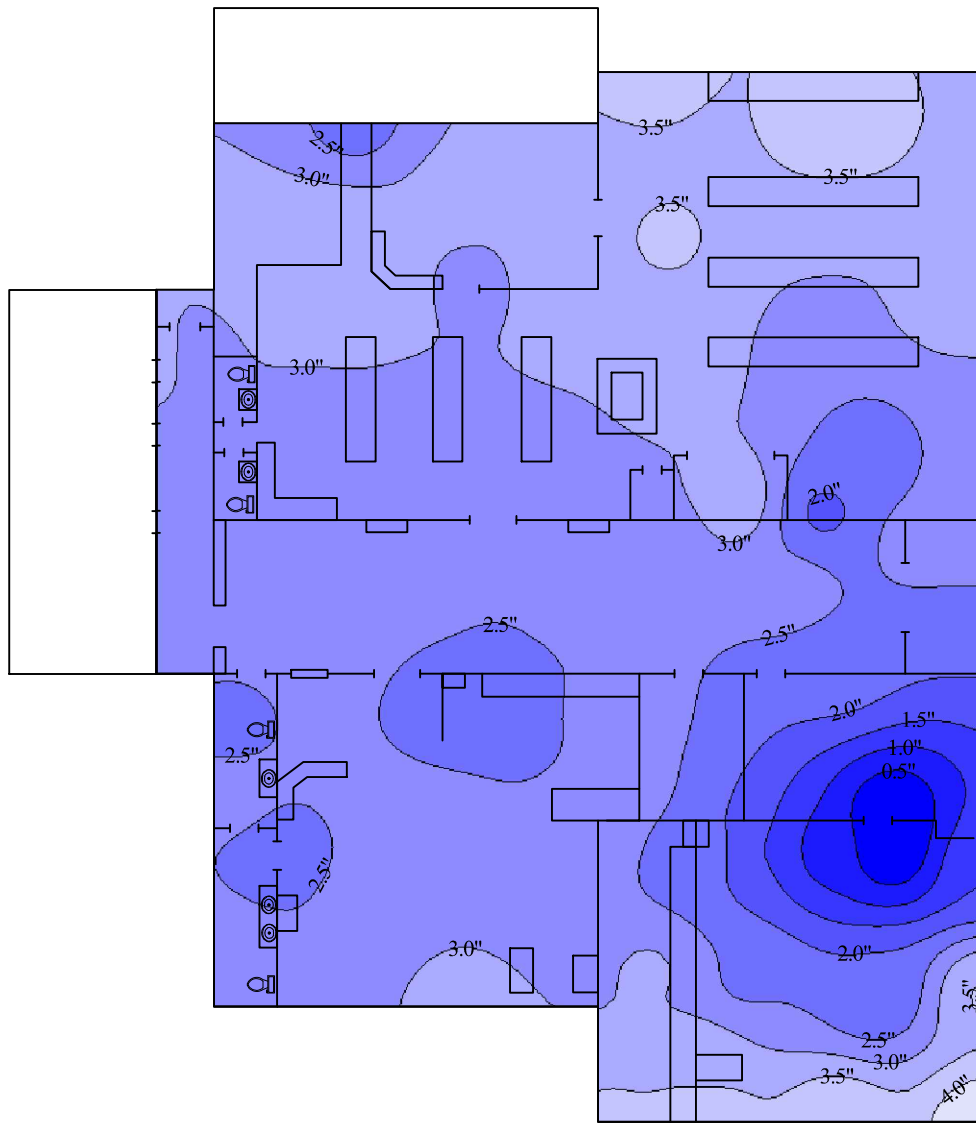
FIGURE
 3

The first-floor interior relative floor elevation survey indicates approximately 4.5 inches of elevation change occurs across the floor. The approximate northern half of the building is relatively level, with elevations generally ranging from about 3.0 to 3.5 inches, indicating less than approximately 0.5 inches of variation across that area. The southeastern portion of the building exhibits a gradual slope downward toward the south, with approximately 2.5 to 3.0 inches of elevation change across that portion of the building. The lowest elevations, on the order of approximately 0.5 to 1.0 inches, are observed in the southeastern portion of the floor.

Historical differential settlements were observed within the floor systems of the subject building. Maintenance personnel described that these settlements had been observed decades ago and were not a concern. Refer to Figures 3 & 4 for the results of the Relative Floor Elevation Surveys.

In order to improve the serviceability of the Micanopy Town Hall structure, GSE recommends that new pier foundations be installed below existing deflected supporting floor beams or that new beams and pier foundations be constructed to supplement the existing foundation system. Bottle jacks should be installed at the top of each new pier. These bottle jacks would be used to methodically and uniformly support and lift the areas of the greatest differential settlement.

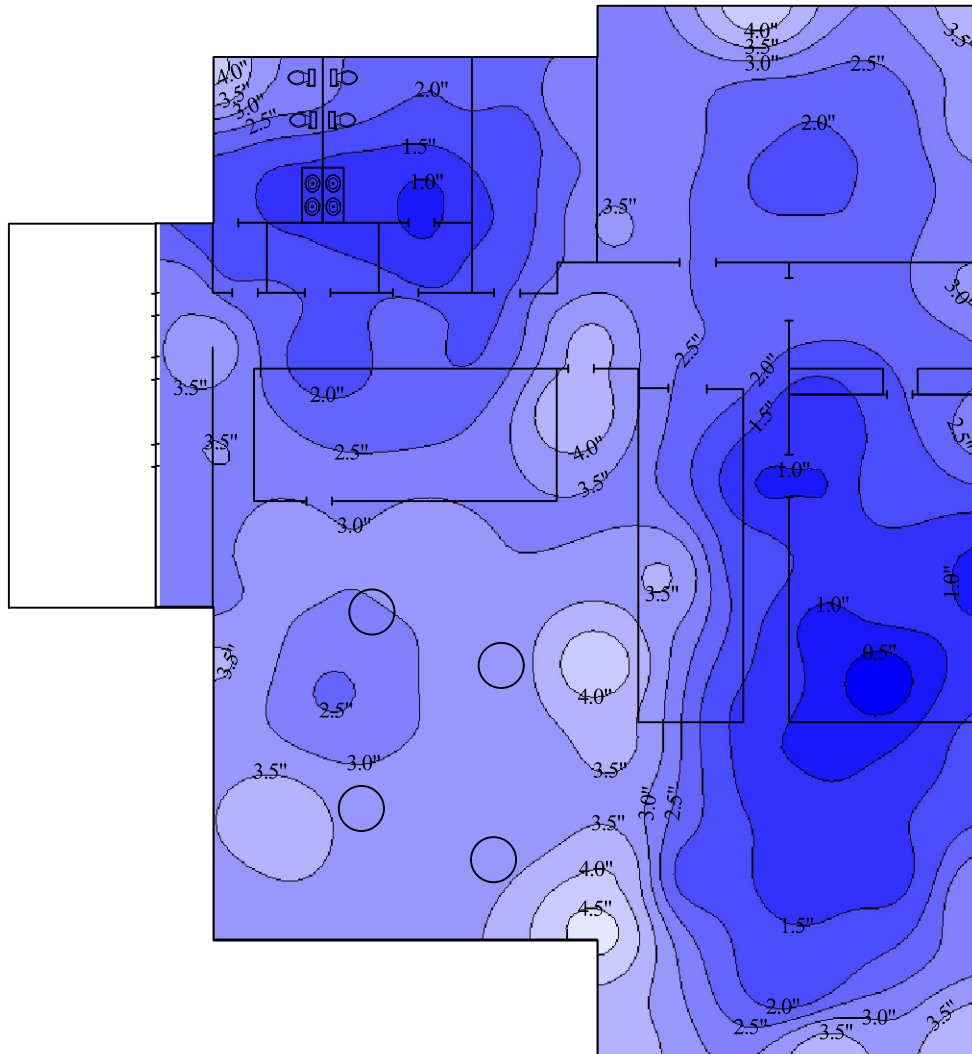
4

The second-floor interior relative floor elevation survey indicates approximately 4.9 inches of elevation change occurs across the floor. The floor elevations generally range from about 3.0 to 4.5 inches across much of the building, indicating moderate variability. A distinct low area, with elevations on the order of approximately 0.5 to 1.0 inches, is present in the southeastern portion of the building, consistent with the first-floor trends. Additionally, a secondary low area with elevations of approximately 1.0 to 2.0 inches is observed in the northwestern portion of the second floor. These areas have about 2.5 to 3.5 inches of elevation difference relative to nearby higher areas, indicating movement across the building, with the greatest settlement in the southeastern portion and some variation toward the northwest.
