# MILES CITY, MT SPLASH PAD

**Preliminary  
Engineering  
Review**

**PRELIMINARY ENGINEERING REVIEW**  
**SPLASH PAD**  
**MILES CITY, MONTANA**  
July 2025  
WR25-04-106

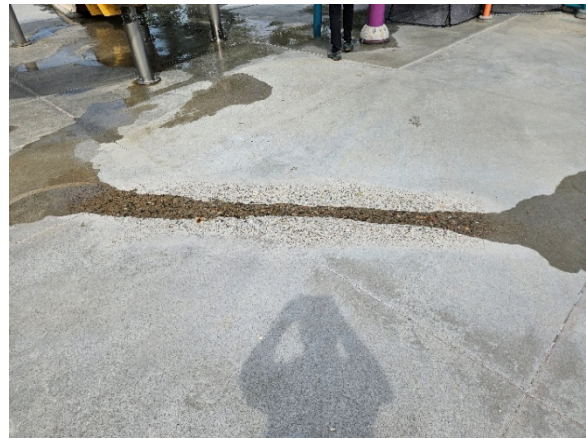
- The pad is a cast-in-place concrete splash deck. When originally constructed, concrete control joints spaced at approximately 10-foot intervals with little surface cracking between joints. The concrete deck originally had an area that held water, however this was addressed via surface grinding a channel into the concrete to drain the puddle.

Figure 1: Concrete drainage grinding.

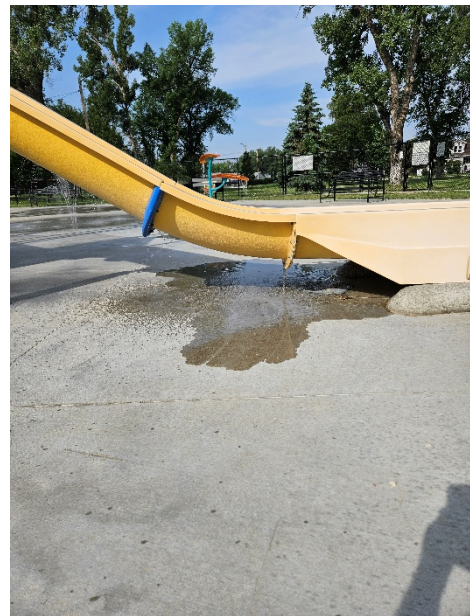
- A large play feature is roughly centered on the splash pad. The structure features an elevated play tower with two slides, dump features and numerous aerial and ground sprays. While onsite it was observed that the same dump bucket from the 2024 meeting was stuck upside down. The operators found a hex key, loosened a set screw, rotated the spray bar, tightened the set screw and the dump bucket began working properly the rest of the time we were onsite. It was also noticed that the slide structures have excessive oxidation staining and the slide flanges are cracked and leaking at numerous joints.

Figure 2: Joint leak below slide.

- The waterslides should be put on a minimum annual maintenance schedule. The waterslides are oxidized, the slide joints are cracked and leaking water, and it was stated that kids have informed the staff of rough joints when sliding down the surface. If an operations and maintenance manual isn't on record for the

- o [https://www.waterplay.com/files/6816/1644/5504/Fiberglass\\_Slide\\_Maintenance\\_and\\_Repair\\_Manual\\_210318.doc.pdf](https://www.waterplay.com/files/6816/1644/5504/Fiberglass_Slide_Maintenance_and_Repair_Manual_210318.doc.pdf)
- o The slide surfaces should be waxed per manufacturer recommendations at least yearly.
- o If the riders are stating an unpleasant surface or water is seen coming out of the bottom of the flange, the existing joint filler should be removed and replaced.

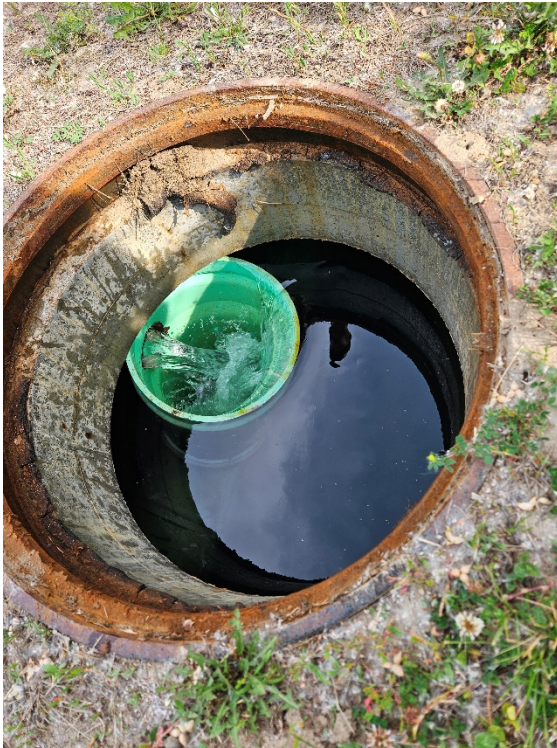
- Four main drains gather the feature water off the splash pad and drain it into a settling strainer manhole. From the strainer manhole, it's piped into a 4,000 gallon fiberglass storage tank where the recirculation system draws water. During operations, it was noticed that the city staff was straining cotton and debris out of the storage tank instead of the strainer manhole. The strainer manhole has a vertical PVC tee in it with a standpipe that has perforated holes to strain said debris

out prior to making it to the storage tank. During operation, the flow rate of the water draining from the splash pad would exceed the allowable flow through the standpipe penetrations so the water level would completely fill the strainer manhole before dumping into the top of the standpipe, thus creating a water imbalance between the two tanks. When the pumps for the splash pad system turn on, a large water draw is put on the storage tank and the slow draining strainer manhole didn't allow the water to recirculate fast enough to keep the storage tank levels from dropping low. During a normal operation, this would turn the autofill on as the tank is demanding water but then when the splash pad turns off and the tanks finally balance out, the storage tank would be overfull and waste out the overflow line. Interstate recommended that either the staff drill additional larger penetrations in the standpipe or remove the standpipe entirely. Before leaving the facility, the pipe was removed and the water levels balanced between the two tanks.

**Figure 3: Strainer manhole full of water with standpipe.**

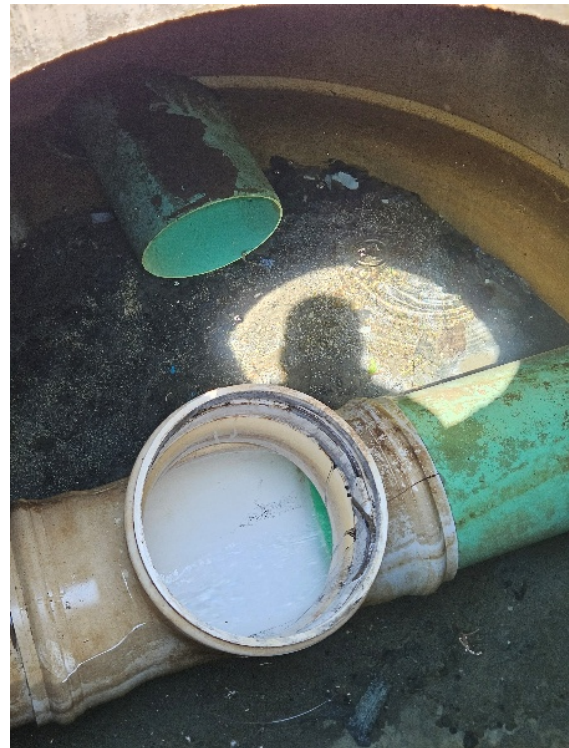
**Figure 4: Strainer manhole after standpipe removed.**

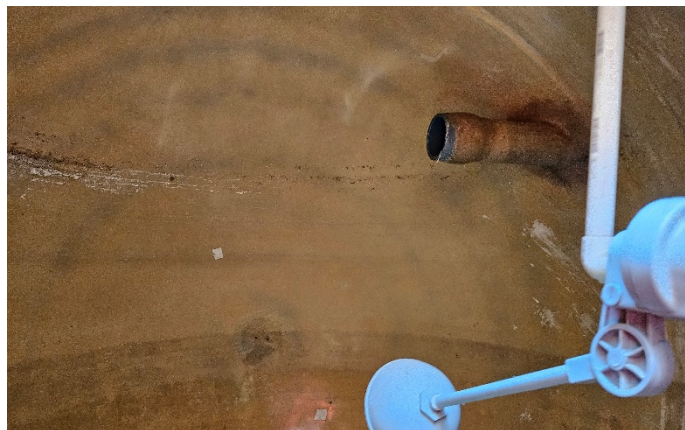
- The autofill system is a 1" line that runs from the mechanical building into the storage tank and is controlled with a ball float valve at the end. The city stated that even when the ball is completely submerged, the water wont shut off unless the staff manually pull it up. There is an overflow pipe that will drain the water into a gravel sump basin in the park if the tank level increases to much. With the fill water running 24/7 there's a

**Figure 5: Scum line on tank walls at overflow pipe penetration.**

possibility of the tank wasting water to the park, as evidence by debris scum lines in the tank.

- **Estimated Cost: \$200**
- The existing float valve doesn't shut off and should be replaced. The valve can be unscrewed from the fill line and a new float and valve purchased at a local hardware or agricultural store and installed.

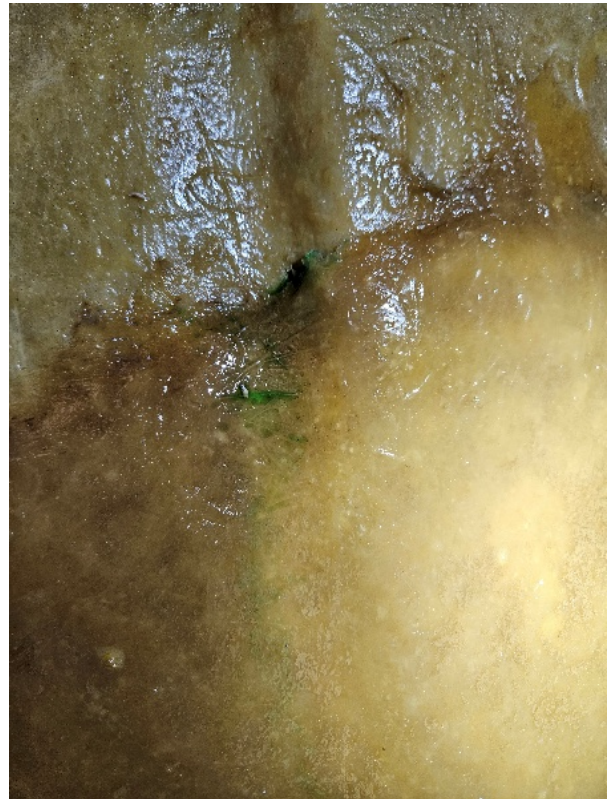
- The staff state that the water level will drop an entire stair rung (approximately 12 inches) overnight if the autofill line is turned off.
- Dye testing was conducted in the strainer manhole and storage tank. The manhole showed no signs of leakage around the pipe penetrations. The floor/wall seal was not directly evident due to sediment on the ground, but the tank water was very stagnant when the splash pad was not functioning. The fiberglass tank did not reveal any significant sources of leaks once the water level was drawn down to a safe level and the recirculation pump turned off. The inlet pipe from the manhole was recently fiberglass patched in place. A small section on the top of the new fiberglass appeared to allow dye behind the patch. This was above the water level in the tank at the time of testing so it's unclear if water is capable of leaving the tank at this location, however it should be investigated further.

Figure 6: Dye migrating behind fiberglass surface.

With few areas of potential leaks discovered during the dye test, additional testing should be performed to further evaluate the facility components and piping. It was recommended to the city staff that they isolate the underground piping from each structure via inflatable pipe plugs, fill the structures full of water and record the water levels in the structures for a couple days. If the water levels do not fluctuate, then the tanks can be deducted from the equation and one by one each pipe penetration should be opened and individually tested for water loss. If a tank(s) level drops, then the leak can be isolated in the structure and fixed.

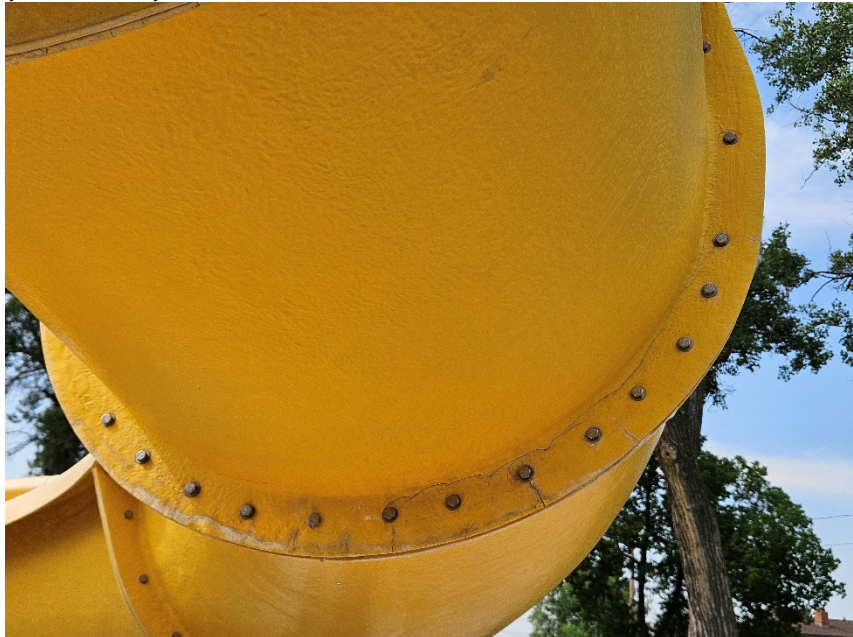
Figure 7: Cracked flange on waterslide.

- The cracks in the fiberglass flanges are severe and should be repaired to limit further damage or the sections should be on a schedule to be replaced. As stated in the Waterplay repair manual, “fiberglass fractures are found... typically on the bolting flanges. The flanges are critical to the structural integrity of the part. Any fractures to the slide component could seriously degrade the structural integrity of the slide section and must be fixed immediately.”
