MILES CITY, MT FROG POND

**Preliminary
Engineering
Review**

**PRELIMINARY ENGINEERING REVIEW
OUTDOOR FROG POND
MILES CITY, MONTANA**

July 2025
WR25-04-106

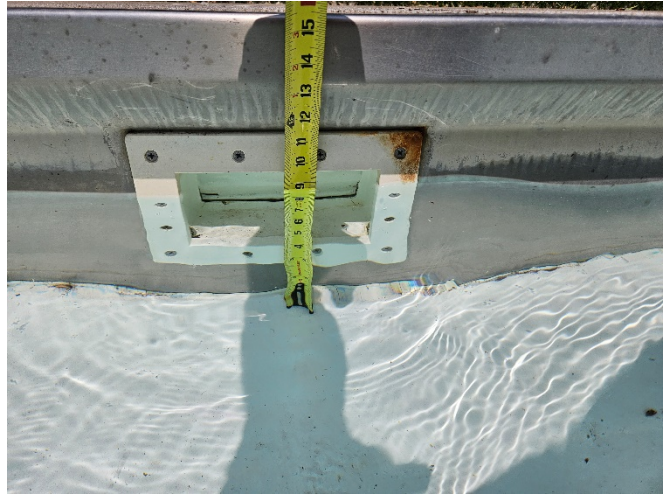
- The city staff referenced the distance between screws in the flange of the West skimmer when referring to how much water is lost during a normal open swim day. The screws in reference are 2" apart which equates to approximately 2,000 gallons of water loss each day while in operation. The loss of water in a pool can come from a number of things but the main contributors are leaks in the structure or plumbing, splashing from play activity and evaporation. Based on historical local weather conditions in Miles City the estimated pond evaporation is approximately 0.2 in/day averaged over the months of operation. The result is a water loss of roughly 200 gallons per day from evaporation. A bather load estimate wasn't received, however a high bather load in a shallow facility typically leads to an elevated splash volume.

Figure 1: Surface water skimmer.

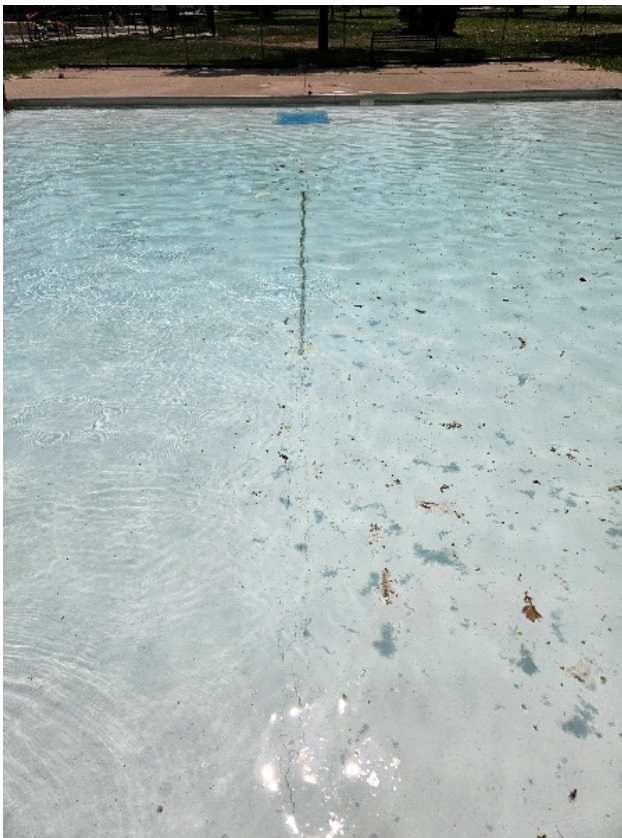
- The pool is a cast-in-place concrete floor with an epoxy paint coating over the concrete and no major cracks or differential settlement is evident. There are multiple hairline cracks in the epoxy paint flooring. A construction joint runs north-south in the middle of the floor slab and appears to be uniform in width along most of its length. The joint sealant along the middle of the structure was partially missing, and staff noted patrons frequently play with the caulking once it starts to loosen from the . The stainless-steel walls show no signs of failing welds, and the sealant between the walls and floor is intact.

Figure 2: Joint sealant failure.

- **Estimated Cost: \$25,000**
- Remove and replace all joint sealant around the perimeter wall to floor transition and along the center pool construction joint. The existing sealant shall be completely removed and the joint cavity cleaned of debris and loose concrete, as epoxy paint prevents adhesion of caulking. A two part joint sealant applicable for use in pools and submerged locations shall be installed.

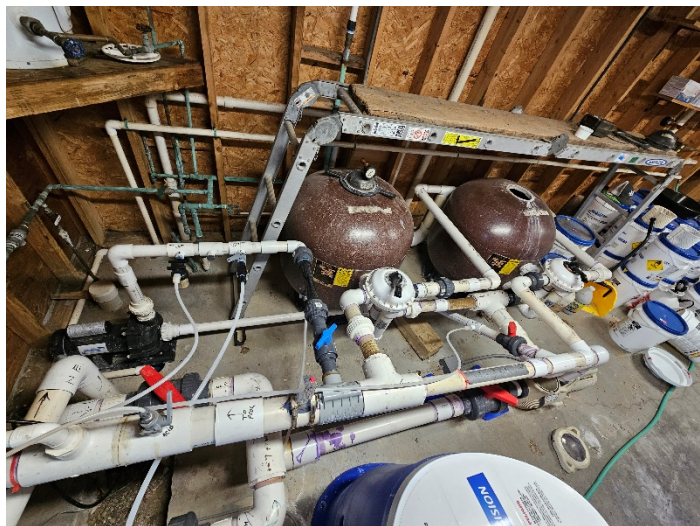
Figure 3: Mechanical Room

- The filtration system utilizes two vertical pressurized sand filters, which are original to the facility. The pool operator didn't state any loss of sand during backwash procedures or normal operation.
- The 5 HP Pentair Whisperflo XFE self-priming pump operates most efficiently between 200 and 280 GPM which aligns with the 233 GPM design turnover flow rate of the pool. A throttle control valve is located on the discharge side of the pump to artificially create head loss which reduces the GPM flow rate of the pump. The staff have expressed issues with getting the pump initially primed for operation.

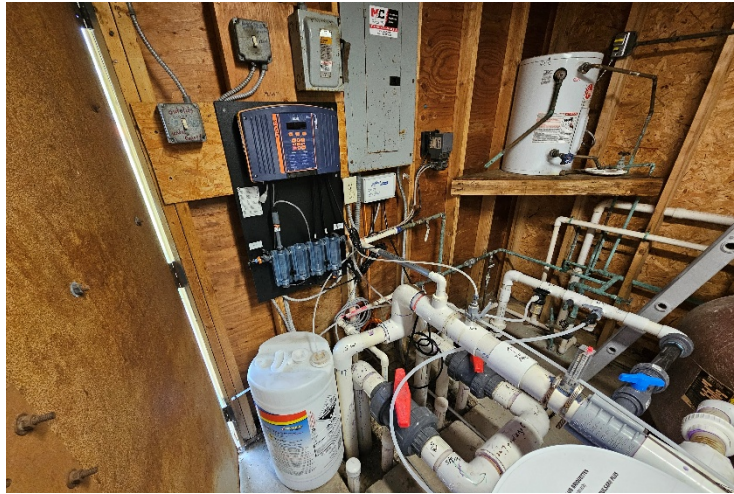
- The recirculation piping in the mechanical room is Sch-40. Although it isn't a part of the wading pool recirculation system, the copper piping for the hot water heater has significant corrosion. It is unclear how the main drain piping was abandoned underground when the drains were plugged.

Figure 4: Tank Hot Water Heater and piping
