## CONSULTING SERVICES REPORT

### Mechanical, Electrical and Plumbing (MEP) Assessment and Testing Report

1126 Yosemite Drive  
Milpitas, CA 95035  
Terracon Project No. F3196204  
July 2, 2019

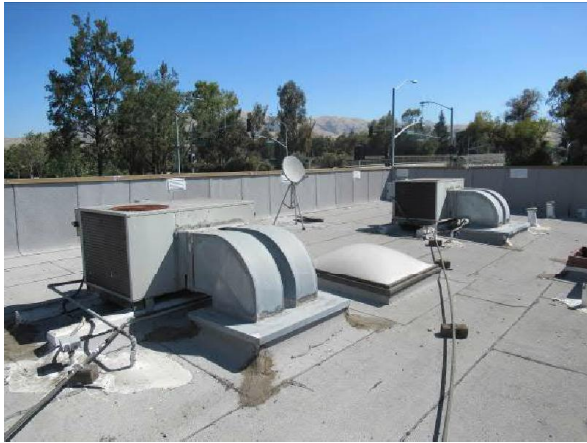
Terracon observed and performed limited testing of the mechanical RTUs. Please see the table below. The two 3-ton RTUs were observed to be in fair to poor condition and beyond typical Estimated Unit Life (EUL) and are recommended for replacement. Please see the Cost Tables.

**Photo #1** View of two 3-ton RTUs on the lower level roof.

- Replace the two existing 3-ton RTUs with DX heat pump RTUs utilizing R-410a refrigerant to meet 2020 EPA requirements. Provide new units with seismic restrains to meet the state of California code. Replace power disconnect with new one. (OPTIONAL)
- Provide existing 4-ton RTU with seismic restraint to meet the state of California code.
- Reroute the 3-ton RTUs condensate piping to the sing in the janitor room.
- Repair damaged duct insulations to prevent condensation above ceiling. (See example in the photos)

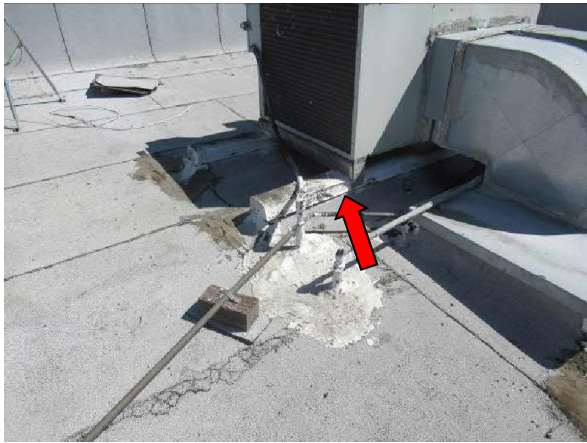
**Photo #3** RTUs are not provided with seismic restraints.

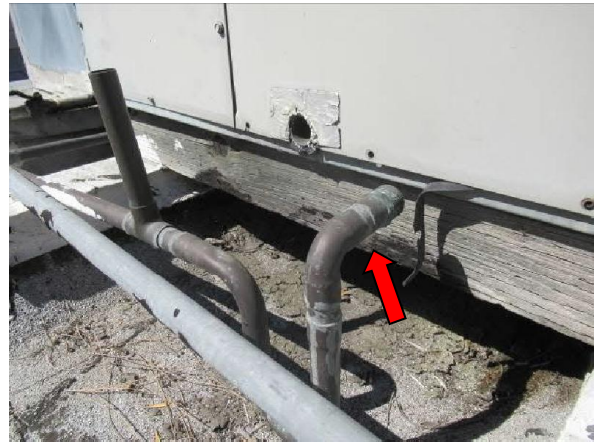
Condensate drain from 3-ton RTUs was observed to be routed to the roof drain. It is required by code to rout the condensate drain piping to the sink in the janitor room.

**Photo #4** View of broken condensate water drain pipe.

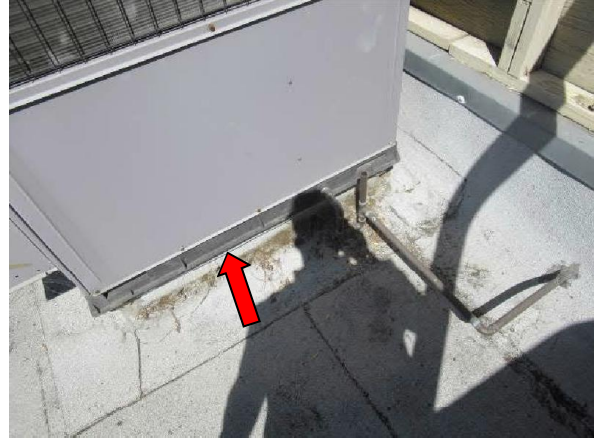
The 4-ton RTU was observed and tested to be generally in good working condition. The fan compressor were operated in the cooling and heating modes and were functional with wall mounted electronic thermostats. The discharge airflow temperature of 58.5-degree F was measured on most of the supply air diffusers. The measured values were within acceptable ranges for units installed in this type of property. The exhaust fan provided to the restrooms was observed to be in good to fair operation condition. The RTUs are not provided with seismic restraints and it is required per code to provide seismic restraints to all RTUs on the roof.

**Photo #8** 4-ton RTU is not provided with seismic restraint.

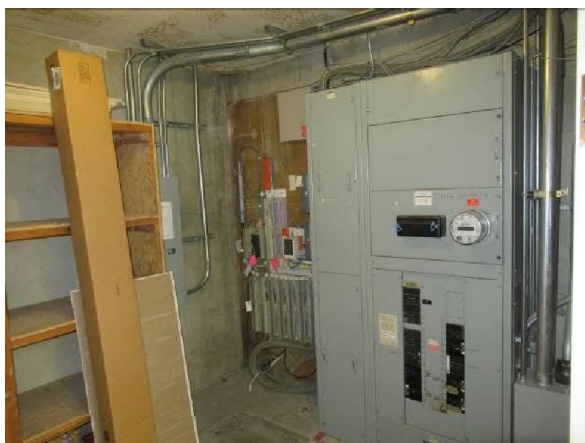
Electrical service to the building is supplied by utility-owned, pad-mounted electrical transformers and conductors routed below ground to the electrical room inside the building. Electrical service within the building is rated at 400-amps, 120/208-volt, 3-phase, 4-wire. Electrical wiring within the building is copper. Exterior lighting consists of pole-mounted and wall-mounted high intensity discharge (HID) light fixtures reportedly timers controlled. Interior lighting mainly consists of T-8 fluorescent light fixtures. The interior lighting is controlled by manual switching. Exterior lighting fixture were observed to be in fair condition. all exterior lighting fixtures needs to be cleaned and maintained. The electrical room was not provided with a cooling system. A wall mounted DX cooling unit is recommended to be provided and to avoid electrical panels from being overheated. Please see the cost tables.

**Photo #11** View of the main electrical main switch board in the electrical room.

- Install wall mounted DX cooling unit in the electrical room.
- Update all electrical panels indexes.
- Maintain and repair all exterior lighting.

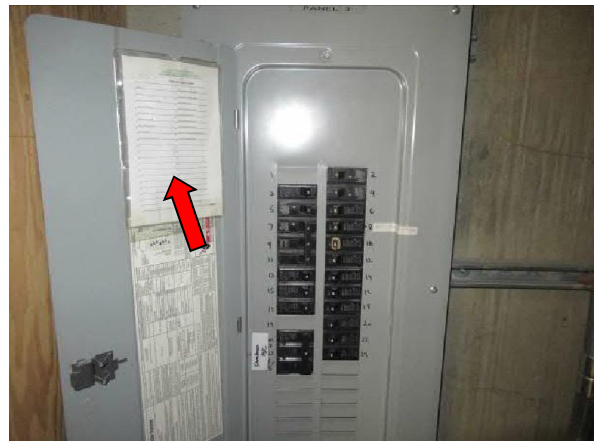
**Photo #12** Typical electrical panel with index that needs to be updated.

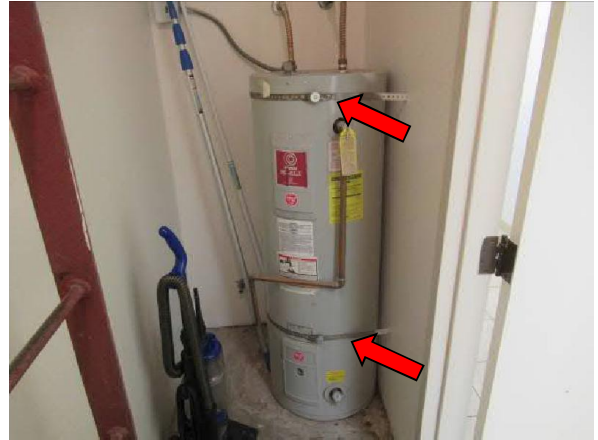
The electric water heater were observed to be in good working condition, domestic hot water temperature were measured in the restrooms to be 105-degree F to 115-degree F. The electric water heater is provided with seismic restrains on the upper and lower side per code. Plumbing fixtures were observed to be in good condition. Natural gas and meter are provided to the building, a seismic gas shutoff valve is not provided and is recommended to provided per code. Please see cost tables.

**Photo #20** View of 50-gal. electric water heater located inside janitor room and provided with seismic restraints.

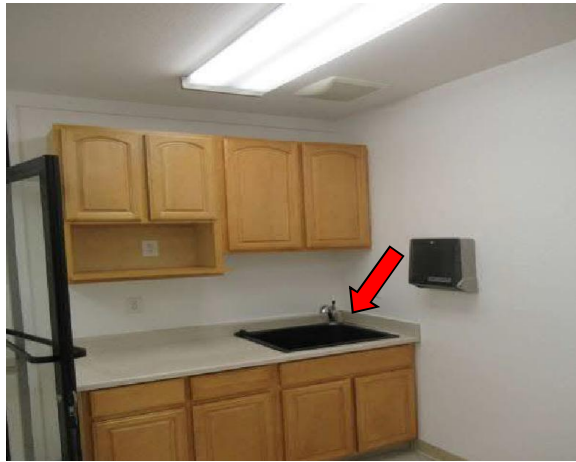
**Photo #25** Example of code violation of industrial sink installed and provided with water pump to pump the drainage water out to the sink inside the janitor room.

- Install seismic automatic shutoff valve on the natural gas line before the gas meter to meet the state of California code.
- Remove sink located by the electrical room.

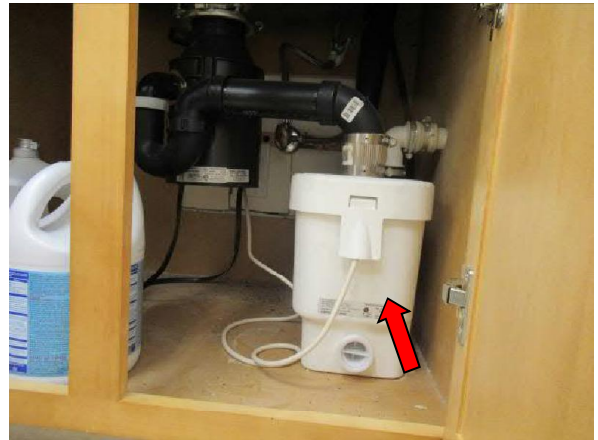
**Photo #27** View shows the industrial sink drainage collected and pumped to the sink in the janitor room with water pump.

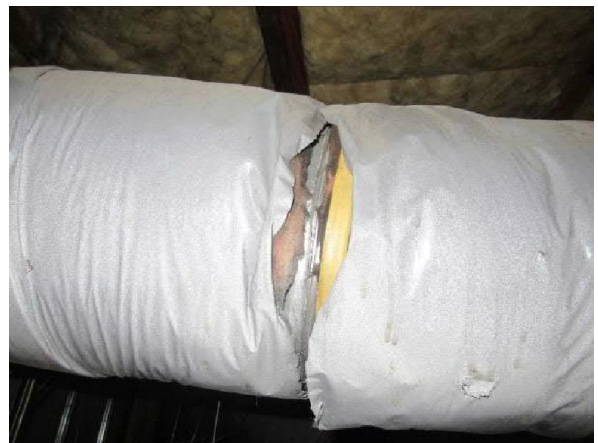
**Photo #29** View shows damage in the duct insulation.

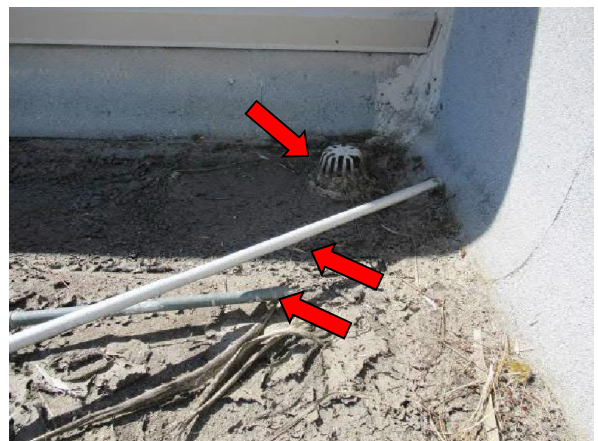
**Photo #31** Example of a code violation of condensate drains free discharging the condensate water to the roof drains.

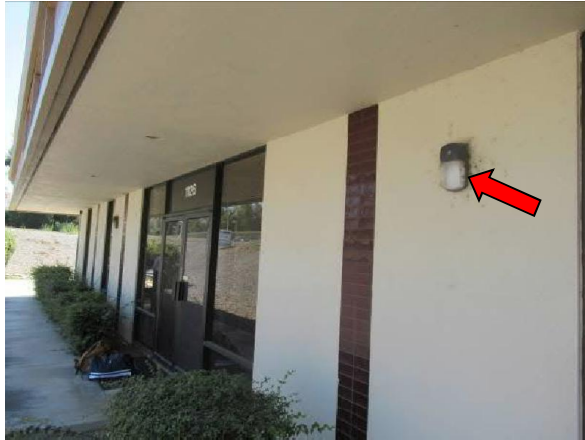
**Photo #32** Typical external lighting fixtures needs to be cleaned and maintained.

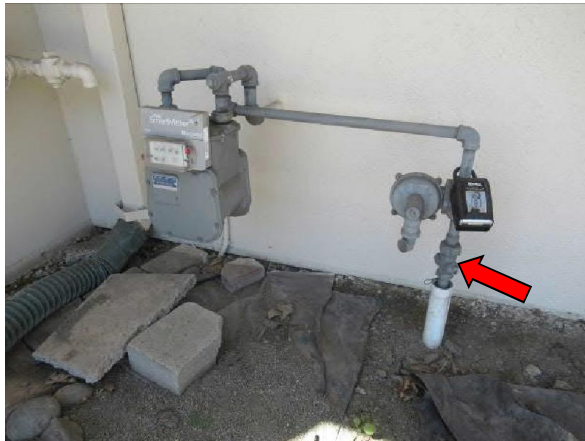
Natural gas service and a meter are provided to the building. A seismic natural gas shutoff valve is not provided with the gas meter.

**Photo #35** View shows natural gas meter, seismic shutoff valve is not provided per code.
