Town of Mineral

CONDITION ASSESSMENT REPORT

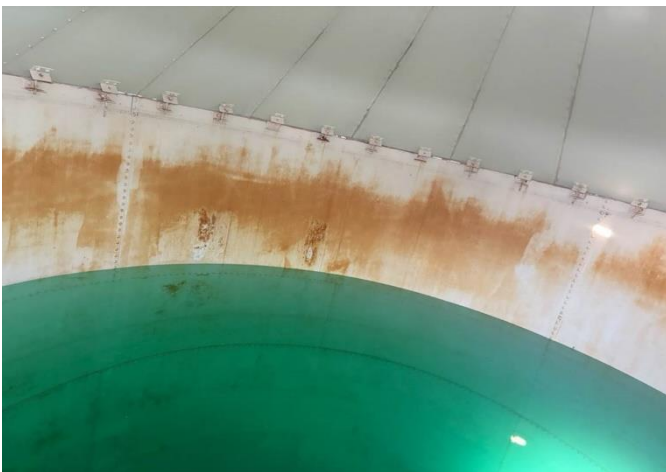
Interior Roof and Sidewall Coating

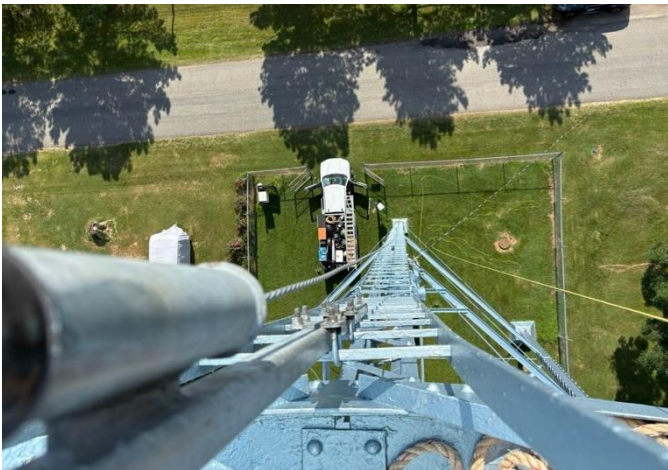
Ladder Equipped with Safety Climb Device

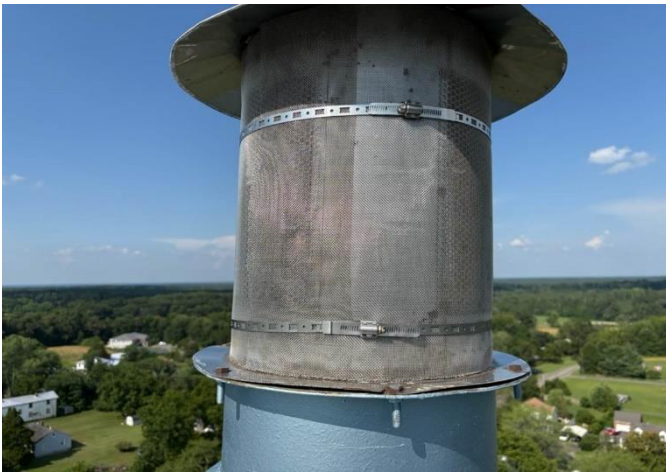
- **Vent Screen:** No deficiencies noted with vent screen.
- **Overflow Pipe Screen Flapper:** Overflow pipe is equipped with flap gate and screen. No deficiencies noted with flapper.
- **Evidence of Foreign Matter:** No evidence of foreign matter observed.
- **Sediments:** Sediment is present in bottom of tank. The tank will be cleaned at the next scheduled washout.

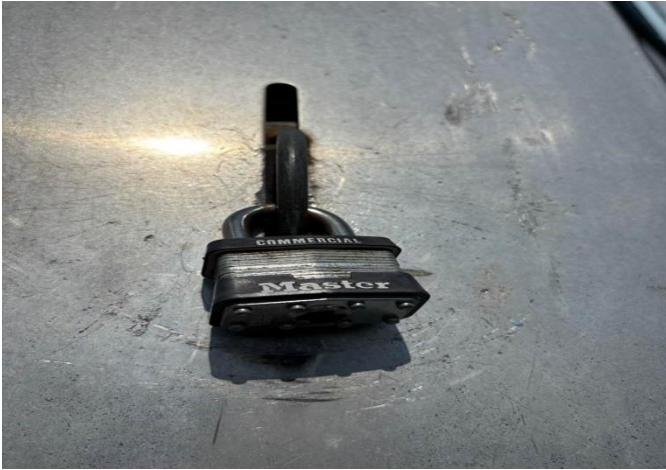
- **Fence Around Site:** Tank is located inside a fenced-in area that is secure.
- **Ladder Gate/Access Door:** Exterior ladder has a ladder gate installed and is locked.
- **Access Hatch Locked:** Access hatch is locked and secured.
- **Evidence of Vandalism:** No evidence of vandalism was found.

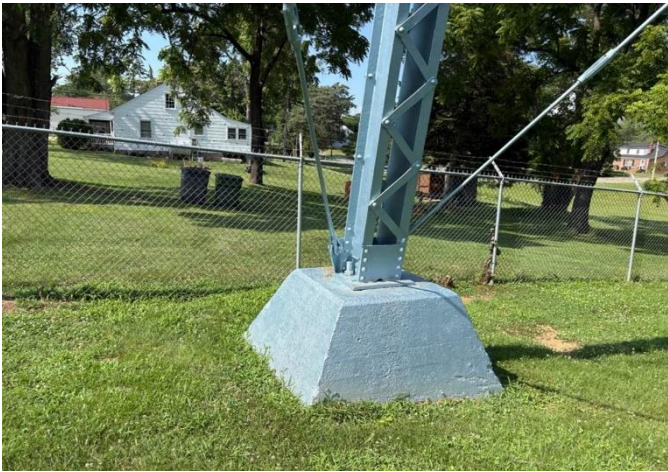
Foundation, Anchor Bolt, and Rod Connection

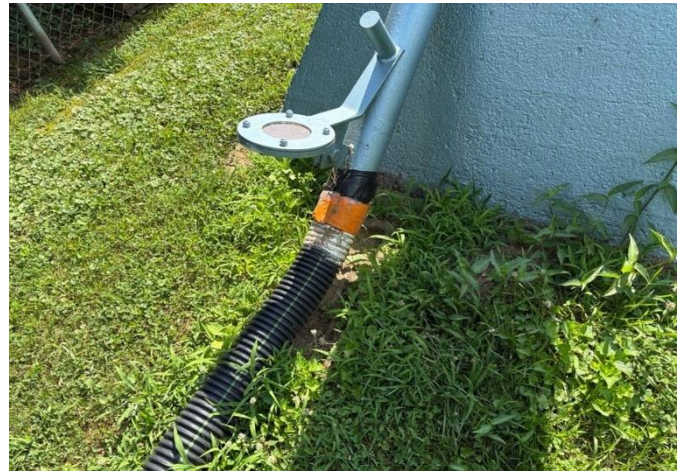
Overflow Pipe Termination
