Author: James Reynolds, PE- Field Director, Richmond Field Office

Date: May 19, 2025

Incident: Louisa County Water Authority 12-inch Water Main Break (PWSID 2109510)

Date of Incident: May 14, 2025

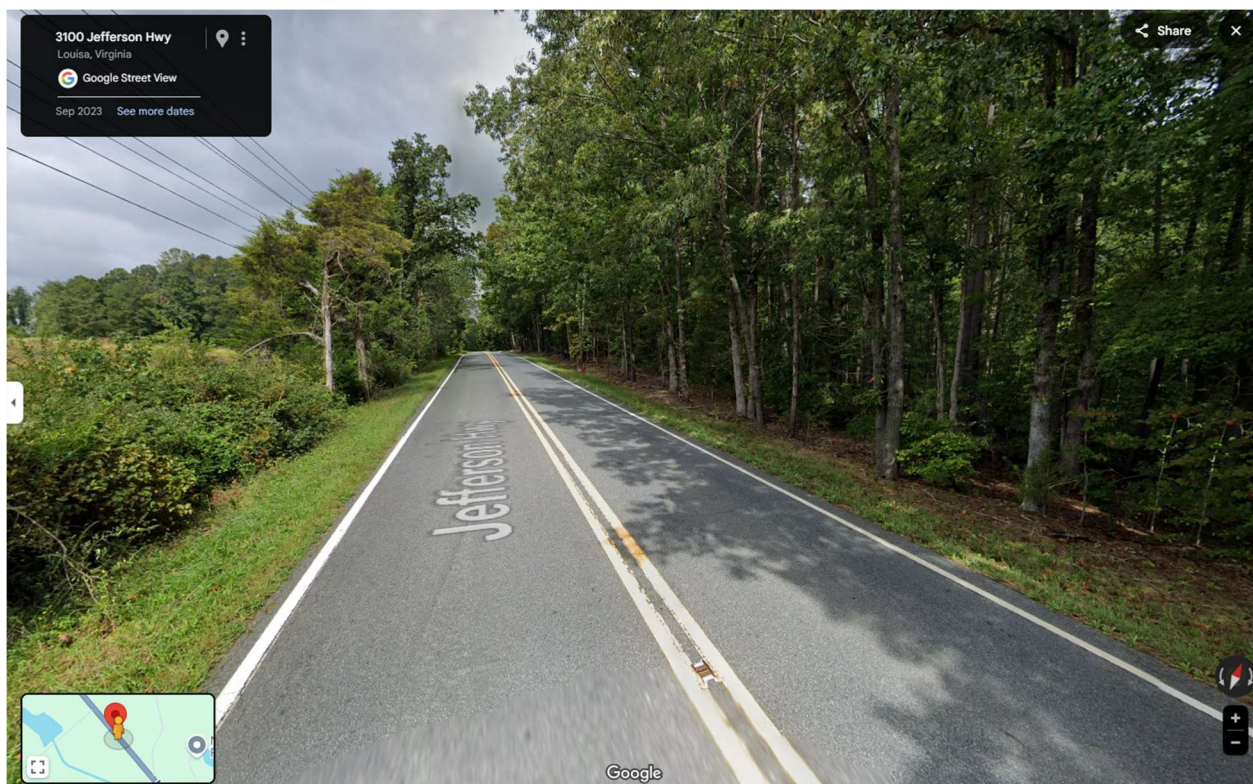
May 14, 2025 0645- LCWA staff locate leak approximately 0.5 miles west of WTP on Jefferson Highway. Staff put in emergency ticket with Miss Utility to come out and mark water line location. Additional maintenance crews called in to assist with repairs. Equipment staged and ready to go.

The highway is rural with no development on either side of the road and grass shoulders that slope to divert surface water runoff from the road into a vegetated swale. The line is a 12-inch major transmission main that takes water from WTP to the distribution system and is made of ductile iron. The pipe appears to be located near the bottom of the swale. There are no customers between WTP and break site.

Figure 2. Location of break site

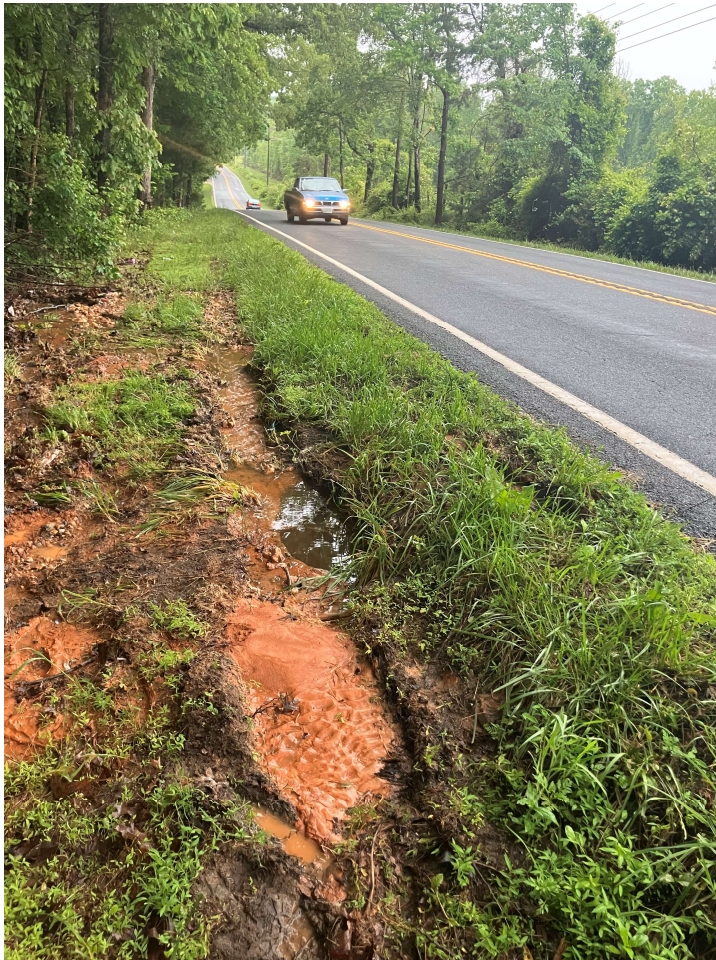
LCWA staff observe what appears to be tire tracks at location of break on top of the water line. It is thought that someone may have veered off the road overnight but did not have an accident. Rains occurred overnight and saturated soil.

Figure 3. Break site. Appears to be tire tracks over pipe location

2. A vehicle runs off the road overnight during rainy conditions. No accident occurred, but tire tracks indicate vehicle could have been directly over water main and appear to be parallel to water main for several feet. This increased stress along the length of the pipe and possibly causing the leak to grow to the point it was observable by dropping tank levels overnight when the plant was offline

1. Standing meetings between LCWA and others should include operations to provide a perspective of current events and allow for technical input.
2. LCWA may experience an increase in heavy machinery traffic on Jefferson Highway as construction of a data center campus begins across from the WTP site. Heavy machinery should be transported with care and avoid driving on the shoulder where the water main is located.

4. During future pipe replacement projects, LCWA should investigate if ductile iron is the best pipe material for locations like unprotected shoulders that may experience occasional spikes in loading by vehicles, etc. Casing of water main in the area or other materials such as HDPE may provide extra protection against breaks.

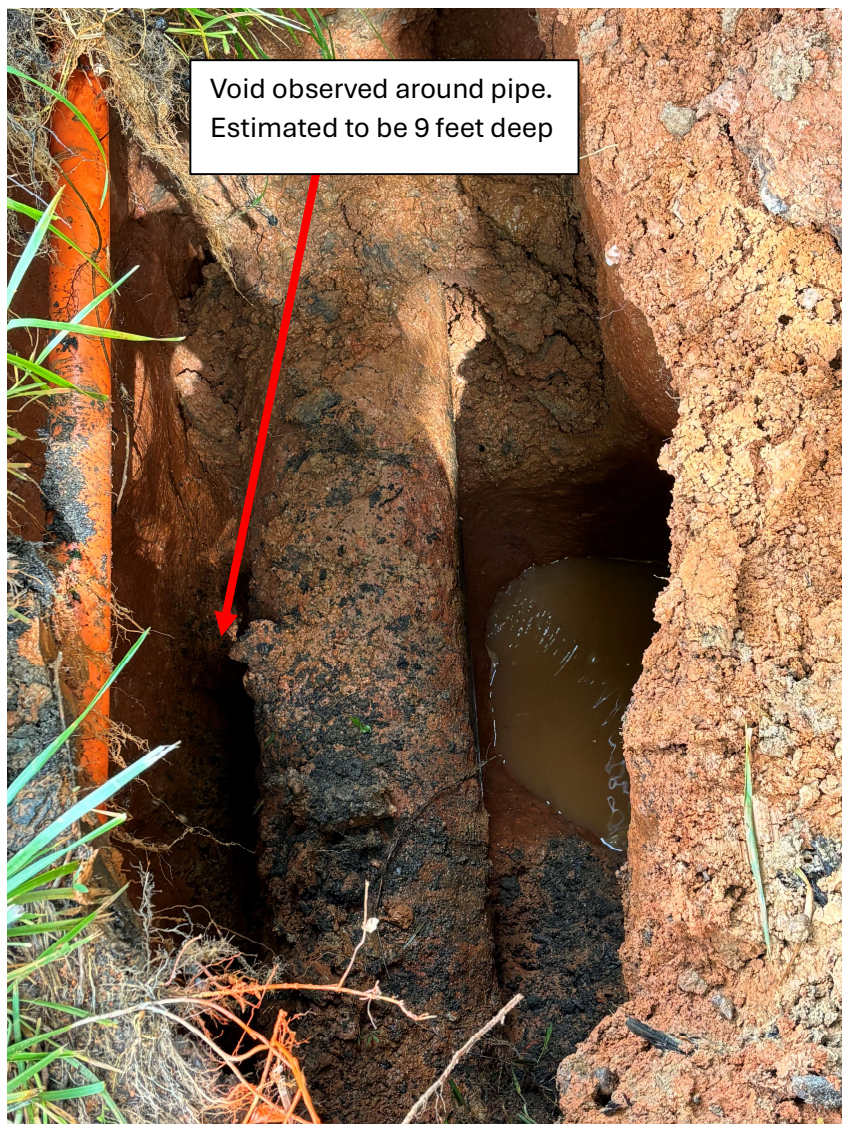
May 14, 2025 1200- Water main repair completed. Exposed break site shows an approximately 9 foot void around leak location when digging. Water main at break site was cut and replaced. Approximately 15-inch longitudinal split on bottom of excavated pipe observed. Marking of underground utilities took approximately 2-3 hours.

Figure 4. Exposed water main at break site

1. A small leak has possibly been occurring at the break site for an extended period of time. LCWA reported there were no visible standing water in this location in the days leading up to the event and that they travel past this location frequently. The leak was small enough that it did not appear visible on the surface. This may have primed the soil for further pipe damage by undermining support bedding and allowing pipe to settle in softened soil

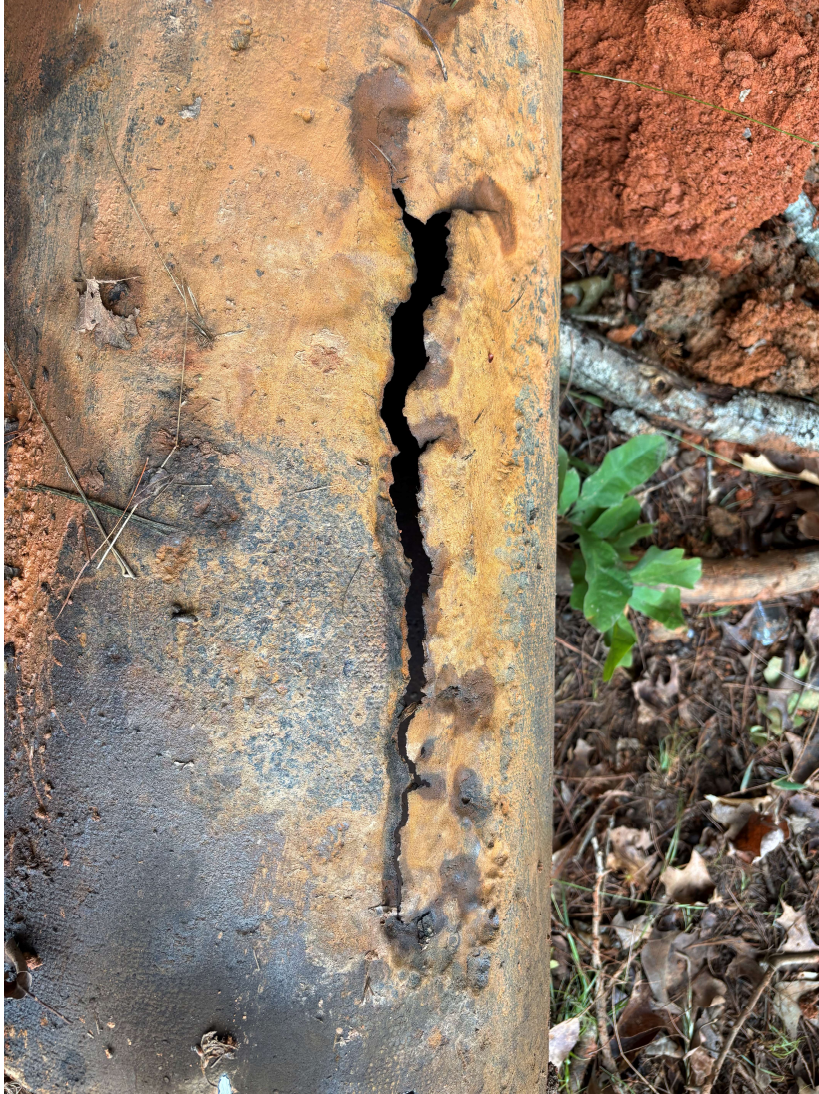
Figure 5. Excavated and replaced water main break

3. LCWA WTP starts a high service pump which causes an internal surge in water pressure which completes the longitudinal break in the pipe and results in a large main break that began dropping tank levels rapidly. Figure 5 appears to show failure going from inside the pipe outward (internal pressure) vs outside the pipe inward (crushing force).

1. LCWA should investigate the use of variable frequency drive motors for high service pumps for higher level of operator control of pumps. High service pumps at LCWA utilize a star delta starter which ramps up the speed of the pump motor over a set period of time. While this results in a stepped increase in motor speed and potentially increases water pressure in a stepwise manner, it does not provide a controlled stop in similar fashion. Water hammer may still be experienced on the stop of the pump. In addition, the operator has less control over the ramp up time as that is set by the starter. If the ramp up time is not in tune with the hydraulics of the system, there may still be a water hammer as flow is not developed until the pump head overcomes the system pressure. If this occurs after the pump reaches full speed, it would act similar to a direct on and off pump starter.

5. LCWA should evaluate main break historical information to determine if ductile iron piping is approaching the end of its useful life. If so, LCWA should investigate why service life of ductile iron piping is shorter than industry averages.
