# BELLM BRIDGE MINTURN TEMPORARY SCOUR PROTECTION DESIGN MEMO

DATE: July 13, 2023

RE: Bellm Bridge Design Minturn, CO  
Taylor St Over Eagle River  
Temporary Scour Protection Design  
SEH No. MINTU\_173117

The goal of this memorandum is to describe the temporary scour protection design for the Taylor Street Bridge over Eagle River (Bellm Bridge) in Minturn Colorado.

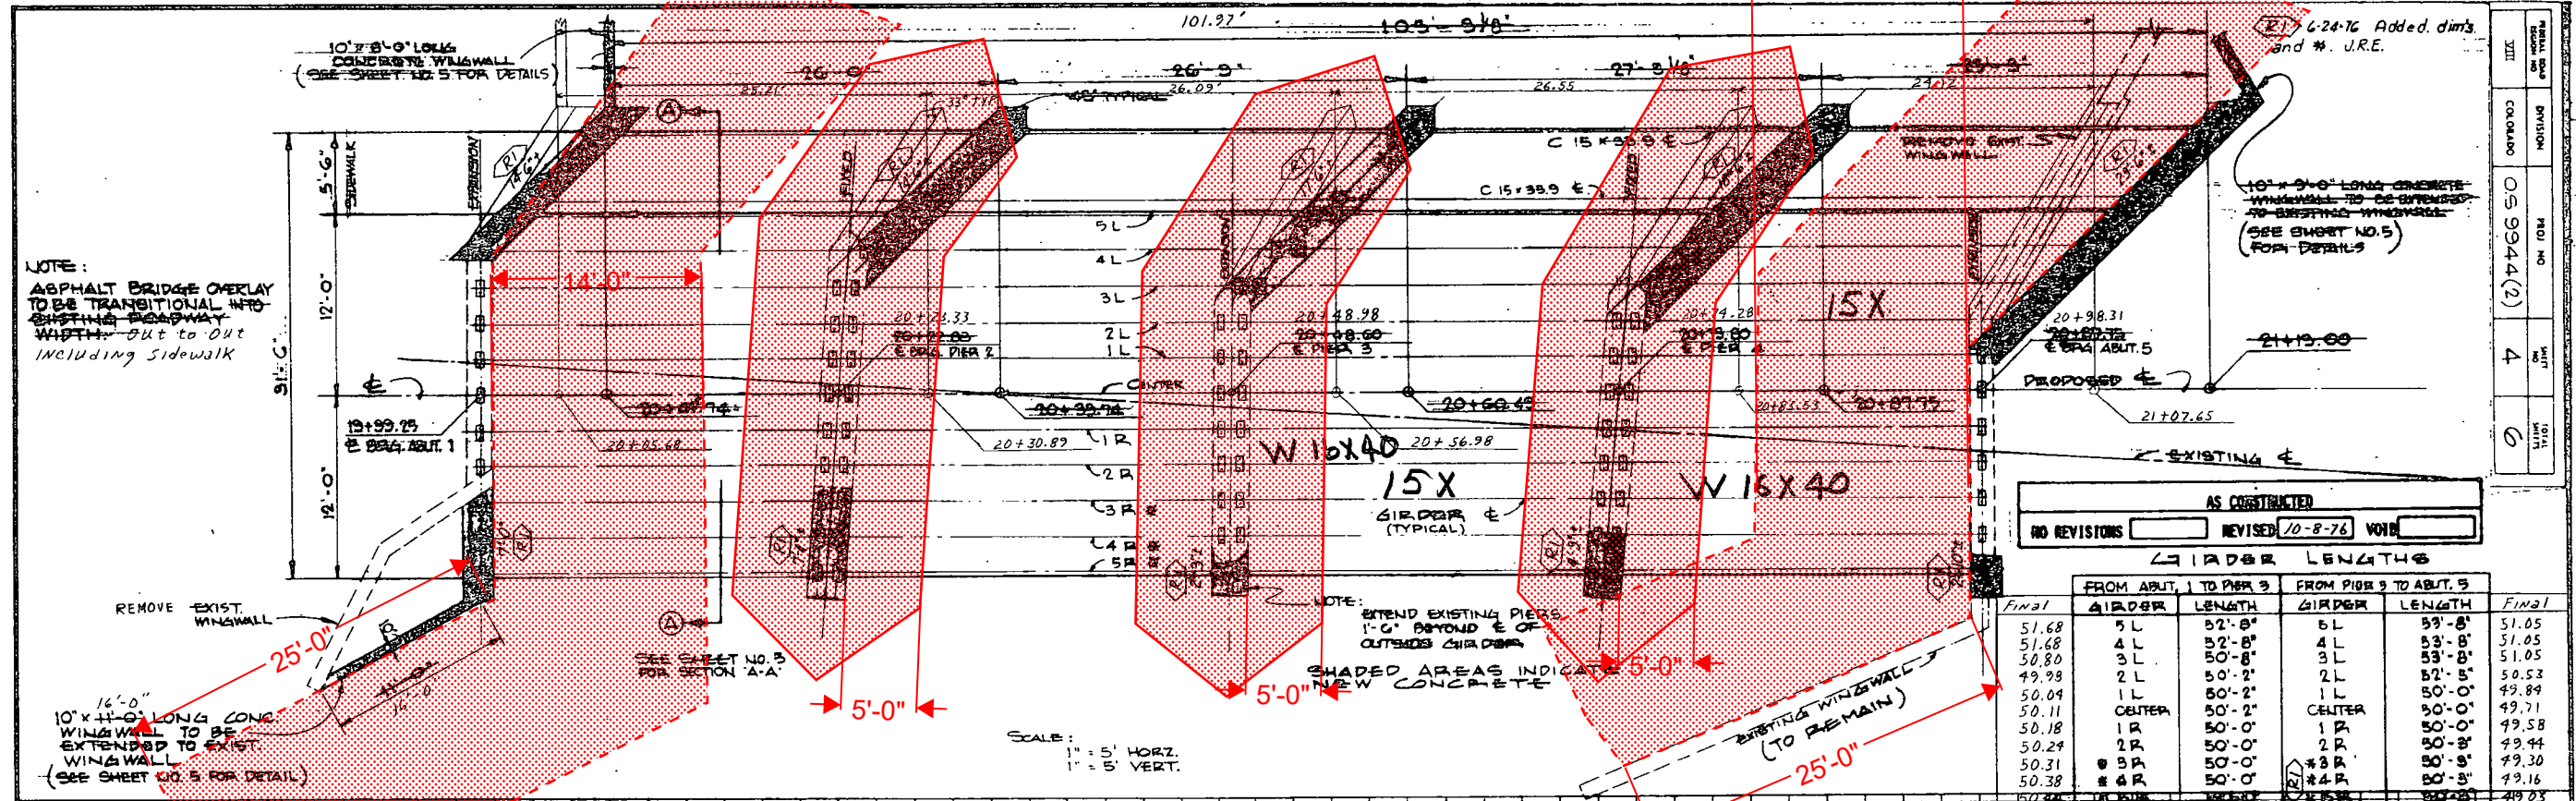
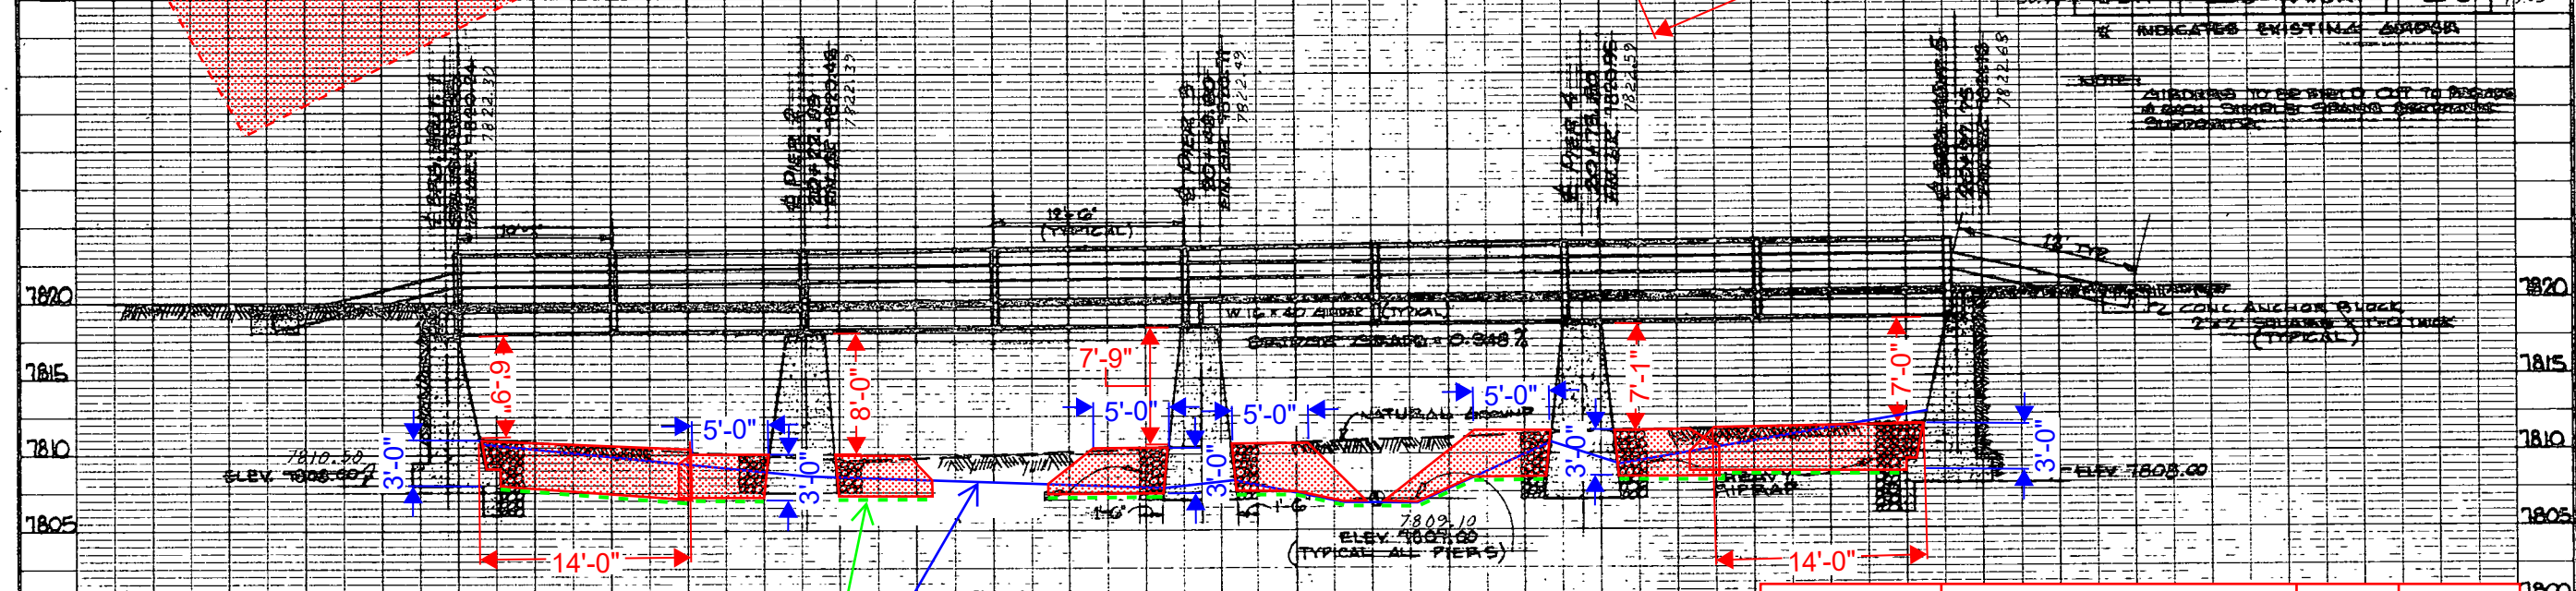
Job 76010  
 Drawn ADP  
 Appr. JEA  
 Date APRIL '76  
 Scale NOTED  
 Sheet 4

Using HEC 23 Design Guideline 14 to calculate riprap size it was determined that 18" D50 Riprap with a depth of 36" is required for this protection in both the as-built and ERFH scenario. Riprap should extend to a width of 5' encircling each pier then slope at 2h:1V to the existing channel surface. Riprap should extend to a width 14' from each abutment and 25' downstream. A mark-up of the as-built plans showing the riprap can be found on the following page attached to this memo.

The temporary scour protection required for this bridge will be 18" D50 at a depth of 36" with appropriate bedding. The plan view of the riprap can be found on the following page and in the mark-ups to the as-built plans attached to this memo. While the addition of riprap will cause a rise relative to the current existing condition, it is anticipated that it is intended to not have an effect on the mapped floodplain. This temporary solution will provide protection against additional scour or damage to the bridge while a permanent solution is found.

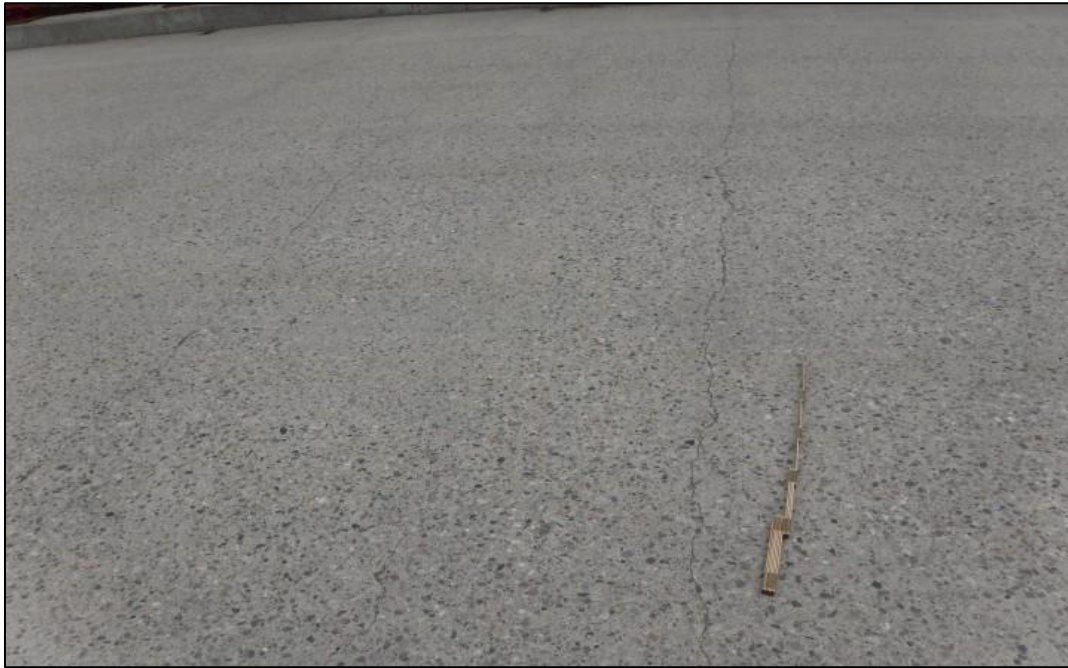
Transverse cracking and abrasion throughout deck surface.

Seal the concrete deck to inhibit further moisture penetration.

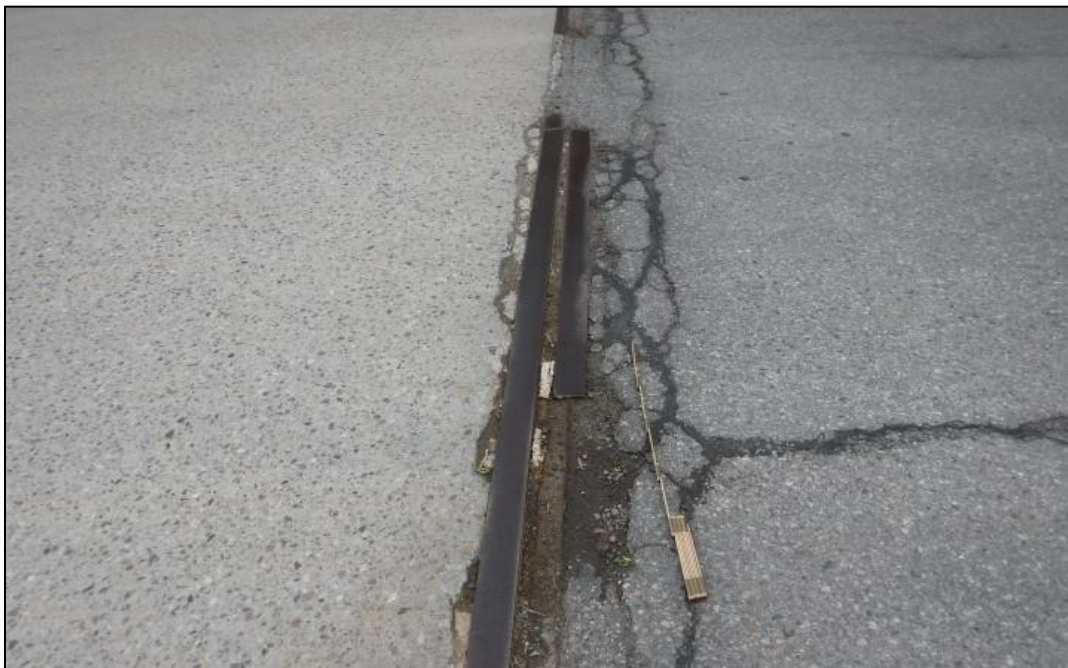
General view of damaged joint armor at N joint-Typical debris in joint.

Replace expansion devices at both ends of deck.

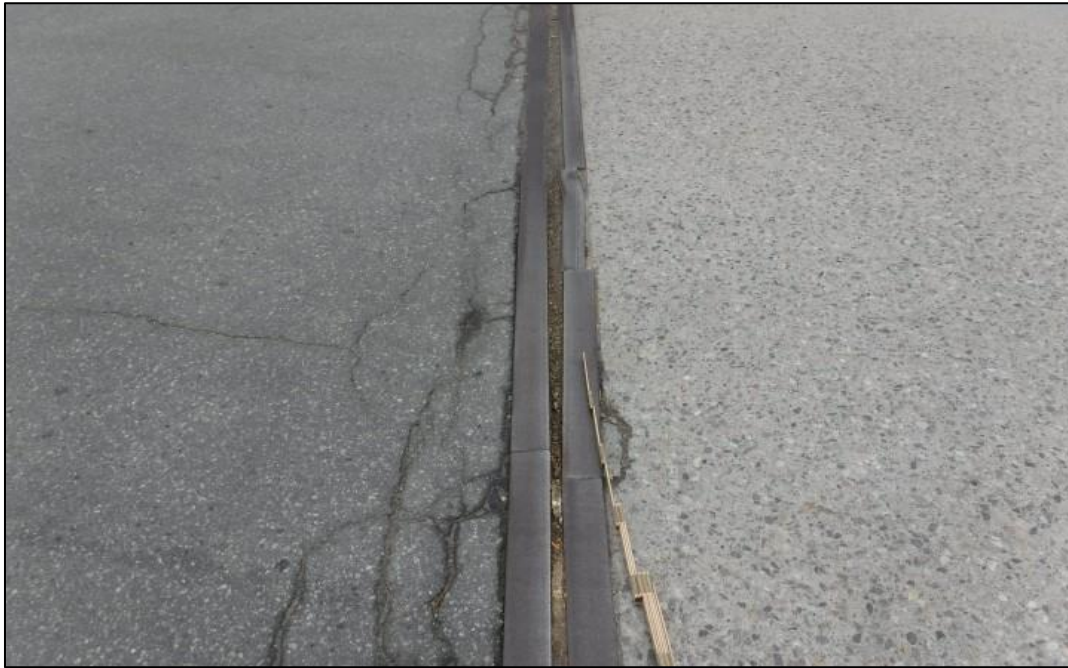
Delamination and spalls in south end of deck.

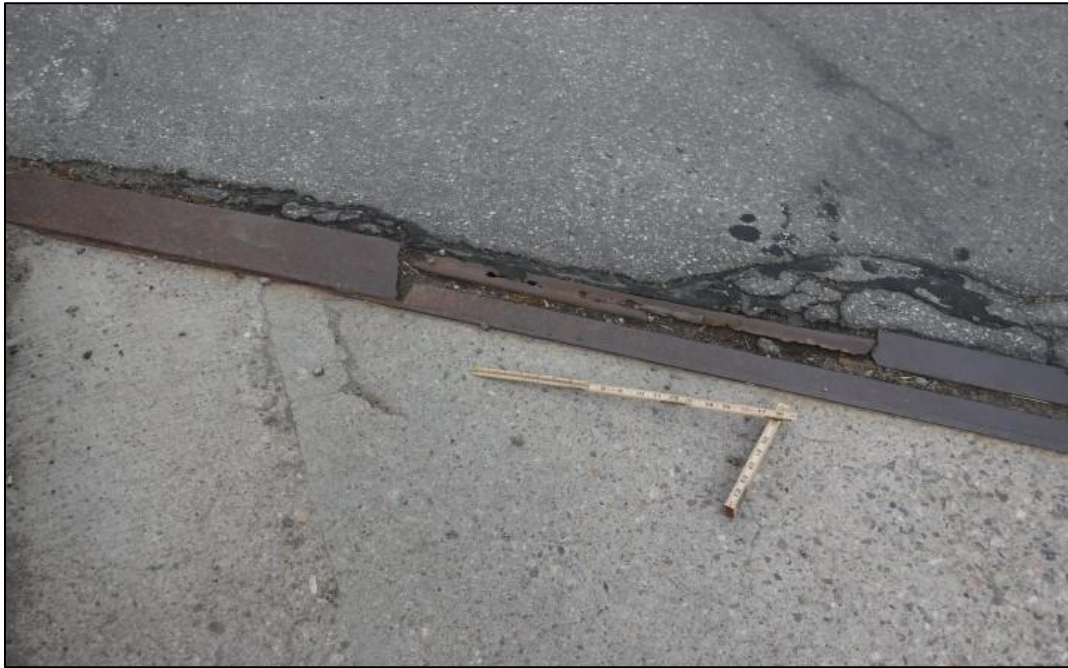
Cover plate missing and rust holes in armor angles at S joint near E curb.

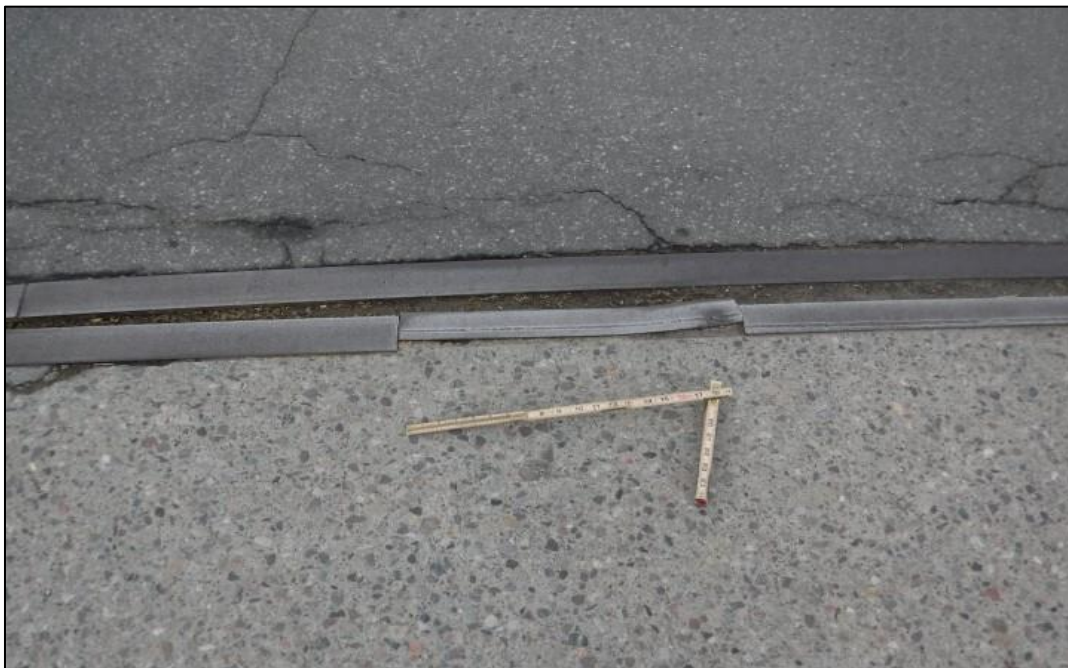
Damaged joint angle at south joint near centerline of roadway.

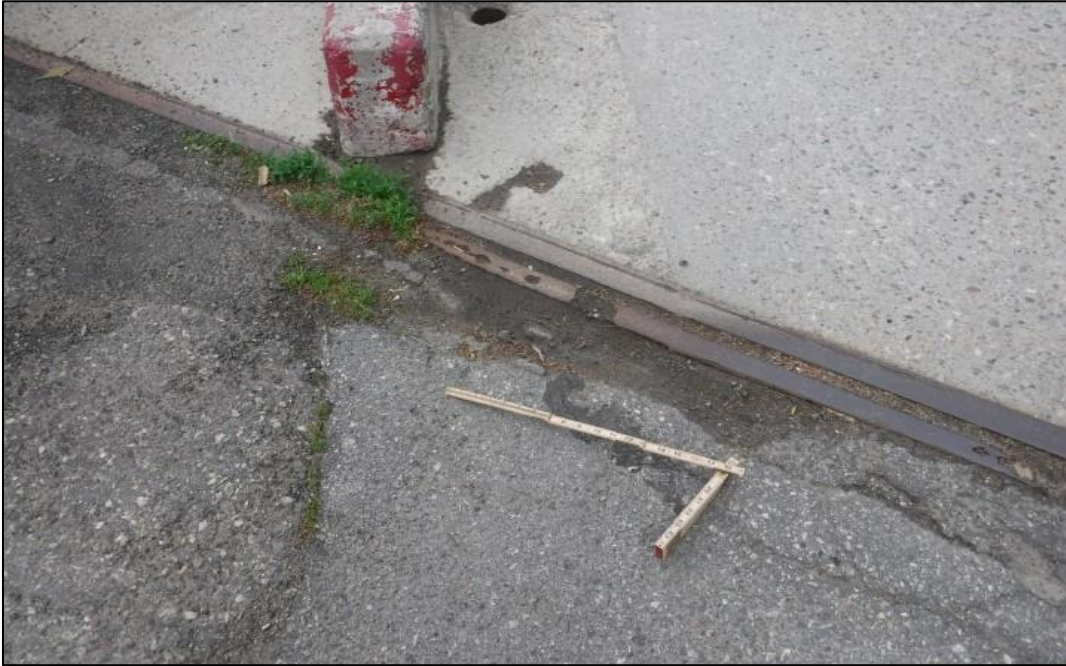
Broken and settled asphalt in walkway at NE corner of deck.

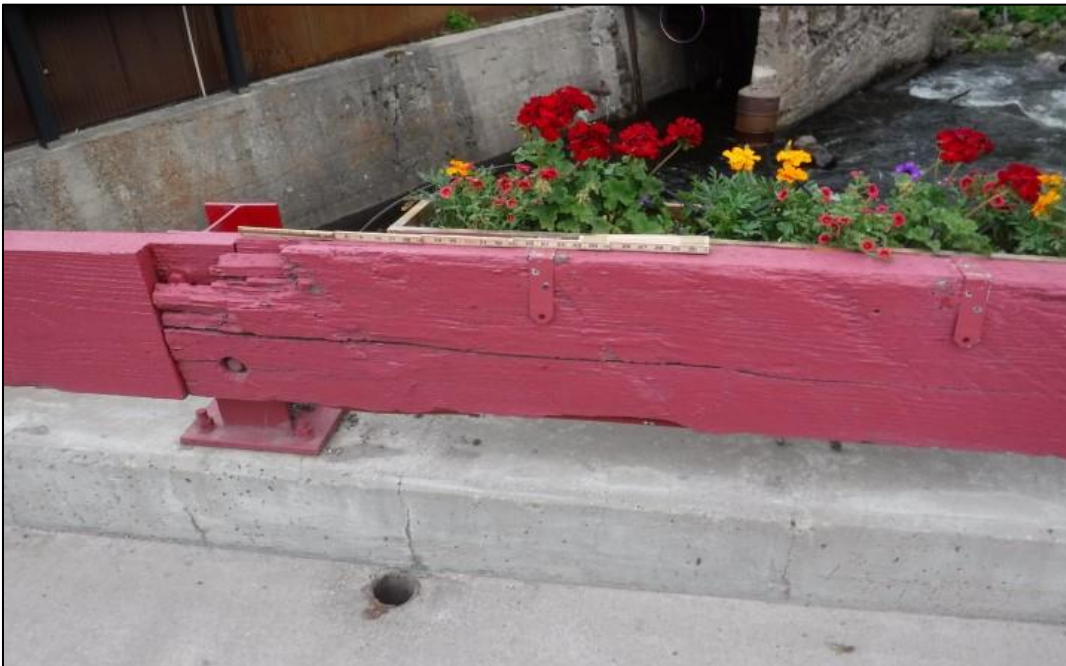
West timber rail broken plank.

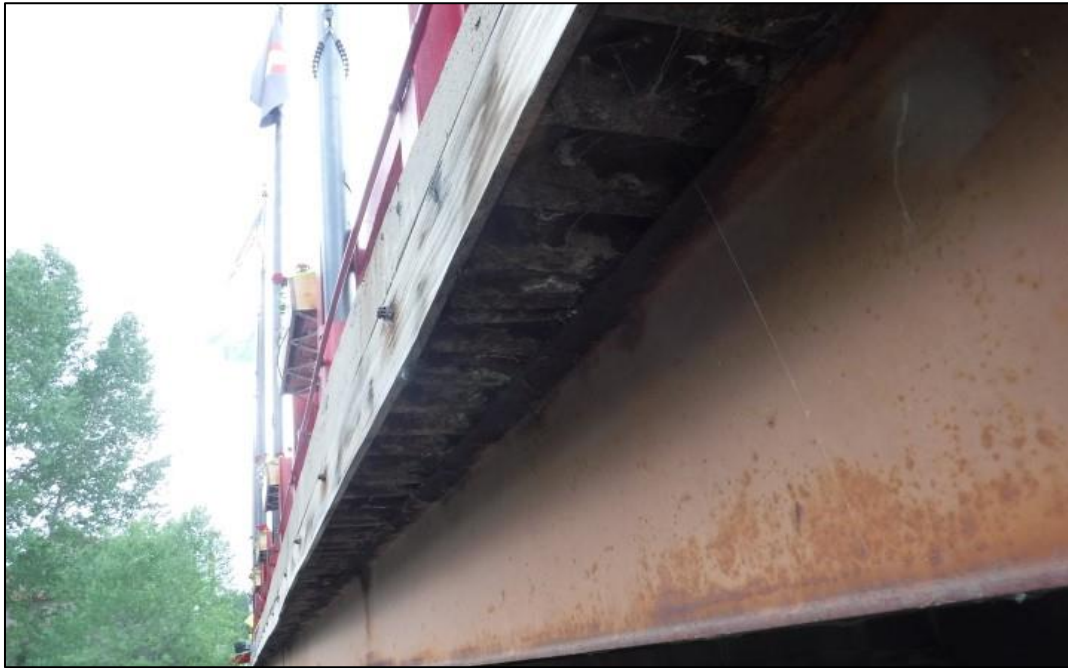
Failed deck forms and desintegrating deck along east overhang in Span 4.

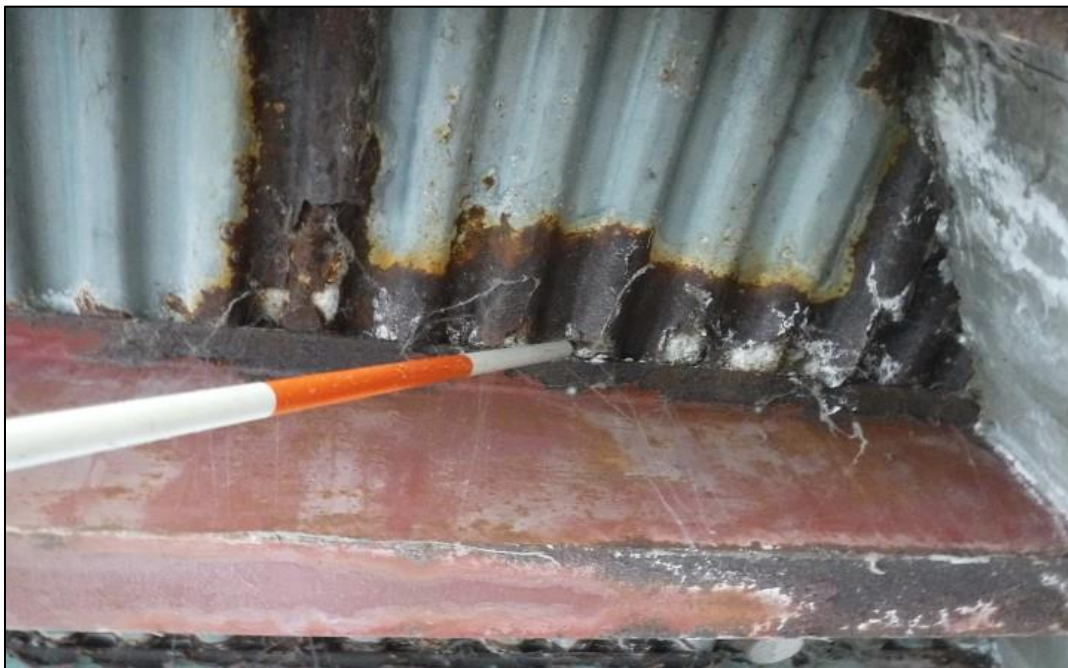
R4 rust and holes in deck forms and exposed concrete in bays 4L and 4M.

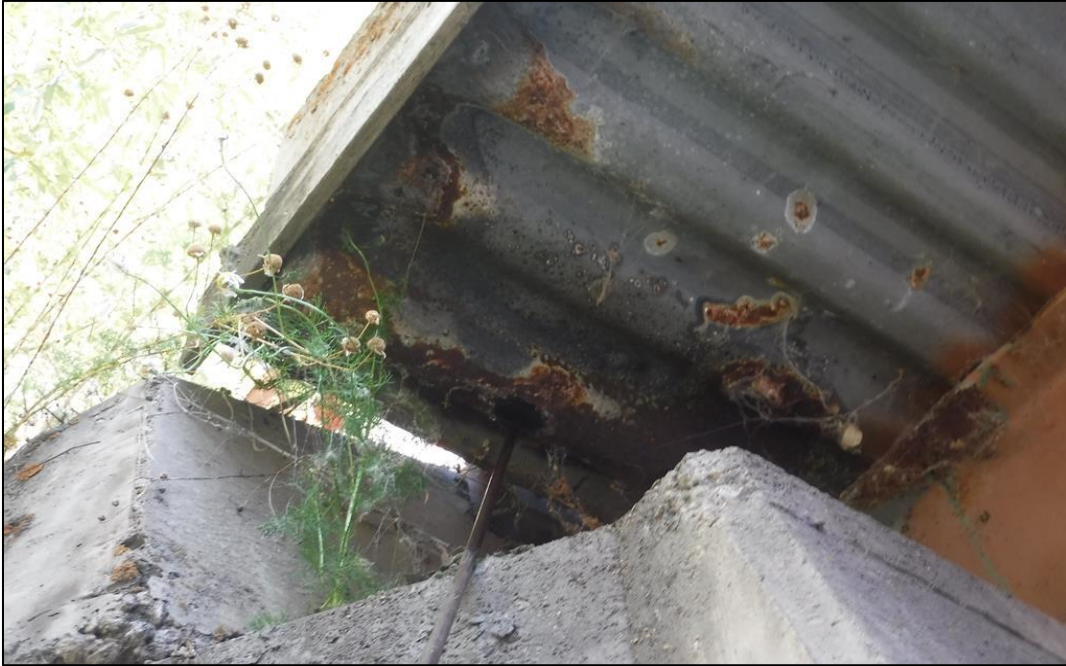
Metal deck has a hole at the northwest corner.

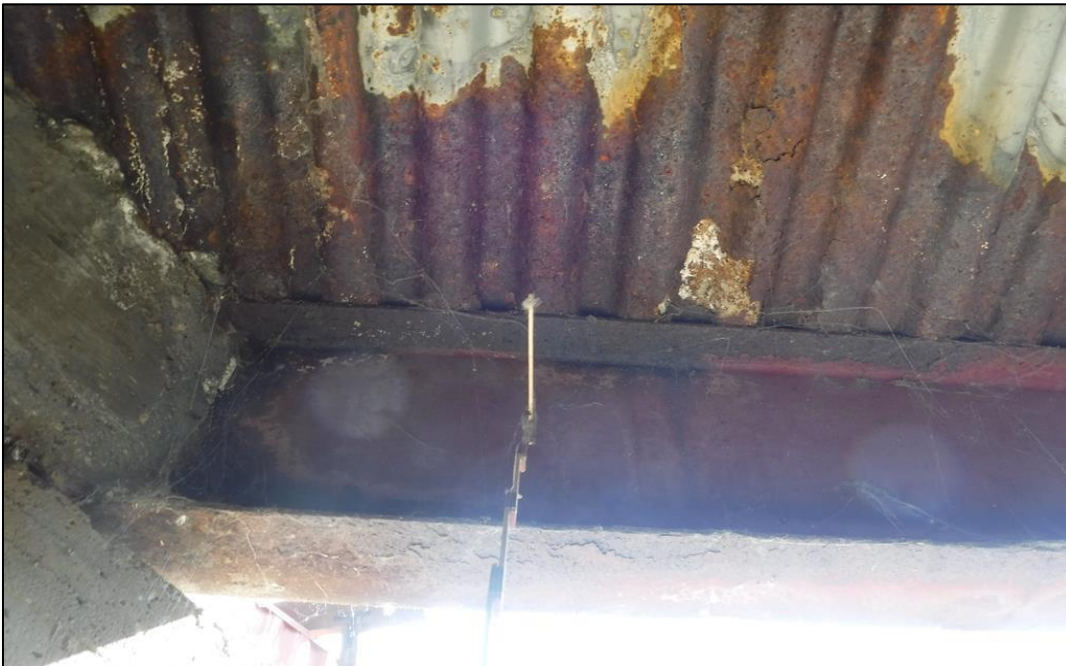
Metal deck at Bay 4N has corrosion.

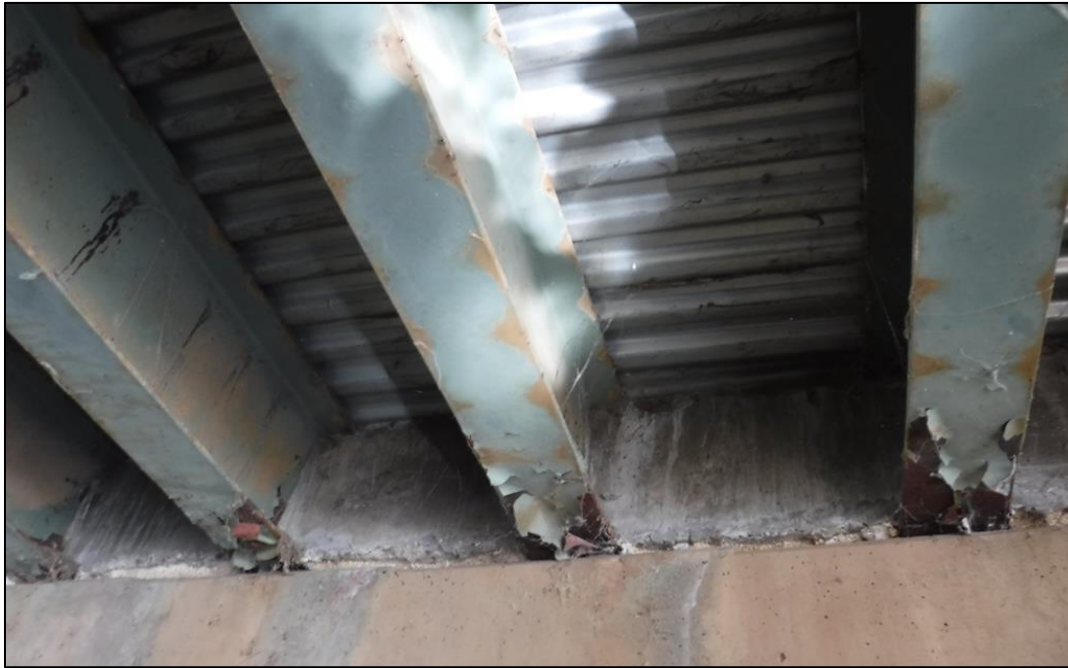
Peeling paint with corrossions at ends of Girders A to K at Span 5.

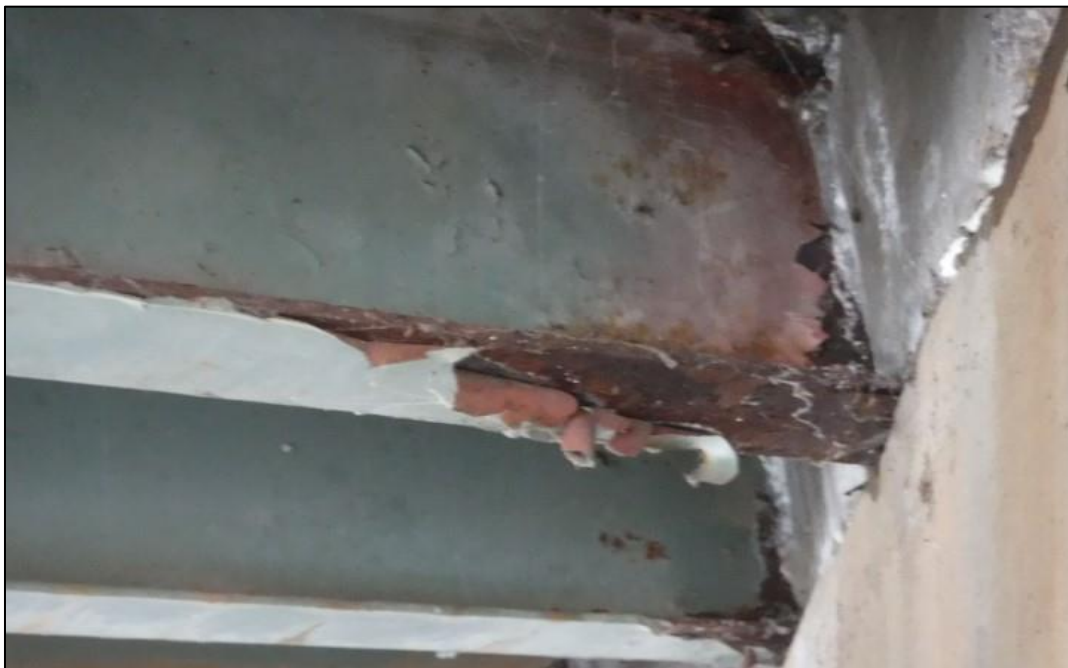
Failed paint on ends of girders (Typical girders A-K).

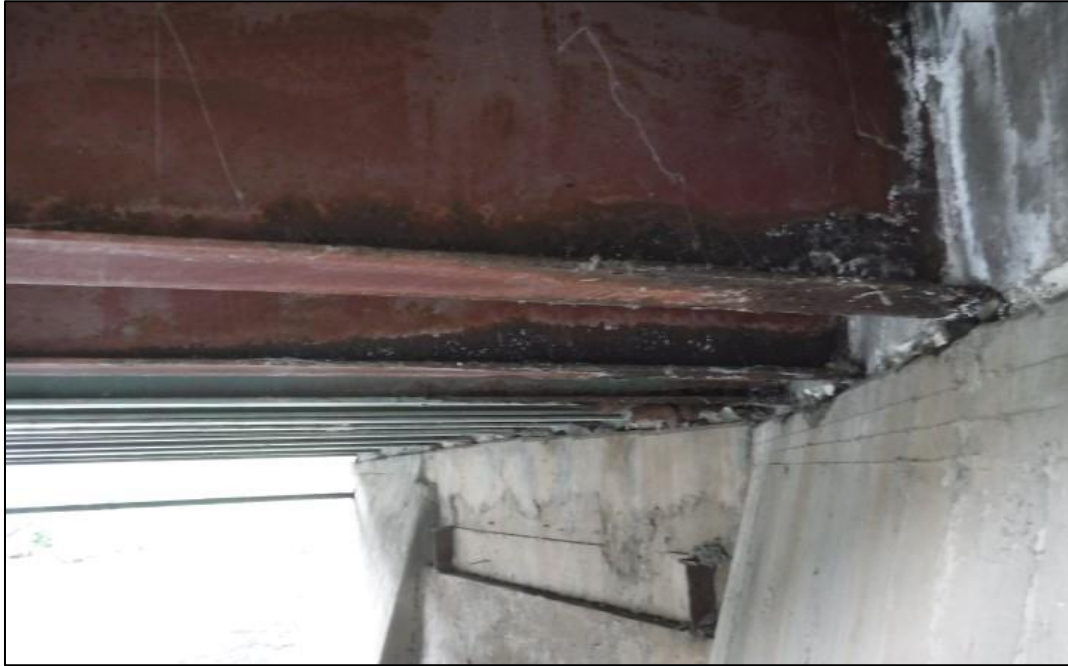
View of corrosion at ends of Girder 4K.

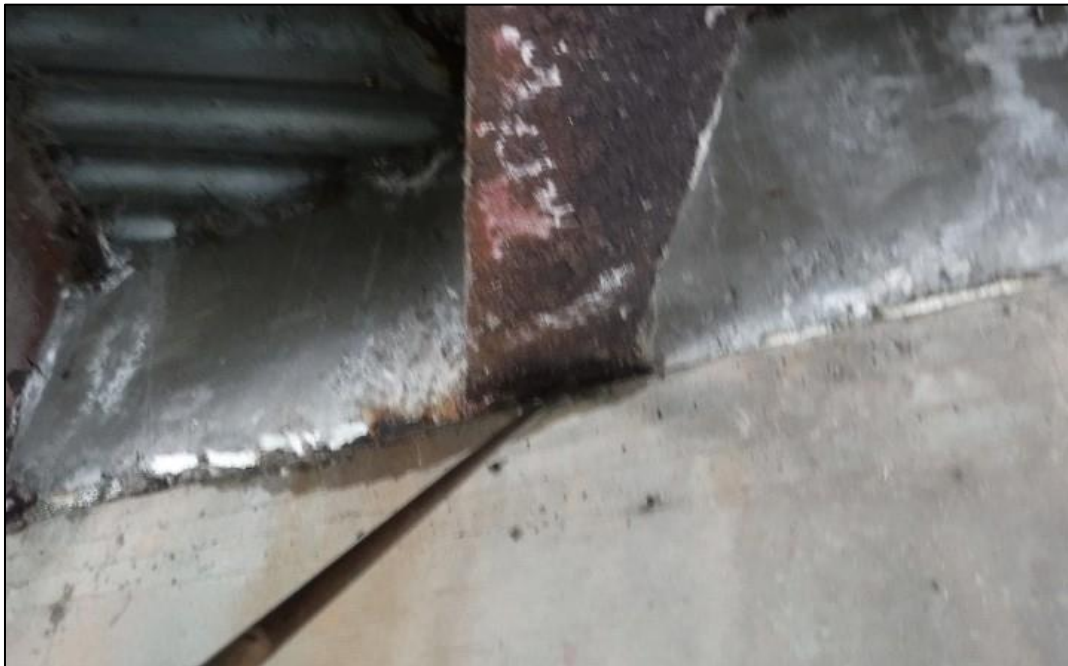
Flaking rust and section loss in bottom flanges of Girders L, M, and N.

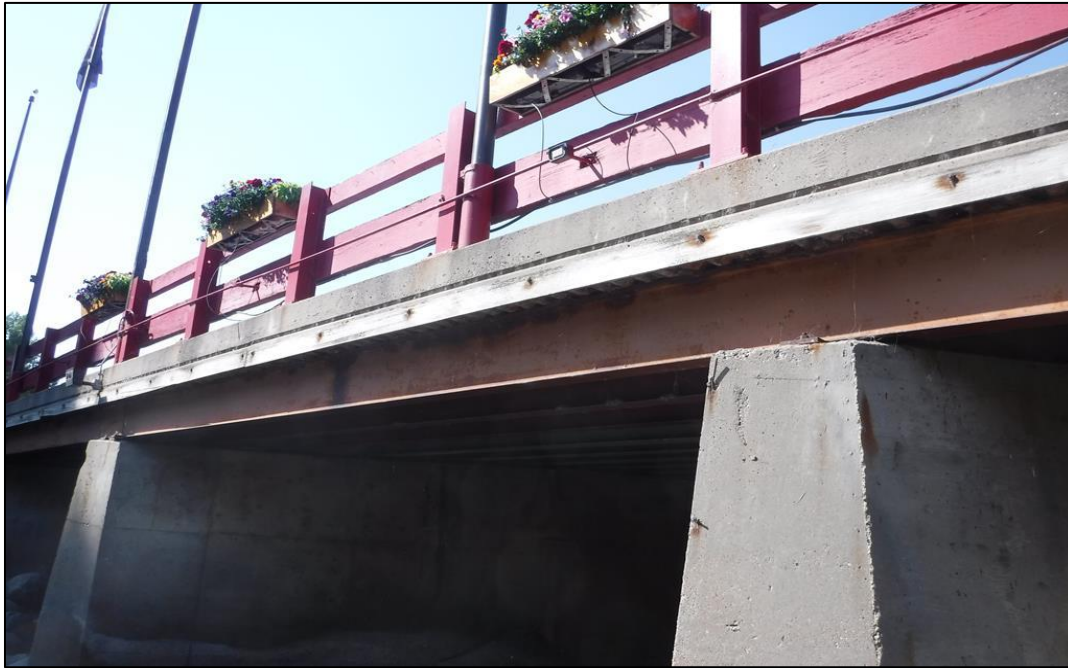
Girder 3L has heavy corrosion.

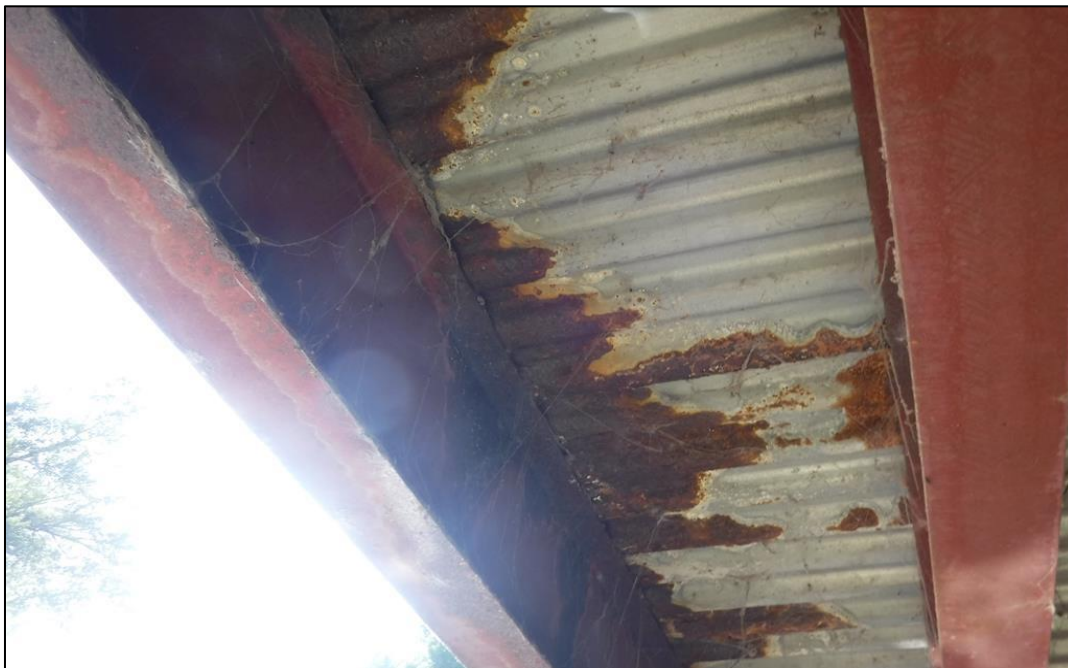
Girder 4K has heavy corrosion.

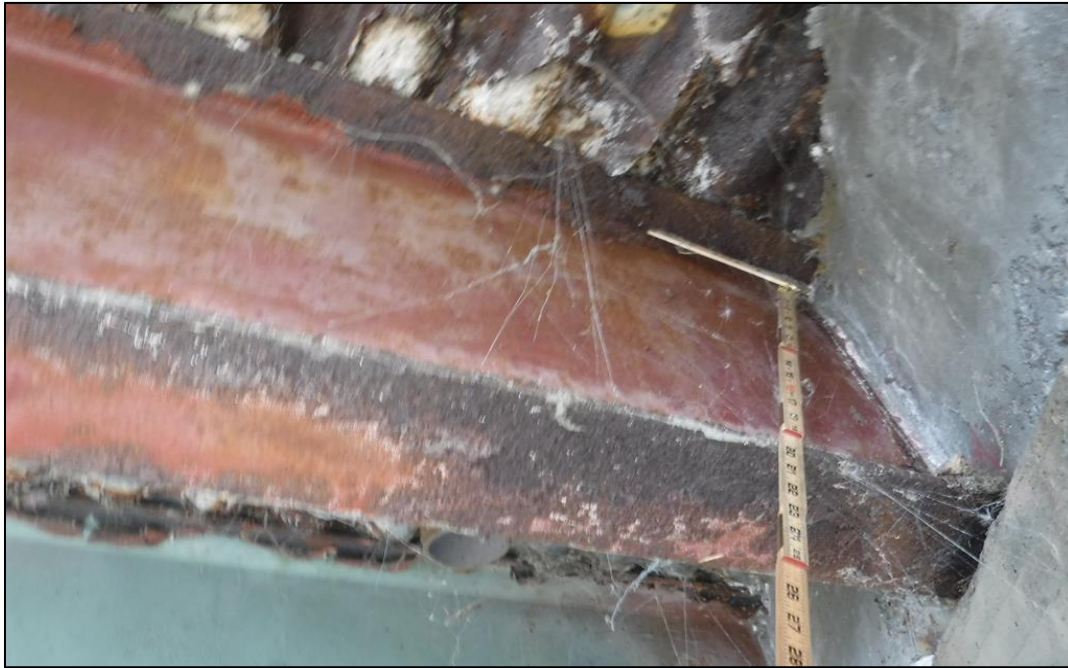
Girder 4L has heavy corrosion.

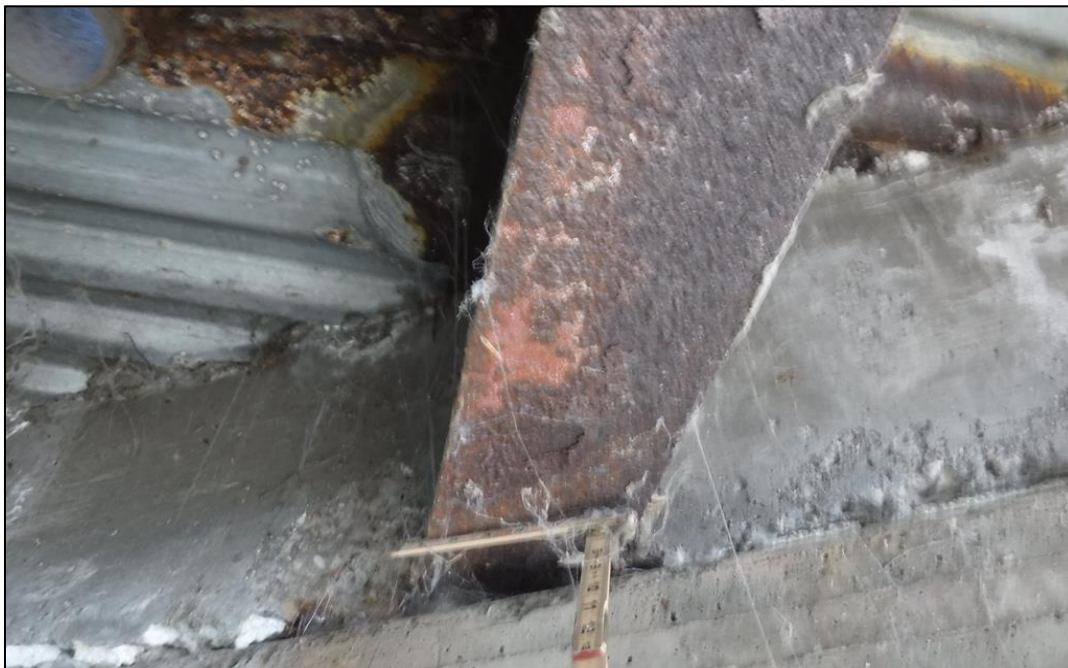
Girder 4M has heavy corrosion.

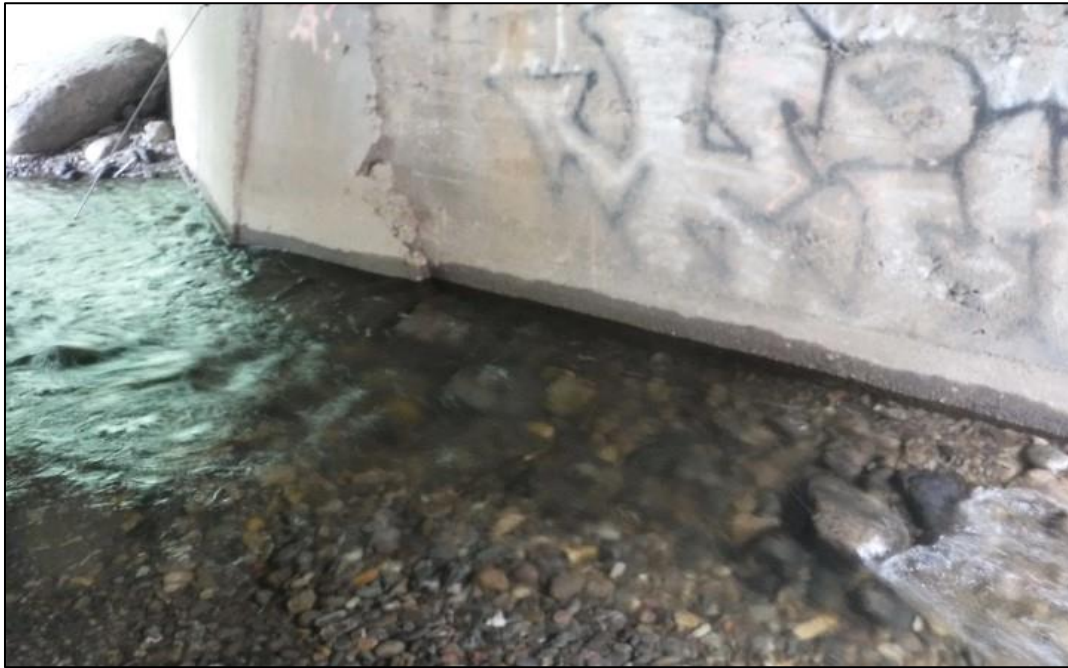
General view of scour in front of A1.

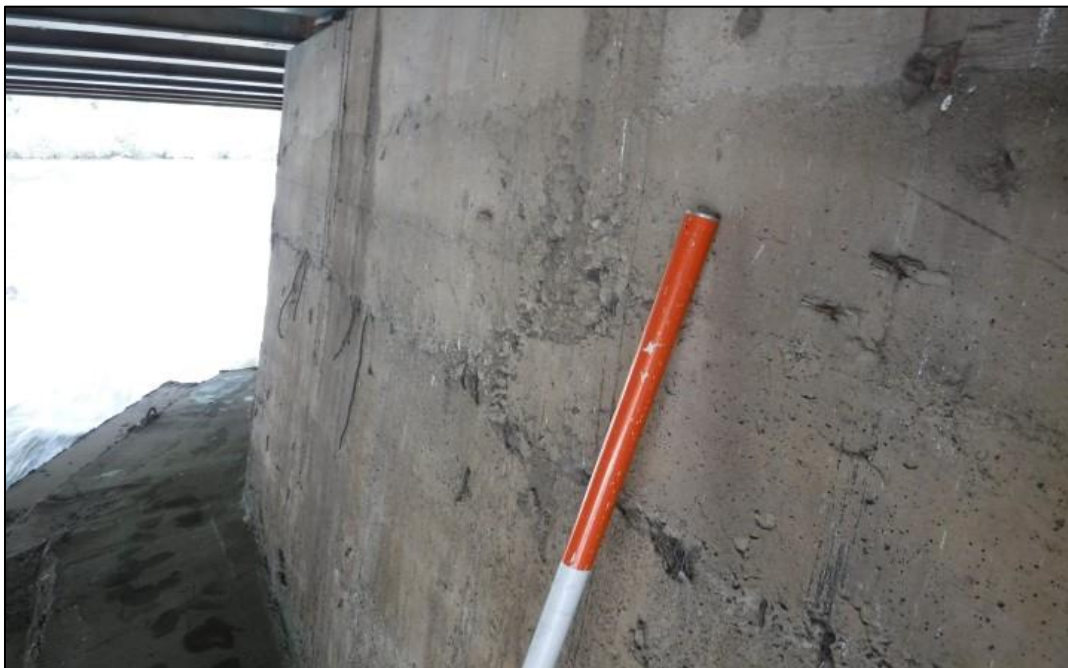
Honeycombs at Pier 2.

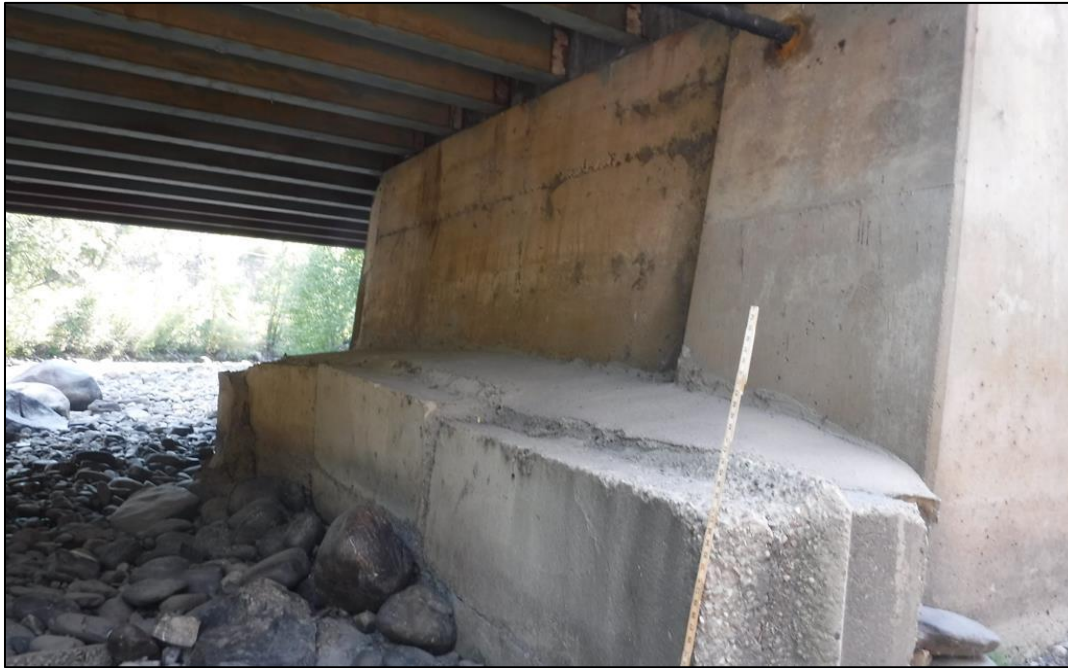
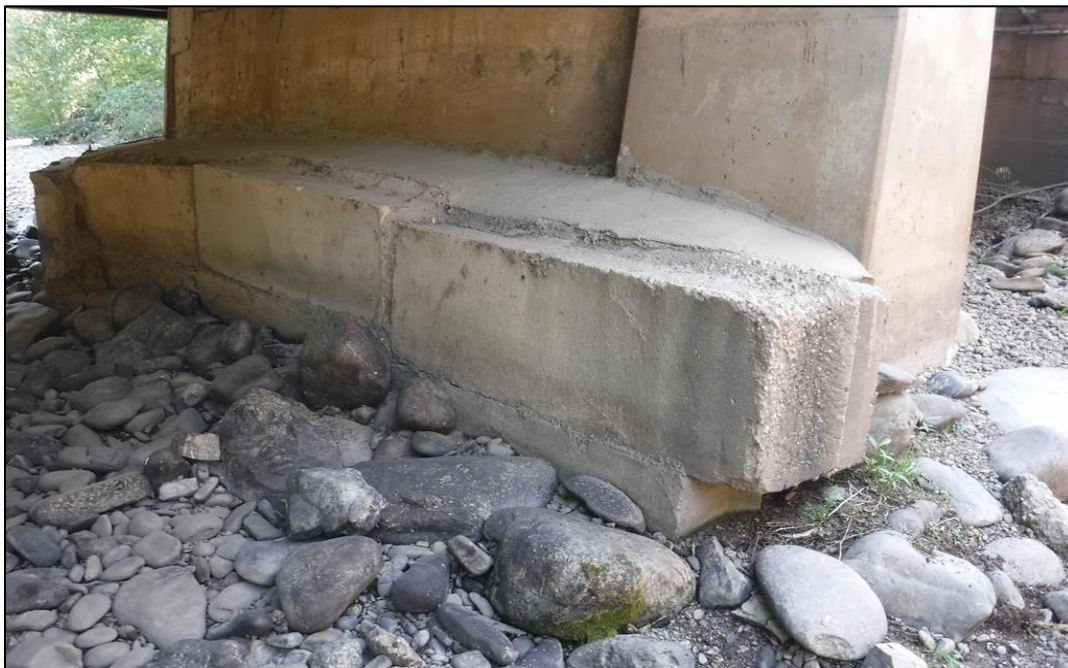
Scour around Pier 2 footer (1 of 2).

Scour around Pier 2 footer (2 of 2).

We recommend that scour countermeasures be installed at the piers and the north abutment footing within 90 days and be installed in accordance with an engineered design. Structure should be monitored after high-flow or flood events until countermeasures are installed. The Essential Repair for this structure has been given a **YELLOW** Priority.

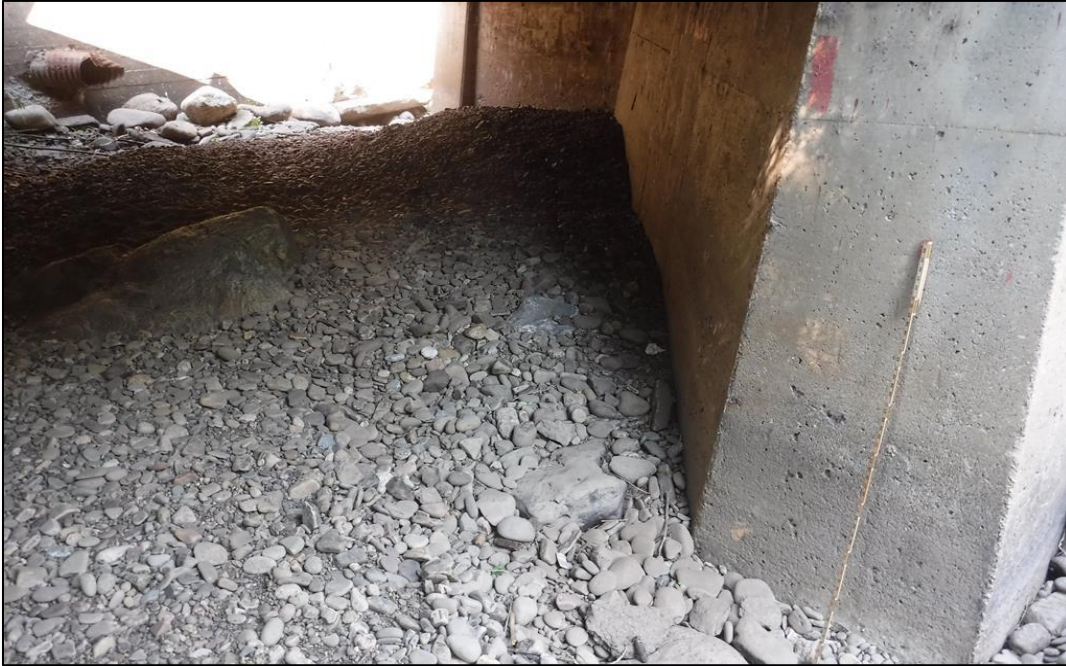
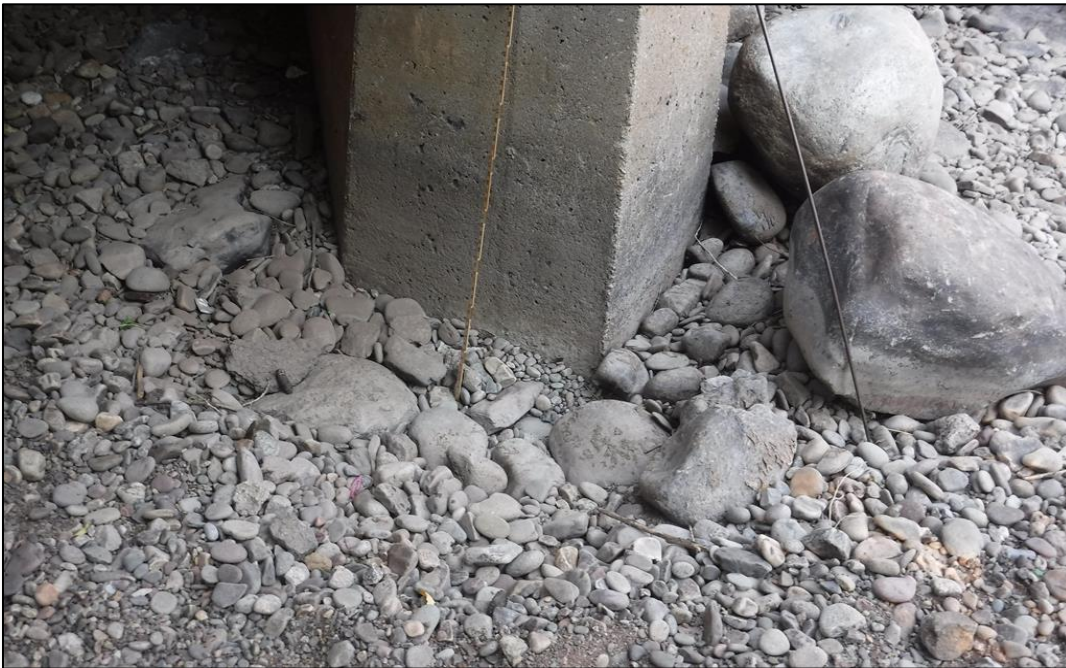
Pier 2 scour at downstream side (1 of 2).

Pier 2 scour at downstream side (2 of 2).

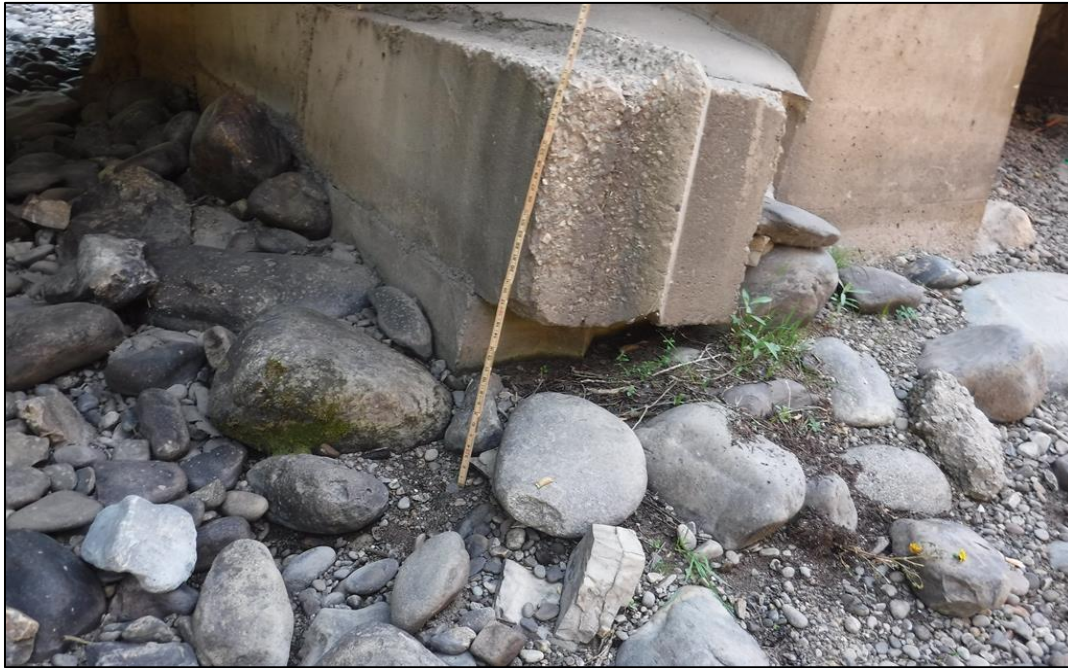
Pier 2 scour at upstream side.
