# BELLM BRIDGE MINTURN TEMPORARY SCOUR PROTECTION DESIGN MEMO

DATE: July 13, 2023

RE: Bellm Bridge Design Minturn, CO  
Taylor St Over Eagle River  
Temporary Scour Protection Design  
SEH No. MINTU\_173117

The goal of this memorandum is to describe the temporary scour protection design for the Taylor Street Bridge over Eagle River (Bellm Bridge) in Minturn Colorado.

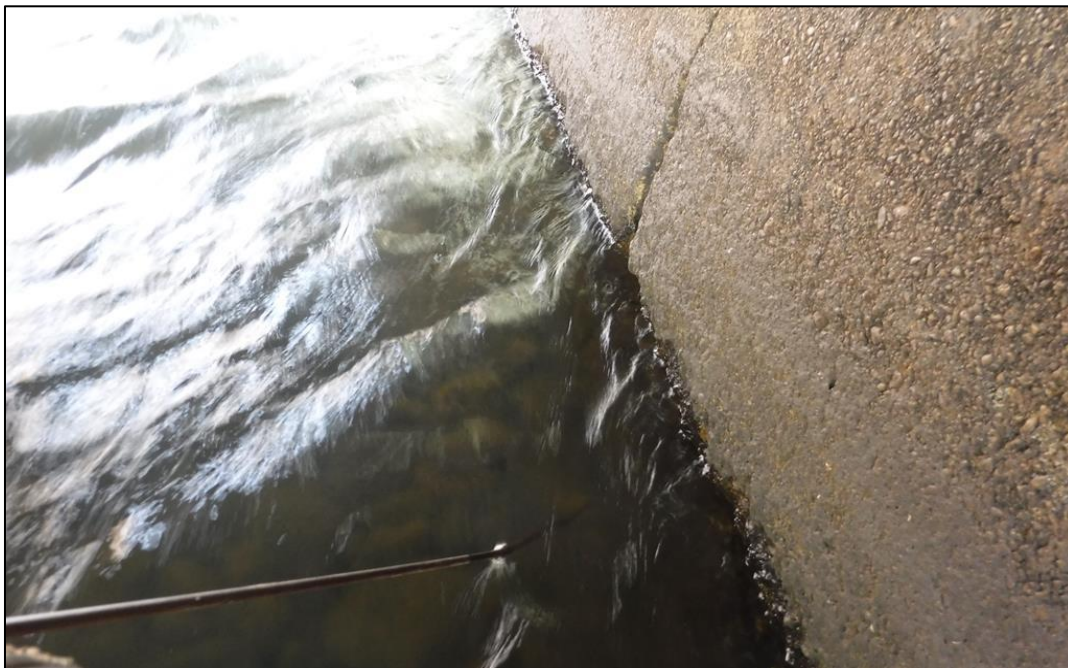
P3 undermined footing at upstream south side.

We recommend that scour countermeasures be installed at the piers and the north abutment footing within 90 days and be installed in accordance with an engineered design. Structure should be monitored after high-flow or flood events until countermeasures are installed. The Essential Repair for this structure has been given a **YELLOW** Priority.

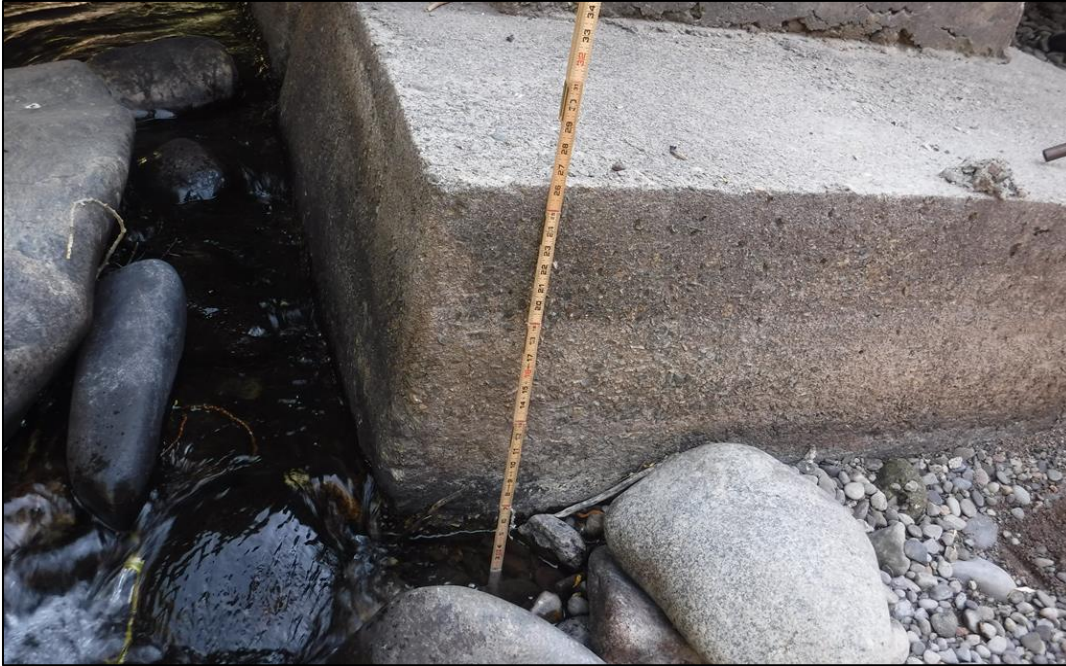
P3 exposed footing at downstream side.

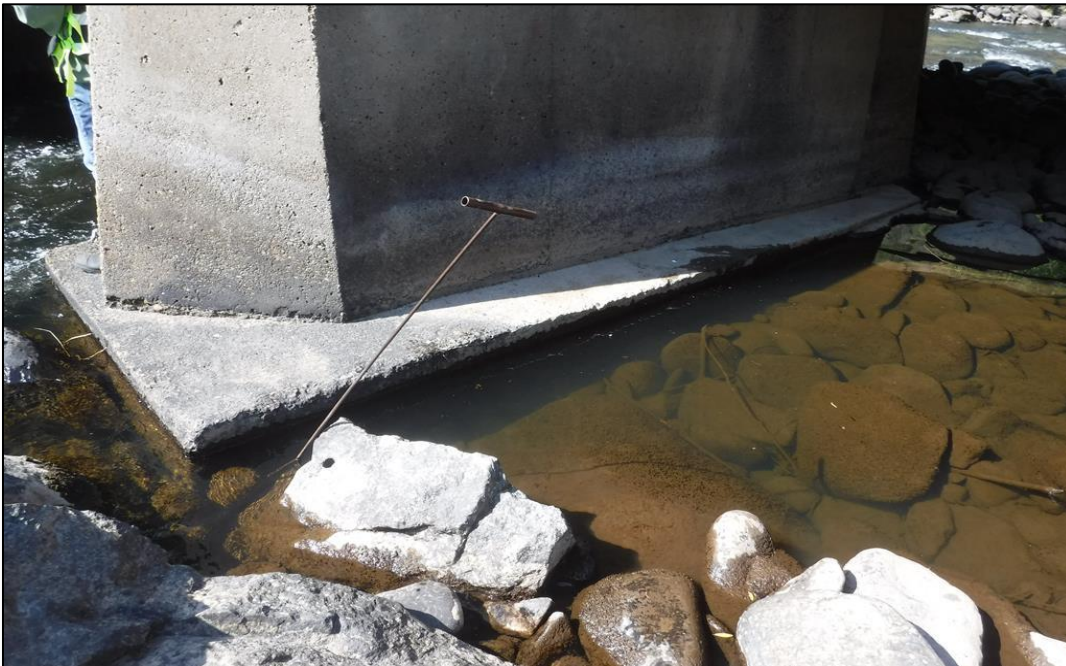
P4 exposed footing at north side.

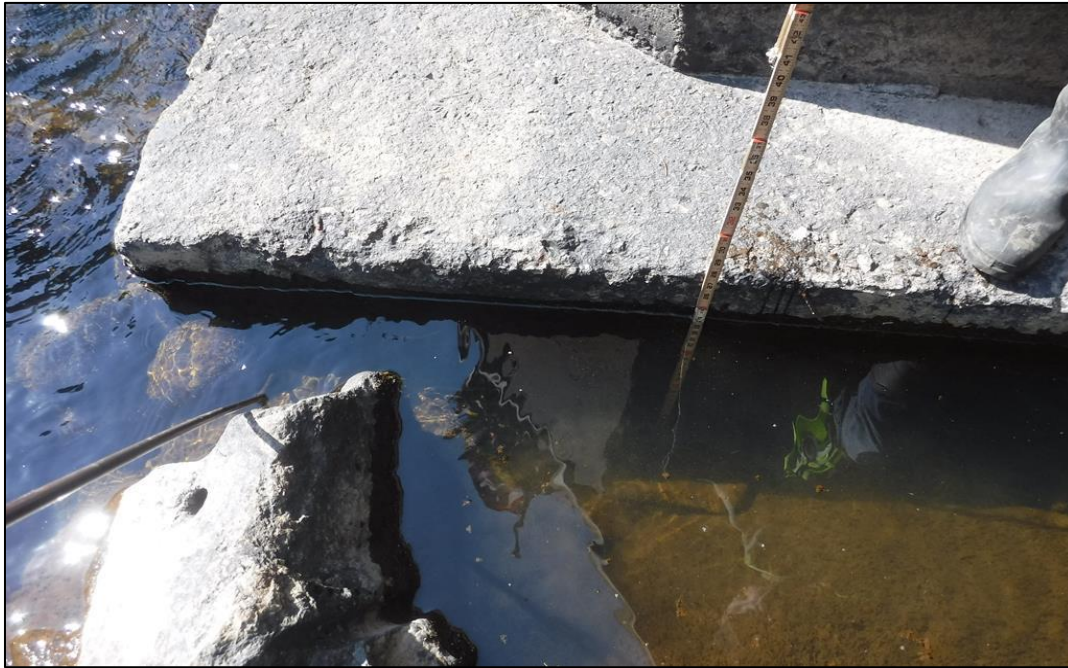
P4 exposed footing at northwest corner.

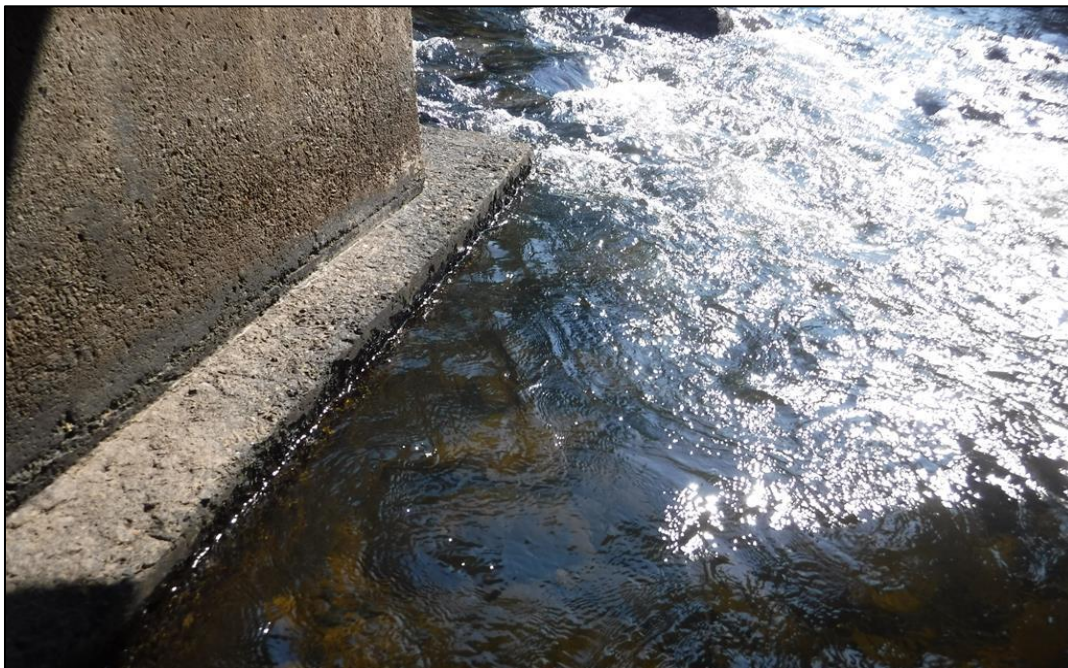
P4 exposed footing at south side.

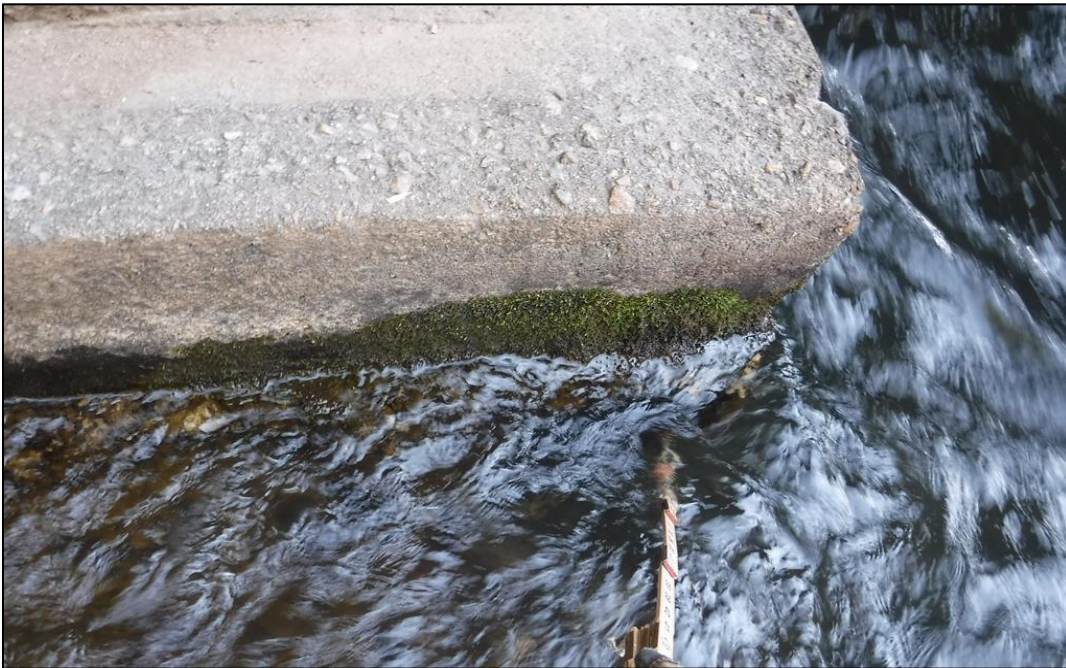
P4 undermining at SW corner upstream side.

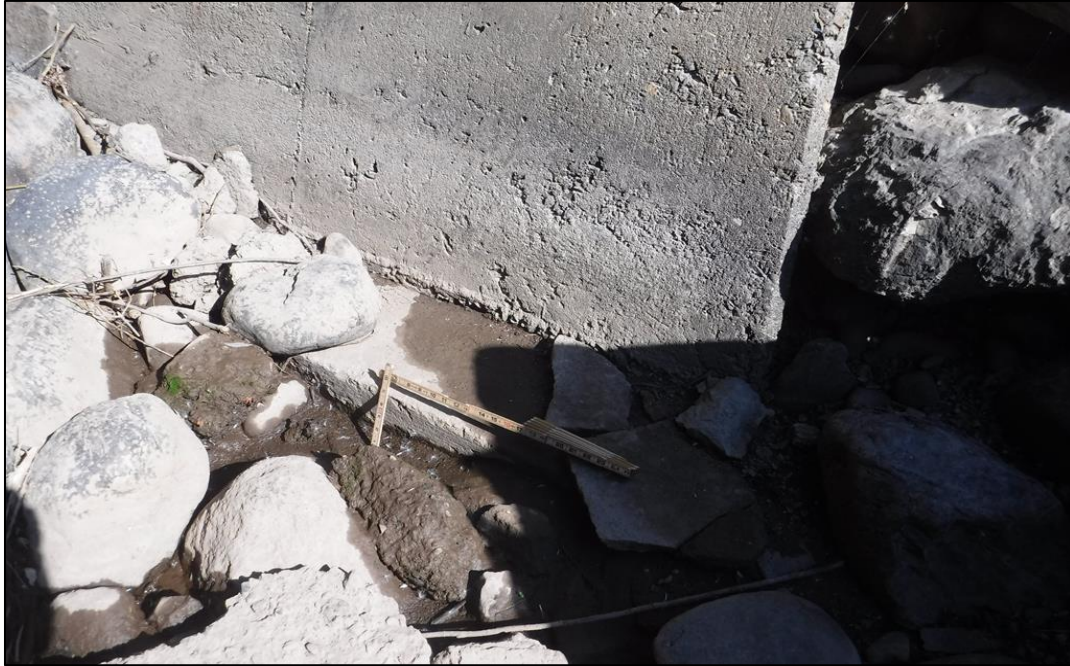
Abutment 5 exposed footing at downstream side.

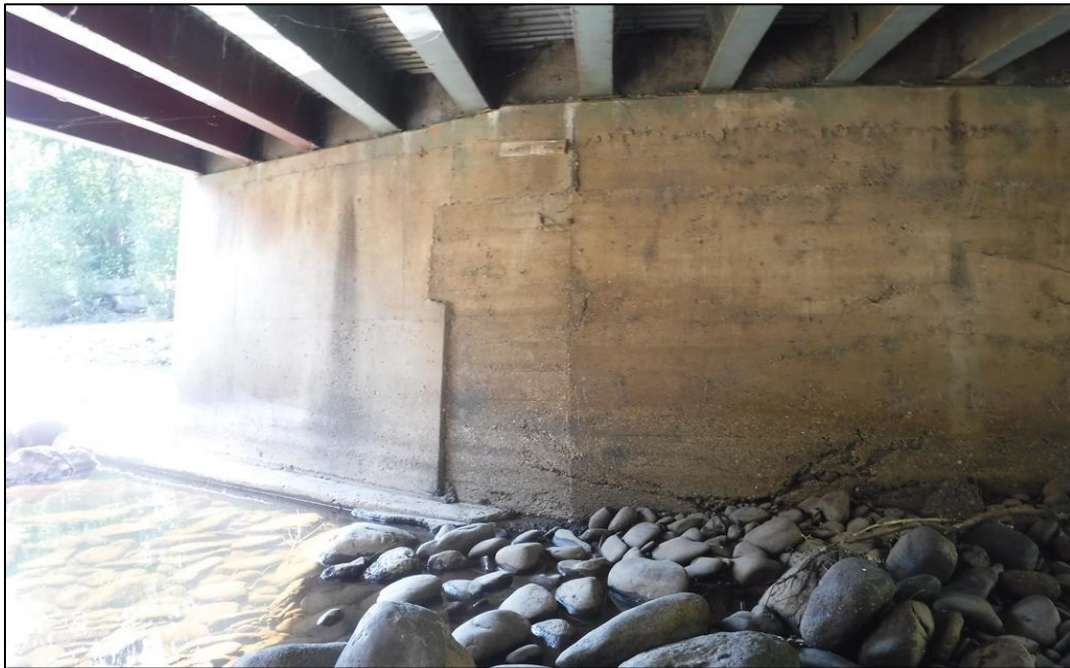
Abutment 5 exposed footing at mid section.

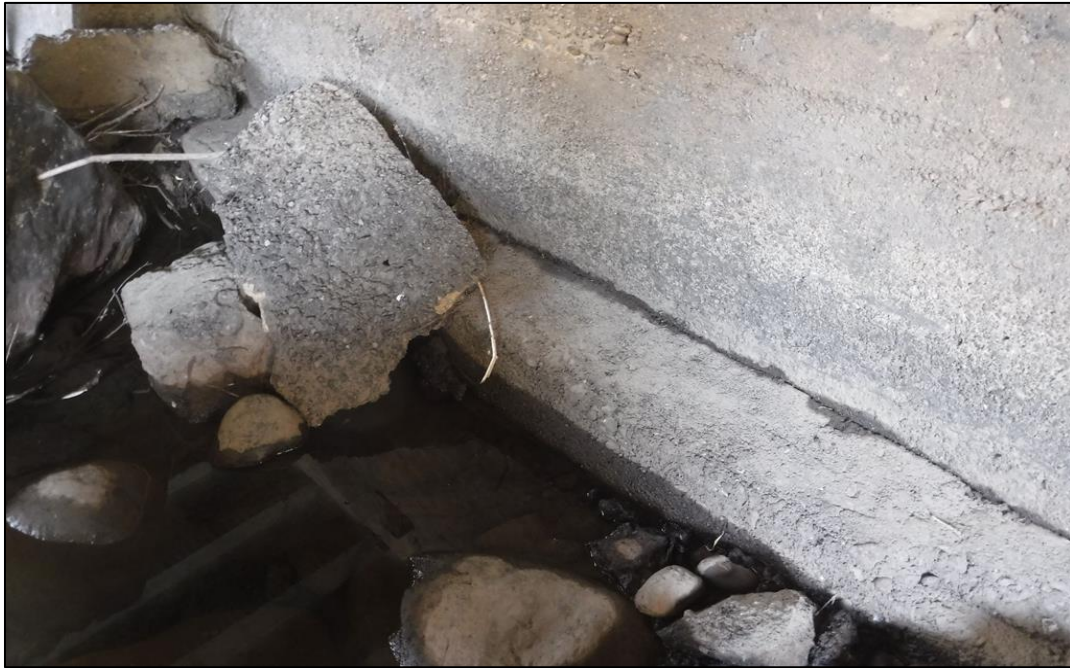
Abutment 5 exposed footing near mid length.

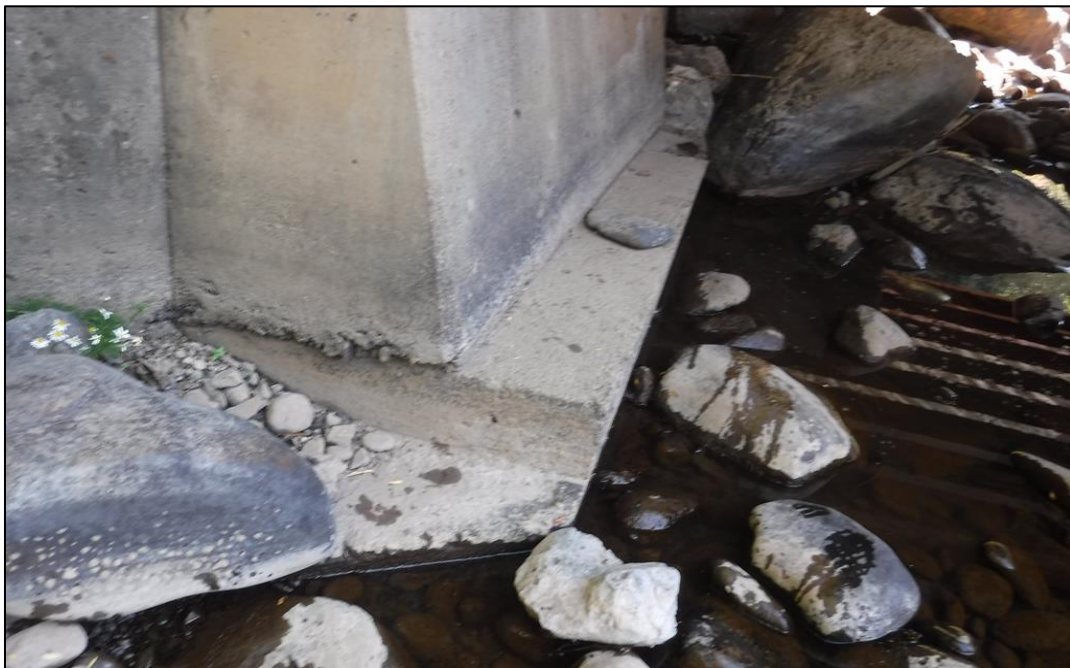
Abutment 5 exposed footing at northwest corner.

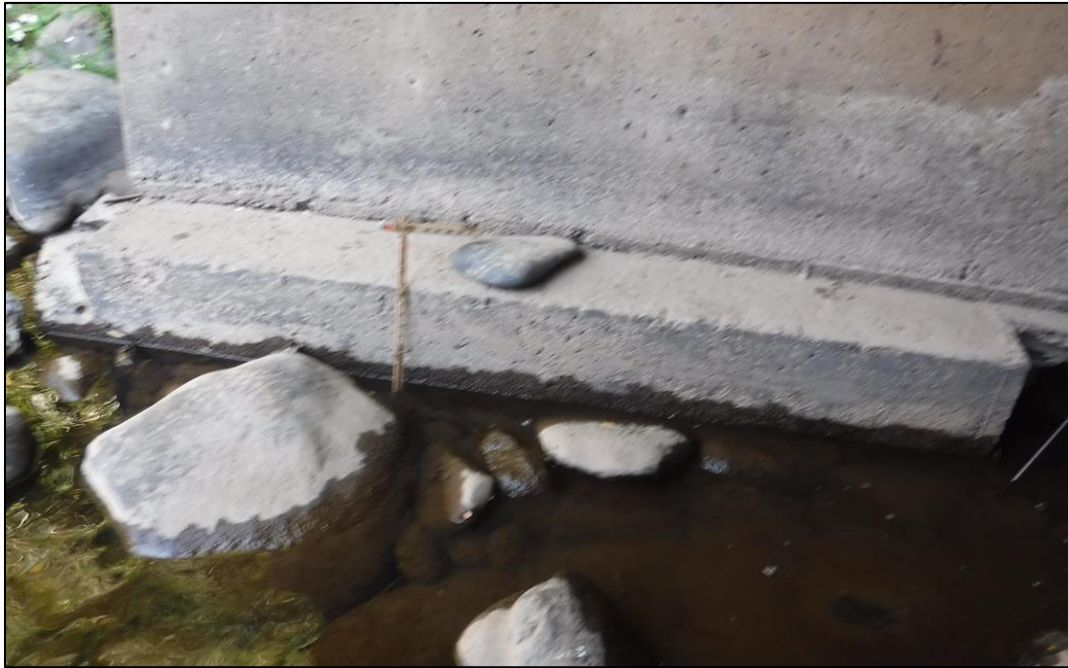
Abutment 5 exposed footing at north end (upstream).

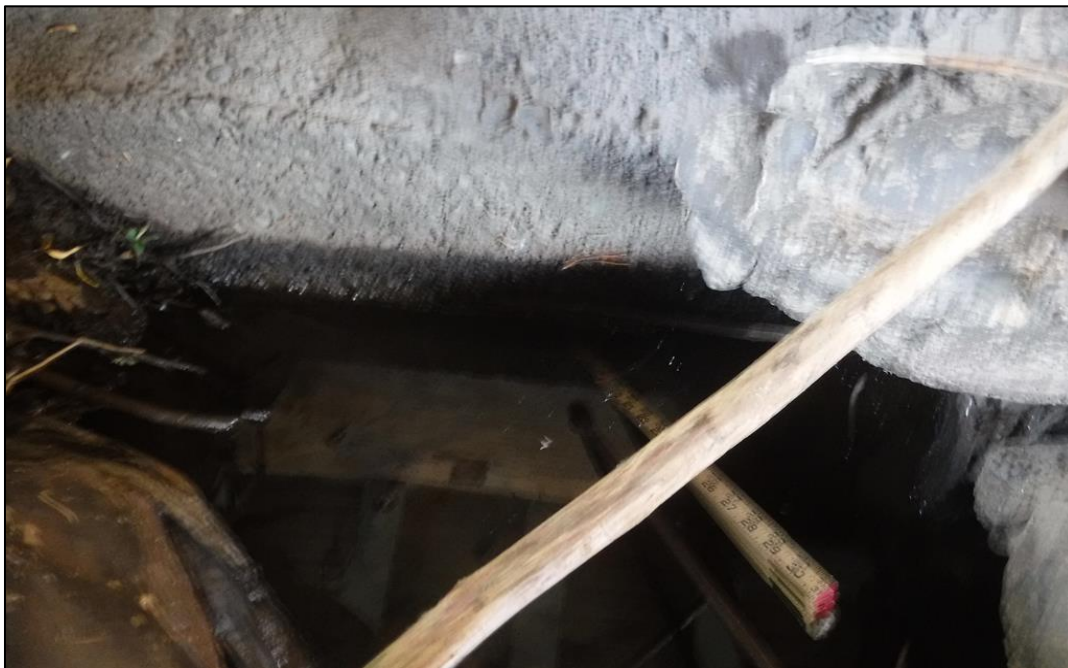
Abutment 5 undermining.

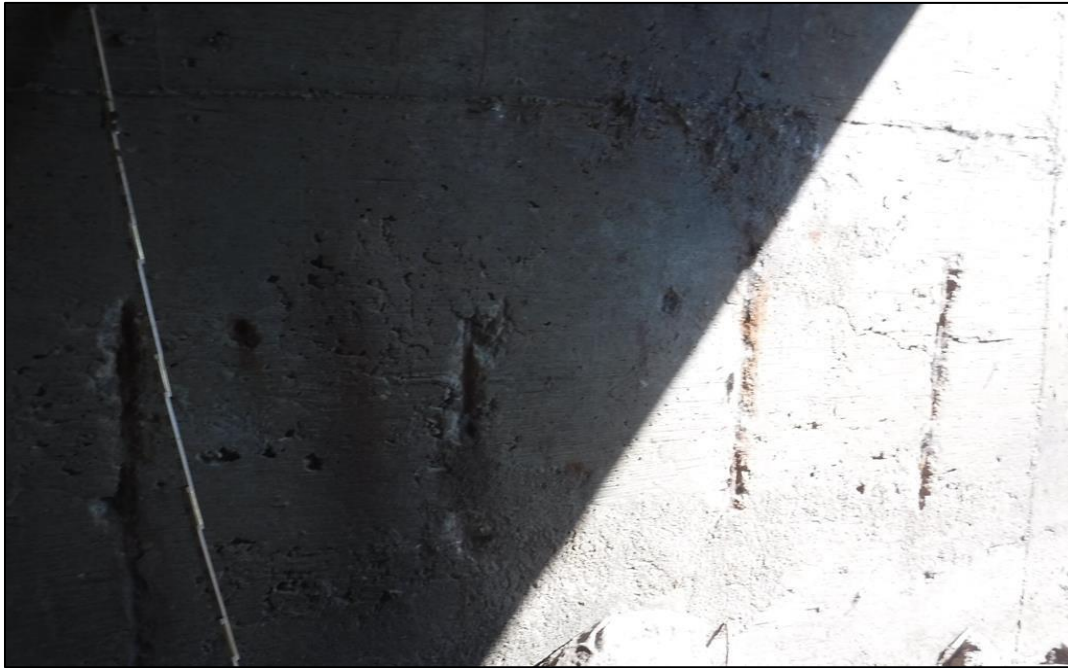
Abutment 5 has 5 locations of exposed rebar.

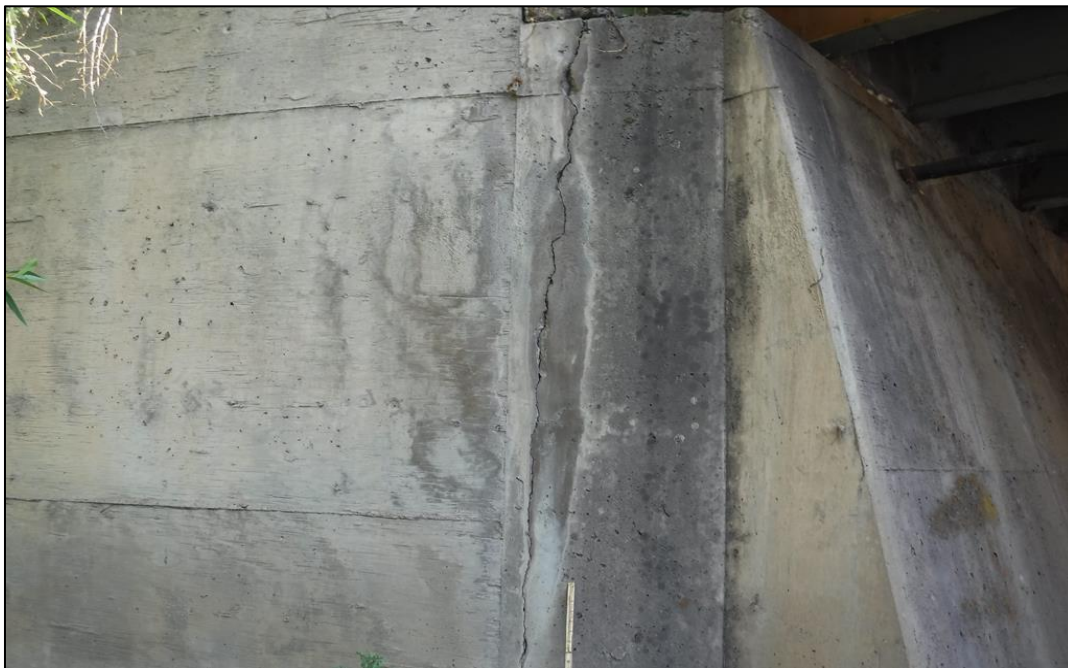
NW wingwall has a vertical crack at Abutment 5 joint.

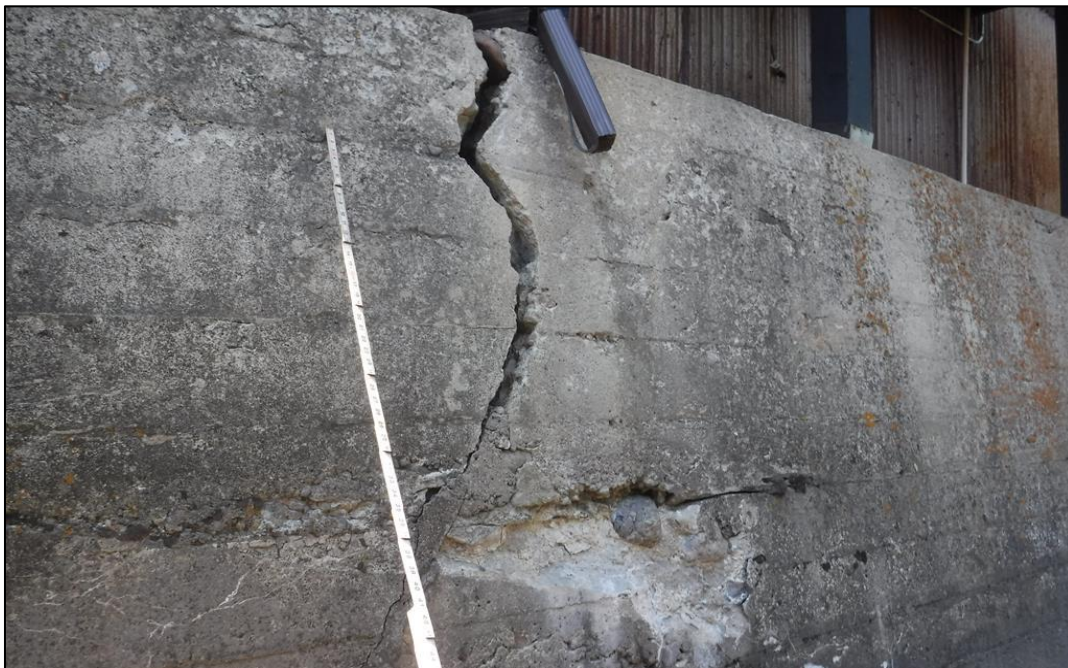
SW retention wall vertical crack.

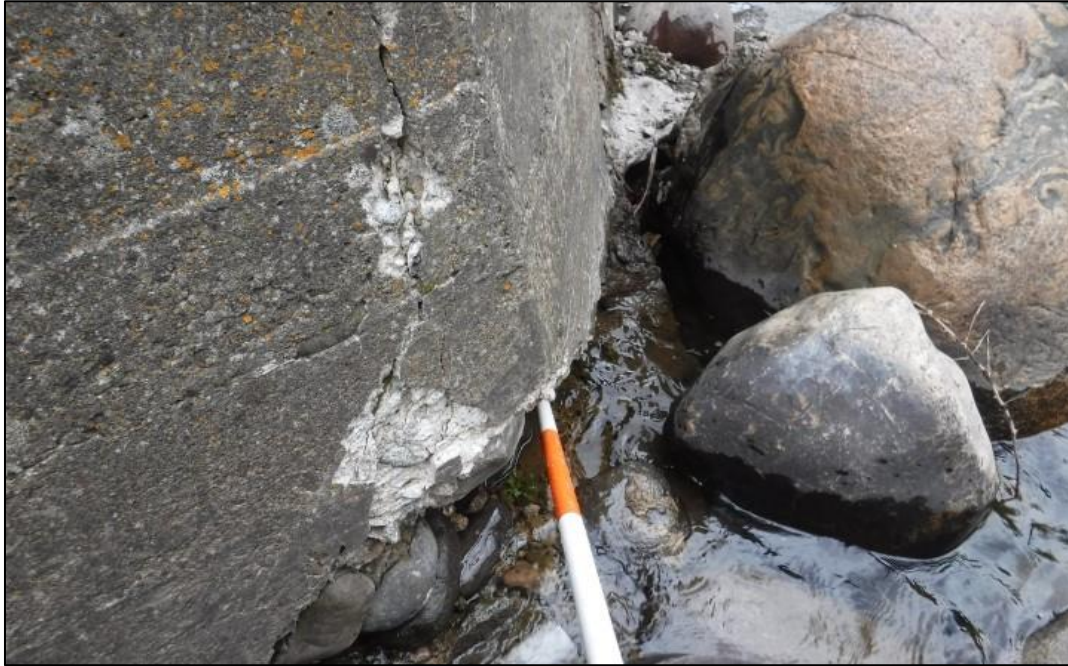
Close up view of undermining at SW retaining wall.

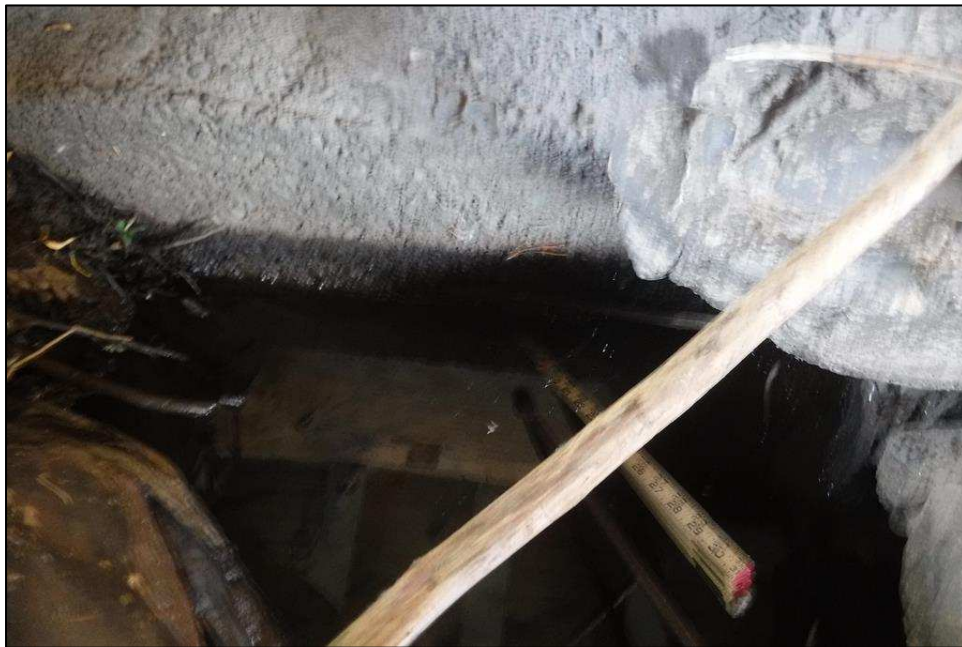
**Abutment 5 undermining at mid-section.**
