**SUMMARY**

478 Eagle St , Minturn, CO 81645

David Ford  
05/24/2024

Chris Jobson  
True Perspective Home Consultants  
970-209-2041  
[chris@trueperspectivehc.com](mailto:chris@trueperspectivehc.com)

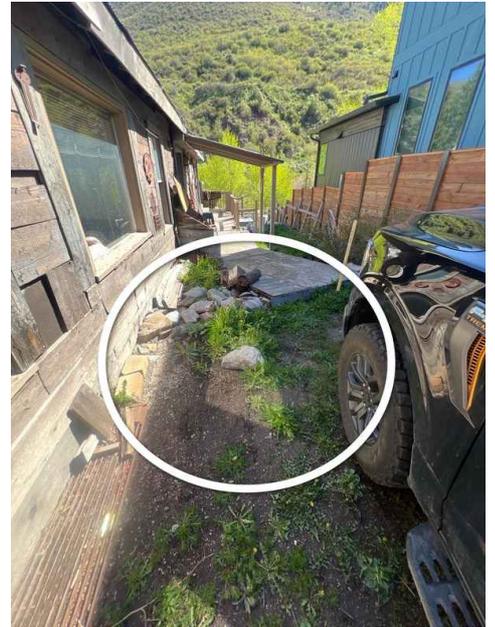
## 3.3.1 Driveway Condition

**POOR DRAINAGE**

The driveway drainage shows signs of poor drainage toward the house. The condition can lead to adverse effects on the foundation walls and surrounding soils. We recommend that the driveway area be evaluated to understand better the present situation and cost associated with correction as deemed necessary.

Contact a qualified driveway contractor.

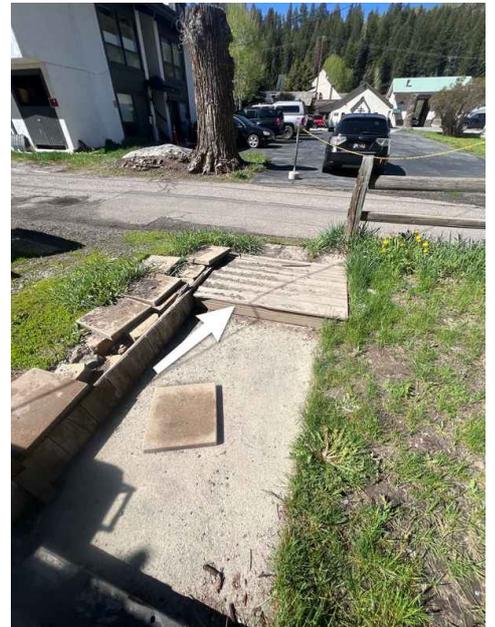
## 3.5.1 Walkways Condition

**DAMAGES STAIR BOARD**

While still functional damage was noted to the exterior stairs. We suggest review with repairs made as deemed necessary.

Contact a qualified professional.

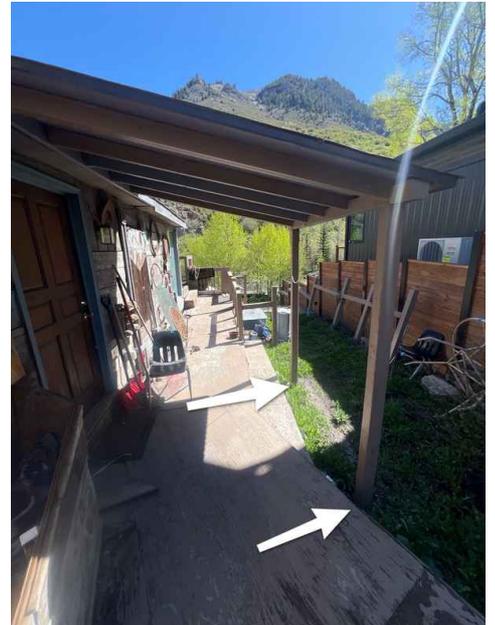
## 3.9.1 Entrance Cover

**POST BASES NOT VISIBLE**

The concrete post bases (if present) were below grade and not visible and the wood posts are buried below grade. This condition will accelerate the decay and deterioration of building materials.

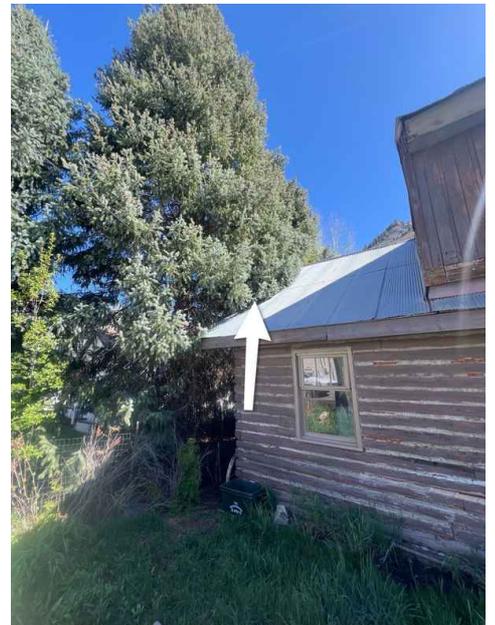
Trees near the building had overhanging branches or branches in contact with the roof surface, which may cause damage to the roof surface. We recommend that all overhanging/contact branches should be cleared to reduce the potential damage to the roof surface.

Contact a qualified landscaping contractor

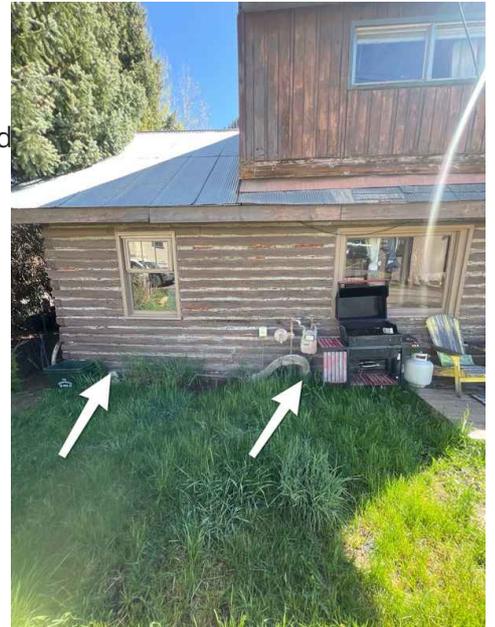
### 3.14.1 Site Grading **NEGATIVE GRADE**

The grading was sloped toward the building condition promotes water accumulation near the building, which could result in deterioration of the foundation and water penetration under the structure. We recommend re-grading areas near the building as needed to ensure the unobstructed flow of the surface water away from the foundation.

Recommendation  
Contact a qualified grading contractor.

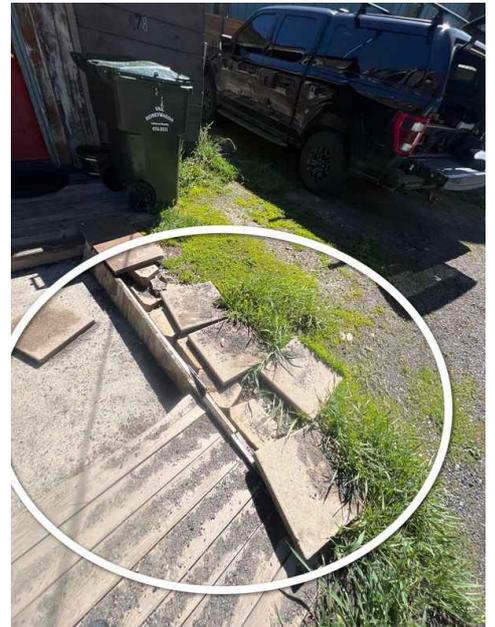
### 3.16.1 Retaining Walls **DISPLACED**

The retaining walls were observed to be displaced. The movement of the wall should be monitored with correction as necessary.

Recommendation  
Contact your builder.

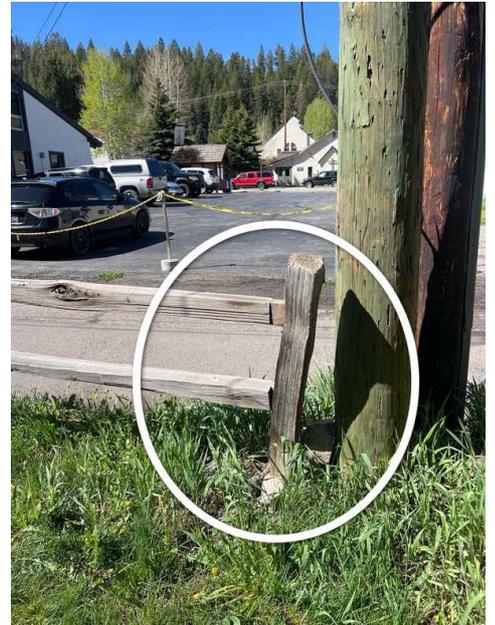
## 3.17.1 Fencing

**DAMAGED**

The site fencing was damaged. We recommend that the affected sections be repaired or replaced.

Contact a qualified fencing contractor

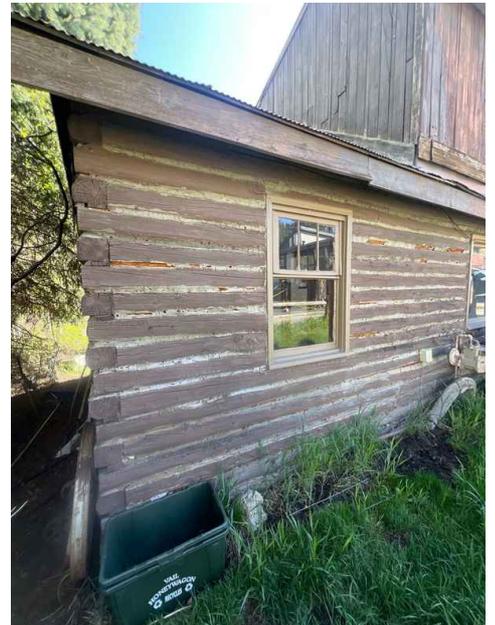
## 4.1.1 Structural

**LOG HOME**

Portions or all of the homes are constructed with log framing. Complete evaluation of log homes is beyond a general home inspection scope. Many hidden conditions may exist. We recommend further review by a log framing contractor or engineer to better understand replacement/repair costs and present conditions.

Contact a qualified professional.

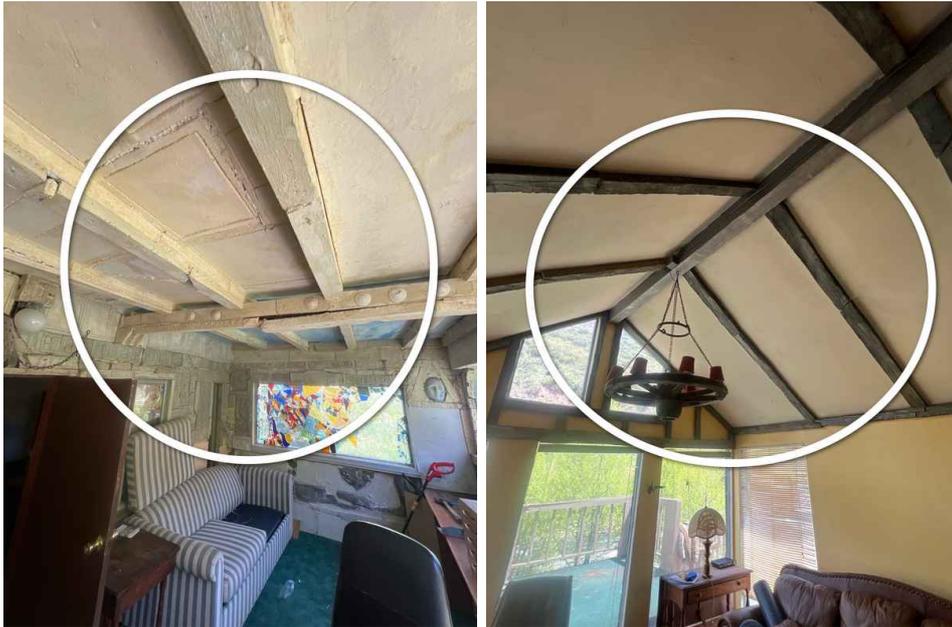
The visible beams in the house appeared to be made of styrofoam and were not structural.

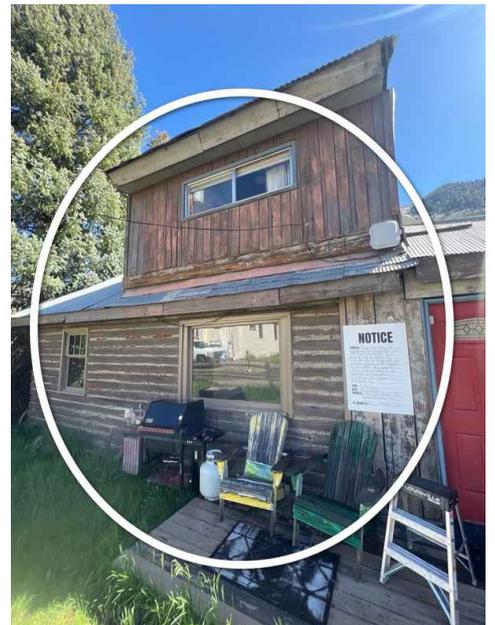
## 4.3.1 Wood siding

**SIDING FINISH WEATHERED OR DETERIORATED**

The exterior wall paint/stain is in a weathered condition. Attention is required to prolong the life of the exterior wood cladding and aesthetics. We recommend further review to understand better the present condition and cost associated. Photographs are examples only. No attempt was made to list all areas. A qualified contractor should inspect all areas, with repairs made as deemed necessary.

Contact a qualified painting contractor.

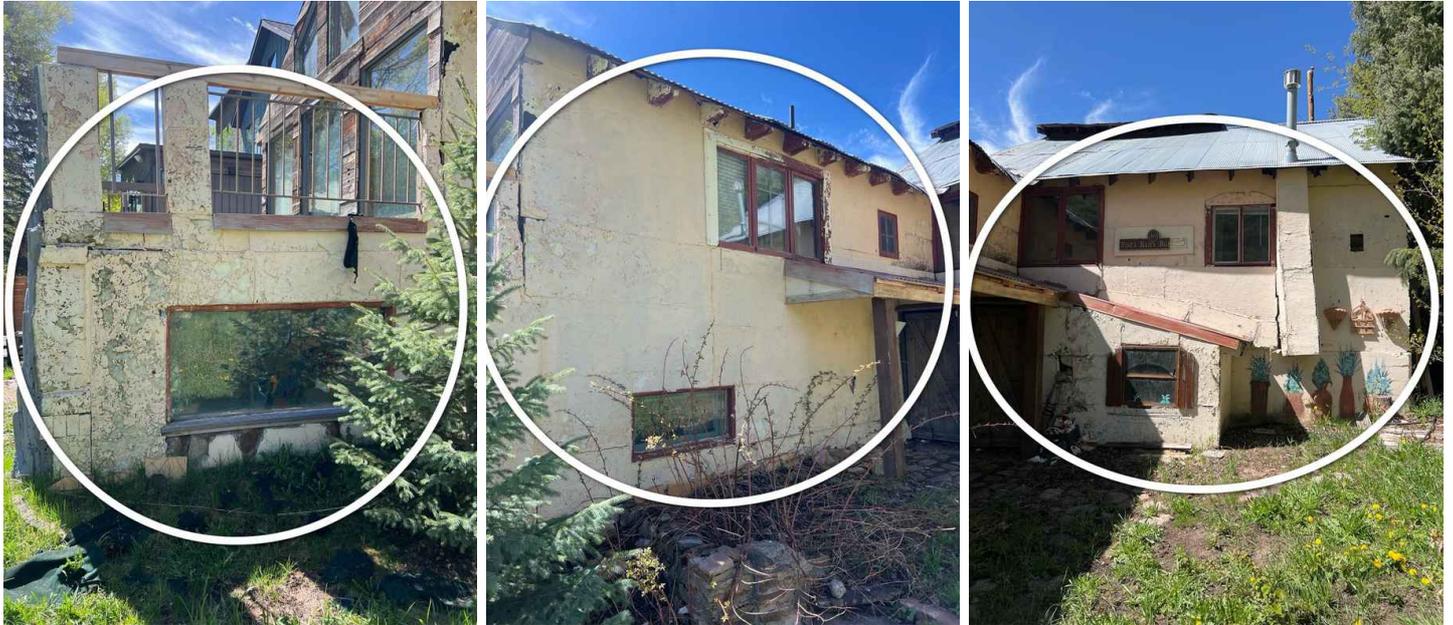
## MISSING SIDING

Missing siding was noted. We suggest installing to prevent moisture and pest intrusion.

Contact a qualified siding specialist.

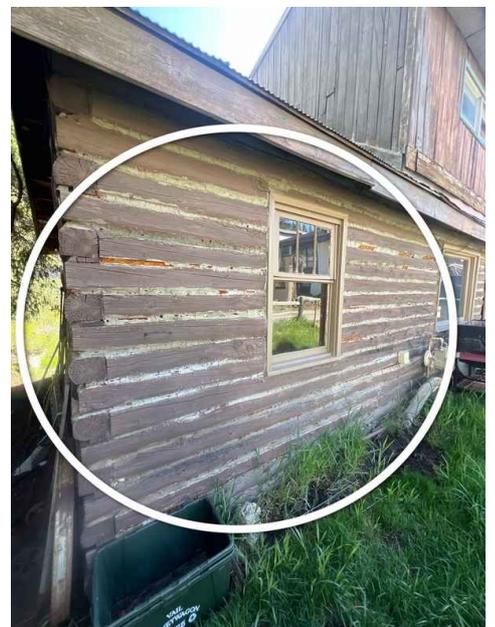
### 4.3.6 Wood siding

## CHINKING REPAIRS NEEDED

Chinking was noted to be weathered and failing. We suggest maintenance to prevent water and pest intrusion.

Contact a qualified professional.

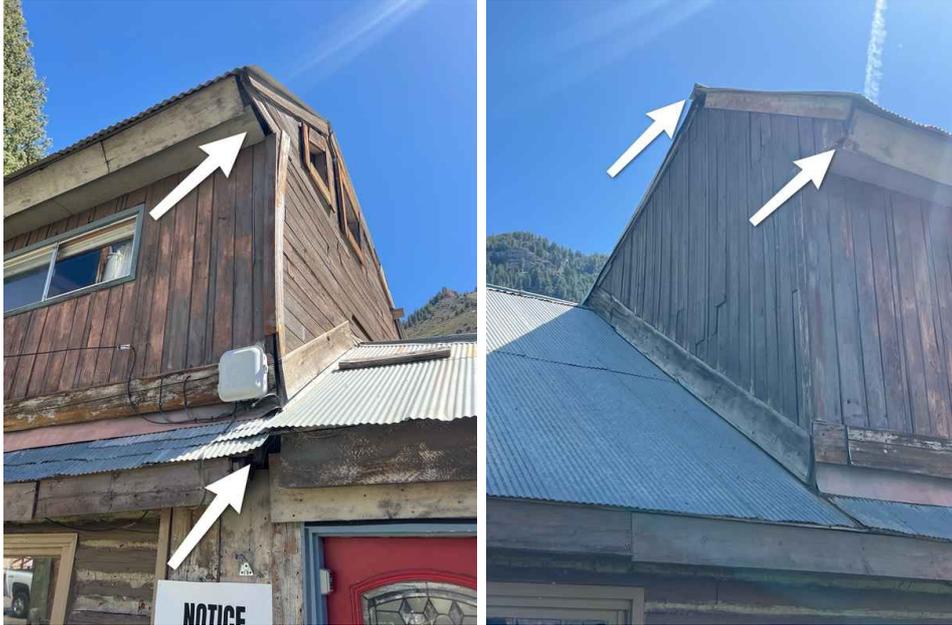
There is an opening, gap, or hole in the fascia/soffit which should be repaired. This can allow water intrusion and pest infestation as well as deterioration of the surrounding material.

Contact a qualified handyman.

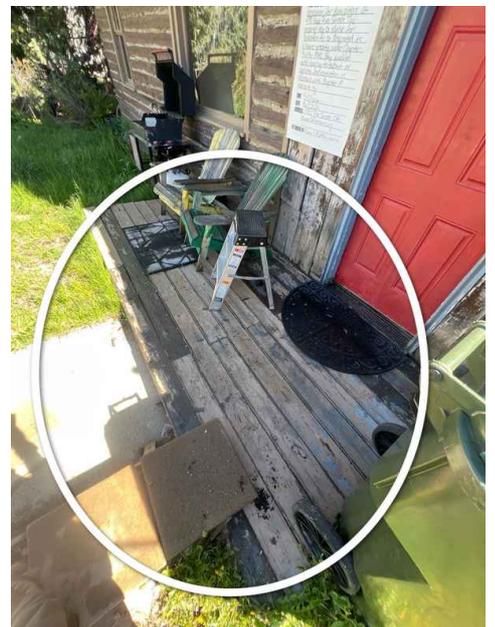
## 5.6.1 Deck surface

**WEATHERED**

The deck(s) surfaces were weathered and in need of general maintenance. We suggest refinishing to restore UV and moisture protection as well as to restore aesthetics

Contact a qualified painting contractor.

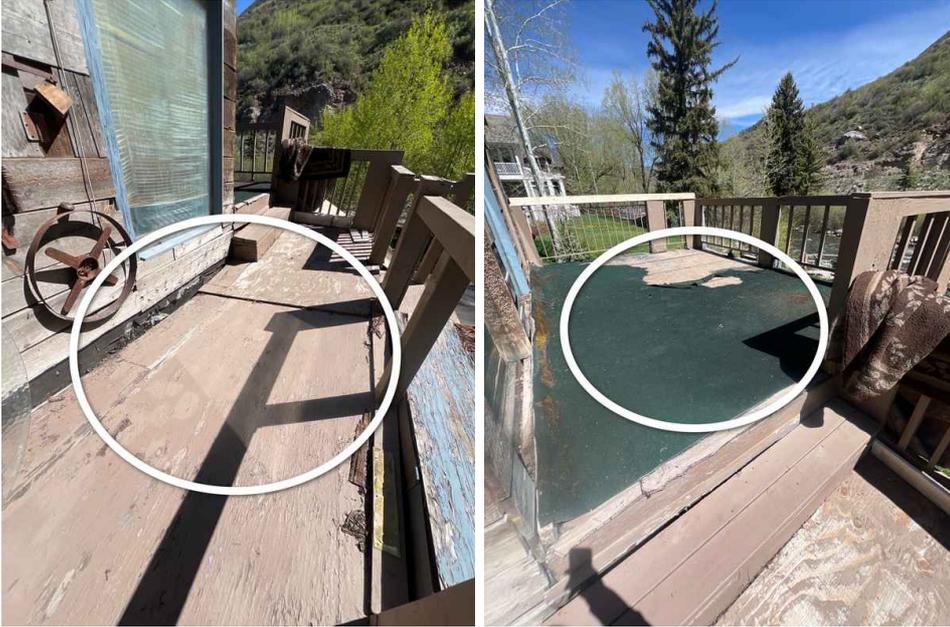
The deck surface was not level from apparent structural settlement. We suggest a further review with repair or replacement as needed.

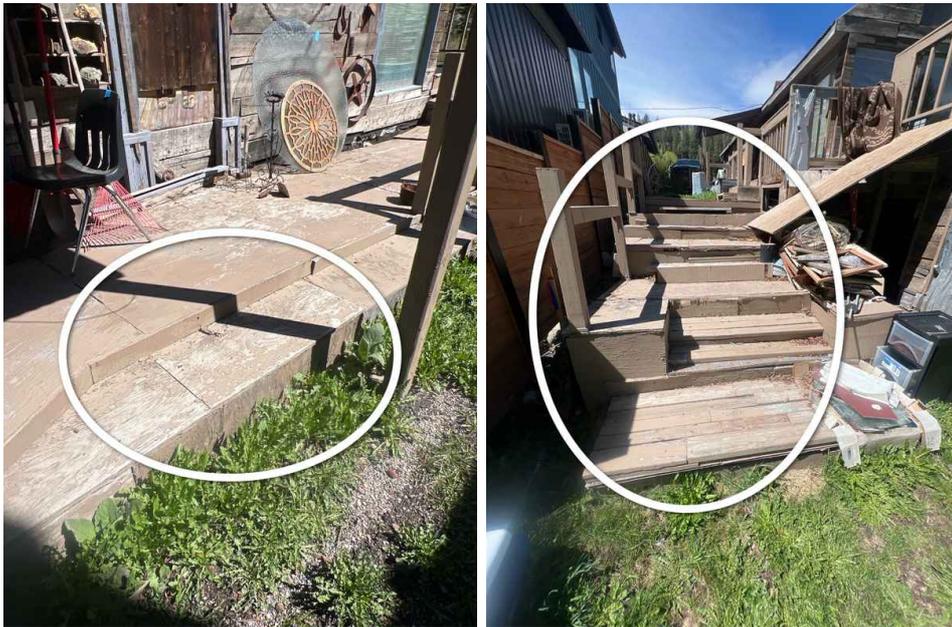
At this staircase, the tallest riser height measurement exceeded the shortest height by more than the 3/8-inch maximum dictated by generally-accepted current standards. This condition is a potential trip/fall hazard. We recommend considering upgrading the stairs to prevent a trip or fall.

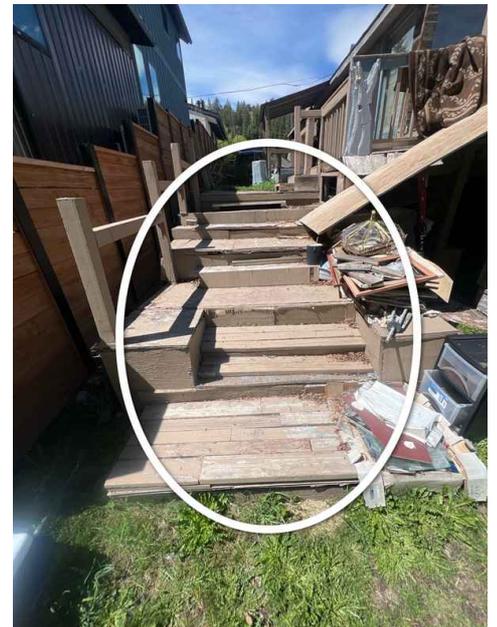
## 6.8.2 Deck steps

**DAMAGED OR DETERIORATED**

The steps were generally deteriorated and/or structurally damaged, making them potentially hazardous to a person who might use them.

We recommend further review for a better understanding of replacement costs/repairs and present condition.

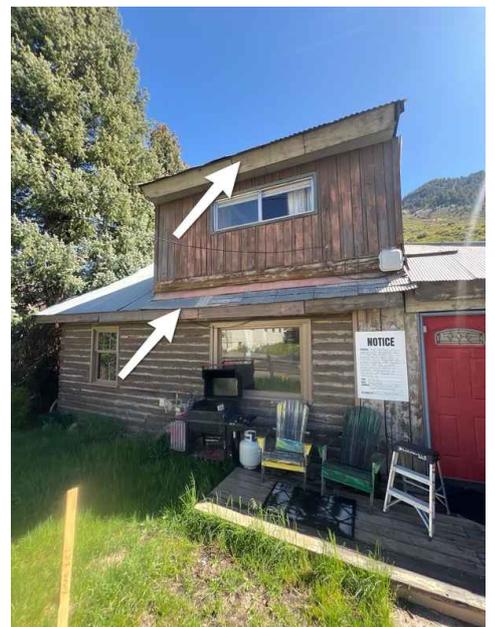
There are no gutters present on the structure or on certain areas of the structure. Gutters are recommended because they collect rainwater from the roof and direct it away from the building.

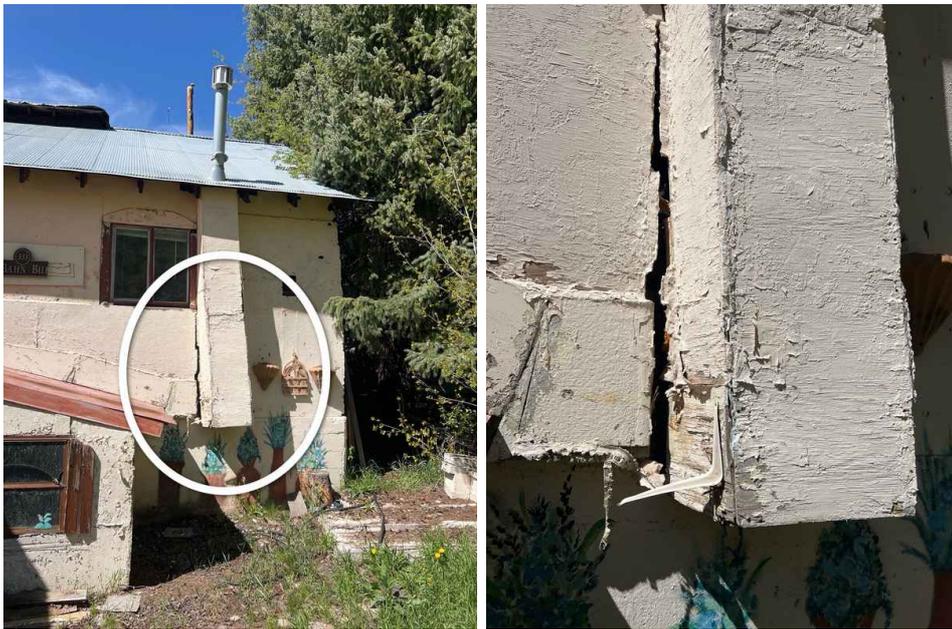
## 8.3.1 Finish conditions

**DETERIORATED/DAMAGED**

The exterior chimney has deteriorated and is badly damaged. Repair or replacement is required to keep functioning as designed as well as to prevent fire danger

Contact a qualified painting contractor.

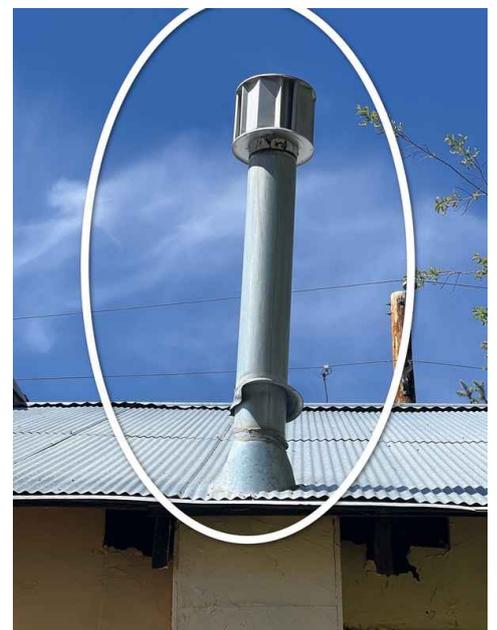
## 8.4.1 Flue/ vent pipe condition

**DAMAGED**

The flue pipe has visible damage, we suggest repairs as needed.

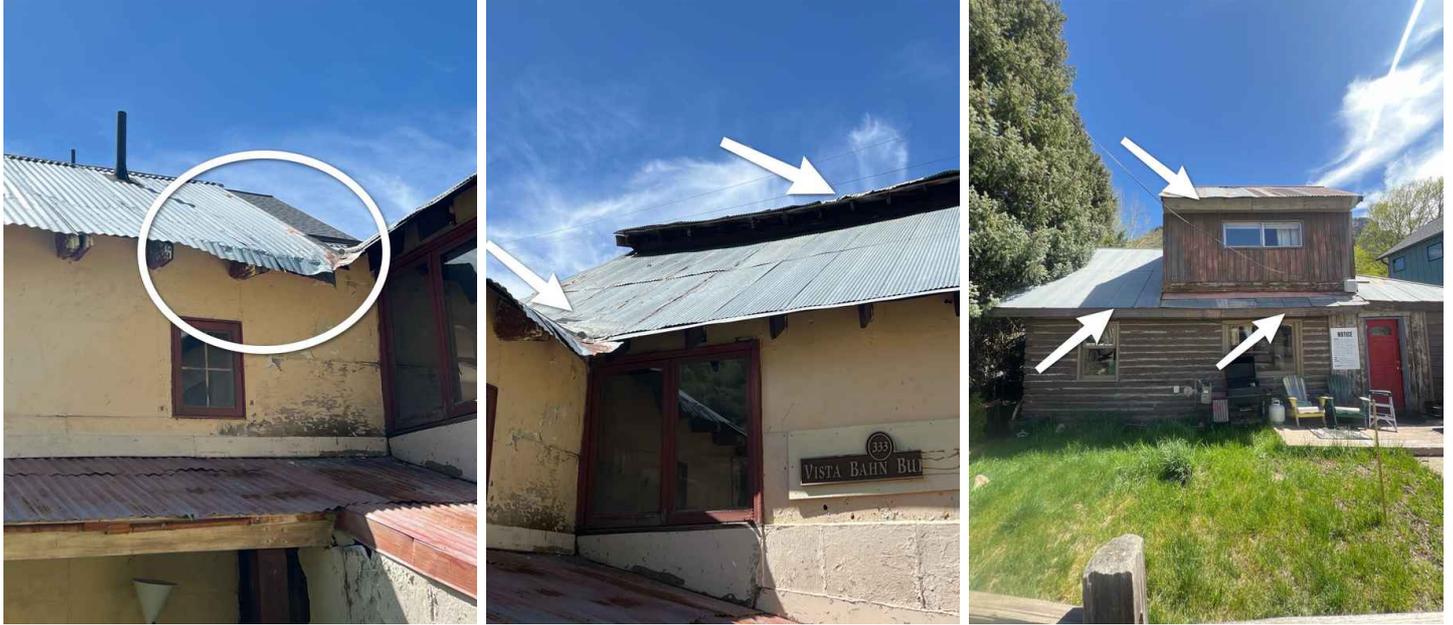
## 9.4.1 Metal roofing material condition

**DAMAGED ROOF PANELS**

The metal panels are damaged. This damage should be repaired to avoid the possibility of damage to the home structure or materials from roof leakage. All corrections should be made by a qualified contractor.

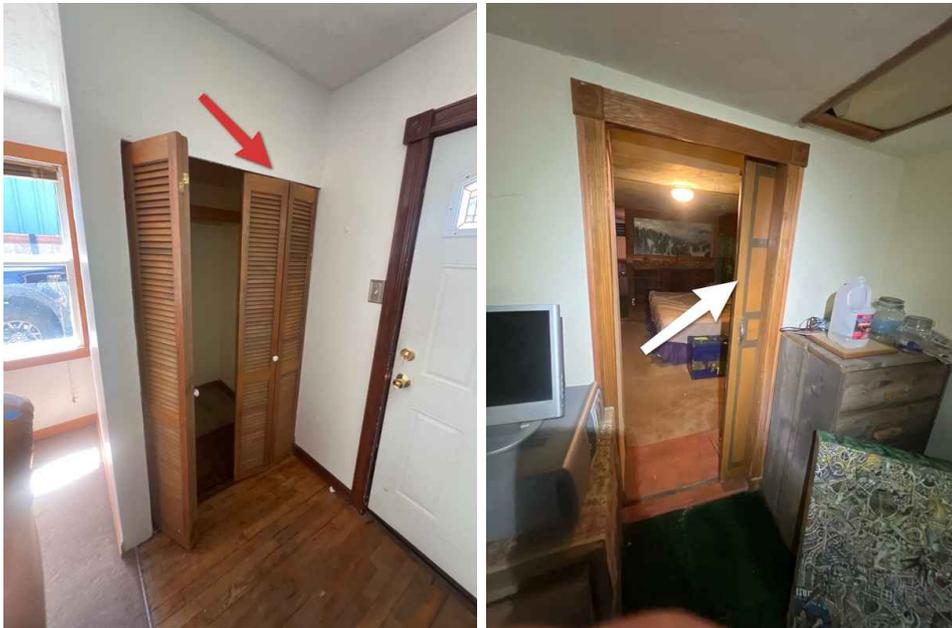
The door was off its track or had a restrictive movement. Hardware may be missing, damaged, or in need of adjustment at the track or door rollers. We recommend repair as required for the full operation of the door.

Contact a qualified handyman.

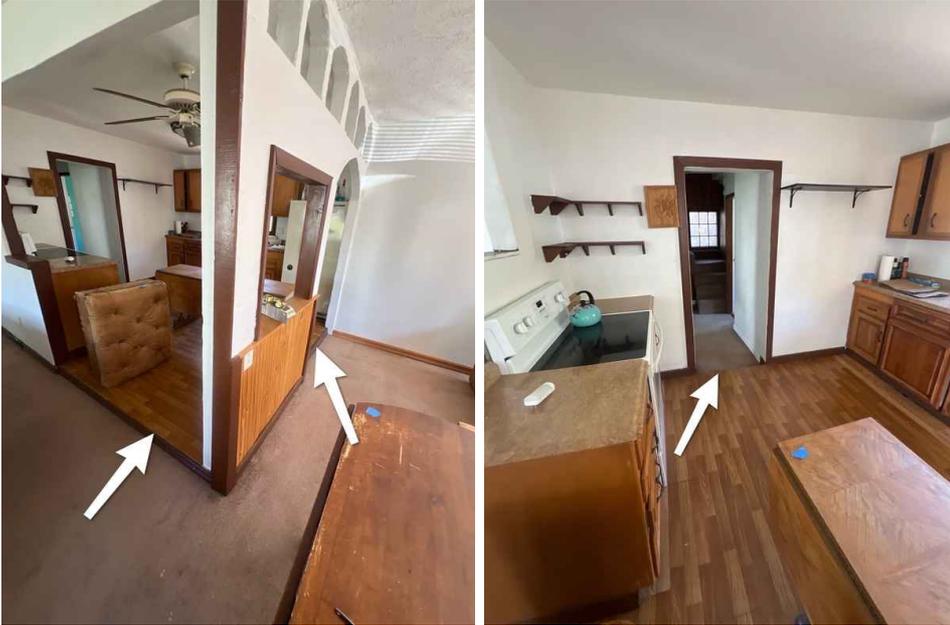
An elevation change of fewer than 4 inches was observed. This creates a trip hazard and should be corrected before personal injury results. We recommend that the lip be corrected as necessary.

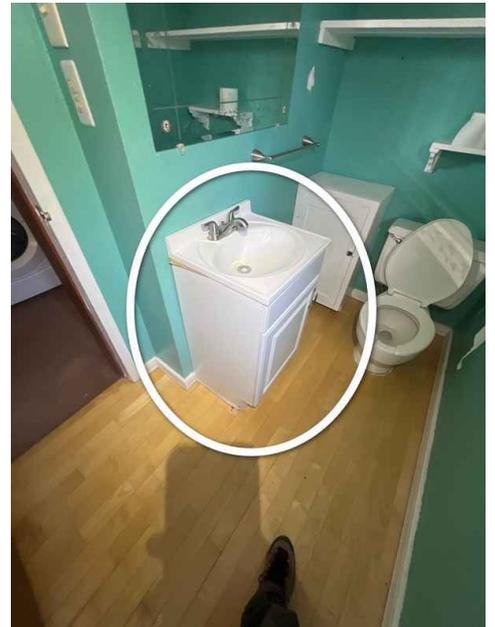
Vanity was improperly installed and not secured. Recommend qualified contractor secure vanity properly.

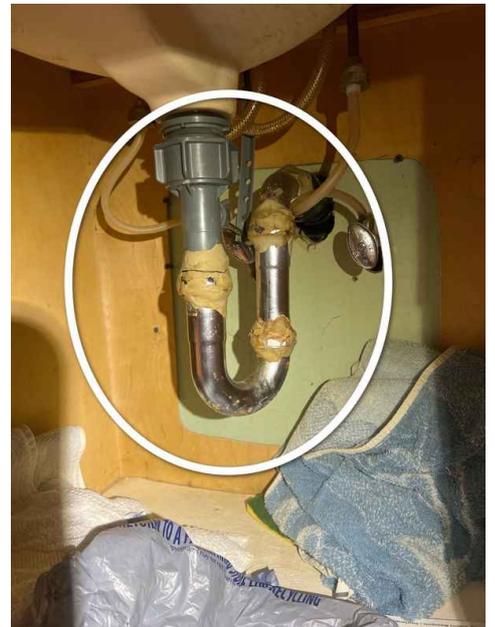
Evidence of past leakage was noted under the bath sink(s). We recommend that the sink(s) be reviewed and repaired as necessary.

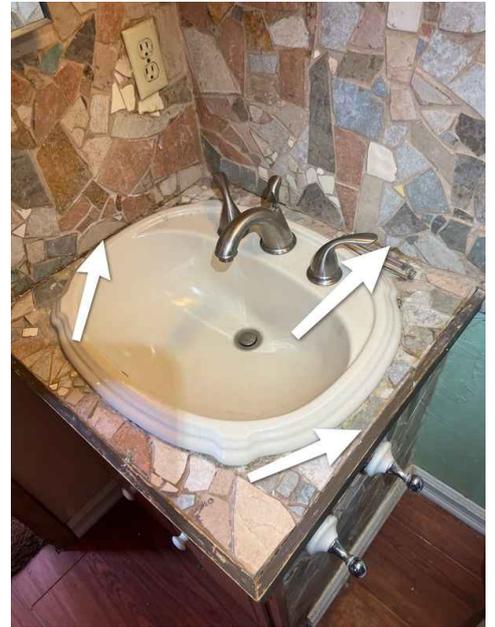
## 13.4.1 Counter tops

**CAULK BACK SPLASH**

The caulking or grout for the backsplash is in need of repair or replacement. We recommend that caulking be installed and/or gaps filled to prevent possible water intrusion at the wall areas.

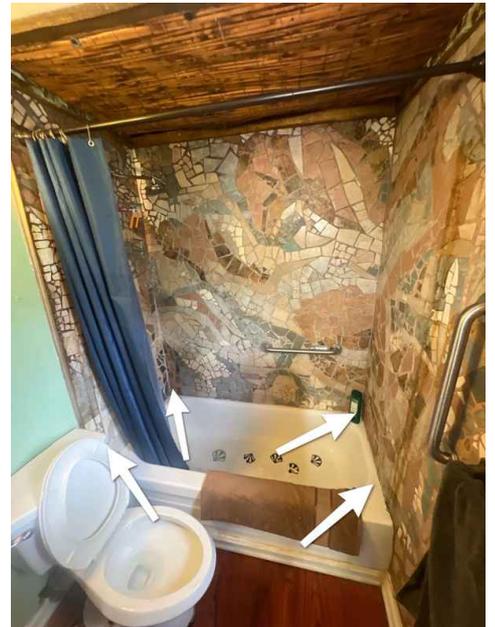
## 13.5.1 Tile

**JOINT CAULKING**

Joint caulking at the shower/tub wall area in the bathroom(s) was deteriorated in one or more places. We recommend that the deteriorated caulking be repaired to reduce water penetration and possible damage to the surrounding areas.

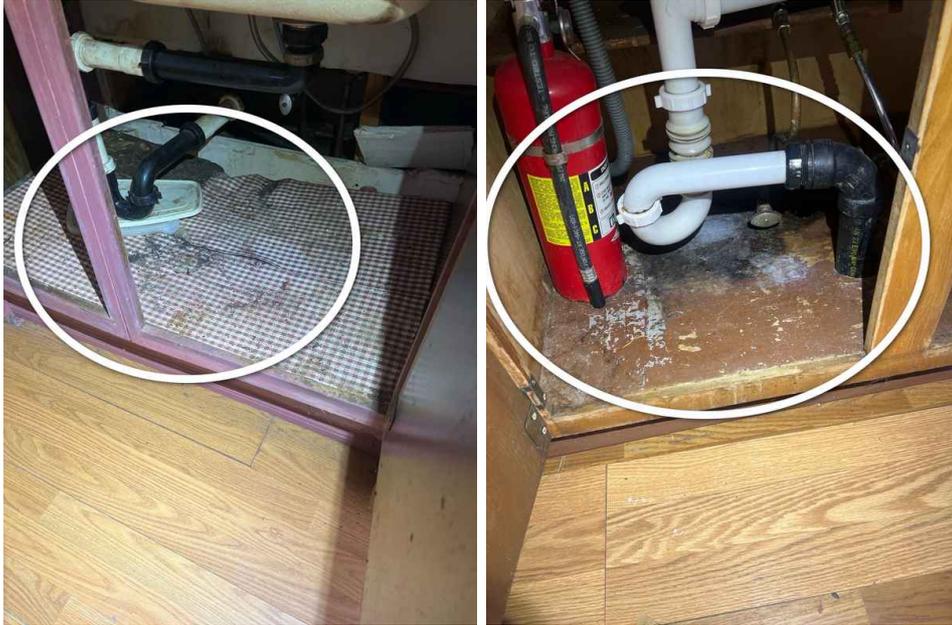
The inside base of the kitchen sink cabinet was water damaged from a leak. Environmental concerns may be present anywhere excessive moisture is present.

Recommendation  
Contact a qualified professional.

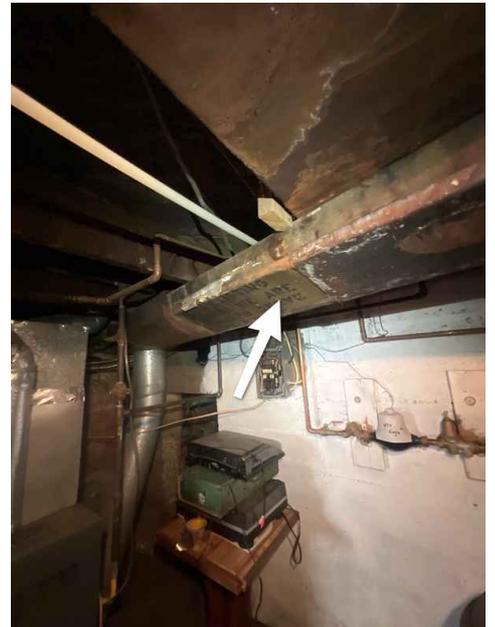
**DUCTS NOT SEALED**

Air supply ducts were not properly sealed. Recommend a qualified HVAC contractor to seal supply and return ducts for maximum efficiency.

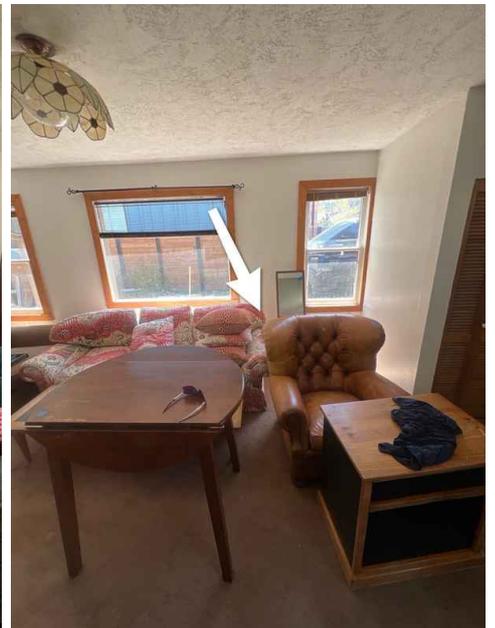
Current standards dictate electrical outlets every 6 feet. Areas of the home do not meet this standard. We recommend a licensed electrician add additional receptacles as deemed necessary.

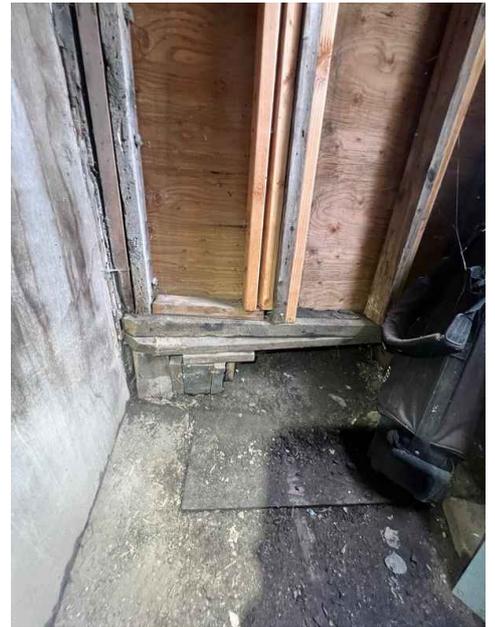
24.4.3 Foundation walls

**OLD BUILDING PRACTICES**

Portions of the home did not appear to have a foundation, the photo below shows a wall sitting on wood and rock. We suggest a further review.

Recommendation  
Contact a qualified professional.

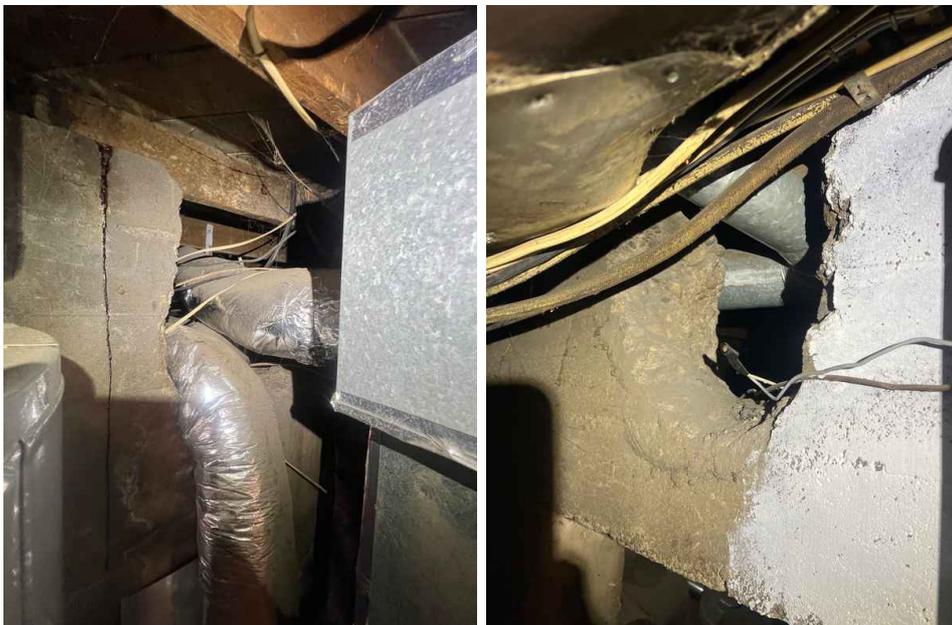
## 25.4.1 Foundation walls

**ALTERED OR CUT FOUNDATION WALLS**[Further Review](#)

The foundation walls were noted to have been cut to accommodate HVAC ducts. We suggest a further review of this condition by a qualified professional.

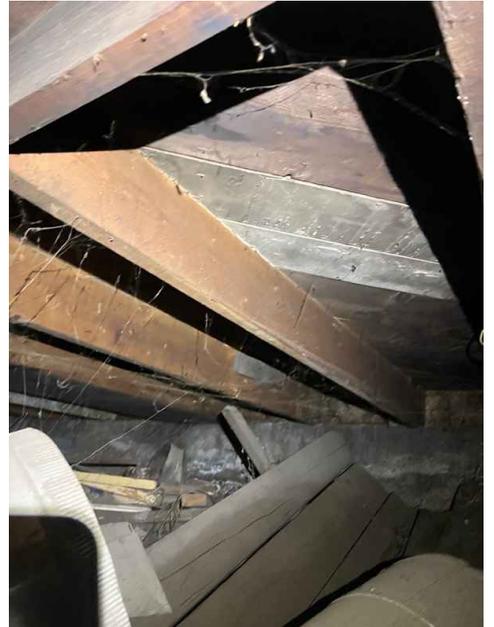
25.9.1 Insulation  
**NO INSULATION**

Insulation was not present at the floor areas of the crawlspace. This condition may lead to moisture buildup and/or energy efficiency losses. We recommend that the floor structure be evaluated for insulation requirements with repair as necessary.

Recommendation  
Contact a qualified insulation contractor.
