**CITY OF MINNETRISTA**

**Subject:** SWAMP Update

## Memorandum

Re: 2025 Pond Maintenance Project  
City of Minnetrista, MN  
WSB Project No. 028841-000

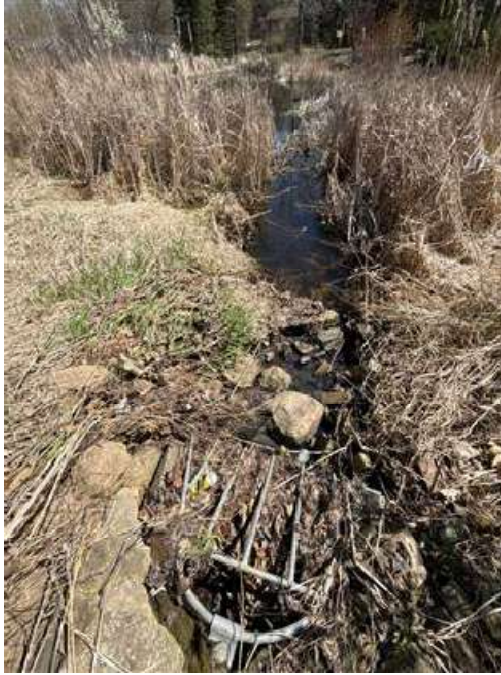
Figure 1: 18" RCP Inlet (SW)

The 24" southwest inlet, shown in **Figure 1**, is clogged with leafy debris. The outlet pipe, shown in **Figure 2**, is impeded by vegetative debris.

WSB recommends Option 4 as shown in **Table 2**, dredging the pond to an average depth of 4.7 feet to remove the accumulated sediment and improve TP and TSS removal efficiencies. As a part of the dredging project, we recommend clearing the vegetation and debris from the inlet and outlet.

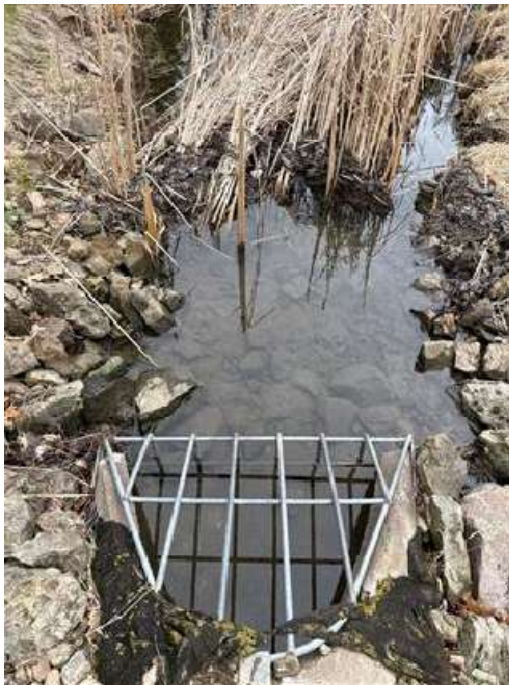
**Figure 3: 18" RCP Inlet (N)**

The 18" northern inlet shown in **Figure 3** appears to be in good condition. The 15" RCP outlet, **Figure 4**, is approximately 10% filled with sediment and a small sinkhole has formed over the pipe.

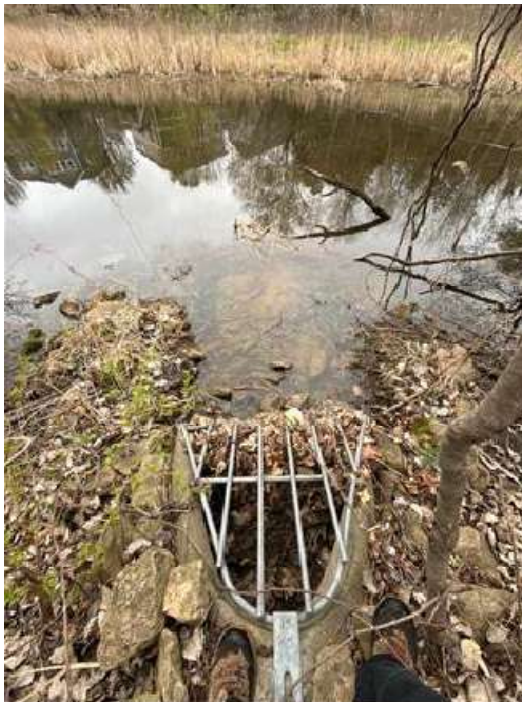
**Figure 5: 15" RCP Inlet (SW)**

Both the 15" and 24" inlets, shown in **Figures 5 and 7** respectively, are partially filled with debris. The 21" RCP outlet is fully submerged and shown in **Figure 6**. Based on the as built and the noted NWL, this is a skimmer (back sloped) outlet pipe.

We recommend Option 5 as shown in **Table 6**, dredging the pond to an average depth of 5.4 feet to remove the accumulated sediment and improve TP and TSS removal efficiencies. As part of the dredging project, we recommend removal of debris in the inlet pipes to allow for better drainage.

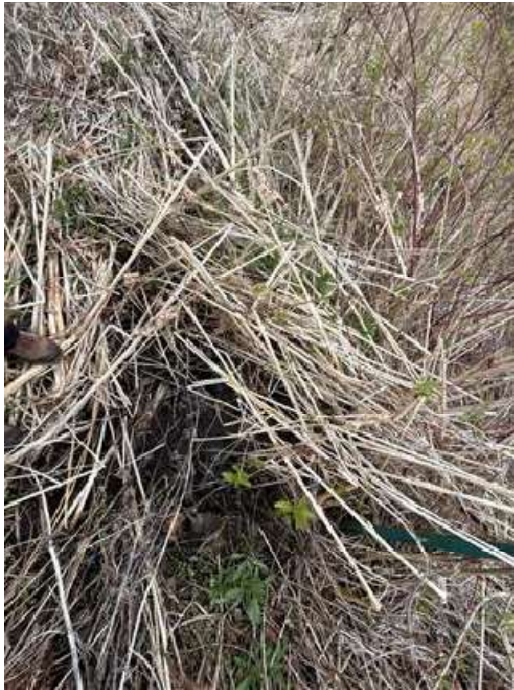
**Figure 8: 15" RCP Inlet (NE)**

The 15" inlet shown in **Figure 8** is nearly full of sediment. The 24" RCP inlet is approximately 60% filled with sediment and debris as shown in **Figure 9**. Some damage to the weir in the outlet control structure as shown in **Figure 10**, was noted during the inspection.

With the existing pond footprint, the maximum achievable average depth is approximately 3.5 feet. We recommend Option 3 as shown in **Table 8**, dredging the pond to an average depth of 3.5 feet to remove the accumulated sediment and improve TP and TSS removal efficiencies. Additionally, we recommend updating the SWAMP managed depth to 3.5 feet. As part of the dredging project, we recommend removal of debris in the inlet pipes to allow for better drainage.

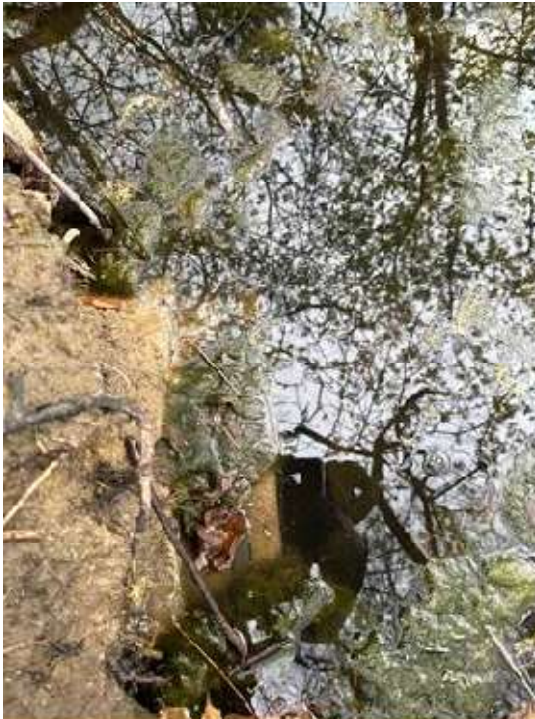
**Figure 11: 12" RCP Inlet (N)**

The 12" inlet shown in **Figure 11** is damaged, and the pipe is separated from the flared end section. The 15" RCP appears to be in good condition, as shown in **Figure 12**. The 12" outlet was underwater at the time of the survey, as shown in **Figure 13**.

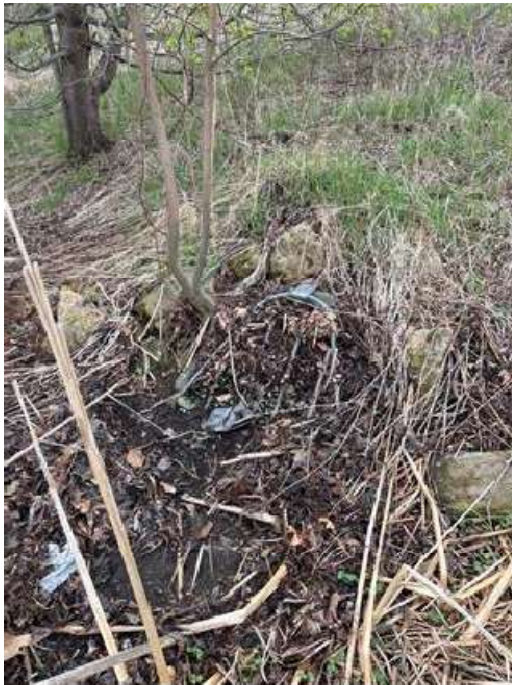
**Figure 14: 15" RCP Inlet (S)**

The 15" inlet, shown in **Figure 14**, is plugged with debris. The 12" RCP outlet appears to be in good condition, though is impeded by some vegetation, as shown in **Figure 15**.

This pond is functioning reasonably well, so we do not recommend a dredging project at this time. The pond's function should be re-evaluated in approximately 5 years to determine its function at that time. As possible, we recommend removal of debris and vegetation in and around the inlet and outlet pipes to allow for better drainage.
