Remove rear wing
of house; salvage
materials as
practical

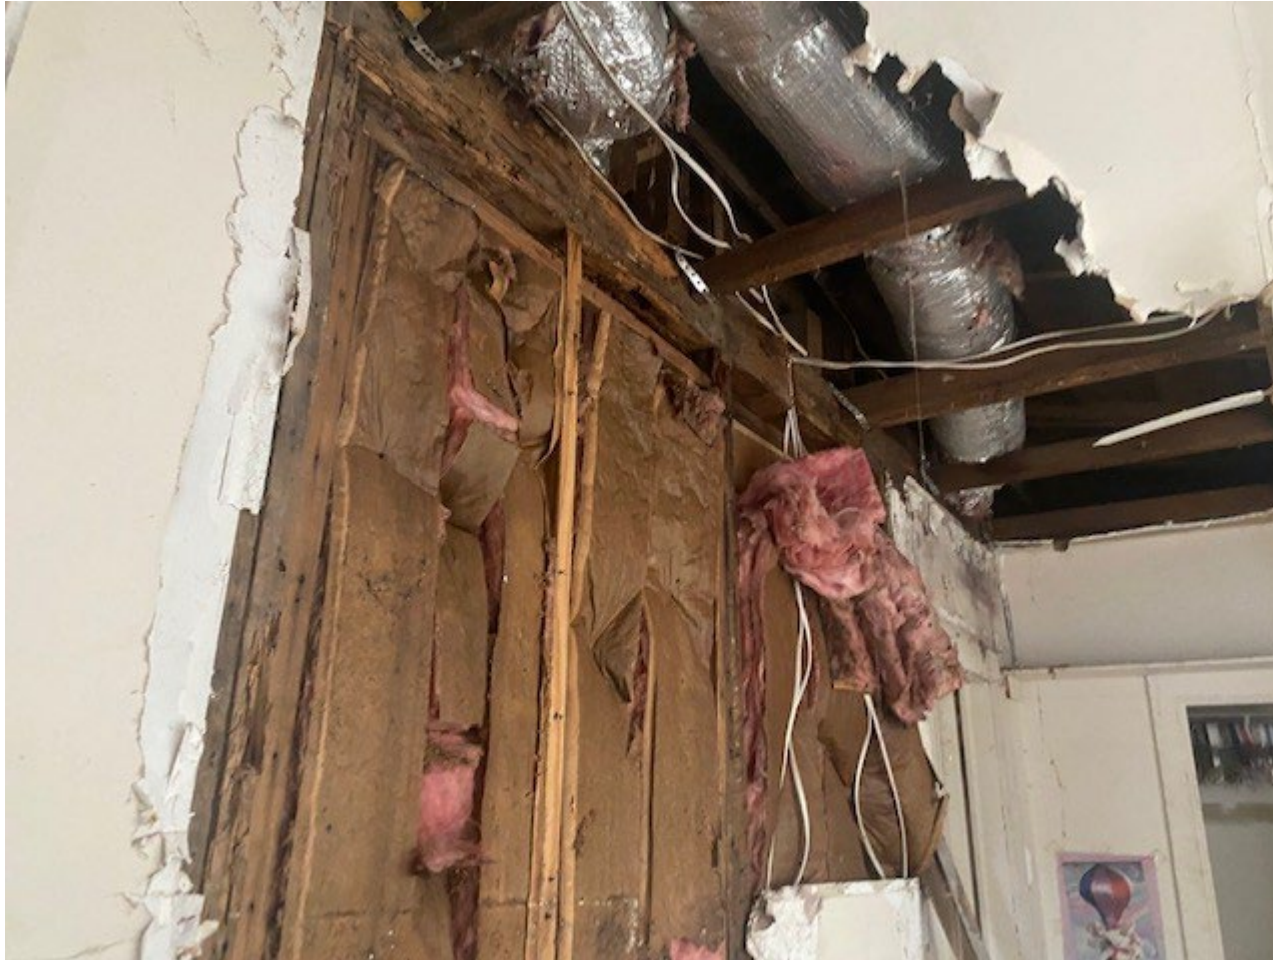
1st Addition to the original structure. This picture shows the condition of the framing.

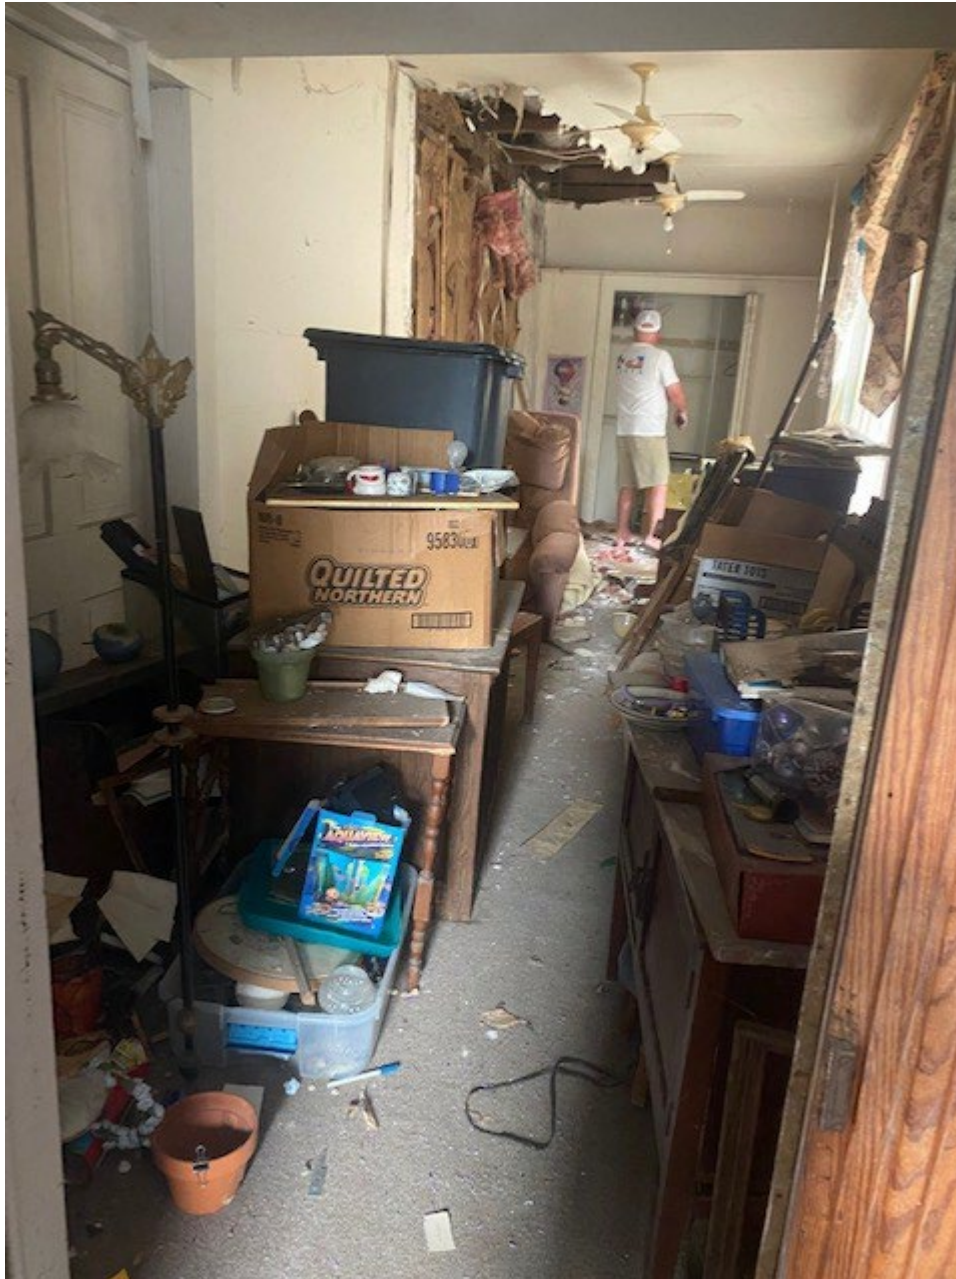
This is another example of the 1st failed addition to the home. Along with extensive frame damage, there are multiple areas where the subfloor is rotting.

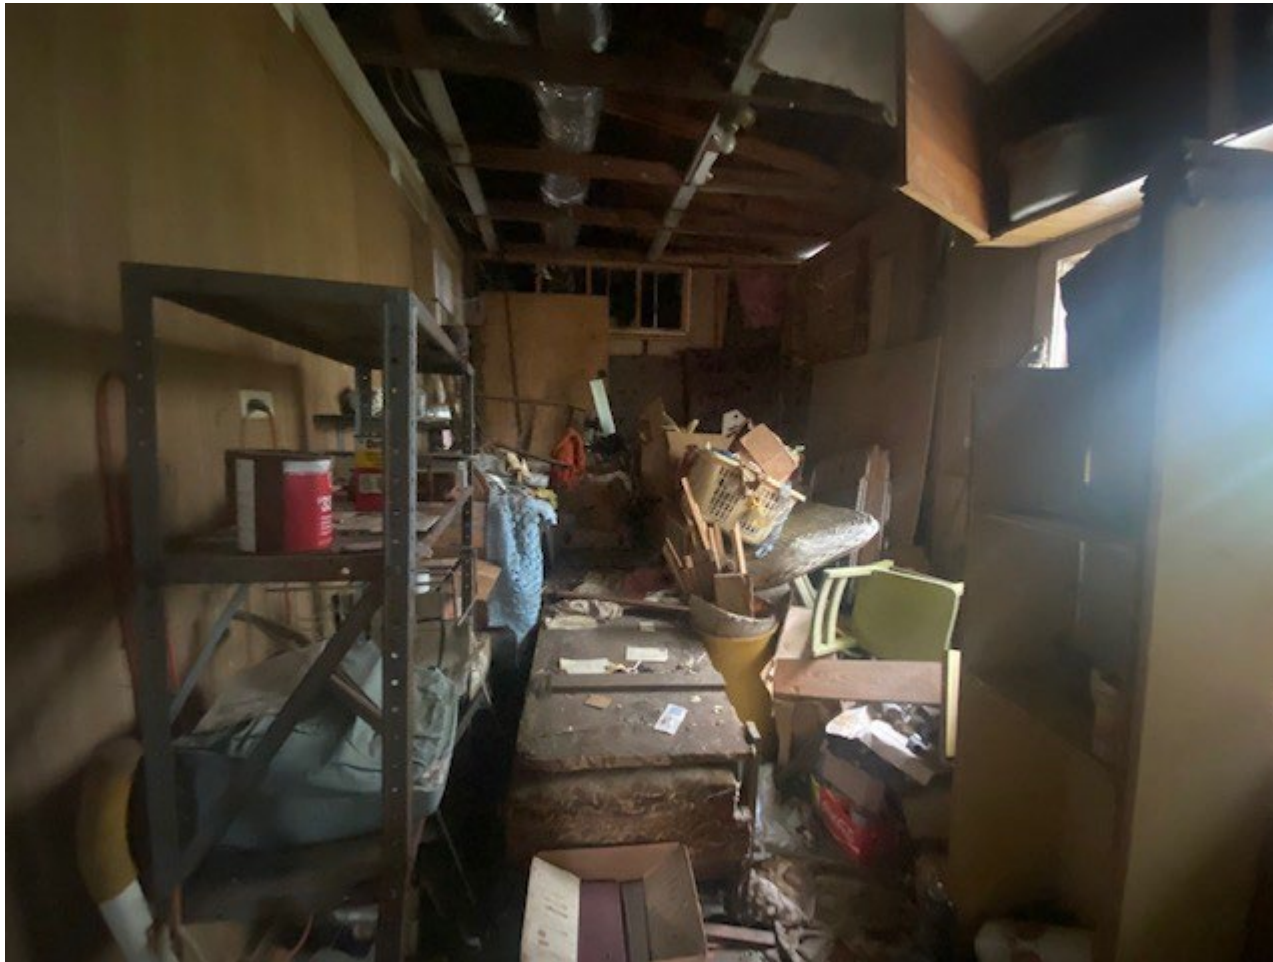
The 2nd addition to the original home. The ceiling has fallen due to water intrusion, massive frame and subfloor damage.

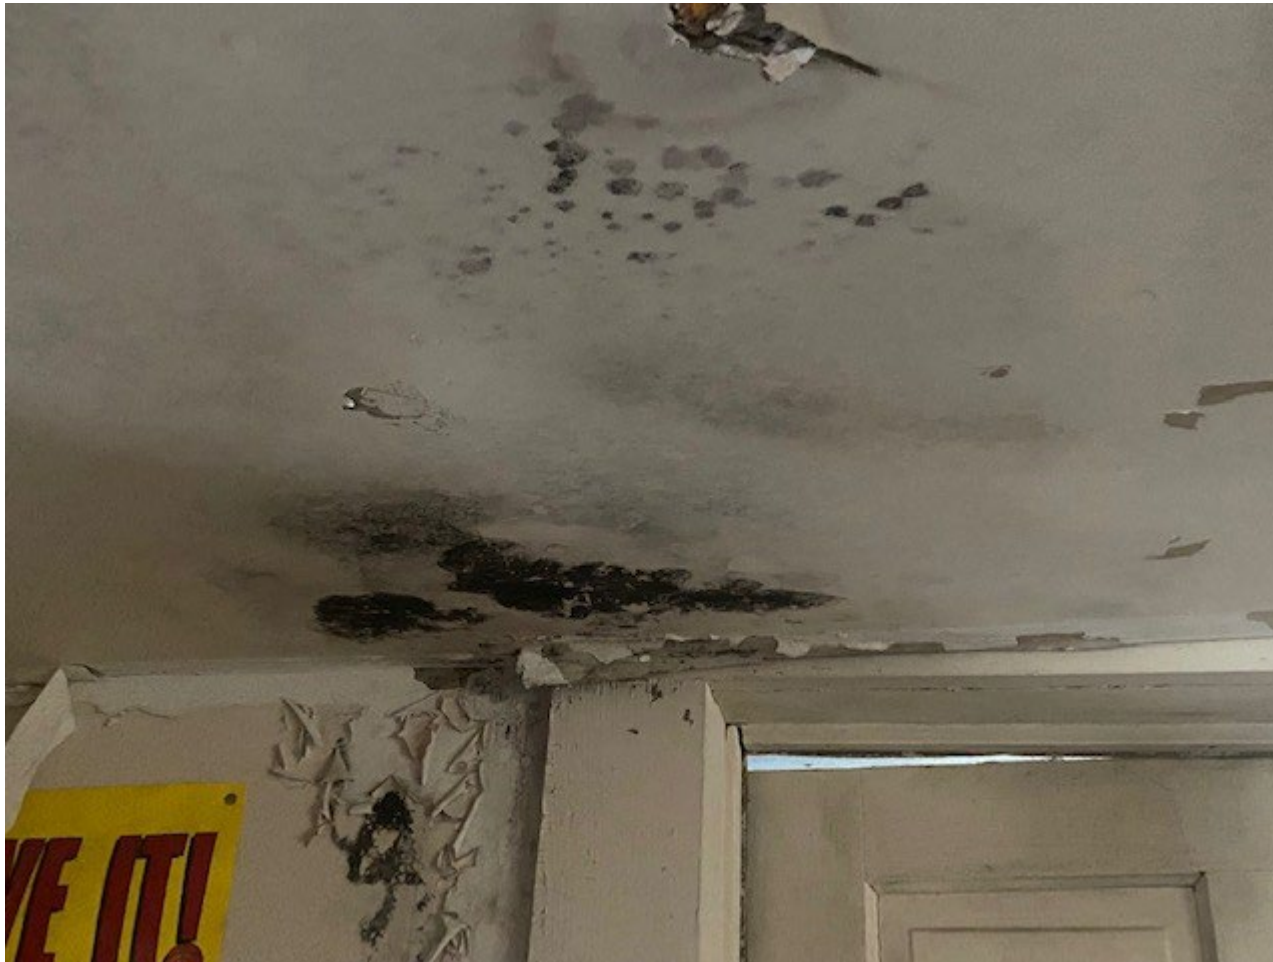
This is also located in the 2nd addition.
